NIST Special Publication 778

Performance of Structures During the Loma Prieta Earthquake of October 17, 1989

H. S. Lew, Editor

January 1990

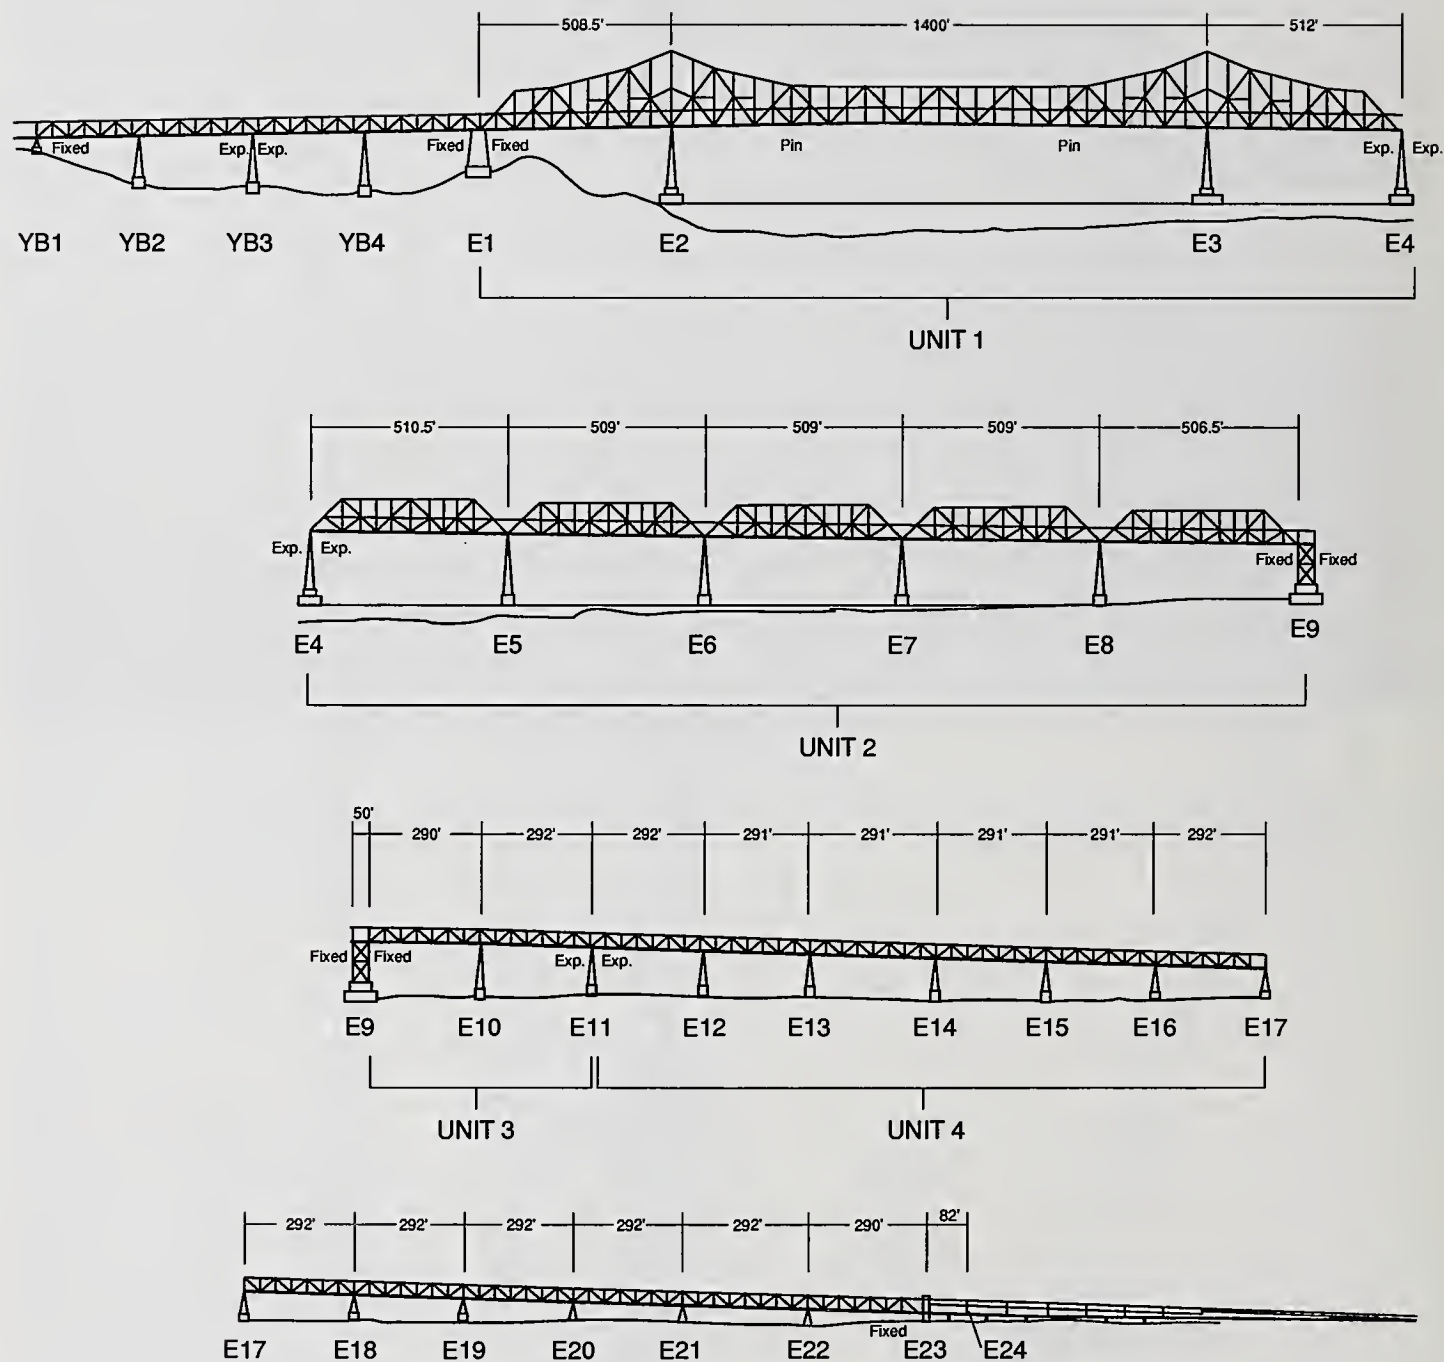
Figure 5.7.3 Detail of the east bay truss spans. Unit 3 was determined to have moved eastward as much as 10 inches, causing the collapse of the two deck segments at Pier E-9. Additional damage, generally involving the failure of retainer bolts, occurred between Piers E-17 and E-24.

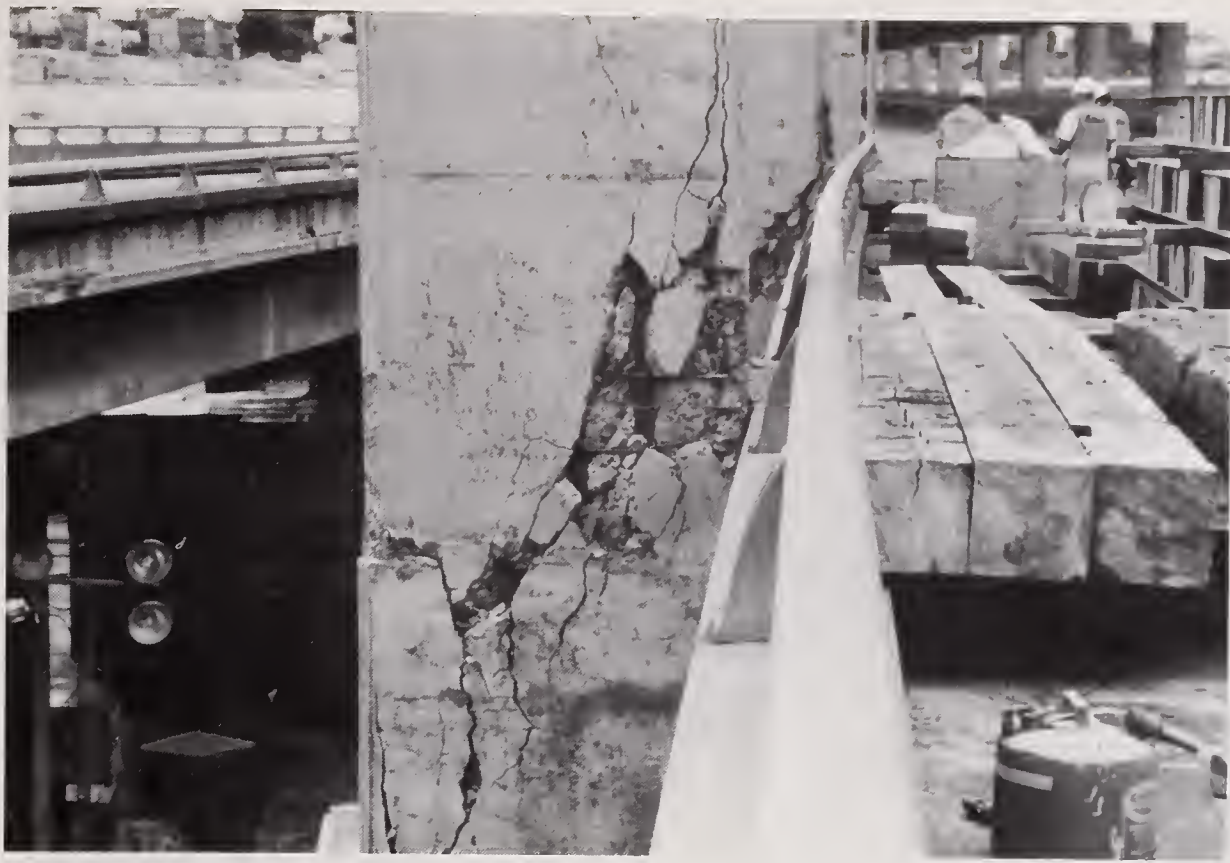
Figure 5.9.7 Diagonal cracking of the east-side column of Bent 52 (north face).

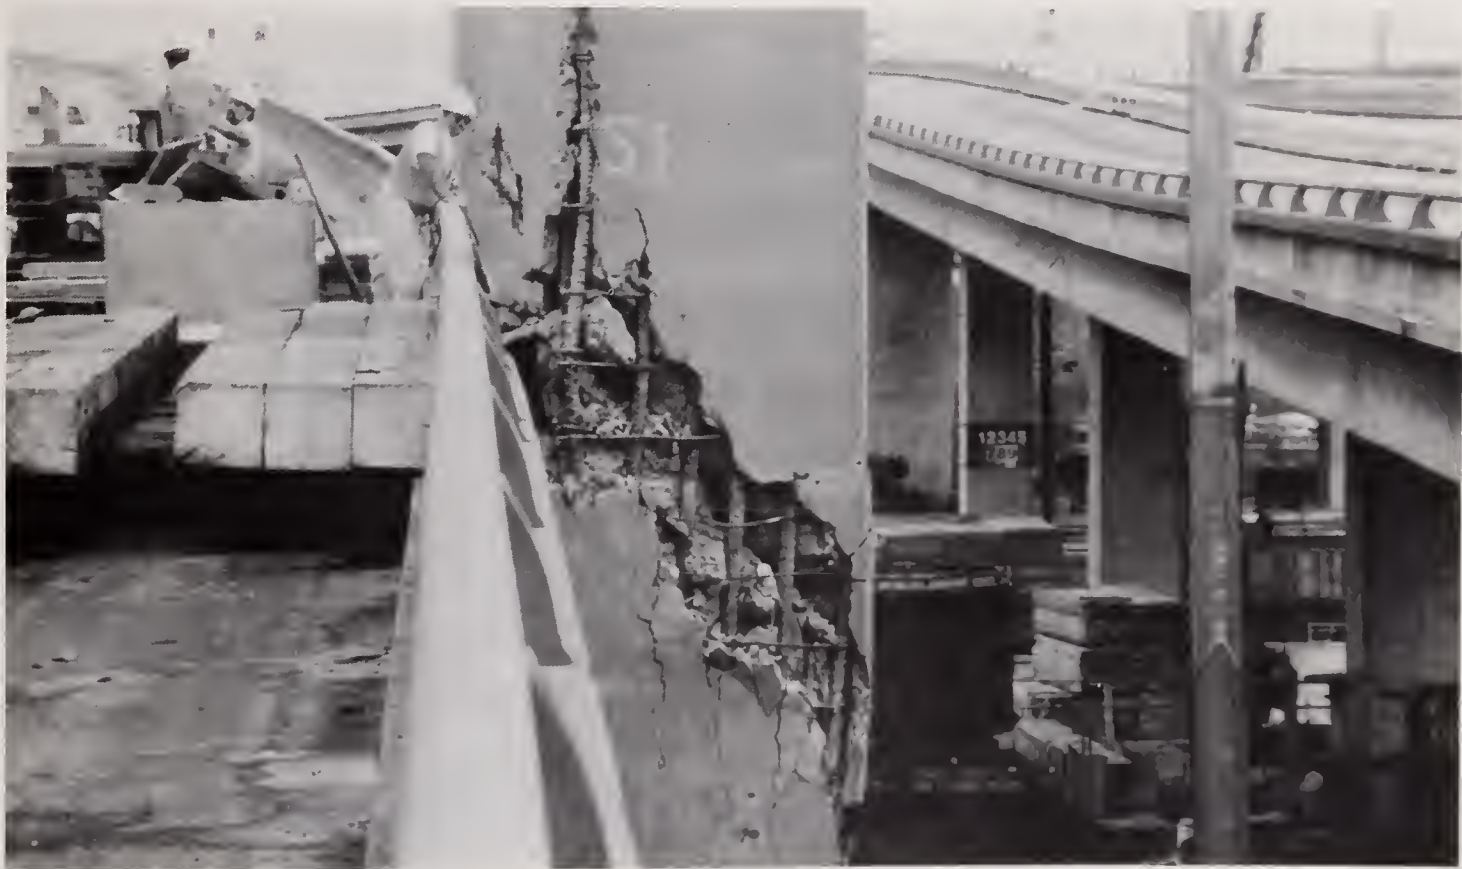
Figure 5.9.8 Diagonal cracking of the east-side column of Bent 51 (south face).

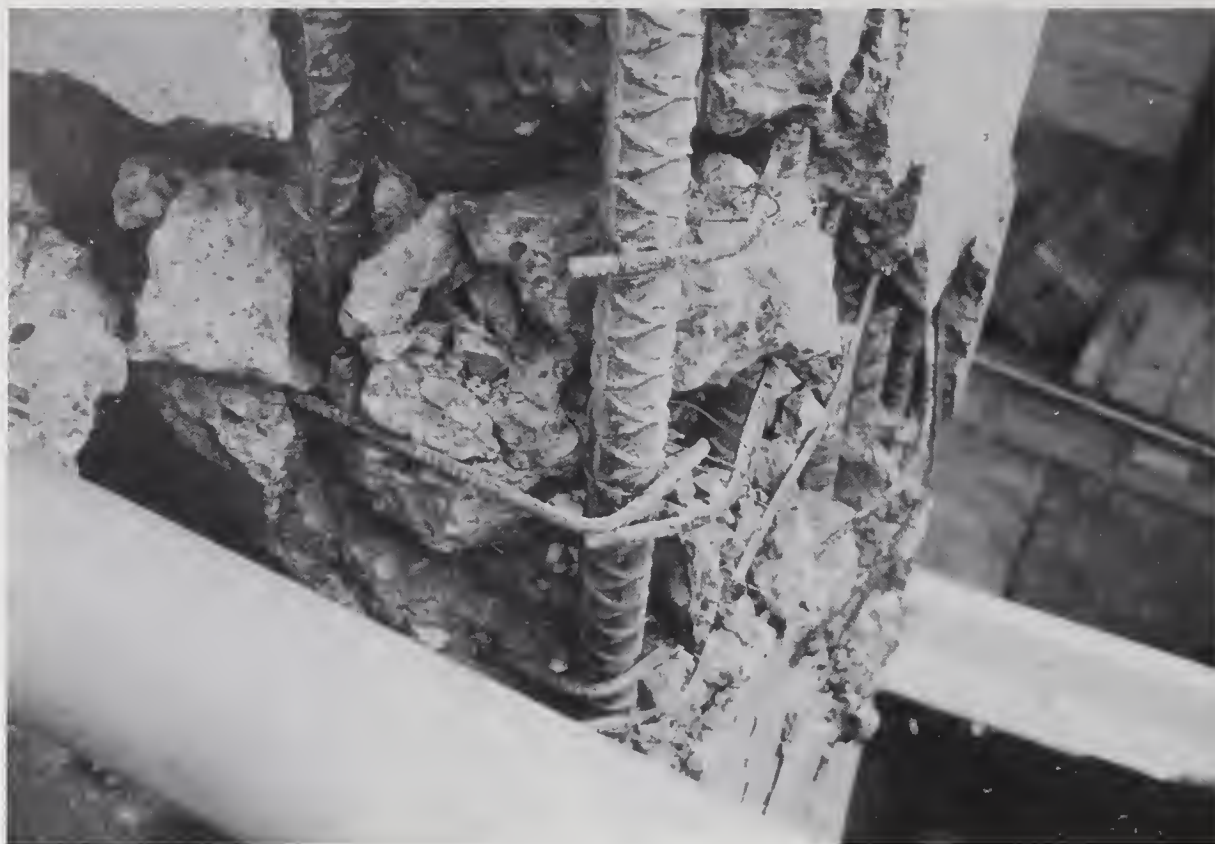
Figure 5.9.9 Close-up view of the failure zone of Bent 51, showing anchorage failure of ties.

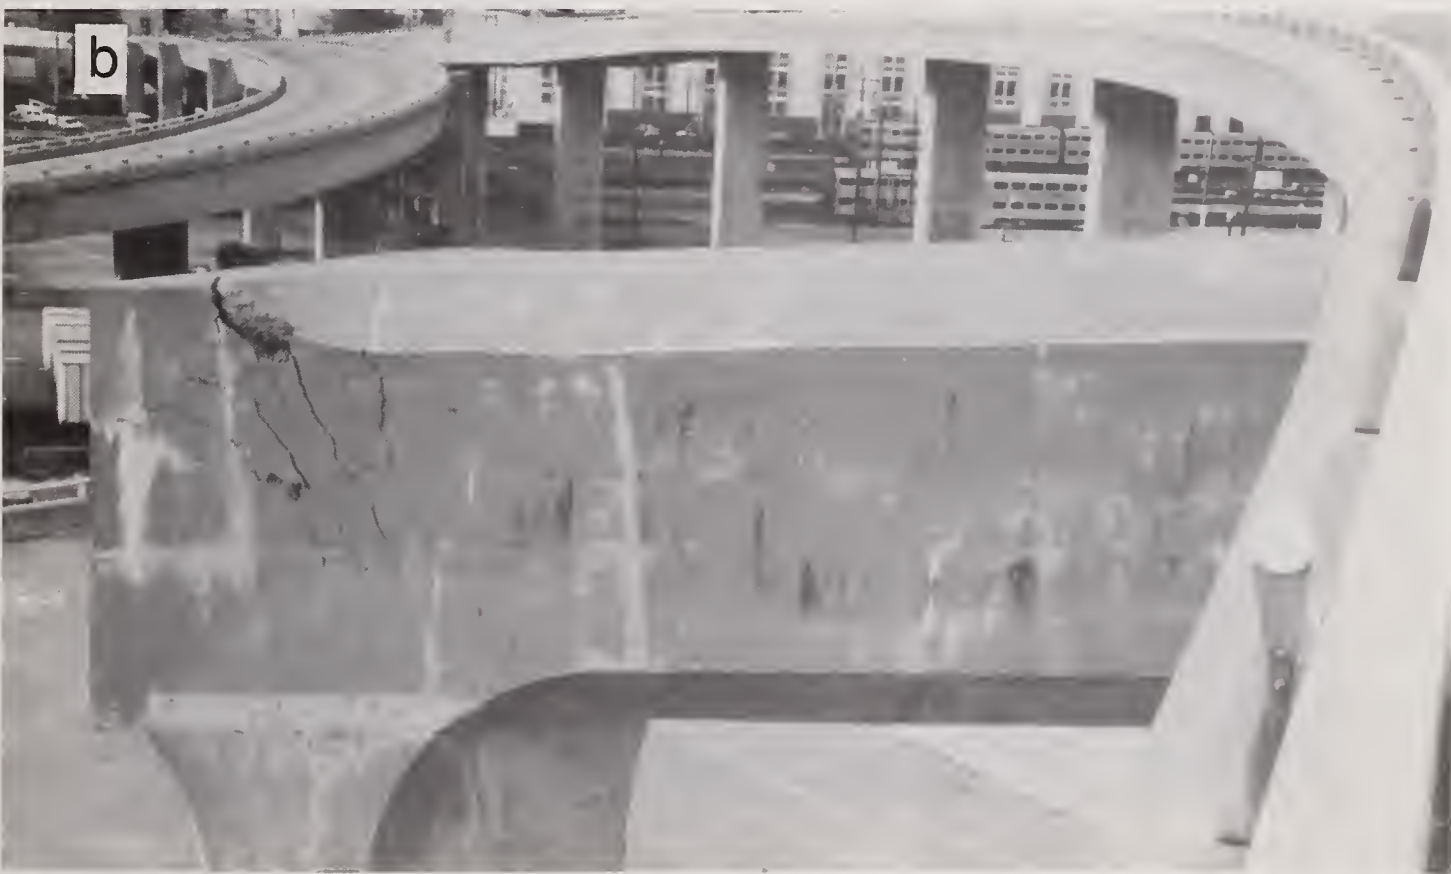
Figure 5.9.14 Damage to girder supporting exit ramp: (a) eastern portion and (b) western portion.

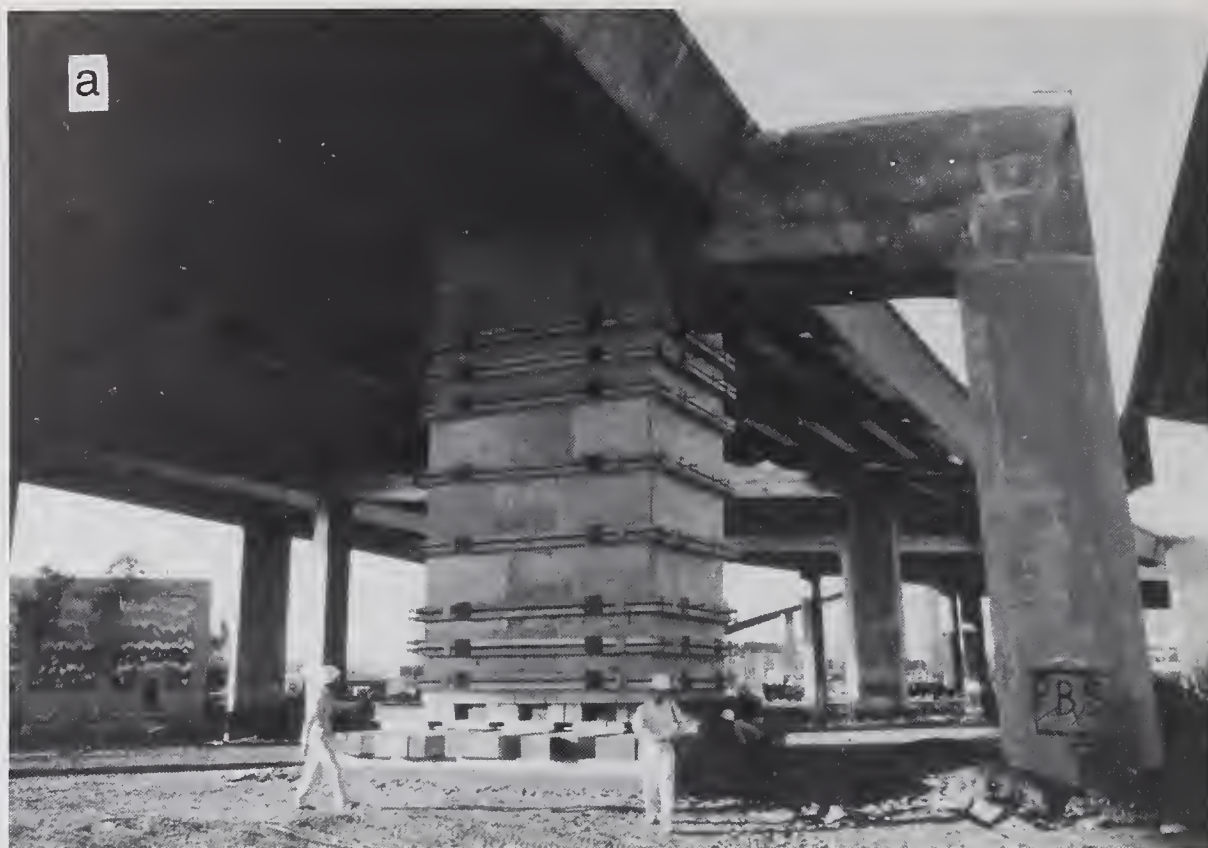
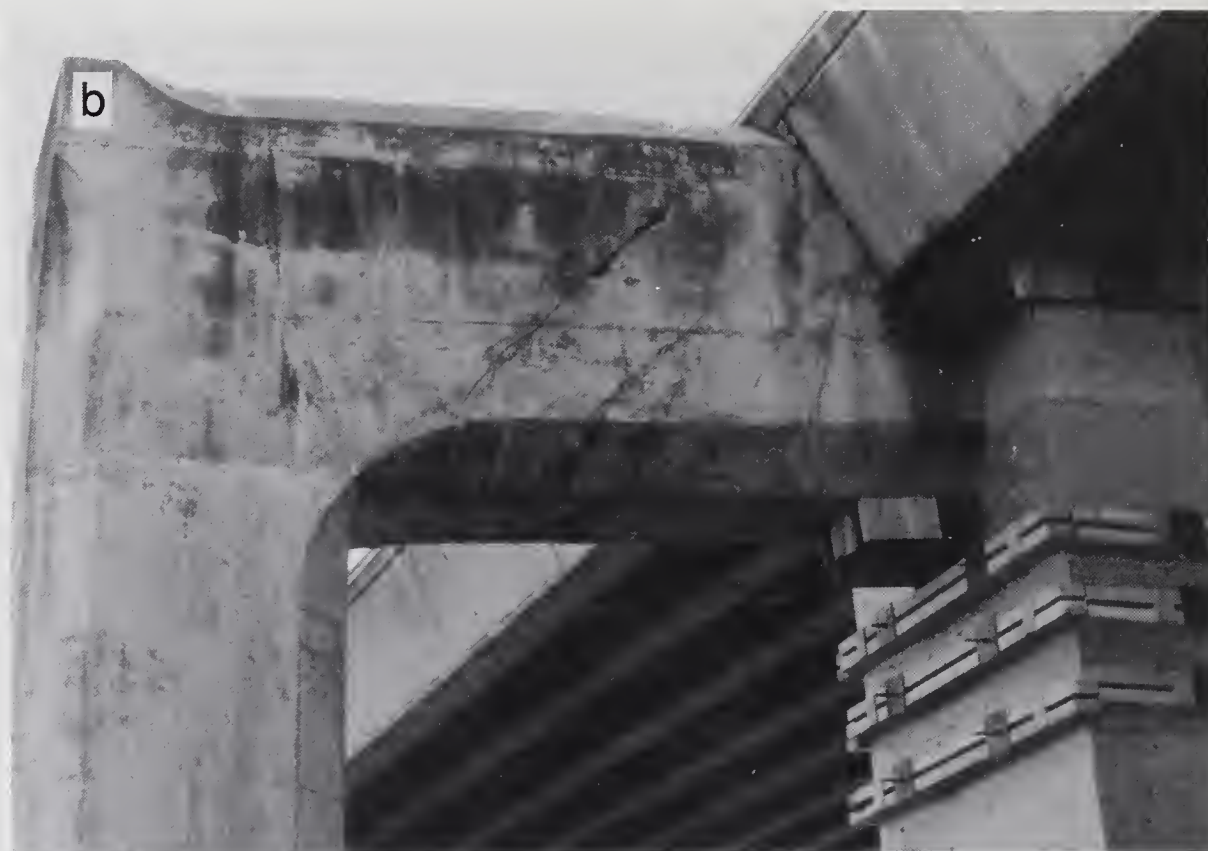
Figure 5.9.15 (a) Bent 32 supporting I-280 at Sixth St. exit ramp and (b) close-up of girder showing diagonal cracking.

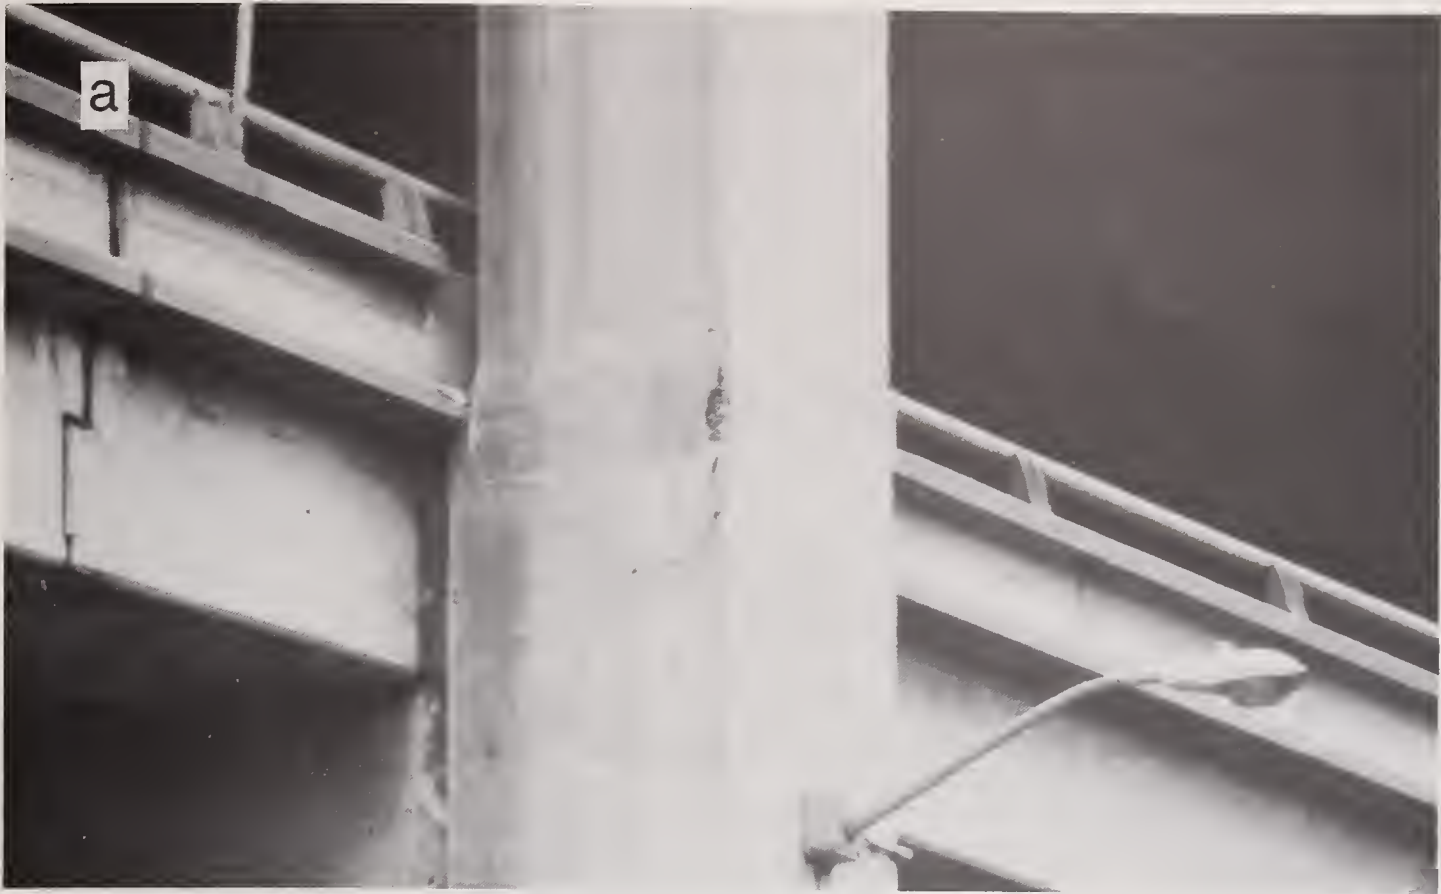
Figure 5.10.5 (a) Close-up view of west side of Bent 78 showing diagonal cracking in joint and vertical cracking at girder-column boundary; (b) close-up view of east side of Bent 79 showing diagonal cracking in joint.

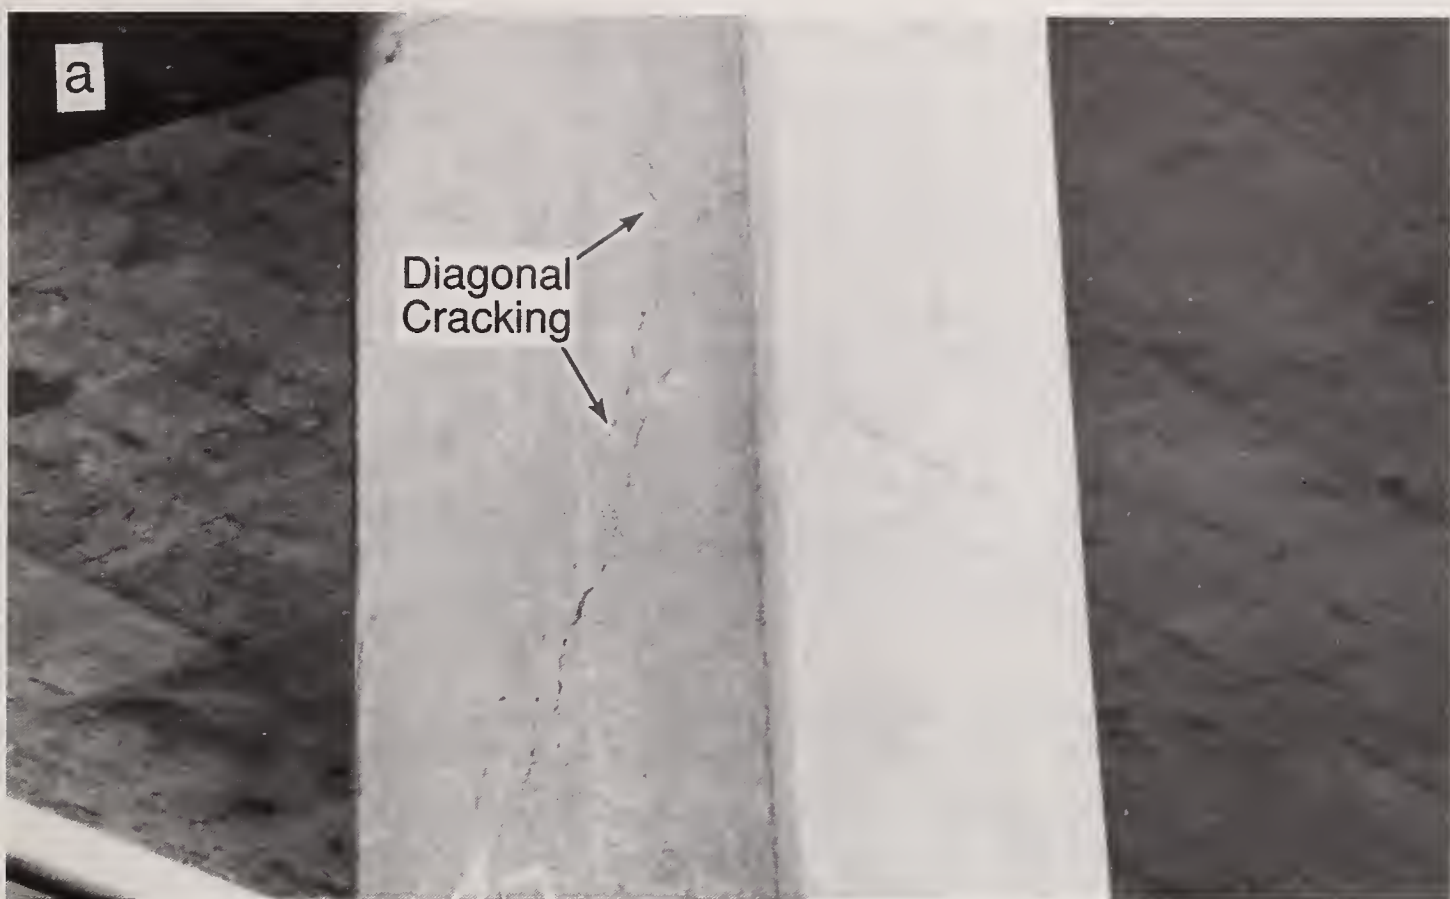
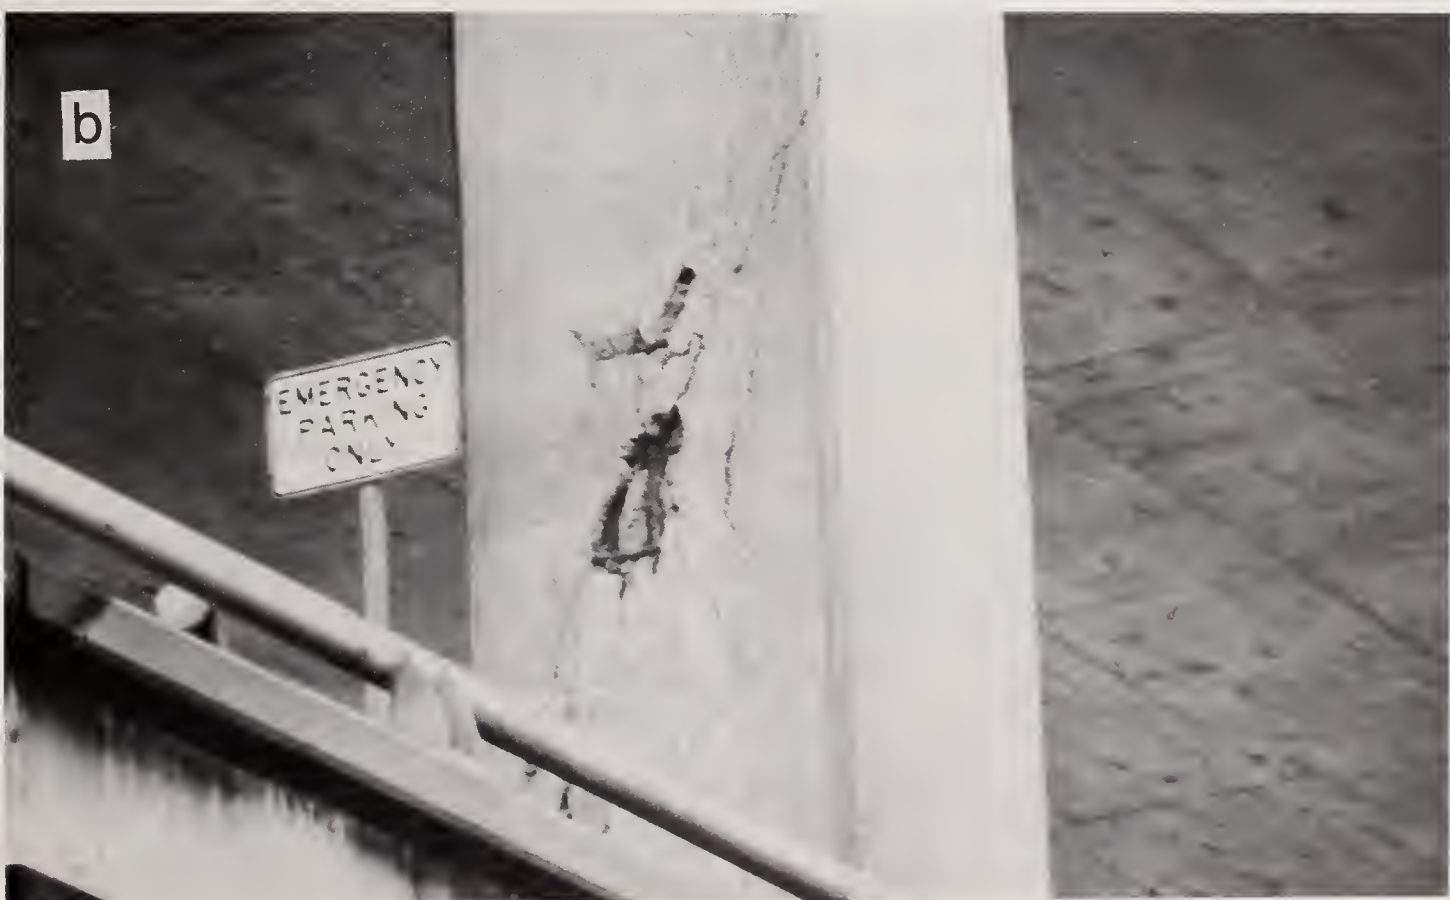
Figure 5.11.3 Close-up views of east side columns of (a) Bent 42 and (b) Bent 43.
