NIST Special Publication 862

1994 Northridge Earthquake

Performance of Structures, Lifelines, and Fire Protection Systems

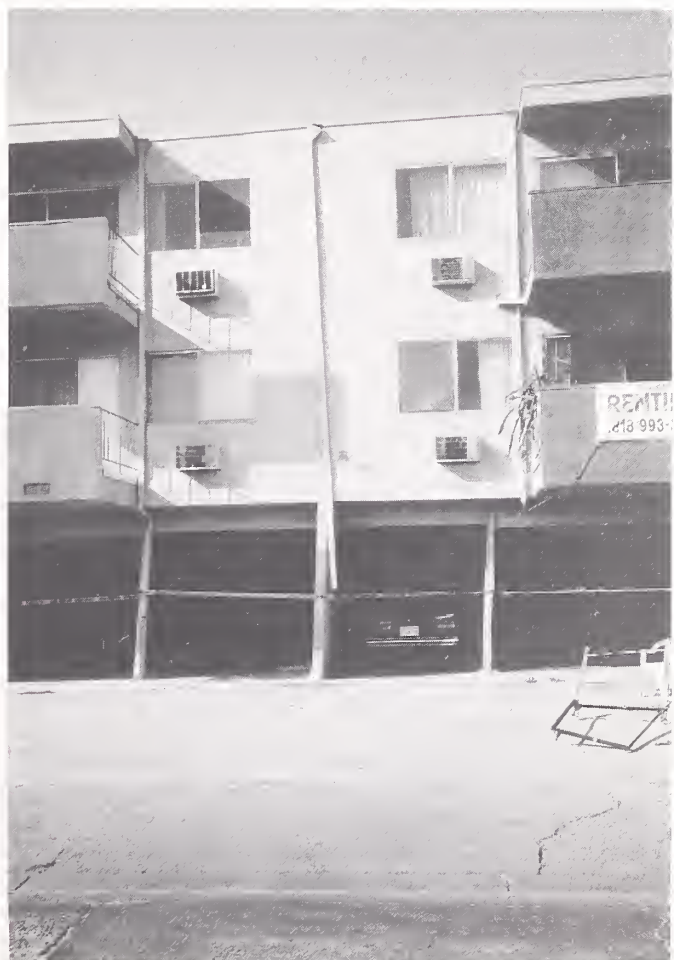
Figure 3.7. Racking, or leaning, of open first story parking areas was a common feature of damaged two and three-story apartment buildings.

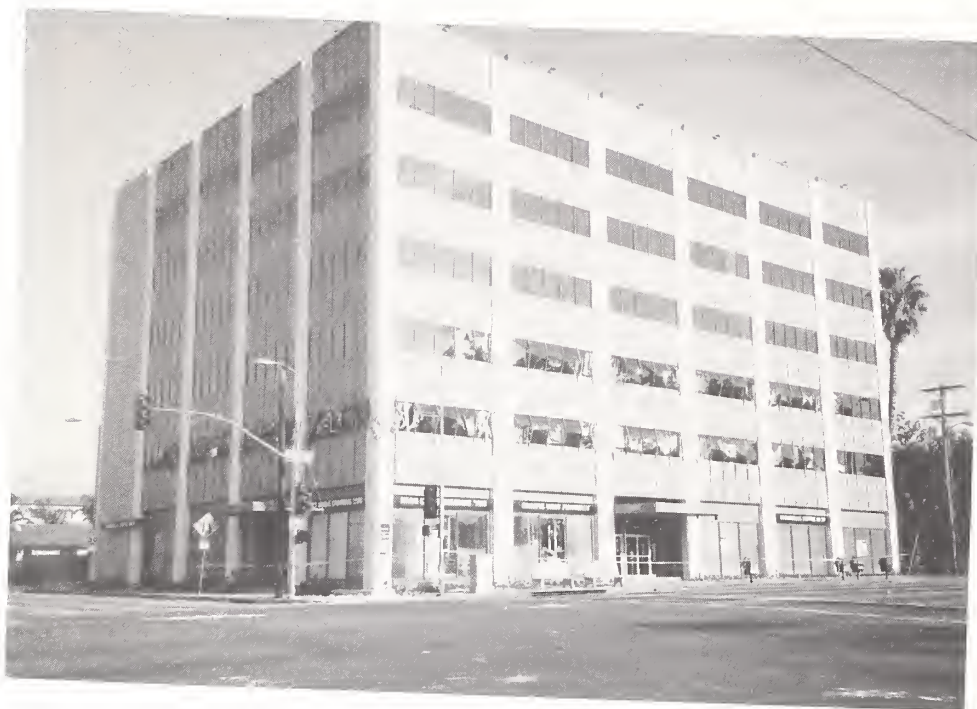
Figure 3.45. The six-story L-shaped concrete-frame Barrington Building on Olympic Boulevard in West Los Angeles lost its vertical-load carrying capacity at the second story.

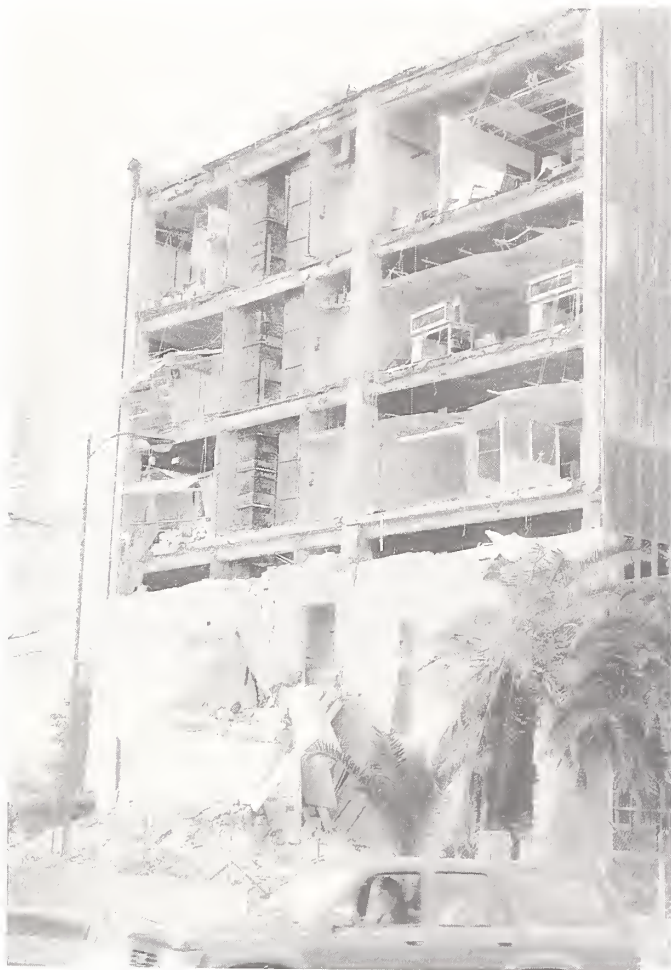
Figure 3.49. The east end wall and stair tower of a five-story apparently steel-framed office building on Sherman Way in Reseda collapsed. The enclosing masonry wall became detached from the structure and slid to the ground, with the upper stories remaining intact. The doorway opening in the wall, shown here resting at about the second story level, originally provided access from the top story to the stair tower.

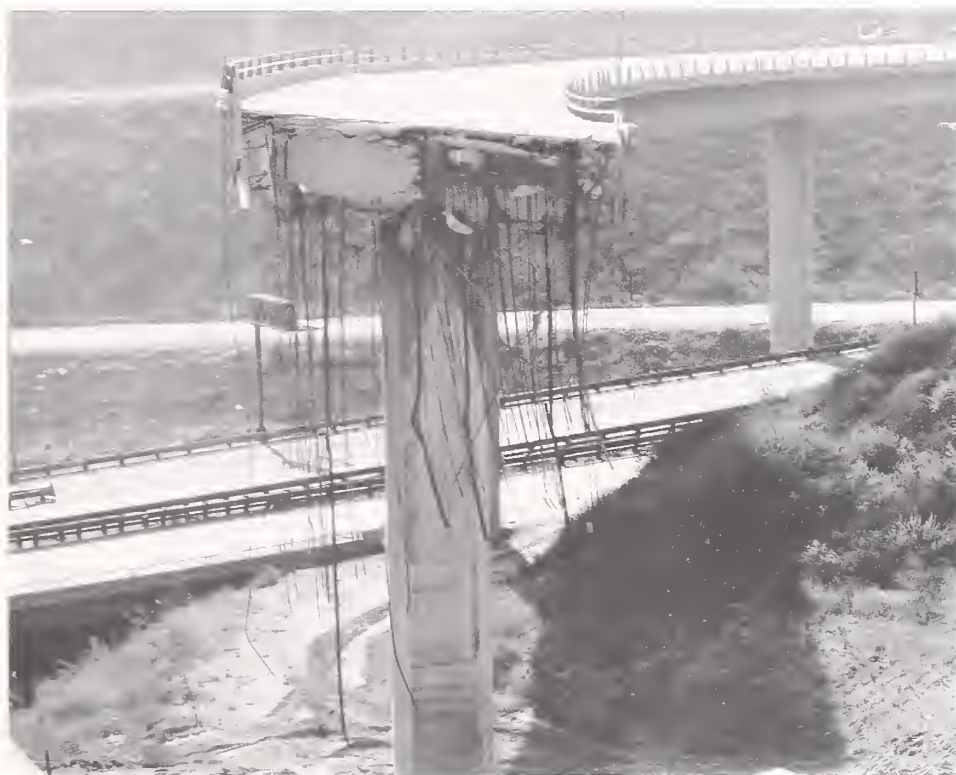
Figure 4.15. View of the flexural failure at Pier 3 of the SR14/I5 North Connector Overcrossing, looking to the south.

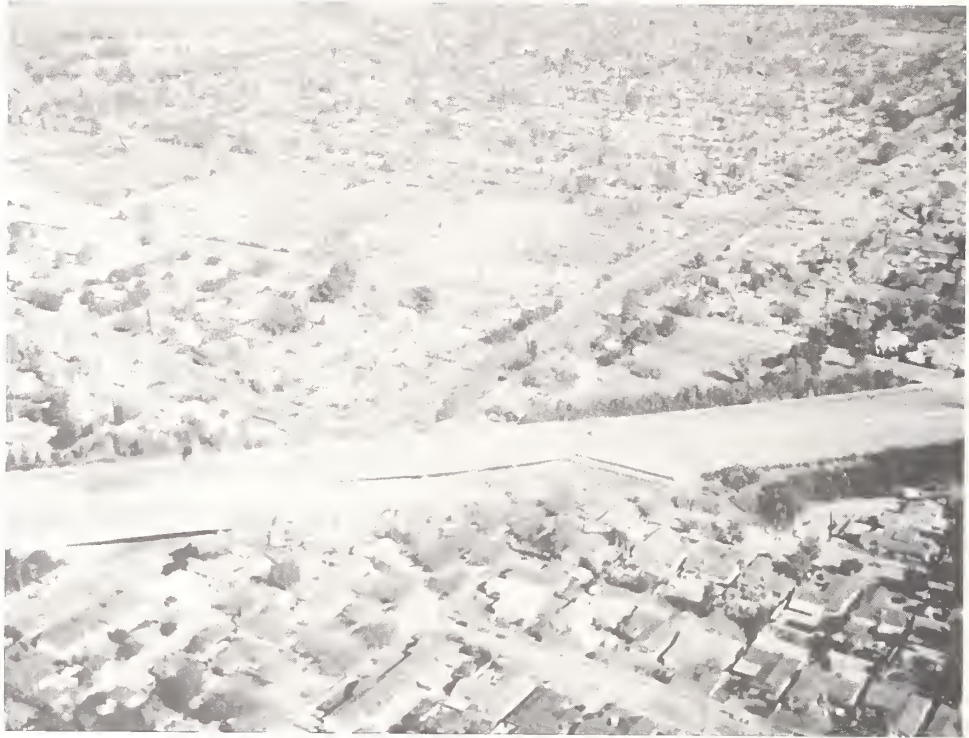
Figure 4.19. Aerial view of the SR118 Mission-Gothic Undercrossing, looking to the north showing collapsed eastbound bridge (Photo courtesy of FHWA).

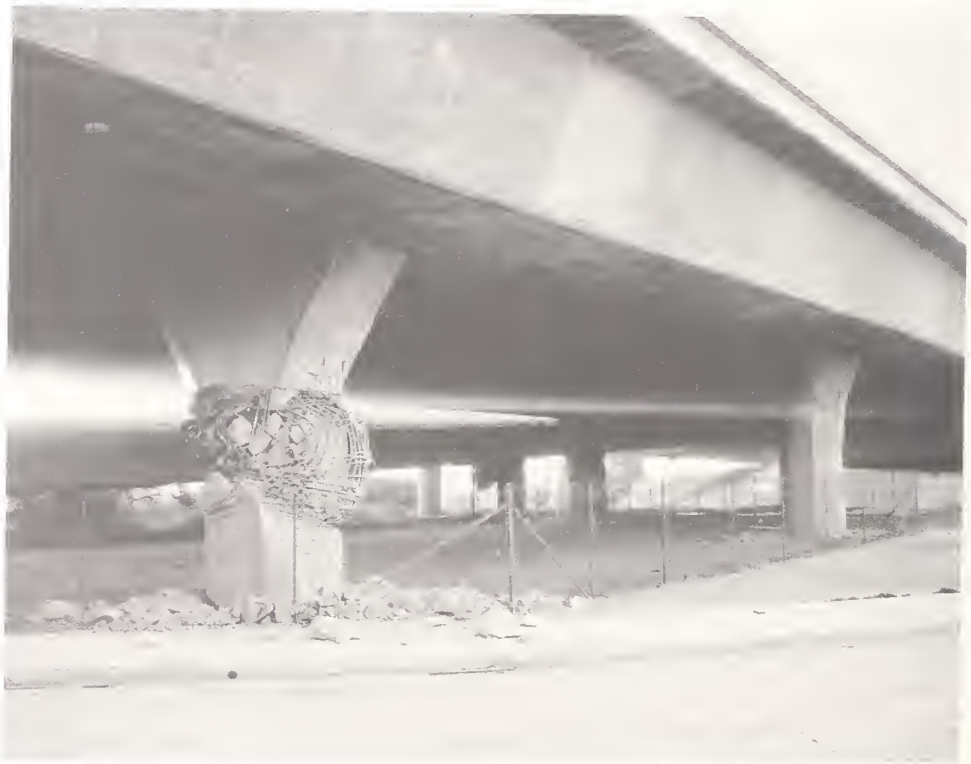
Figure 4.20. Damage to piers of the SR118 Mission-Gothic Undercrossing, looking to the northwest at the north face of the westbound bridge, Bents 3 (foreground) and 2.

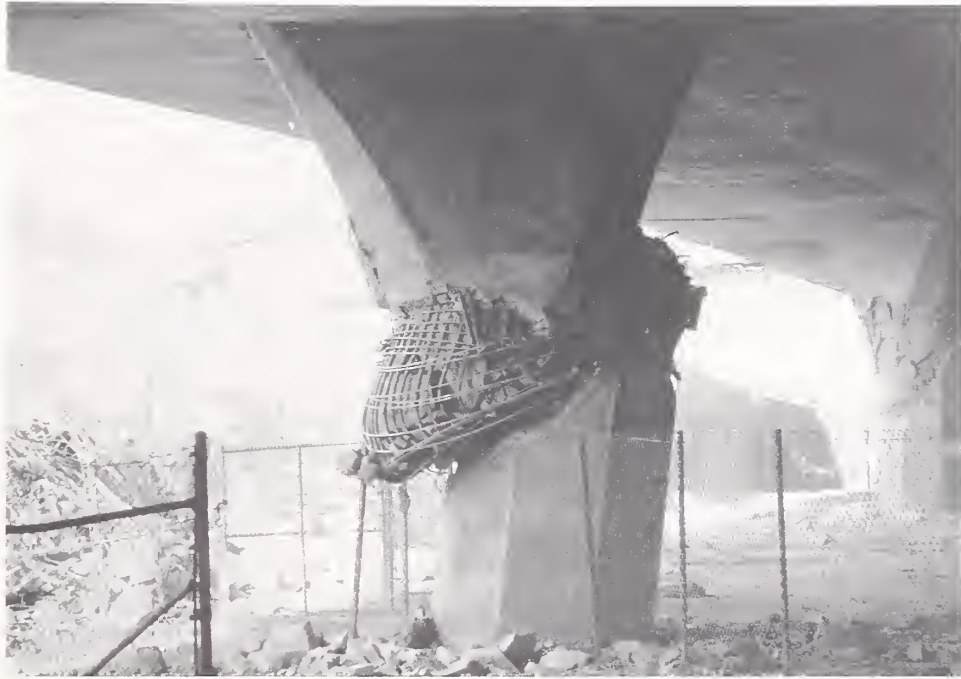
Figure 4.21. Damage to a pier of the SR118 Mission-Gothic Undercrossing, looking to the northwest at the southernmost pier of Bent 3 of the westbound bridge.

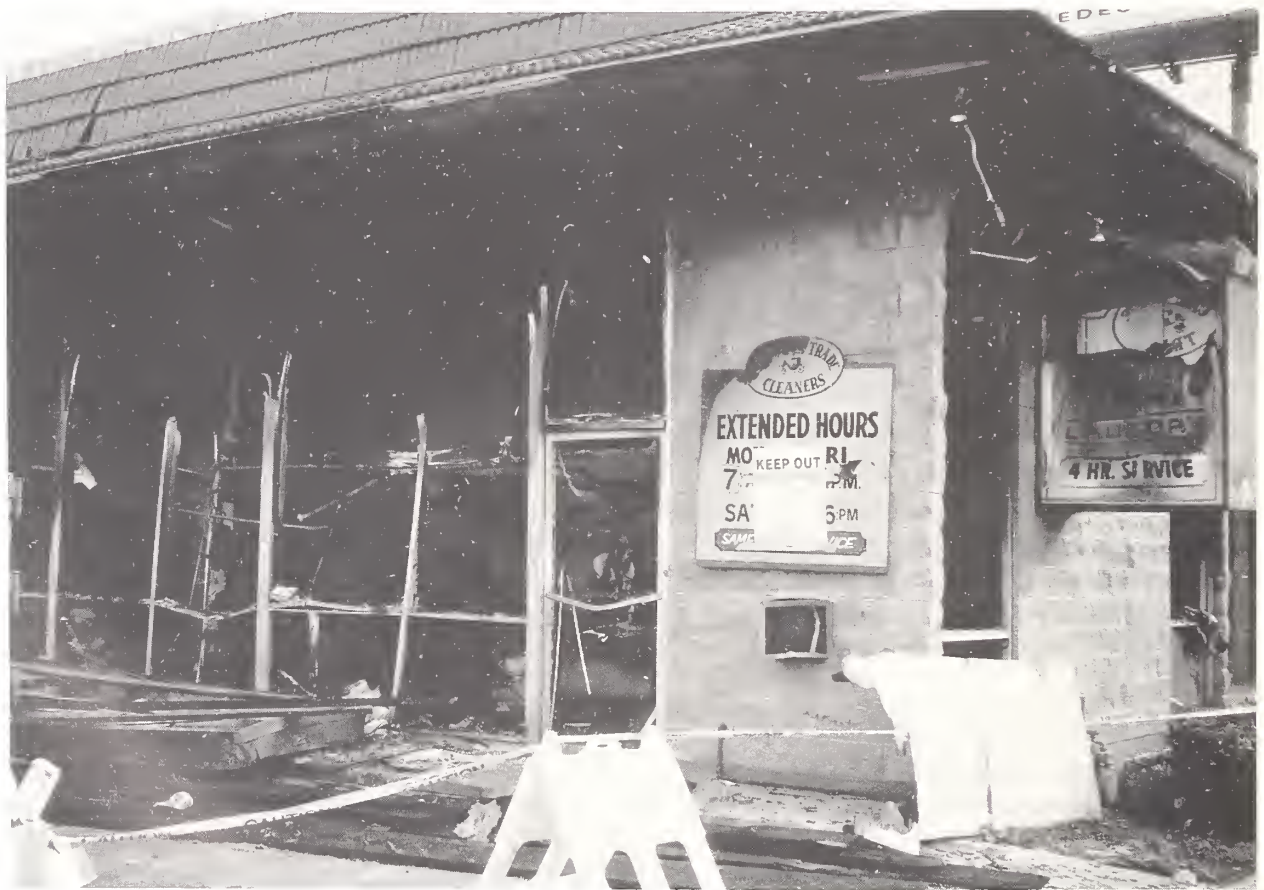
Figure 6.1. Fire damage in a single story commercial building.
