Performance of Physical Structures in  
Hurricane Katrina and Hurricane Rita:  
A Reconnaissance Report

# NIST Technical Note 1476

*National Institute of Standards and Technology  
Gaithersburg, MD 20899*

June 2006

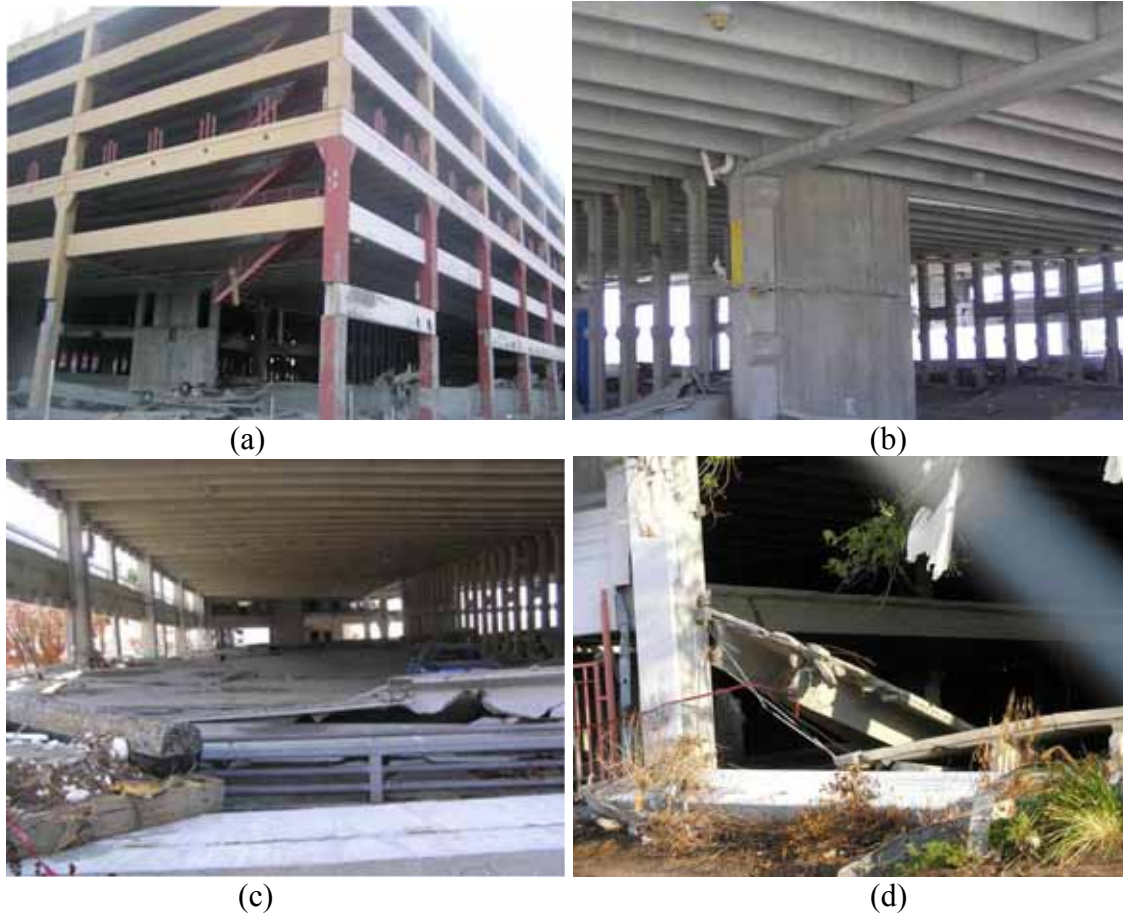
**Figure 3-1 Partial, first-level collapse of precast, prestressed double-tee deck parking structures in (a) Gulfport, MS and (b,c,d) Biloxi, MS (Photo credit: NIST).**

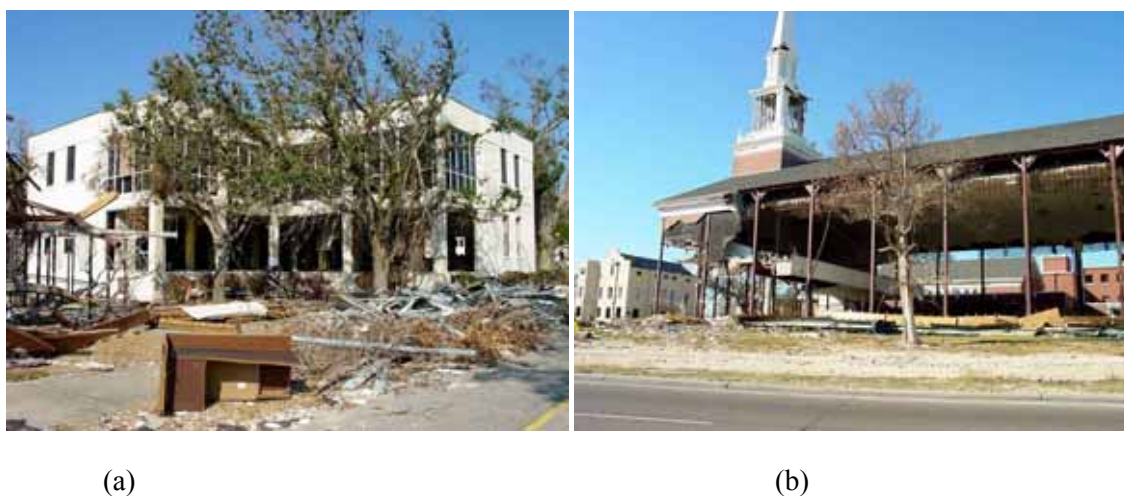
**Figure 3-6** Damage due to storm surge at (a) the Department of Veterans Affairs hospital, and (b) First Baptist Church, in Gulfport, MS (Photo credit: (a) Habib Rahman, National Research Council of Canada, (b) Jack Hayes, USACE).

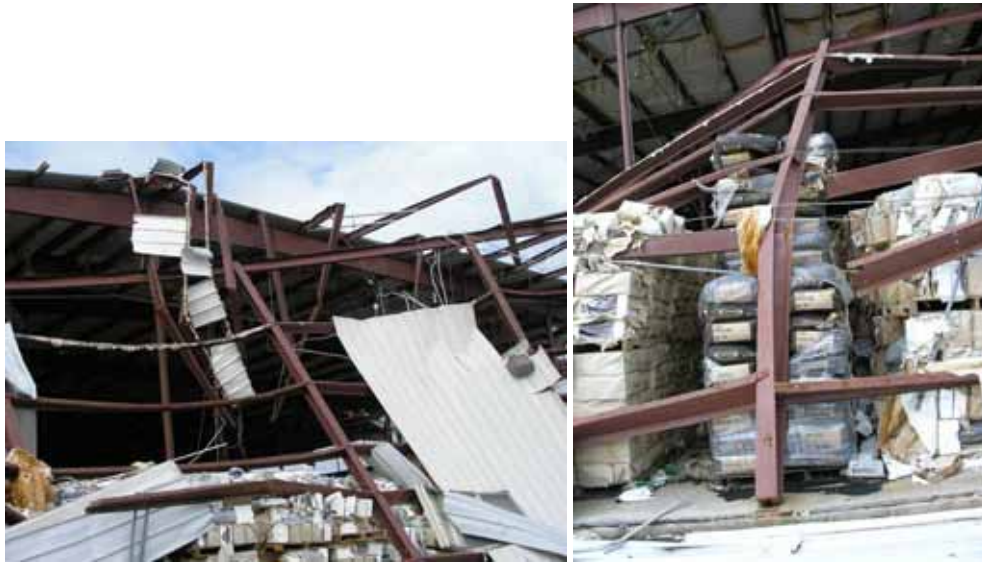
**Figure 3-15** Collapse of the entire end bay of a steel-frame warehouse from wind pressure near Long Beach, MS (Photo credit: NIST).

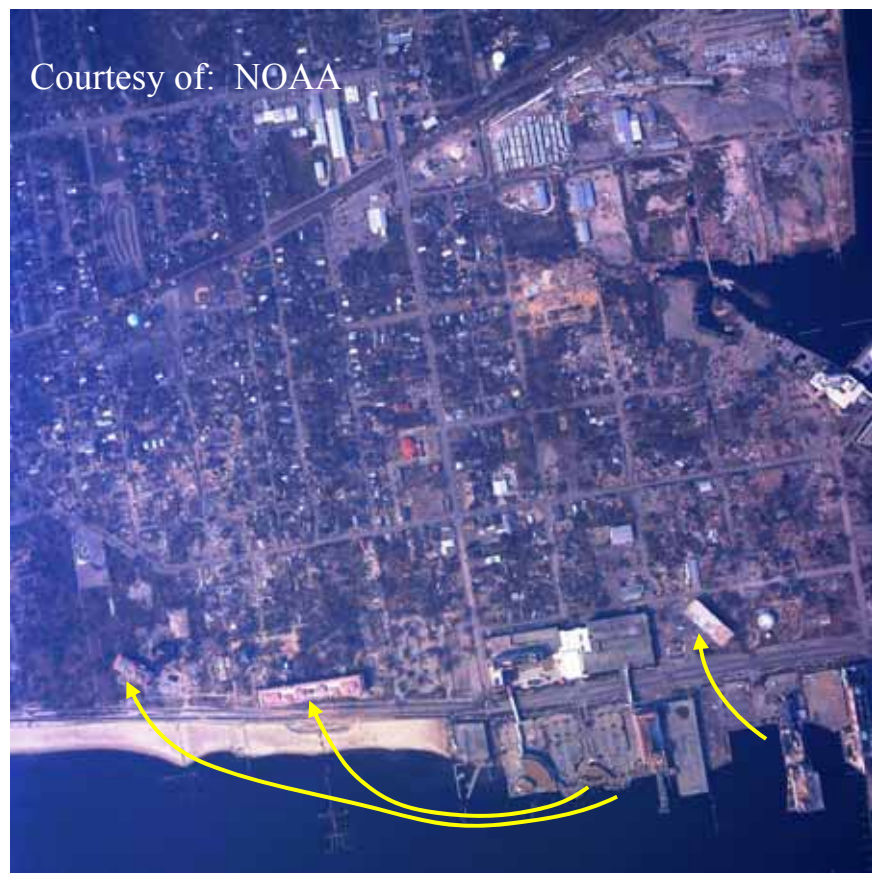
**Figure 3-19** Movement of three casino barges that broke completely free from their moorings and were deposited inland (Photo credit: NOAA).

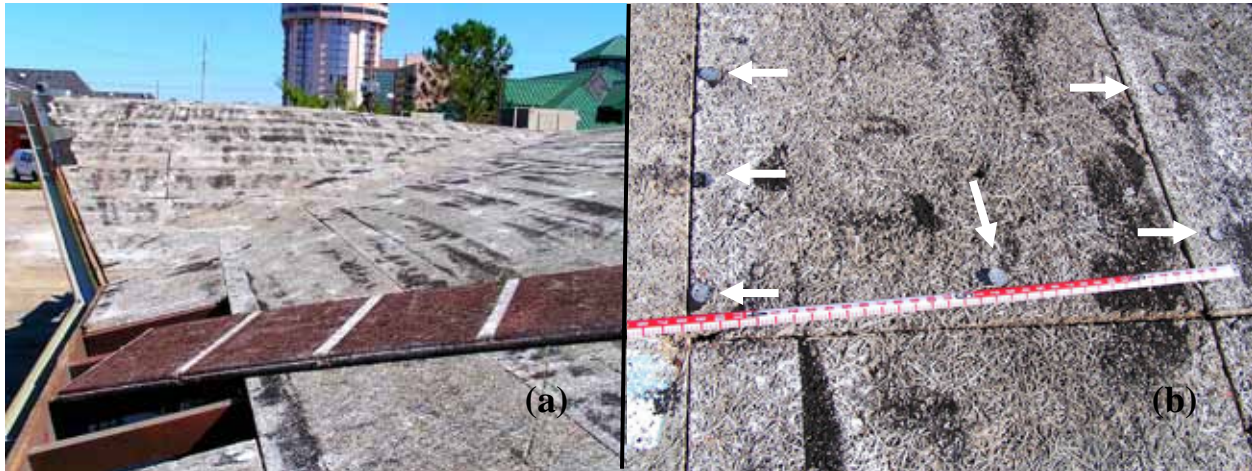
**Figure 3-28** Blow-off of a bituminous roofing membrane from a wood fiber cementitious panel deck in New Orleans (a), precipitated by uplift and tearing of the membrane base sheet from around the fasteners (arrows) (b). An insufficient number of fasteners had been installed (Photo credit: Robb Smith, Amtech Roofing Consultants).

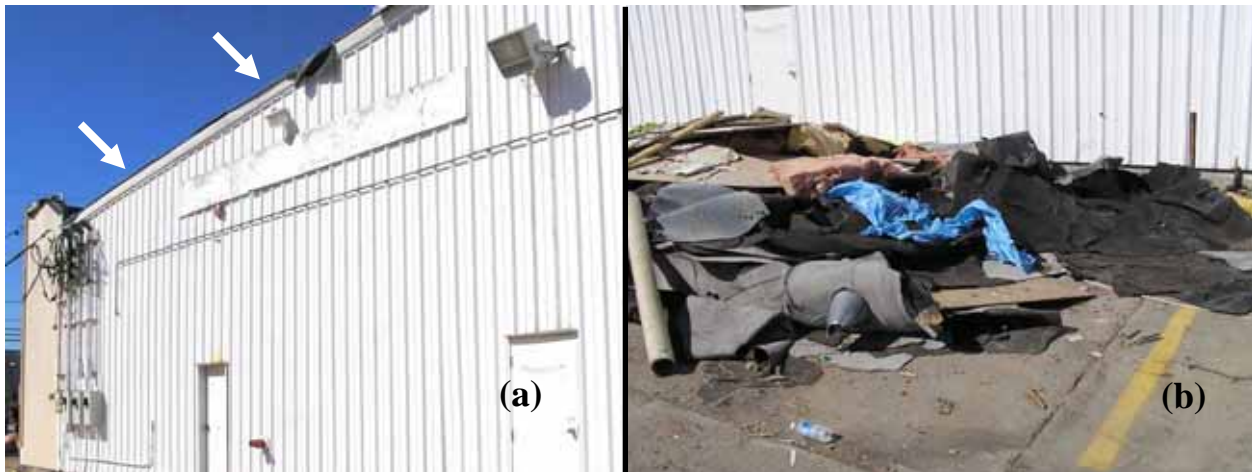
**Figure 3-29** A commercial metal building in New Orleans that suffered damage to its modified bituminous membrane roof likely<sup>15</sup> as a result of insufficient fastening to the deck. Note in (a) damage to the edge detail (arrows). Note in (b) the debris pile, found below the damaged edge detail, containing sections of a modified bituminous membrane (Photo credit: Robb Smith, Amtech Roofing Consultants).

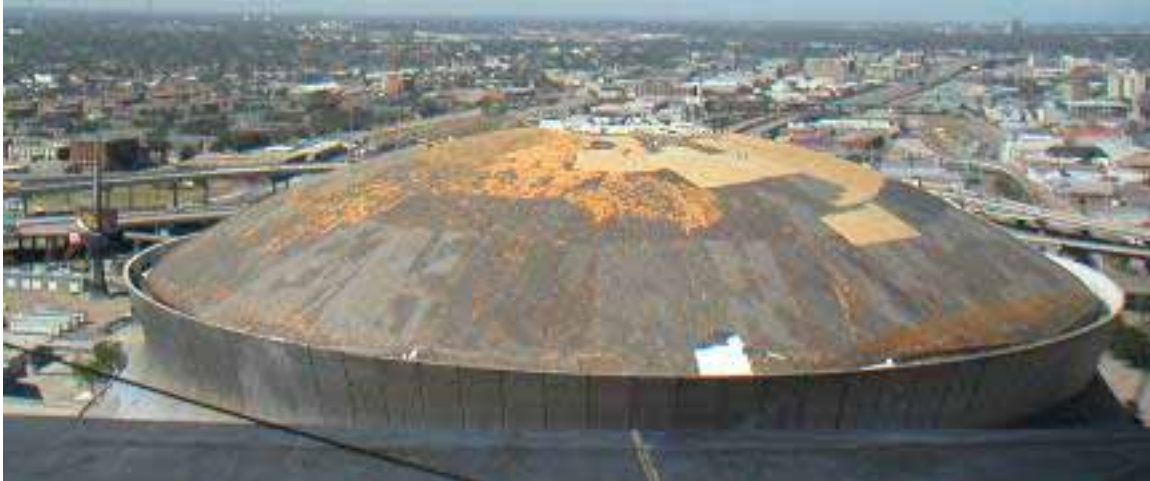
**Figure 3-31 Louisiana Superdome. Gray areas are remaining polyisocyanurate insulation with a gray/black facer. Rust color is the original sprayed polyurethane foam (SPF). Tan is new SPF. The white area is a small section of white coated EPDM membrane that was not blown off. Before Hurricane Katrina, only the white coated EPDM membrane would have been visible on the roof (Photo credit: NIST).**

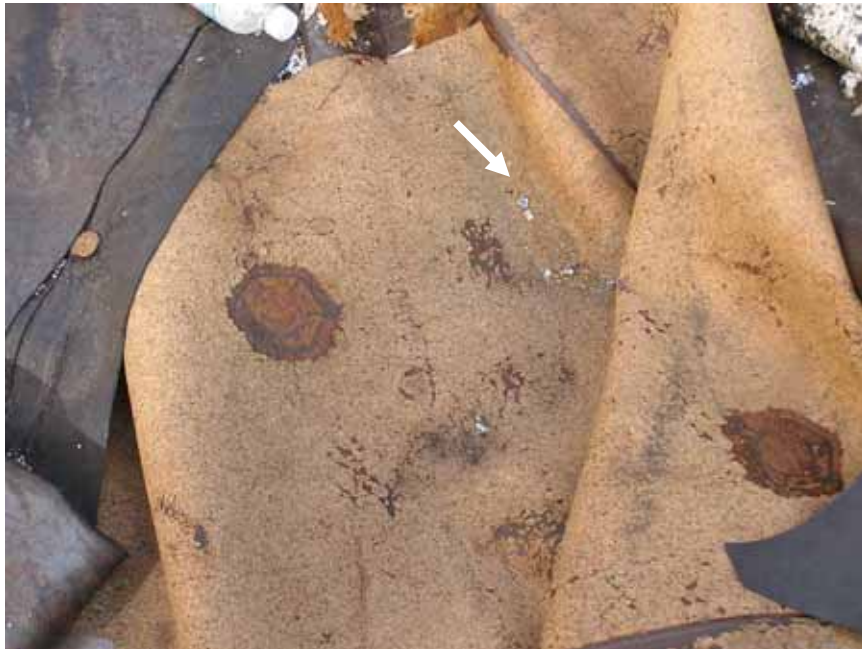
**Figure 3-32 Section of damaged EPDM membrane found on the roof of a building downwind from the Superdome. The tan color represents adhesive used to attach the EPDM to the insulation on the Superdome. The white specs (arrow) are pieces of broken glazing from windows of a nearby building that was also downwind from the Superdome (Photo credit: Robb Smith, Amtech Roofing Consultants).**

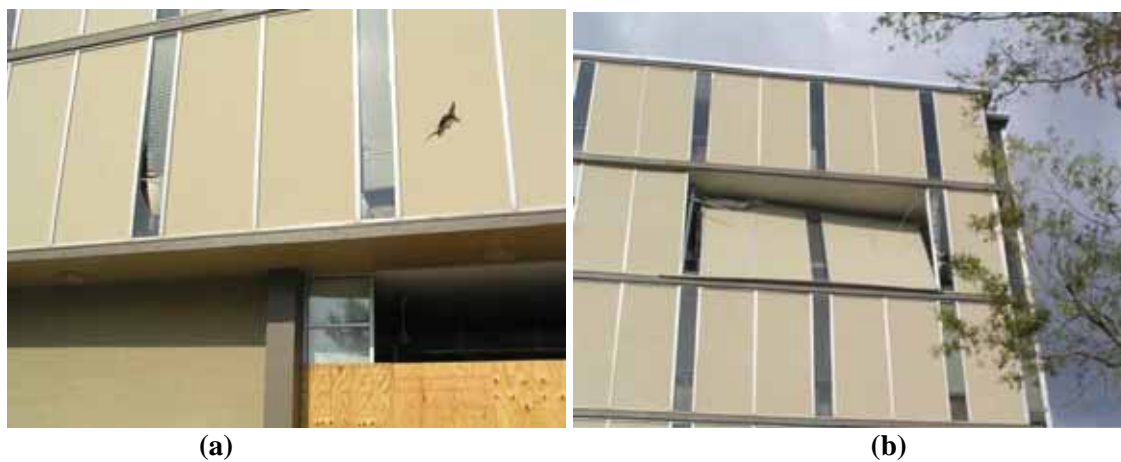
**Figure 3-49** Damage to the St. Tammary Parish Government Administration Complex in Slidell, LA: (a) flood damage to the ground floor and wind-borne debris, (b) pushed in cladding wall (Photo credit: NIST).

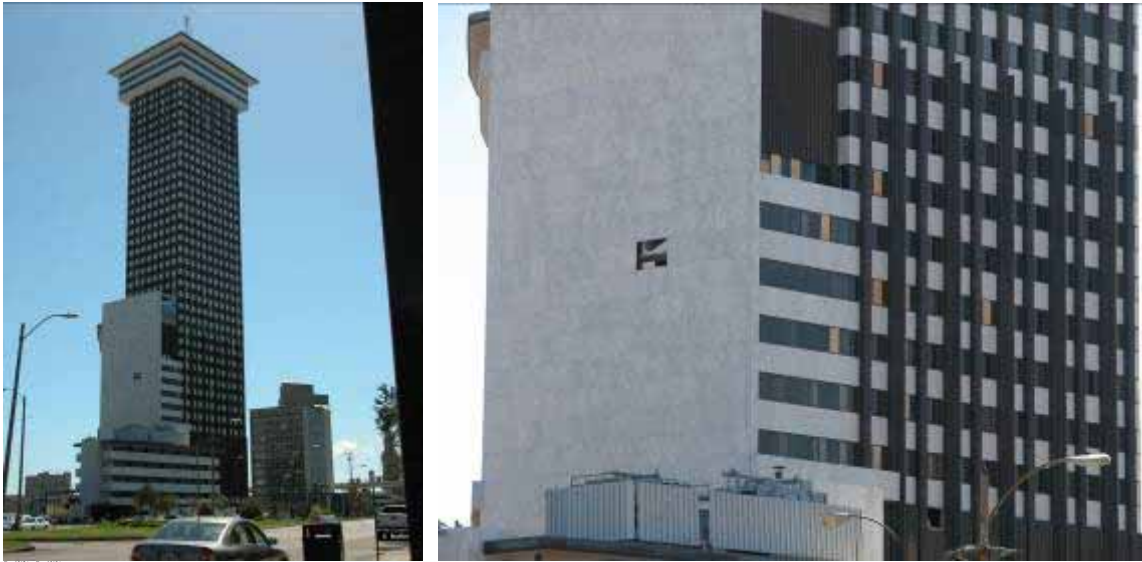
**Figure 3-51 Unusual instance of damage to stone cladding due to wind pressure (Photo credit: Keith Porter, Scawthorn Porter Associates).**

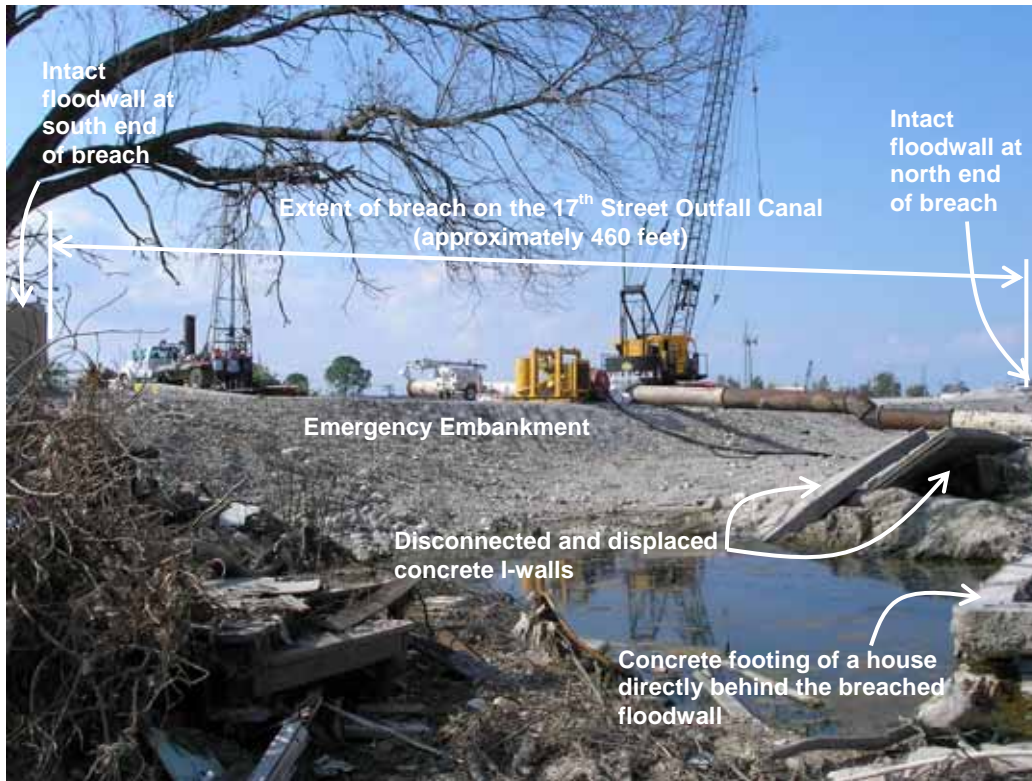
**Figure 4-4 View to the northwest of the 17th Street Outfall Canal breach from the protected side (photo credit: NIST)**

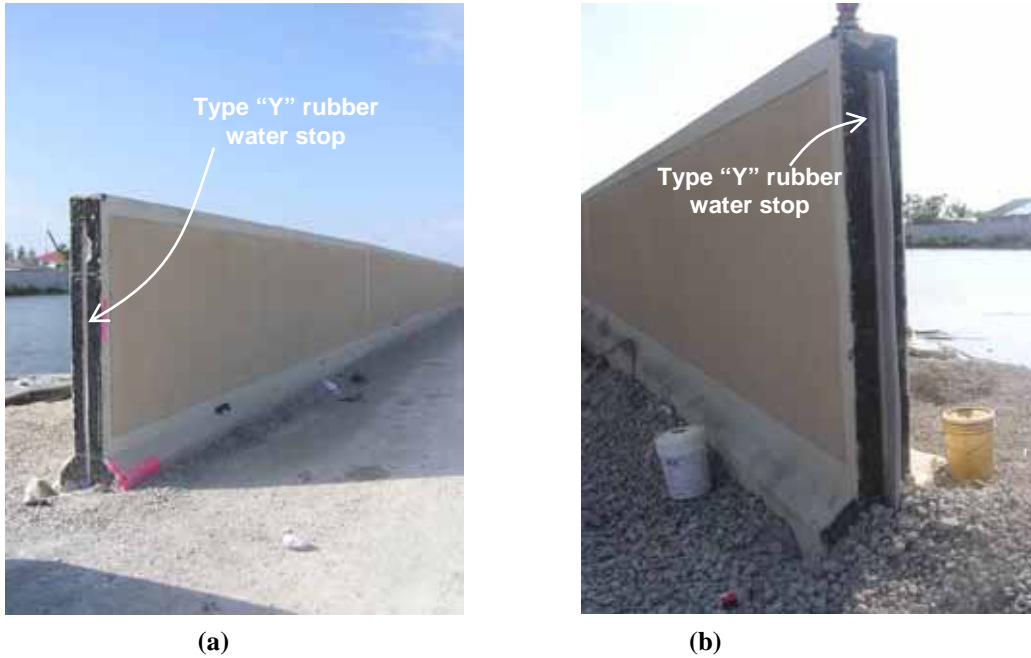
**Figure 4-5** View looking north (a) at the north edge of the breach, and (b) at the south edge, showing no scour along the toe of the floodwall and the clean failures at the vertical joints between the failed and intact I-wall sections (photo credit: NIST)

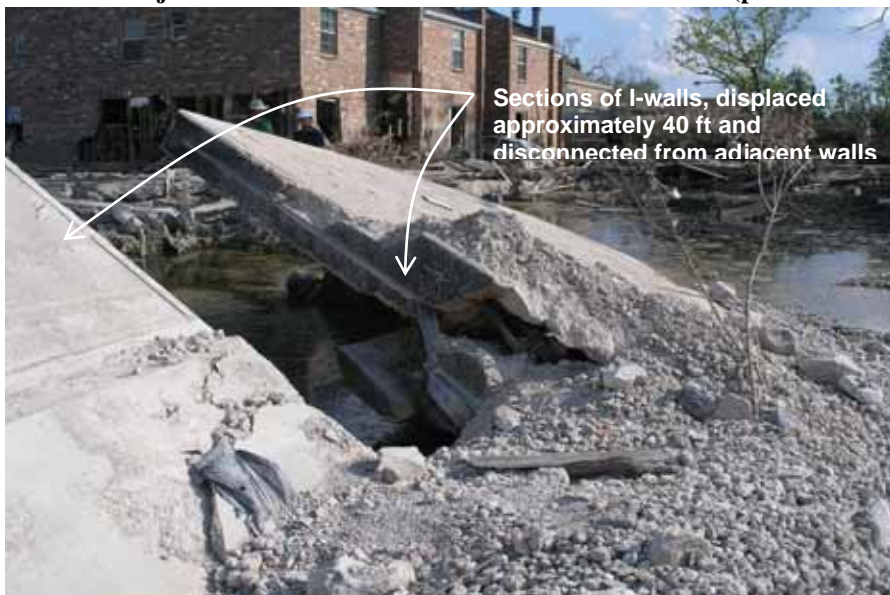
**Figure 4-6** Sections of concrete I-walls displaced and disconnected from each other and from the steel sheet piles (photo credit: NIST)

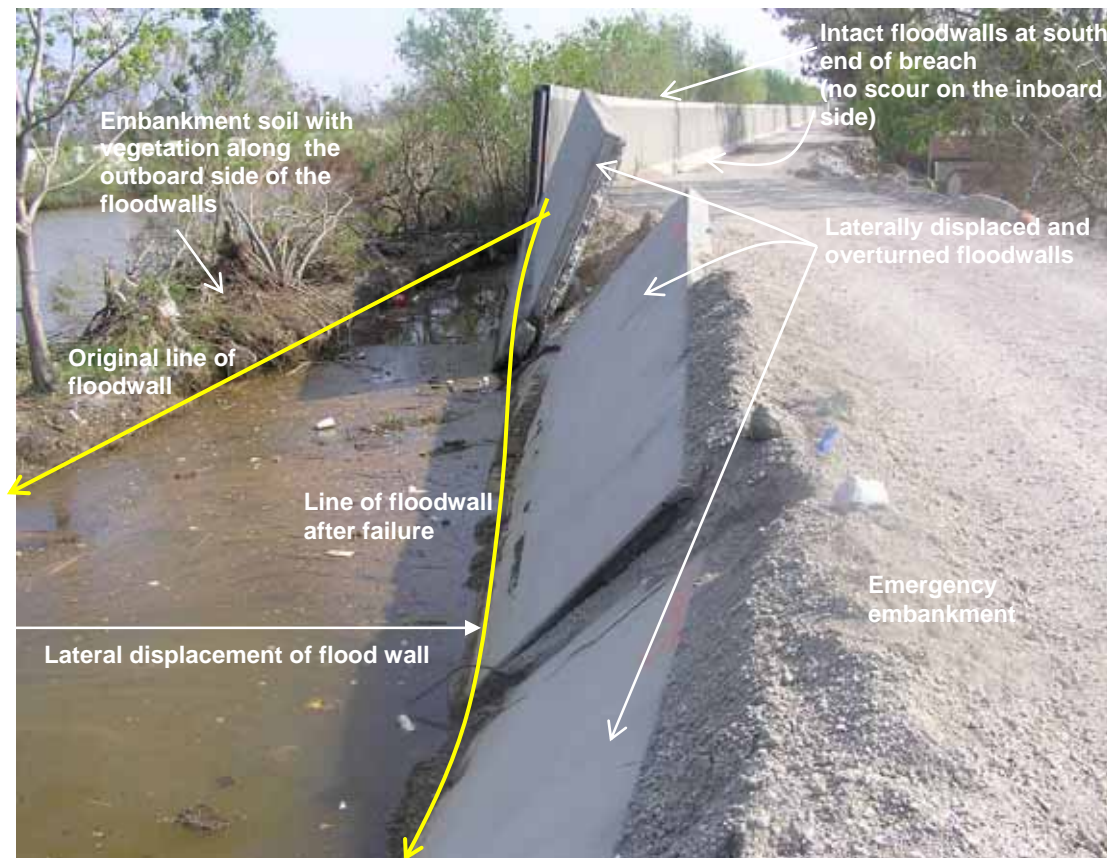
**Figure 4-8 View looking south of the breach on the west bank of the London Avenue Outfall canal near Robert E. Lee Road (photo credit: NIST)**

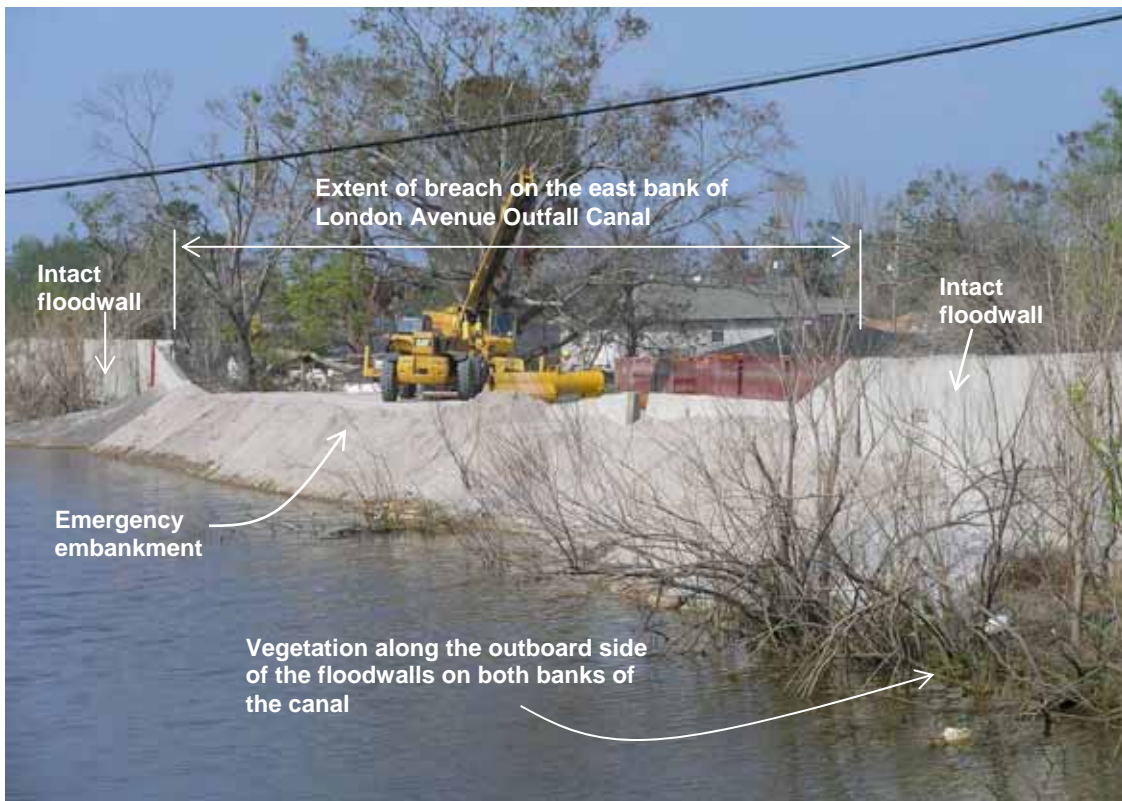
**Figure 4-11** View looking north from Mirabeau Road bridge toward the breach on the east bank of the London Avenue Outfall Canal (photo credit: NIST)

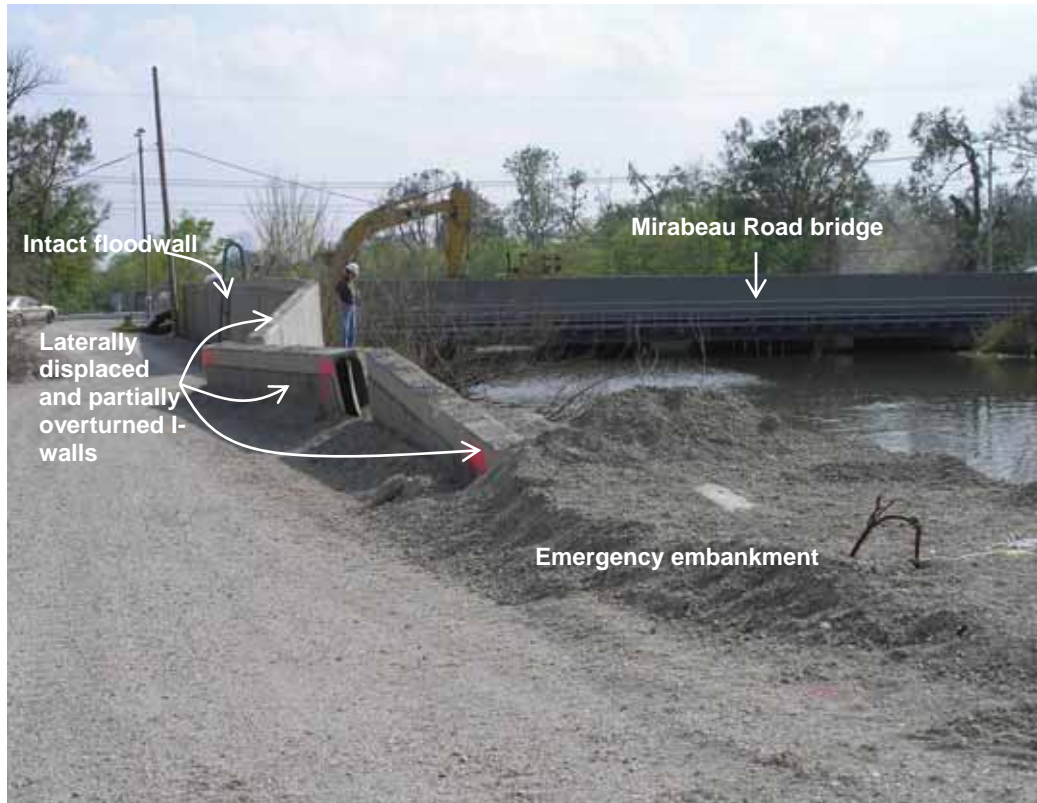
**Figure 4-12** View looking south from the breach on the east bank of the London Avenue Outfall Canal toward Mirabeau Road bridge (photo credit: NIST)

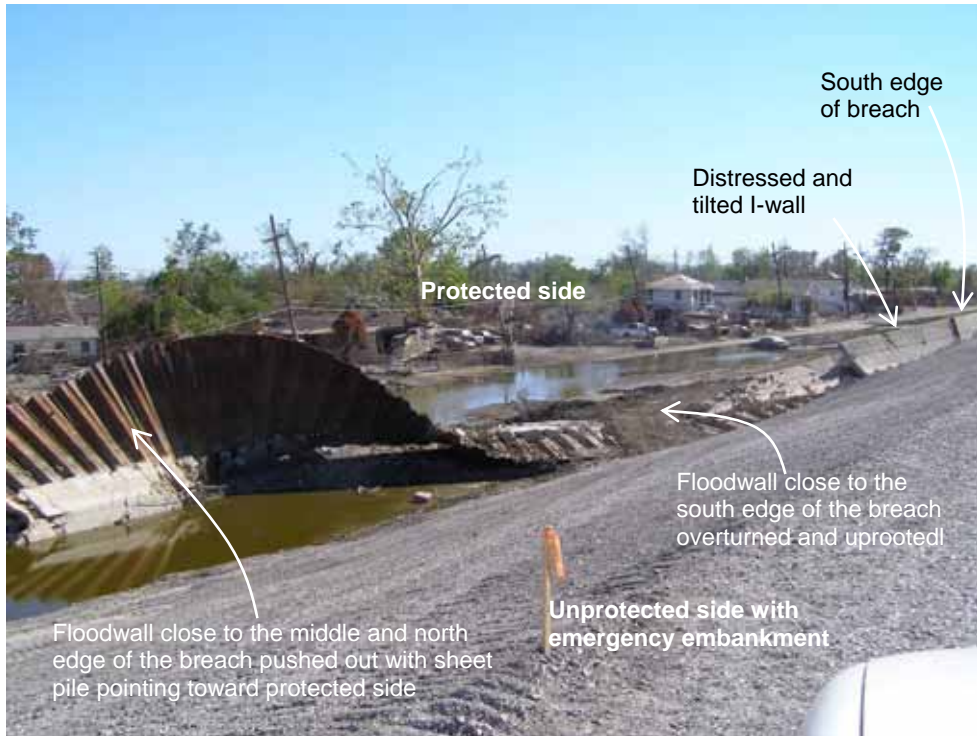
**Figure 4-22** View looking south at the IHNC Lower Ninth Ward North breach (photo credit: NIST)

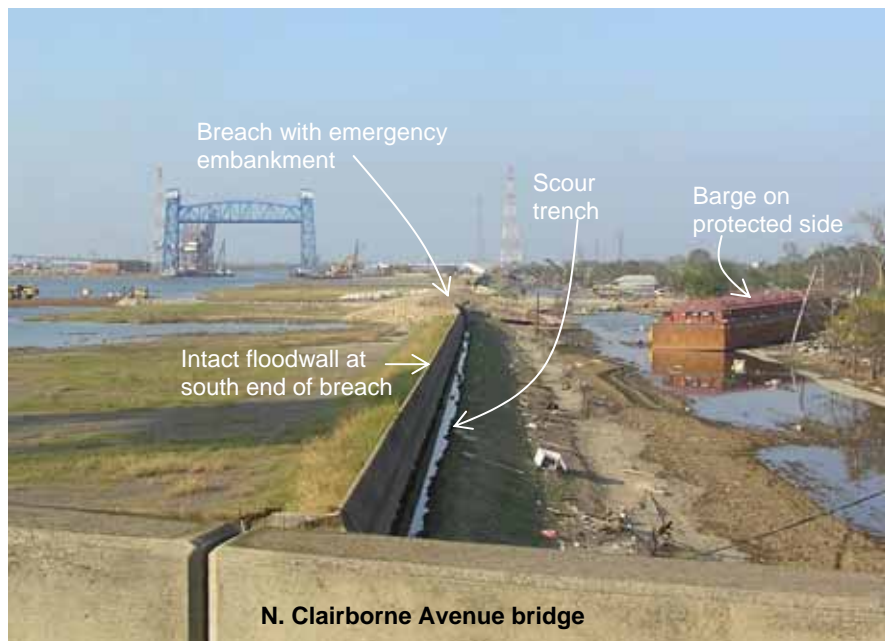
**Figure 4-24 View looking north at the IHNC Lower Ninth Ward South breach (photo credit: NIST)**

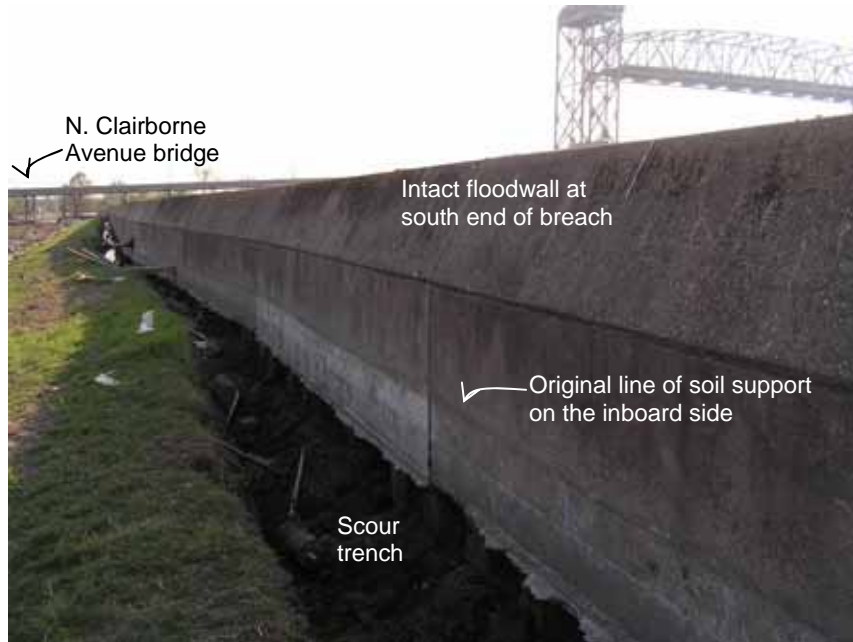
**Figure 4-25** View looking south along the inboard side of the IHNC Lower Ninth Ward South breach (photo credit: NIST)

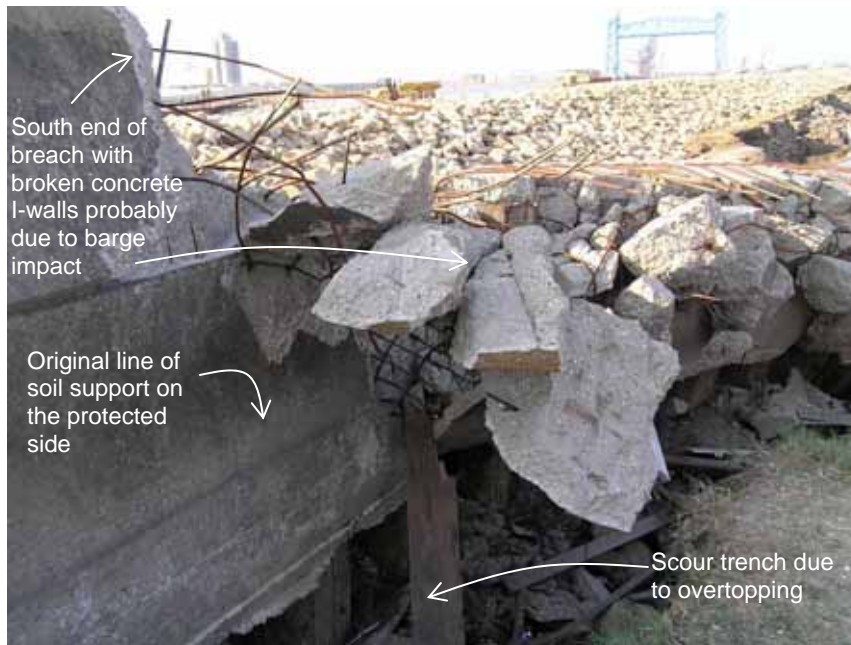
**Figure 4-27** South edge of breach with broken concrete I-walls apparently<sup>15</sup> due to barge impact (photo credit: NIST)

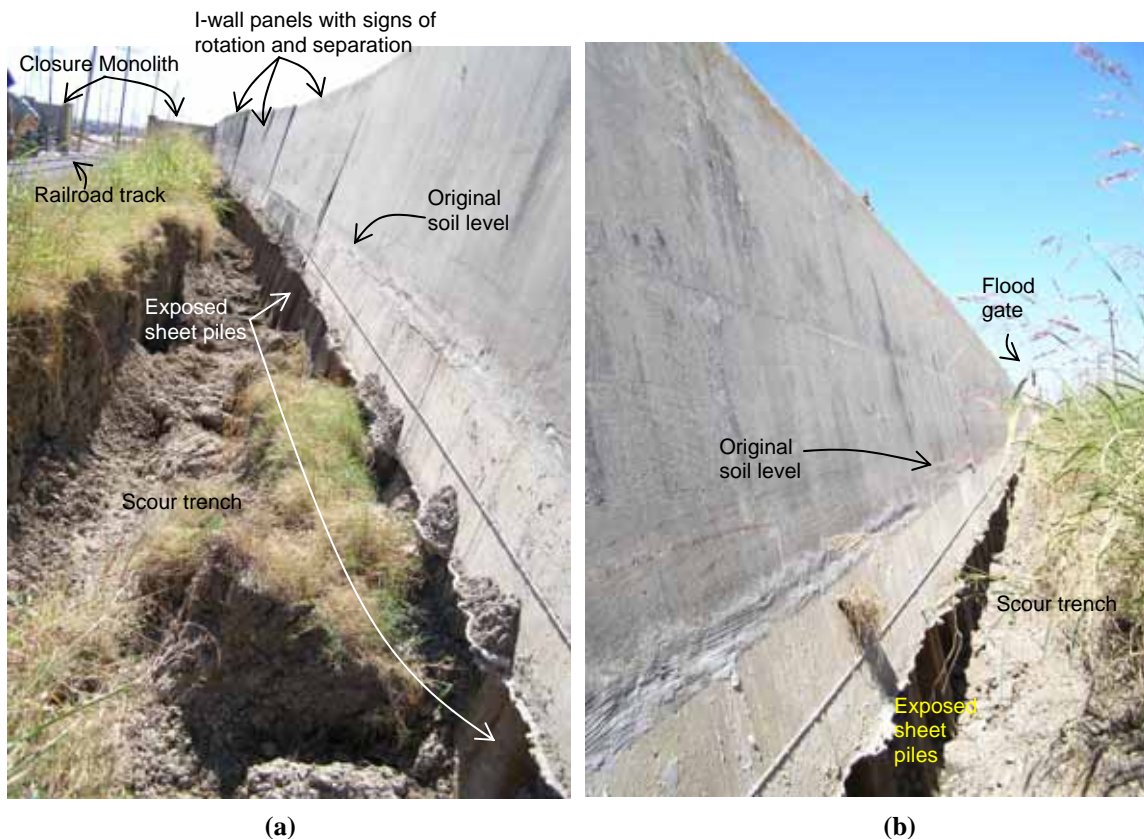
**Figure 4-28** View of scour trench on the outboard side toward junction of floodwall and closure monolith (a); View looking north along scour trench on the outboard side toward flood gate (b) (photo credit: NIST)

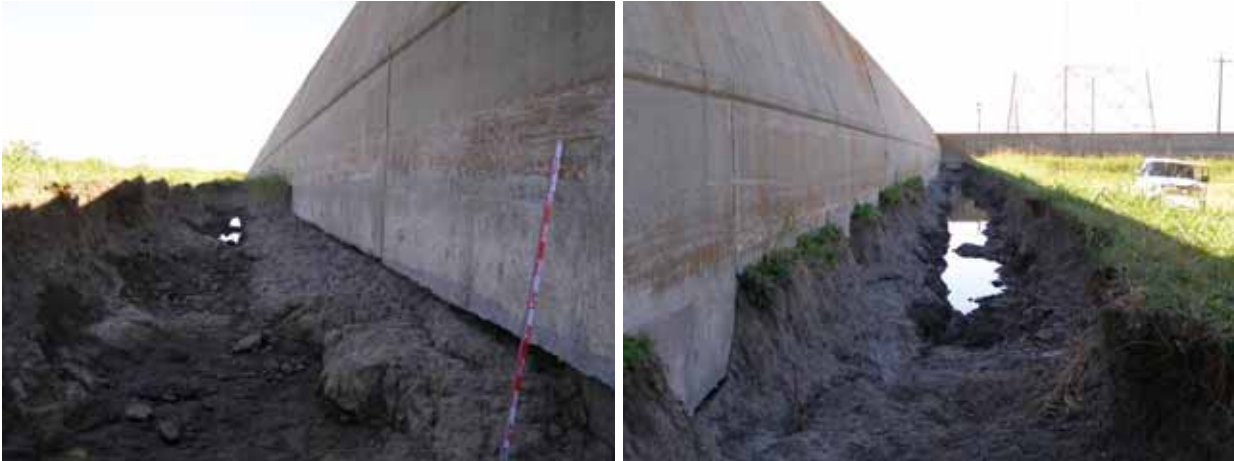
(a) (b)  
**Figure 4-29 Scour trench along floodwall next to Entergy Michoud Power Plant (photo credit: NIST).**

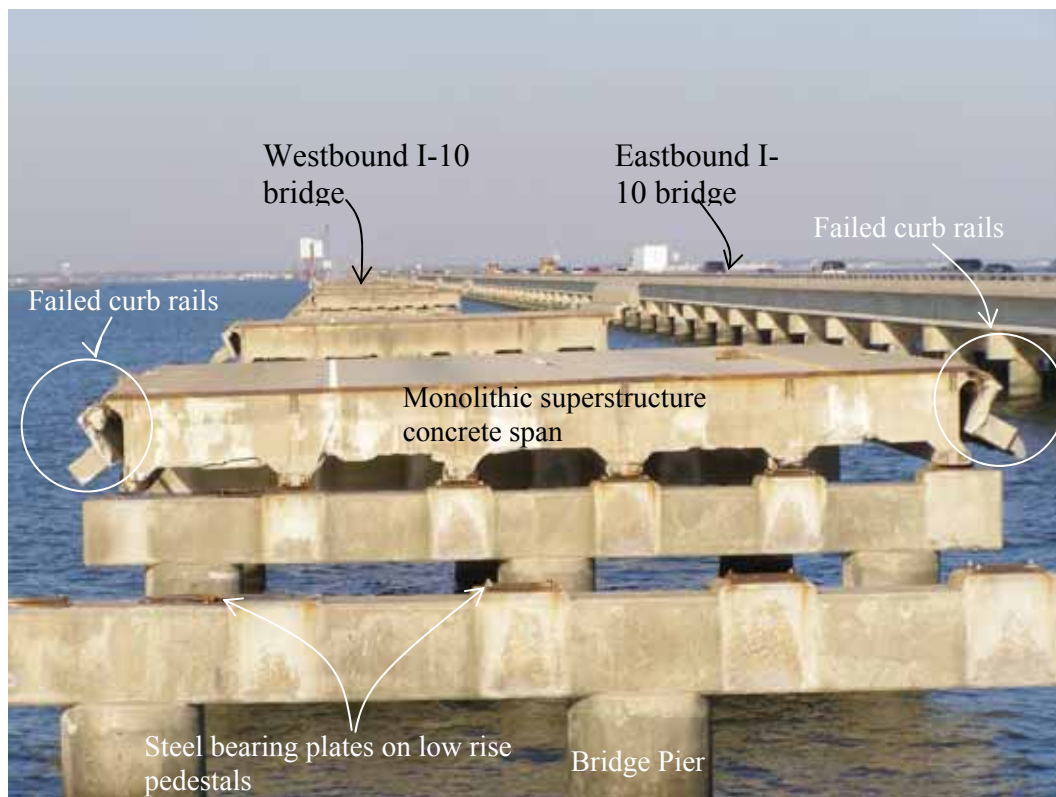
**Figure 4-31** View looking north from west abutment of I-10 twin span bridges over Lake Pontchartrain (photo credit: NIST).

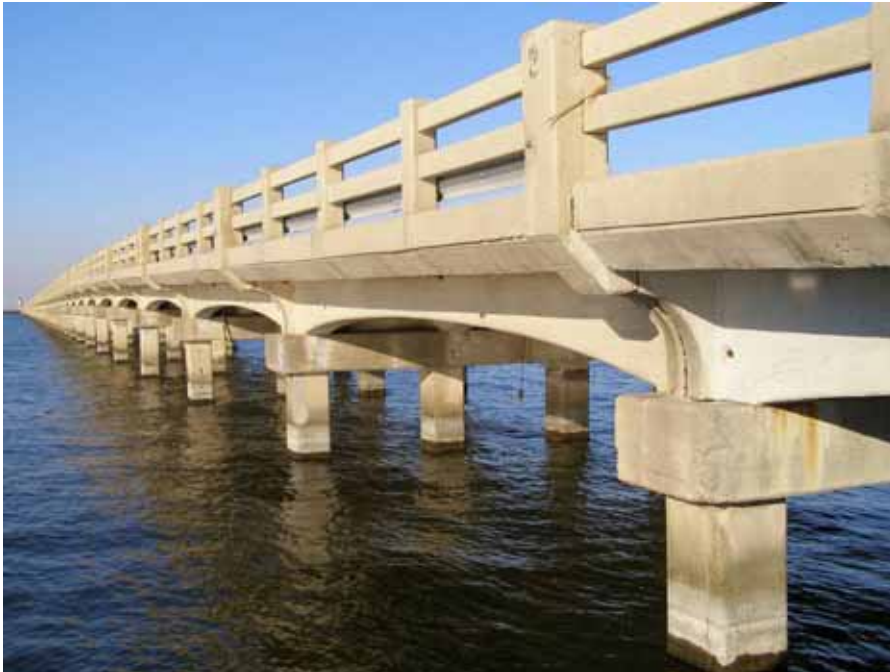
**Figure 4-32** Cast-in-place concrete bridge carries the traffic of US-11 over Lake Pontchartrain (photo credit: J. O'Connor, MCEER).

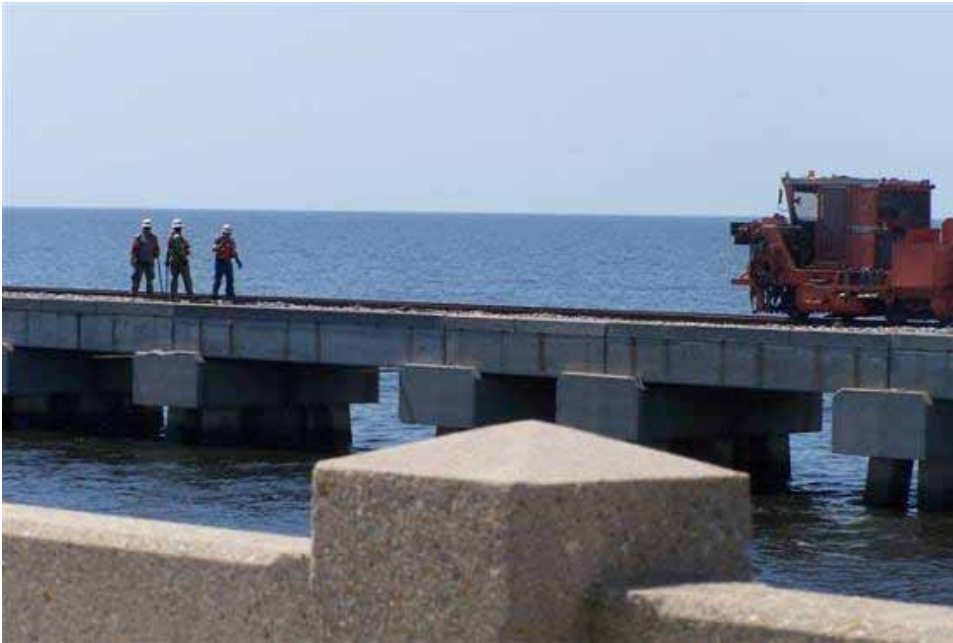
**Figure 4-33** The Norfolk Southern Railroad bridge over Lake Pontchartrain had its tracks stripped from the superstructure but otherwise remained intact (photo credit: J. O'Connor, MCEER).

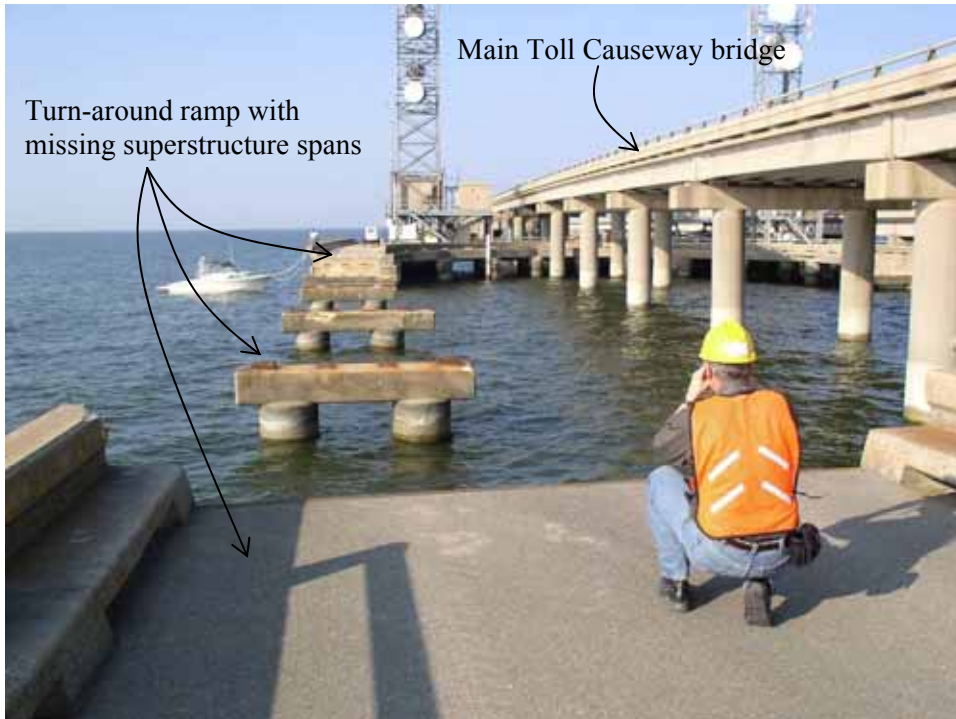
**Figure 4-34 Toll Causeway turnaround bridge ramp failures (photo credit: Ron T. Eguchi, ImageCat).**

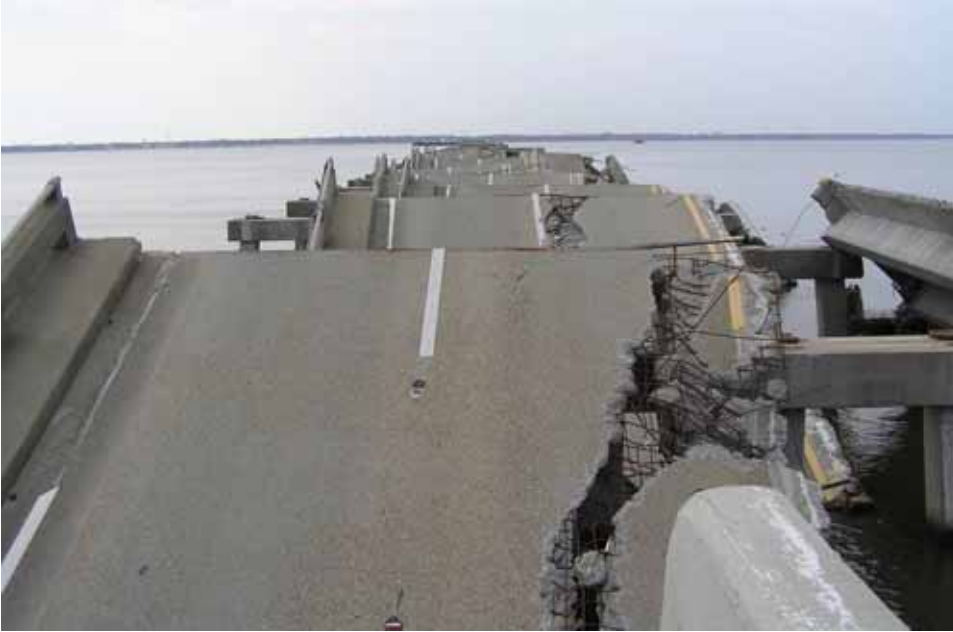
**Figure 4-38** Displaced and dropped superstructure spans of US-90 bridge over St. Louis Bay (photo credit: NIST).

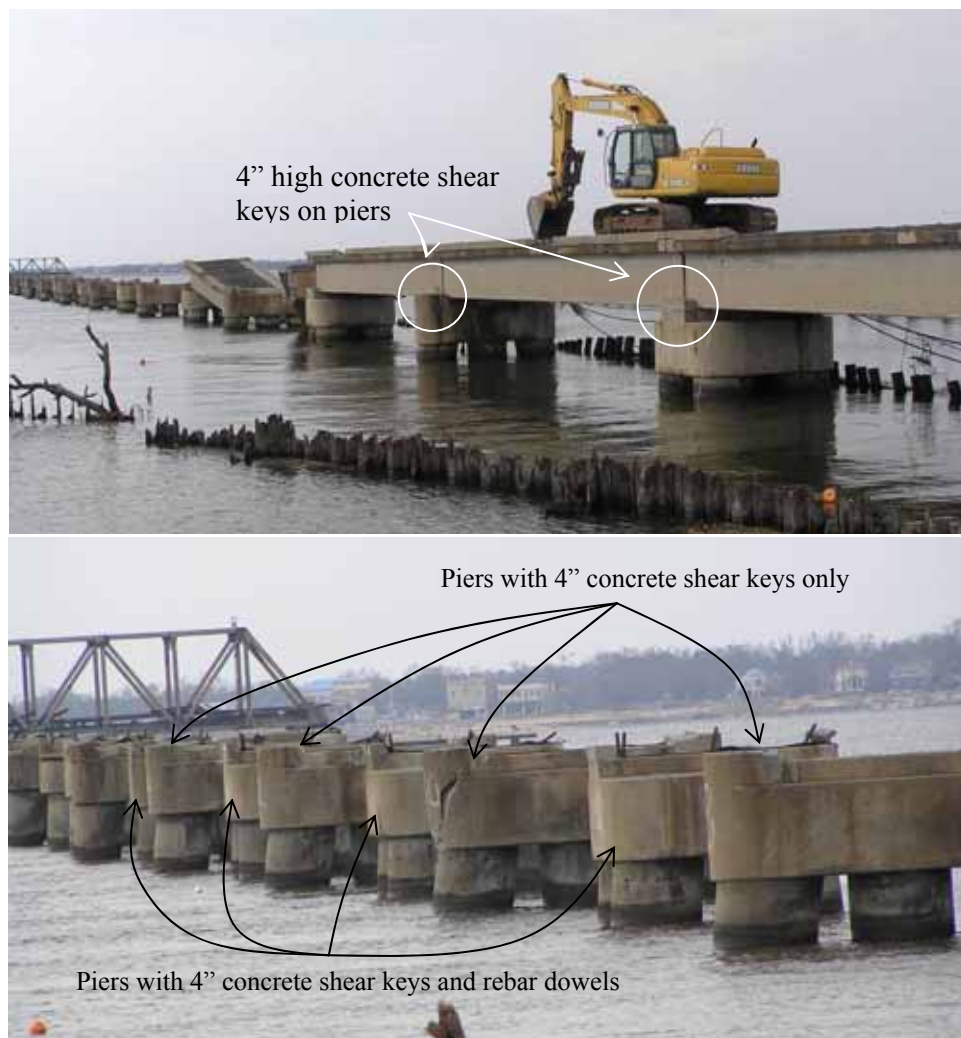
**Figure 4-40 CSX railroad bridge with remaining spans (top) and the supporting piers (bottom) (photos credit: NIST).**

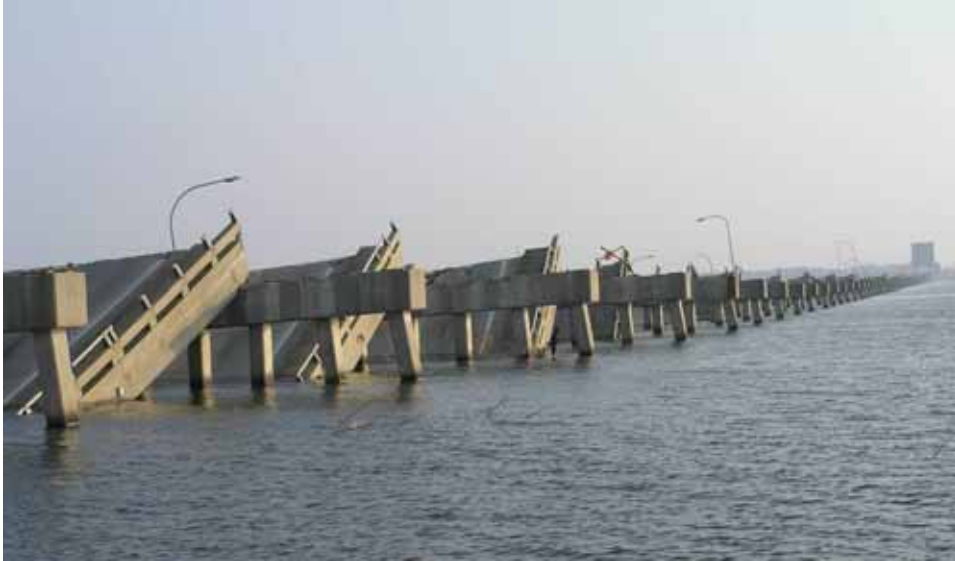
**Figure 4-42** Looking west toward Biloxi from the east shore, many superstructure spans of US-90 Biloxi-Ocean Springs bridge were displaced north off their piers (photo credit: J. O'Connor, MCEER).

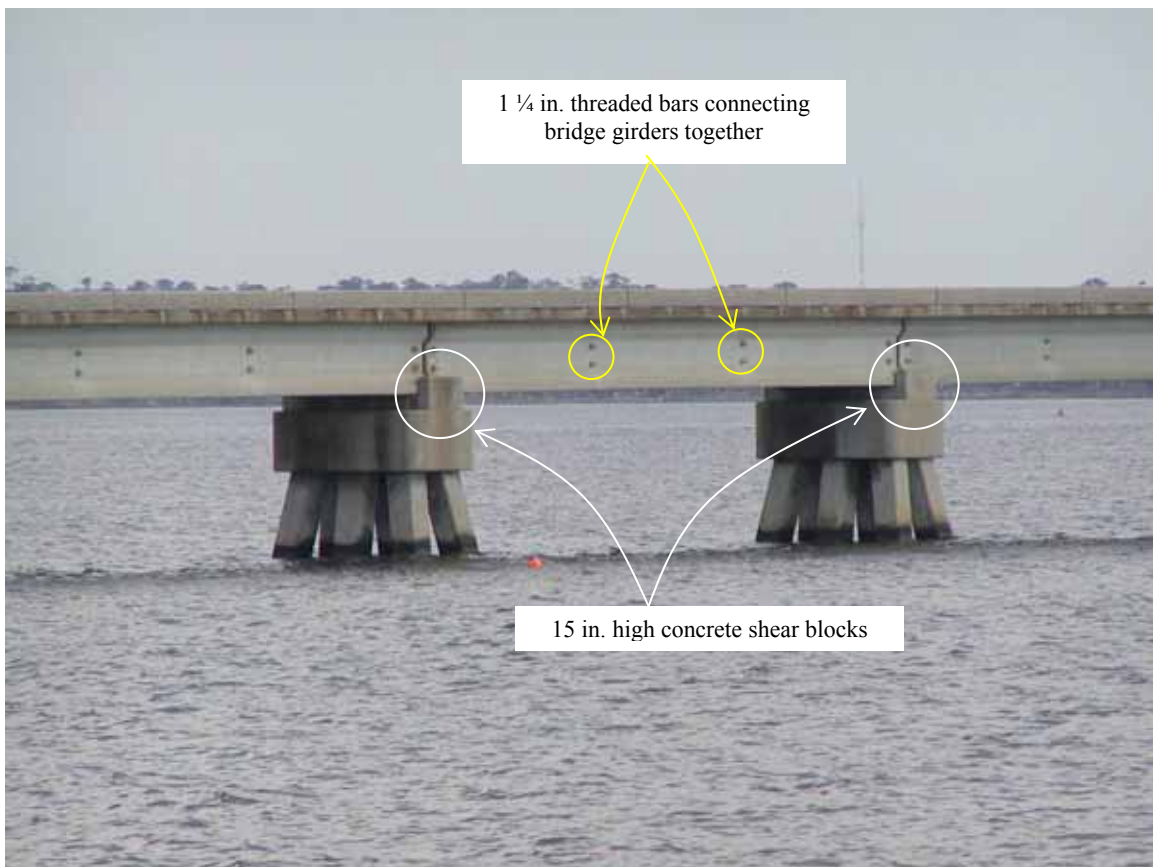
**Figure 4-44** The CSX railroad bridge survived with minor damage, most likely<sup>15</sup> due to the presence of high shear blocks (photo credit: LA DOTD).

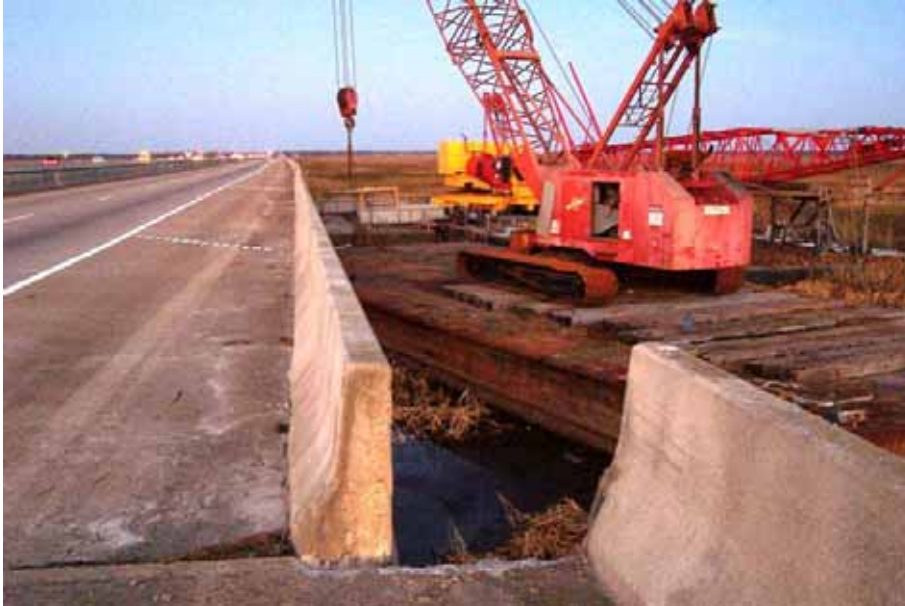
**Figure 4-49** US-90 bridge over Pascagoula River with displaced spans due to barge's impact (photo credit: MSDOT, provided by J. O'Connor, MCEER)
