Performance of Physical Structures in  
Hurricane Katrina and Hurricane Rita:  
A Reconnaissance Report

# NIST Technical Note 1476

*National Institute of Standards and Technology  
Gaithersburg, MD 20899*

June 2006

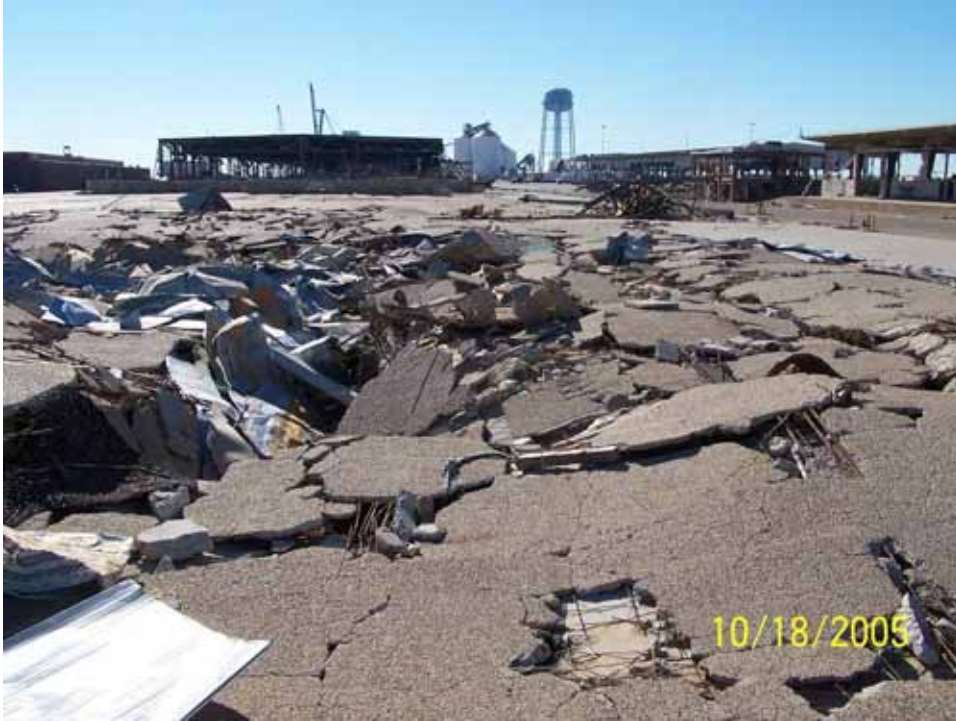
**Figure 4-62** West Pier, showing collapse of wharf structure due to pile failure (photo credit: Thomas B. Rodino, Shiner Moseley and Associates, Inc.)

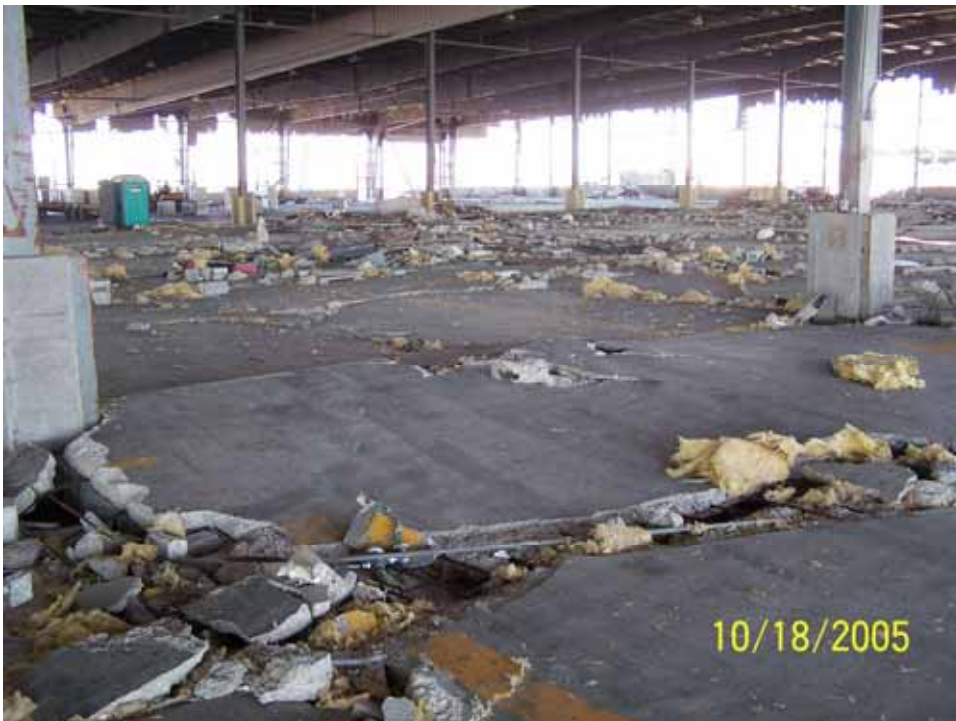
**Figure 4-63** East Pier, showing damage to cargo shed deck and sheet metal siding (photo credit: Thomas B. Rodino, Shiner Moseley and Associates, Inc.)

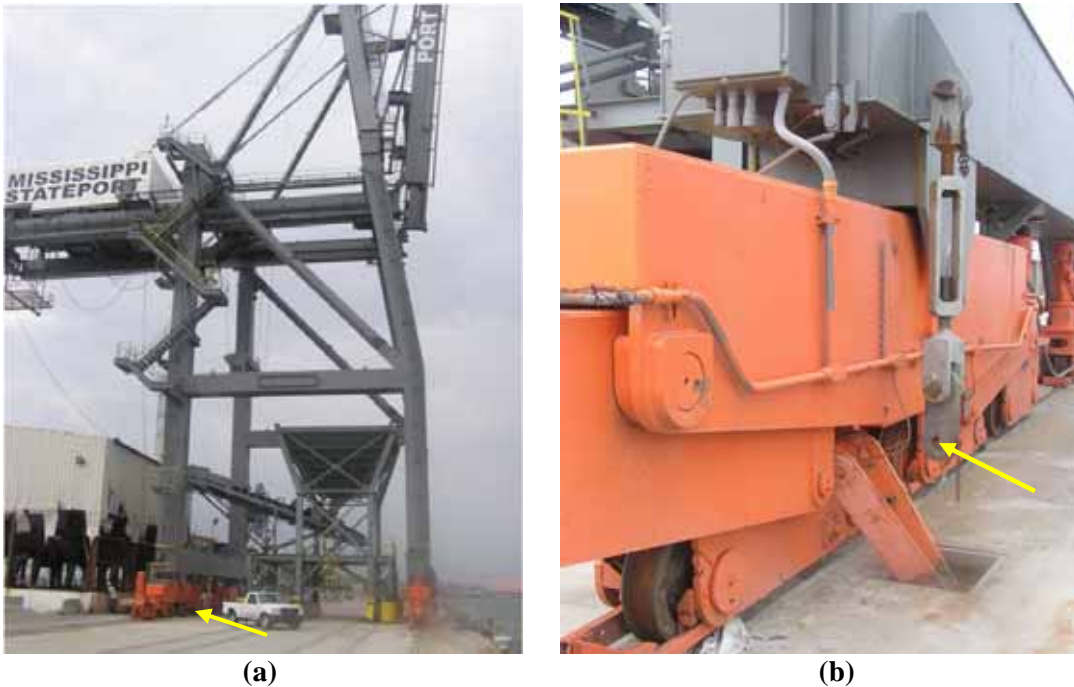
**Figure 4-65** (a) Container crane with tie-down damage at Port of Gulfport, Mississippi and (b) Broken restraint (photo credit: NIST)

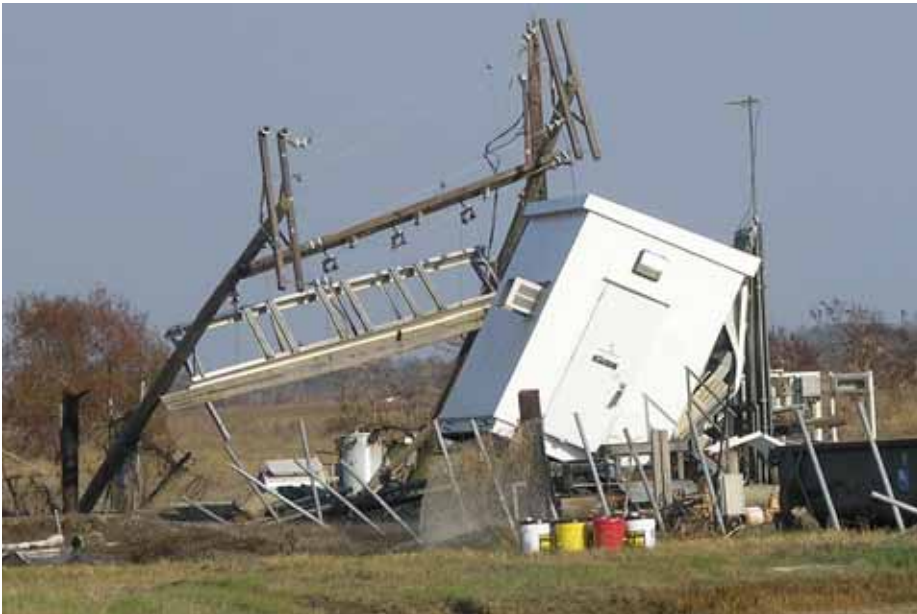
**Figure 4-72 Substation damaged by surge and waves on US Route 82 in Louisiana following Hurricane Rita (photo credit: NIST)**

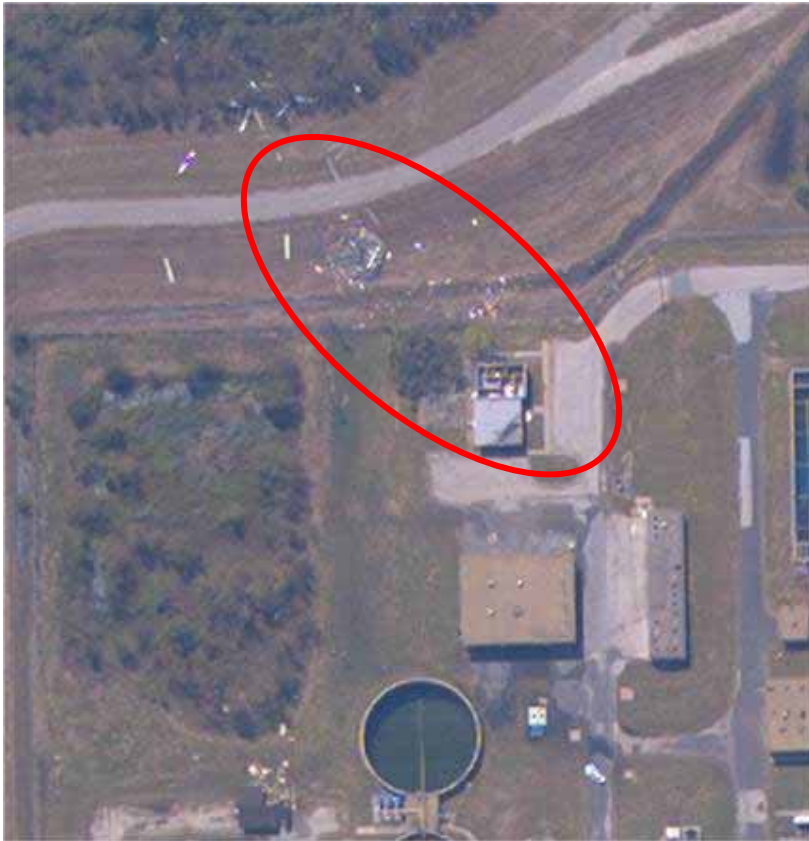
**Figure 4-74** Port Arthur Sewage Treatment Facility showing laboratory roof destroyed and resulting debris field (photo credit: R.T. Eguchi, ImageCat)

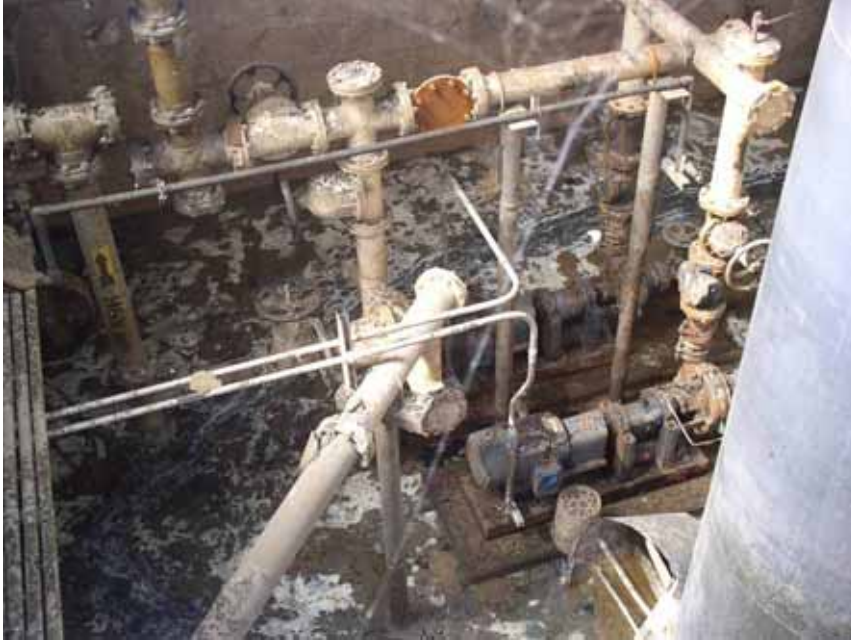
**Figure 4-75 Eastbank Wastewater Treatment Facility. Damaged pumps in lower right-hand corner. Facility was under water for approximately three weeks (photo credit: Ron T. Eguchi, ImageCat)**

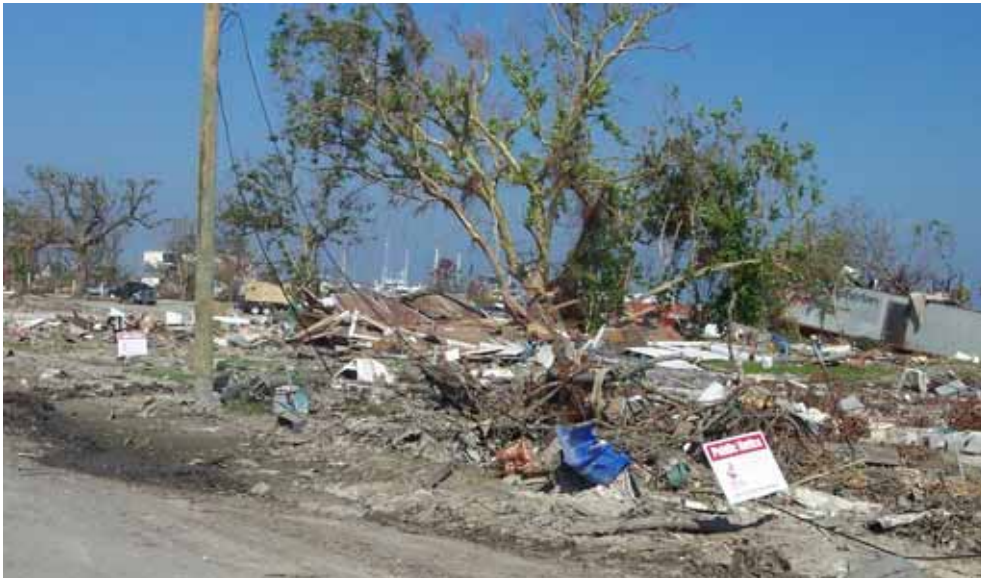
**Figure 5-1 Residential destruction from storm surge in Biloxi, Mississippi. (Photo credit: Thomas B. Rodino, Shiner Moseley and Associates, Inc.)**

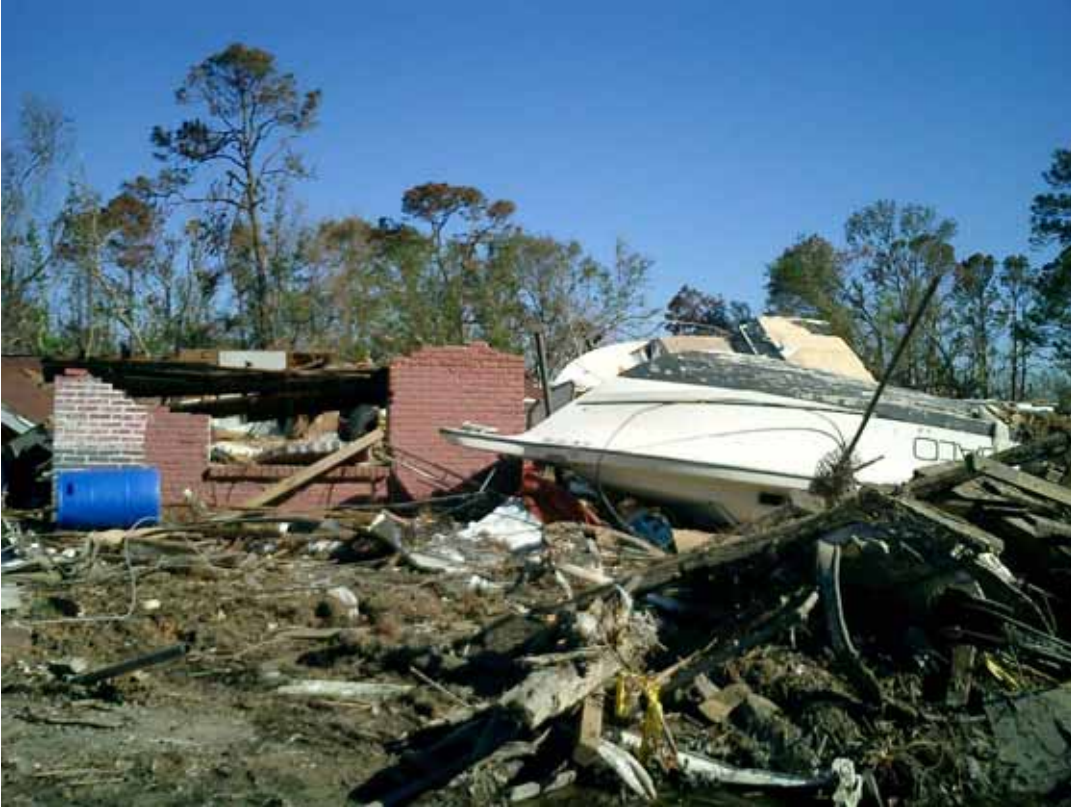
**Figure 5-2** Surge damage in a residential neighborhood in Biloxi, Mississippi. (Photo credit: Thomas B. Rodino, Shiner Moseley and Associates, Inc.)

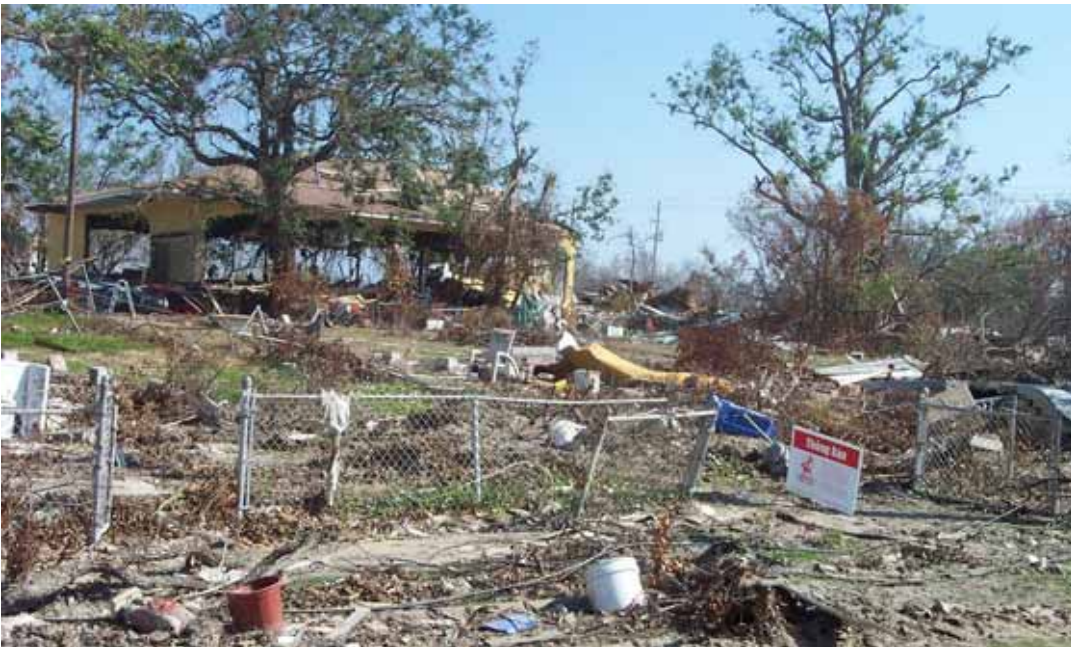
**Figure 5-3** Residential damage in Biloxi, Mississippi. Masonry components survived. (Photo credit: Thomas B. Rodino, Shiner Moseley and Associates, Inc.)

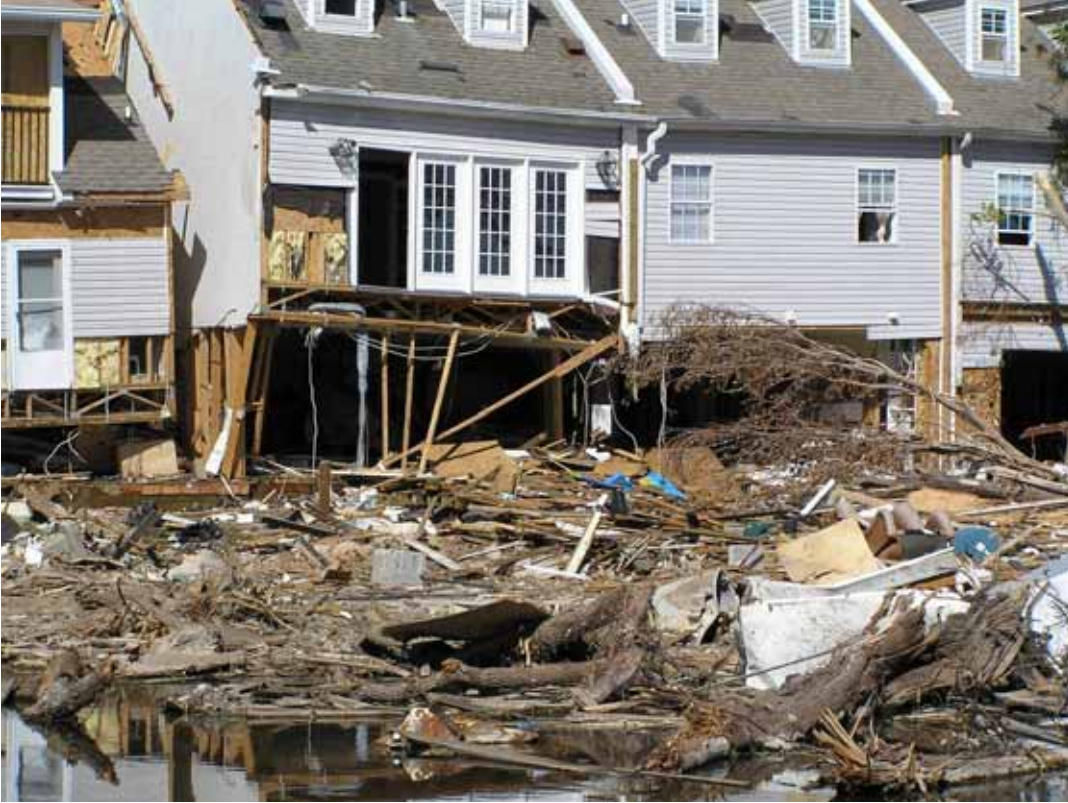
**Figure 5-4** Severe damage and destruction to townhomes in Gulfport, Mississippi. (Photo credit: NIST)

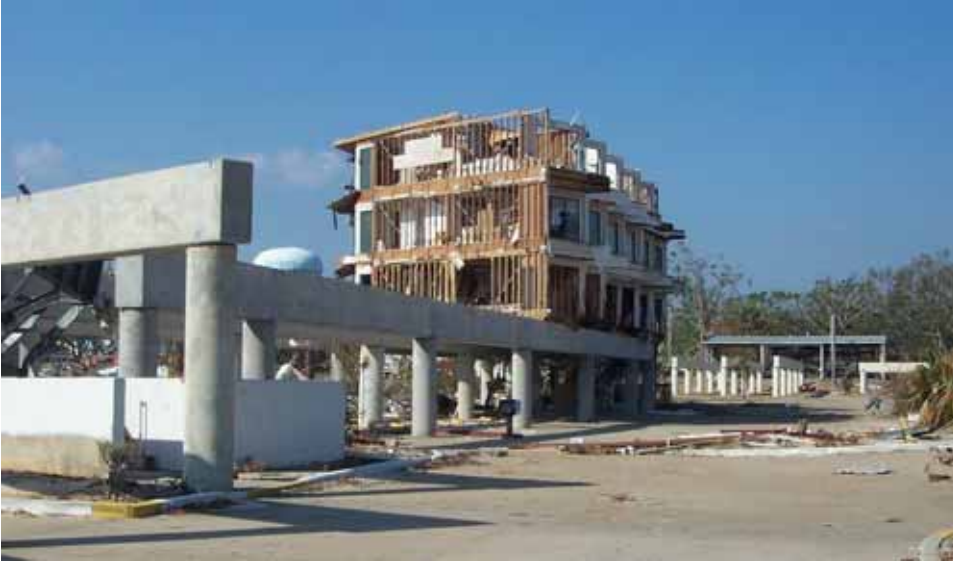
**Figure 5-6** Condominiums on the north side of U.S. Route 90 at Biloxi, Mississippi supported on precast concrete beams and piers. (Photo credit: Thomas B. Rodino, Shiner Moseley and Associates, Inc.)

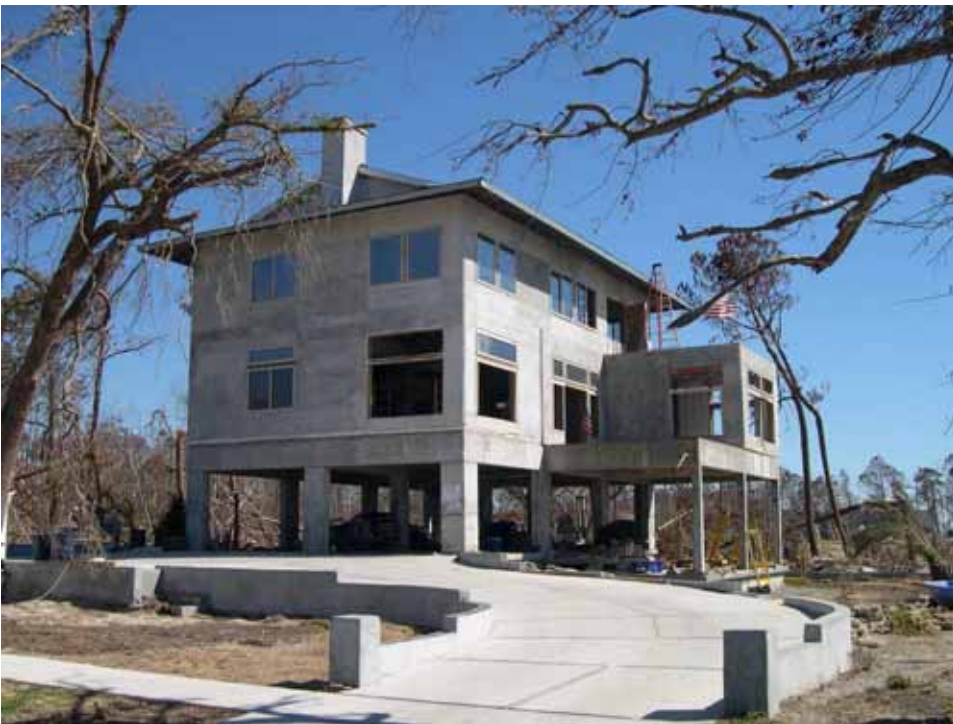
**Figure 5-7** Reinforced concrete residential structure that survived storm surge impacts. Though the lower level is washed out, the structure suffered no apparent structural or wind damage. (Photo credit: Jay H. Crandell, Applied Residential Engineering Services)

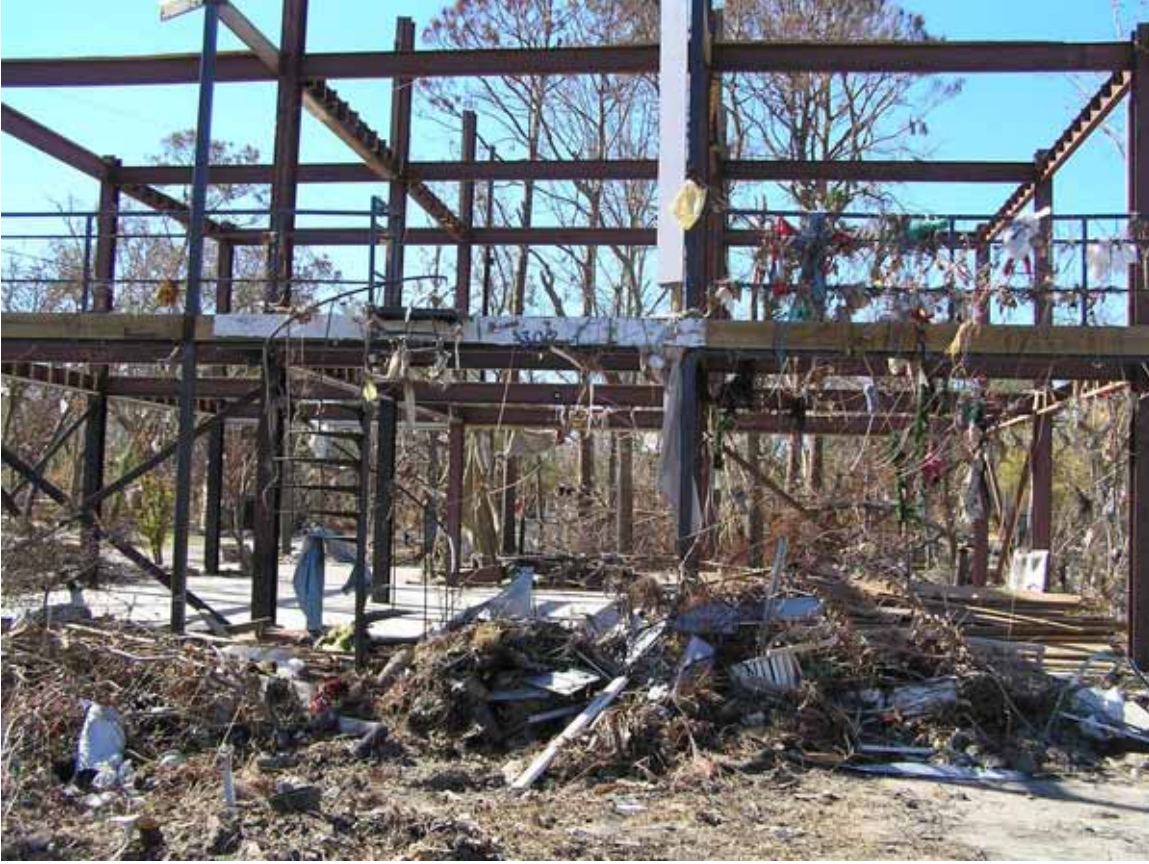
**Figure 5-8 Coastal residential structure with steel-frame skeleton and in-fill wood framing West of Bay St. Louis, Mississippi. The steel frame survived, but the in-fill wood framing was destroyed. (Photo credit: NIST)**

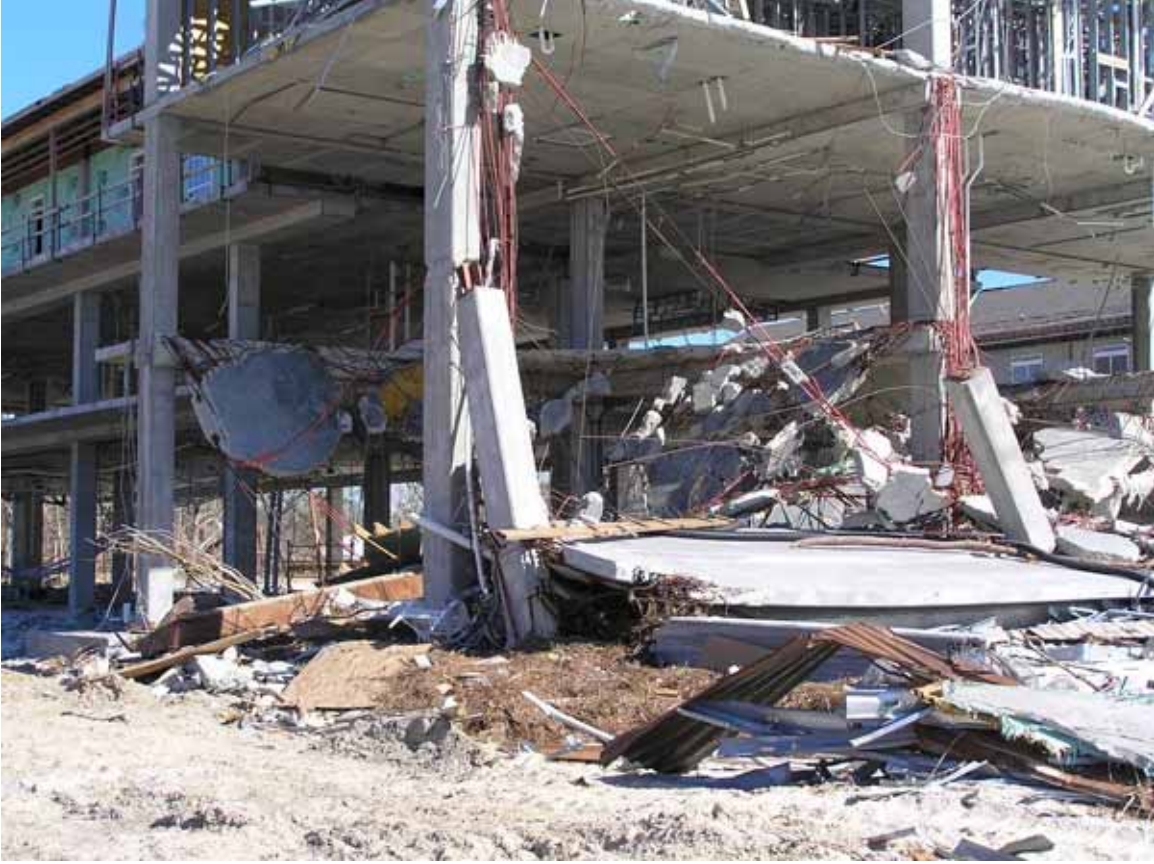
**Figure 5-9** Post-tensioned concrete residential structure in Pass Christian, Mississippi, north of US 90. (Photo credit: Jay H. Crandell, Applied Residential Engineering Services)

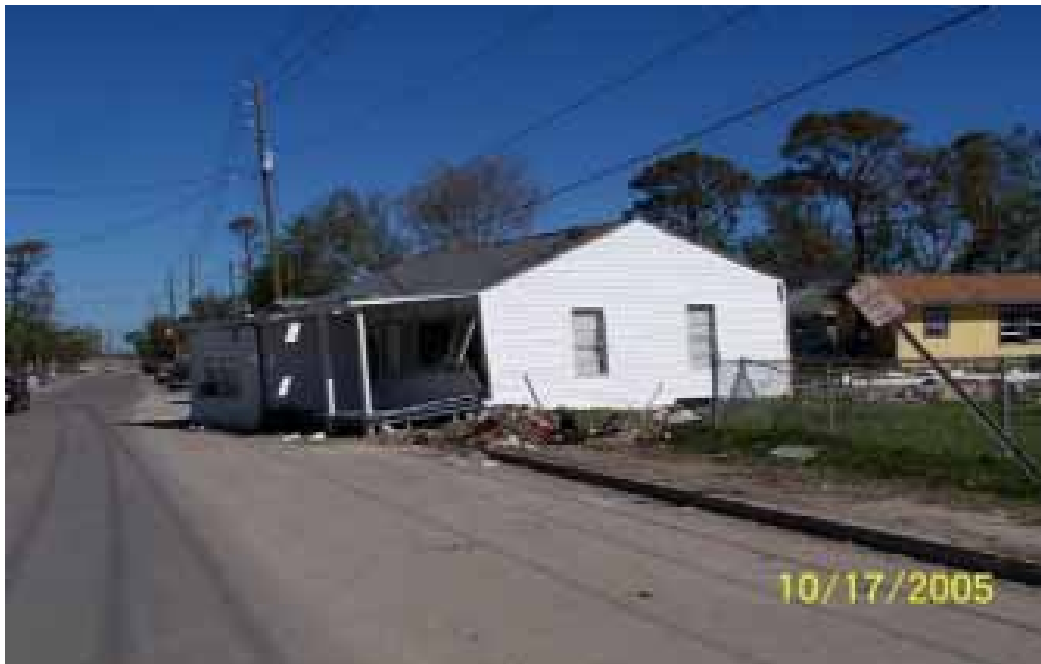
**Figure 5-10** A single-family residential structure in downtown Biloxi was pushed or floated off its low foundation. (Photo credit: Thomas B. Rodino, Shiner Moseley and Associates, Inc.)

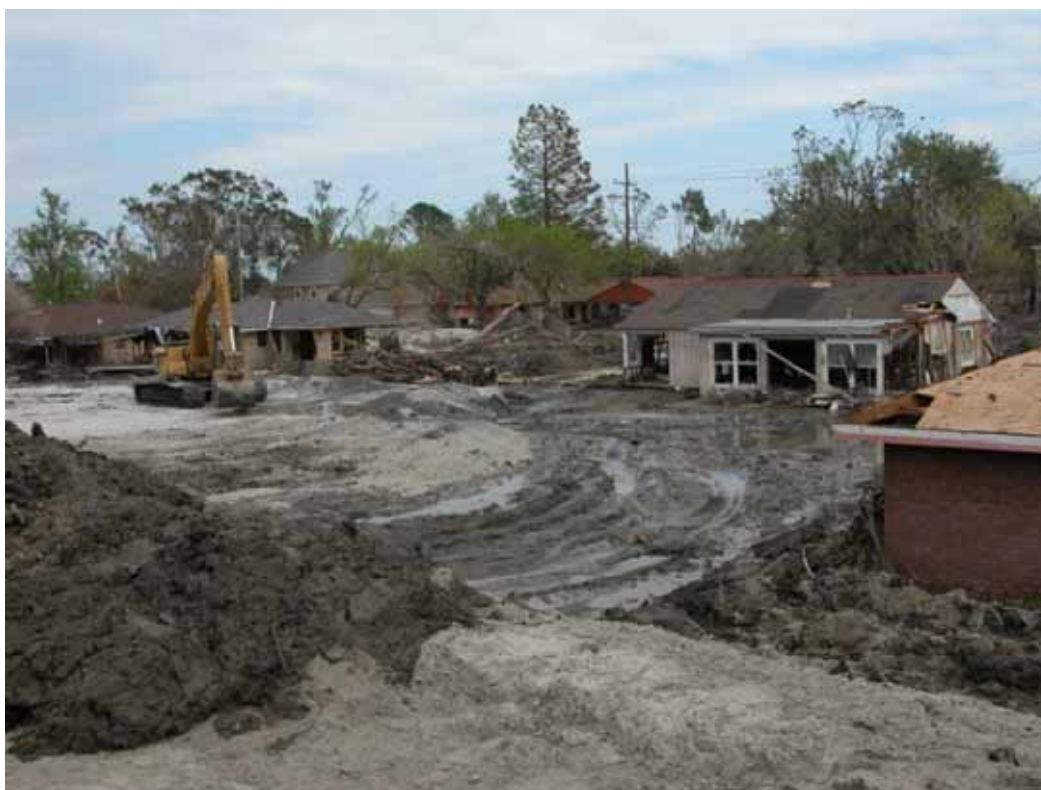
**Figure 5-11** Destruction of residential structures near the London Ave Outfall Canal breach in New Orleans. (Photo credit: Keith Porter, Scawthorn Porter Associates)

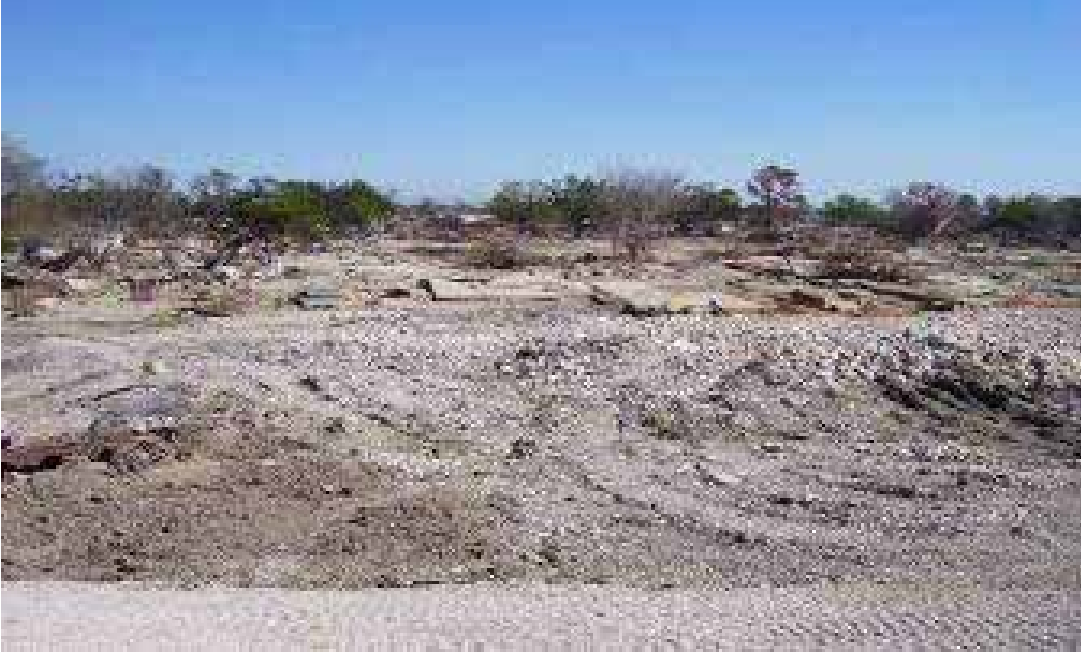
**Figure 5-12** Destruction of residential structures near the failure of the Industrial Canal Levee in New Orleans. (Photo credit: Edwin T. Huston, Smith and Huston Inc.)

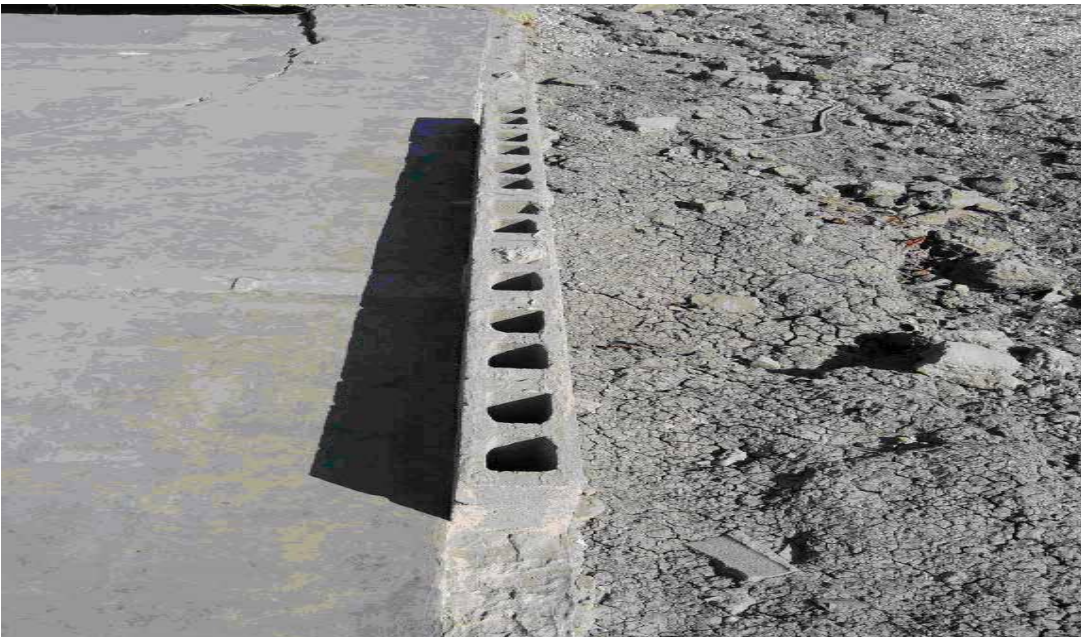
**Figure 5-13** Typical foundation in New Orleans showed lack of anchor bolts. (Photo credit: Edwin T. Huston, Smith and Huston, Inc.)

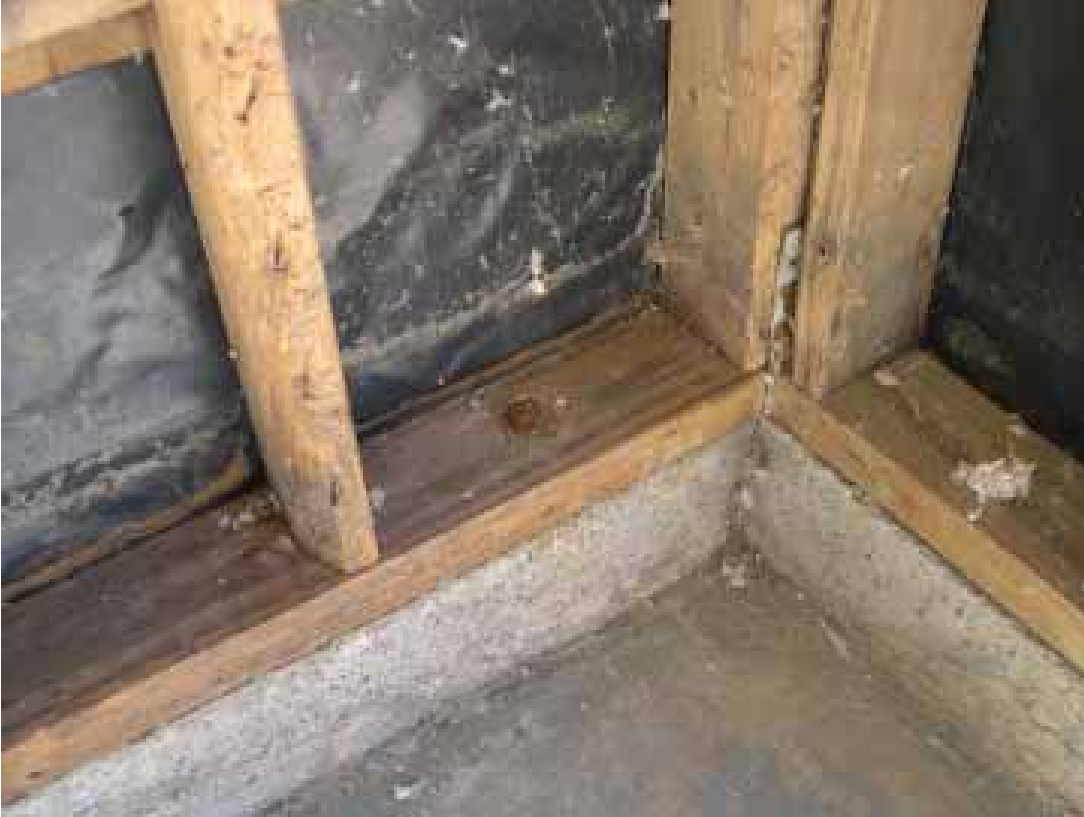
**Figure 5-14** Walls anchored to the foundation remained intact. (Photo credit: Edwin T. Huston, Smith and Huston Inc.)

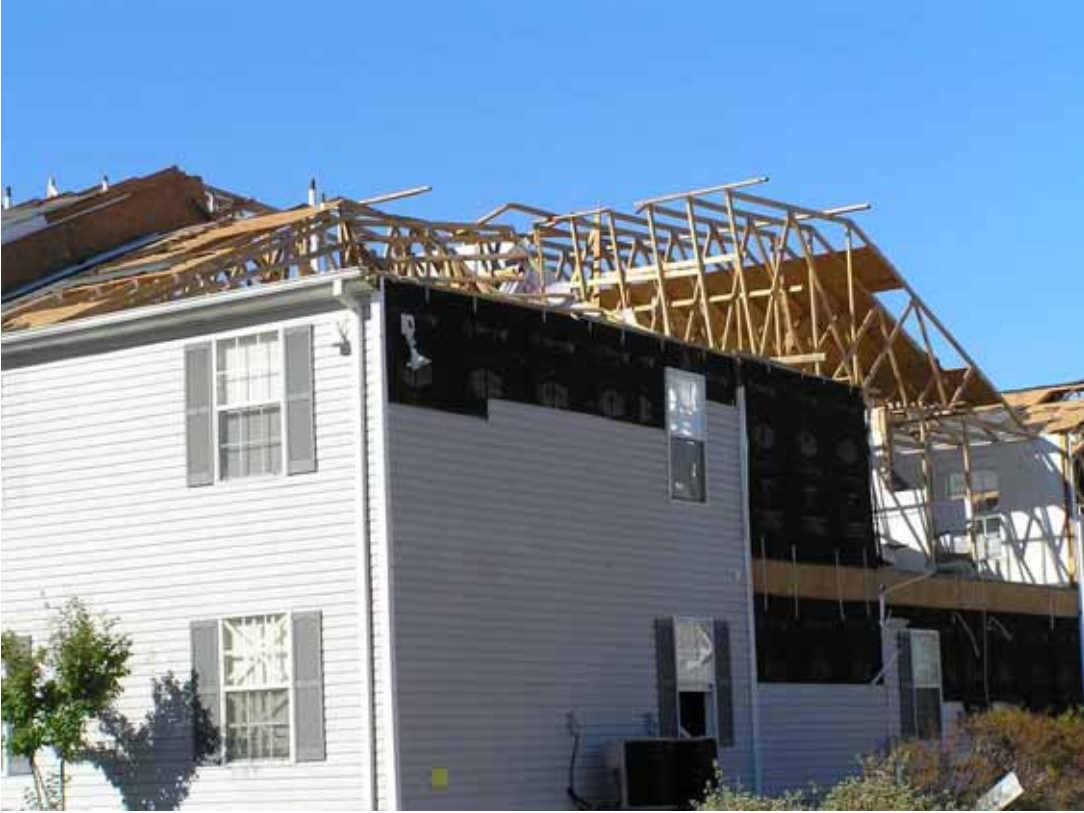
**Figure 5-15** Wind damage to an apartment building in Waveland, Mississippi. (Photo credit: NIST)

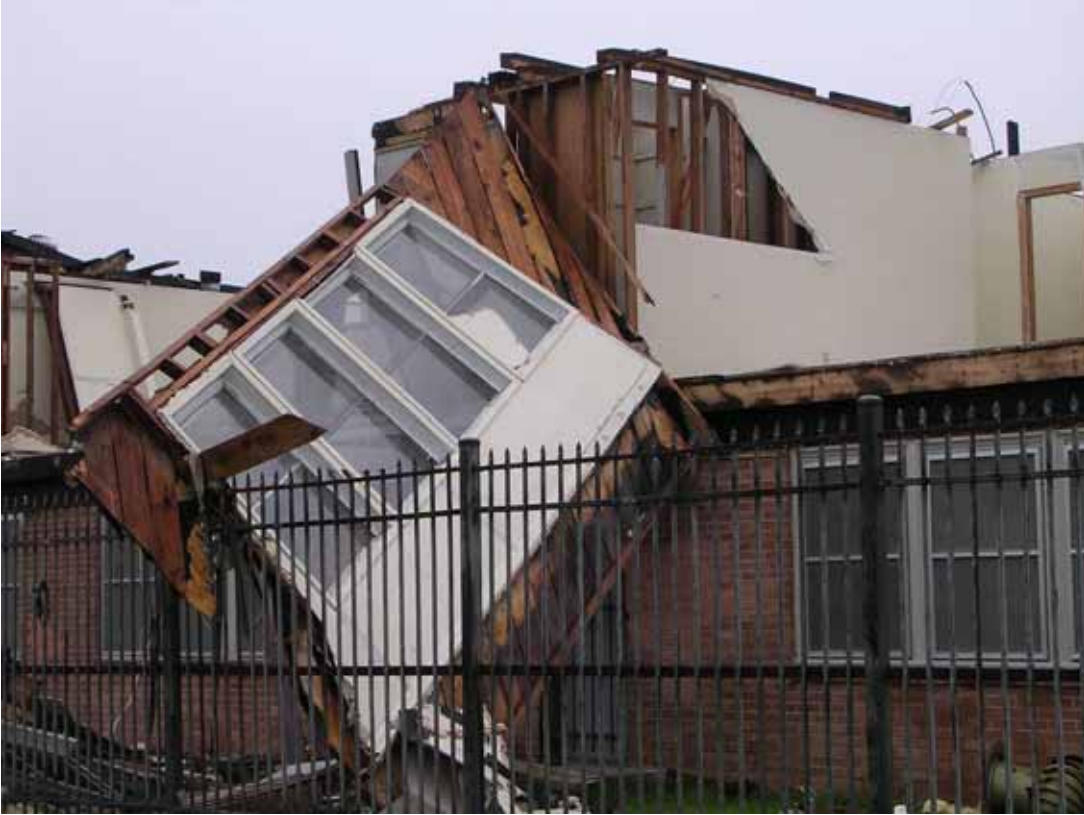
**Figure 5-16** Localized damage to an apartment building in Orange, Texas likely<sup>15</sup> attributable to tornadic or microburst effects. (Photo credit: Hua He, Texas Tech University)

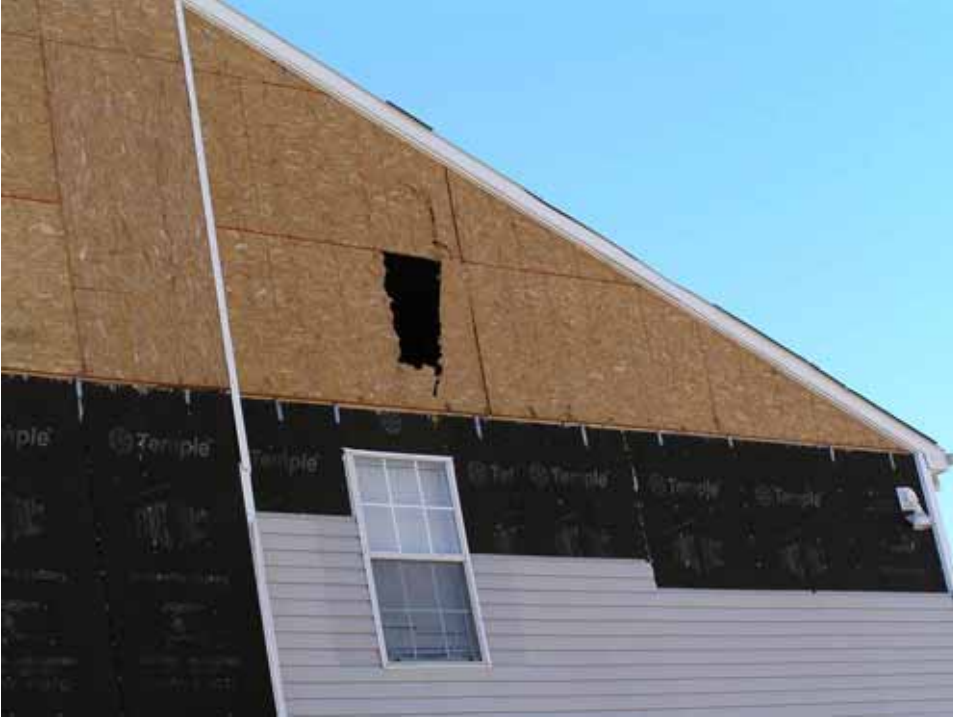
**Figure 5-17** Damage to apartment building in Waveland, Mississippi due to wind-borne debris. (Photo credit: NIST)

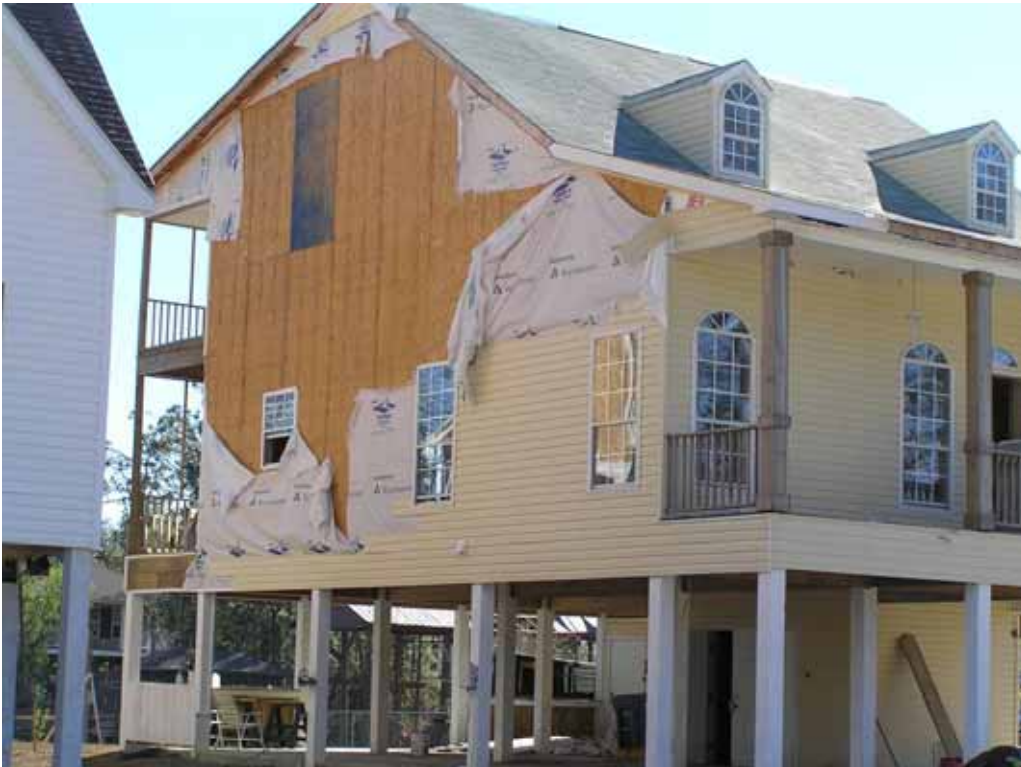
**Figure 5-28** Damage to exterior cladding of a single-family residential structure near Pass Christian, Mississippi. (Photo credit: NIST)

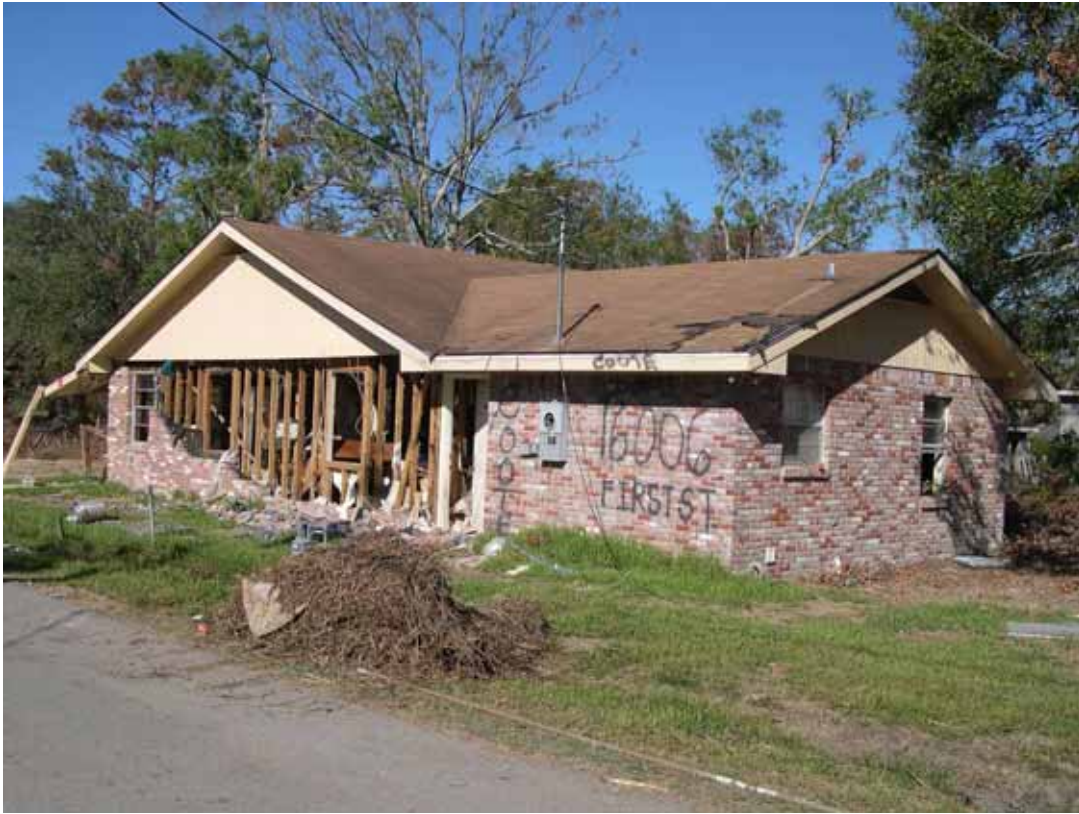
**Figure 5-29** Damage to brick cladding and other exterior wall components for a single-family dwelling in Pearlington, Mississippi. (Photo credit: Jay H. Crandell, Applied Residential Engineering Services)
