*NIST Technical Note 1491*

# Performance of Thermal Imaging Cameras In High Temperature Environments

November 2007

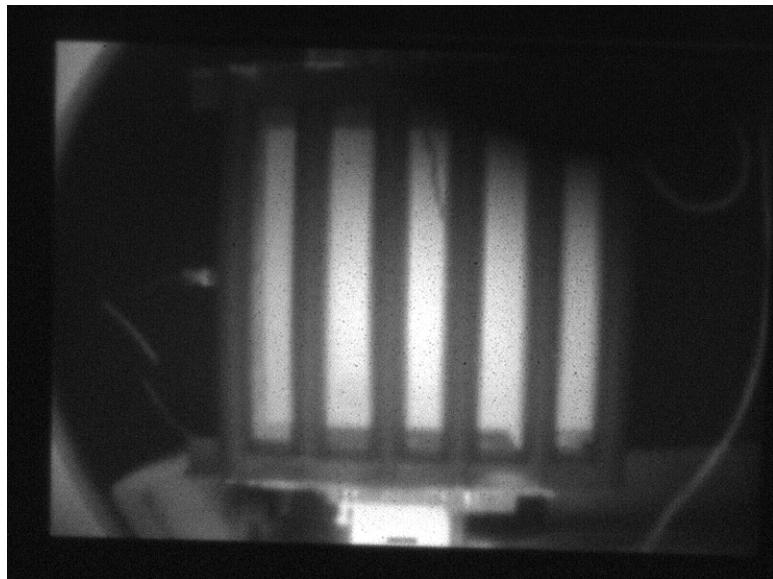
Camera 1 was then tested at the Thermal Class III condition of 260 °C exposure for 5 min. This camera survived the 5 min exposure with no changes in the display and no degradation of the picture; however, it failed immediately afterwards during the cool down. Approximately 45 s into the cool down, the top edges of the screen began to darken. The darkening of the screen continued over the next 120 s, working from the edges to the interior until the entire image was gone. Figure 8 shows a picture taken 80 s into the cool down, with darkening of the screen visible in the upper right hand corner (compare with Figure 2). After cool down, an inspection of the camera revealed that the casing of the battery had melted and deformed. Other than the warping of the battery case, there was no other observable melting, deformation, or damage of any kind to any other parts of the camera. The battery housing area was inspected and showed no internal damage. A new, fully charged battery was then supplied to the camera; however, camera operation did not recover.

**Figure 8**      **Photograph showing the screen of TIC 3 darkening just before failure.**
