NBS TECHNICAL NOTE 558

LUBBOCK TORNADO: A Survey of Building Damage in an Urban Area

N. F. Somes, R. D. Dikkers, and T. H. Boone

Building Research Division
Institute for Applied Technology
National Bureau of Standards
Washington, D.C. 20234

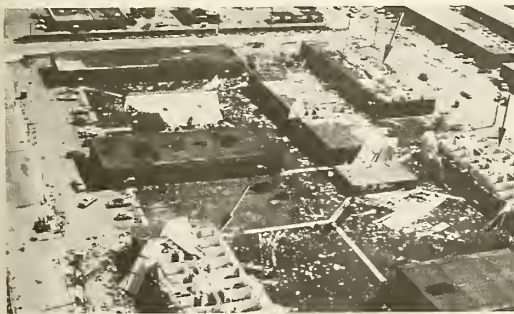
Photograph 1 shows roof decks completely ripped from low-rise apartment buildings. Photograph 2 shows how wind struck the corners of the buildings, attacked the edge flashing, ripped the flashing apart,

Photograph 1—Apartment complex with considerable loss of structural roof deck. View looking south. (Location 1)

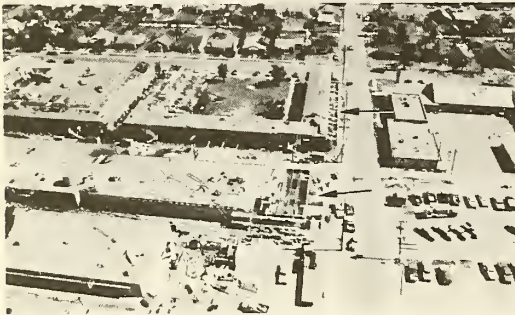
On that part of its path shown by the broken line in figure 5, the tornado traveled east-west, touching ground discontinuously. One touchdown point is shown in photograph 4. In the foreground, the west end of buildings of the Hygeia-Ozarka Water Com-

Photograph 4—Roof and wall damage to building of Hygeia-Ozarka Water Company located in center foreground. View looking south. (Location 3)

pany suffered damage to roofs and walls. In the center of the photograph, an apartment complex lost a considerable portion of its roof.

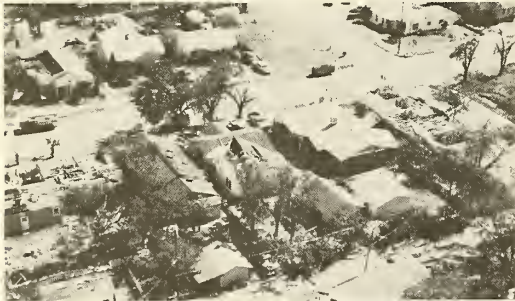
Photograph 5—Random damage to gable roofs of wood framed houses. View looking south. (Location 4)

The erratic distribution of damage to the gable frame roofs of in-city houses is illustrated in photo-

graph 5. Some houses sustained complete destruction of the structural roof while others had only slight damage to the tabs of asphalt shingles. Such variations were discussed at the beginning of this chapter. Many non-reinforced masonry chimneys on older houses in this same area had toppled over causing considerable damage to the roofs.

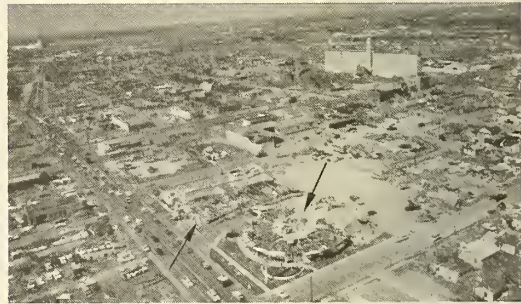
Newsom's Living Center is shown in the foreground of photograph 6 and comprises a circular one-story building and an adjoining two-story building, rectangular in plan. The tornado is believed to have passed directly over these structures before changing its direction of travel to the northeast. The one-story building was destroyed while the second floor of the two-story building was badly damaged. Considerable distortion of the steel frame occurred in both structures.

Photograph 6—View looking northeast from center of city. Note destruction of Newsom's Living Center and neighboring buildings in the foreground. (Location 5)

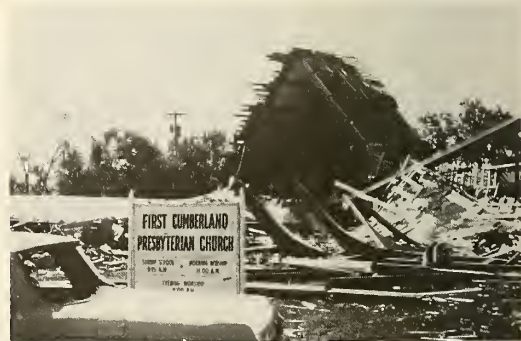
The all-timber superstructure of the First Cumberland Presbyterian Church was destroyed as shown in photograph 7. Damage to a nearby house is shown in photograph 8. Free-tab lightweight asphalt shingles were torn off the south slope of the house roof.

Photograph 7—Church of timber construction. View looking northwest. (Location 6)

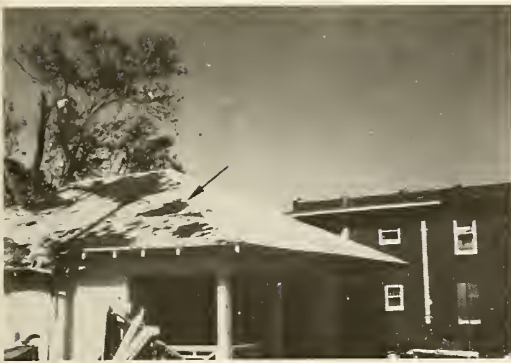
Photograph 8—Partial loss of asphalt shingles on south slope of roof. (Location 6)

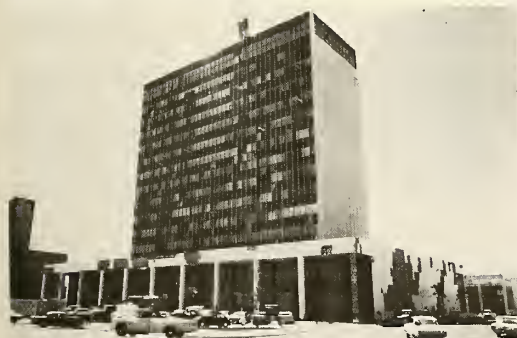
Damage to the 15-story First National-Pioneer Building was estimated at \$1 million.³ This reinforced-concrete frame building was completed in January, 1969, and consists of a large two-story base and a 13-story tower. As shown in photograph 9, exterior marble veneer was stripped from portions of the two-story base. Some loss of marble veneer was observed on all four elevations of the building. Extensive damage to the glazing and the glass spandrels of the 13-story tower can also be seen in photograph 9. Interior building damage was reported to be severe and included damage to suspended ceilings.

Photograph 9—View of First National-Pioneer Building looking southeast. Glazing, spandrel glass veneer and marble veneer severely damaged. (Location 7)

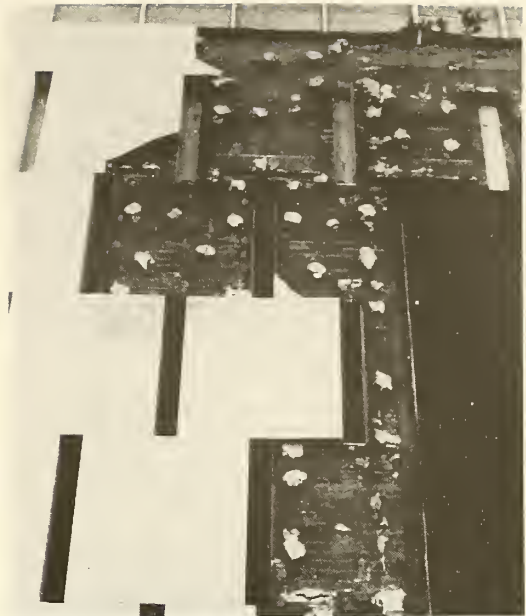
Close-up views of the marble veneer damage on the east elevation of the building are provided by photographs 10 and 11. Typical pieces of marble

Photograph 10—Close-up of marble veneer on east elevation of First National-Pioneer Building. (Location 7)

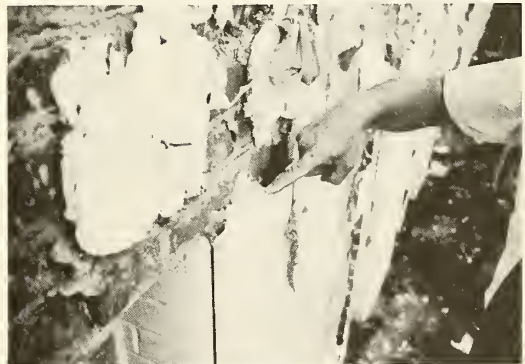
Photograph 11—Marble veneer anchorage failure; First National-Pioneer Building. (Location 7)

veneer are approximately 8 sq. ft. (2 ft. by 4 ft.) in area and $\frac{7}{8}$ -in. thick. This veneer was tied by copper wire anchors to masonry or concrete backup. In most places the loss of marble veneer was due to the wire anchors pulling out of the holes in the edge of the veneer. Splitting of the marble veneer at the anchor holes was also observed; note photograph 11.

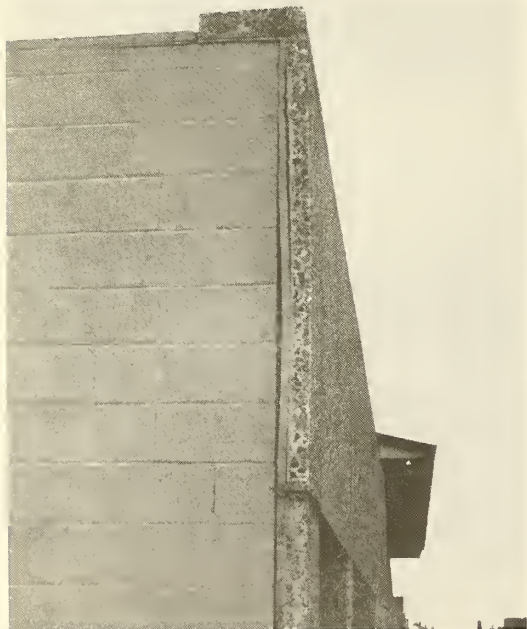
A dislodged precast concrete panel was noted at one exterior corner of the Sanders Funeral Home (photograph 12). In the front part of this building, the overhanging roof had been lifted and damaged. In the interior of the building, cracking along the wall/roof intersection was also noted.

Photograph 12—Dislodged precast concrete panel at northwest corner of Sanders Funeral Home. (Location 8)

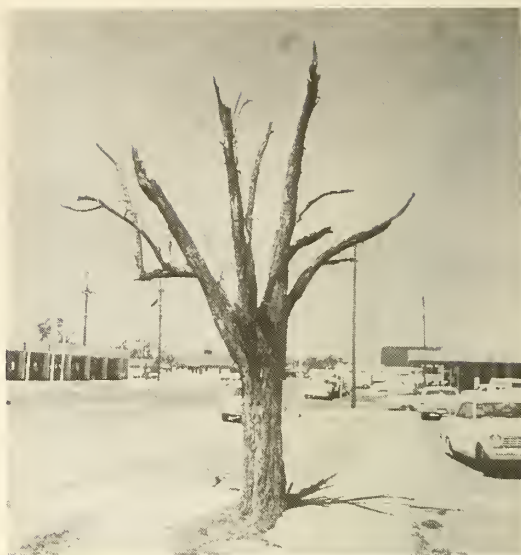
Typical tree damage is shown in photograph 13. A few trees in this area had also been uprooted.

Photograph 13—Typical tree damage. View looking west. (Location 8)

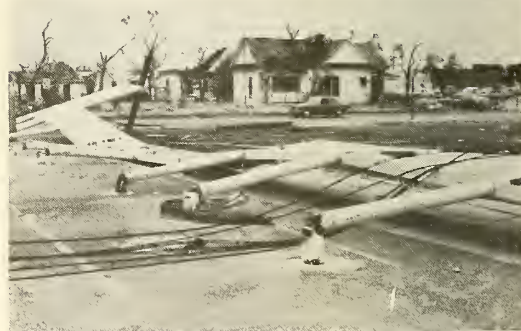
Although heavily damaged, the steel sign in photograph 14 was anchored sufficiently to prevent it from being blown away; failures at the base of the steel posts occurred at weld locations (photograph 15).

Photograph 14—Damage to sign with tubular steel posts. View looking north. (Location 9)

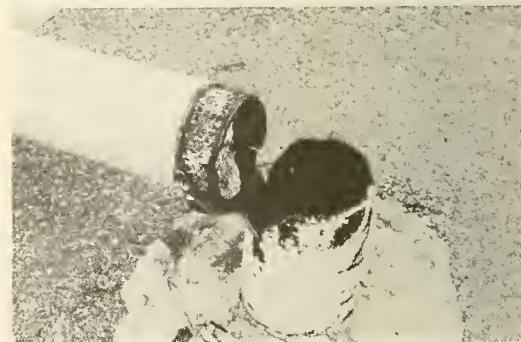
Photograph 15—Weld-fracture at base of sign posts shown in Figure 14. (Location 9)

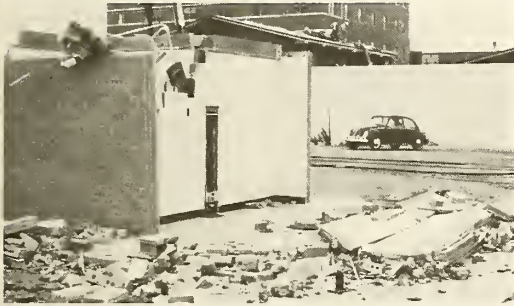
Photograph 16—Small office building for dealer in used automobiles. Roof structure completely removed and non-reinforced masonry walls badly damaged. (Location 9)

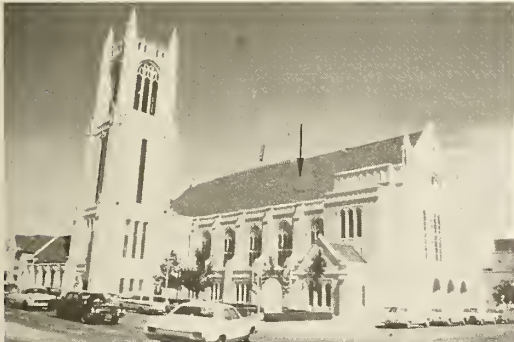
Photograph 17—View of First Methodist Church looking northwest. This masonry structure sustained only minor damage to clay roof tiles and to glazing. (Location 10)

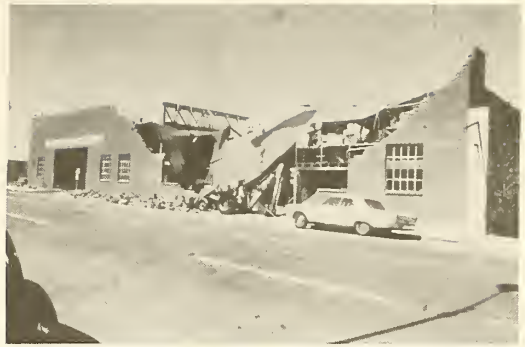
Photograph 18 shows the Texas, New Mexico and Oklahoma Coach Company maintenance shops and damage to the east wall and roof structure of this one-story building which is almost square in plan. At the south end of the west elevation, an 18-foot-wide overhead door was pushed into the building. The combination of wind pressure inside the building and wind force on the approximately four-foot-high parapet caused the outward collapse of the lightly-loaded masonry east wall shown in the photograph. The wood roof collapsed with the loss of support from the wall. The masonry wall was 12 inches thick and consisted of a 4-inch brick facing and 8-inch clay tile backup.

Photograph 18—Maintenance shops of Texas, New Mexico and Oklahoma Coach Company. View looking southwest. (Location 11)

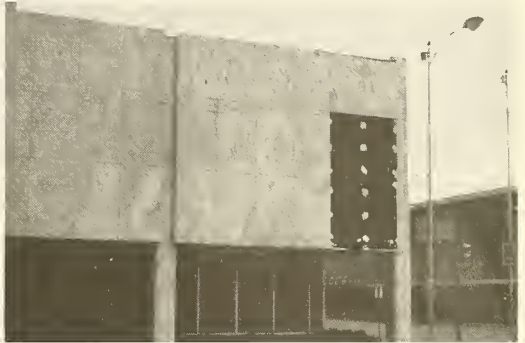
The west elevation of a store is shown in photograph 19. Near the south end of this elevation four panels of marble veneer were missing from the facade.

Photograph 19—West elevation of store with loss of marble veneer. (Location 12)

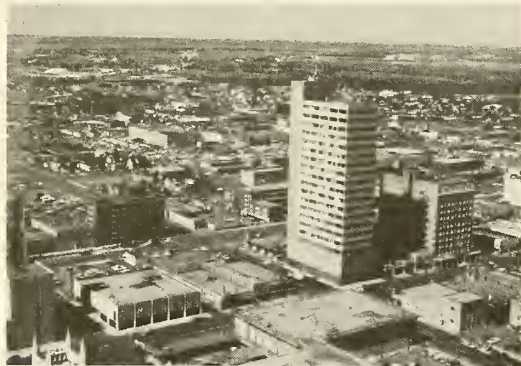
Approximately 50 percent of the glazing was pushed into the building on both the south and west elevations as shown in photograph 20. This effect is concentrated near the southwest corner as shown in photographs 20 and 21. On the east elevation,

Photograph 20—Center of City with 20-story Great Plains Life Building in foreground. View looking northeast. (Location 13)

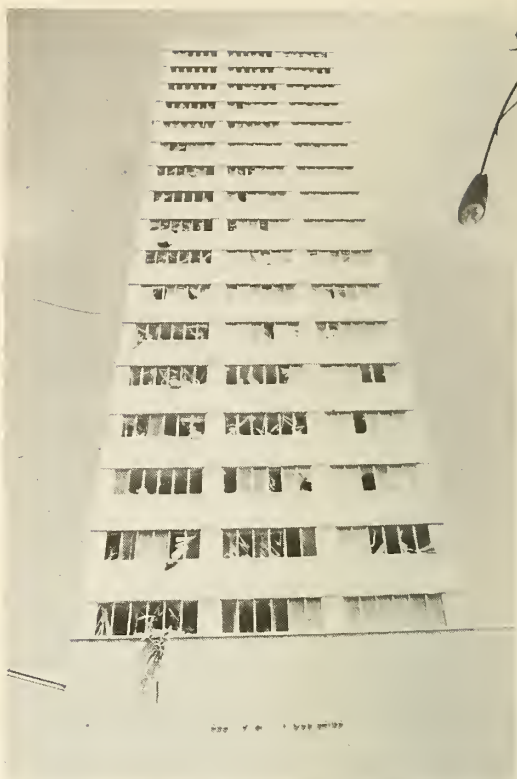
Photograph 21—South elevation of Great Plains Life Building. Glazing damage was particularly severe on southwest corner of building. (Location 13)

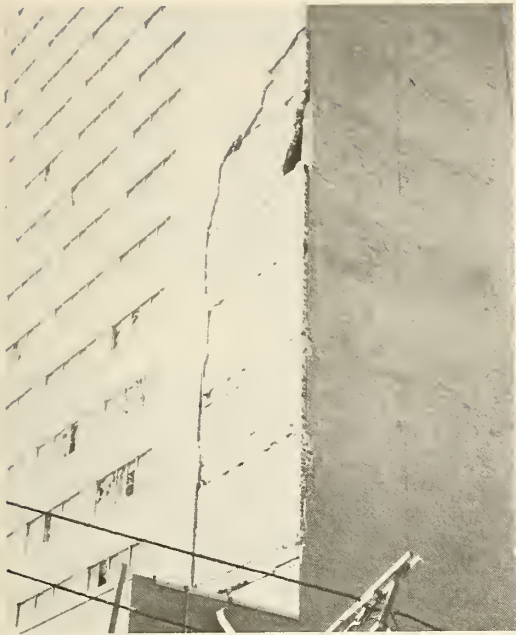
On the north edge of the east elevation the combination of the air flow around the building and the twisting of the building caused the loss of brick veneer over a clay tile infill wall panel enveloping the utility tower. This area extended vertically over seven stories with a maximum width of 20 feet; note photograph 22. From ground level it appeared that the brick was bonded by brick headers to the clay tile backup.

Photograph 22—Northeast corner of Great Plains Life Building with loss of brick veneer over clay tile infill wall panels enveloping the utility tower. (Location 13)

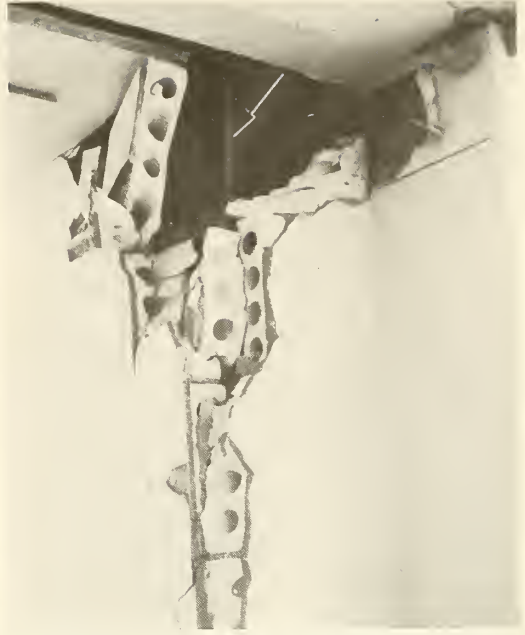
Photograph 23—Disruption of gypsum-tile fire protection to steel column in the Great Plains Life Building. (Location 13)

Other evidence of this torsional rotation was provided by similar cracking of fire protection to steel columns adjacent to the utility tower. In these columns the cracks were at 45 degrees to the horizontal. Photograph 23 shows that the movement of one steel column on the sixth floor was large enough to cause disruption of gypsum tile.

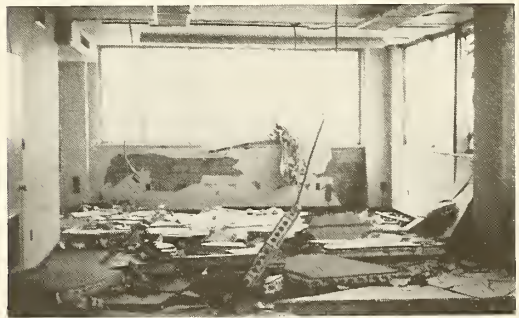
Photograph 24—Southwest corner on the sixth floor of Great Plains Life Building. The 3-inch gypsum tile non-loadbearing walls were shattered by wind pressure. (Location 13)

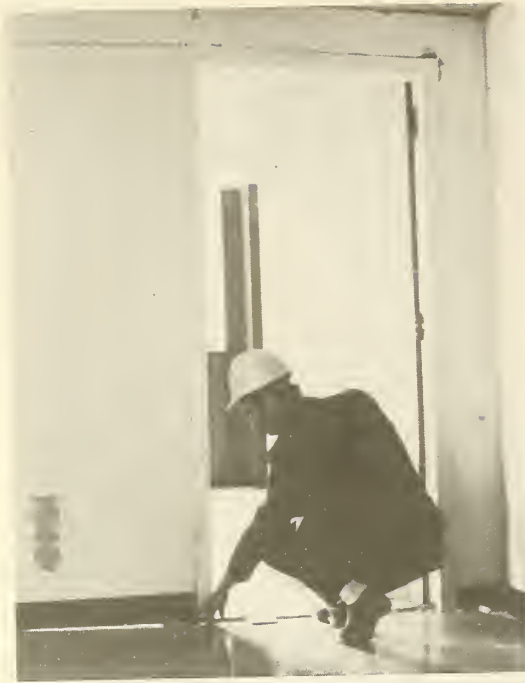
Photograph 25 shows a one-inch vertical movement of the gypsum tile partition at the southeast corner of the sixth floor. In this case the ceiling and wall remained in contact and the resulting movement racked a door frame.

Photograph 25—One inch vertical movement of gypsum tile partition at southeast corner of sixth floor of Great Plains Life Building. Note racking of door frame. (Location 13)

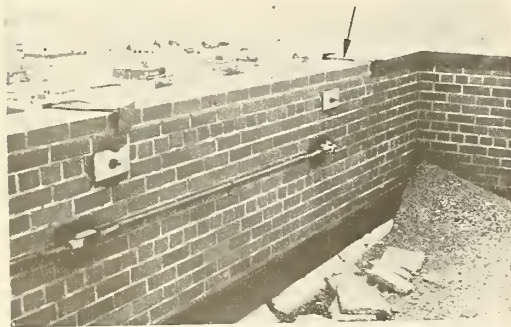
Photograph 26—Eight-foot lengths of stainless steel coping were completely stripped from east parapet wall on the roof of the Great Plains Life Building. (Location 13)

There was considerable damage at both the roof level and at the top of the utility tower which rises 40 feet higher. In one area where an exhaust vent passed through the roof, a 4 foot square area of built-up roofing around the vent was lifted. The brick parapet wall on each side of the roof was capped by stainless steel coping in 8-foot lengths.

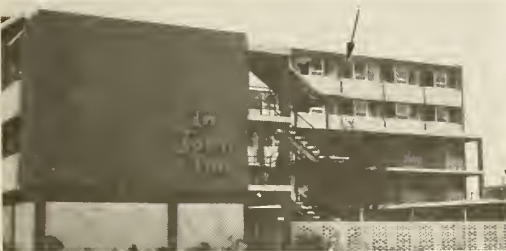
Photograph 27—South elevation of five-story motel with damage to glazing in upper floors. (Location 14)

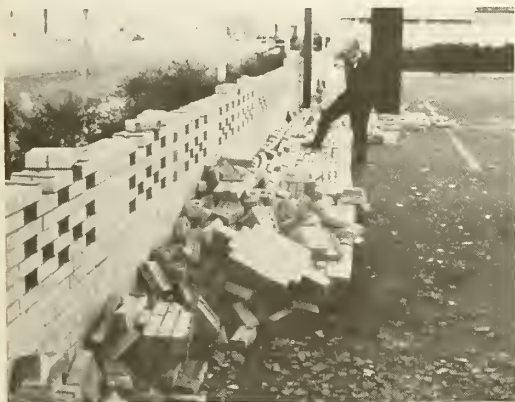
Photograph 28—East-west brick wall with the upper 40-inch height overturned. (Location 14)

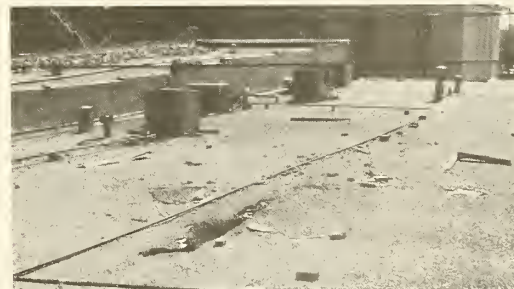
Photograph 31—View looking northeast showing roof of Recruiting Station for U.S. Military Services. Note punctured roof in foreground and overturned parapet wall to the rear. (Location 16)

As shown in photograph 31, the damage to the

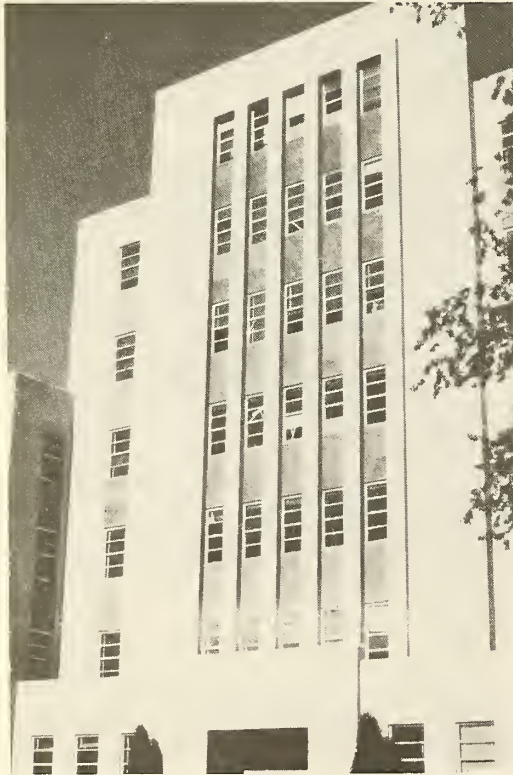
Photograph 33—West elevation of County Court Building suffered only slight glazing damage. (Location 18)

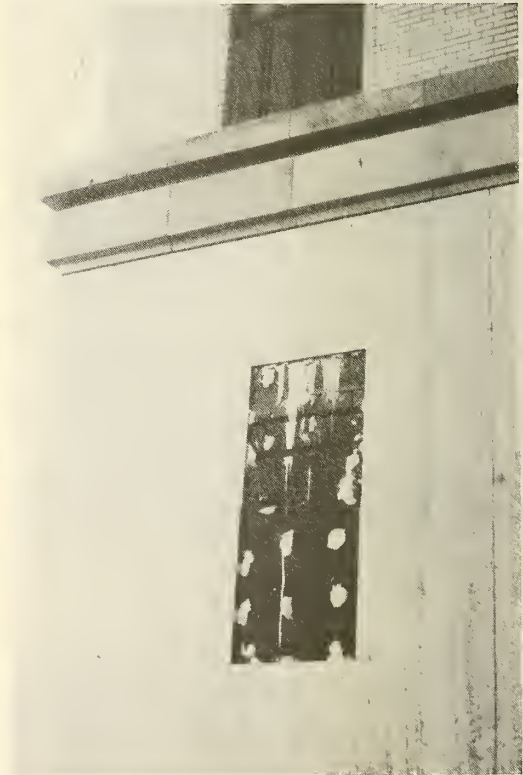
Photograph 34—Marble veneer dislodged from east elevation near southeast corner of Lubbock National Bank. (Location 19)

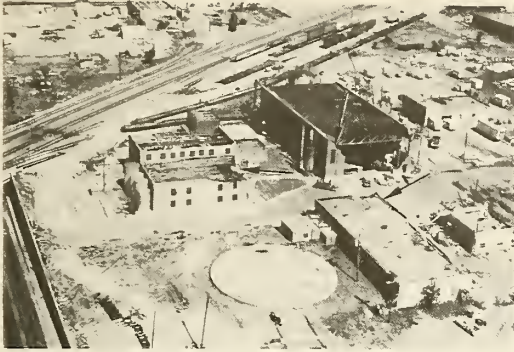
Photograph 35—Wall and roof damage to light industrial buildings. View looking east. (Location 20)

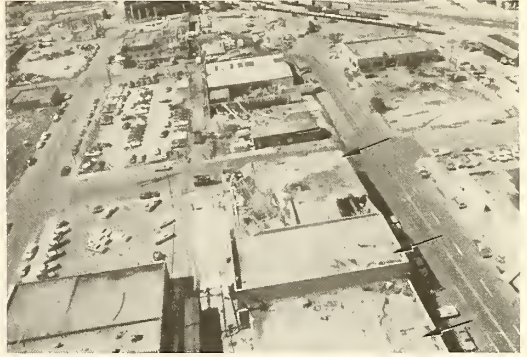
Photograph 36—Roof damage to light industrial buildings. View looking north. (Location 20)

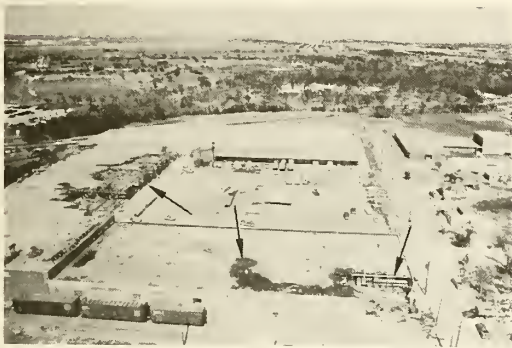
Photograph 37—K. T. Ibell Wholesale Grocery Warehouse with roof and wall damage. View looking west. (Location 21)

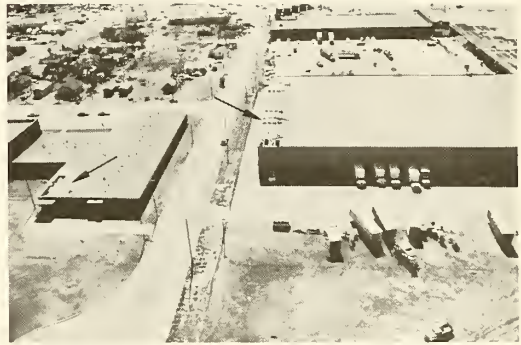
Photograph 38—K. T. Ibell Wholesale Grocery Warehouse with damage at edge of roof. View looking west. (Location 21)

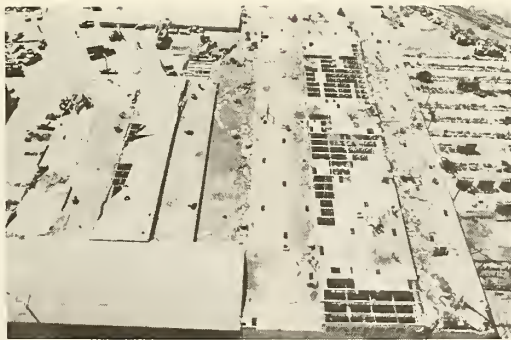
Photograph 39—Damage to roofs of light industrial buildings of the Hancock Division of Clark Equipment Company. View looking west. (Location 22)

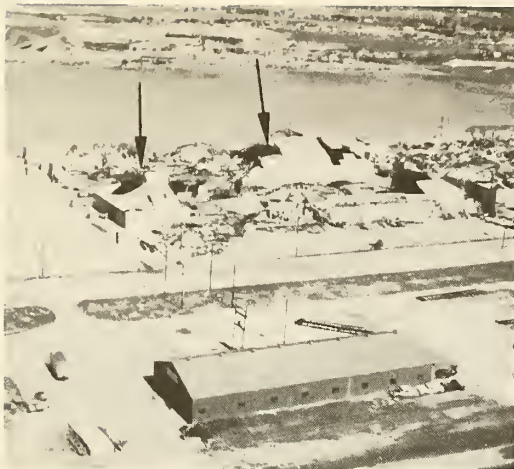
Photograph 40—Destruction of cotton process buildings. View looking east. (Location 23)

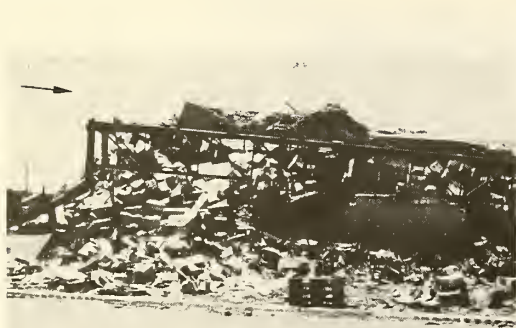
Photograph 41—Destruction of a soft-drink warehouse. View looking west. (Location 24)

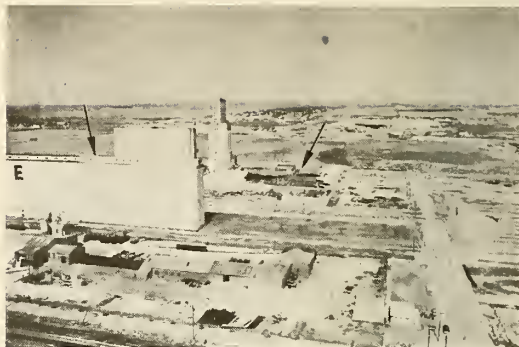
Photograph 42—Damage to roof structure of light industrial building. View looking east. (Location 25)

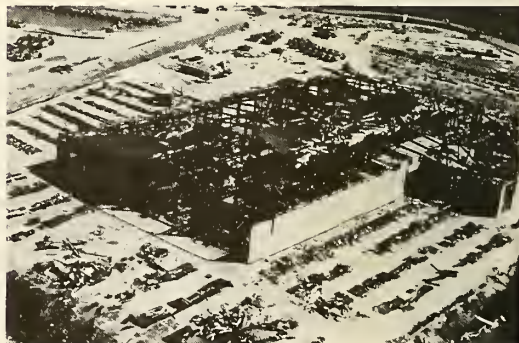
Photograph 43—Clark Equipment Company workshop with stripping of corrugated metal roofing and distortion of the structural steel frame. View looking south. (Location 26)

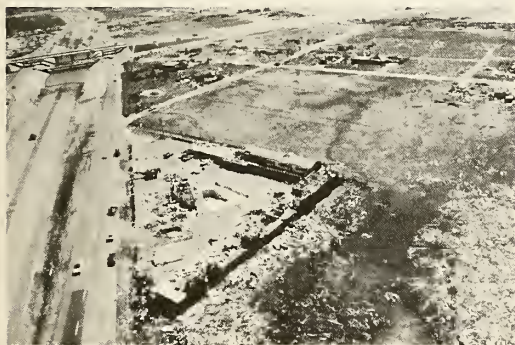
Photograph 44—View looking south over the destroyed two-story Ramada Inn Motel. (Location 27)

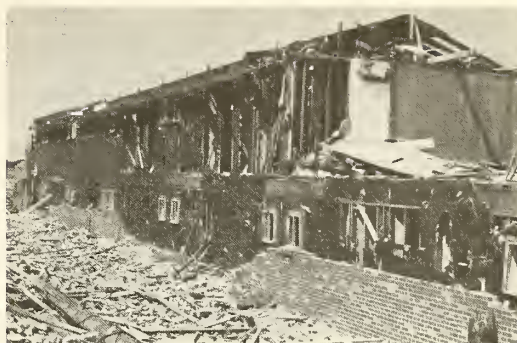
Photograph 45—Southwest elevation of Ramada Inn with effect of intense bombardment by debris. (Location 27)

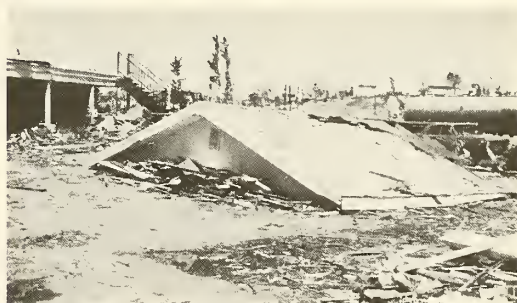
Photograph 46—Complete wood frame roof sucked from the forecourt building of the Ramada Inn Motel and transported 40 feet. (Location 27)

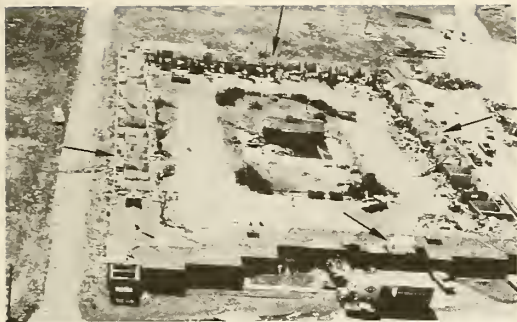
Photograph 47—Motel with loss of complete roof structure on south, west and north sides and loss of some roof covering on east side. View looking west. (Location 27)

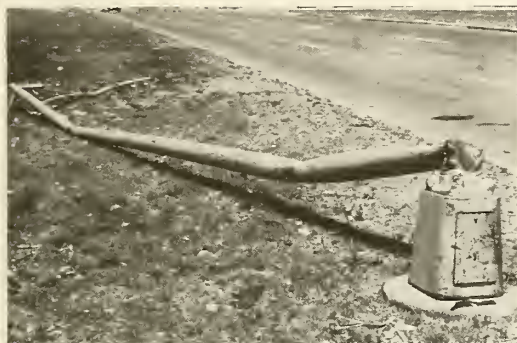
Photograph 48—Collapsed steel lighting standard on U.S. Route 87. View looking north. (Location 28)

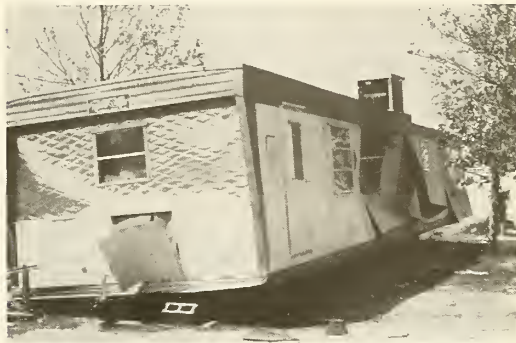
Photograph 51—Typical damage to light aluminum skins of mobile homes at Quirt Road. (Location 30)

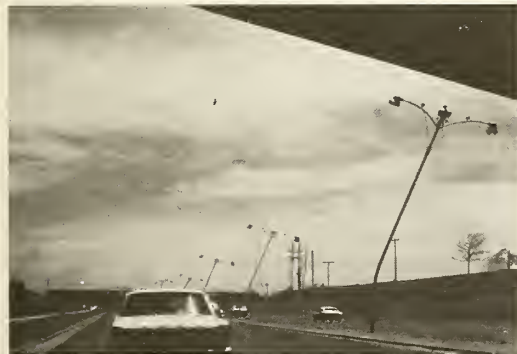
Photograph 49—Median strip lighting standards leaning to the north on U.S. Route 87. (Location 29)

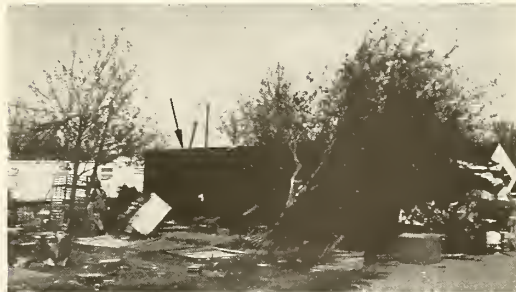
Photograph 52—Several unanchored mobile homes overturned. (Location 30)

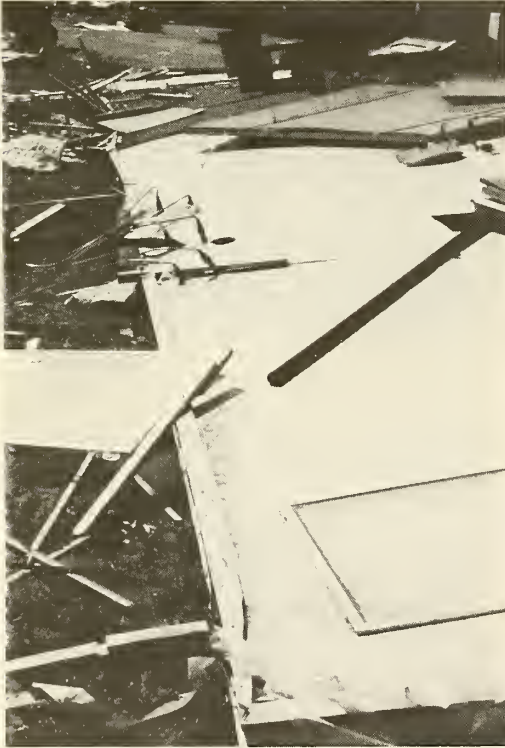
Photograph 53—Base of mobile home from which complete superstructure has been stripped. (Location 30)

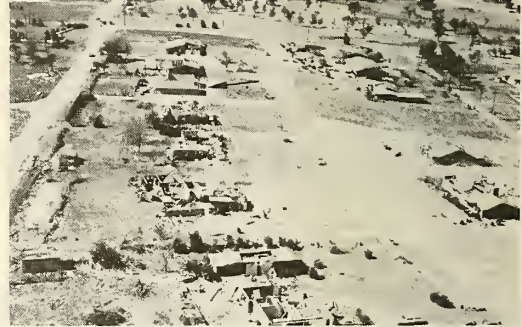
Photograph 54—View looking north on destruction of expensive housing which was in the direct path of the tornado. Note that one house (upper left) in this line escaped damage. (Location 31)

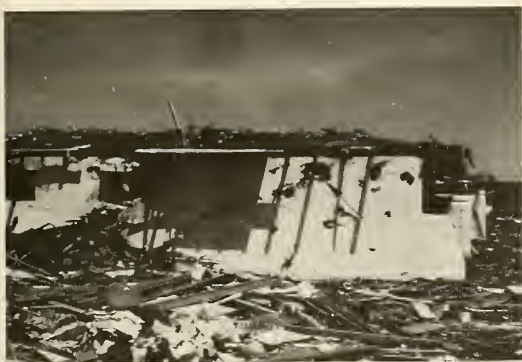
Photograph 56—Damage to a house constructed with stucco-wood frame and roofed with rounded clay tiles. Note bombardment of walls by debris. (Location 31)

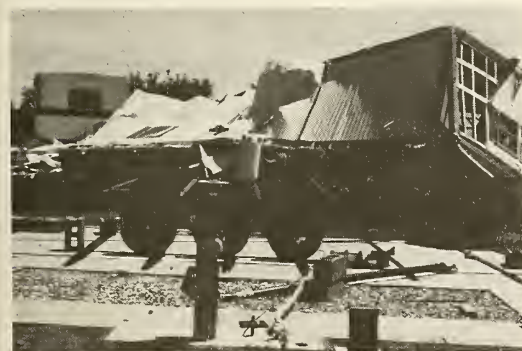
Photograph 58—Mobile home park at Purdue Street with one unit dislodged from its chassis and partly overturned. (Location 32)

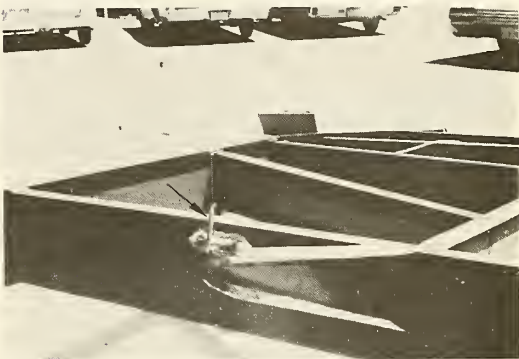
Photograph 59—Typical holdingdown screw which failed to prevent separation of mobile home from its chassis. (Location 32)

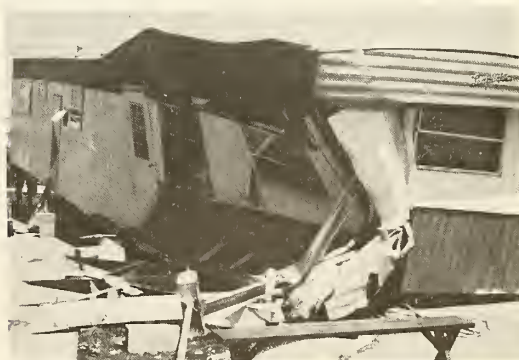
Photograph 60—This mobile home probably collided with a neighboring unit. (Location 32)

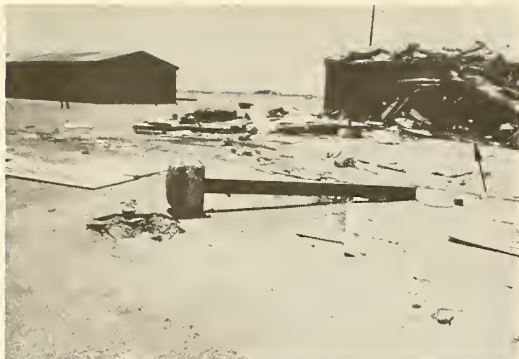
Photograph 61—An overturned steel column is all that remains of several private airplane hangars on the east side of Lubbock Municipal Airport. (Location 33)

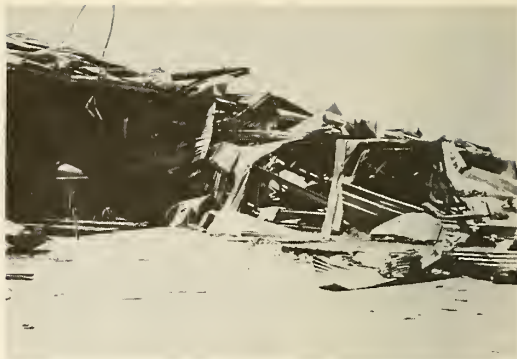
Photograph 62—Considerable damage was caused to private planes both inside and outside hangars. (Location 33)

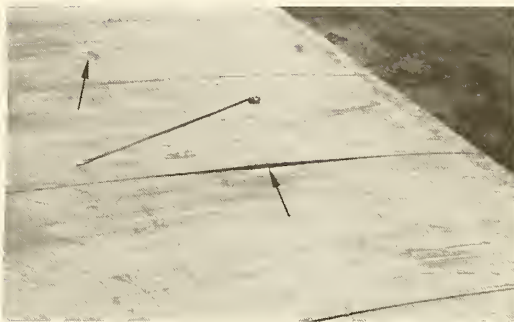
Photograph 64—Mobile home aluminum roof shows denting and splitting of seams caused by hailstone impact. (Location 34)

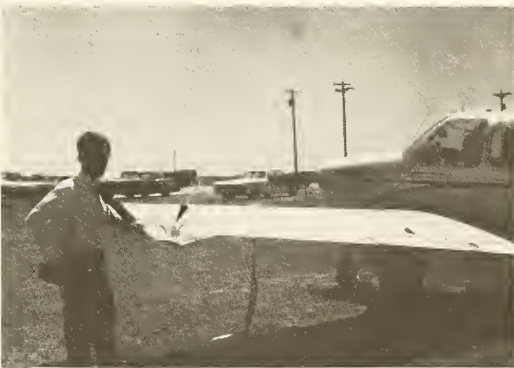
Photograph 65—Hailstone damage to the wing of a light aircraft at the Town and Country Airport, five miles south of Lubbock. (Location 34)
