# NBS TECHNICAL NOTE 783

## Durability and Maintenance as Related to the Selection of Flooring

National  
Bureau  
of  
Standards

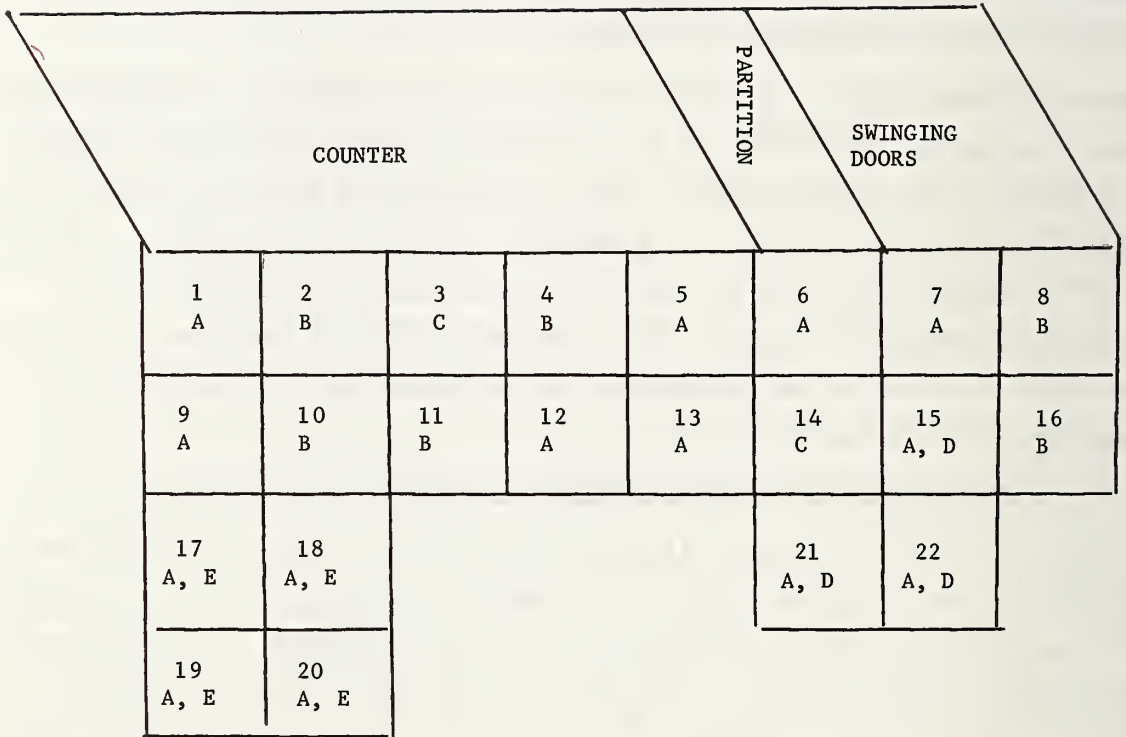
Figure I. Computer Test Area Flooring Layout

A test of resilient floor tiles was performed in front of the counter, partition, and swinging doors of a computer facility. The area behind the counter, partition, and swinging doors is occupied by the equipment and staff of the facility. The test area is illustrated in Figure I.

In Figure I, the access panels covered with test tiles are numbered and the test tiles are indicated by letters A through E. The original tile corresponds to letter A. The 2-foot square access panels, covered with 12-inch square vinyl tiles were installed in May 1967. After two years of service, the tile appeared scratched and scuffed and were somewhat hard to clean. Following is a table of the kinds of resilient tiles used in the test area and the dates of the installation:
