NBS TECHNICAL NOTE 807

Building Performance in the 1972 Managua Earthquake

Following the Managua, Nicaragua, earthquake of December 23, 1972, a team of engineers representing the U.S. Department of Commerce's National Bureau of Standards (NBS) and the National Academy of Engineering (NAE) performed field investigations in Managua, Nicaragua, from December 26, 1972, to January 4, 1973. The objectives were to assist the Nicaraguan government in surveying major buildings to determine whether each was suitable for emergency use, repairable, or appropriate for clearance. The team also viewed the patterns of successful performance and damage to identify needs for improvements in building practices for mitigation of earthquake hazards and opportunities for more detailed investigations which could provide information for future improvements in practices.

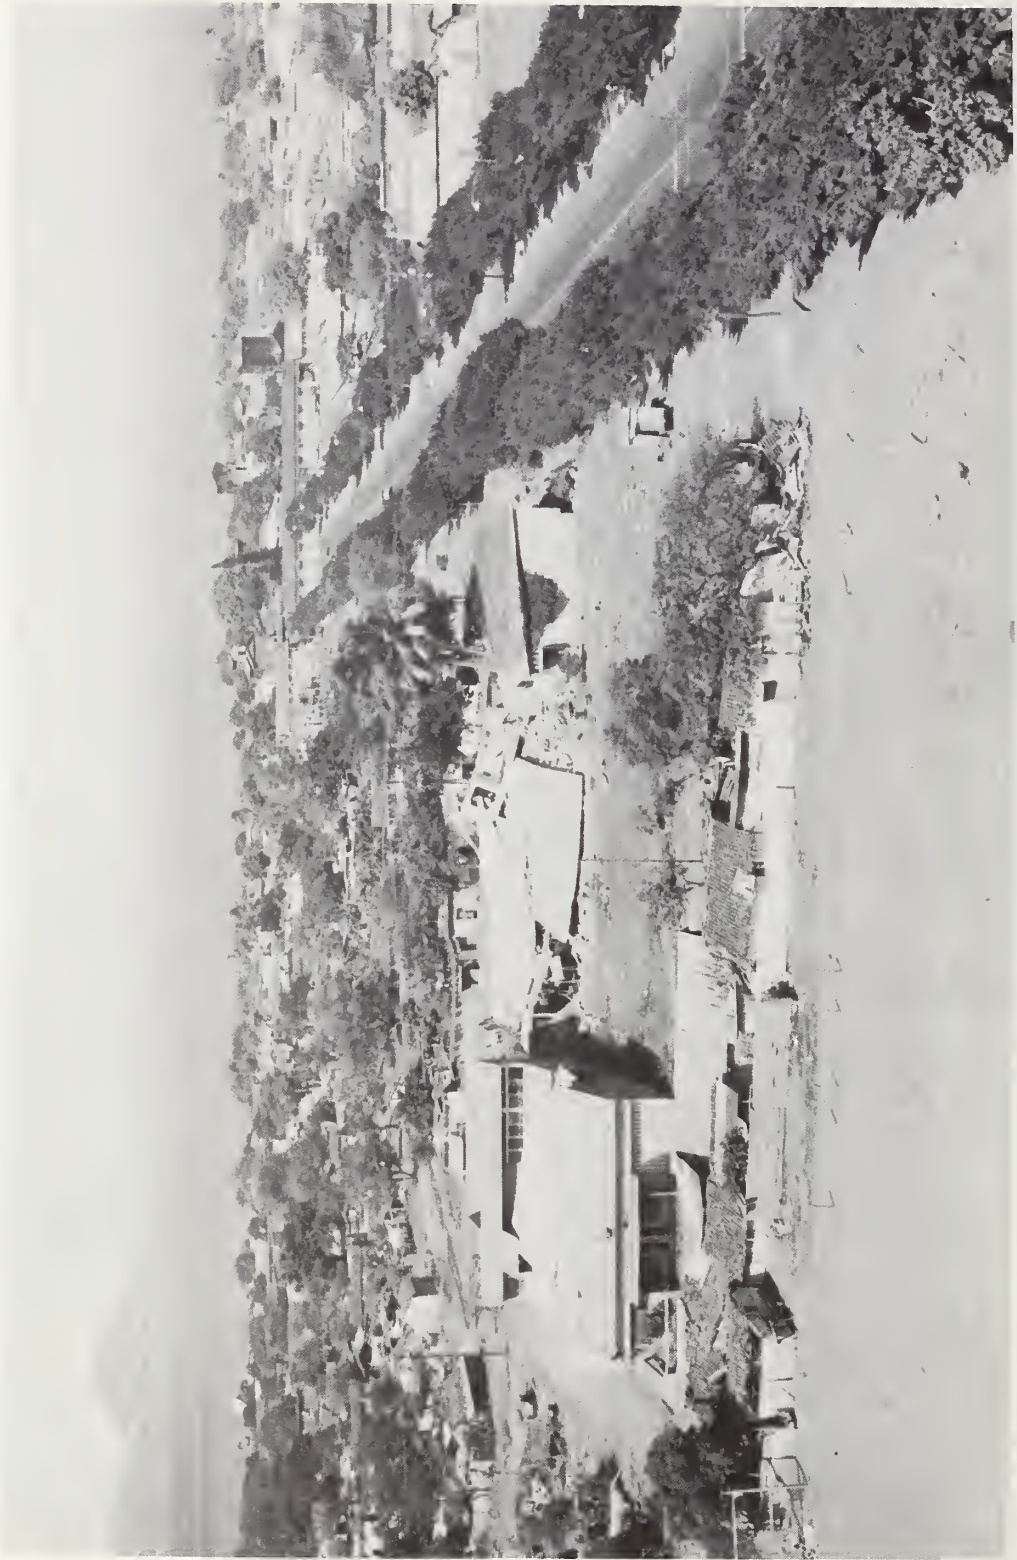
Figure 18 Red Cross building collapsed on ambulances and emergency supplies.

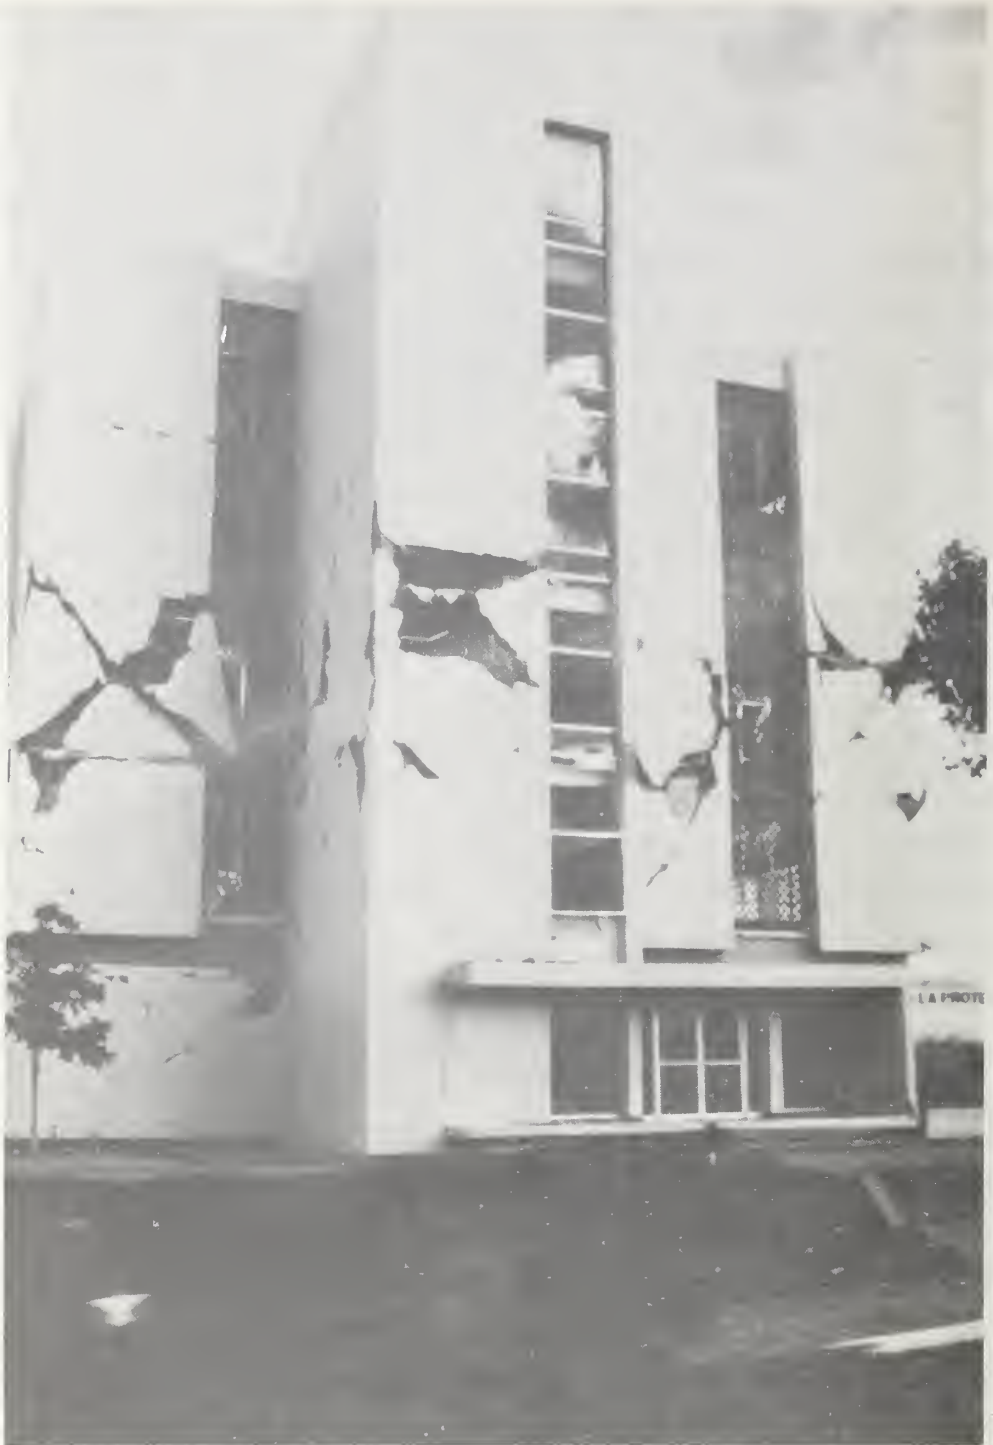
Figure 19 Severe exterior nonstructural damage in unbraced frame building, Seguros La Protectora.

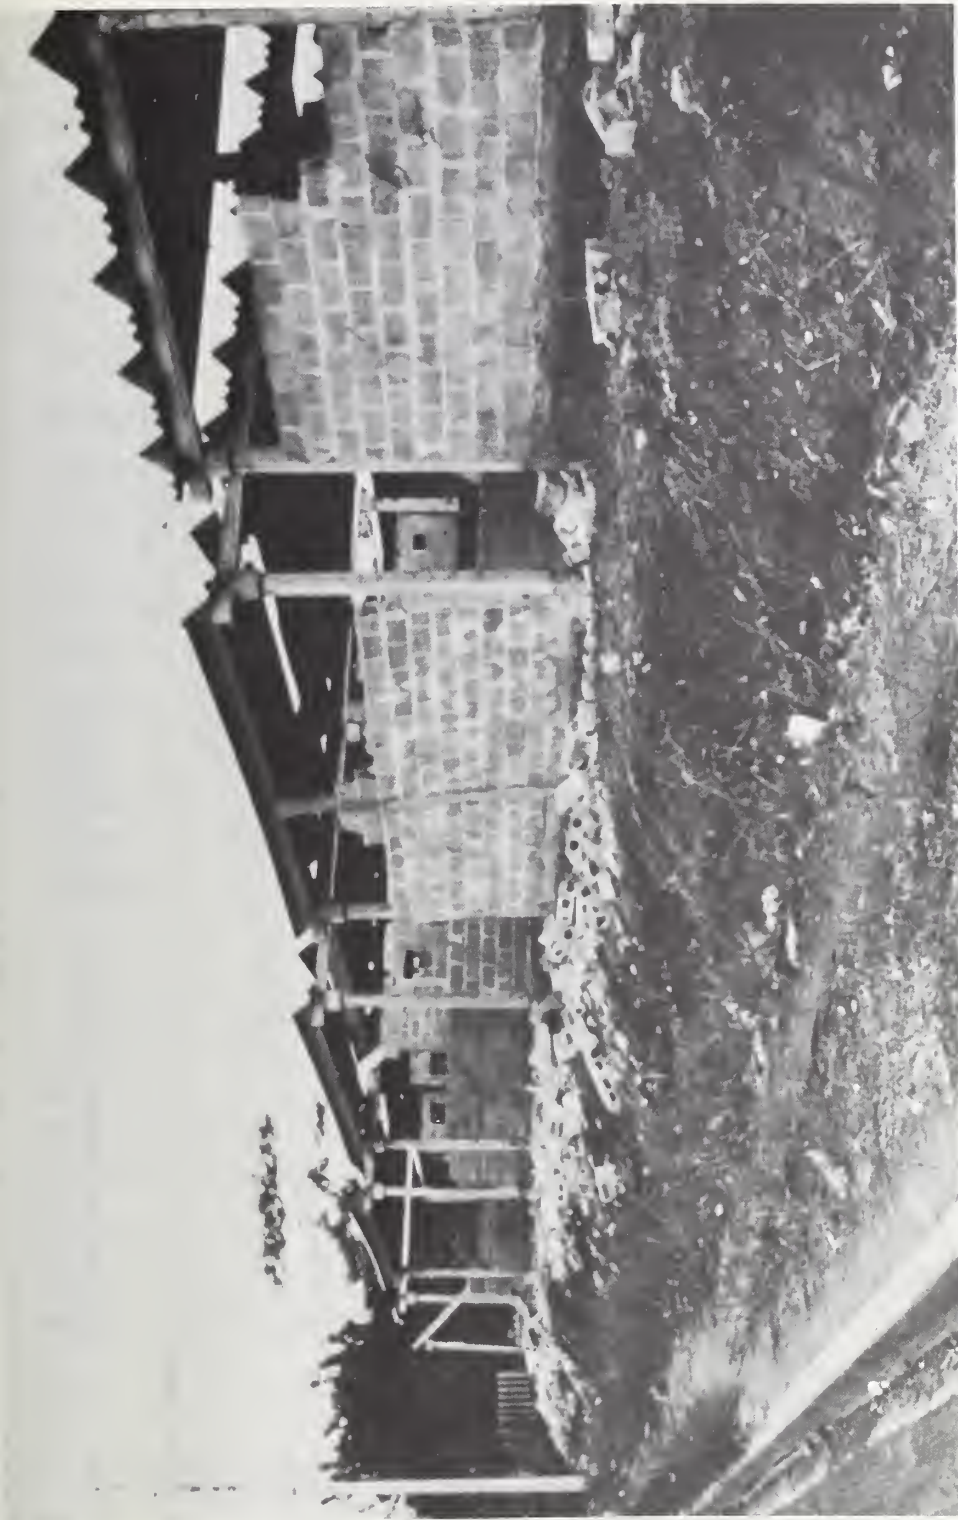
Figure 21 Failures of inadequately anchored walls of houses under construction.

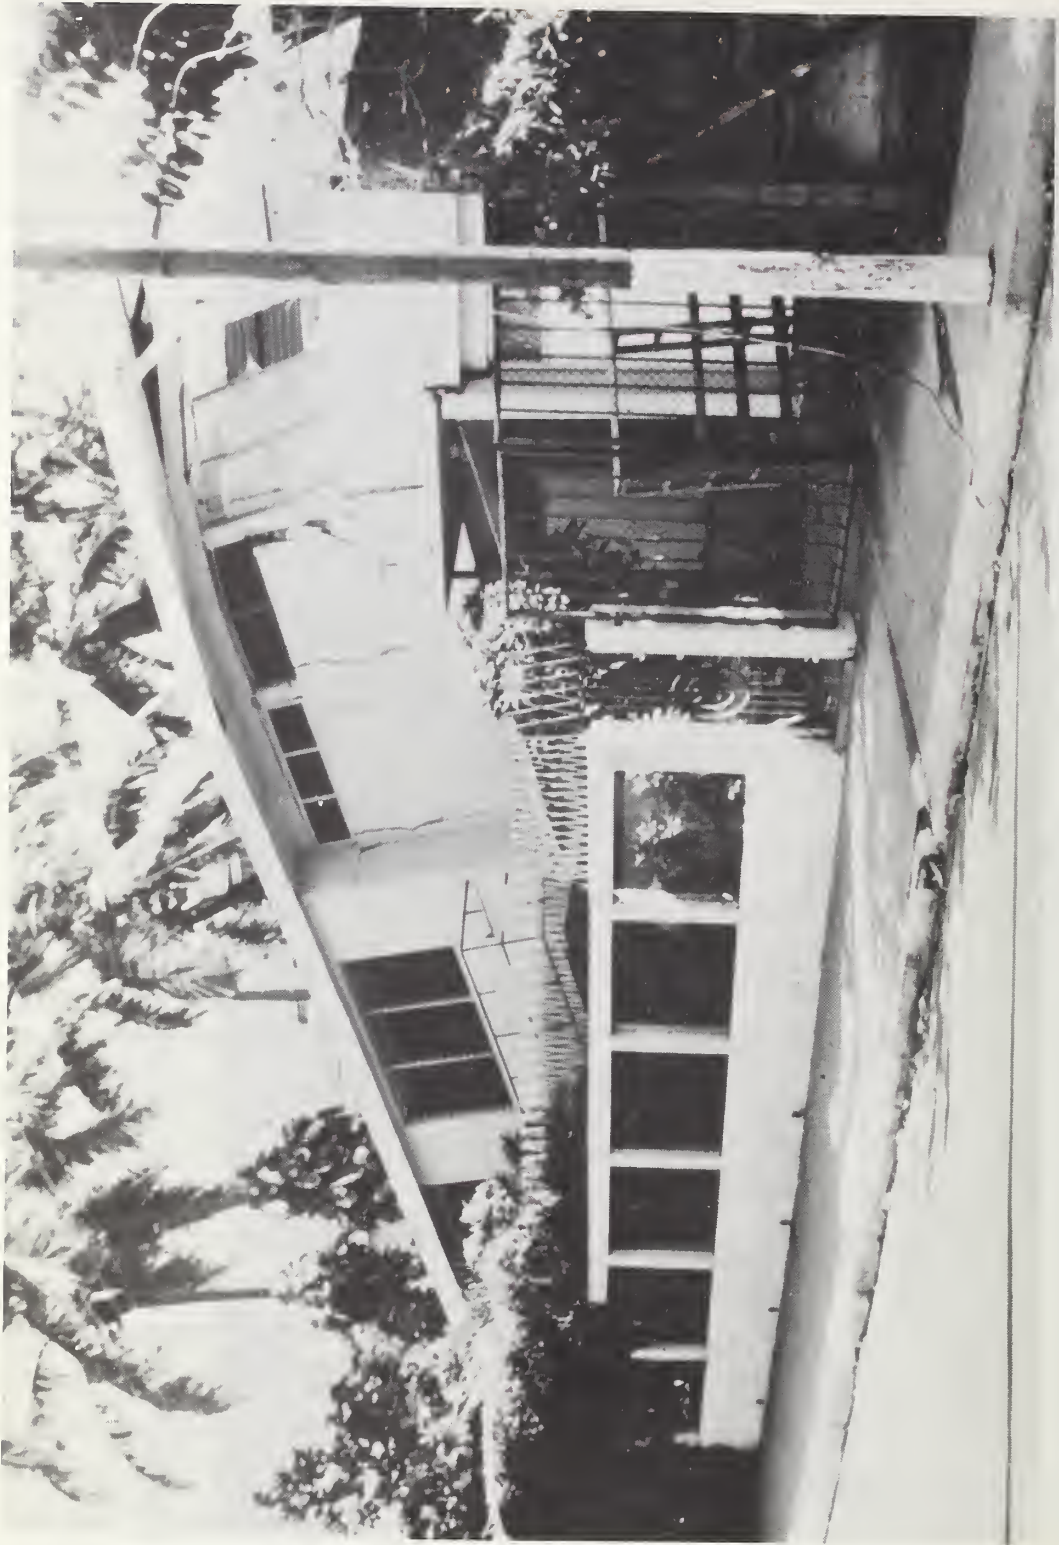
Figure 22 Collapse of modern house of "good quality."

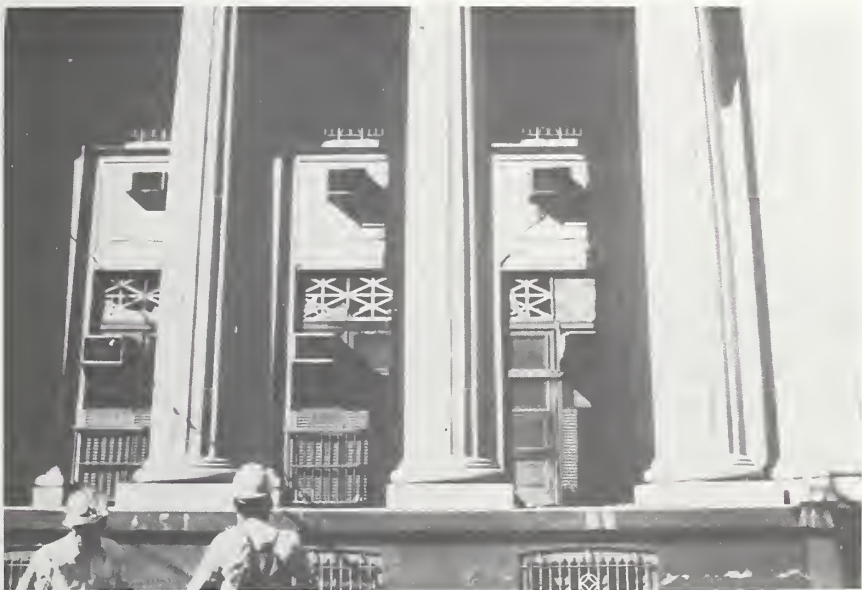
Figure 3-2 Cracking in panels between columns where pierced for air conditions, Palacio Nacional.

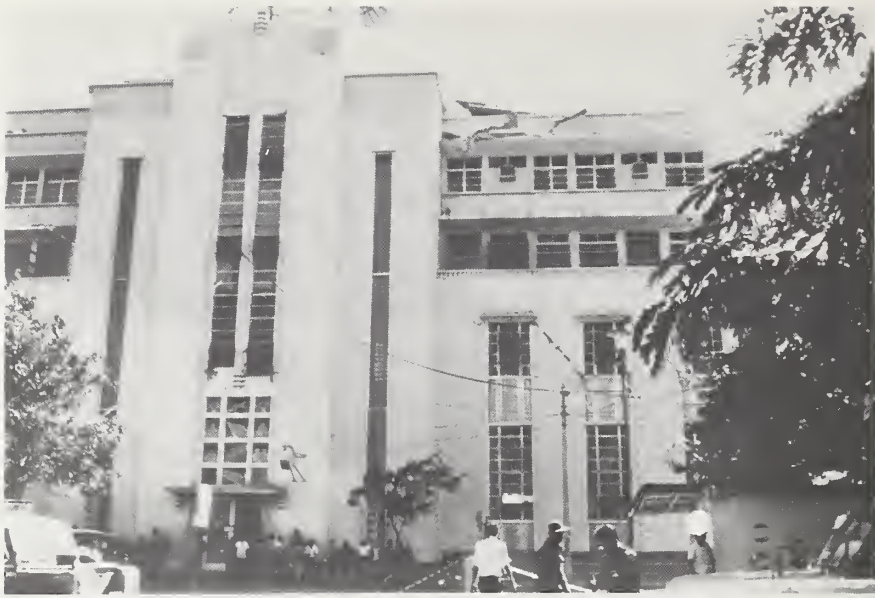
Figure 5-1 Front of the Palacio de Comunicaciones, limited damage except at fourth floor.

It was recommended immediately to personnel of the Palacio de Comunicaciones that measures be taken to protect people in the streets adjacent to the east and west sides of the building. It is also recommended that valuable communications equipment installed on the fourth floor be relocated to eliminate hazards to the equipment and personnel using it, since the roof structure easily could fail from a strong wind or an earthquake aftershock. It is further recommended that the new construction on the fourth floor be removed and reconstructed appropriately. Elsewhere, repair should eliminate glass, blocks, walls, and other elements showing nonstructural damage. It is important to remove glass panels from the third floor which are particularly dangerous to people working nearby.

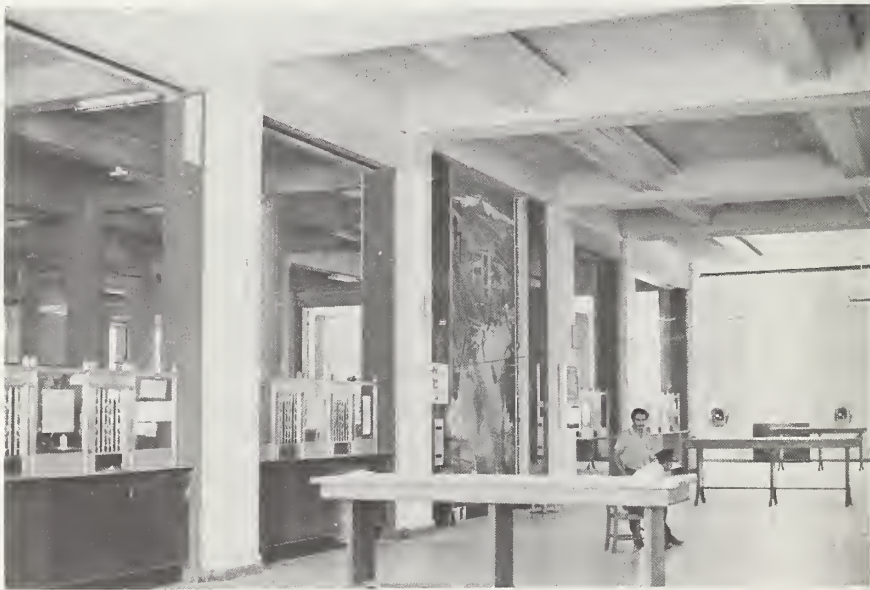
Figure 5-2 Main floor with light cracking of columns and damage to infilled mural, Palacio de Comunicaciones.

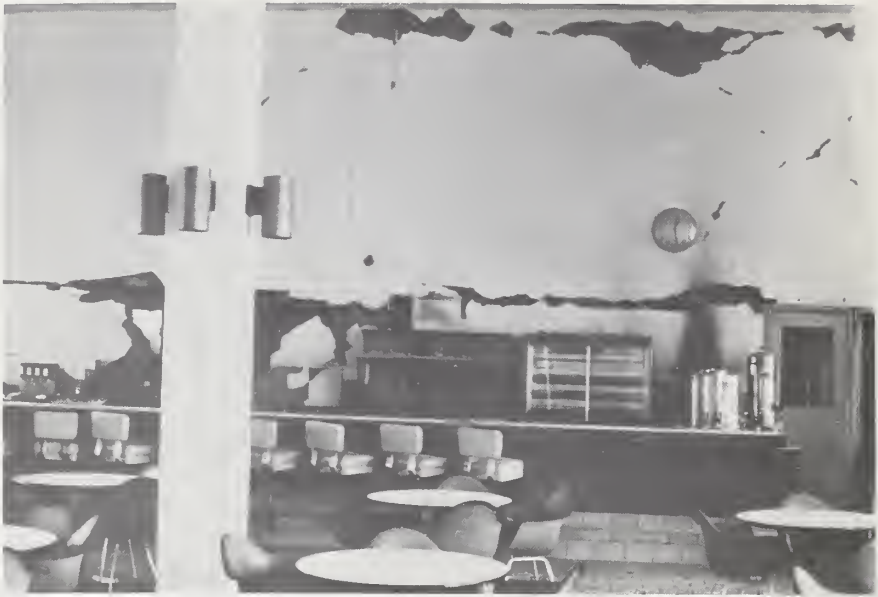
Figure 13-2 Cracked infill wall east of lobby, Aeropuerto Internacional.

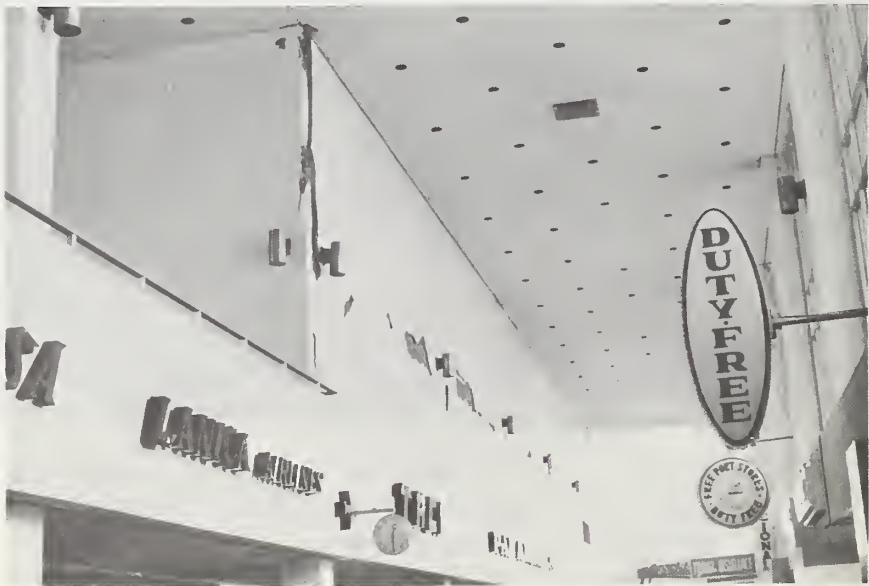
Figure 13-3 Overlaid curtain wall cracked at anchorage to frame, Aeropuerto Internacional.

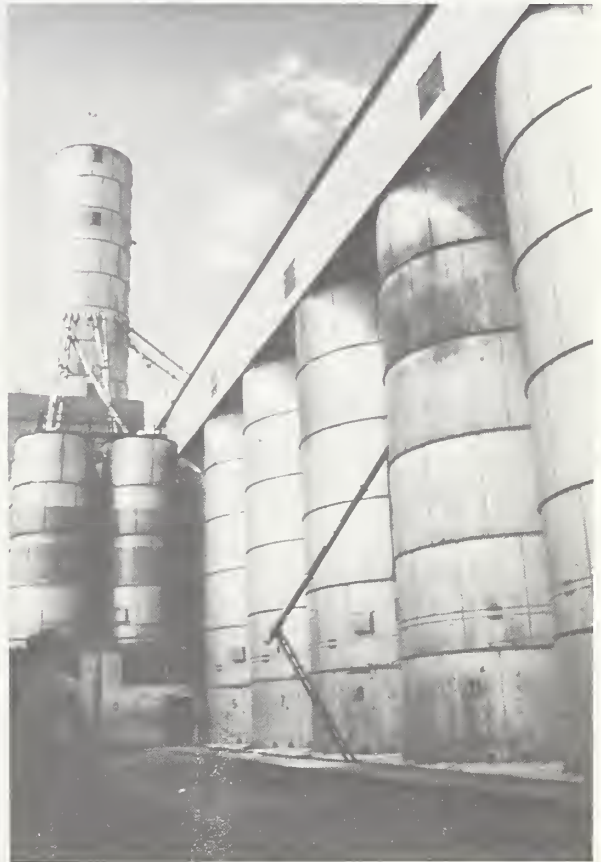
Equipment which should be functional following an earthquake must be adequately designed and anchored for earthquake forces. The power generation facilities for Managua were put out of service by small movements of the generators, inadequate anchorage of the boiler columns, figure 22-2, fractures of condenser castings, and sliding of unanchored transformers. The grain storage tanks of the INCEI, figure 16-4, showed uplifting of their anchor bolts to the south, figure 16-5, and local buckling of the tanks to the north, figure 16-6, as well as near the top, figure 16-4.

Figure 16-4 Shear buckling is visible at tops of INCEI elevators.

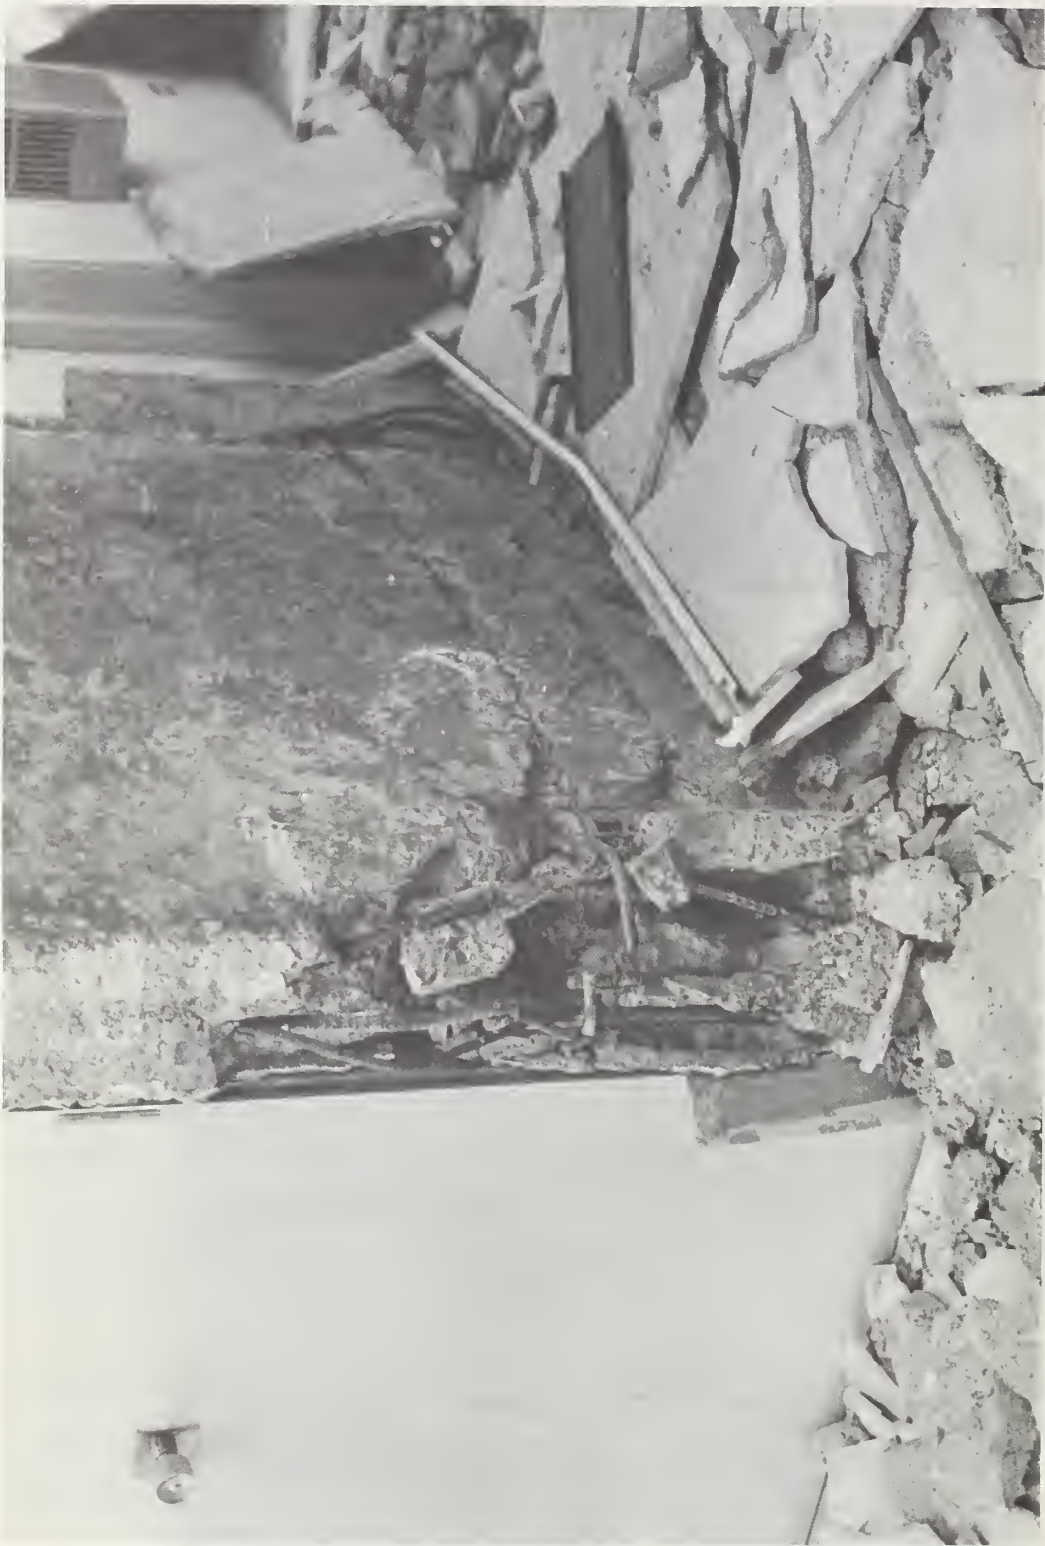
Figure 23-3 Shear wall crushing at first floor where weakened by telephone chase, Edificio Administrativo ENALUF.

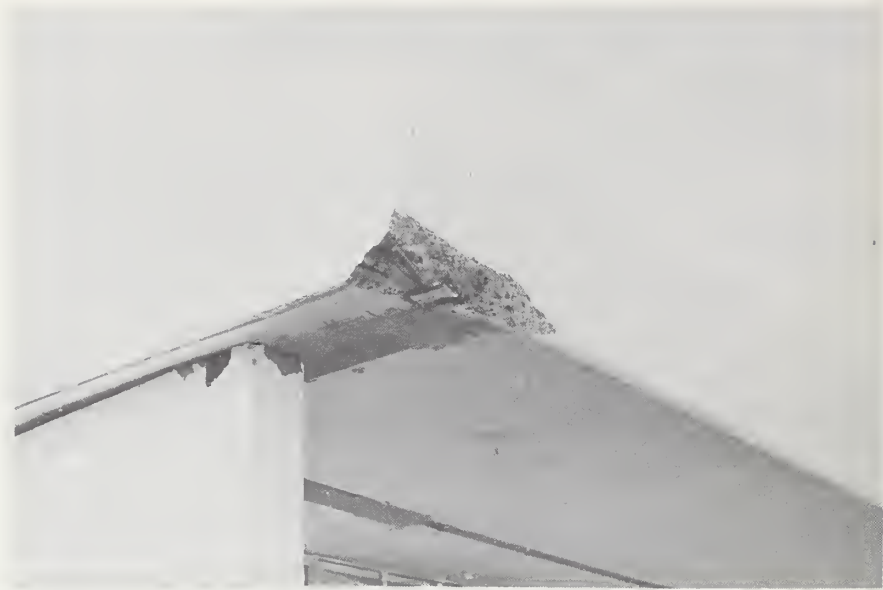
Figure 24-3 Broken weld at connection of roof channel, Bello Horizonte.

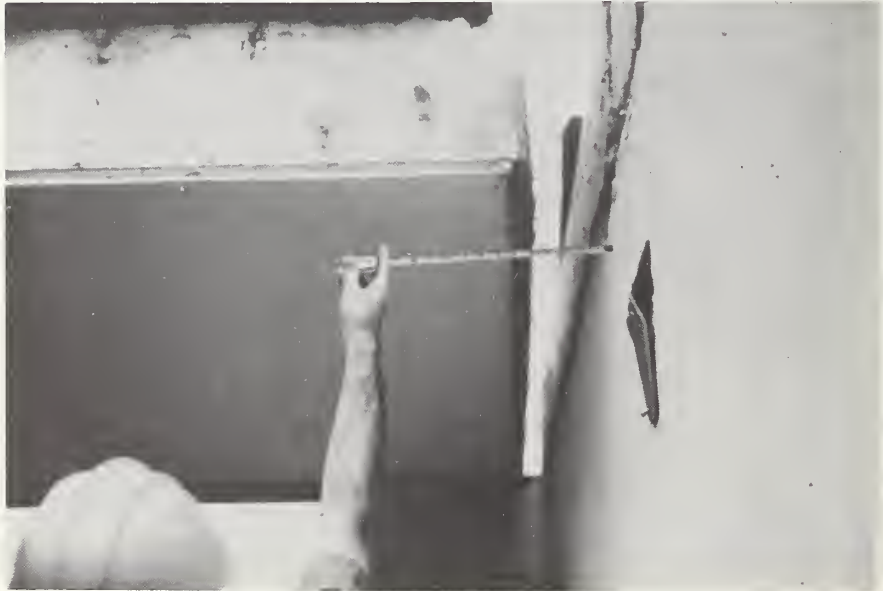
The generally poor performance of taquezal housing which led to large losses of life and property has been previously discussed. Also some modern houses, using materials such as prestressed concrete, reinforced concrete, and masonry with precast members and prefabrication techniques as well as other so called modern technologies, were designed or constructed without adequate attention to the potential earthquake forces and performed poorly. A housing development under construction with reinforced concrete frames infilled by concrete block walls, figure 21, showed wall failures because of inadequate attachment to the frames. Some more expensive modern houses also collapsed, figure 22. A development of cast-in-place concrete houses, with prestressed, precast channel roof elements approximately 8 ft wide by 20 ft long, failed due to inadequate attachment of the roofs to the walls, figure 24-1. At best the precast channels were connected only at the four corners by an inch or two of small fillet weld, figure 24-3. On duplex units where two roof channels bore on a party wall, it apparently was considered inconvenient to make any connection whatsoever, figure 24-4.

Figure 24-4 Unfastened roof channel in duplex unit, Bello Horizonte.

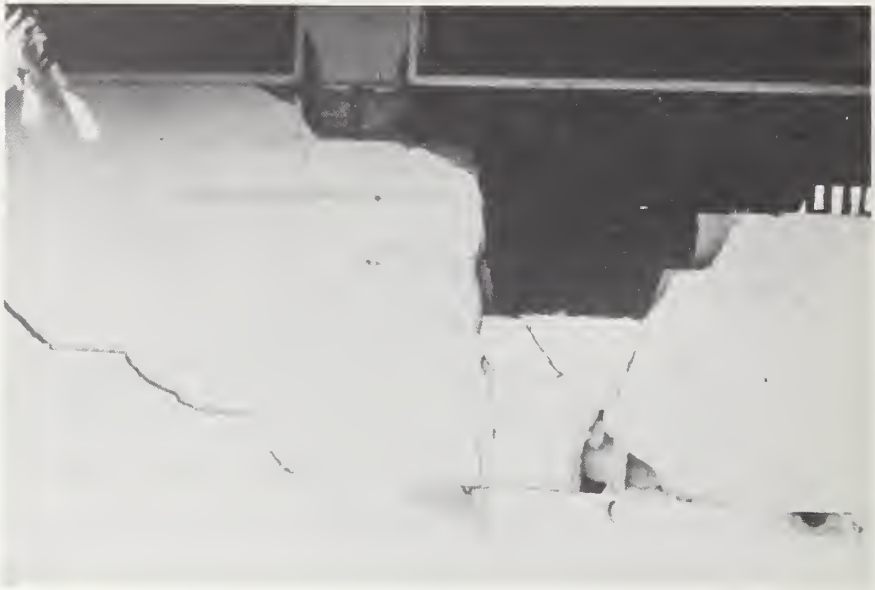
Figure 25-1 New damage over repaired cracks from the 1968 earthquake, Centro Escolar Salvador Mendieta.

Because the roof is light, reducing the earthquake forces in the structure, it appears feasible to repair these damages and return the structure to service. Attention should be given to improving the reinforcing of the block wall during the repairs.

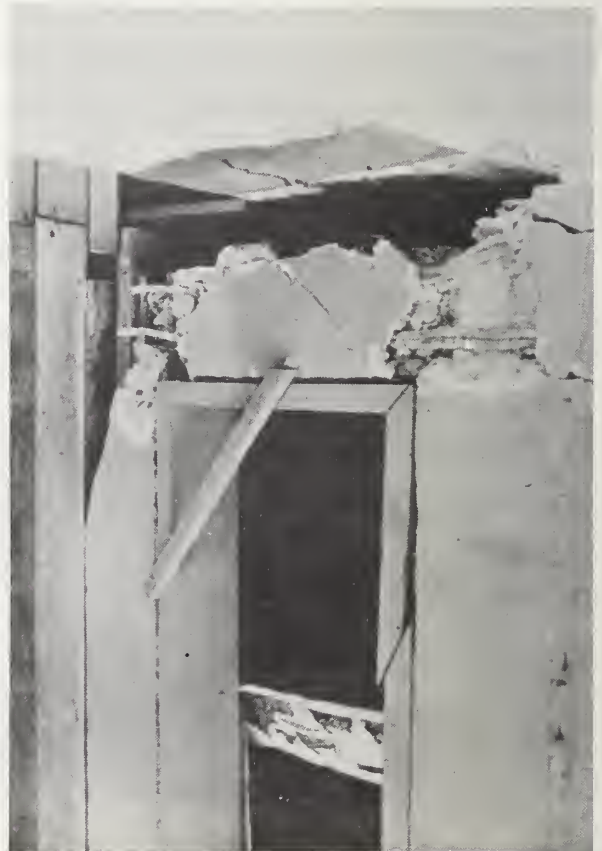
Figure 25-2 Failure of bond beam and column near aperture, note inadequacy of anchorage of reinforcement at corner.

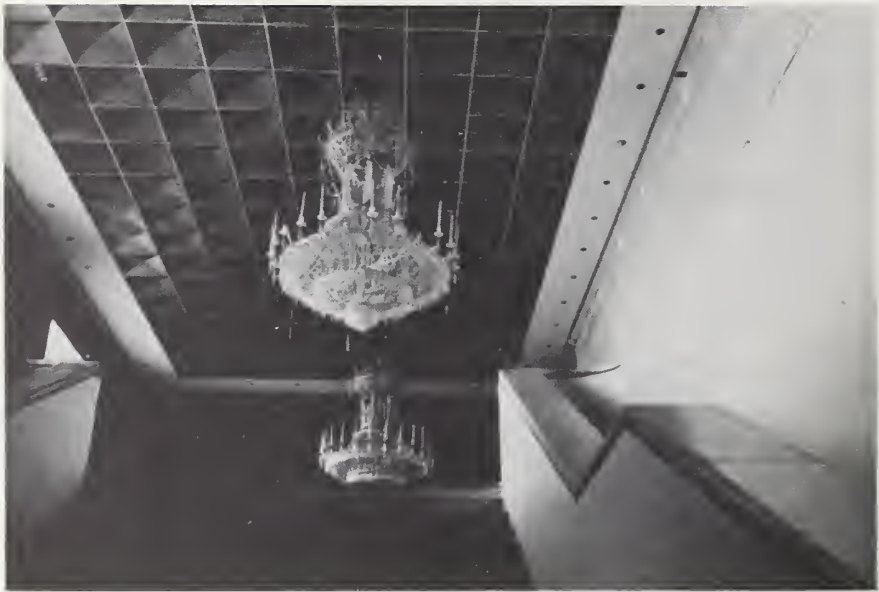
Figure 41-3 Minor finish damage amounted to fallen ceiling panels and some chips from the chandeliers, Teatro Ruben Dario.

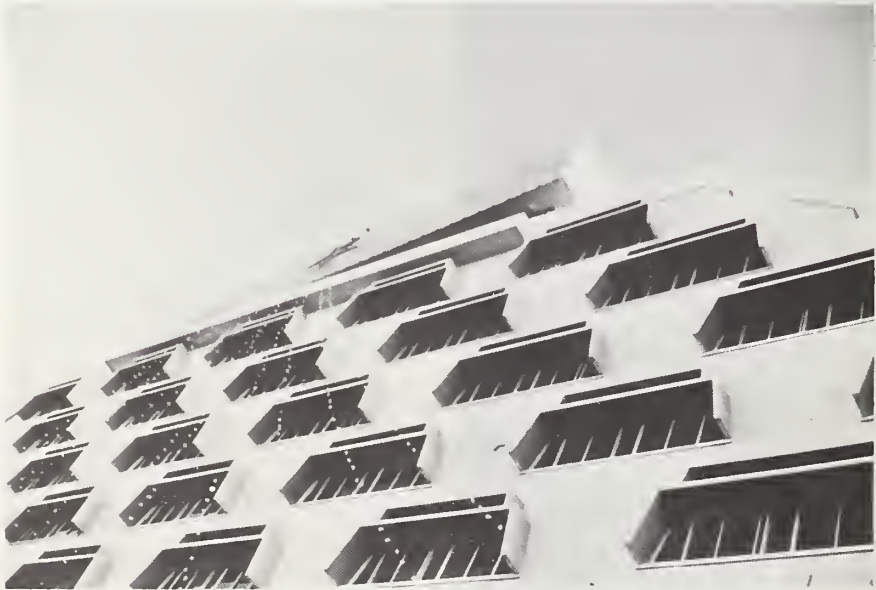
Figure 42-2 Minor facade cracking and displacement of mechanical penthouse, Hotel Intercontinental.

- A. All beam-column connections (currently covered by architectural details) be inspected.
- B. The building reanalyzed before repairs for ground motion 1.5 times that measured at the Esso refinery or for ground motion resulting from a site study.

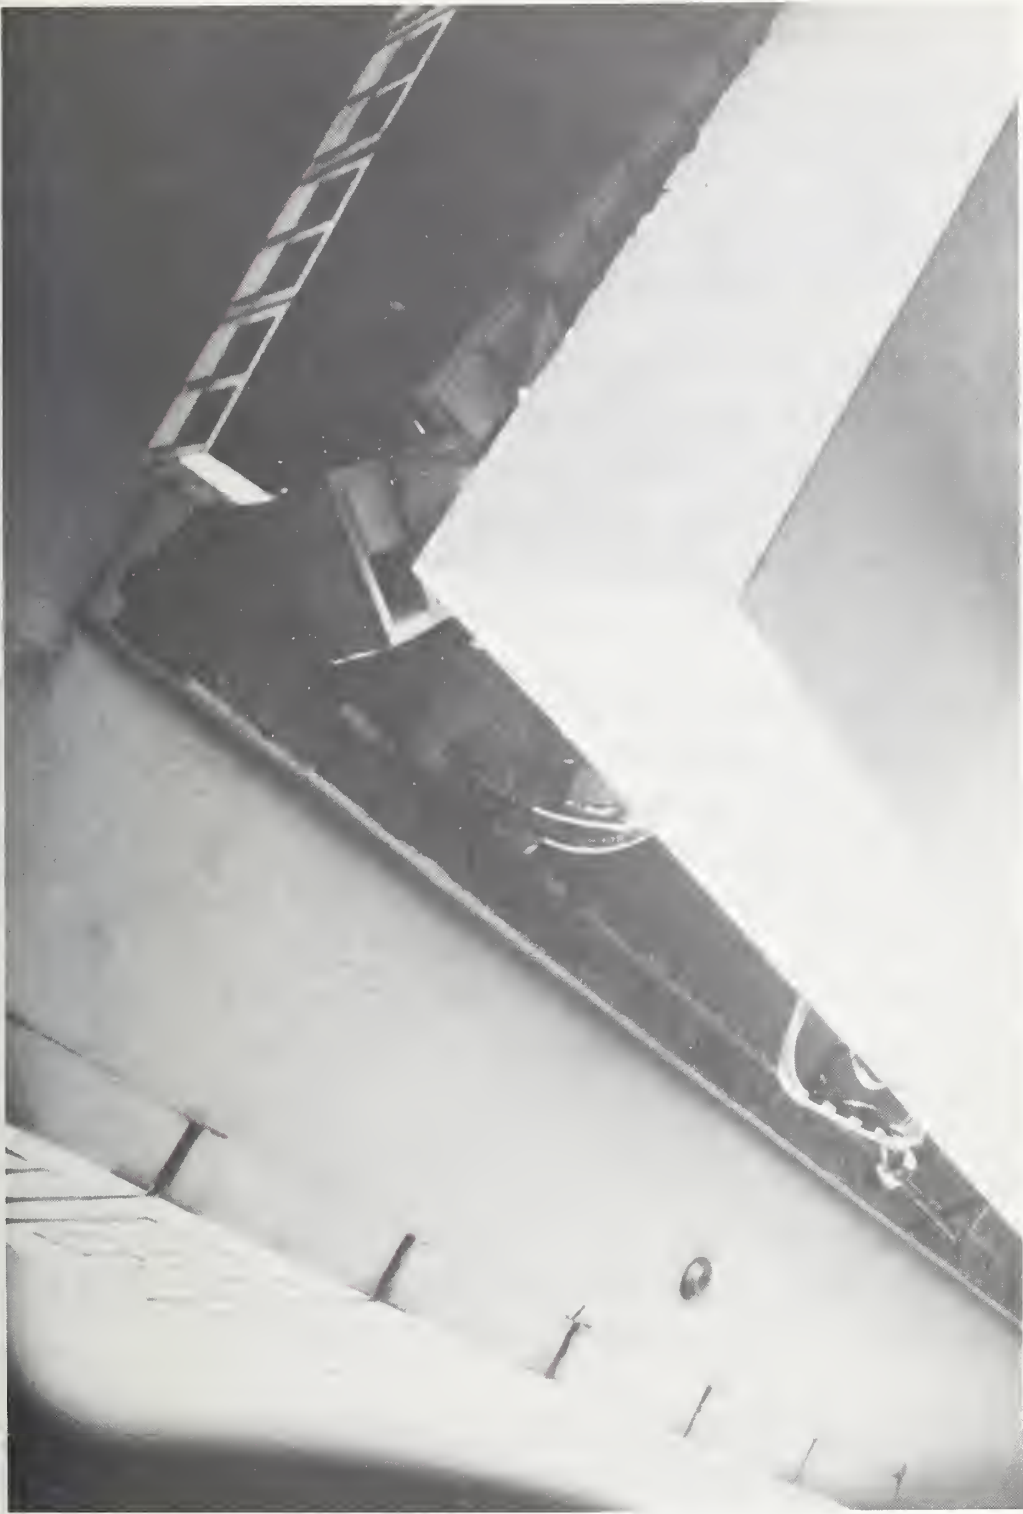
Figure 42-3 Failures of columns supporting mechanical penthouse, Hotel Intercontinental.

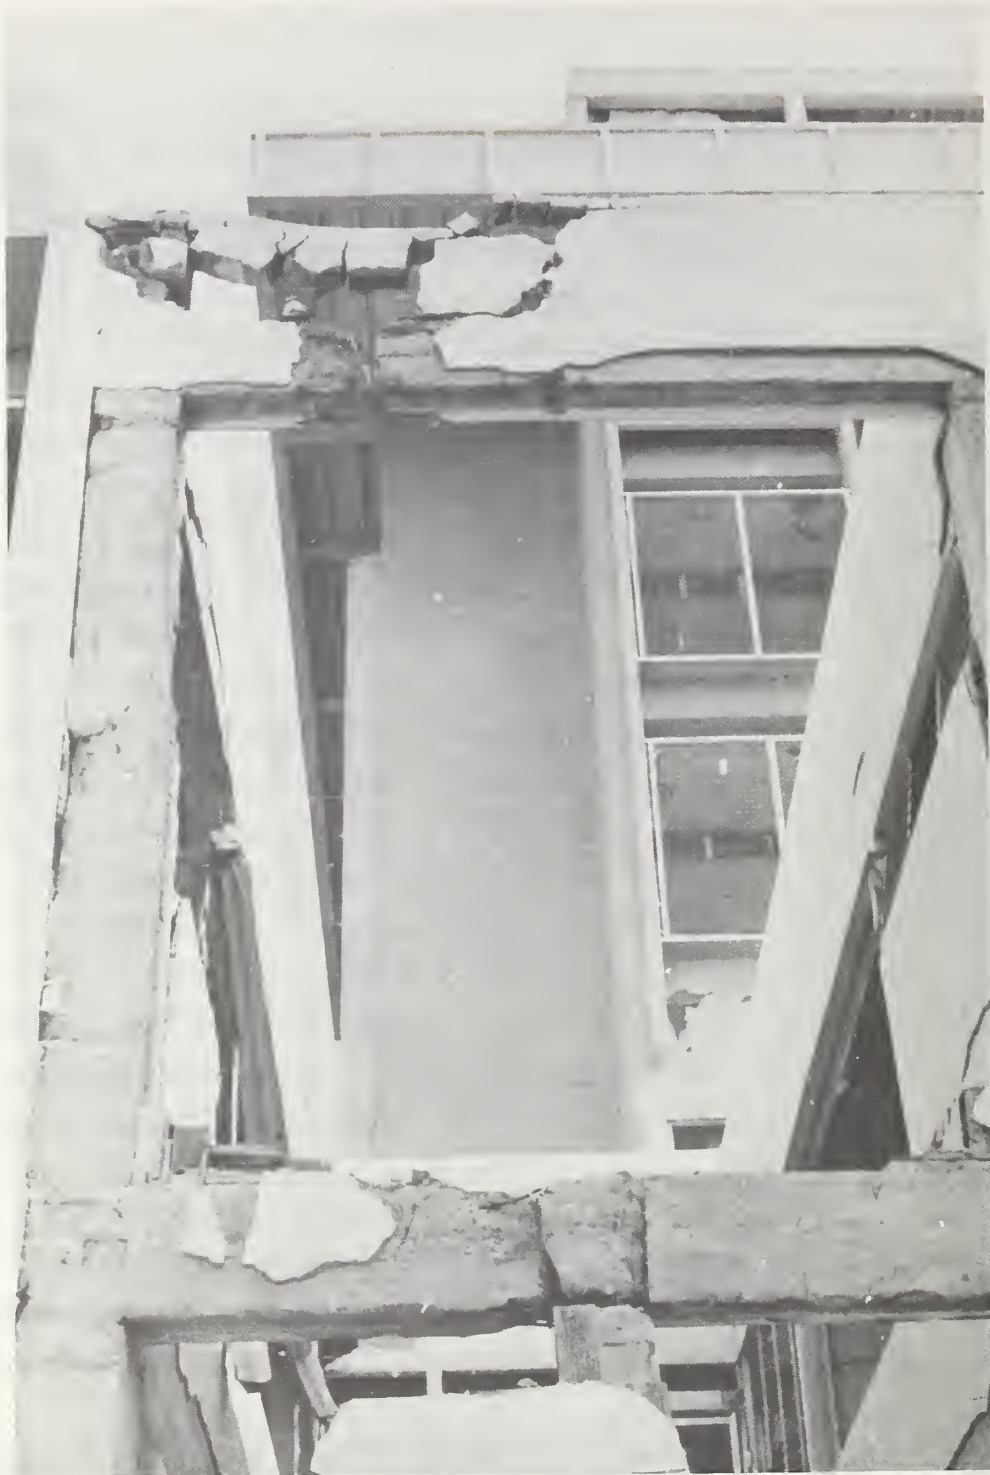
Figure 43-1 Ruptured beams connecting building elements across a courtyard, Corte Suprema de Justicia.

In general, it appears that these buildings can be returned to service following appropriate repairs which will include moderate repairs of damaged structural elements and major repairs of the non-structural elements of the buildings.

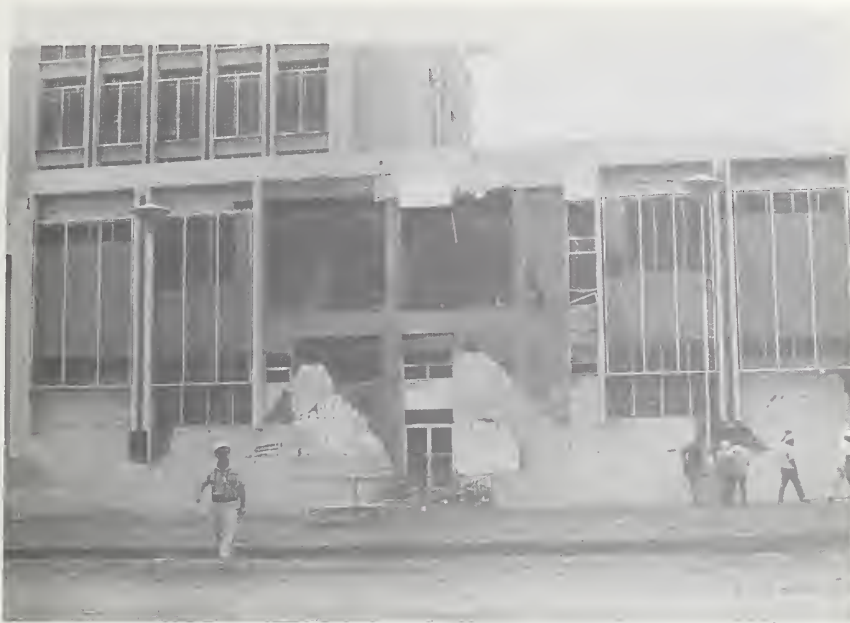
masonry partitions and curtain walls as in the INCEI warehouse, figure 16-3, and the Supreme Court building, figure 43-2; falling shelving, as in the insurance building, figure 20; displaced light fixtures as in the Central Bank, figures 52-3 and 52-4; parapets as in the Social Security Clinic, figure 71-1; and inadequately attached exterior finishes as in the Supreme Court, figure 43-4.

Figure 43-2 Extensive nonstructural damage in two story wing, Corte Suprema de Justicia.

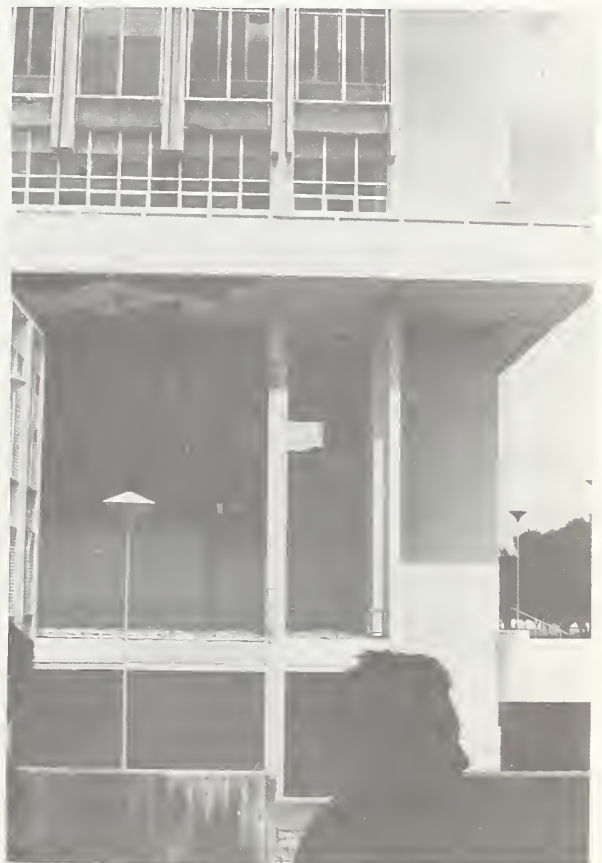
Figure 43-3 Nonstructural damage on 6 story wing, Corte Suprema de Justicia.

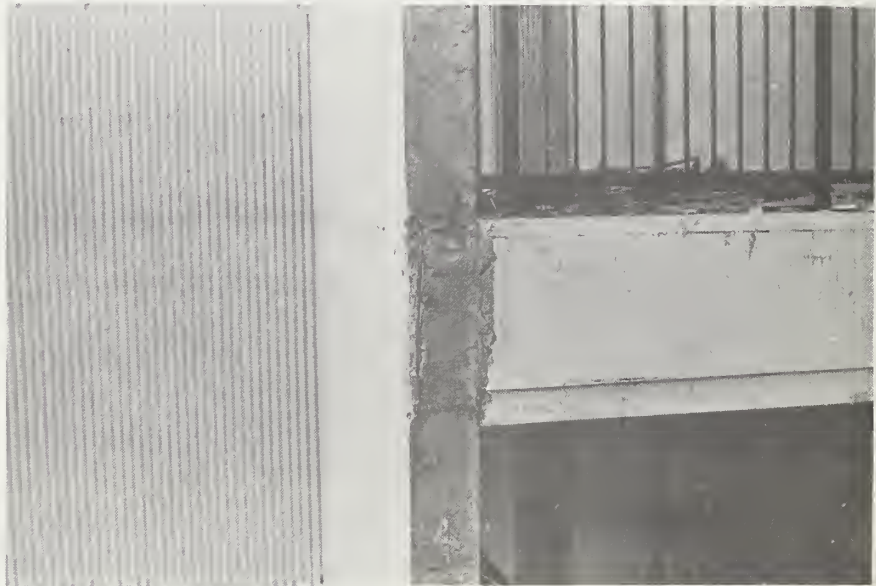
Figure 43-5 Damage to shear walls at first floor level, Corte Suprema de Justicia.

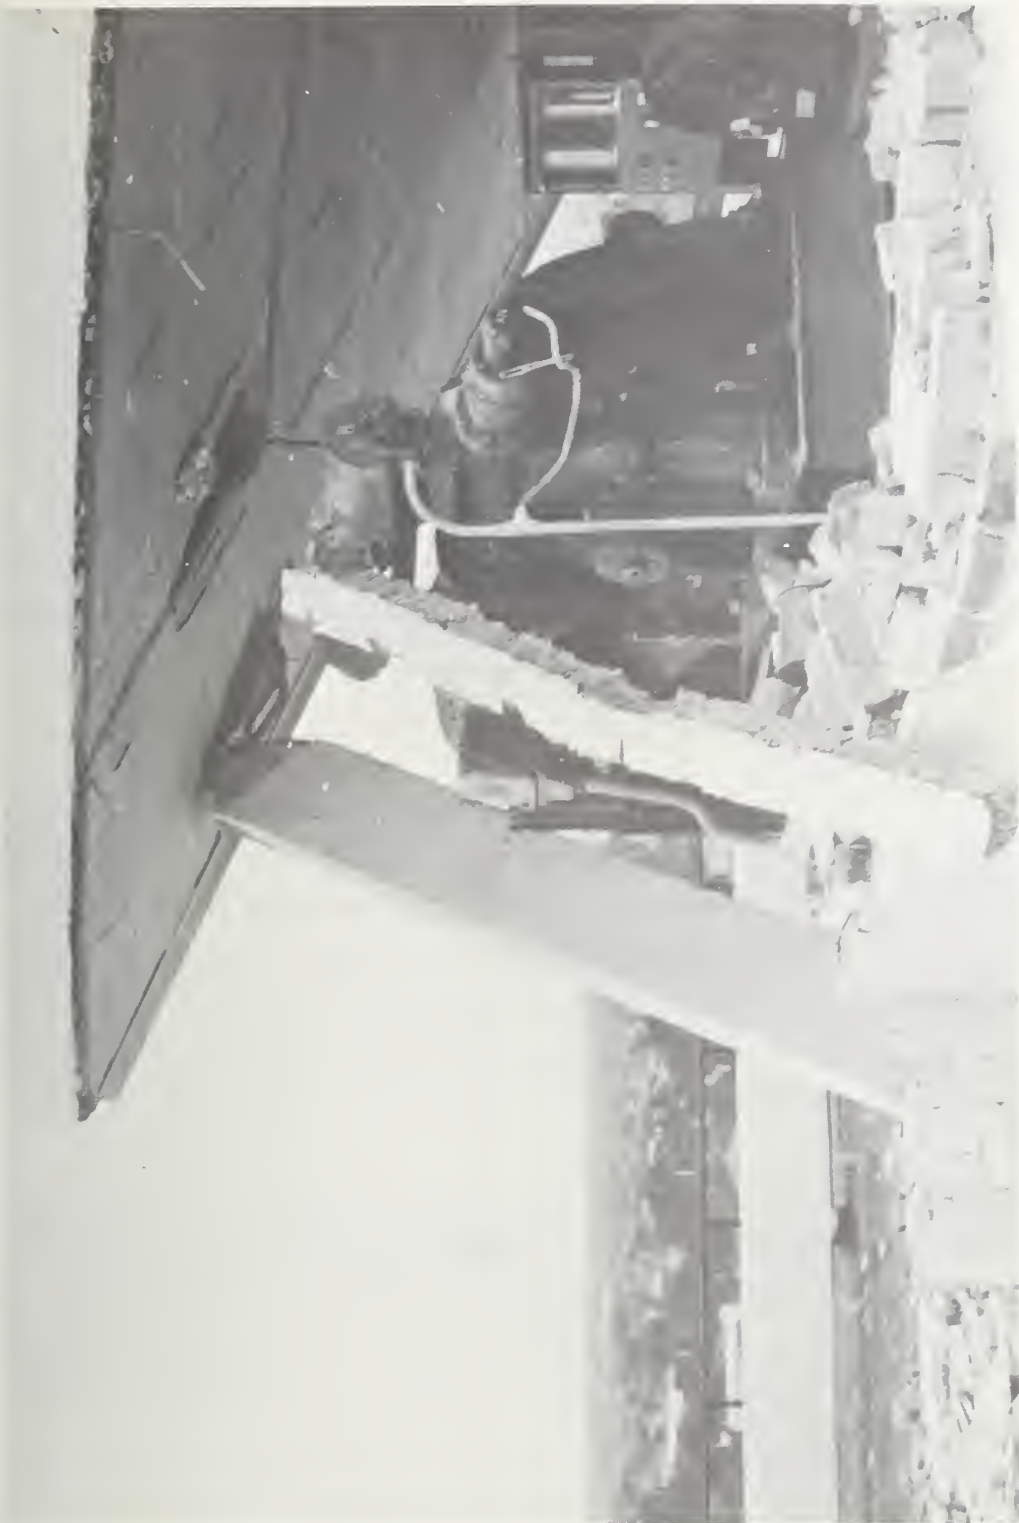
Figure 44-3 Collapsed mechanical penthouse, Edificio Administrativo INSS.

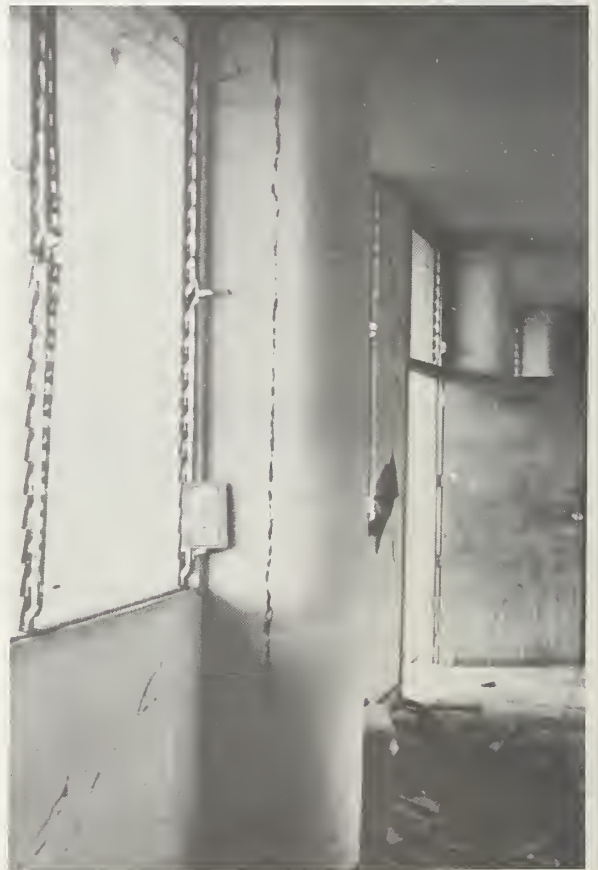
Figure 46-4 Cracking of columns,
Instituto Pedagogico.

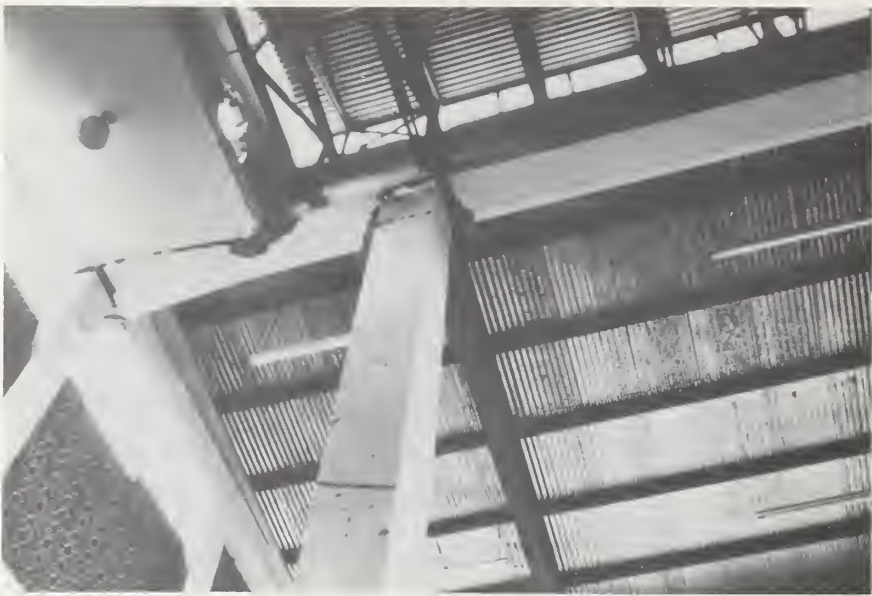
Figure 53-1 Poor continuity of girders to columns of gymnasium, Seminario Catolico.
