NBS TECHNICAL NOTE 807

Building Performance in the 1972 Managua Earthquake

Following the Managua, Nicaragua, earthquake of December 23, 1972, a team of engineers representing the U.S. Department of Commerce's National Bureau of Standards (NBS) and the National Academy of Engineering (NAE) performed field investigations in Managua, Nicaragua, from December 26, 1972, to January 4, 1973. The objectives were to assist the Nicaraguan government in surveying major buildings to determine whether each was suitable for emergency use, repairable, or appropriate for clearance. The team also viewed the patterns of successful performance and damage to identify needs for improvements in building practices for mitigation of earthquake hazards and opportunities for more detailed investigations which could provide information for future improvements in practices.

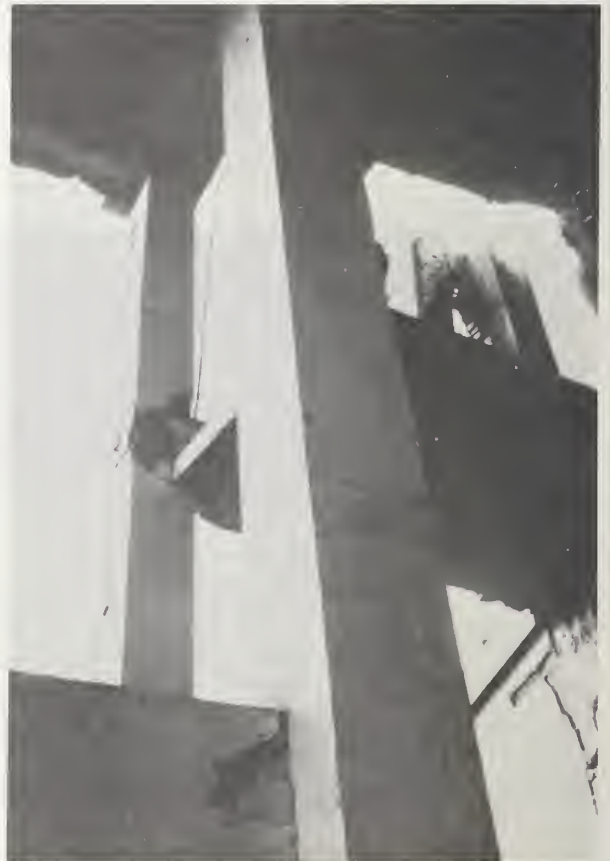
Figure 53-2 Damaged framing of gymnasium, Seminario Catolico.

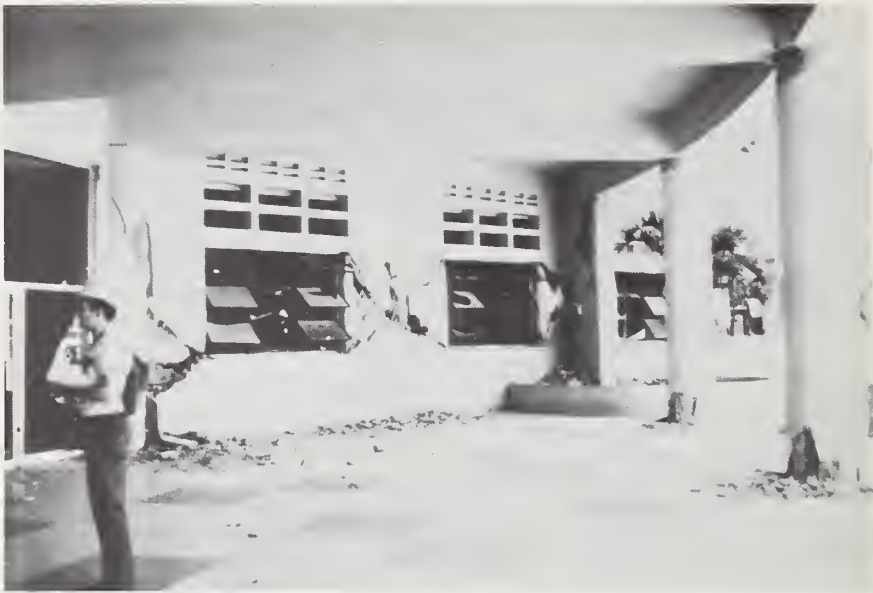
Figure 55-3 Column damage at entry canopy, column and wall damage on wing, Hospital General El Retiro.

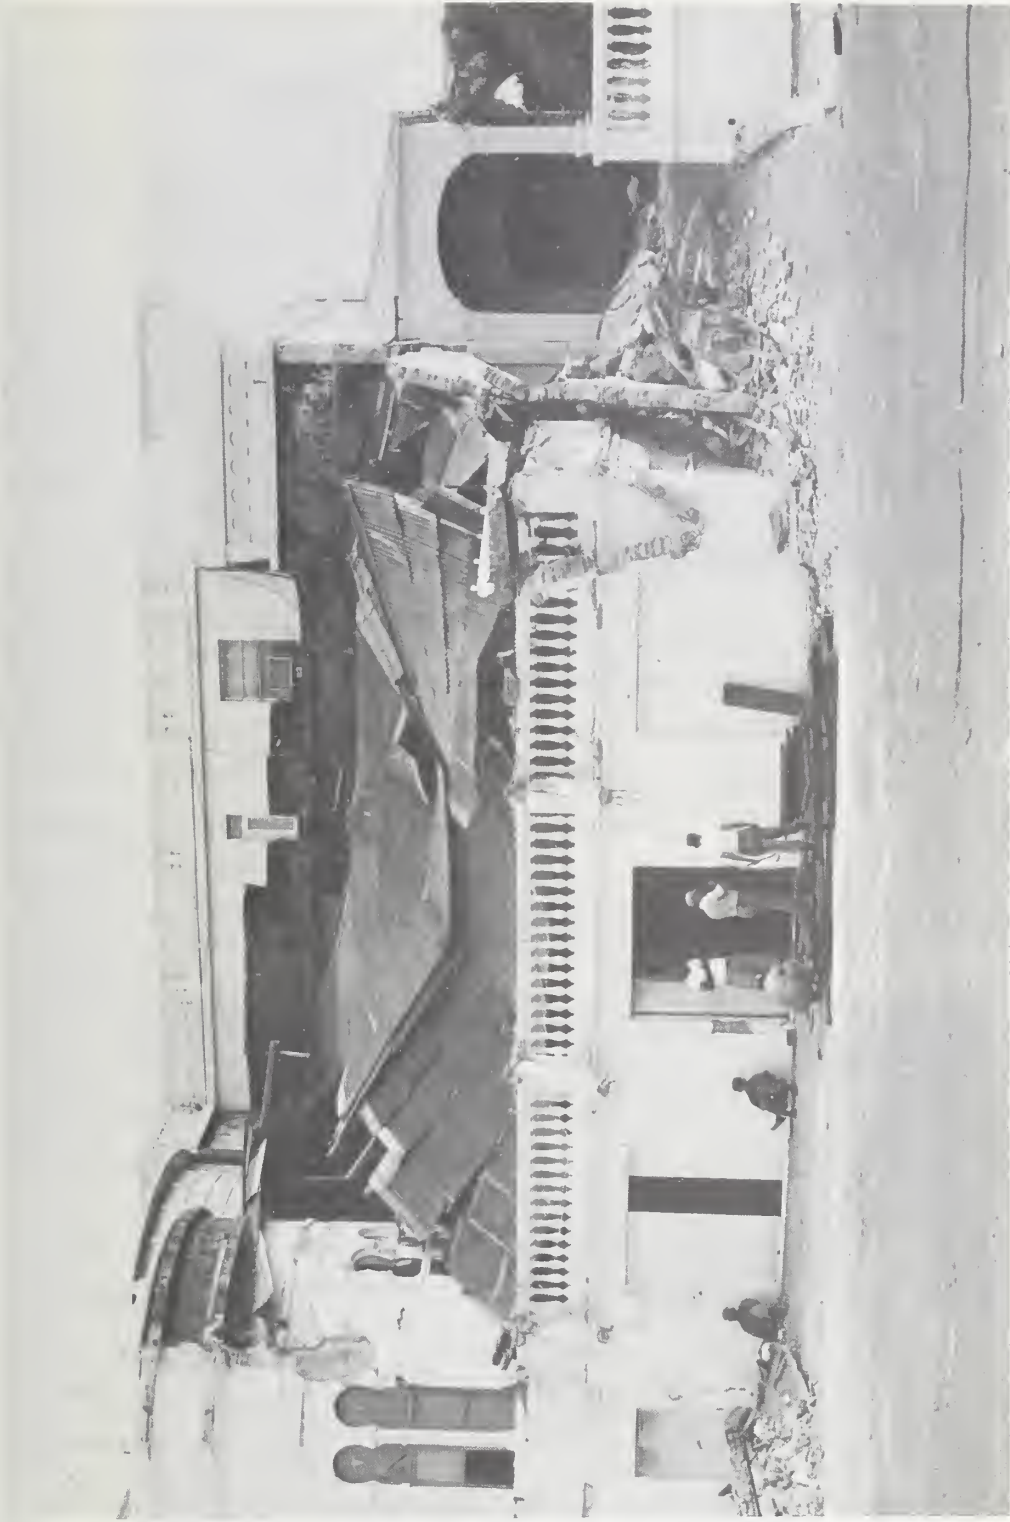
Figure 57-1 Collapse of roof over terrace, Casa Presidencial.

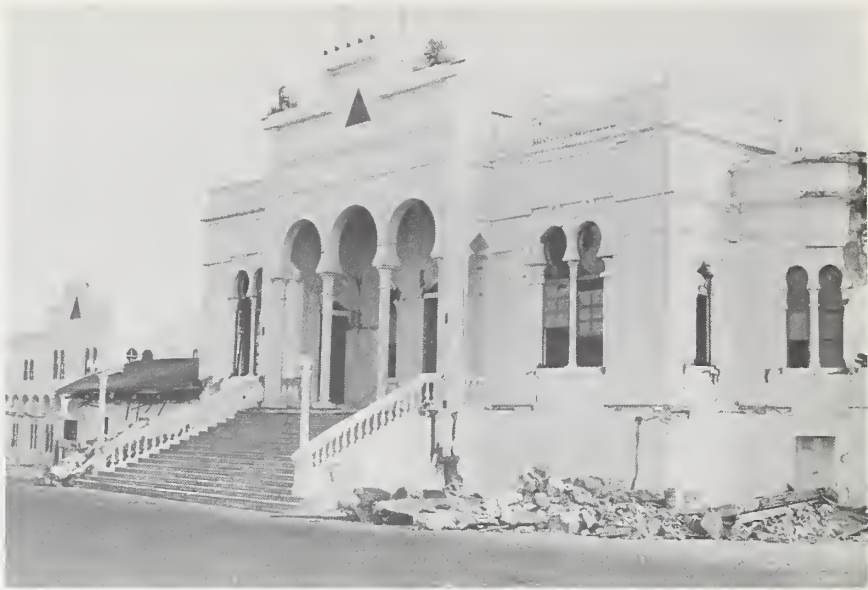
Figure 60-1 Main entrance showing extensive damage, Casa Presidencial.

The building requires extensive and expensive repairs. However, it would be essential to assure stability of the foundations of the building prior to any consideration of repairs. At present, the building site appears to be sliding both to the north down the side of the hill and to the south into the crater lake, figures 60-5 and 60-6.

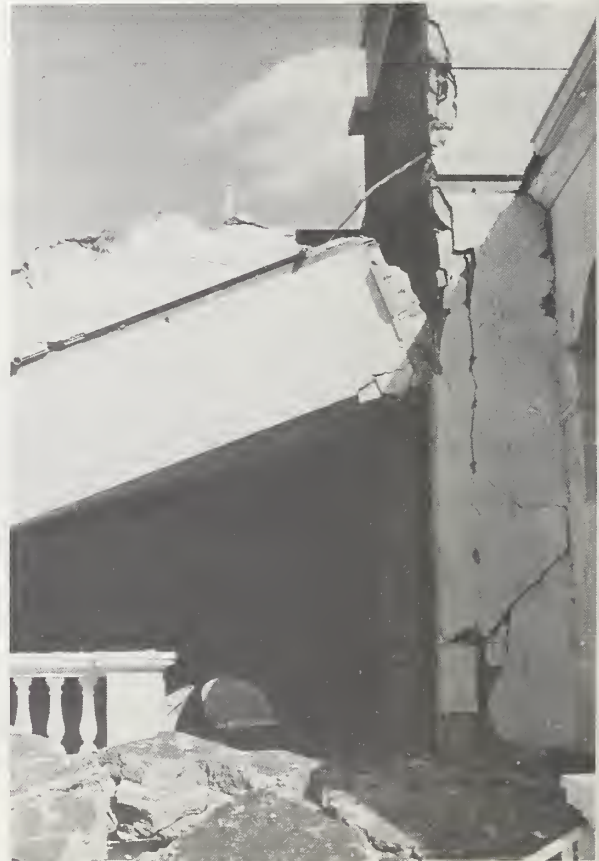
Figure 60-2 Detail of collapsed terrace roof, Casa Presidencial.

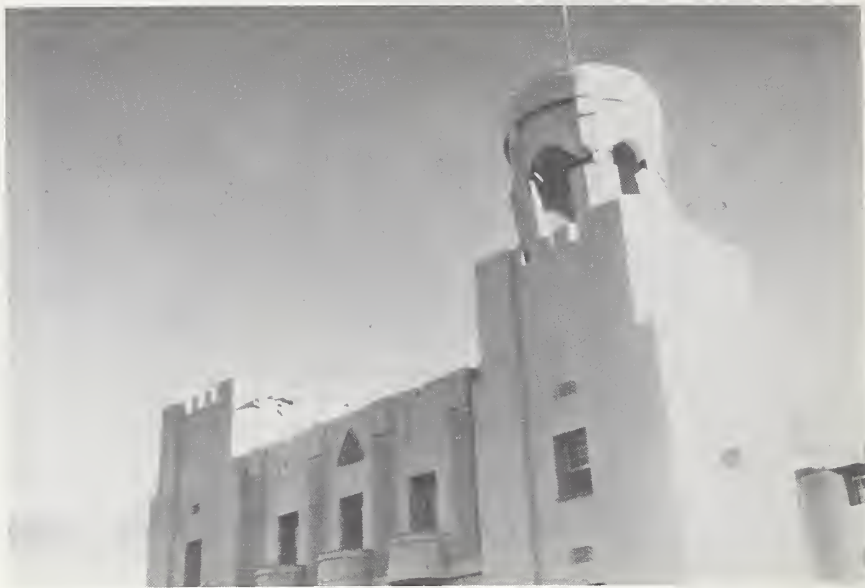
Figure 61-1 One roof tower near collapse, the other fallen, Residencia Jefe Director.

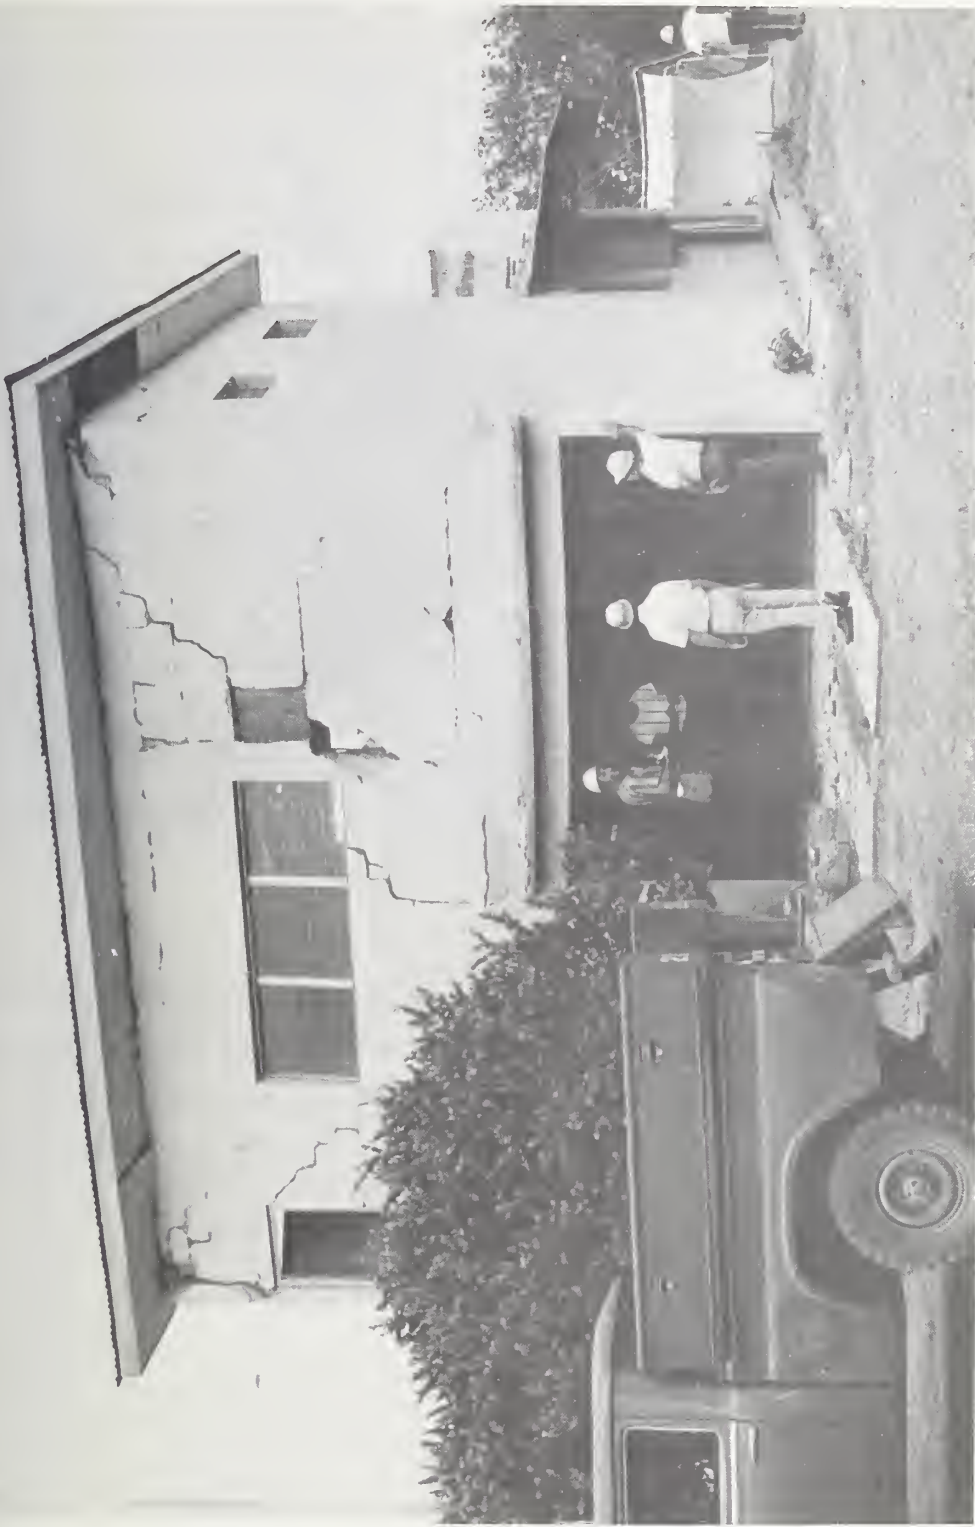
Figure 62-1 A very fragile building housing the country's radio transmission equipment, Radio-Difusora Nacional.

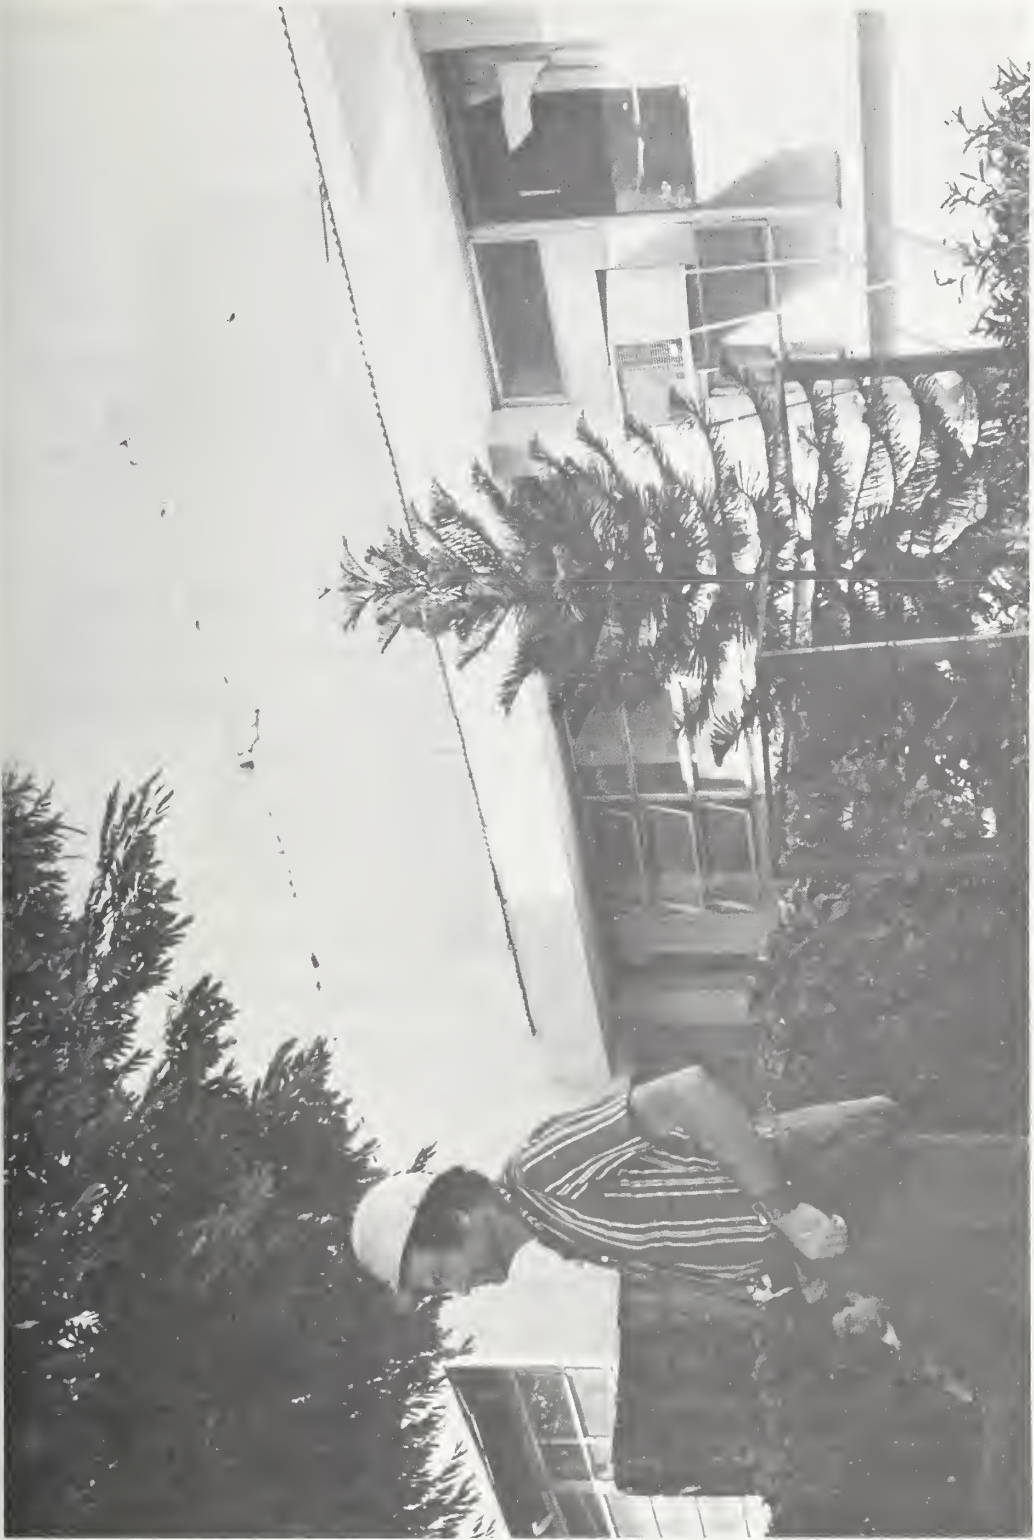
Figure 71-1 Cracked parapet walls, Policlínica Central del INSS.

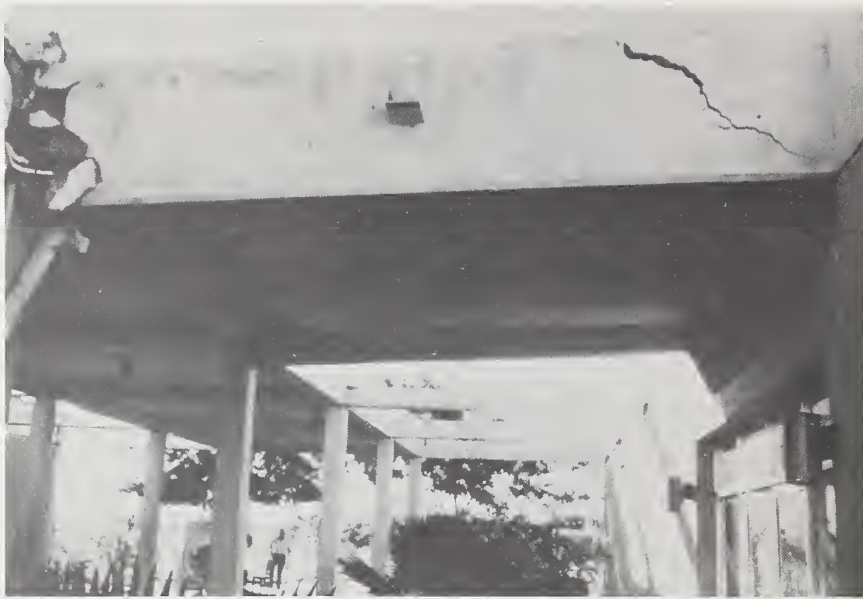
Figure 75-1 Damages to canopy between buildings,
Instituto Geografico Nacional
