NBS TECHNICAL NOTE **833**

# Fire Department Ground Ladders— Results of a Preliminary Study

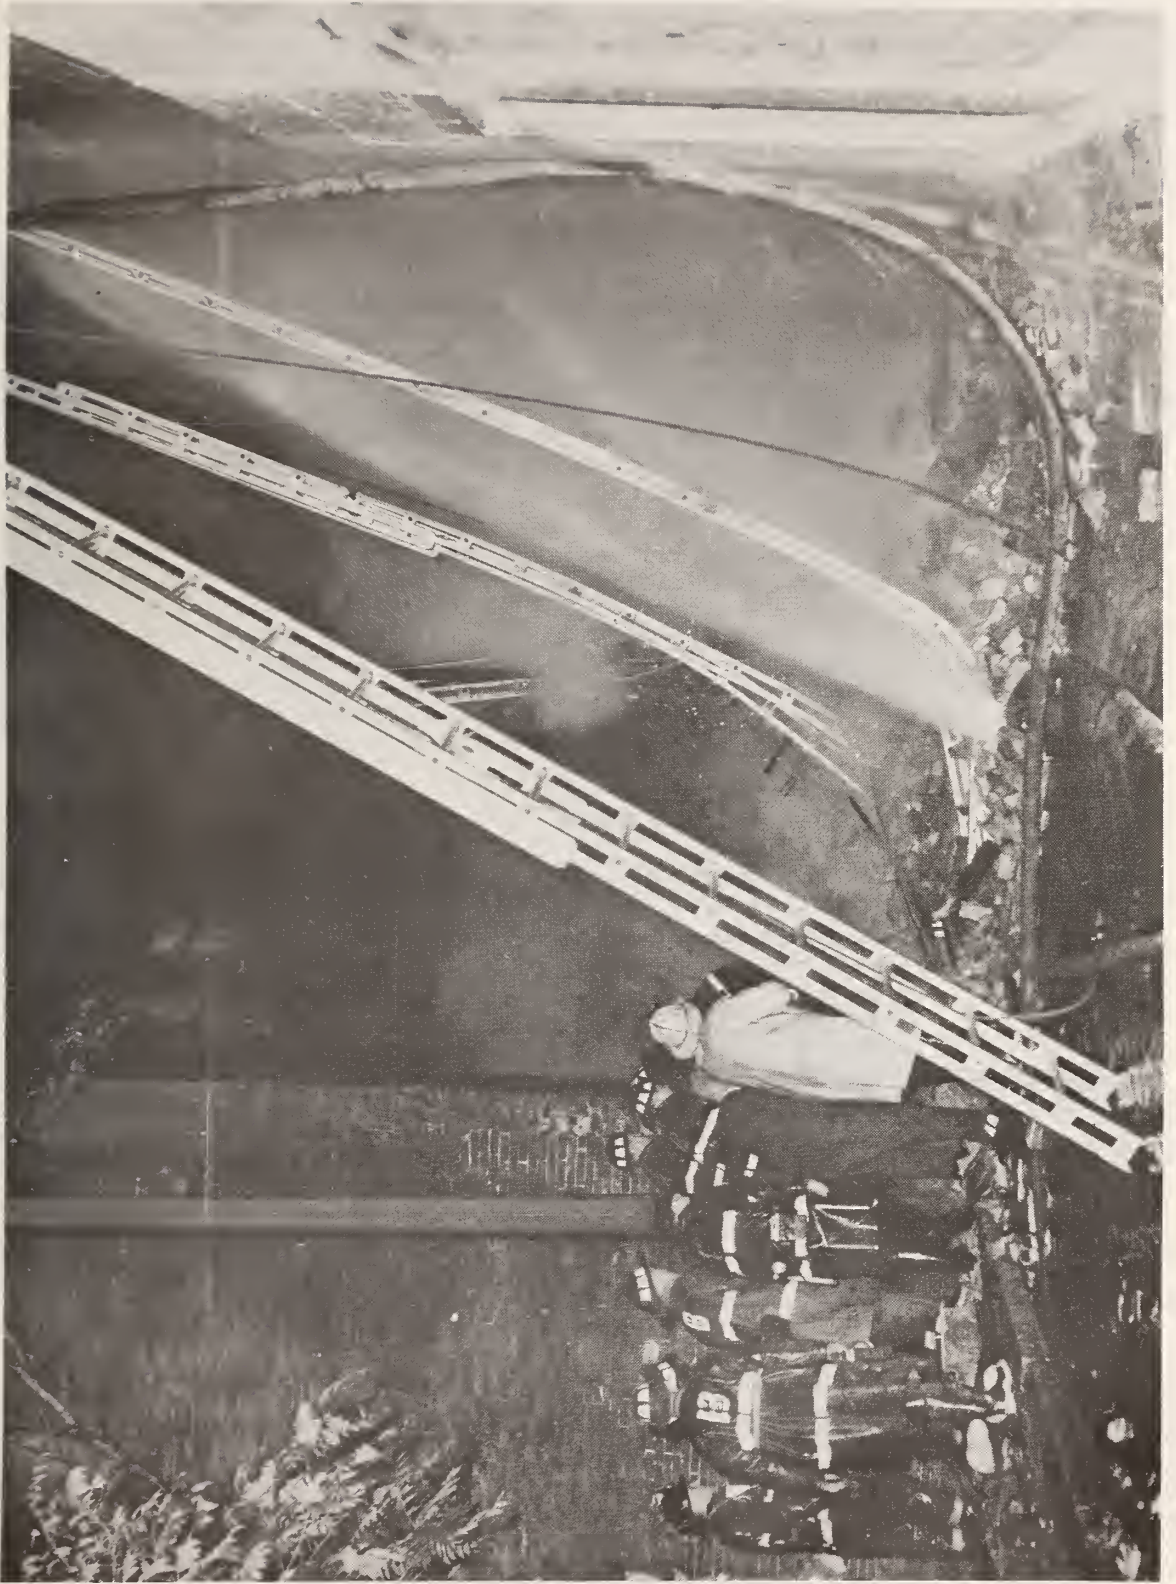
Figure 22. A falling building wall produced the damage shown to these ladders.

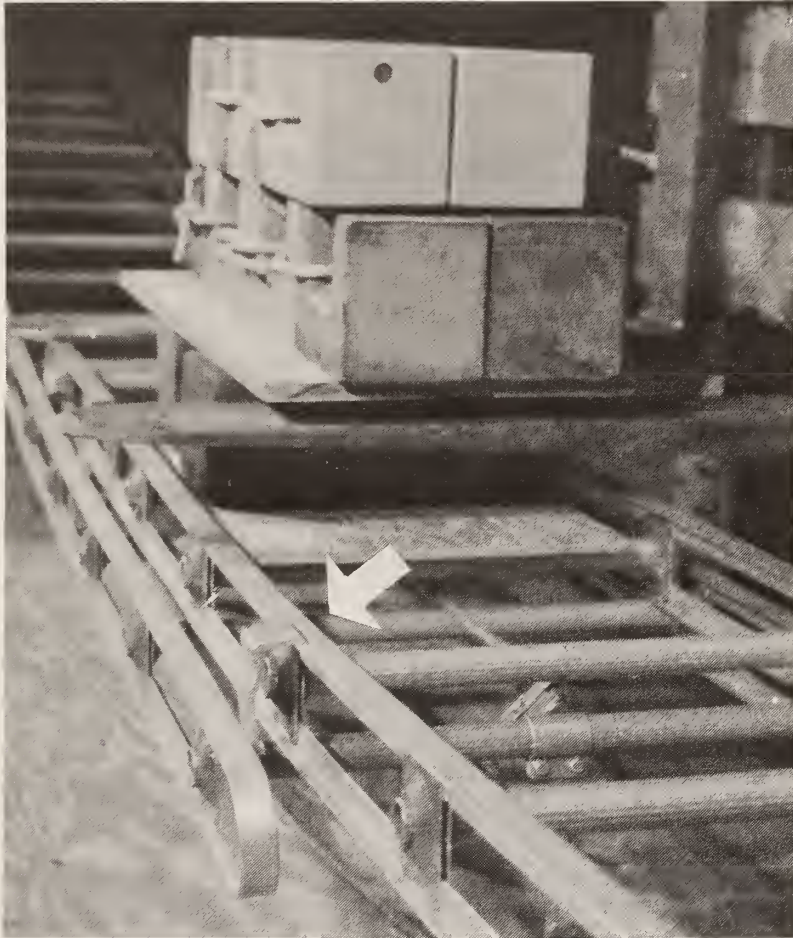
The author is unaware of any tests conducted specifically for the purpose of evaluating ground ladder hardware. However, some of the horizontal bending tests conducted by the National Bureau of Standards and described above (table 3) produced initial failure at the hardware rather than in a structural member. An example is shown in figure 25.

Figure 25. A ladder undergoing test about to give way at a guide (arrow).

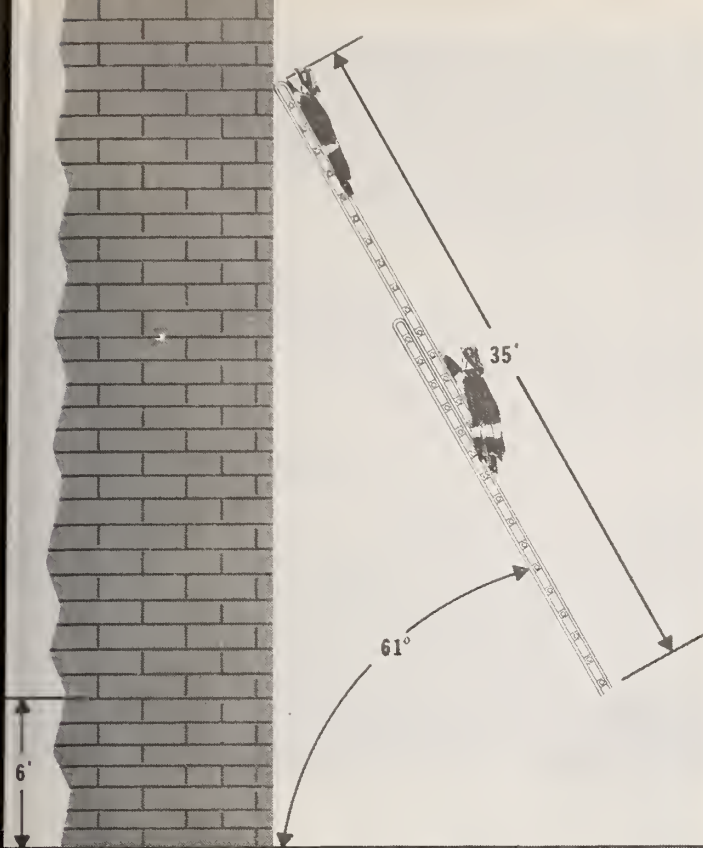
The ladder was being used within the load carrying limits specified in NFPA 193 [2]. According to paragraph 132 of that standard, a trussed extension ladder of length 26 to 35 feet can support up to four men when placed with "The butt of the ladder at a distance not to exceed one-third the ladder length away from the building . . . . At angles less than these the load limit on the ladder will decrease accordingly." Since the ladder was placed at a somewhat longer distance from the building (see figure A-2), it is necessary to calculate a reduced load limit from geometric considerations (see eqs (1) and (2) in section 3). This works out to a 2.75-man load limit. Thus, the 2-man load reportedly applied was within the rated capacity of the ladder, as defined in NFPA 193.

Figure A - 1. Sketch of ladder immediately prior to failure, as reported by fire department.

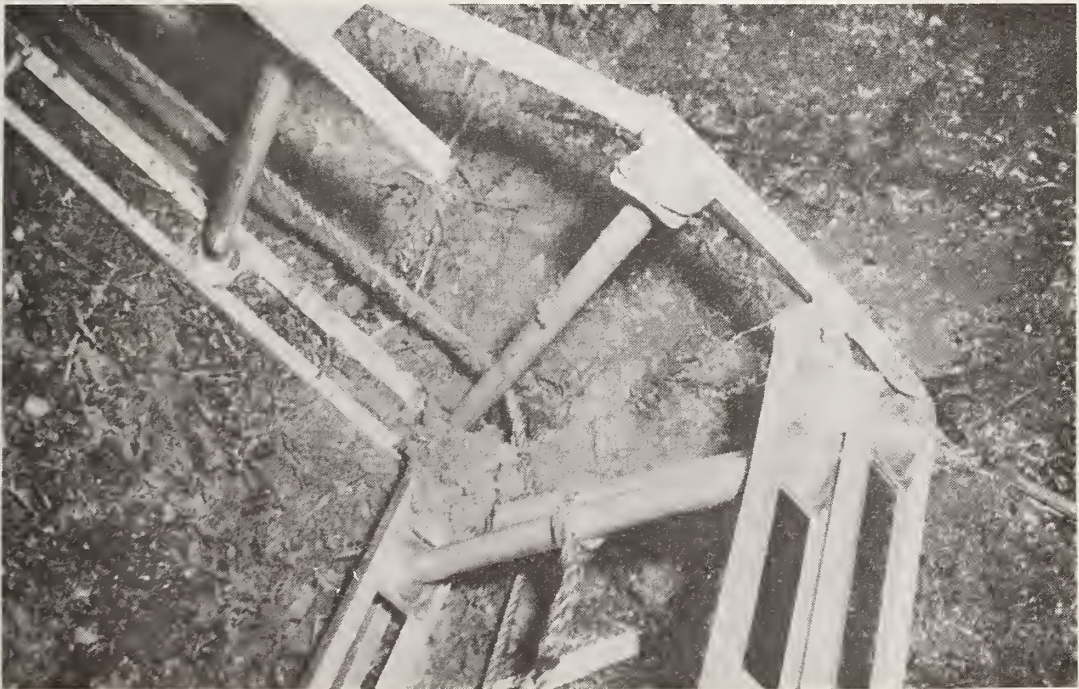
Figure A - 2. Failed portion of ladder immediately after failure. Photograph taken at scene.

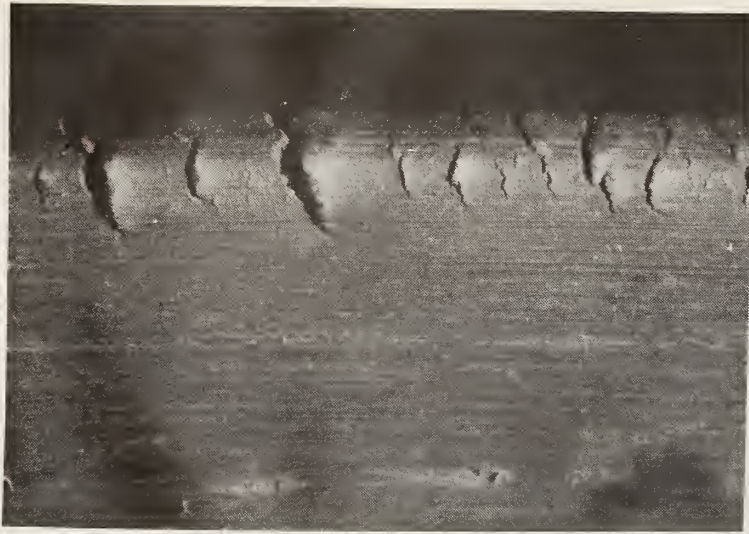
Figure A-4. View of member A showing cracks at the edge of the flange near fracture X 7.

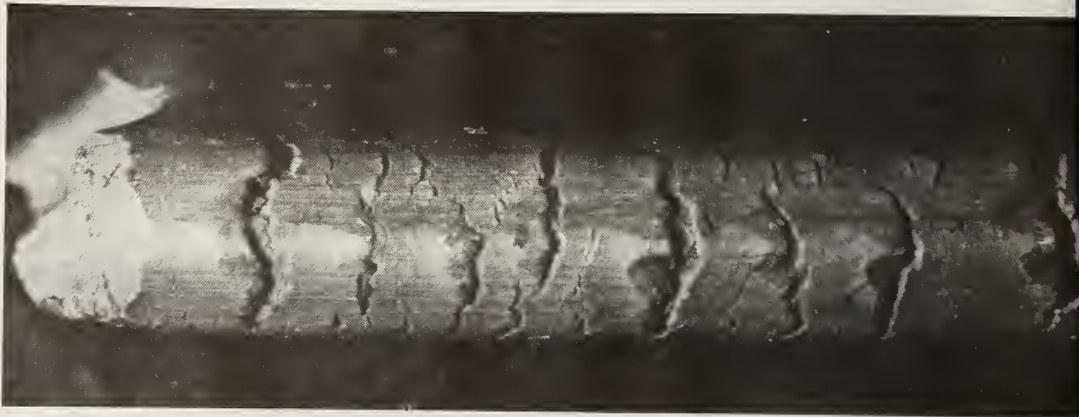
Figure A-5. Cracks at the edge of the flange in member A adjacent to fracture. X 10

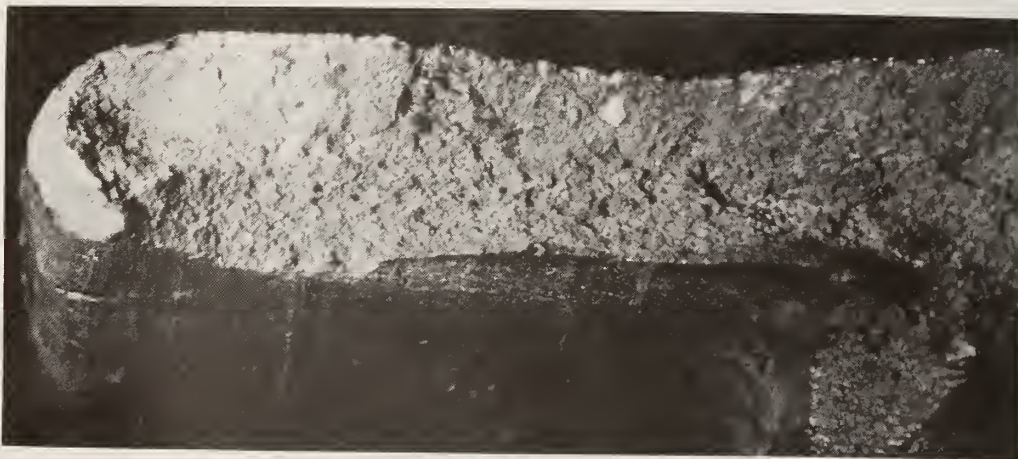
Figure A-6. Fracture surface member A. This fracture went through extrusion crack (left). X 10

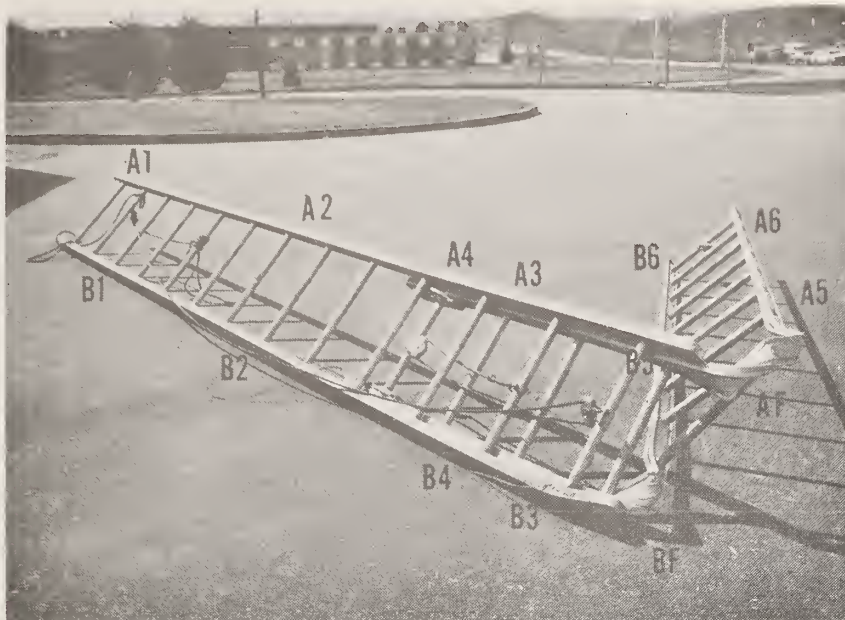
Figure B-1. Failed fire ladder as received. The number and letter designations indicate locations of the ladder rails which were examined. The "A" rails are on the right side and the "B" rails are on the left side.

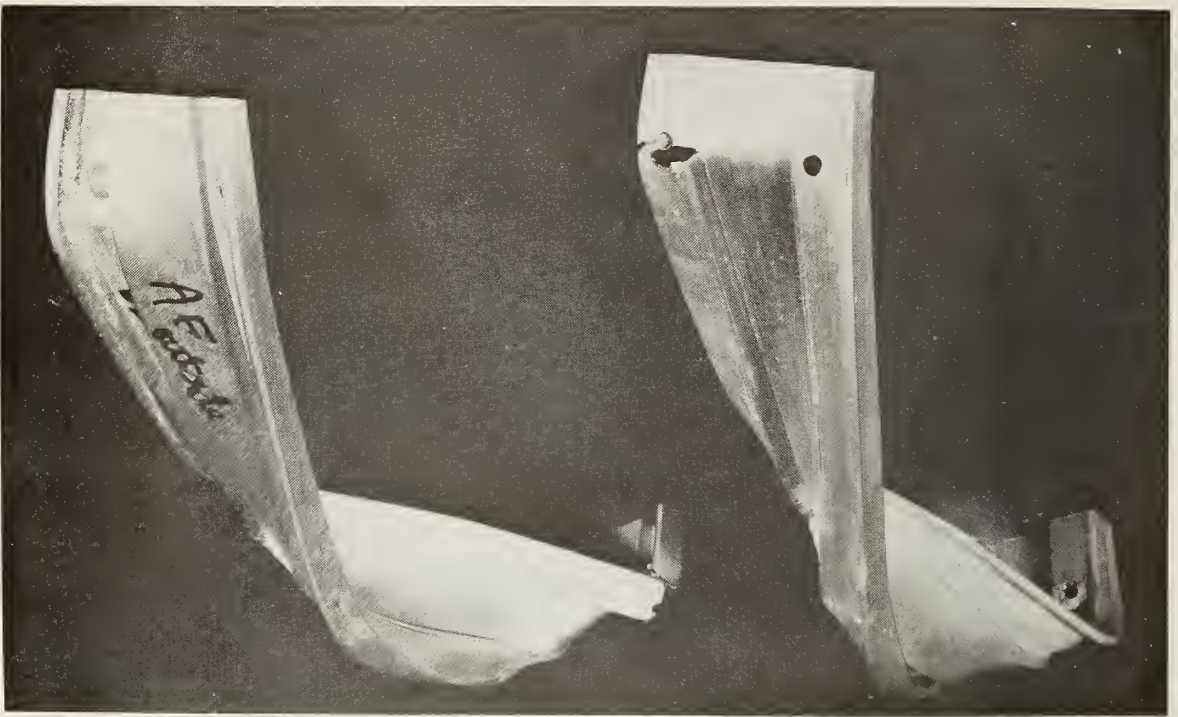
Figure B-3. Parts of the deformed extruded members from location AF. AF outside is at the left and AF inside is at the right. X 1/3

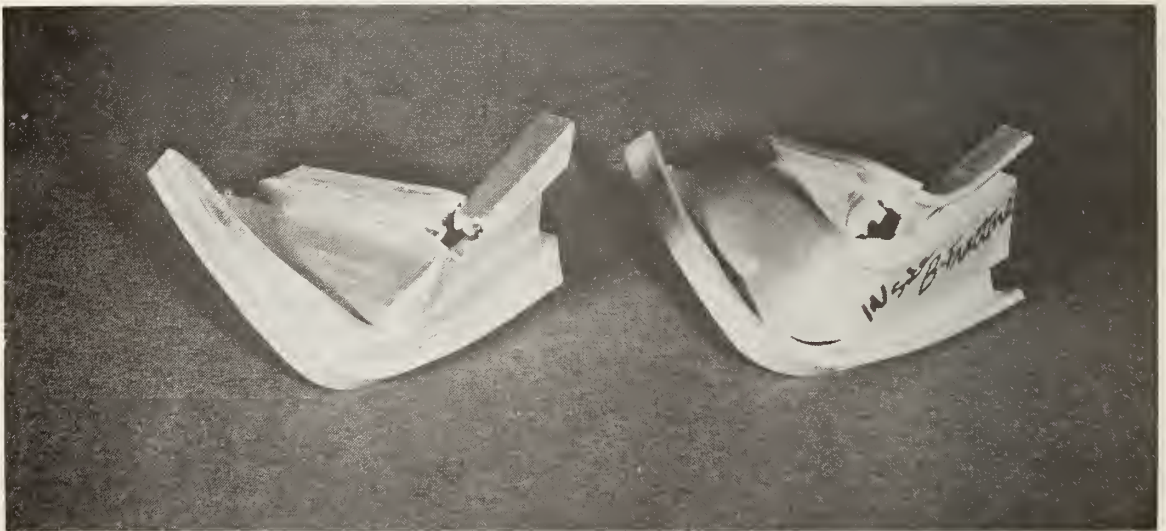
Figure B-4. Parts of the deformed extruded members from location BF. BF outside is at the left and BF inside is at the right. X 1/3

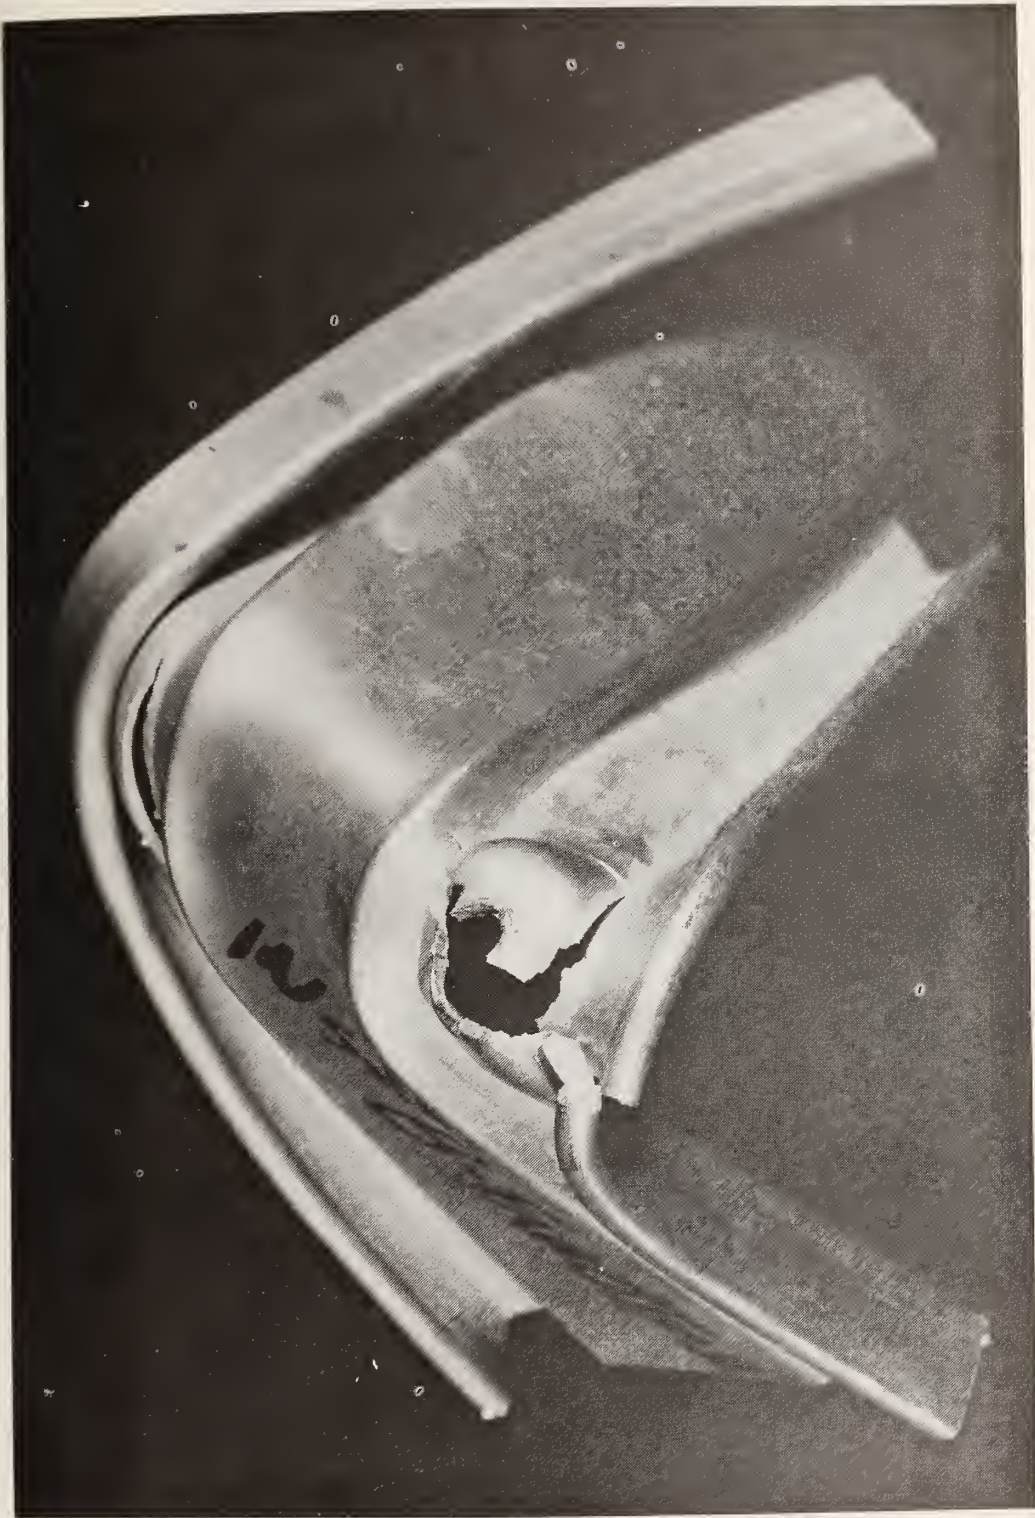
Figure B-5. Deformed part of extruded member B outside from location BF (shown on the right in figure 4). The hole in the center at the top is where a rivet had pulled out. Some cracks can be seen. X 1

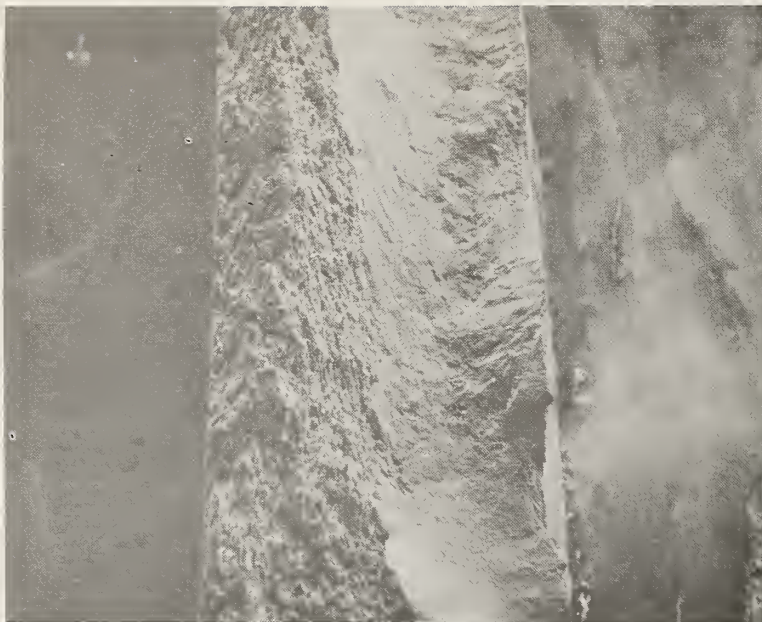
Figure B-6. Scanning electron photomicrograph showing the fracture surface of a crack at location BF inside. The features at the left indicate ductile overload. The features on the right indicate smearing on the compression side of the fracture. X 24

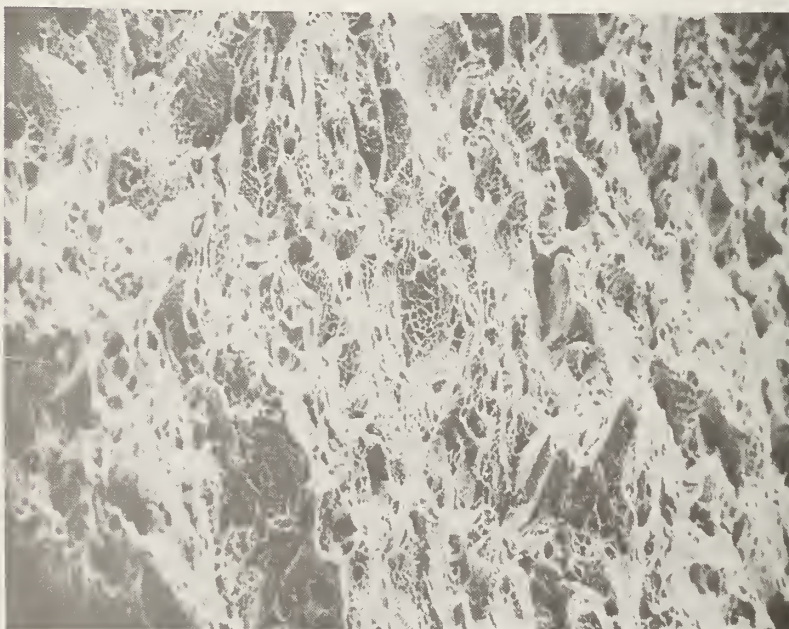
Figure B-7. Scanning electron photomicrograph of fracture at location BF inside showing ductile overload (left side of figure 6). X 240

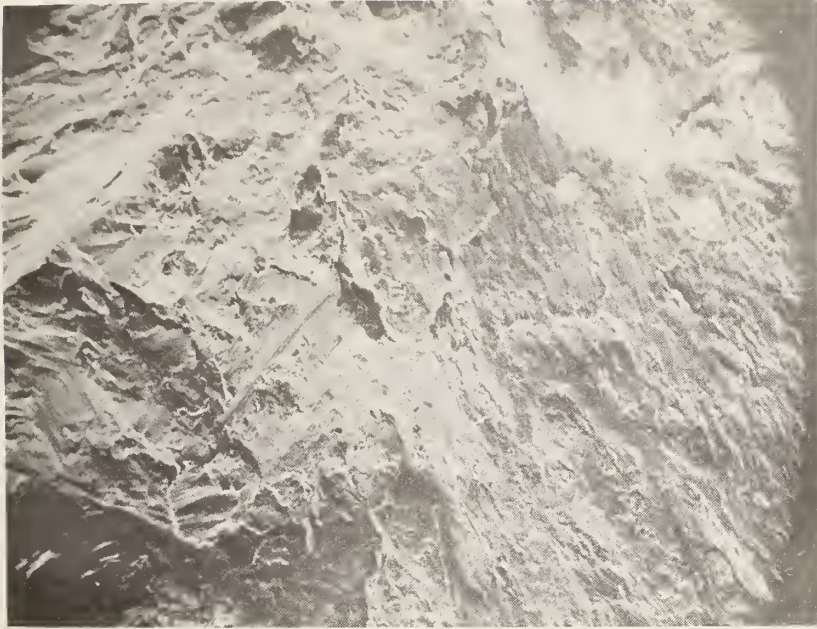
Figure B-8 . Scanning electron photomicrograph of fracture at location BF inside showing smearing on the compression side of the fracture. X 235

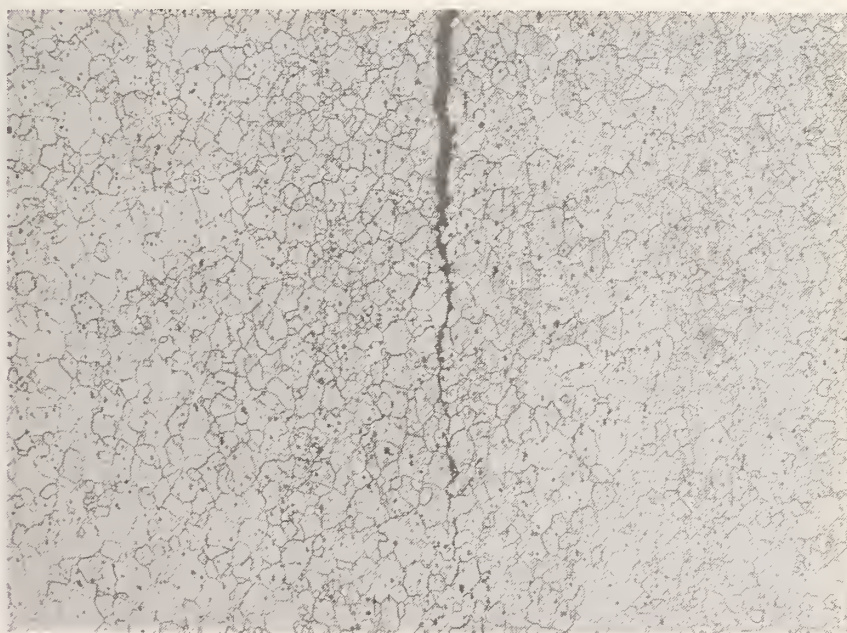
Figure B-11. Microstructure of transverse cross section from location BF inside. The microstructure appears to be nearly completely recrystallized. There is an intergranular longitudinal crack. Etch: 10% NaOH. X 60

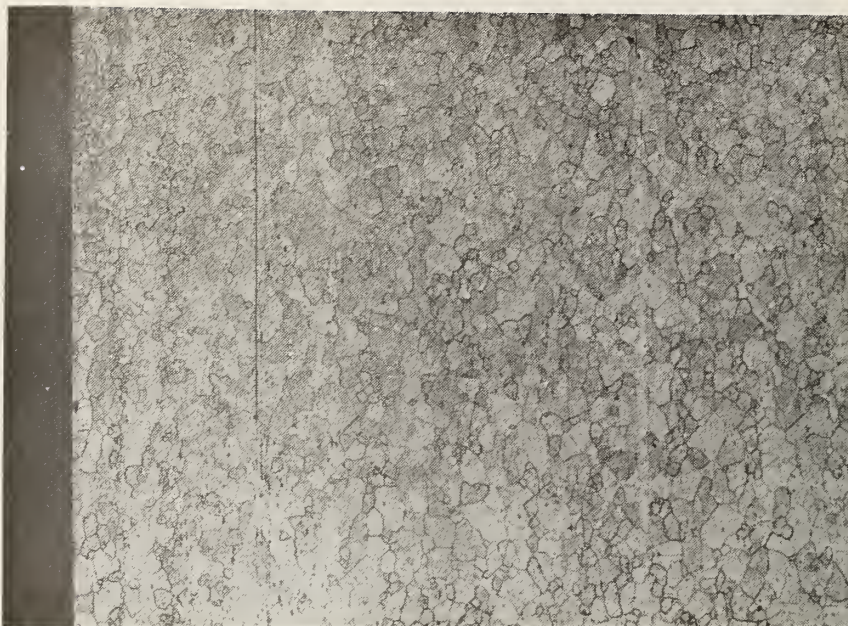
Figure B-12. Microstructure of longitudinal cross section from location BF inside. An extrusion lap or seam is exhibited (running vertically) in the figure. Etch: 10% NaOH. X 60

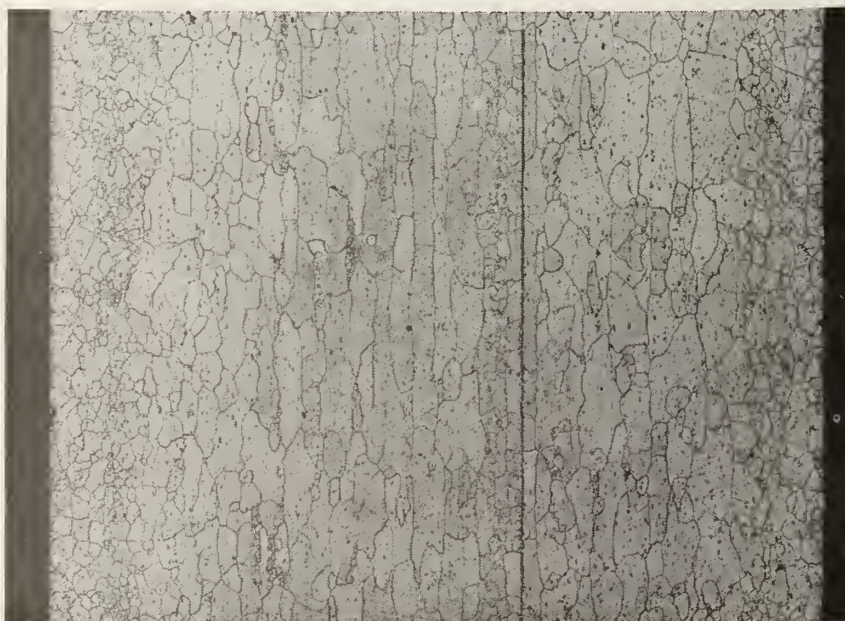
Figure B-13. Microstructure of longitudinal cross section from location A1 inside. There are fine grains near the surfaces and elongated grains in the center. An extrusion lap or seam can be seen. Etch: 10% NaOH. X 60

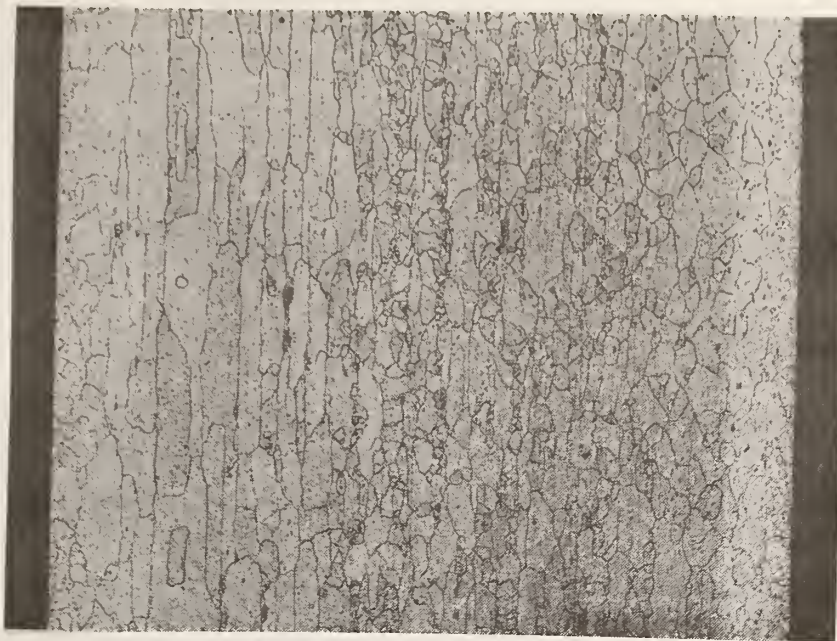
Figure B-14. Microstructure of longitudinal cross section from location AF showing fine grains near the center. There appears to have been incomplete recrystallization and there is considerable fine precipitate. Etch: 10% NaOH. X 60

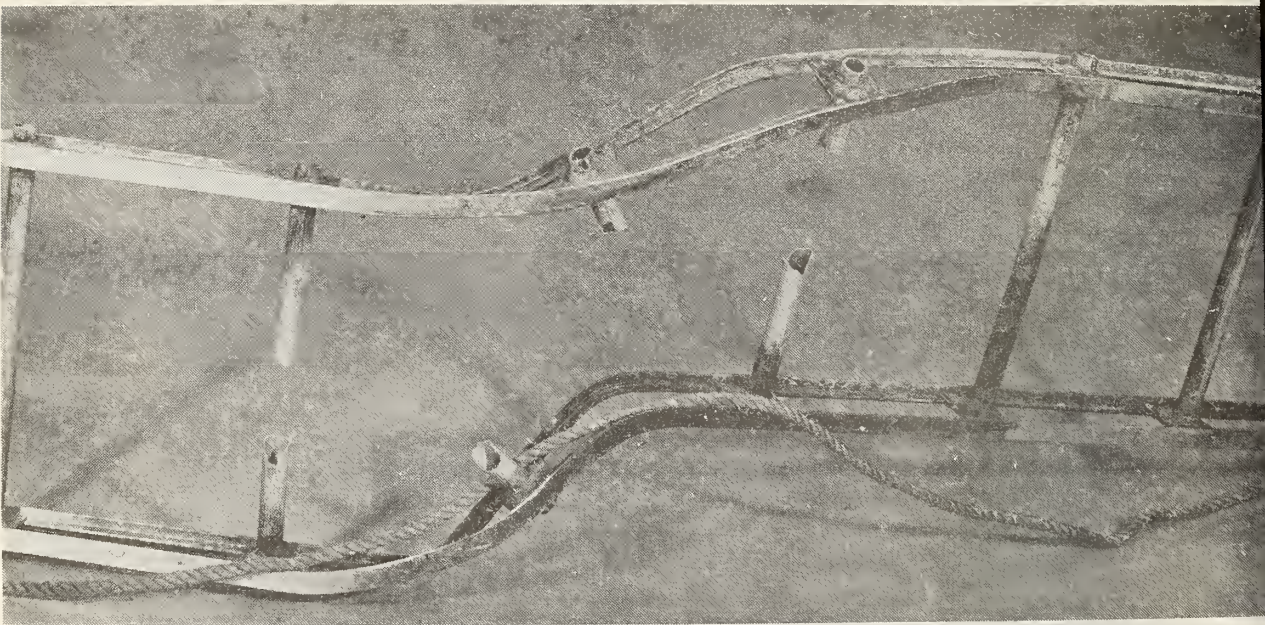
Figure C-1. Fire ladder as received showing damaged area at right. X 1/10

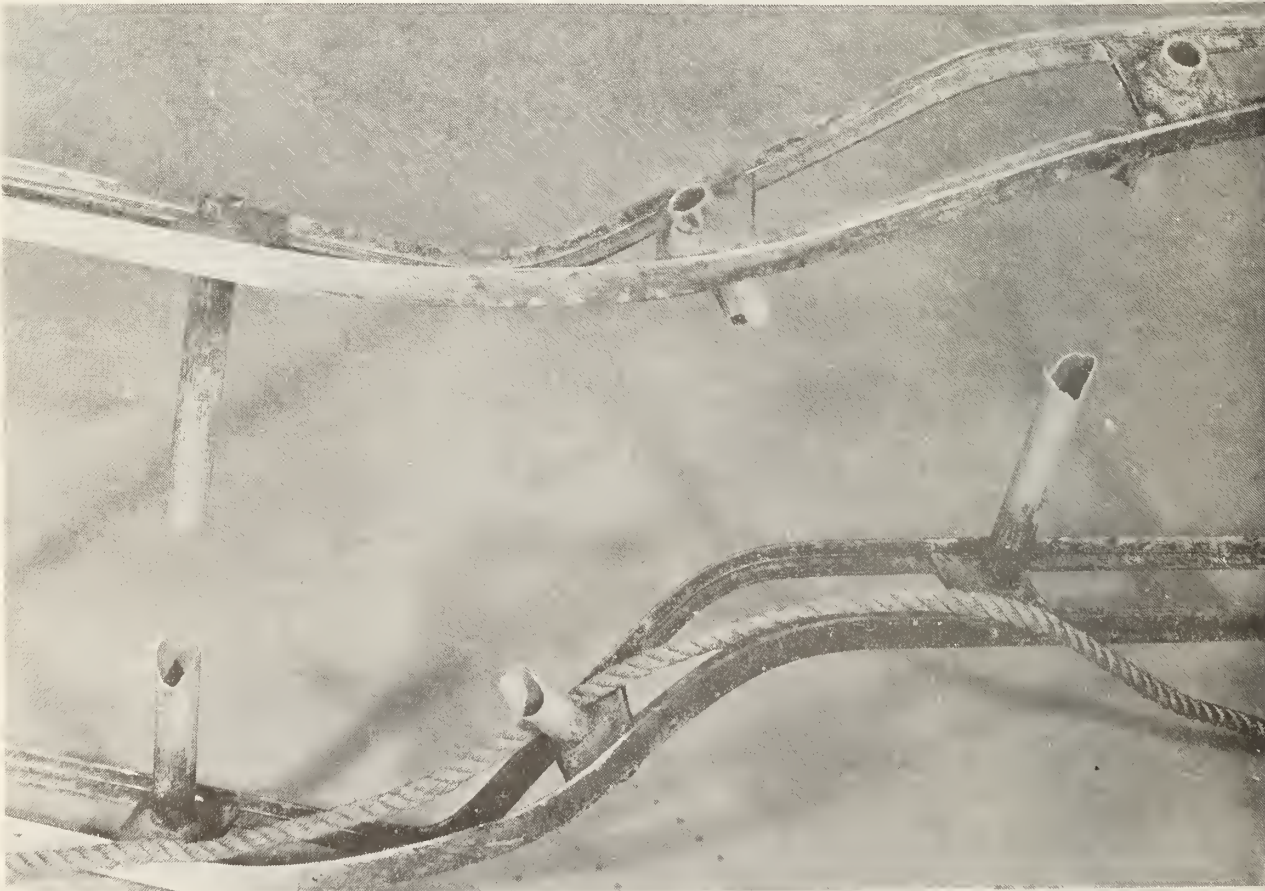
Figure C-2. Damaged portion of ladder as received. X 1/5

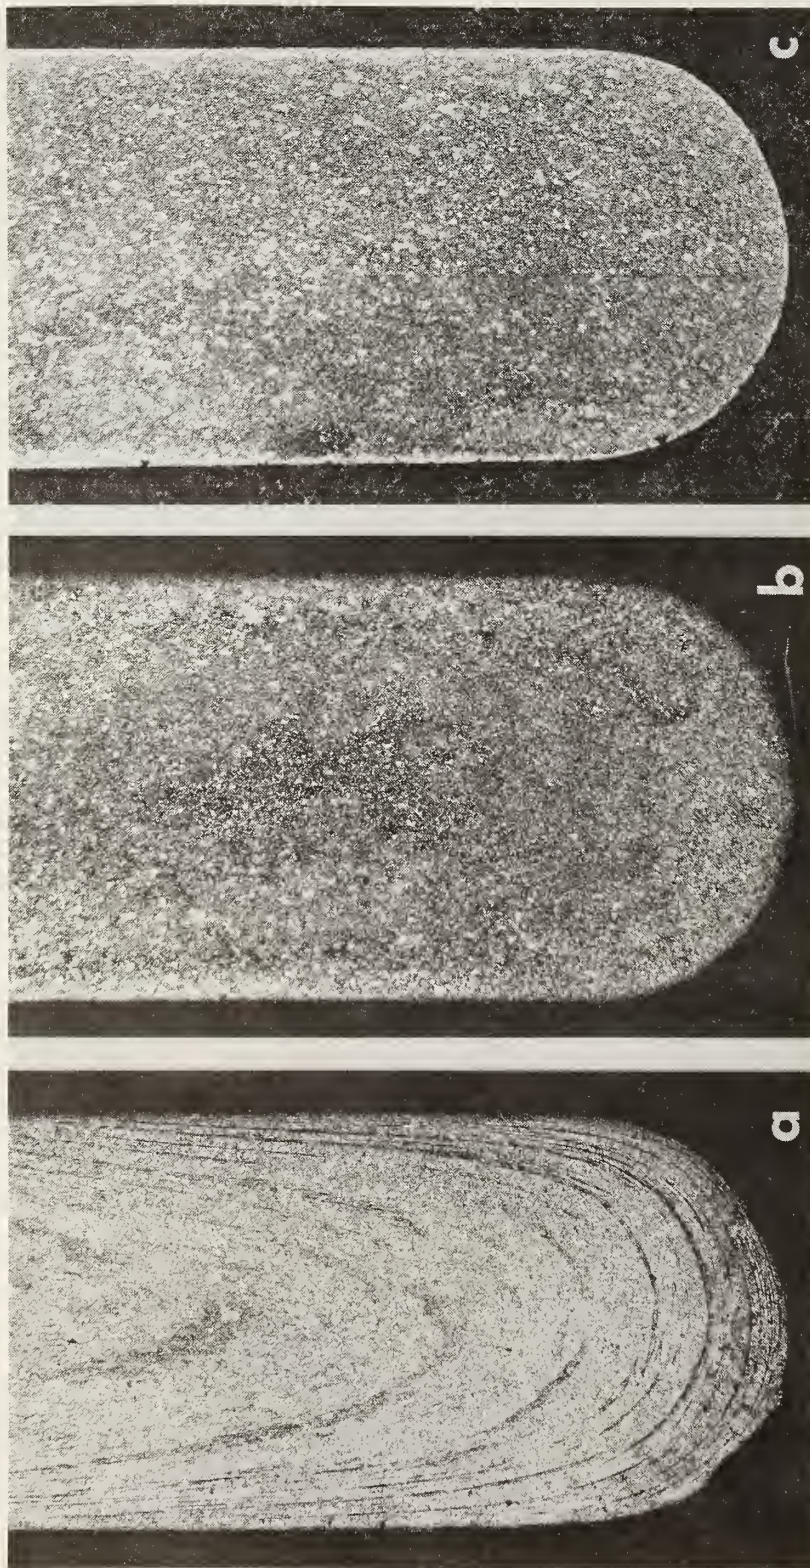
Figure C-3. Macroetched sections of ladder side rail. X 11  
 Etch: Solution containing 2.5 cc HCl, 3.5 cc  
 HNO<sub>3</sub>, 1.0 cc H<sub>2</sub>SO<sub>4</sub>, 2.0 cc HF, 125 cc H<sub>2</sub>O.

- a. Section near bottom unaffected by heat.
- b. Blackened, but undeformed section near top.
- c. Section from twisted area.
