NBS TECHNICAL NOTE 909

Investigation of Wind Damage in the Metropolitan Washington, D.C. Area, April 3-4, 1975

A limited investigation was conducted of wind damage that occurred on April 3 and 4, 1975 in the Metropolitan Washington, D.C. area.

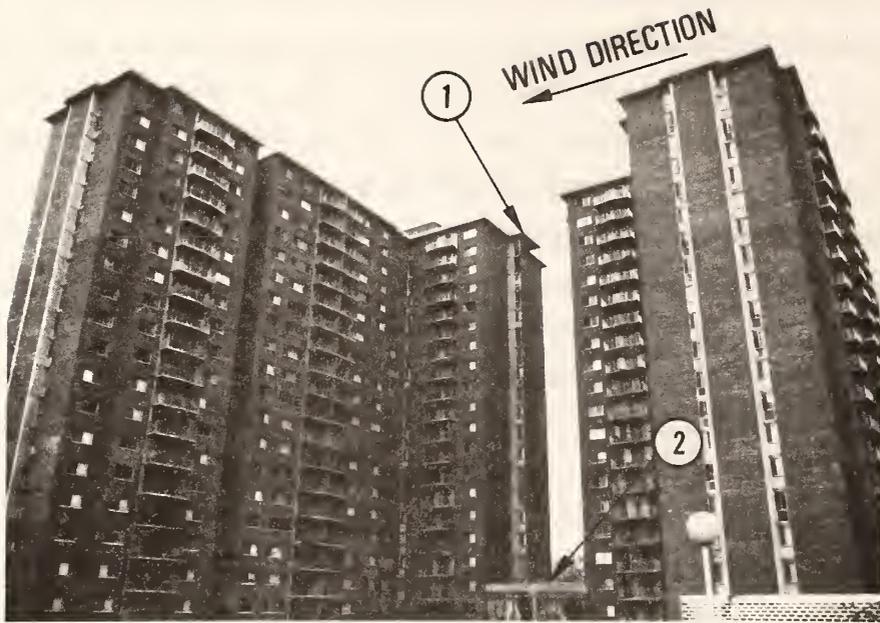
Figure 2 shows the rear elevation of a 19 story apartment building complex. The prevailing wind direction is shown by the arrow at the top of the figure. In this building a masonry wall fell from the location marked 1 into a lobby (location 2) destroying the roof of the lobby. Some of the debris from the wall and the lobby roof resting on the floor of the lobby is shown in figure 3. Figure 4 shows the wall failure in more detail and figure 5 shows an elevation of a similar wall in the opposite wing of the twin buildings which did not fail. The buildings are reinforced concrete structures.

Figure 2 - Damaged areas of high-rise apartment building. Looking south.

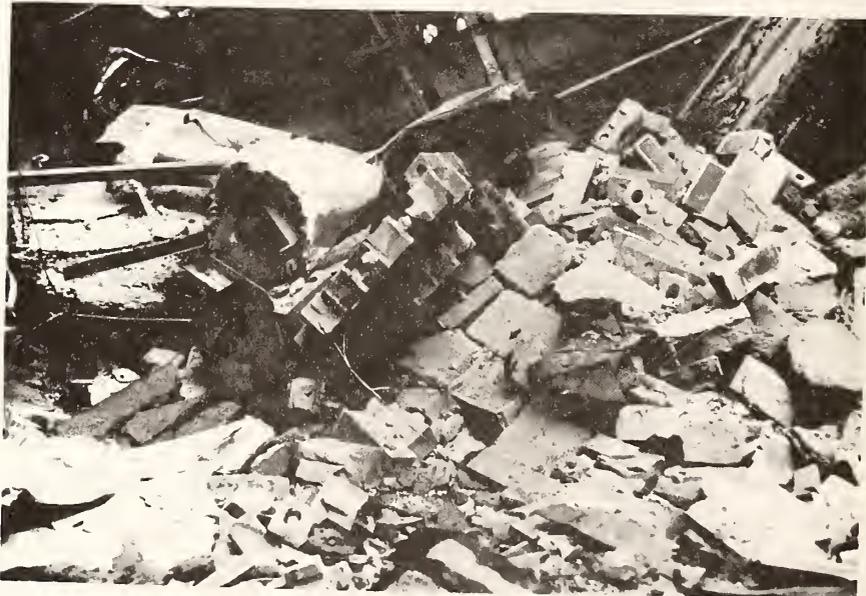
Figure 3 - Partial view of the debris on the floor of the lobby.

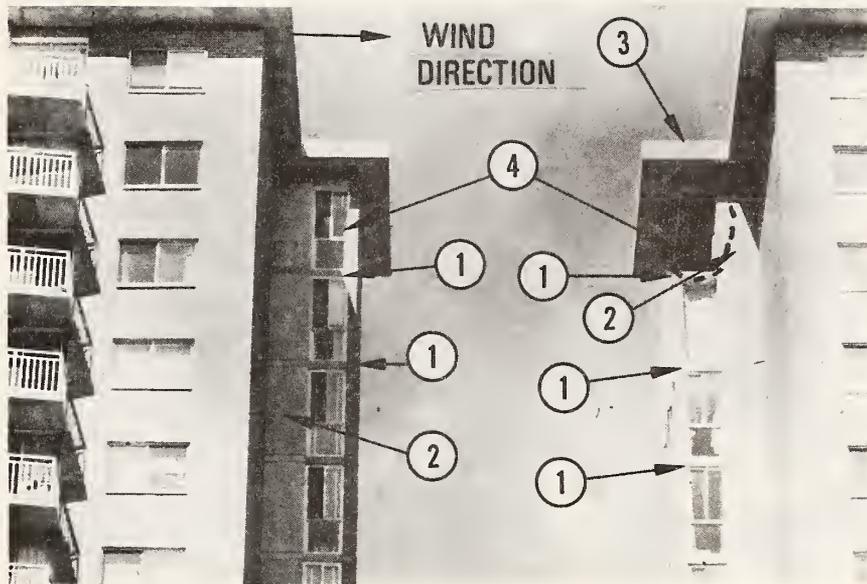
Typically, reinforced concrete flat slabs, marked number 1 in figure 4, are structurally supported by reinforced concrete bearing walls marked number 2 in figure 4. The roof slab, marked number 3 in figure 4 is a reinforced concrete slab which is also supported by the concrete walls and is further stiffened by a reinforced concrete rim beam, marked number 1 in figure 5. The masonry walls are nonstructural curtain walls consisting of one wythe of brick backed up by one wythe of nominally 4 in (10 cm) thick concrete block. Ties between the brick wythe and the concrete block wythe are provided by truss-type horizontal joint reinforcement. There is no vertical reinforcement and the field inspection showed no evidence that reinforcement ties were provided between the masonry wall and the roof or between the masonry wall and the floor slabs. Based on the visual inspection and on occupant accounts the failure mechanism is envisioned as follows: First the window, marked number 4 in figure 4 (see the encircled area on the right hand building) broke inward under the wind pressure, the local wind direction being substantially different from the prevailing direction. Subsequently, outward pressure acted on all the interior surfaces of the room (the opposite window in the same room did not break) and the accelerated flow between the buildings probably resulted in very low pressures acting on the exterior of the wall. In addition to this outward pressure, the roof was quite likely subject to upward pressure on the overhanging part and to suction on the top. The combination of these pressures together with the probable absence of ties between the wall and the roof caused the masonry wall to fail as a cantilever along the top of the floor slab of the uppermost story. Figure 6 shows a portion of the failure surface. It should be noted that the failure surface (near the edge of the floor slab) is clean and smooth with no substantial remnants of the mortar joint above it. This is taken as an indication that the bond between the mortar joint of the concrete block wythe and the floor slab was probably weak. Thus at this cross section, effective moment resistance was provided only by one 3-1/2 in (8.9 cm) wide brick wythe. There was not enough moment resistance available to prevent the wall from failing as a cantilever beam. The weight of the wall section that fell on

Figure 4 - Structural details of the twin buildings. Looking north.

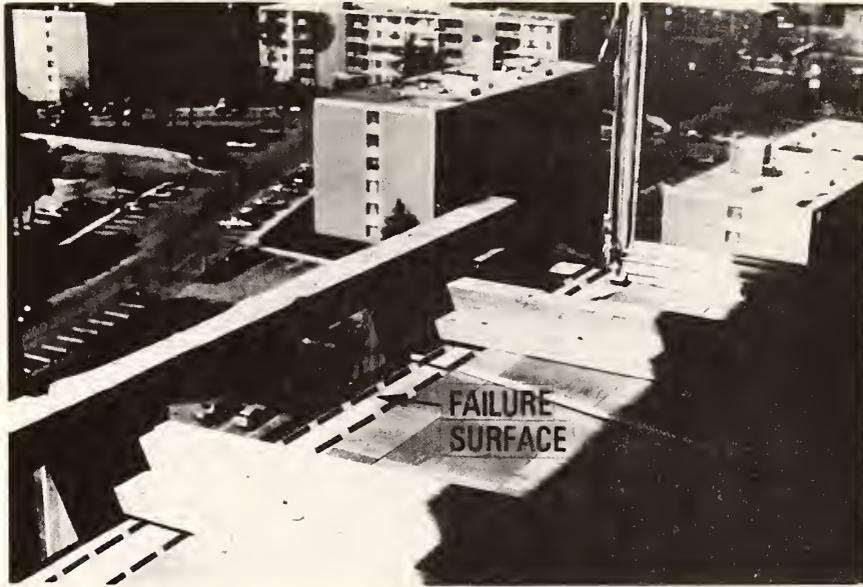
Figure 6 - Failure surface (between dashed lines) on top of floor slab.

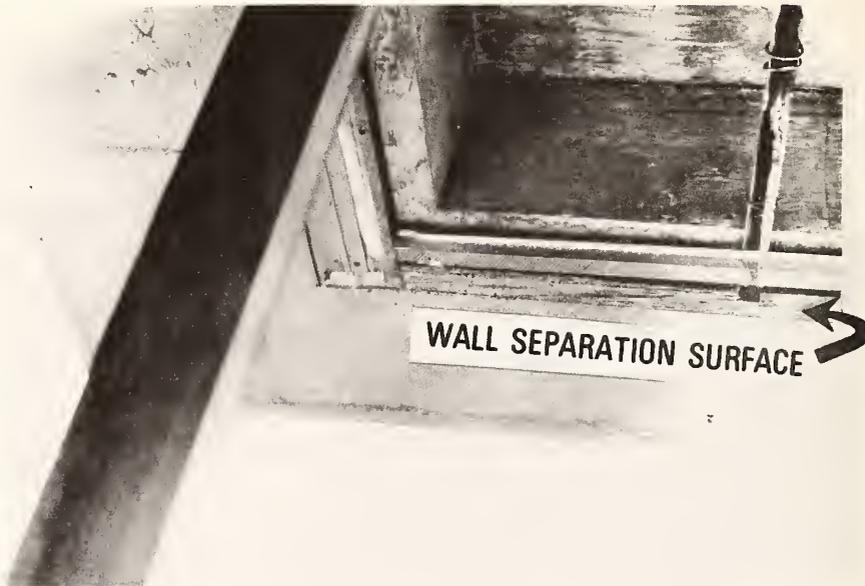
the lobby was considerable and could have caused loss of life. A view from underneath the roof slab is shown in figure 7. Note the concrete rim beam which stiffens the roof slab. The surface where the wall separated is marked by an arrow. It can be reasonably assumed that most of the weight of this portion of the roof slab is transferred by the rim beam to the concrete columns and therefore only a minor part of this weight rests on the masonry wall. Thus no substantial frictional force would resist the outward movement of the top of the masonry wall. Other views of the failure are provided in figures 8 and 9.

Figure 7 - Surface of separation between rim beam and top of wall. Looking at underside of roof slab.

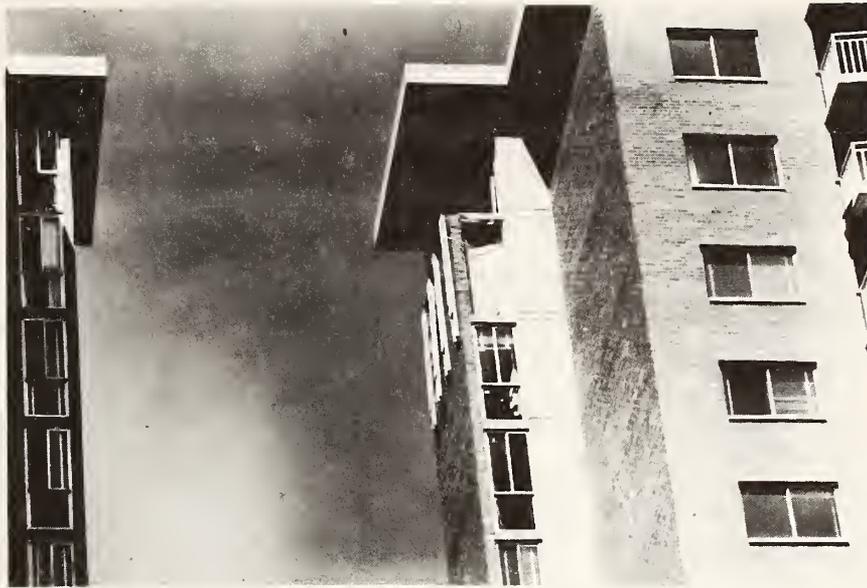
Figure 8 - View of upper-story damage. Looking north.

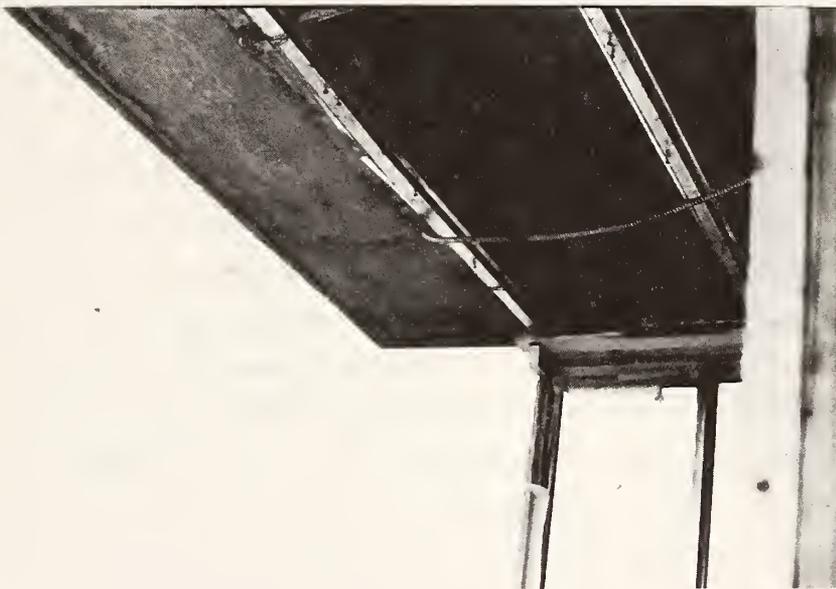
Figure 9 - Closeup of roof slab in damaged area. Looking north.

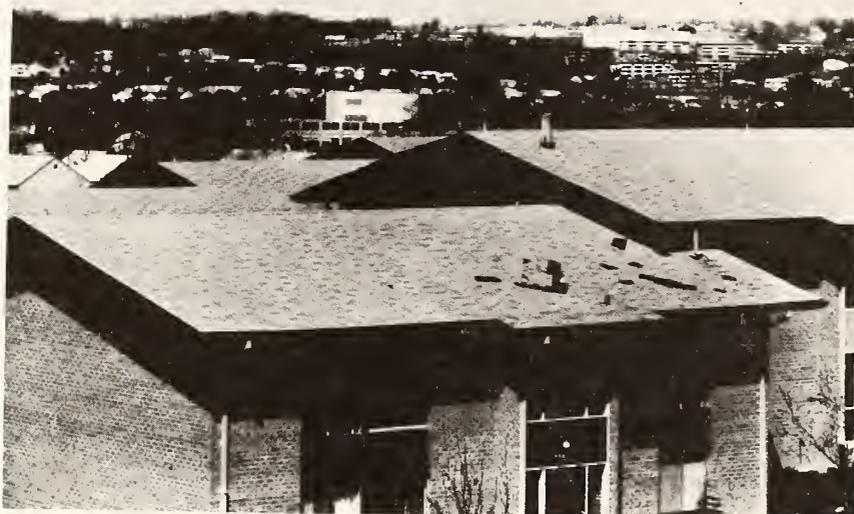
Figure 10 is a rooftop view which shows a portion of a garden apartment complex consisting of two and three-story, wood-frame, brick veneer structures. The end walls of three buildings in this complex were damaged as a result of the brick veneer flexing and separating from the sheathing and wood framing. Figure 11 shows the most severe of the three cases of endwall damage. The brick veneer failed over a large area of the wall. Eyewitnesses reported a transverse deflection of approximately 6 to 8 inches (15 to 20 cm) in the brick veneer before the failure occurred. The walls in the other two similarly affected buildings were shored (or braced) before substantial flexural failure of the veneer occurred. The prevailing wind direction is shown by the arrow in figure 11. The brick veneer was connected to the wood framing by corrugated steel ties. Evidence of broken ties as well as of the ties which were pulled out from the wood construction was found in the field investigation.

*Figure 10 - Rooftop view of garden apartments damaged by wind.
Looking northwest.*

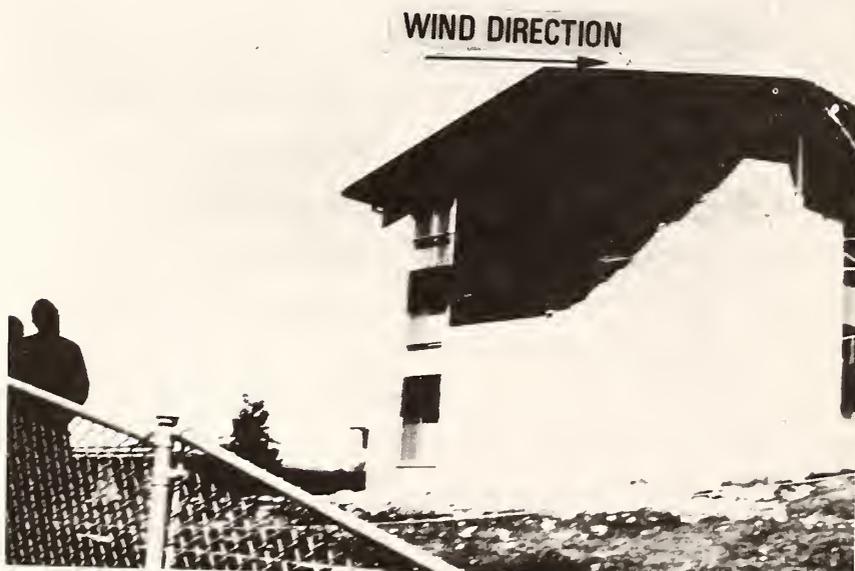
The wind direction, which was parallel to the wall, probably caused suction to act on the brick veneer. Two possible failure mechanism are envisioned: 1. the outward deflection of the gable wall could have exceeded the deflection tolerance of the masonry veneer; 2. the ties could have been too weak or too flexible to prevent a separation between the masonry veneer and the wood framing. The location of the failure area relative to the floor diaphragms which restrain the outward deflection of the wood framing seems to indicate that the failure in this case was caused by separation between the masonry veneer and the wood framing. There also seems to be evidence that the brick veneer could have moved substantially outward before the ties between the brick veneer and the wood framing were actually structurally engaged. This is illustrated by figure 12, which shows a tie connected to a brick taken from the site. The only nail hole in that tie through which a nail was driven is shown by the arrow. The distance of this nail hole from the back face of the brick indicates that the brick could have moved outward substantially before the tie was tight enough to be structurally engaged. Figure 13 shows one of two endwalls which was braced because it was flexing excessively. A total failure

*Figure 11 - Damaged brick veneer endwall in a 3-story building.
Looking north.*

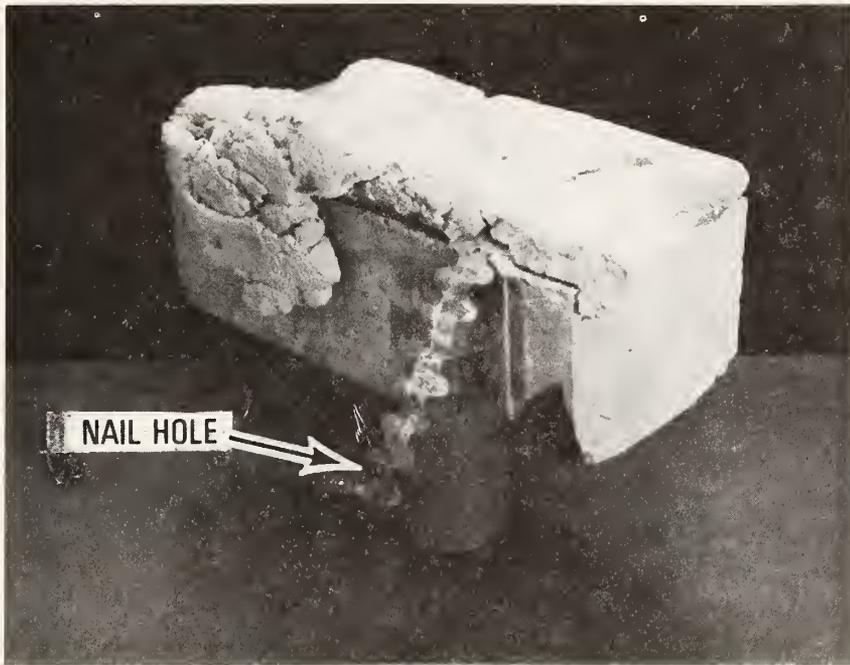
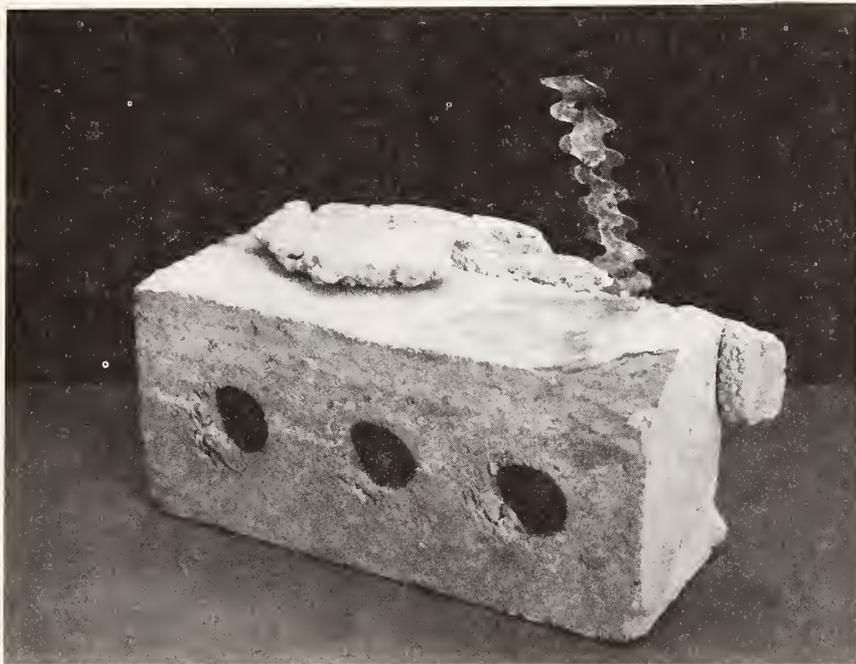
Figure 12 - Two views of a brick and connected tie taken from the endwall debris.

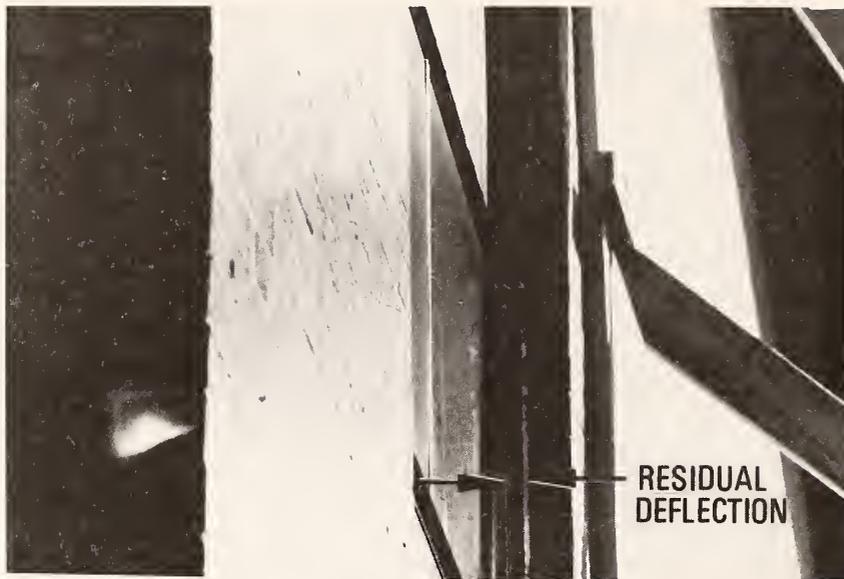
of the veneer was prevented by the bracing. The two arrows show the distance between the present location of the window and its original location relative to the veneer (identified by the remnants of the caulking). Note that the wall moved out considerably. The deflection seen in the picture is actually the residual deflection that remained after bracing. The maximum deflection during the wind storm probably substantially exceeded the deflection seen here. Figure 14 shows the second wall which had to be braced during the storm. It is evident that the strength or stiffness deficiency in the veneer construction was not limited to the building where complete veneer failure occurred.

Figure 13 - A brick veneer endwall braced because of excessive flexing.

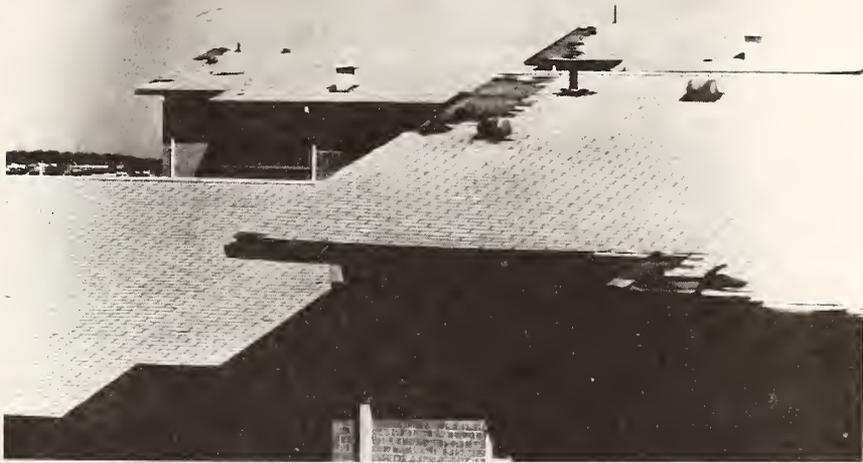
Some of the roof damage in the same apartment complex is shown in figure 15. It occurred mostly near the windward edges of the roofs. It should be noted that not only were roof shingles ripped out, but also, in some instances, the supporting plywood sheets failed. Failure of the plywood sheets tended to occur at the overhanging parts of the roofs. Figure 16 shows a damaged roof under repair. The original projecting purlins which faced the direction of the wind were ripped out and had to be replaced. A measure taken to strengthen the new projecting purlins is shown in figure 17; the timber cleat identified by the arrow was added and nailed to the truss and the projecting purlin respectively. In this manner resistance against uplift pressure was provided.

Figure 15 - Typical roof damage occurring along the windward edges. Looking north.

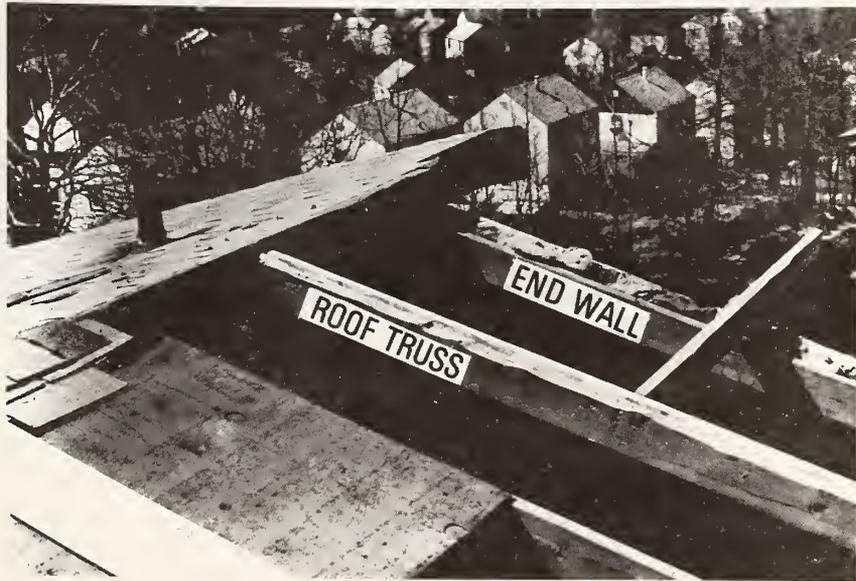
Figure 16 - Partial view of a damaged roof under repair.

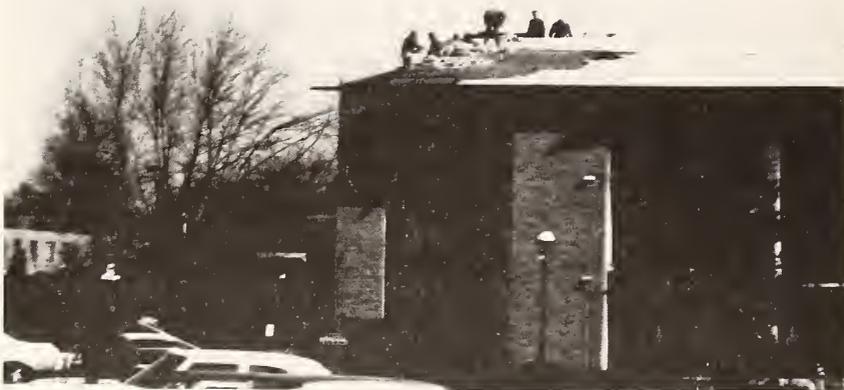
An overall view of the damaged building under repair is shown in figure 18. Figure 19 shows a closer view of the damaged wall and roof overhang. Figure 20 shows a similar undamaged wall in an adjacent building.

Figure 18 - Partial view of a damaged roof overhanging a gable wall. Looking northwest.

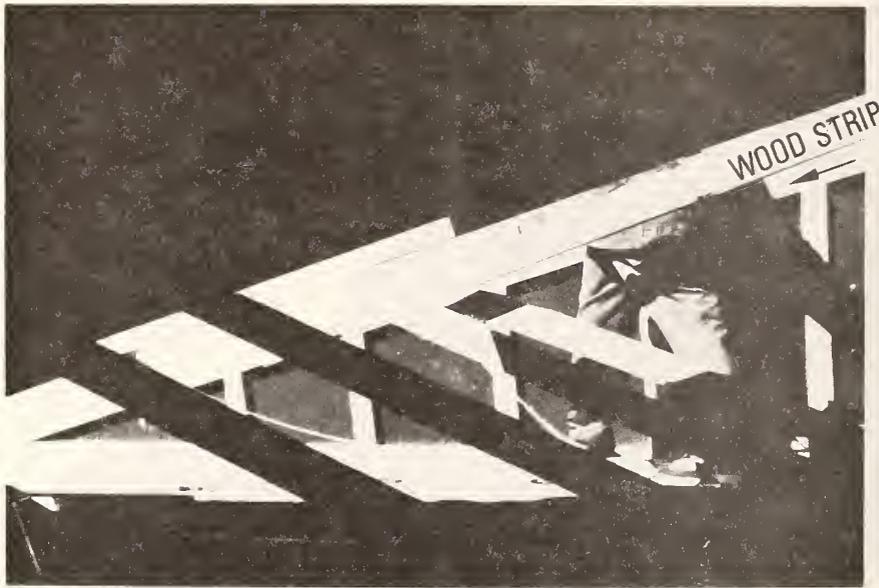
It should be noted that although the gable wall was actually a brick veneer wall up to the upper ceiling level, the wood frame structure was not continued beyond that level. Rather, wood strips were nailed to a fiberboard sheathing which was backed up against the brick veneer. This detail is shown in figure 21. Purlins were then nailed to these wood strips which are shown by the arrow. Lateral support for the top of the cantilevering brick wall was provided by these purlins which were framed into the first roof truss (following the gable wall) and by the plywood sheathing resting on top of these purlins. When the purlins and the plywood sheathing were lifted up by the wind, the brick wall lost its lateral support and was subsequently pushed in. The cantilevering roof section was completely broken off and came to rest on the roof of the building as shown in figure 22.

Figure 21 - Details along the back side of the damaged gable wall. Looking west.

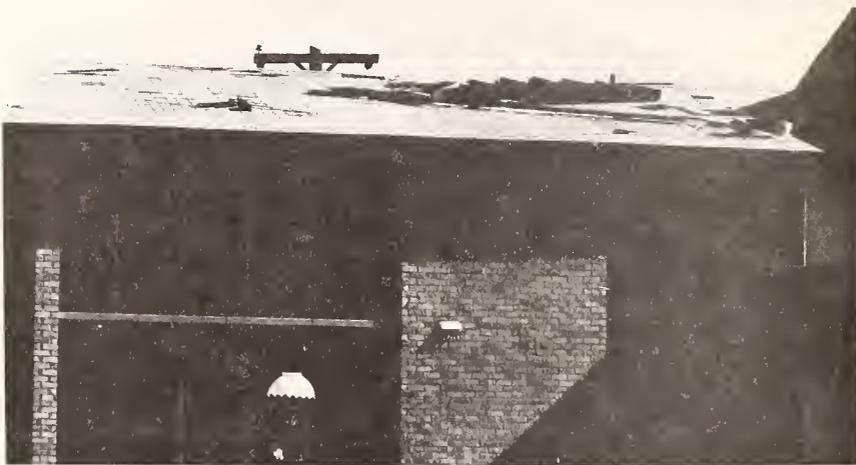
Figure 22 - View of a portion of the damaged overhanging roof.

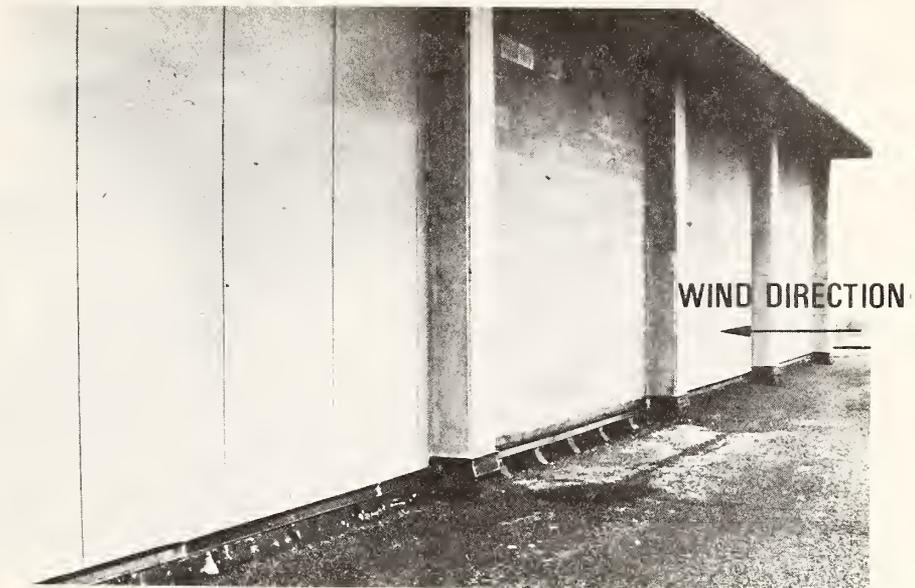
Figure 23 shows part of a 13 ft (4.0 m) high penthouse which is built on top of a 12-story office building. The office building has a flat roof and the penthouse, which houses mechanical equipment, is located about 15 ft (4.6 m) from the edge of the flat roof. The structure of the penthouse consists of a concrete frame with infill masonry walls. As can be seen in figure 23, most of the masonry walls are covered by decorative stucco. Typically, the infill wall is 8 in (20.3 cm) thick hollow concrete block. The columns are 30 in x 22 in (76.2 cm x 55.9 cm) and the masonry panels are 13 ft (4.0 m) wide. The roof overhang shown in the figure projects from a 12 in (30.5 cm) deep beam which rests on top of the concrete block panels, thus making the panels infill panels inside a concrete frame. There is also a concrete beam along the bottom of the masonry panels. The prevailing wind direction was normal to the plane of the wall and the loads acted inward as shown by the arrow in figure 23. The effect of the wind was to cause a violent dynamic response of the masonry infill walls. Eyewitnesses reported that "the wall was wavering visibly in an inward and outward fashion, apparently pivoting about its bottom." It is difficult to interpret this statement exactly but evidently the wall was flexing in and out with an amplitude large enough to be clearly distinguishable by an observer. Inadequate restraint at the top of the wall may have contributed to the large deflections. The flexing of the wall did not lead to a failure, although there is substantial evidence of local distress. Figure 24 shows a view of the bottom of the wall at the interior of the penthouse. Note the crack between the bottom course of the masonry and the concrete beam at the bottom of the wall. Figure 25 shows a similar crack between the top of the masonry wall and the top concrete beam. The picture was taken in the interior of the penthouse in a part which is not covered by a roof (the cooling tower area). Figure 26 shows bracing which was installed in the interior of the penthouse during the storm in order to stabilize the infill panels. The building was evacuated during the storm because of fear that collapse of infill walls might

Figure 23 - Exterior view of the damaged masonry walls of a mechanical equipment penthouse. Looking south.

(b) The dynamic response of the masonry infill wall in Section 4.4 may have been caused by turbulence induced by the building configuration since this type of construction would normally not have experienced distress under the reported wind conditions.

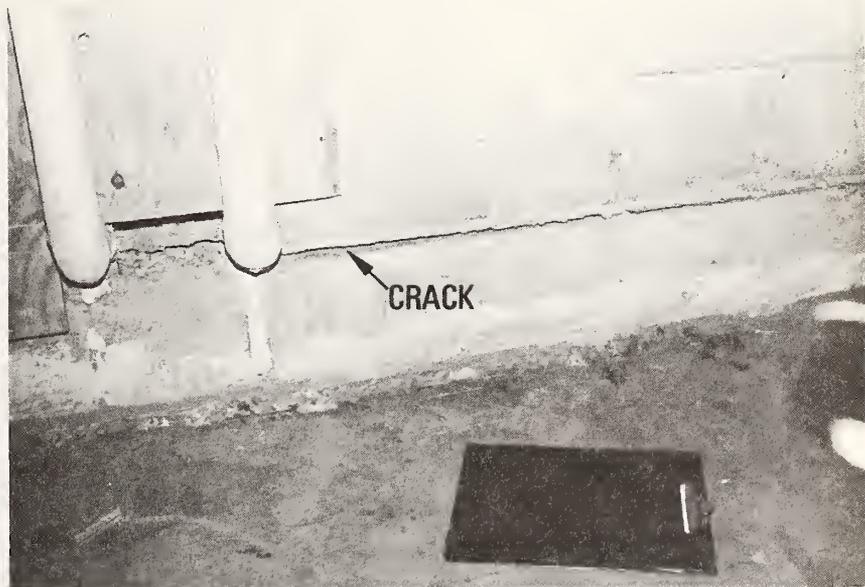
Figure 24 - View of the bottom of a damaged wall at the interior of the penthouse.

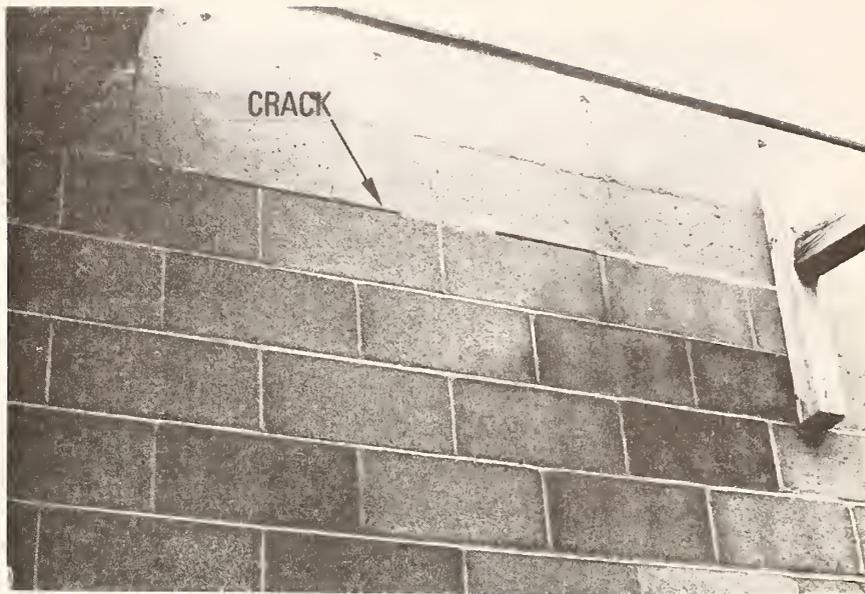
Figure 25 - Mortar crack between top of masonry wall and bottom of concrete beam.

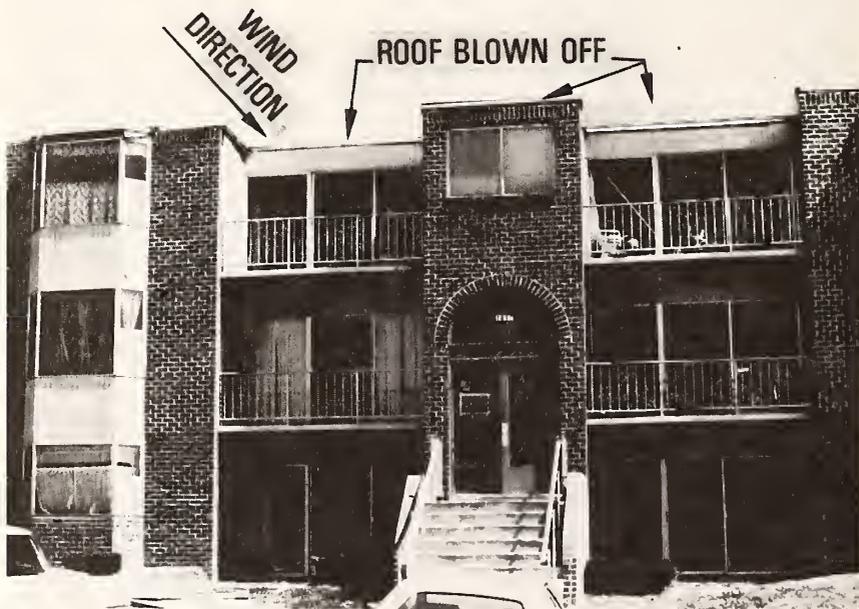
Figure 28 - Front elevation of a building which sustained roof damage. Looking east.

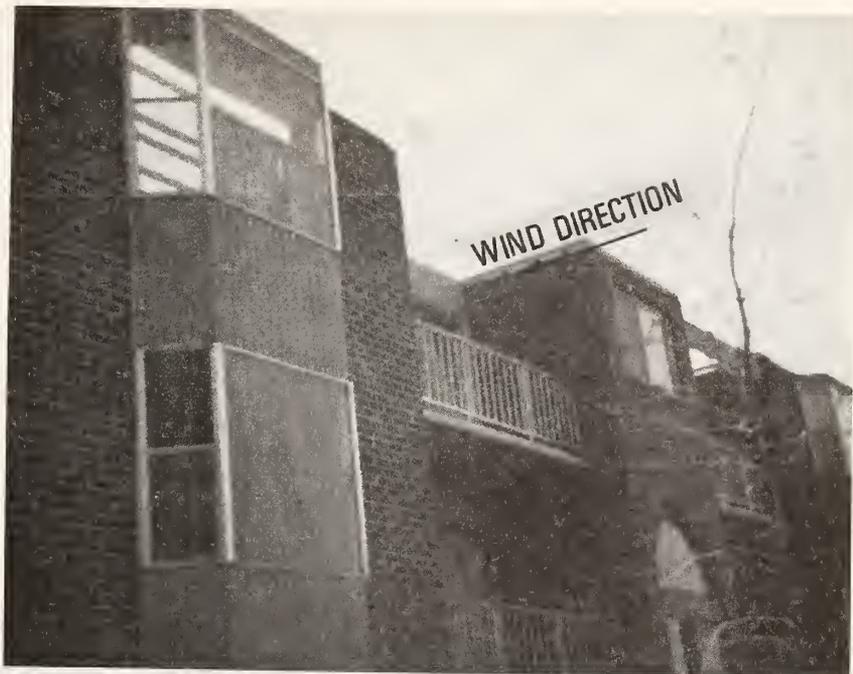
Figure 29 - Closeup view of damage showing loss of roof over living unit and balcony.

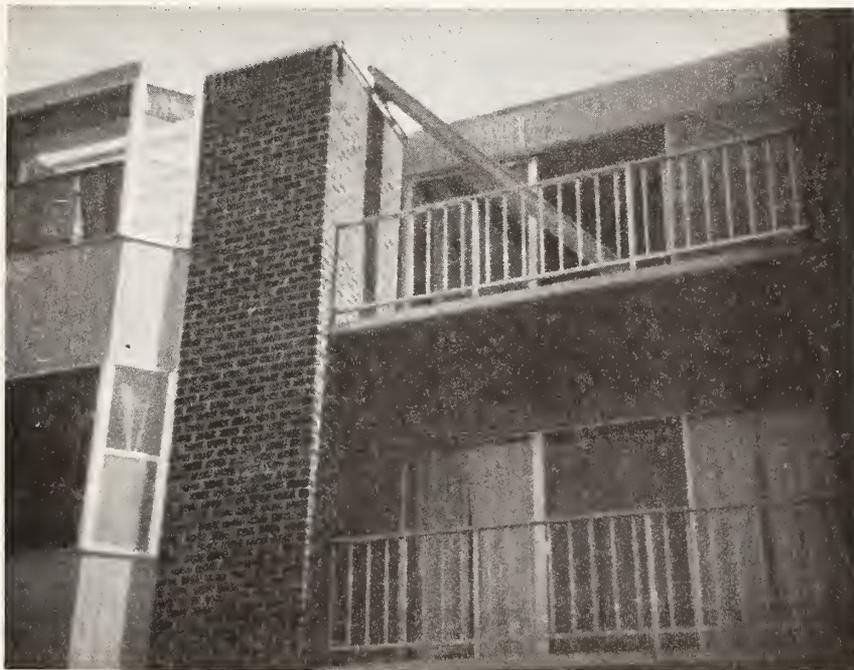
Figure 30 - Closeup view of damage above third-story balcony.

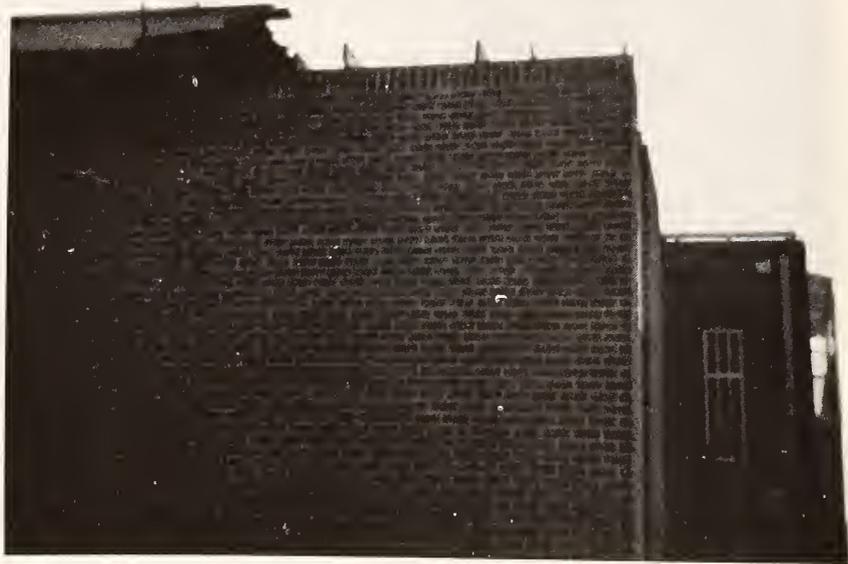
Figure 31 - Side view of damaged building showing partial destruction of roof.

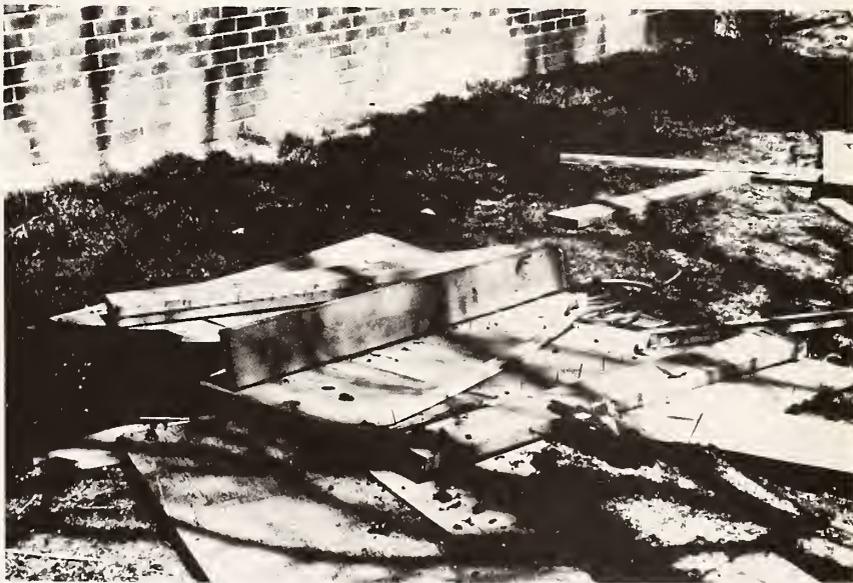
Figure 32 - Ground-level view of some wood framing and sheathing from a damaged roof.

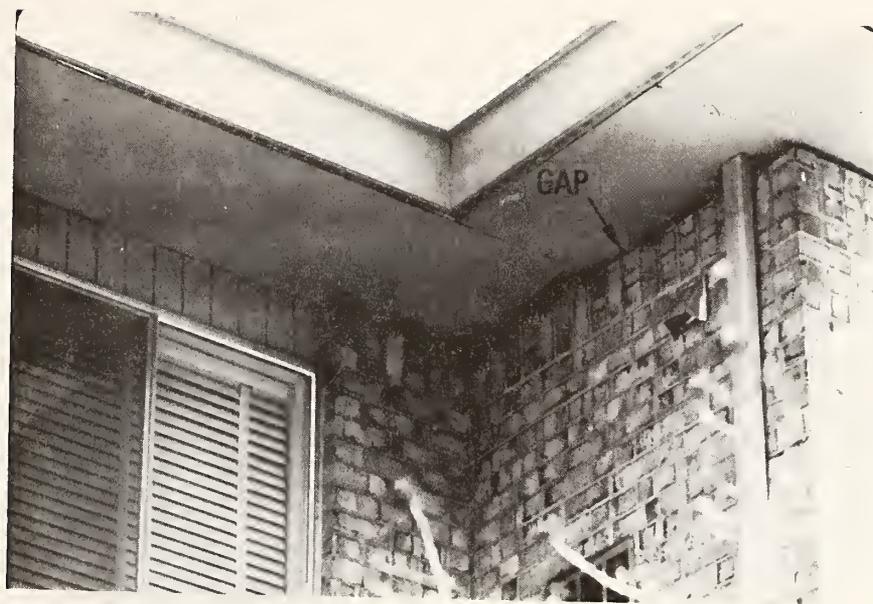
Figure 33 - Residual separation between soffit and masonry wall caused by uplift on roof overhang.

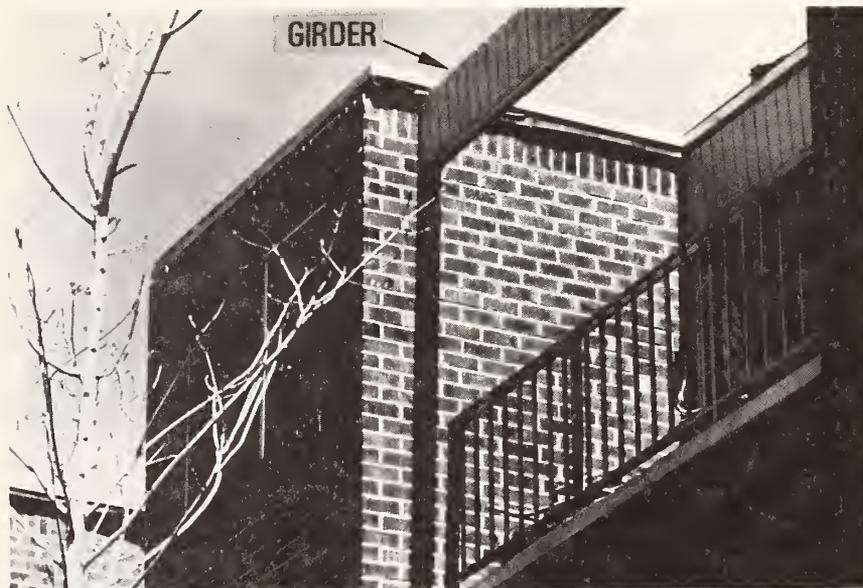
Figure 34 - Girder which supported portion of roof that covered balcony.

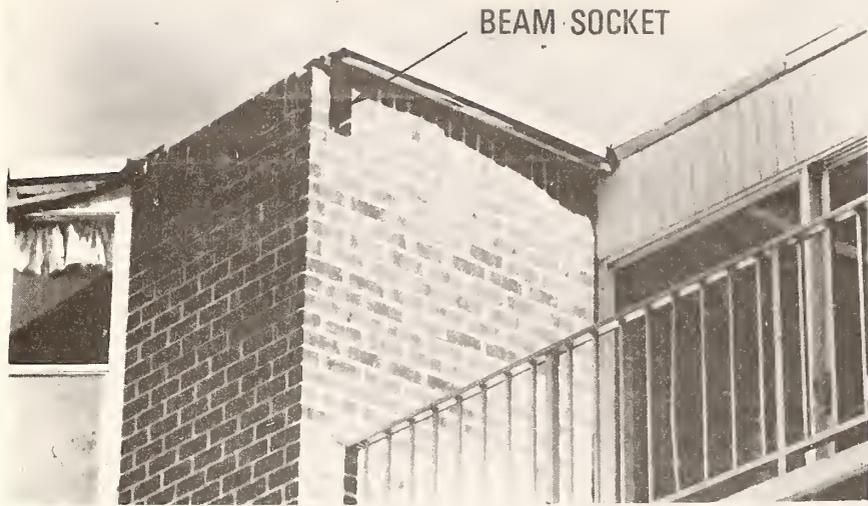
Figure 35 - A balcony above which the roof and supporting girder were removed.

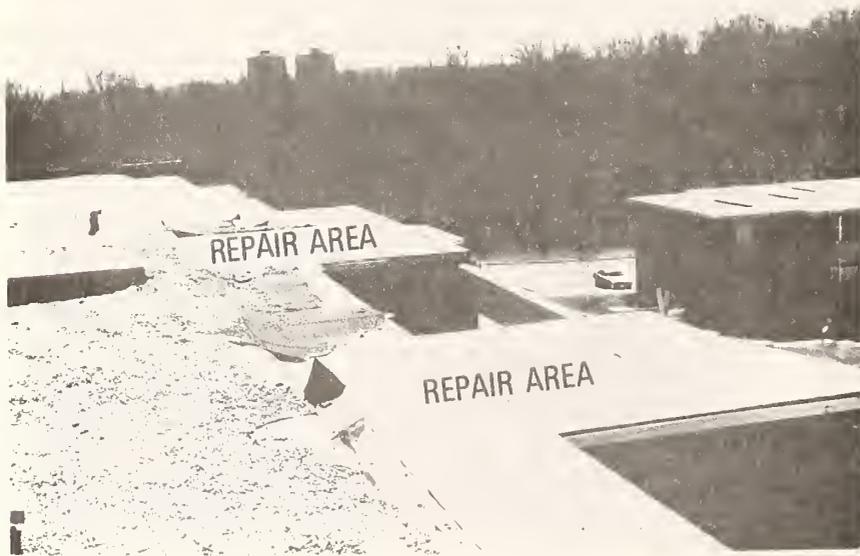
Figure 36 - Overall view of roof under repair.

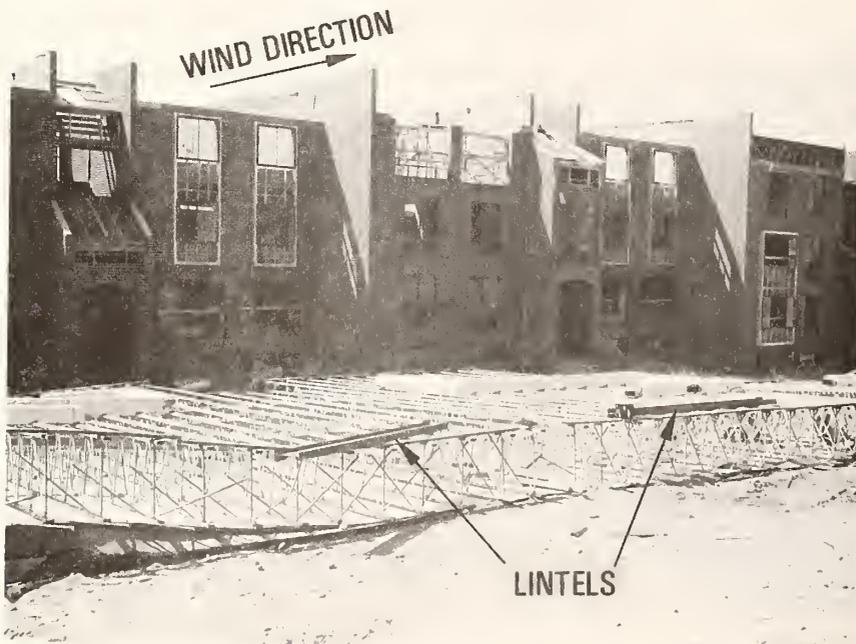
Figure 37 shows a three-story garden apartment building. This is one of the completed units which suffered no damage. Figure 38 shows a row of the same type of units under construction. The prevailing wind direction is indicated by the arrow. Note that in the completed unit (figure 37) the truss structures which support the roofs are closed by siding, giving the appearance of a mansard. Figure 38 shows part of the roofs which were removed by the wind and deposited in front of the buildings under construction. A closer look at an undisturbed roof assembly in place is shown in figure 39. Figures 40 and 41 show details of the roof assemblies which were lifted up, overturned and deposited on the ground. The truss structure had wooden top and bottom chords and galvanized steel tubing as diagonal truss members. The top of the roof was covered by 1/2 in (1.3 cm) thick plywood sheathing. Although this plywood sheathing was in place, the built-up roofing had not yet been installed. The span length of the trusses was 49 ft (14.9m) and spacing between trusses was 24 in (61.0 cm). Connections of the roof trusses to the masonry walls are shown in figures 42, 43 and 44. Figure 44 shows that not only was the roof truss structure removed, but also a steel beam which served as a lintel over a window opening. One of these lintels, in place, is marked by the arrow in figure 45. Two of the displaced lintels are seen, still attached to the trusses in figure 38. The failure of these roofs is probably attributable to two causes: 1. the sides of the trusses were open and the windows were not completed, thus providing openings which caused pressure buildup on the underside of the roof sheathing; this pressure, together with suction acting on the top of roof surface exerted a considerable upward force; 2. the built-up roofing was not yet in place to add weight which could have contributed to the resistance to uplift pressure. Figure 45 shows the details of roof trusses on units which were under construction and which were not damaged by the wind.

Figure 38 - Front elevation of several buildings under construction from which the roofs were lifted and dropped on the ground.

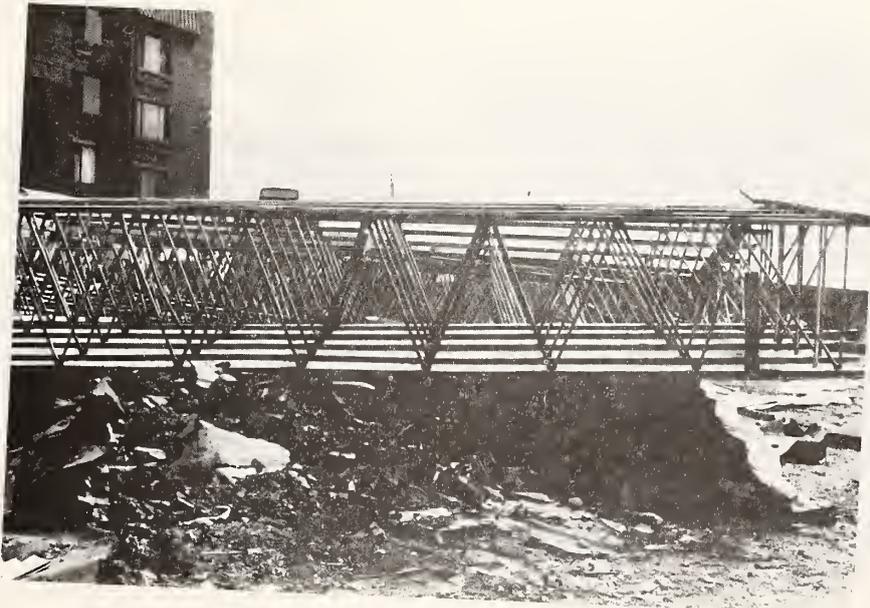
Figure 40 - Side elevation of the roof assemblies lifted up and deposited on the ground.

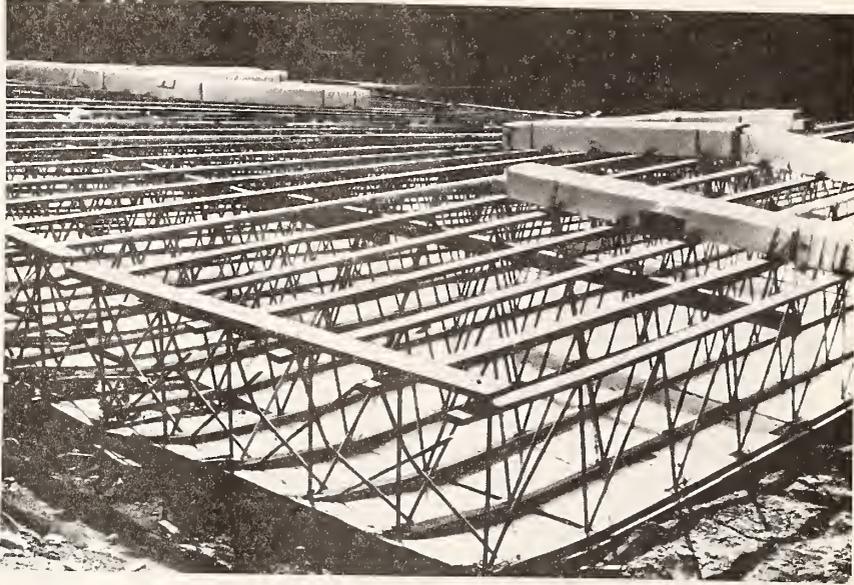
Figure 41 - Closeup view of overturned roof assemblies.

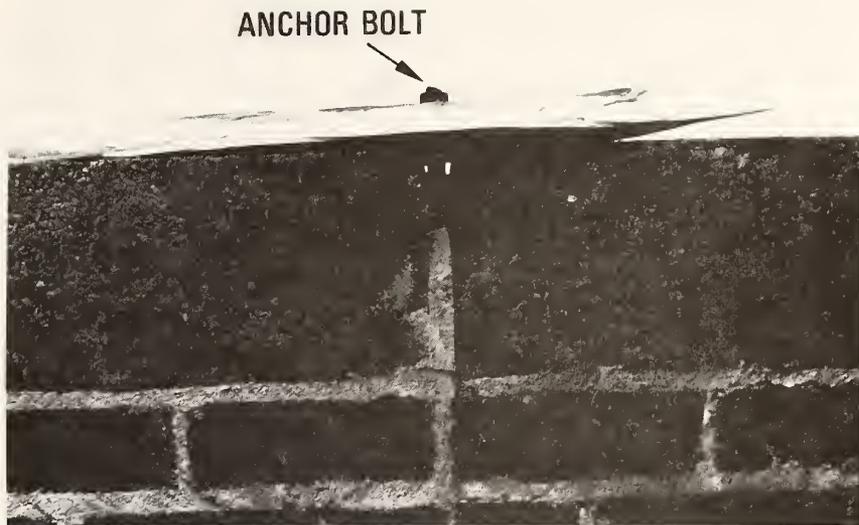
Figure 43 - A portion of a wood bearing plate and a connecting anchor bolt remain atop masonry wall.

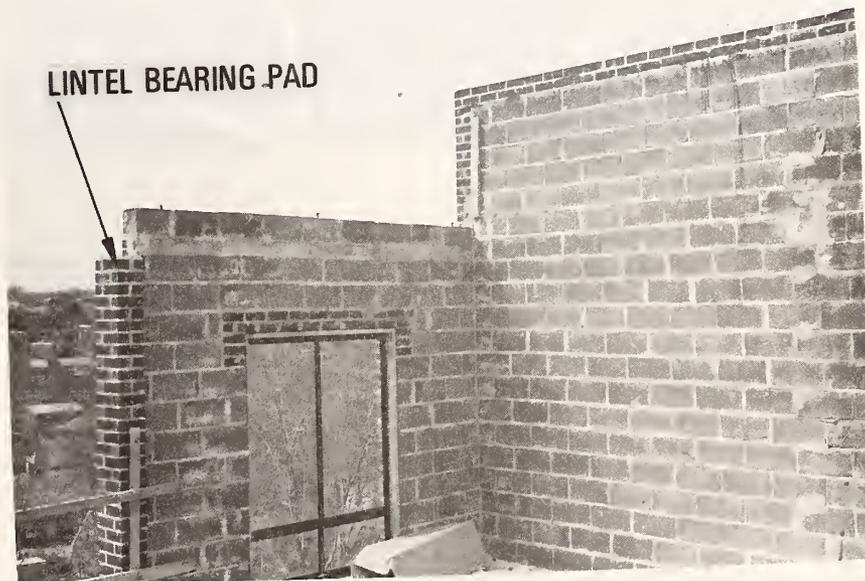
Figure 44 - Elevation of a rear wall from which the roof assembly and lintel beam have been removed. Looking northwest.

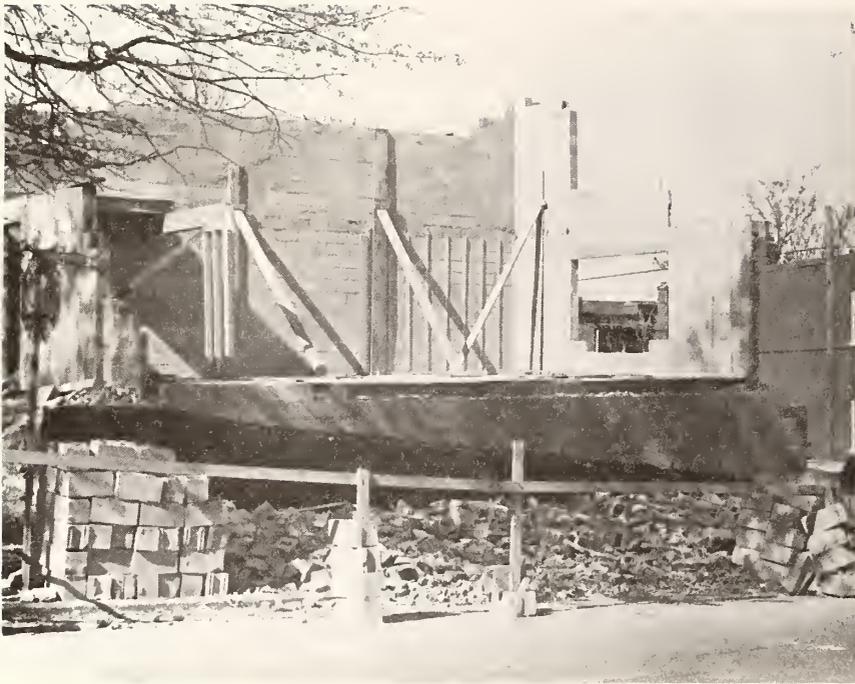
Figure 46 shows the end unit of a four-unit concrete masonry row house under construction. The exterior side wall of this unit collapsed and fell into the street causing two fatalities. (See the debris in the foreground of the photograph). Figures 47 and 48 are other views of the same structure taken from another street at right angles to the one into which the wall collapsed. The direction of the prevailing wind is shown by the arrow in figure 47. Note the partial collapse (figure 48) of cross-walls in other portions of the structure which were parallel to the exterior wall that collapsed. Details of the pulled-out joint reinforcement in one of the damaged cross-walls is shown in figure 49. The construction was 8 in (20 cm) unreinforced hollow concrete block with joint reinforcement. The incident illustrates the vulnerability of masonry walls in the construction stage before they are fully braced at their tops.

Figure 46 - End living unit of a four-unit masonry row house complex damaged during construction.

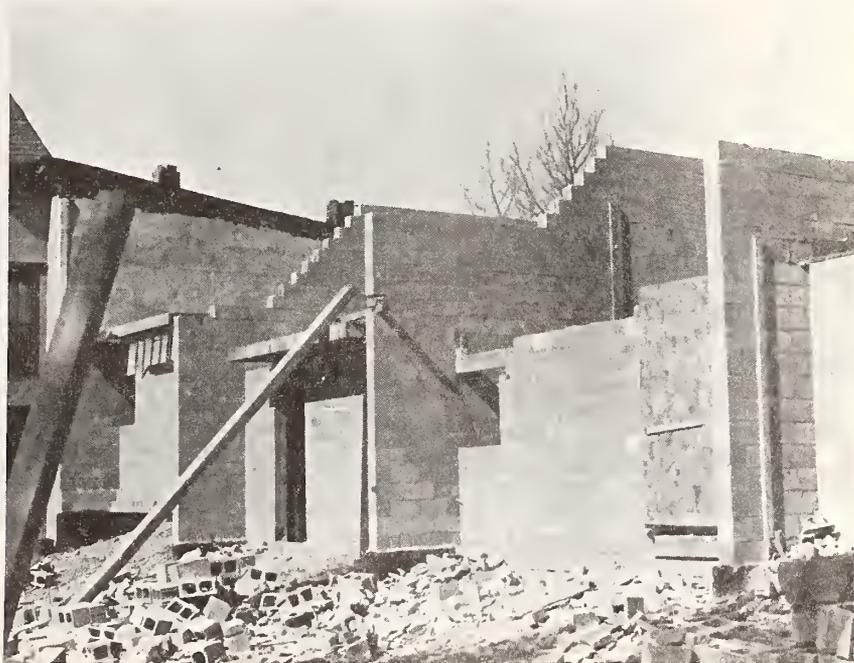
Figure 48 - Closeup front elevation of damaged masonry structures.
