NBS TECHNICAL NOTE 909

Investigation of Wind Damage in the Metropolitan Washington, D.C. Area, April 3-4, 1975

A limited investigation was conducted of wind damage that occurred on April 3 and 4, 1975 in the Metropolitan Washington, D.C. area.

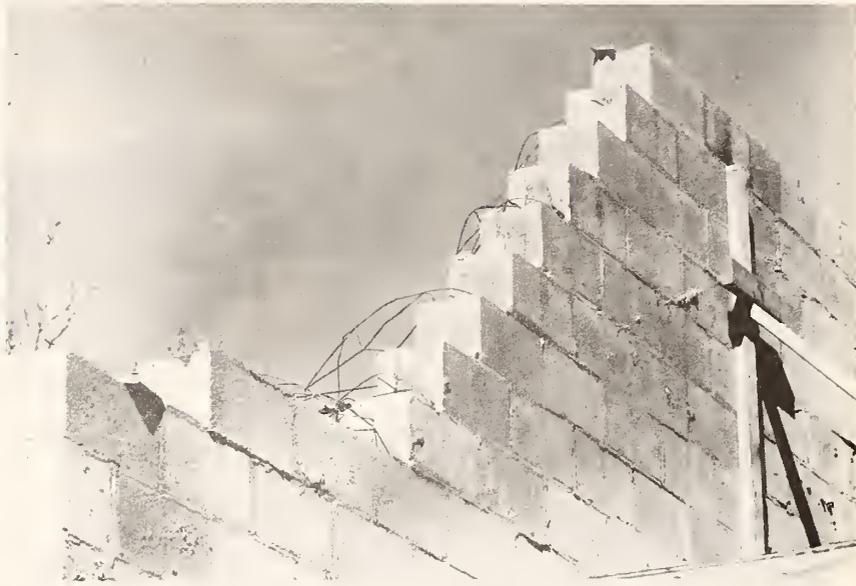
Figure 49 - Details of pulled-out joint reinforcement in a damaged cross wall.

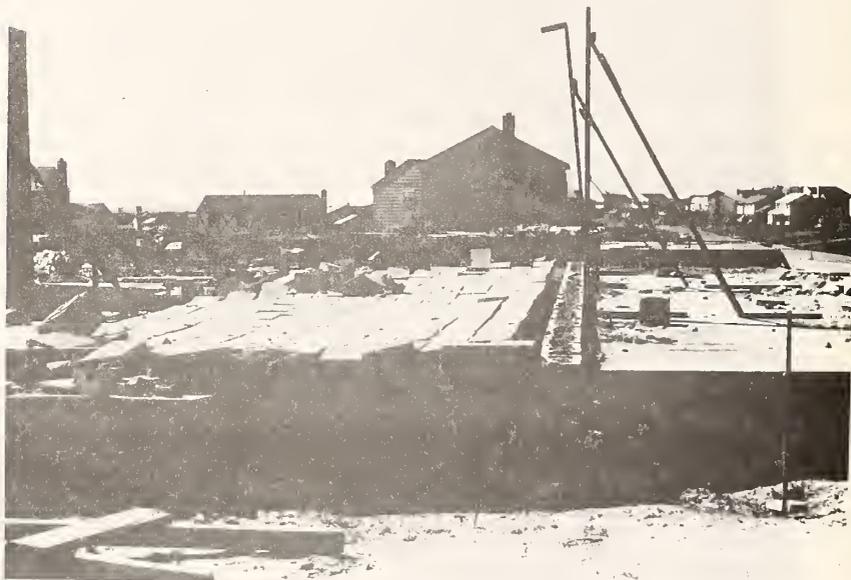
Another instance of masonry wall failure during construction is shown in figures 50 and 51. These walls were braced prior to the storm.

Figure 50 - Masonry wall failure during construction.

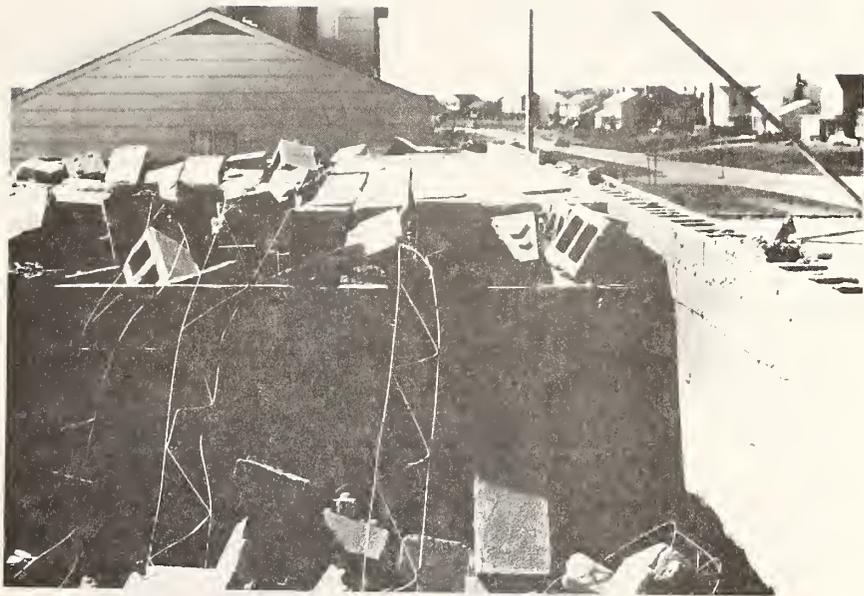
Figure 51 - Closeup view of collapsed wall showing horizontal joint reinforcement.

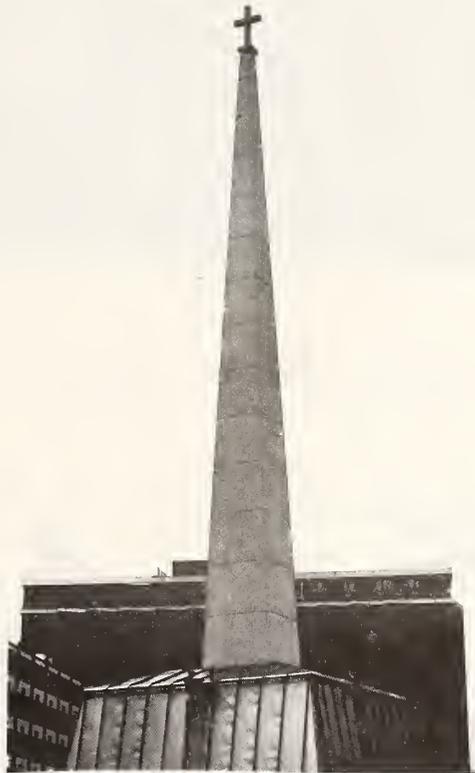
Figure 52 shows an approximately 40 ft (12.2 m) high church steeple which was observed to sway considerably. Figure 53 is a picture of the ceiling at the base of the church steeple. Note the damage that was caused to the cladding by the movement of the steeple. The brittle gypsum ceiling spalled as a result of the movement of the steel truss members.

Figure 52 - Elevation of a church steeple affected by wind.

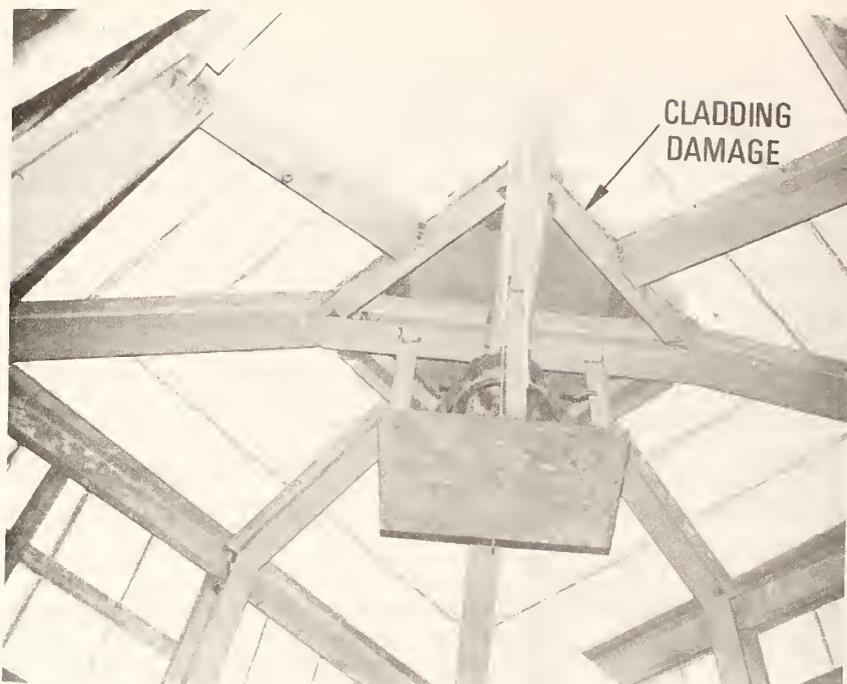
Figure 53 - Damaged ceiling cladding at the base of church steeple.

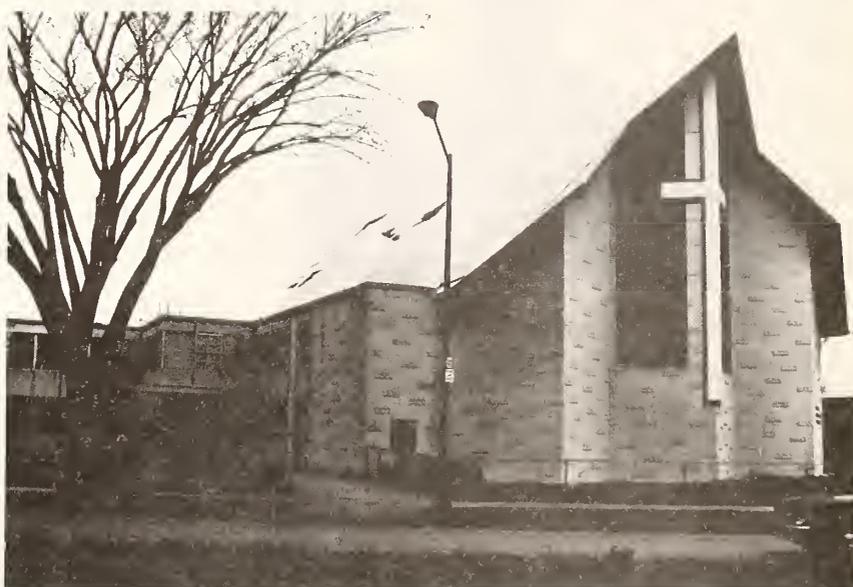
Figure 54 is an overall view of a church which suffered considerable roof damage. Figures 55, 56 and 57 show more detail of the roof damage. Figure 58 shows gaps in the roof which were caused by uplift forces. Damage to the flashing is shown in figure 59. The roofing is rigid asbestos shingles.

Figure 54 - Overall view of a church which suffered roof damage. Looking west.

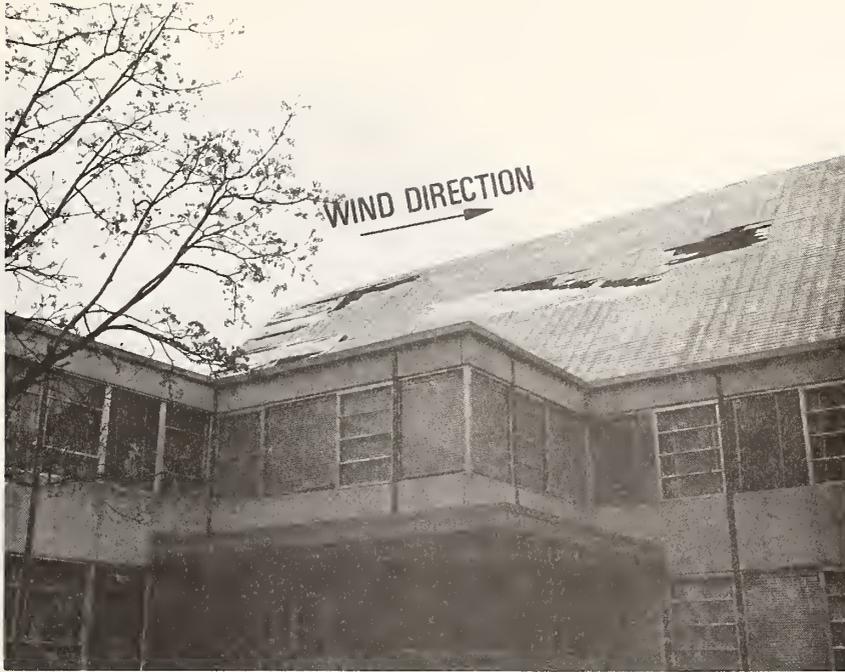
Figure 55 - View along church roof showing extent of roof damage. Looking north.

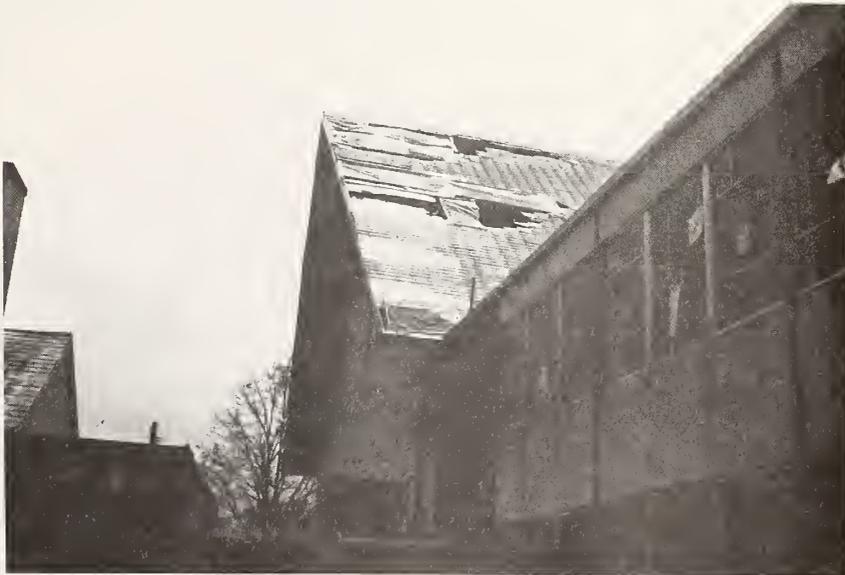
Figure 56 - Roof damage at rear (west side) of church.

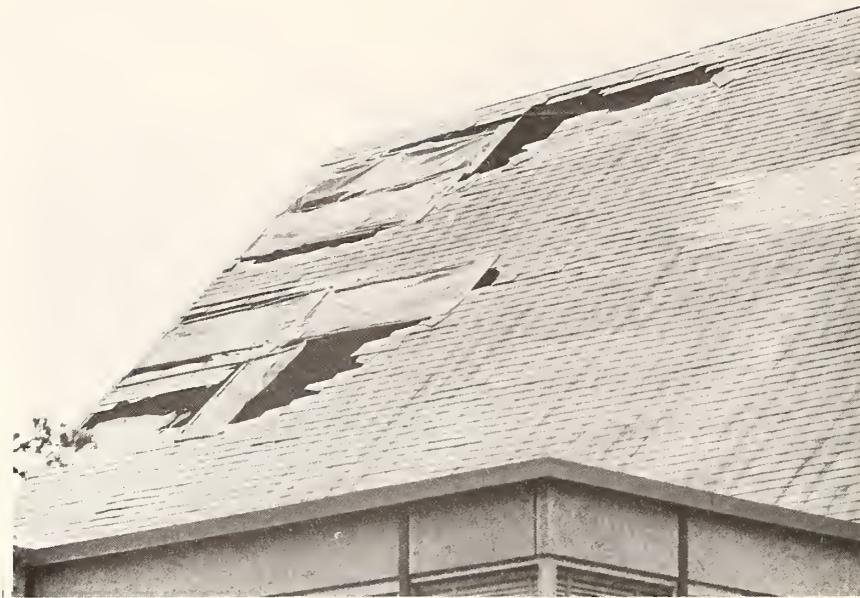
Figure 57 - Closeup view of roof damage at rear of church.

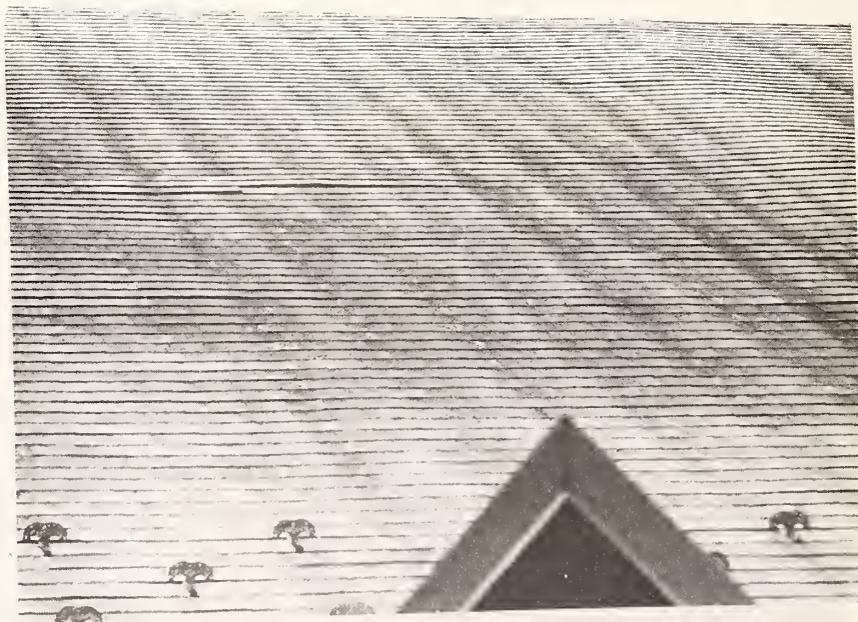
Figure 58 - Uplift of asbestos roof shingles along north side of church.

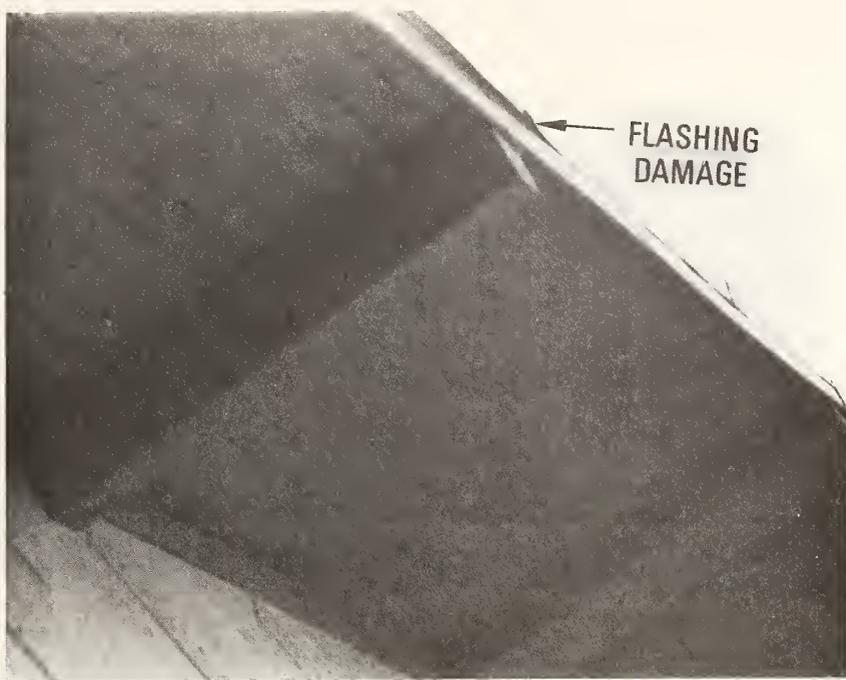
Figure 59 - Damage to roof flashing on gable overhang.

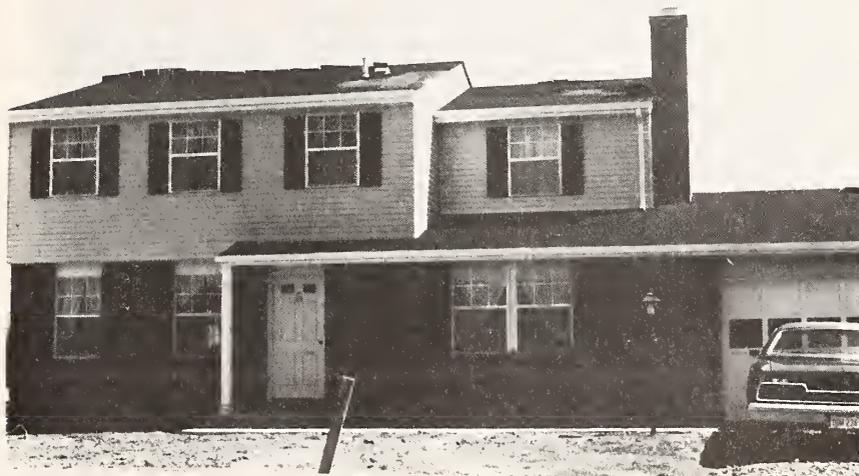
Figure 60 - Damage to asphalt shingle roof located in a new subdivision.

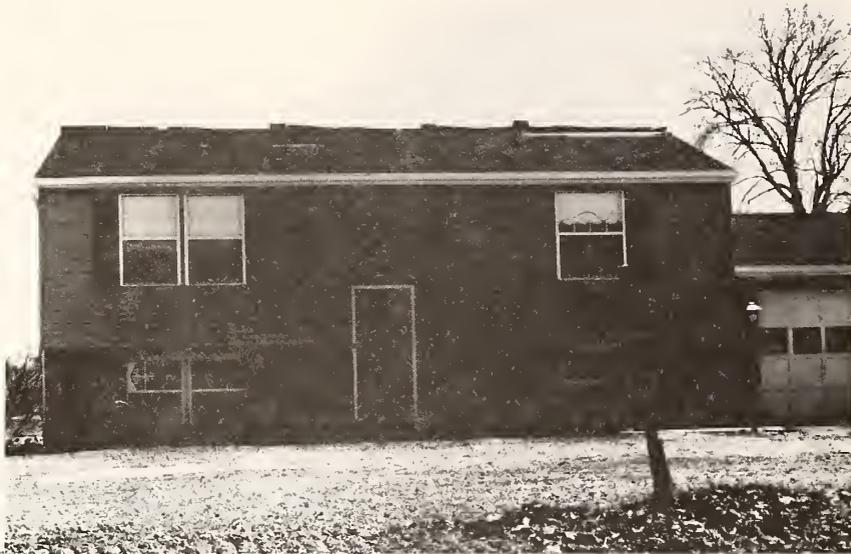
Figure 61 - Uplift of asphalt shingles along ridge and over other roof areas.

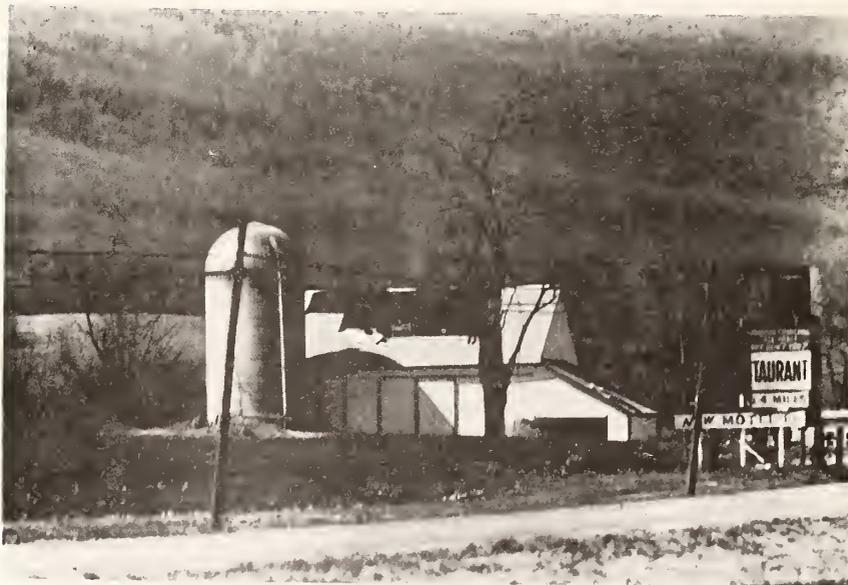
Figure 62 - Roof damage sustained by a barn located in an open area.

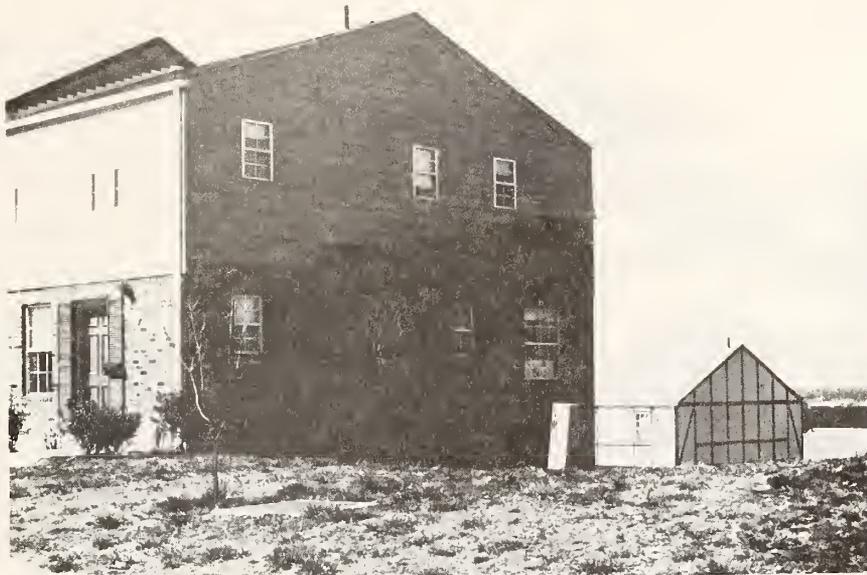
Figure 63 - Damaged sheet metal siding on an end townhouse unit.

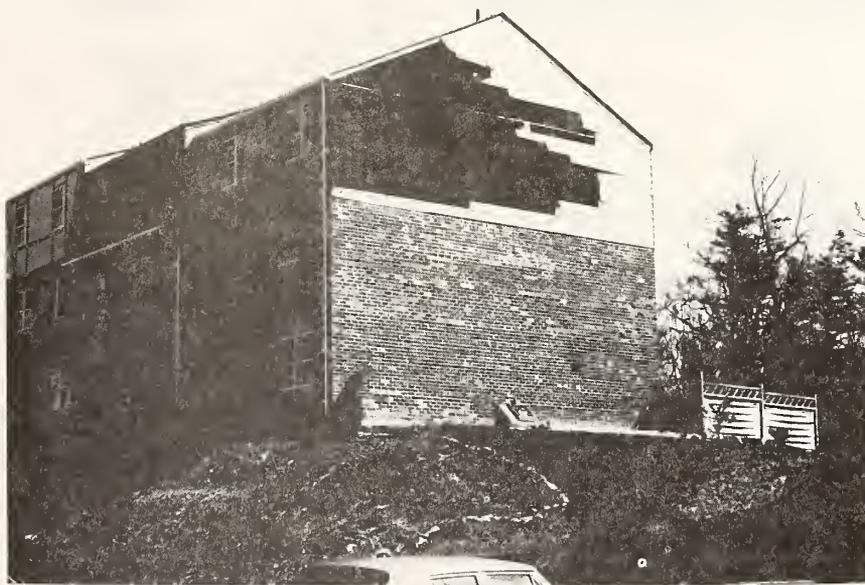
Figure 64 - Damaged sheet metal siding on a townhouse unit.

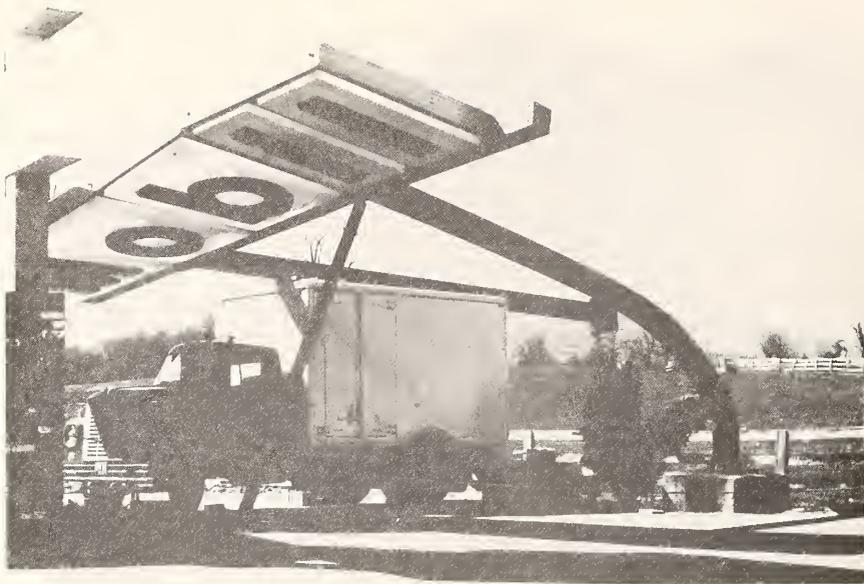
Figure 65 - Overturning failure of a service station sign.

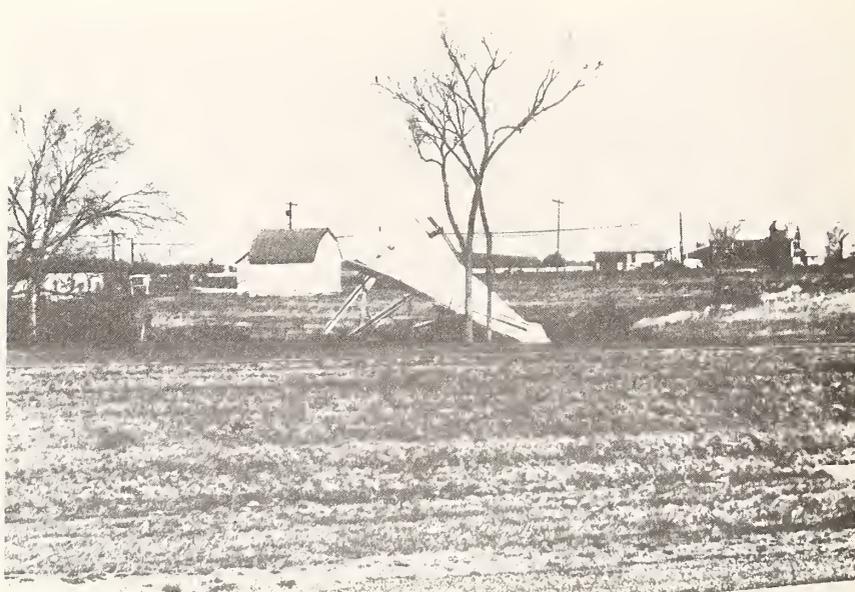
Figure 66 - Overturning failure of a roadside billboard.

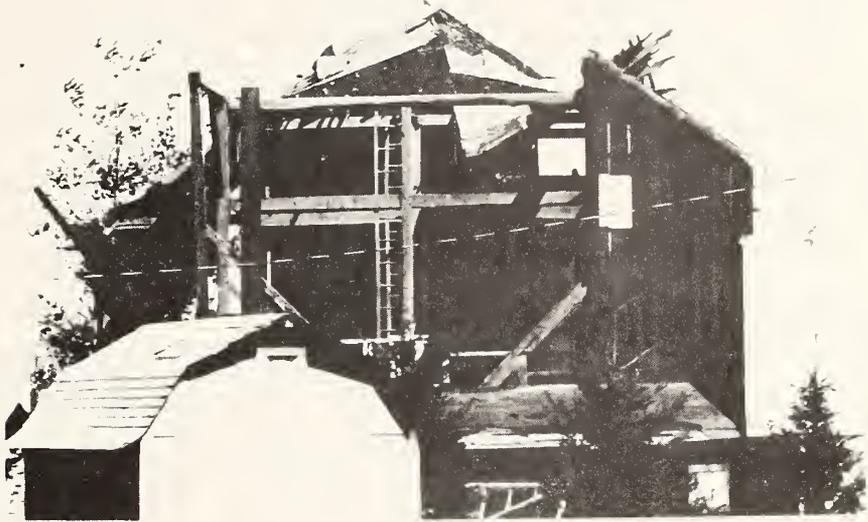
Figure 67 - Partial collapse of a barn located in rural area.
