**NIST-SP 1118 Volume I**

# **Technical Study of the Sofa Super Store Fire - South Carolina, June 18, 2007**

**Nelson P. Bryner**  
**Stephen P. Fuss**  
**Bryan W. Klein**  
**Anthony D. Putorti**

March 2011

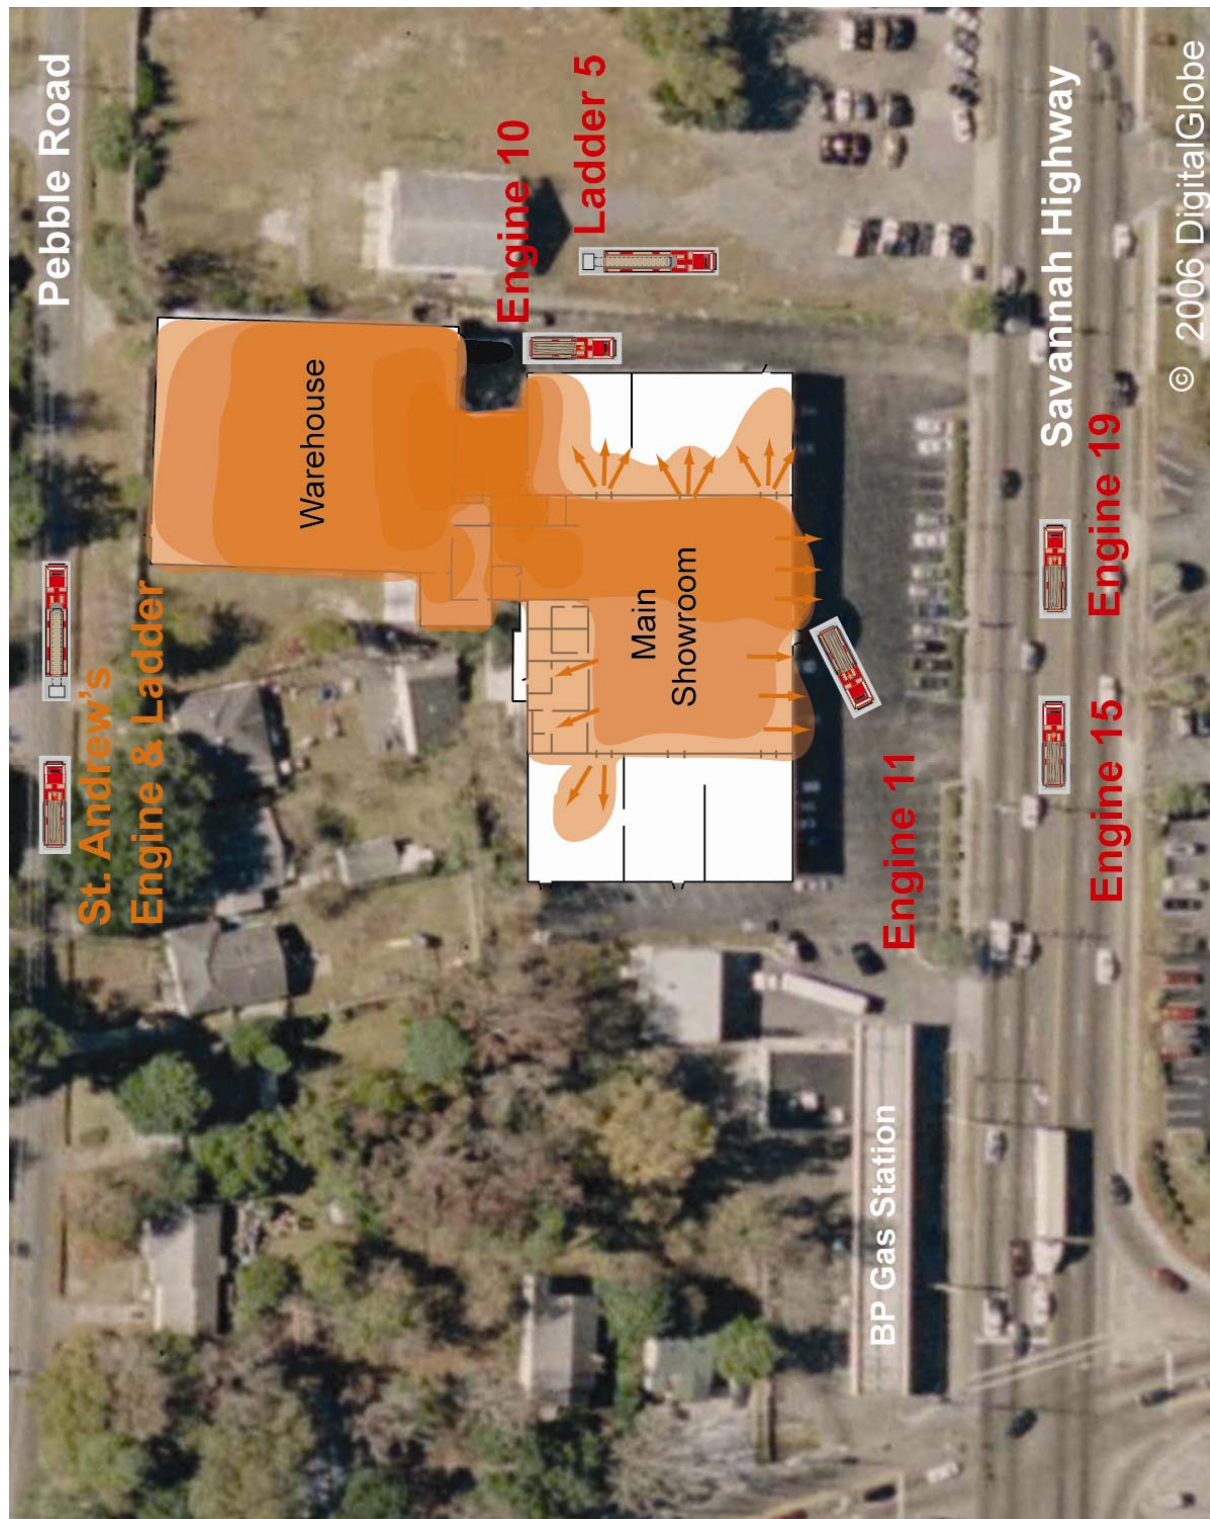
Figure 2-10. Fire spreading to west showroom and the rear of east showroom. This occurred by about 7:38 p.m. Background image used with permission of DigitalGlobe. Enhancements by NIST.

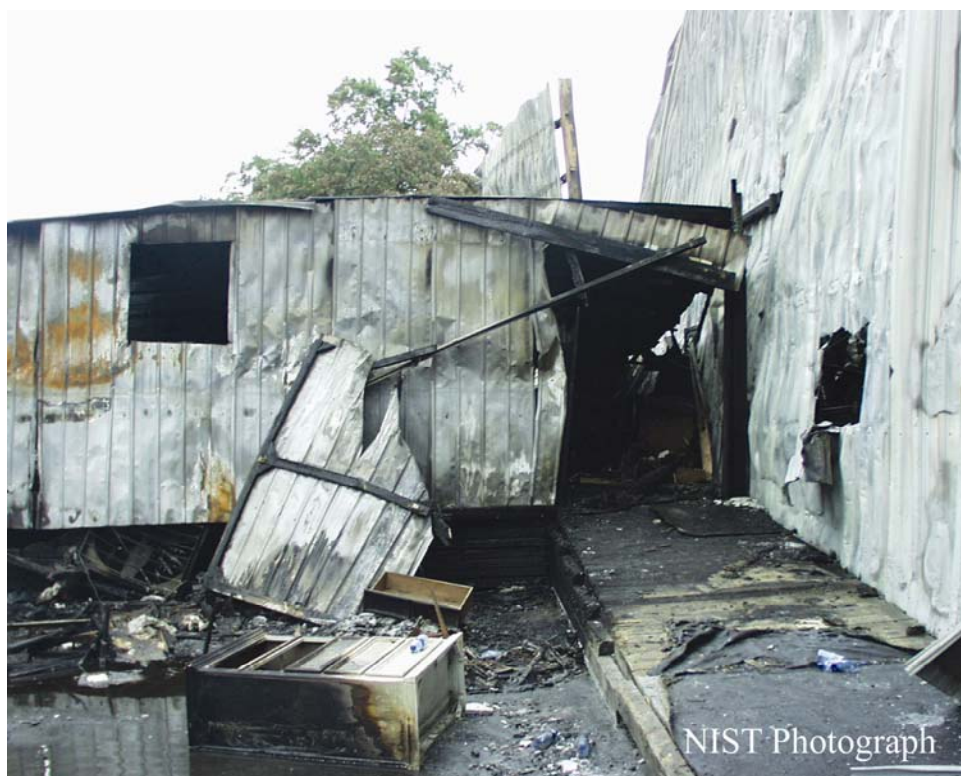
**Figure 4-7. Photograph showing the outside of the loading dock. This was identified as the area of fire origin.**
