**NIST Special Publication 1164**

# **Preliminary Reconnaissance of the May 20, 2013, Newcastle-Moore Tornado in Oklahoma**

December 2013

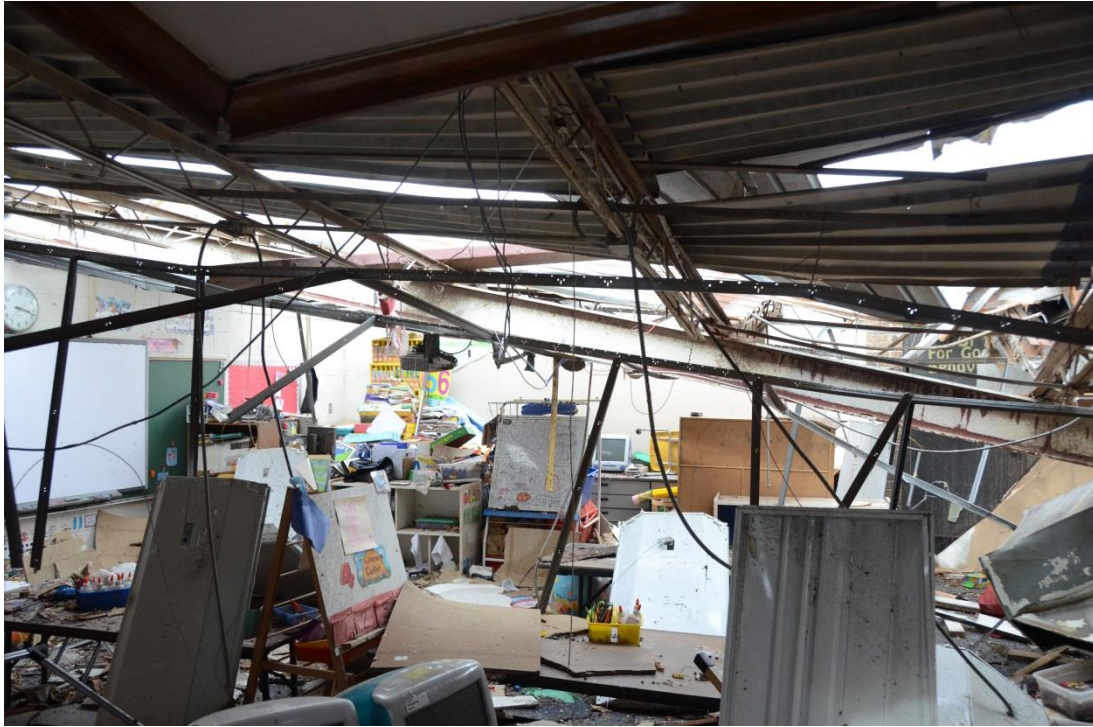
Figure 4-18. An interior view of a classroom in the 400 Building where portion of the building's metal roof system was lost.

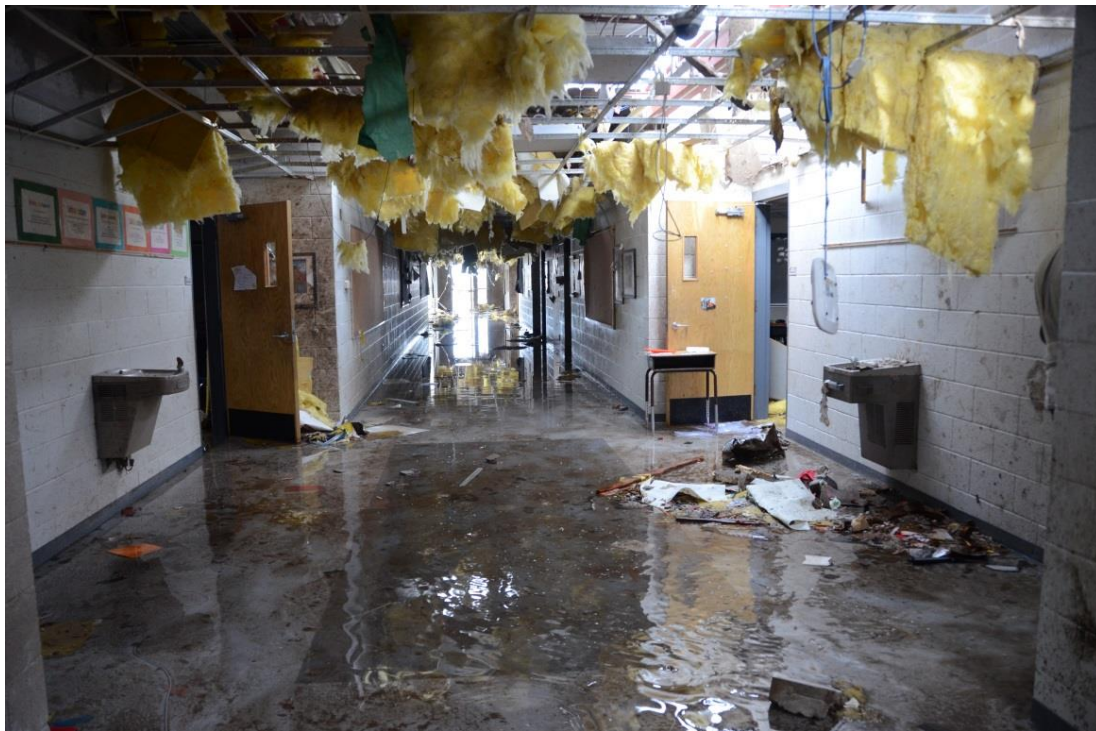
Figure 4-19. Hallway of Building 400 after the tornado (designated tornado safety area and initial location of Building 400 occupants before moving to the bathrooms just before the tornado struck)
