NIST Technical Note 1796

A Case Study of a Community Affected by the Witch and Guejito Fires: Report #2 – Evaluating the Effects of Hazard Mitigation Actions on Structure Ignitions

May 2013

This publication was a joint effort between the National Institute of Standards and Technology and the United States Forest Service (USFS).

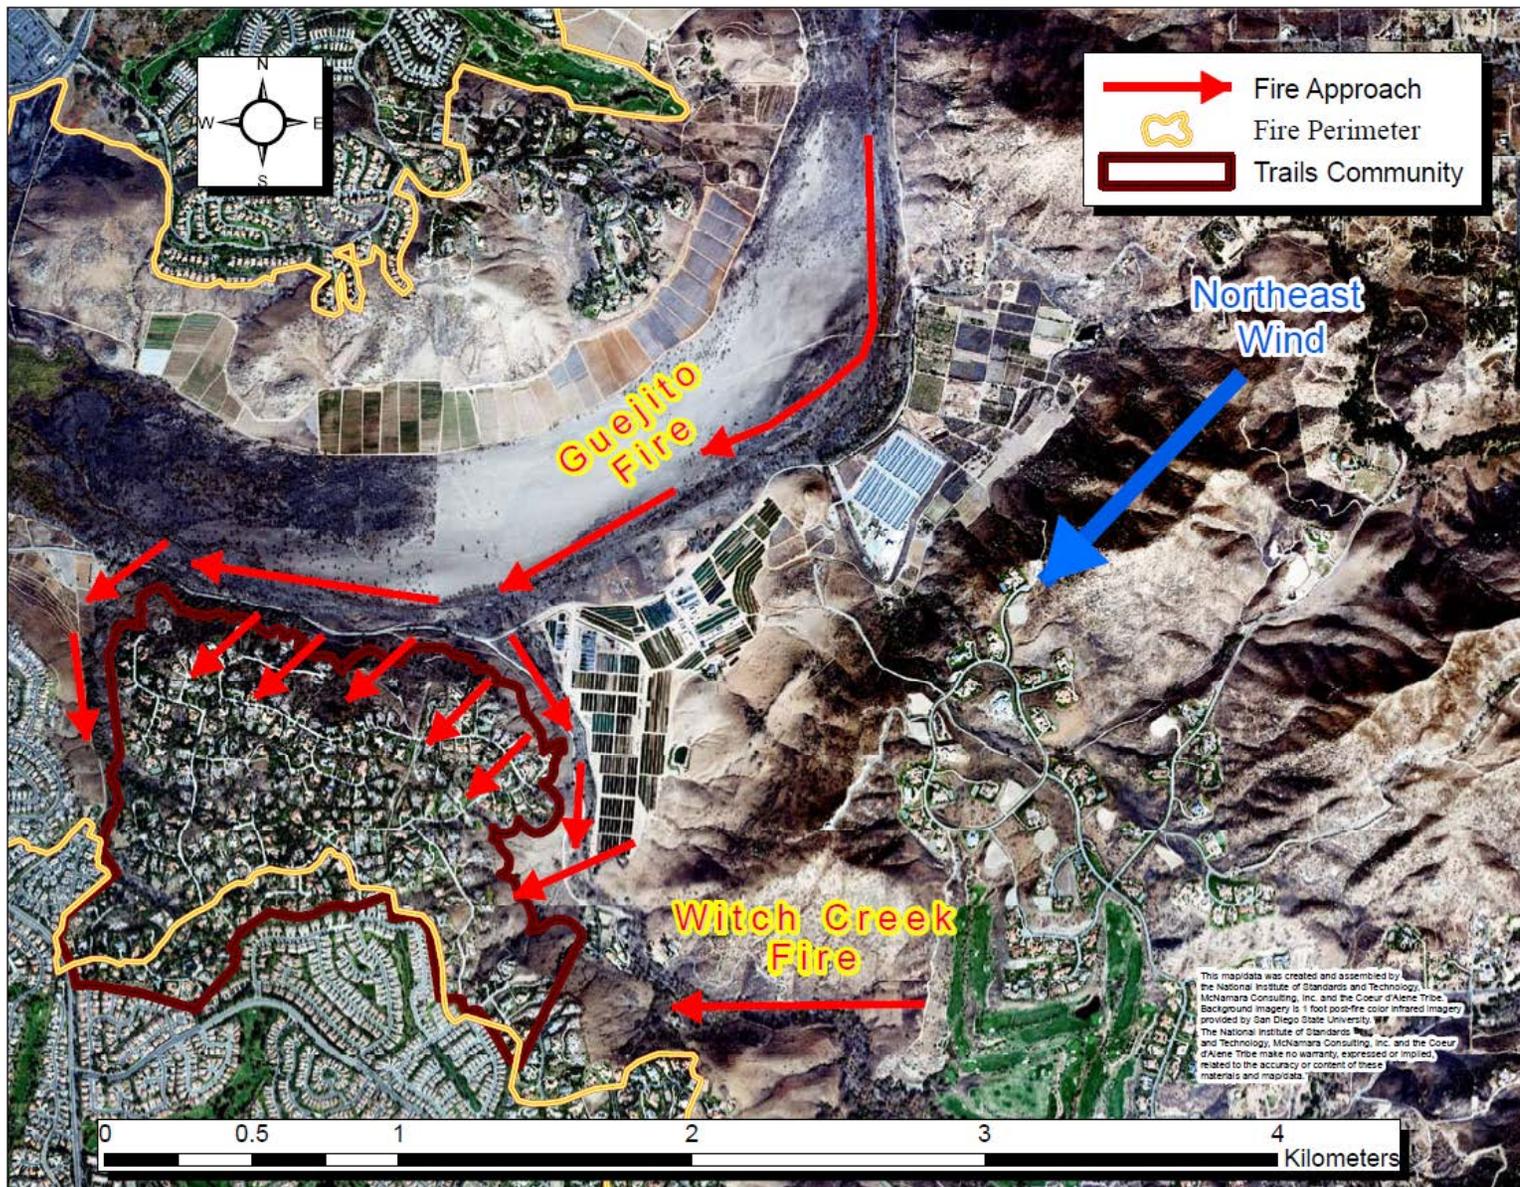
Figure 2 Fire approach to the Trails Community from the Witch and Guejito Fires. Back ground imagery is 1 ft (0.3 m) horizontal resolution color imagery flown shortly after the fires.

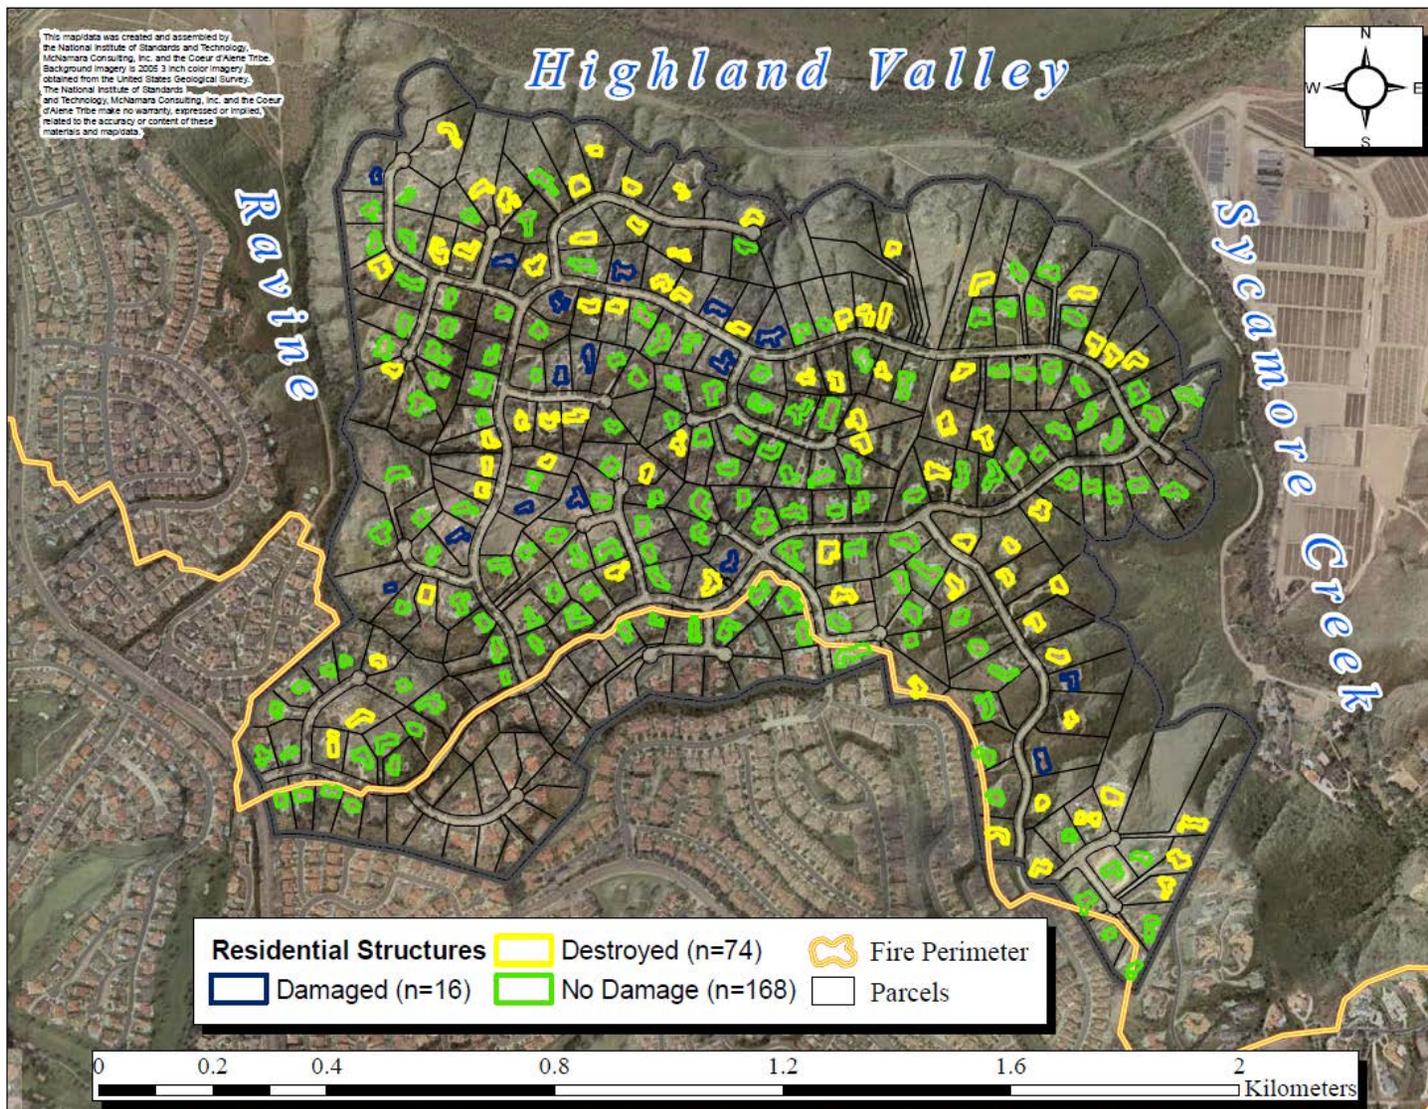
perimeter (Figure 3). Seventy four homes were completely destroyed and 16 were partly damaged (Figure 3).

Figure 3 Trails community in relation to Witch fire perimeter with primary structures displayed by damaged status. Back ground imagery is 3 inch (8 cm) horizontal resolution color imagery from 2005.

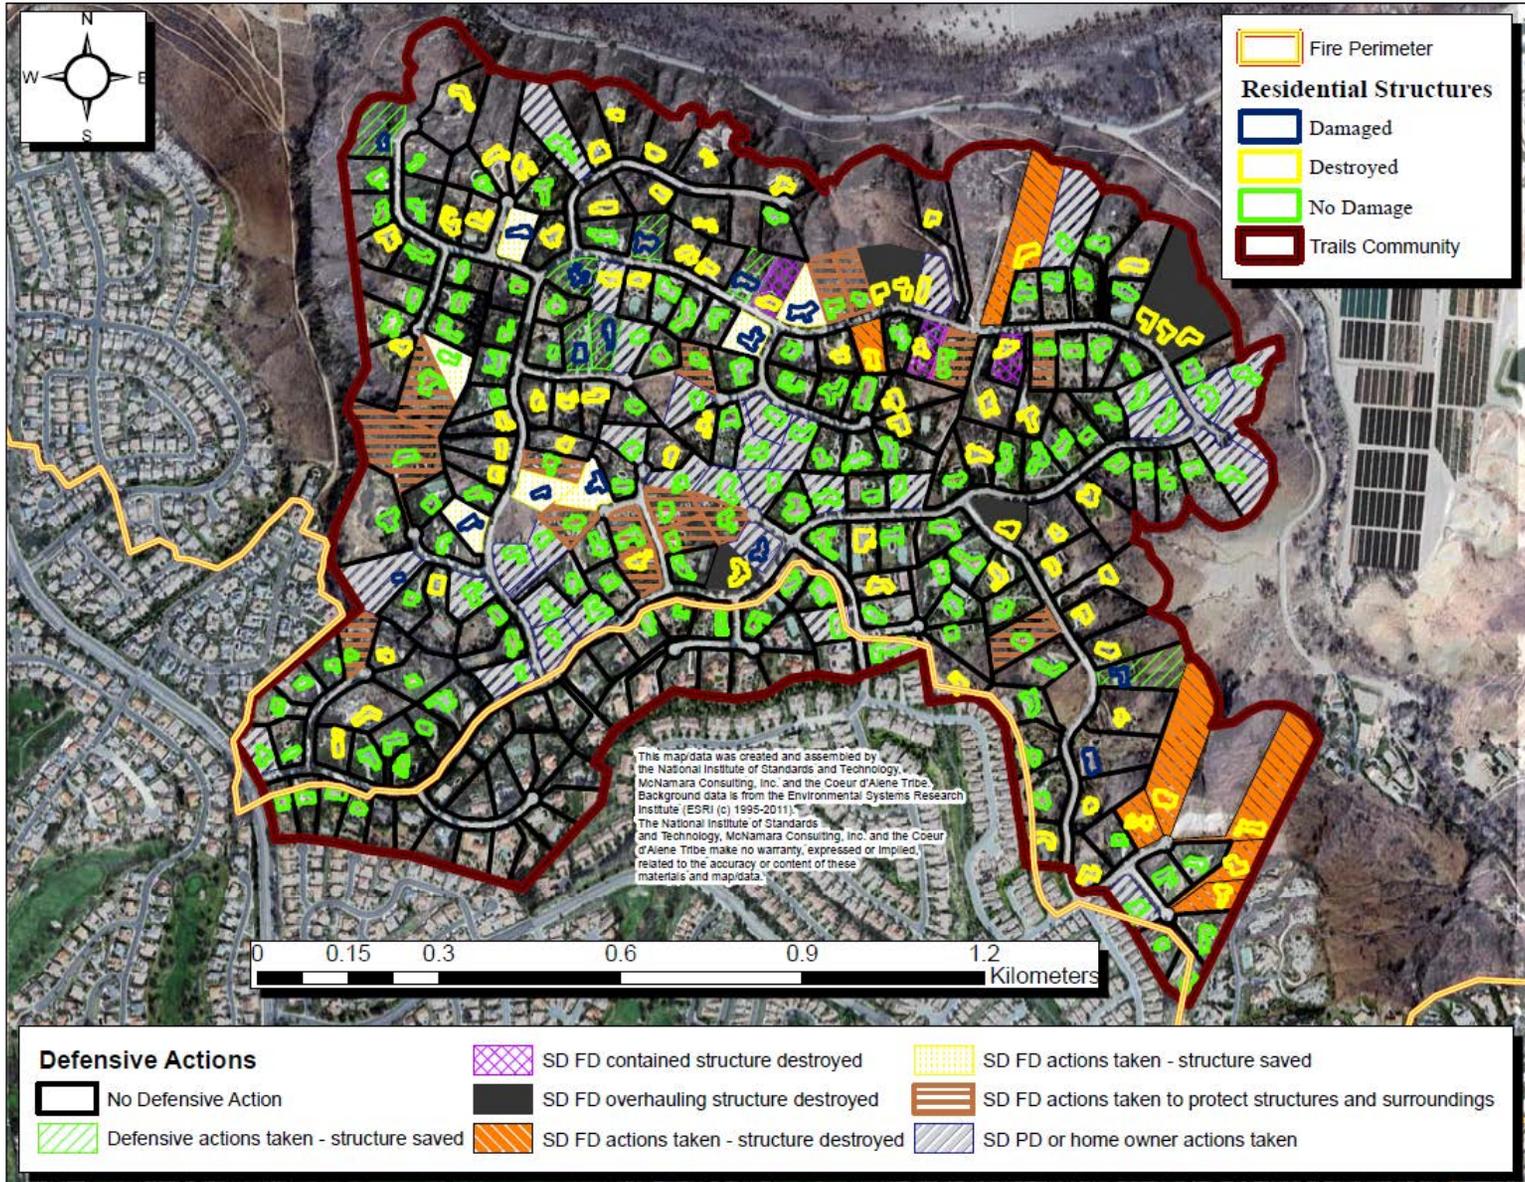
Figure 8 Defensive actions on residential properties overlaid with primary structures displayed by damaged status. Back ground imagery is 1 ft (0.3 m) horizontal resolution color imagery flown shortly after the fires.

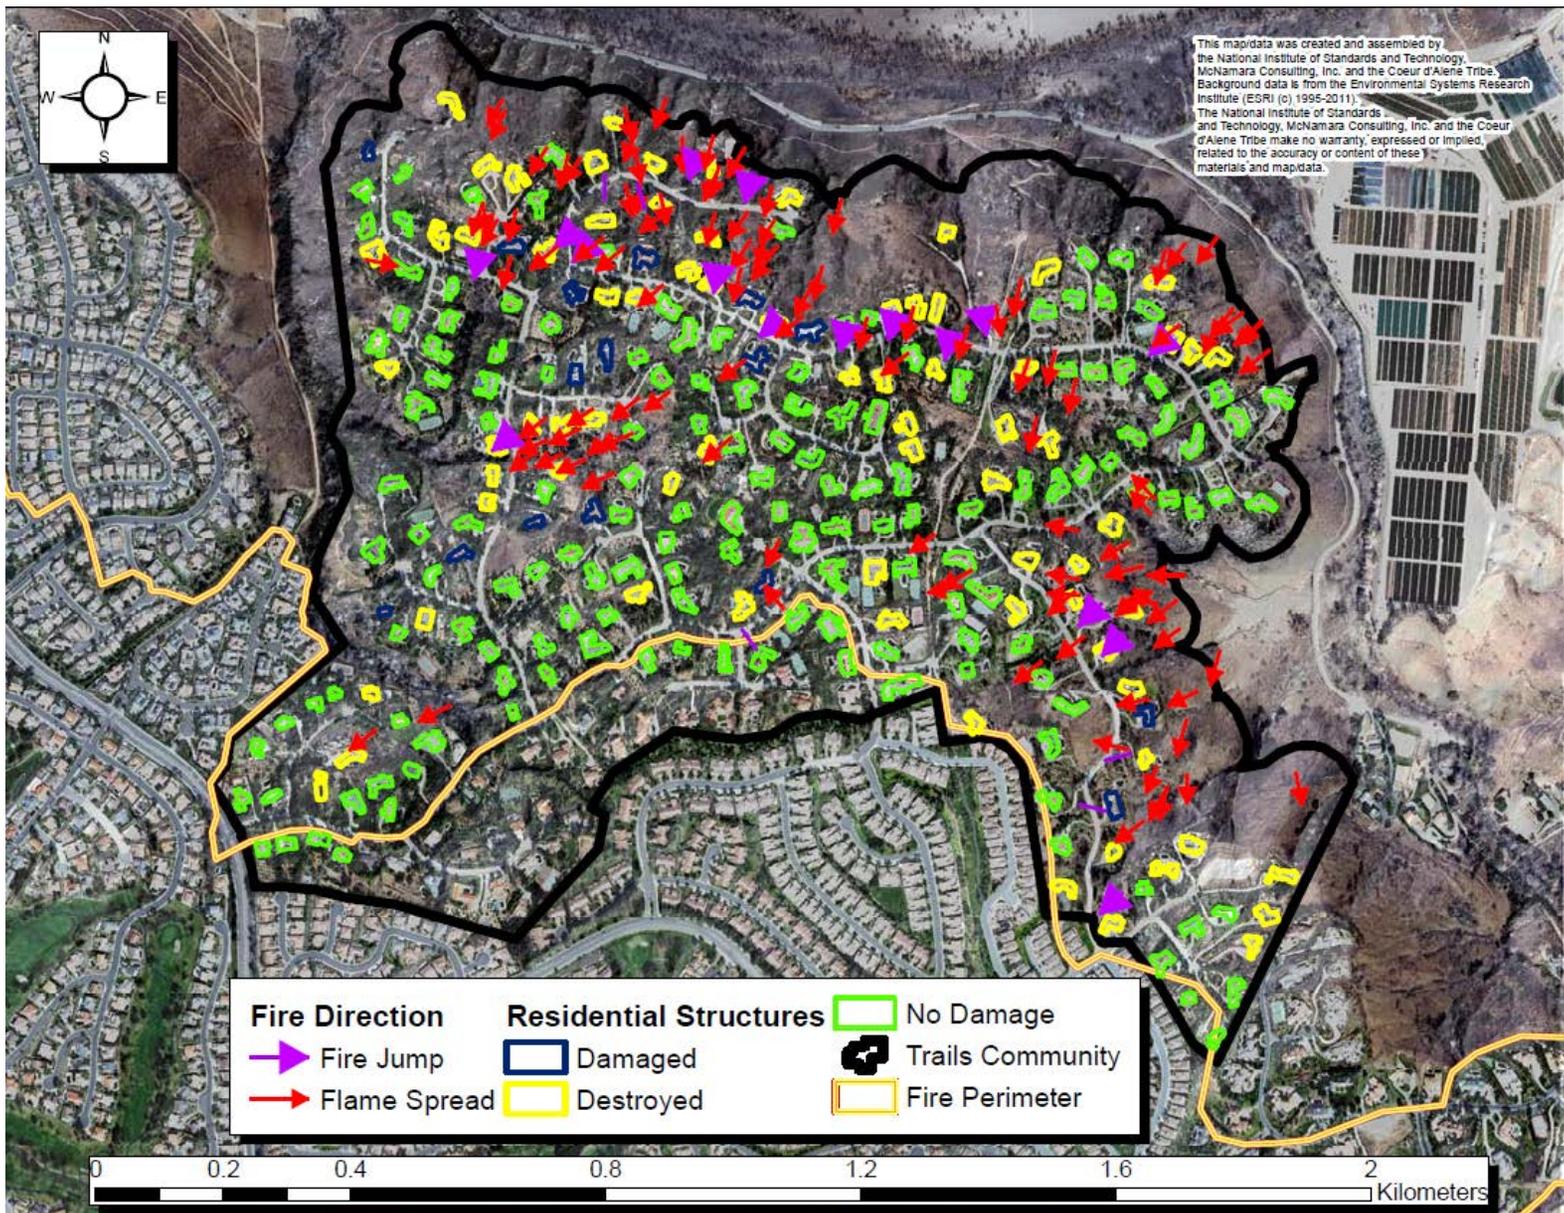
Figure 9 portrays fire direction in the Trails. Fire direction was delineated in the field on hard copy data sheets portraying aerial imagery from Google™ Earth. Several different indicators were used to determine the direction that the fire spread within the Trails. In the wildlands, needle freeze, directional degree of damage to wildland vegetation and the presence of partly damaged golf balls were all used to determine directionality of fire spread. Within the Trails, the extent of burned vegetation around destroyed homes was documented along with the locations that the fire jumped a road. This allowed for the identification of 21 locations representing spotting across the road. Needle freeze, the process of dehydrated foliage aligning or “freezing” parallel to the wind direction, was used to obtain wind direction.¹² Directional scorching was also used to document fire direction within the Trails.

Figure 9 Fire direction in the Trails overlaid with primary structures displayed by damaged status. Back ground imagery is 1 ft (0.3 m) horizontal resolution color imagery flown shortly after the fires.

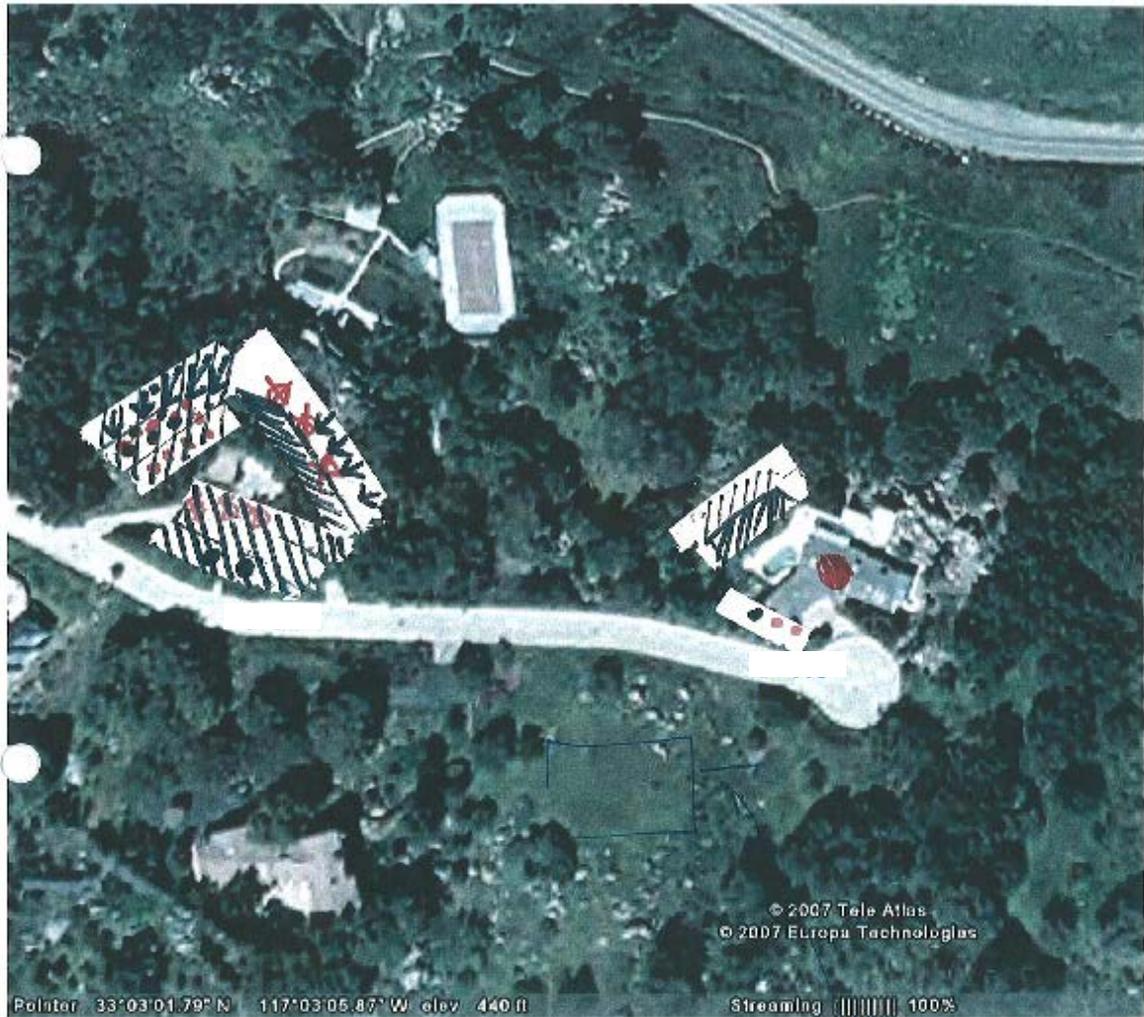
FIRE SPREAD N/E
 APPEARS PATIO ON EAST END
 WAS CONTRIBUTING FACTOR

● 12968 - FIRE SPREAD N/E + N/W
 LHT LHT TREES ~~LHT~~ L
 LHT 1 TREES
