NIST Technical Note 2135

A Case Study of the Camp Fire – Fire Progression Timeline

The Camp Fire ignited on November 8, 2018 in the foothills of the Sierra Nevada in Butte County, California. The first 24 hours were characterized by a fast-moving fire with initial spread driven by high winds up to 22 m/s (50 mi/h) and long-range spotting up to 6.3 km (3.9 mi) into the community. The fire quickly impacted the communities of Concow, Paradise, and Magalia. The Camp Fire became the most destructive and deadly fire in California history, with over 18 000 destroyed structures, 700 damaged structures, and 85 fatalities. After a preliminary reconnaissance, it was determined that abundant data was available to support an in-depth case study of this devastating wildland-urban interface (WUI) fire to increase our understanding of WUI fire spread, fire behavior, evacuation, and structure response. The methodology guiding the case study and a detailed timeline reconstruction of the fire progression and fire behavior are presented. Over 2200 observations about fire spread and behavior were collected during the case study. Subsequent reports will detail additional aspects of the incident includ

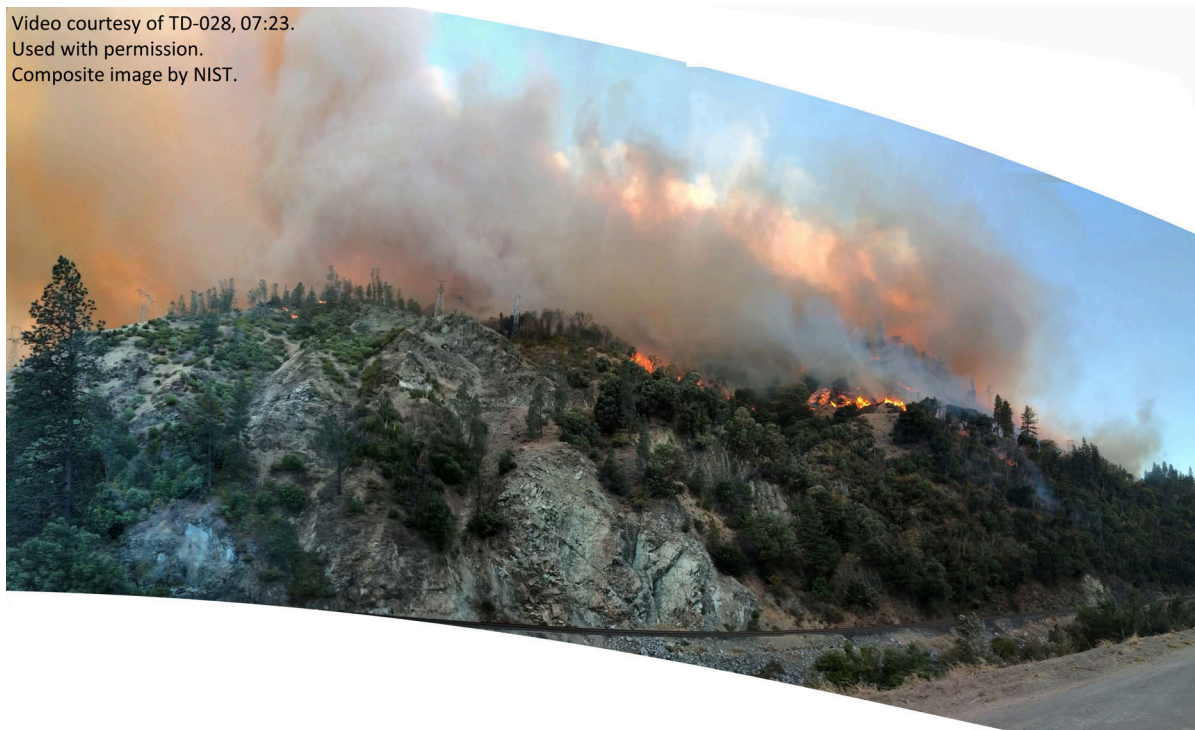
Figure 24. View of the fire looking north from Highway 70 at the Caltrans Pulga Maintenance Yard at 07:23. Panorama created from video recording.

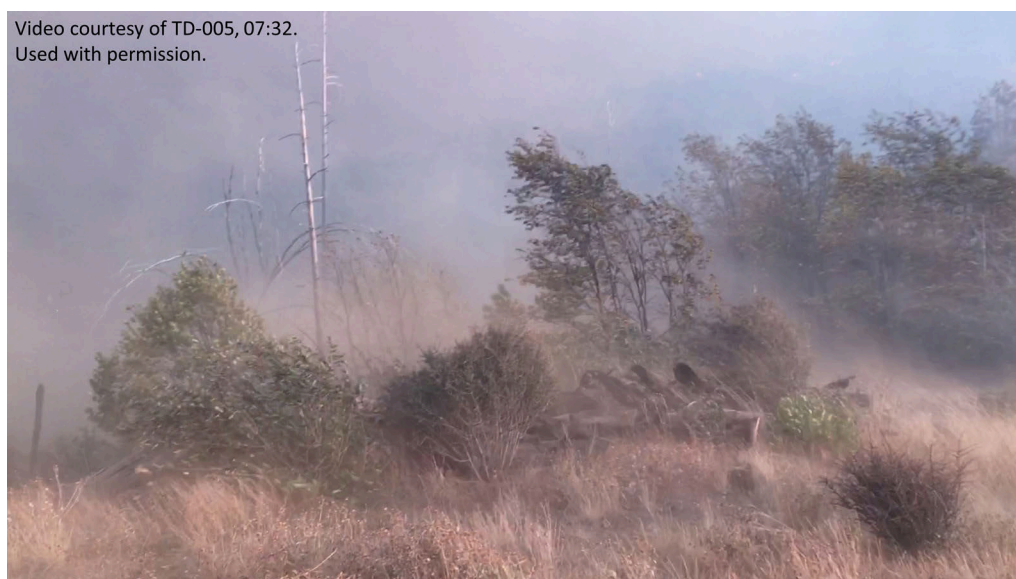
Figure 25. Strong wind gusts blew dirt and rocks whipping across the ridgetop at Rim Road.

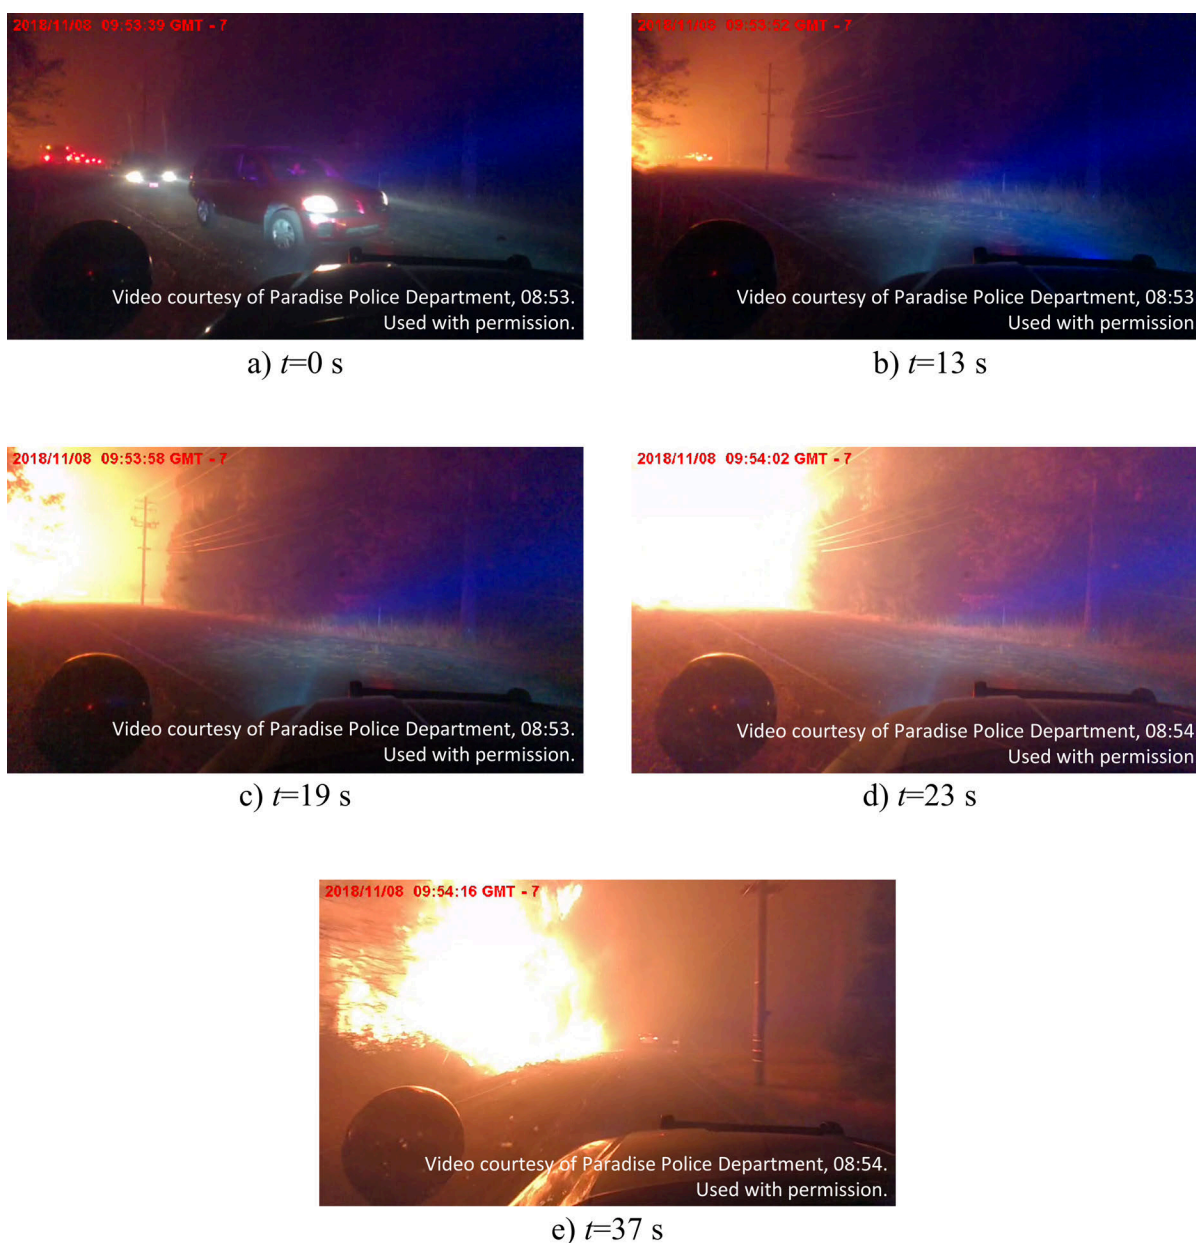
Figure 26. Scenes from a Paradise Police Department dashboard camera show how rapidly conditions can change and impact evacuation routes, as fire is seen impacting evacuating vehicles on Pentz Rd at Merrill Rd.

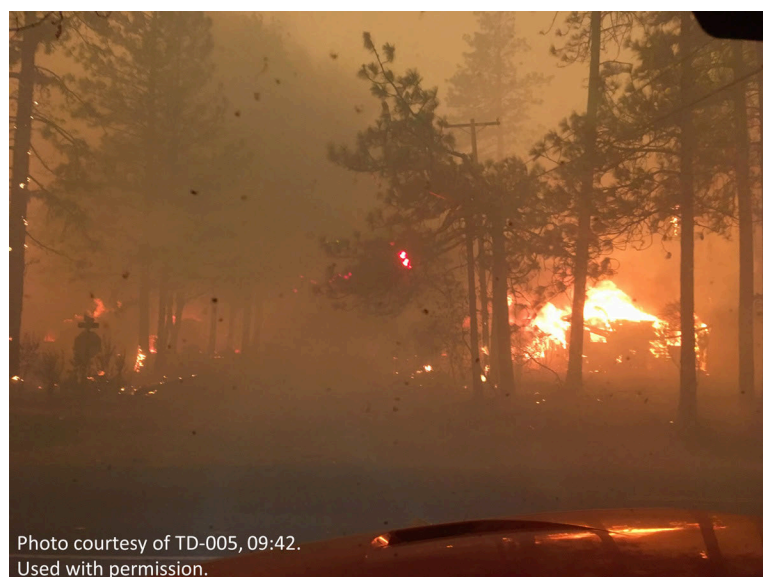
Figure 28. View of everything burning at the intersection of Pentz Rd and Riverview Dr. View west at 09:42.

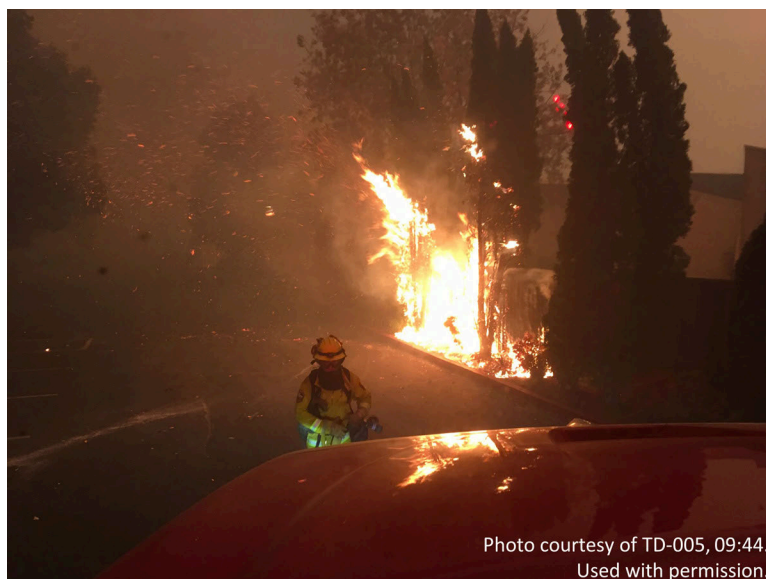
Figure 30. Spot fires in vegetation threatened FRH and generated additional ember showers.

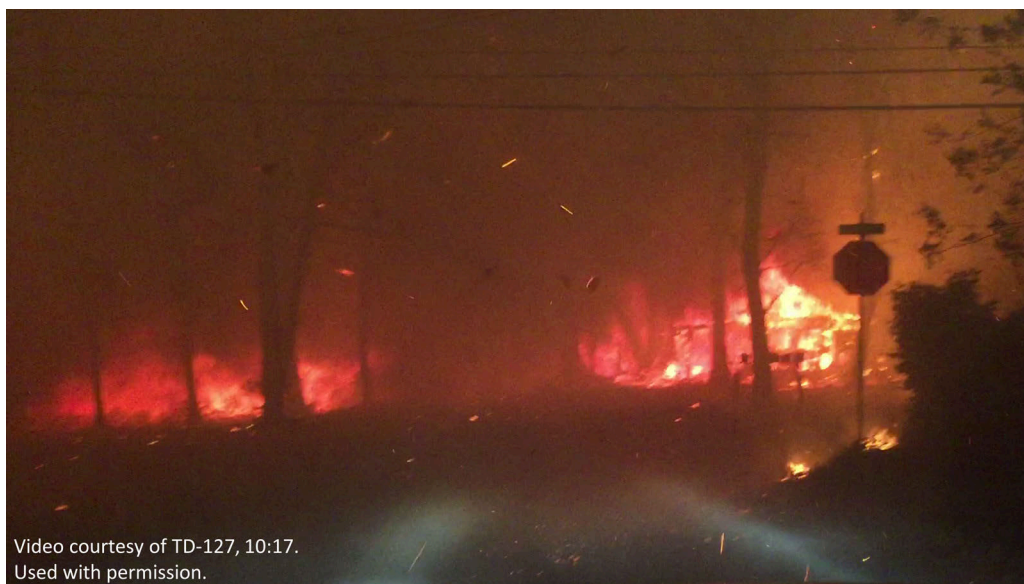
Figure 32. Midnight darkness, swirling winds, heavy ember showers, and fully involved structures at the intersection of Oak Way and Wagstaff Rd at 10:17. View north.

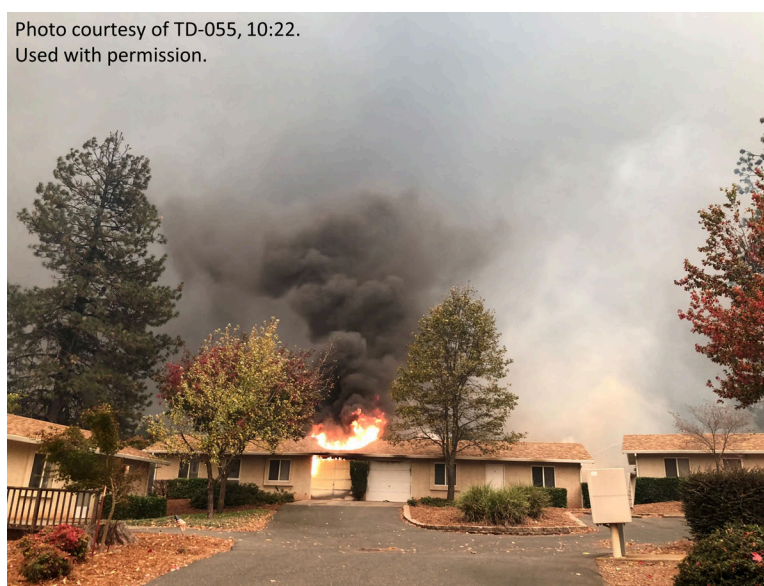
Figure 33. A structure on Wagstaff Rd just east of Clark Rd (behind Save Mart) is burning at 10:22. View south.

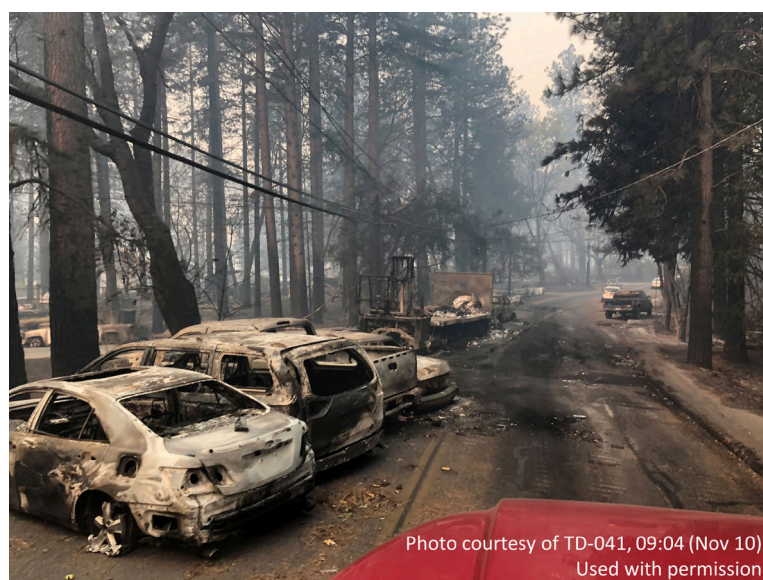
Figure 34. Abandoned vehicles on Bille Rd, seen after the fire, pushed aside by a bulldozer. Evacuees were overrun by fire around 09:50. View west.

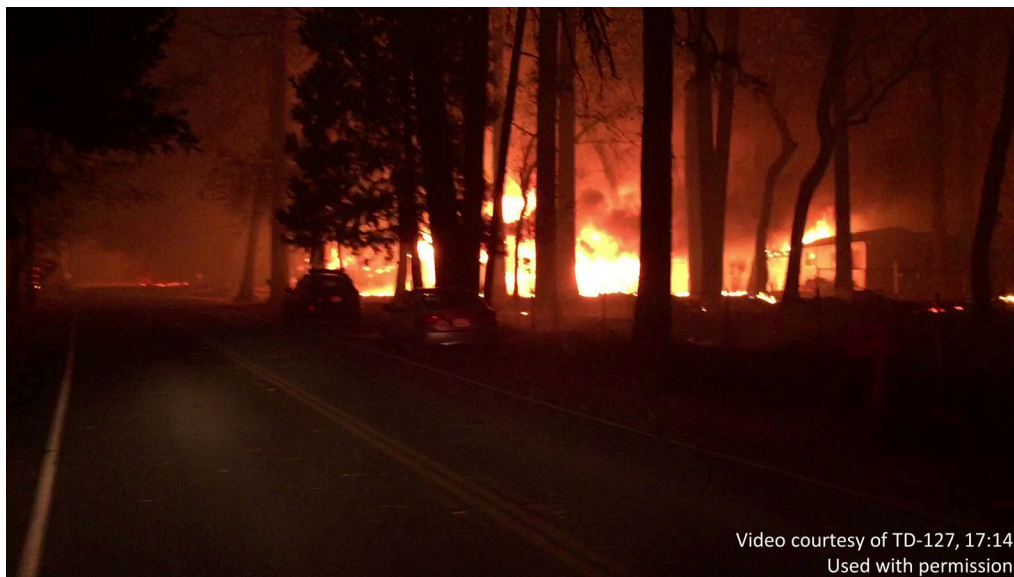
Figure 35. Fire activity on Bille Rd near Lucky John Rd, west of Skyway, at 17:14. Numerous structures are fully involved, while others are burned down or just starting to ignite.

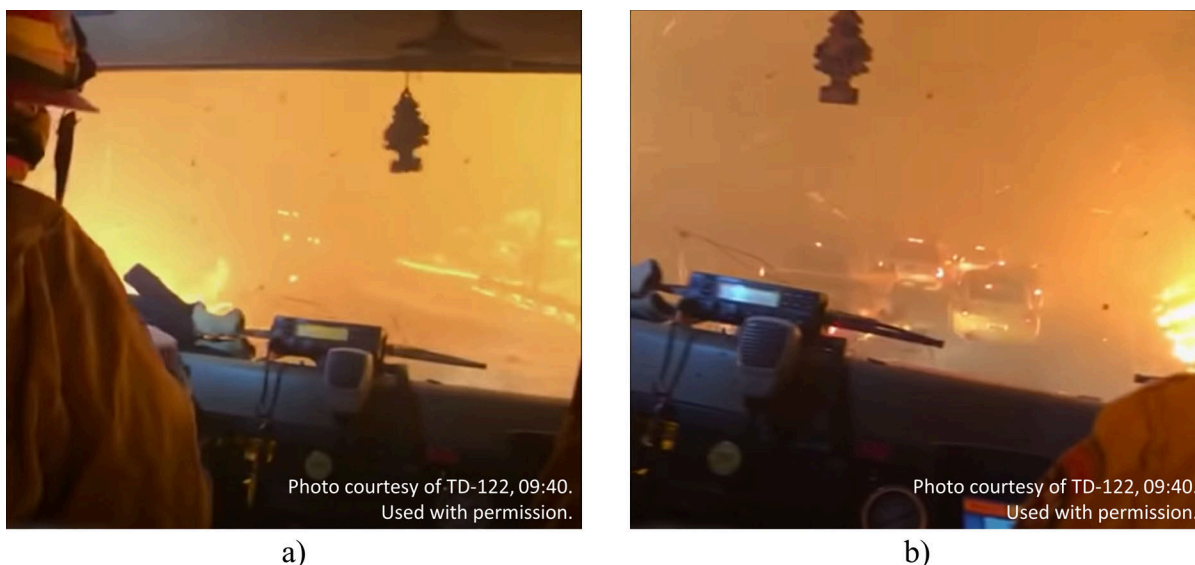
Figure 36. Intense fire activity in the drainage at Pearson Rd and Hilbe Dr while civilians and first responders are stuck in the area. Views are eastbound, a) just east of Hilbe Dr, and b) just east of Hilltop Dr at the tail end of the traffic jam.

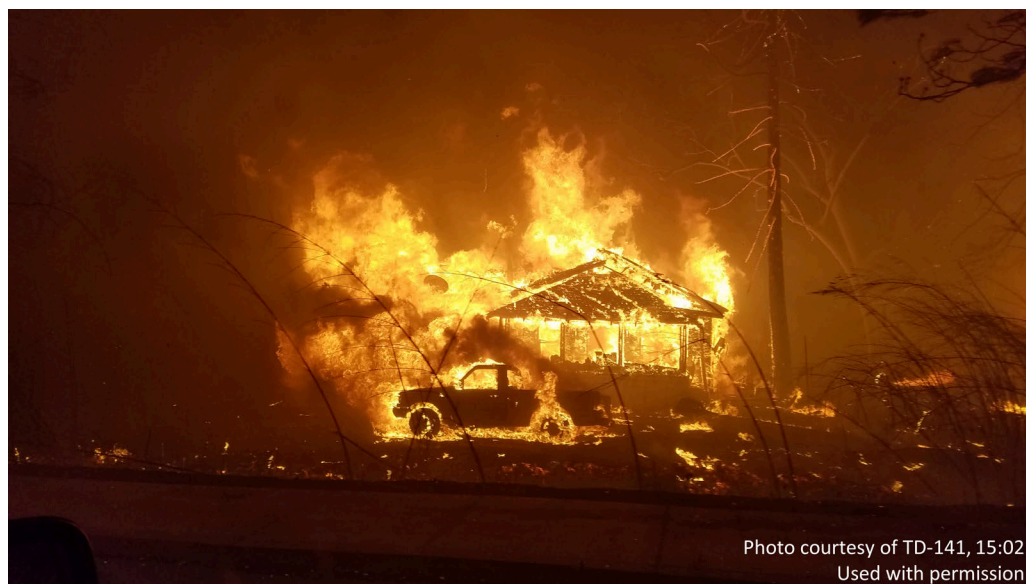
Figure 37. A fully involved parcel on Pearson Rd at Sierra Park Dr.

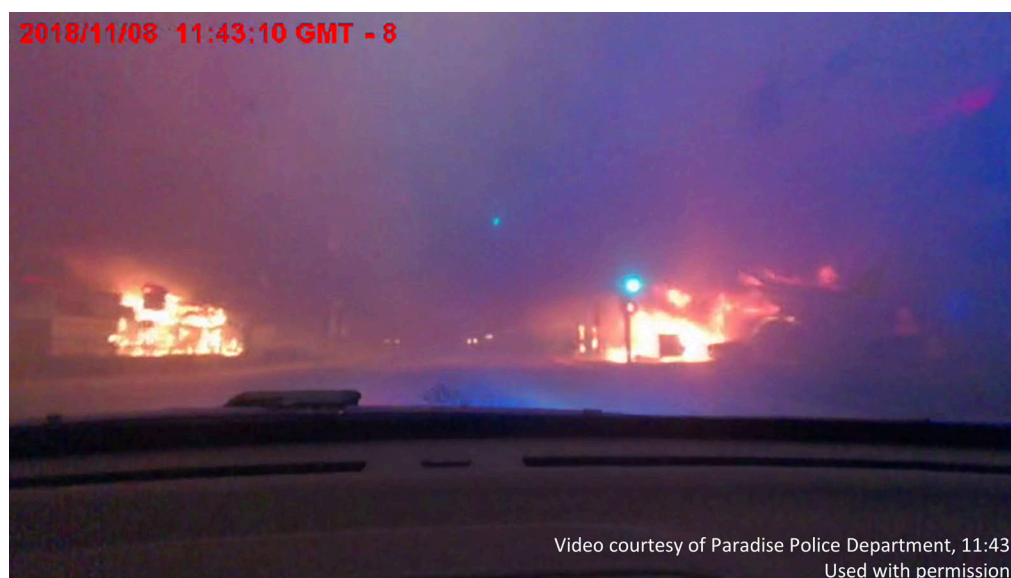
Figure 38. Commercial structures burning along Clark Rd at Central Park Dr. View north.

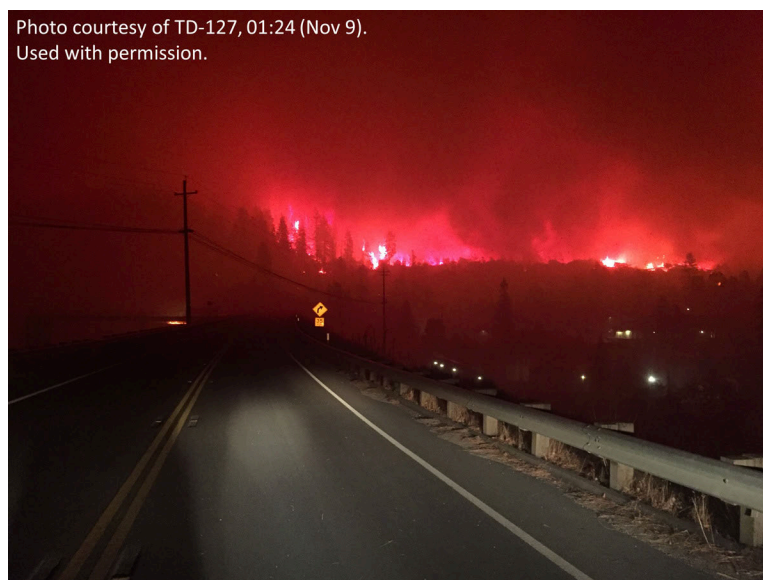
Figure 44. View south from the Magalia Reservoir dam as flames shoot up from the West Branch Feather River canyon over the ridge and Coutolenc Rd.

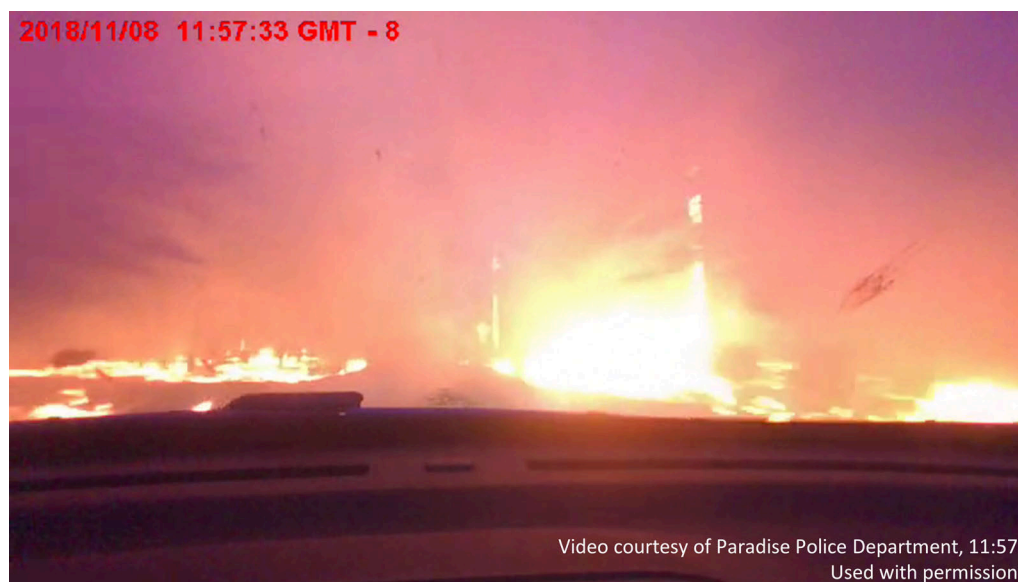
Figure 46. Snapshot from PPD dashboard camera showing representative conditions throughout a 1 km (0.6 mi) stretch of Clark Rd near Forest Service Rd at 11:57.

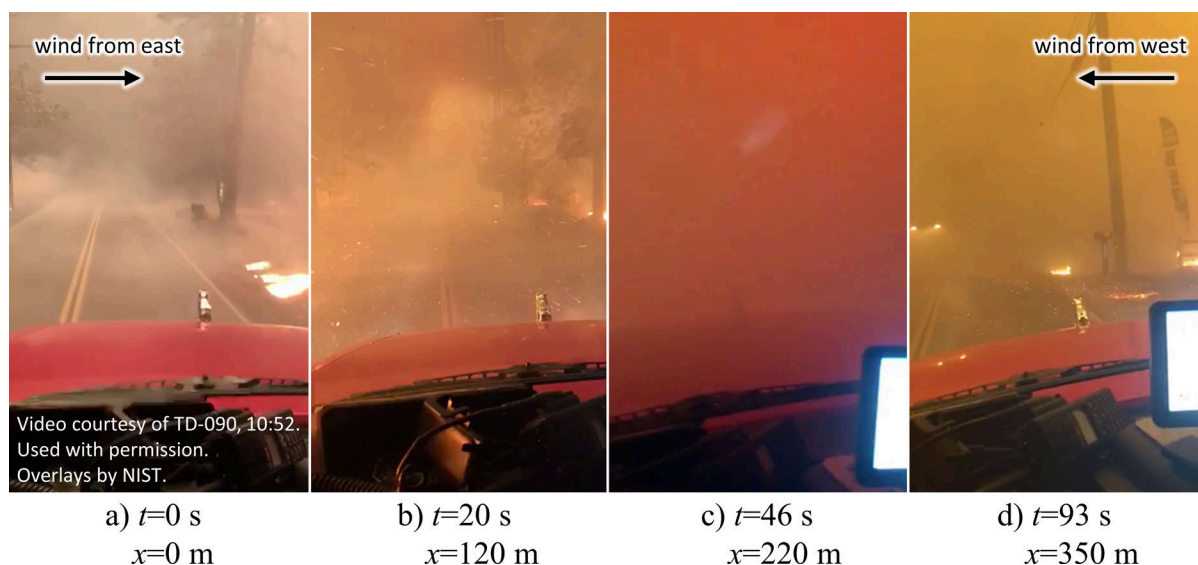
Figure 48. Image sequence from a video recording showing visibility and wind conditions along Pentz Rd, heading south at 10:52. Visibility is intermittent and wind directions shift 180° over short distances and time periods.

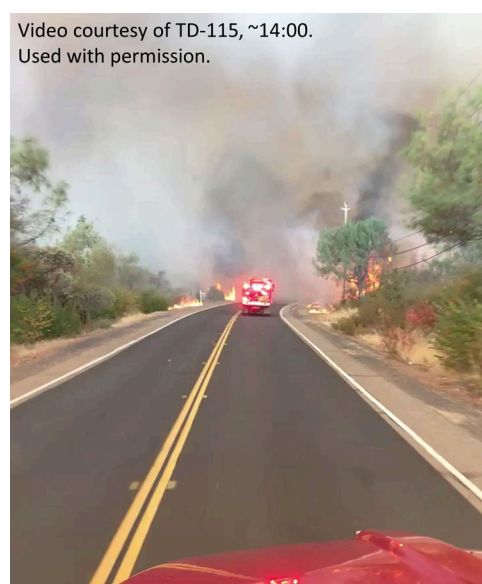
Figure 49. Wall of smoke observed on Pentz Rd, going north, at Dry Creek Rd. This abrupt change in conditions was described by multiple individuals.

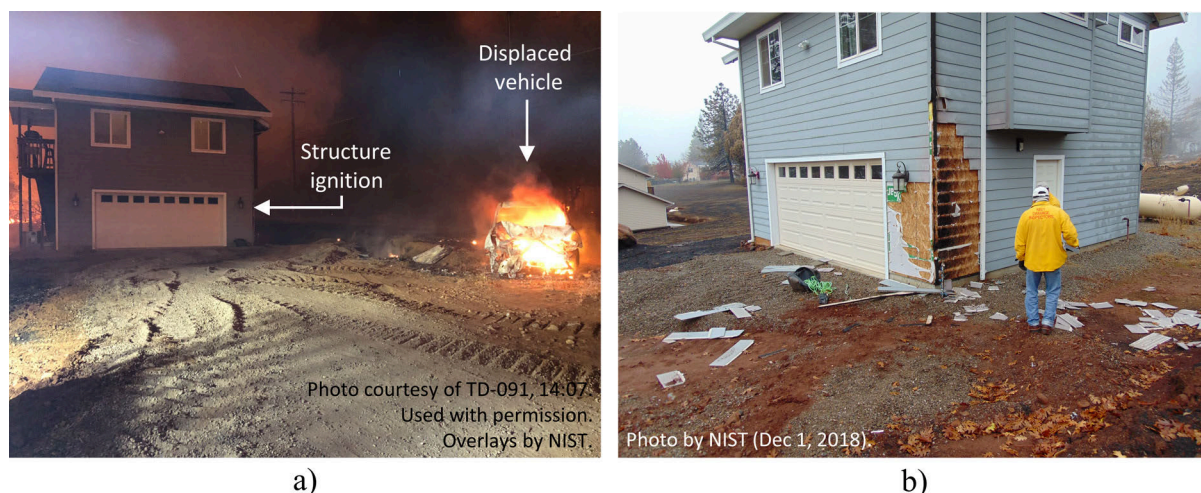
Figure 52. A defended structure on Lewis Ranch Rd where the burning vehicle was igniting the structure, showing a) a dozer displaced the vehicle to stop fire spread, b) the associated evidence of the fire ignition and defensive actions encountered during NIST damage assessments.

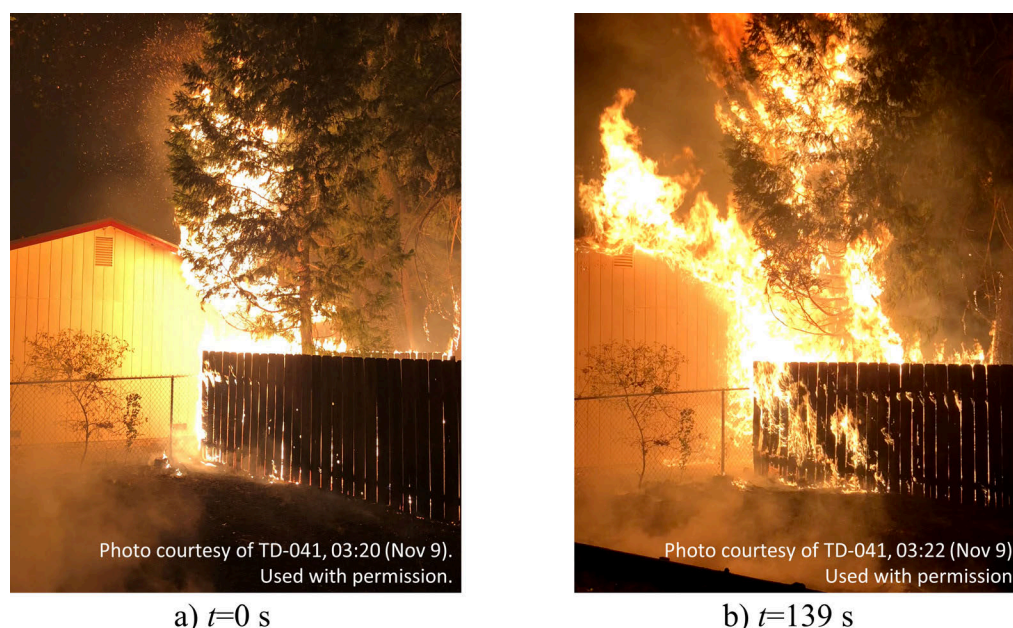
Figure 53. Structure ignition on Dade Ct in Magalia. Images are two minutes apart and show fire spread from surface fuels to fence to vegetation to eaves. The combustible fence is estimated to be approximately 1.8 m (6 ft) away from the structure.

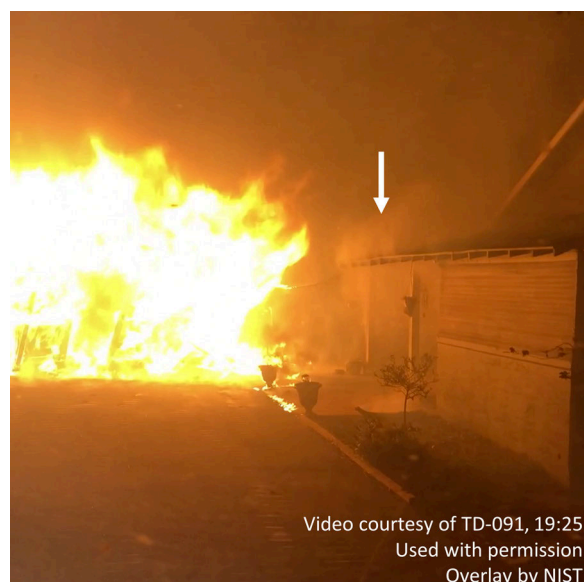
Figure 58. Fully involved shed, 8 m × 4 m (13 ft × 26 ft), located 3 m (10 ft) from the primary structure. Eaves of the primary structure are pyrolyzing (white arrow).
