**NIST Technical Note  
NIST TN 2267**

# **Fire Resilience of a Steel-Concrete Composite Floor System: Full-Scale Experimental Evaluation for Influence of Slab Reinforcement and Unprotected Secondary Beam (Test #3)**

October 2023

Test #3 was conducted to study the effect of enhanced slab reinforcement as well as unprotected secondary beams on the fire resilience of the composite floor systems. Similar to Test #2, the floor slab in the test bay was reinforced with 9.5 mm diameter deformed bars with a center-to-center spacing of 30 cm (230 mm<sup>2</sup>/m). Unlike in Test #1 and Test #2, the secondary beam and its end connections in the test bay were left unprotected in Test #3. The test floor was mechanically loaded to 2.7 kPa to mimic the code-prescribed gravity loads for fire conditions. The compartment test fire created upper-layer gas temperatures like those in standard fire resistance tests. A total of four natural gas burners distributed over the compartment floor created a peak gas temperature exceeding 1100 °C below the test floor. A wide transverse crack with flame leak above the floor developed at 132 min in the mid-panel region. The mid-panel vertical displacement rea

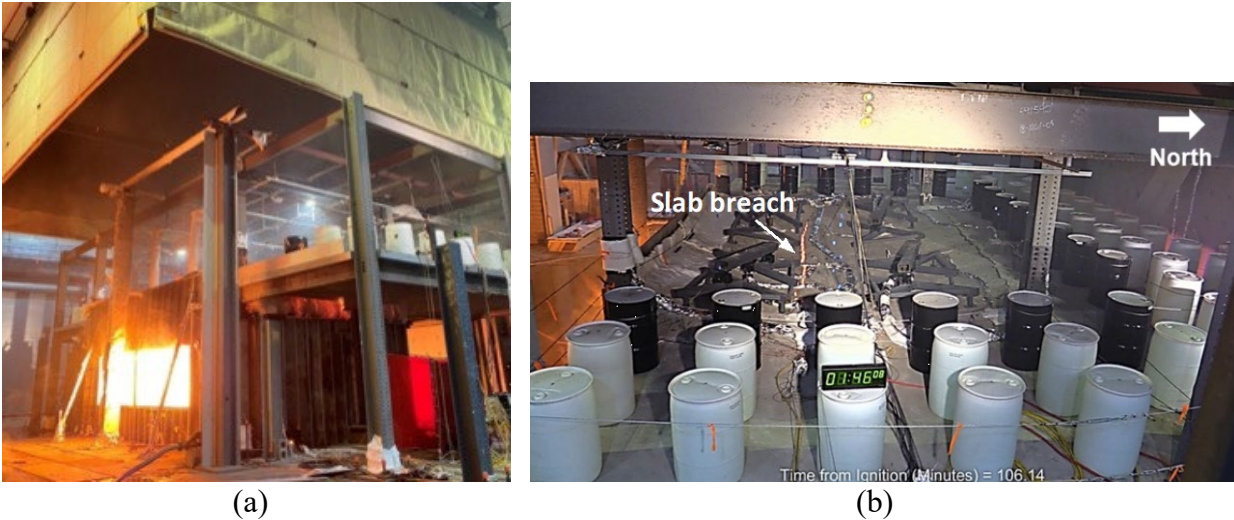
**Fig. 1.** Test #1 (a) compartment fire test in the south middle bay of the two-story building under 20 MW exhaust hood; (b) top of the composite floor developing slab breach at 106 min after burner ignition.

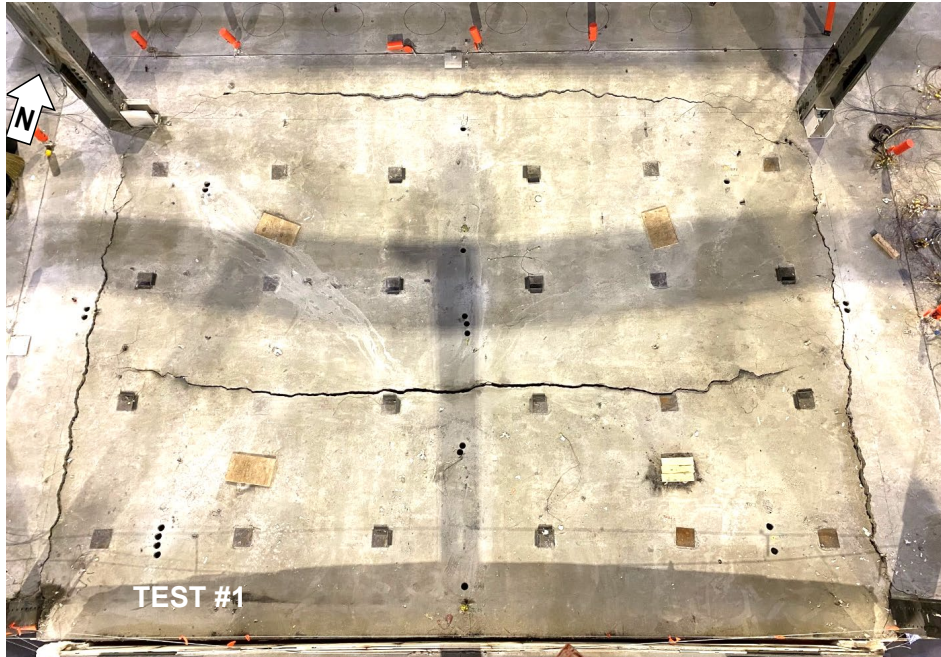
Whereas temperatures of the protected steel beams were acceptable compared to the ASTM E119 [10] limiting temperatures, significant integrity failure (concrete cracks) occurred in the heated composite floor before attaining the specified fire rating period. Large concrete cracks appeared around the hogging moment region (next to the test-bay column gridline) less than 30 min into heating, and the mid-panel concrete cracks began to occur at 70 min, exposing the hot glowing steel deck beneath along the longitudinal centerline (Fig. 2).

The limited ductility of the heated composite slab was the primary cause of the integrity failure which might eventually lead to local collapse mechanisms during longer (uncontrolled) fires and initiate fire spread above the compartment of fire origin. The steel wire reinforcement (60 mm<sup>2</sup>/m) embedded in the test floor slab ruptured in tension at critical locations as the thermally degraded composite floor sagged but before reaching the ASTM E119 displacement limit. The minimum steel reinforcement (60 mm<sup>2</sup>/m) prescribed for concrete crack control in normal conditions and permitted in standard furnace testing may not be sufficient to maintain the integrity of a full-scale composite floor undergoing the 2-hour standard fire exposure.

Fig. 2. Test #1 composite floor after cool down.

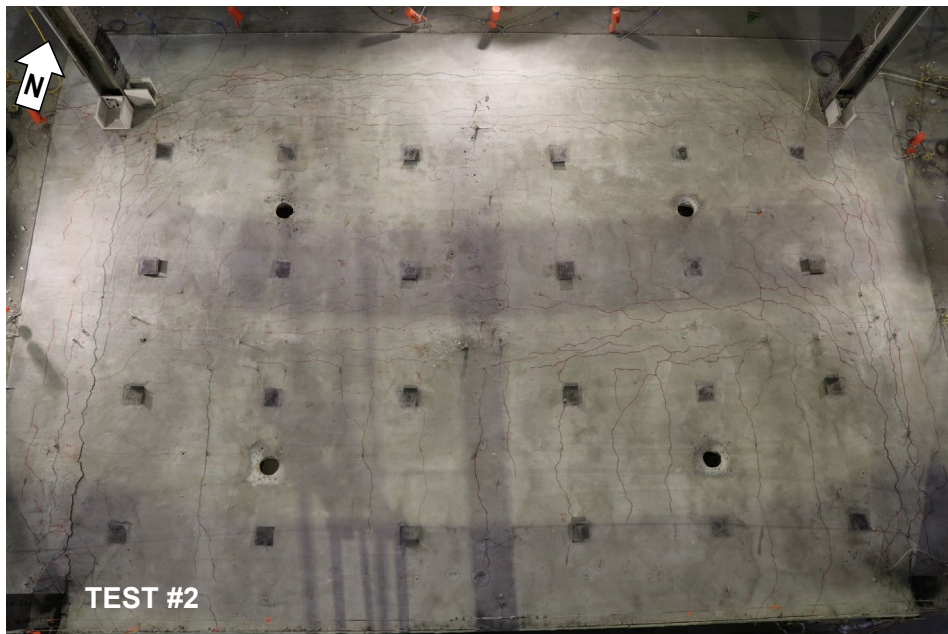
In Test #2, all fire-exposed beams exhibited some degree of permanent global deflection and local buckling; however, all shear-tab connections appeared to be intact and robust after cooling. No steel ruptures in connection elements (plates, bolts and welds) were identified. However, the bottom bolts connected at the south ends of the girders exhibited some degree of bending. All four extended shear tabs connecting the girders significantly bent due to thermal expansion of the floor specimen.

**Fig. 3.** Test #2 composite floor after cool down.

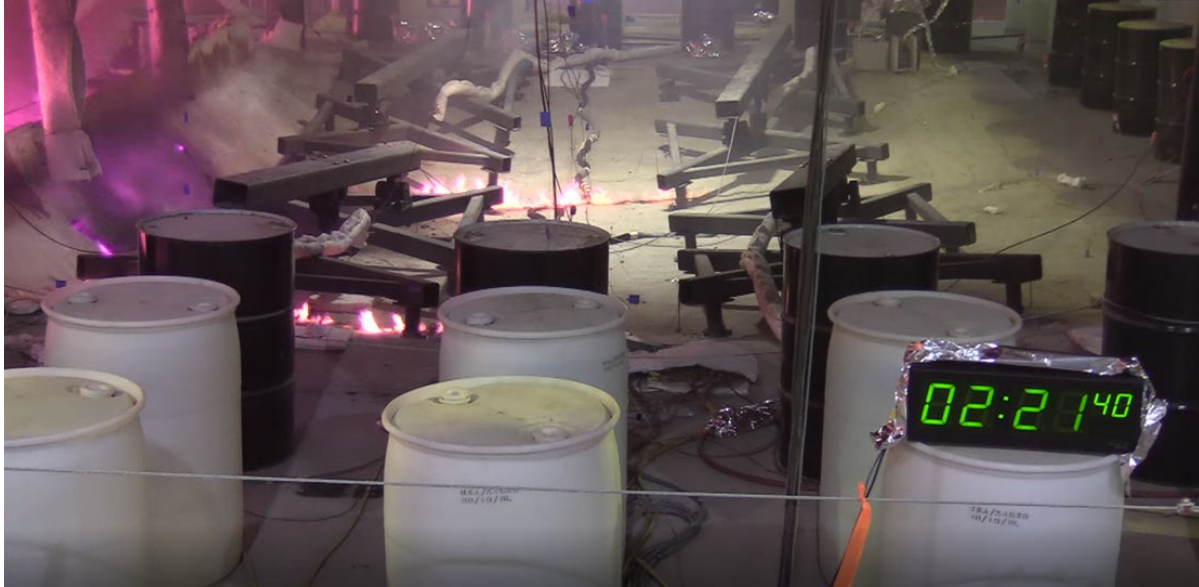
**Fig. 15.** Snapshot from the test video showing top of the test floor specimen at 142 min (2 hr:22 min) after the burner ignition. The pink color at the left side of this image is a camera artifact.

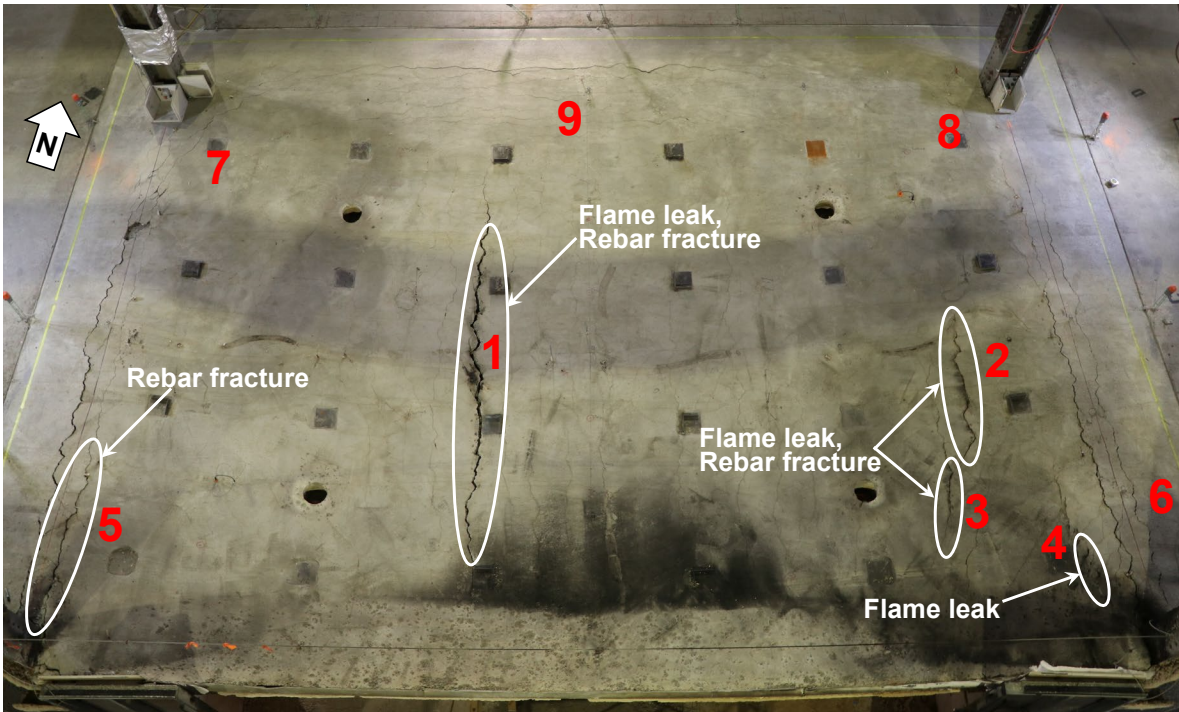
Fig. 34. Crack pattern on the test floor slab.

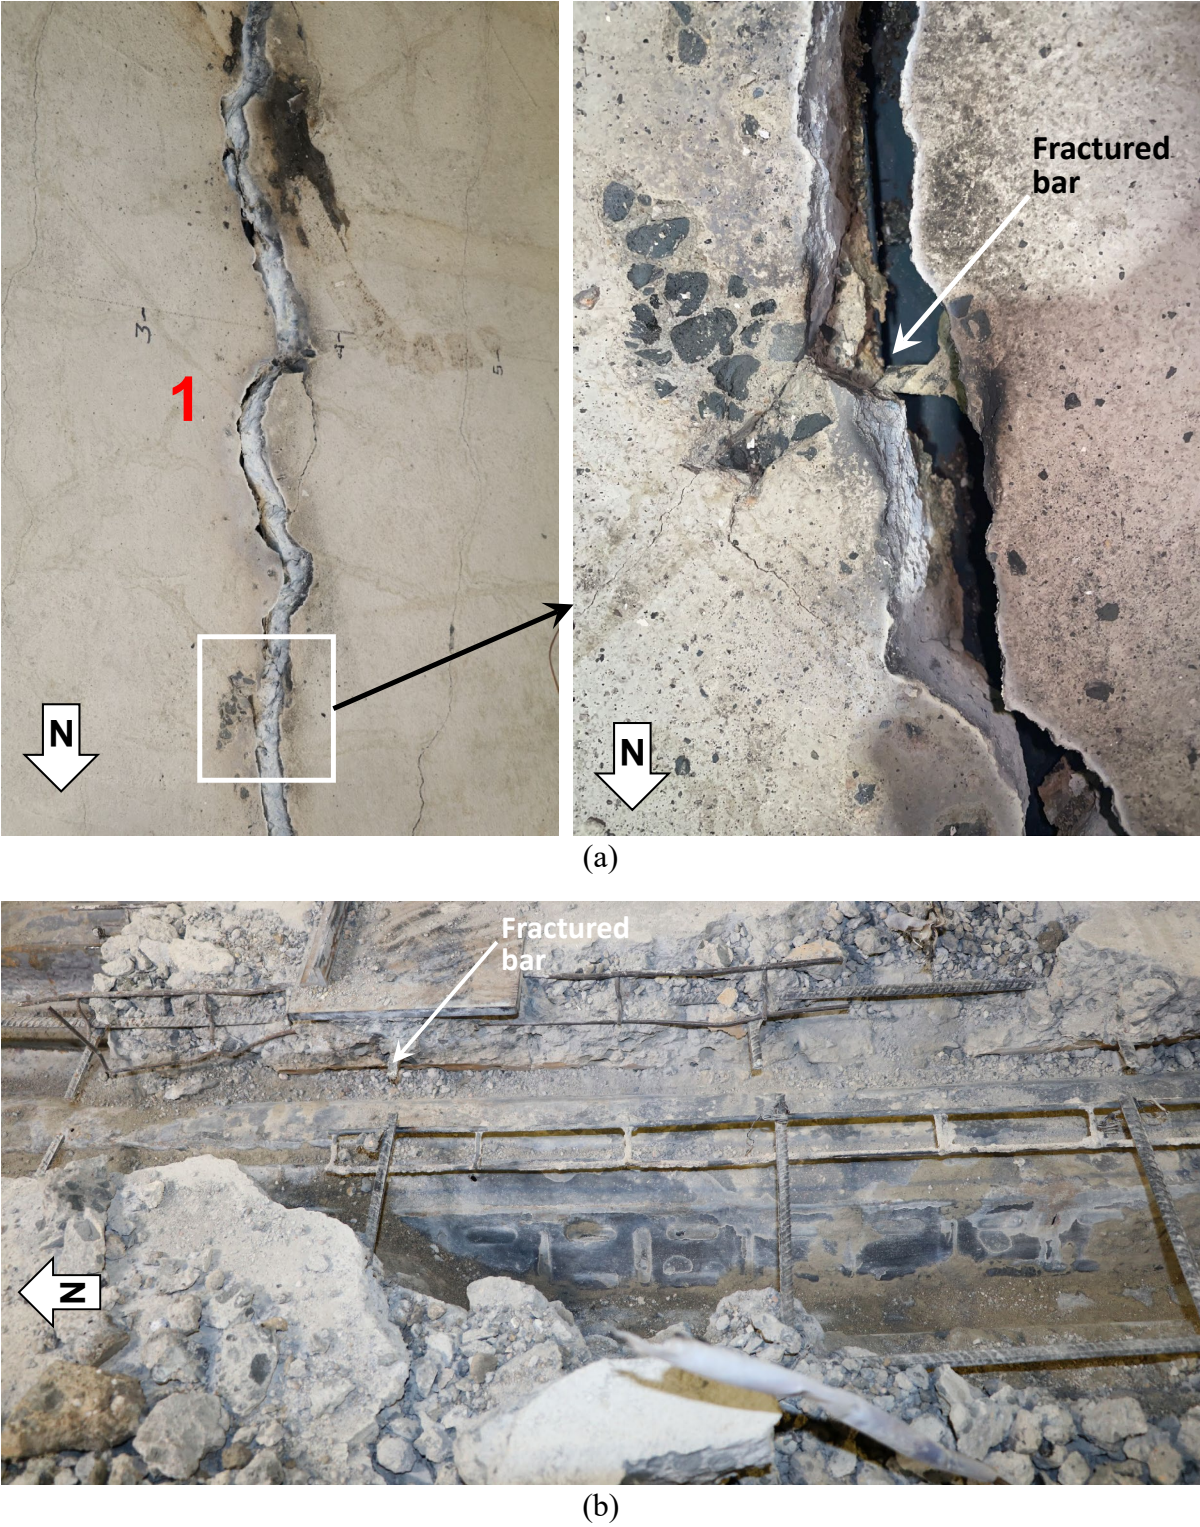
**Fig. 35.** (a) Transverse crack near mid centerline of the test floor slab (at Location 1 in Fig. 20); (b) rebar fractures across the transverse crack.

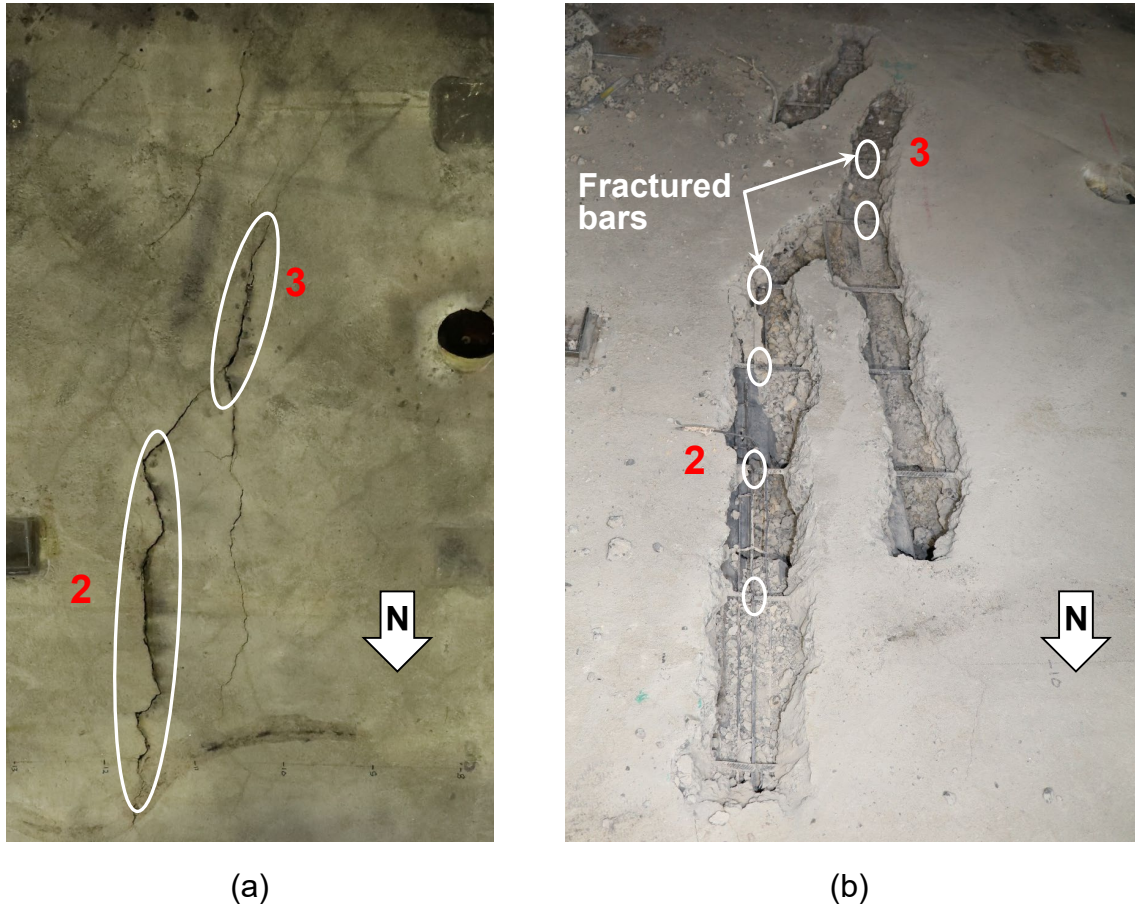
**Fig. 36.** (a) Concrete cracks at the southeast quarter of the slab (at Locations 2 and 3 in Fig. 20); (b) rebar fractures across those cracks.

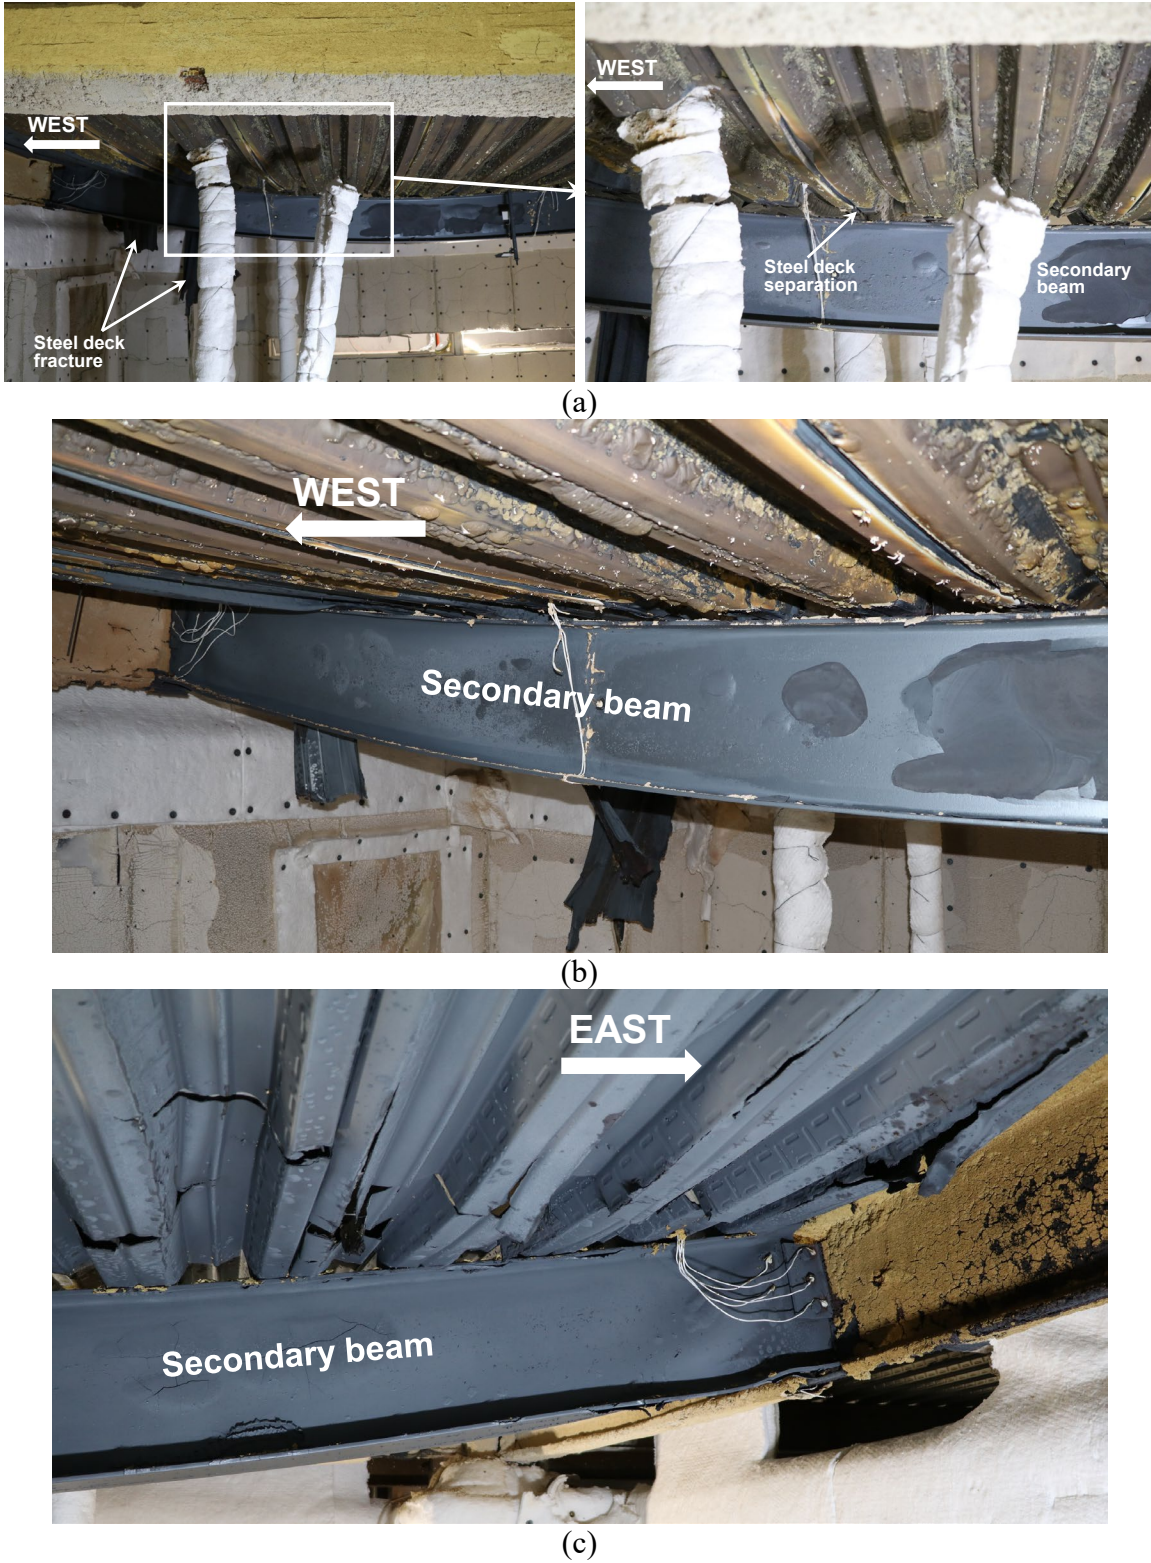
**Fig. 39.** (a) Steel deck rupture and separation from the beam in west half of test floor; (b) steel deck fracture in west half of test floor; (c) steel deck fracture in east half of test floor.

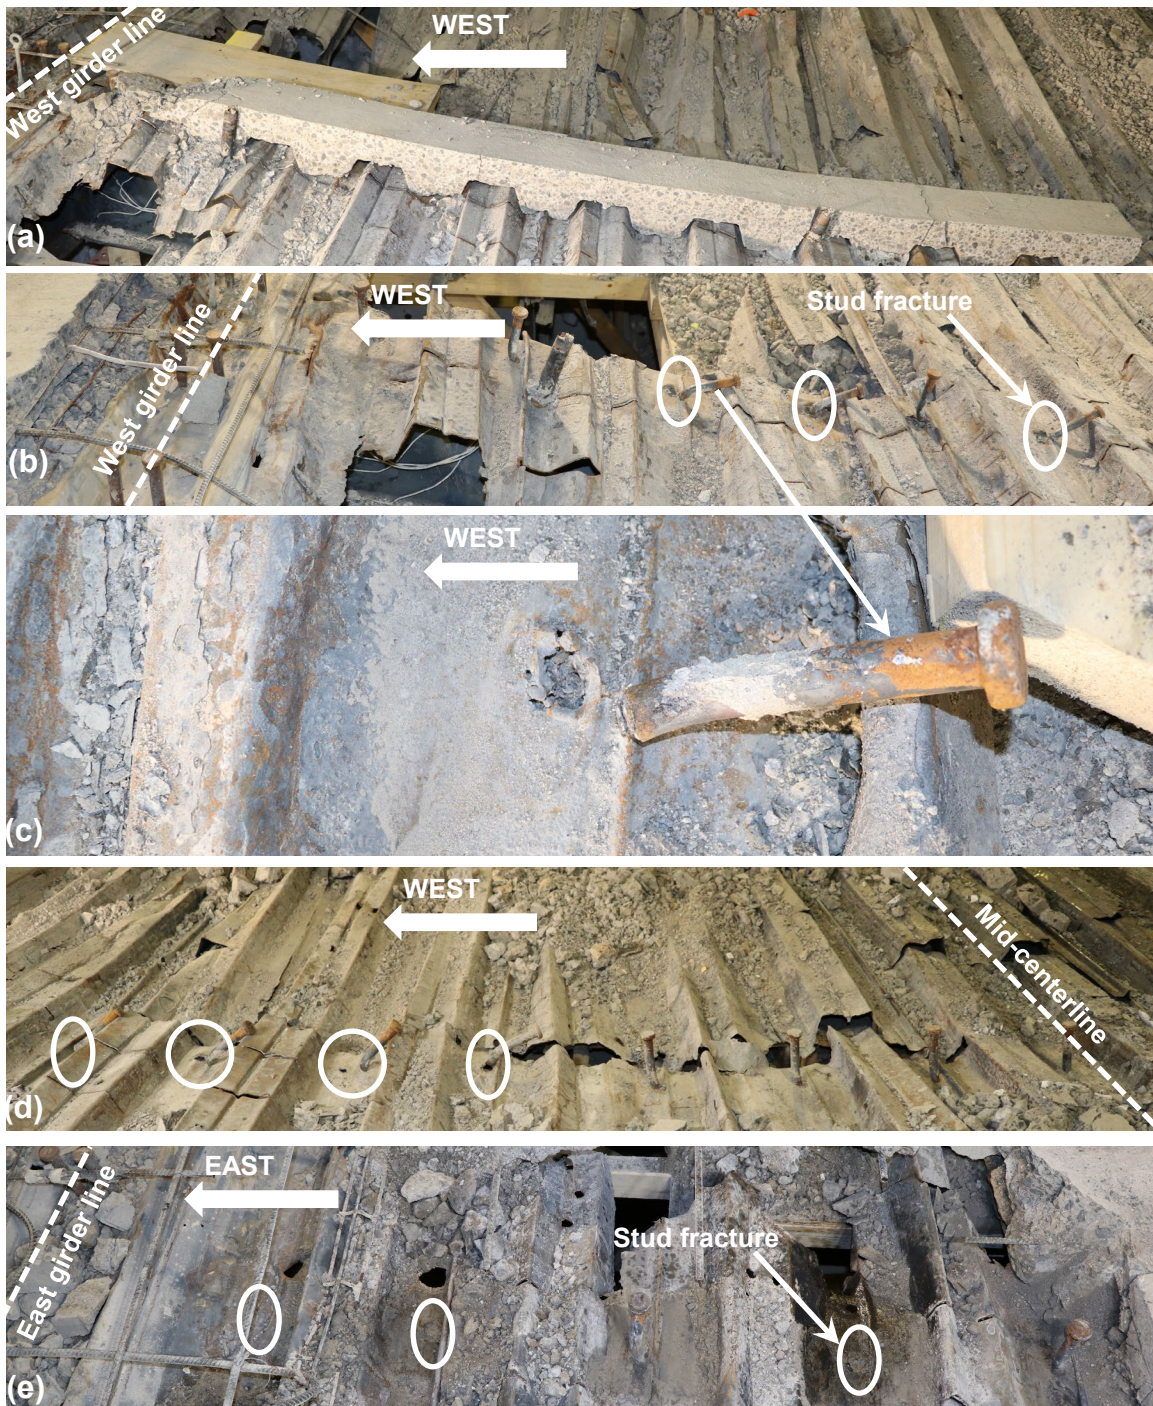
**Fig. 40.** Shear stud fracture along secondary beam (a) before removal of concrete around the shear studs at west end; (b) after removal of concrete at west end; (c) enlarged view of fracture of third shear stud from west end; (d) after removal of concrete at mid-span; (e) after removal of concrete at east end.

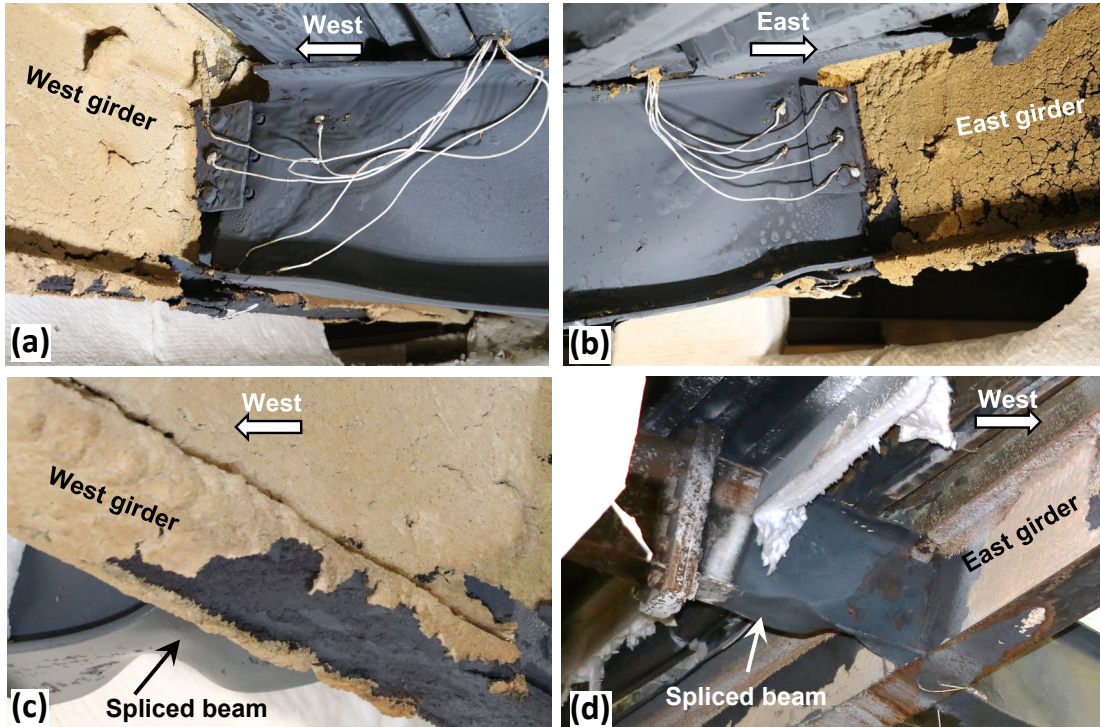
**Fig. 42.** Post-test photographs of the beam ends and connections (a) west end of unprotected secondary beam of test bay; (b) east end of secondary beam; (c) spliced beam in the surrounding bay west of secondary beam; (d) spliced beam in the surrounding bay east of secondary beam.

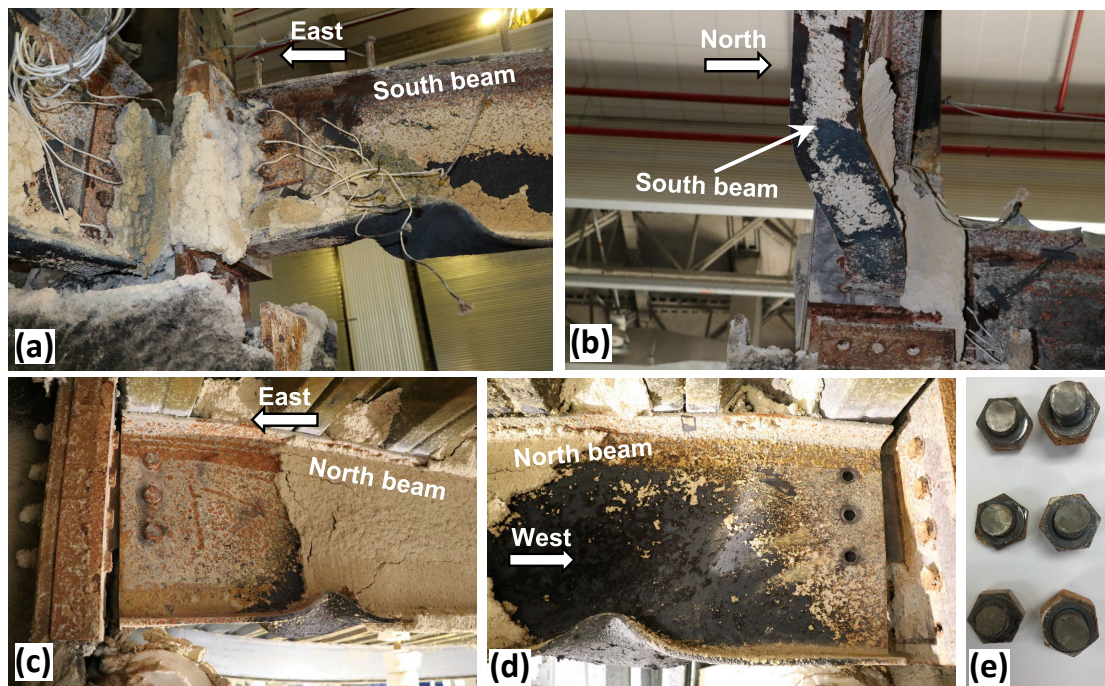
**Fig. 43.** Post-test photographs of the beam ends and connections (a) east end of south beam of test bay; (b) west end of south beam; (c) east end of north beam; (d) west end of north beam; (e) fractured bolts at the west end of north beam.

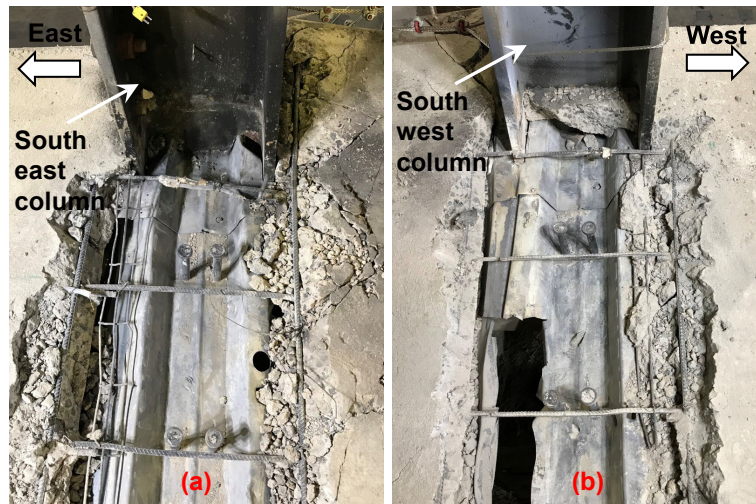
**Fig. 73.** Post-test photographs of headed studs after concrete removal (a) at the south end of east girder; (c) at the south end of west girder in the test bay.

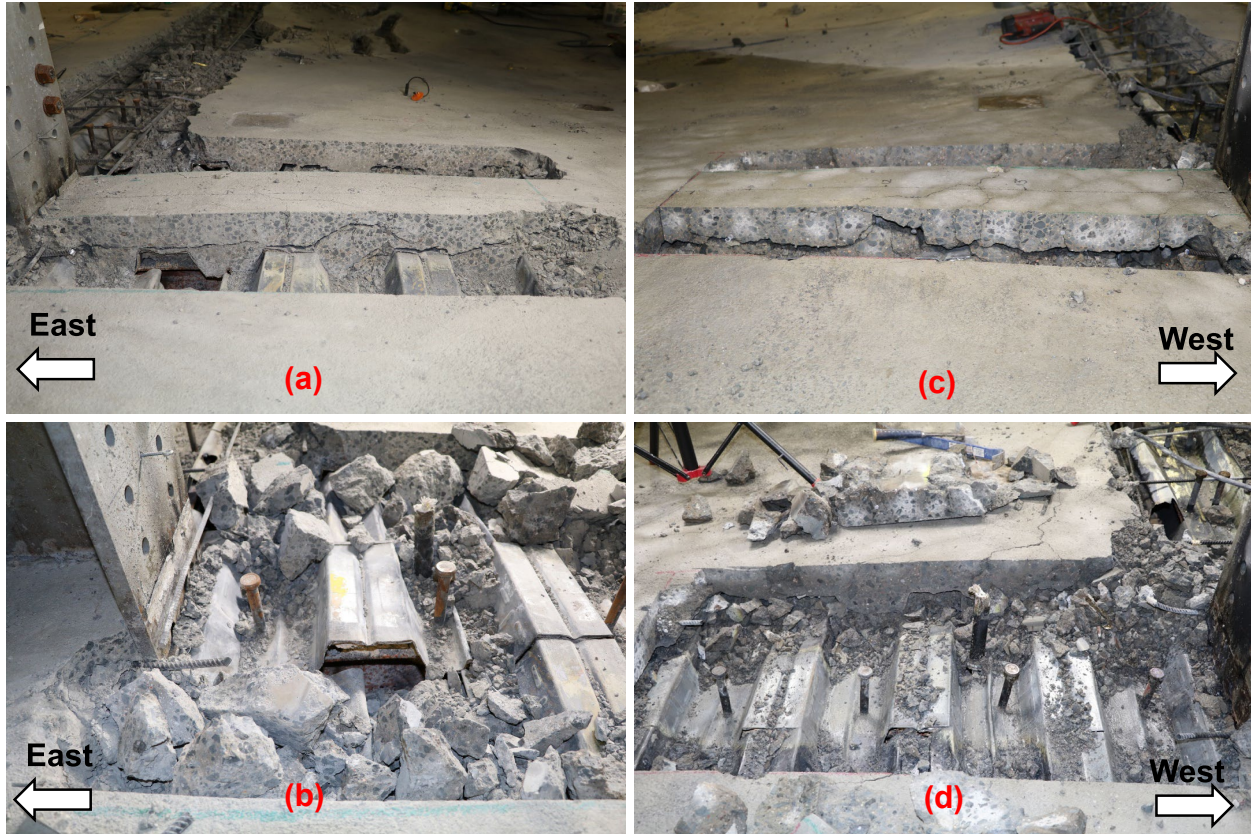
**Fig. 74.** Post-test photographs of headed studs (a) at the east end of north beam before concrete removal; (b) at the east end of north beam after concrete removal; (c) at the west end of north beam before concrete removal; (d) at the west end of north beam after concrete removal.

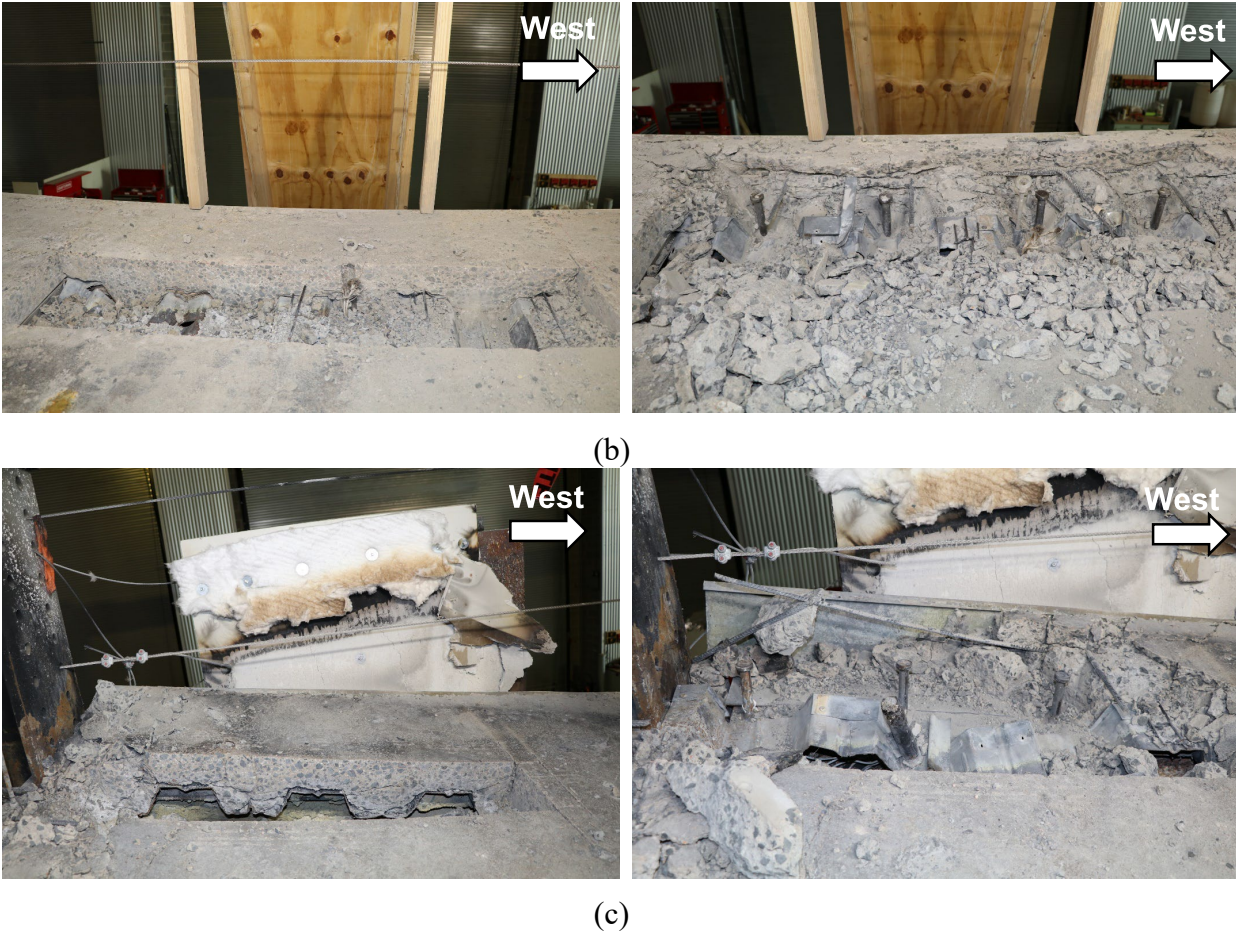
**Fig. 75.** Post-test photographs of headed studs before and after concrete removal (a) at the west end of south beam; (b) at the mid-span of south beam; (c) at the east end of south beam.

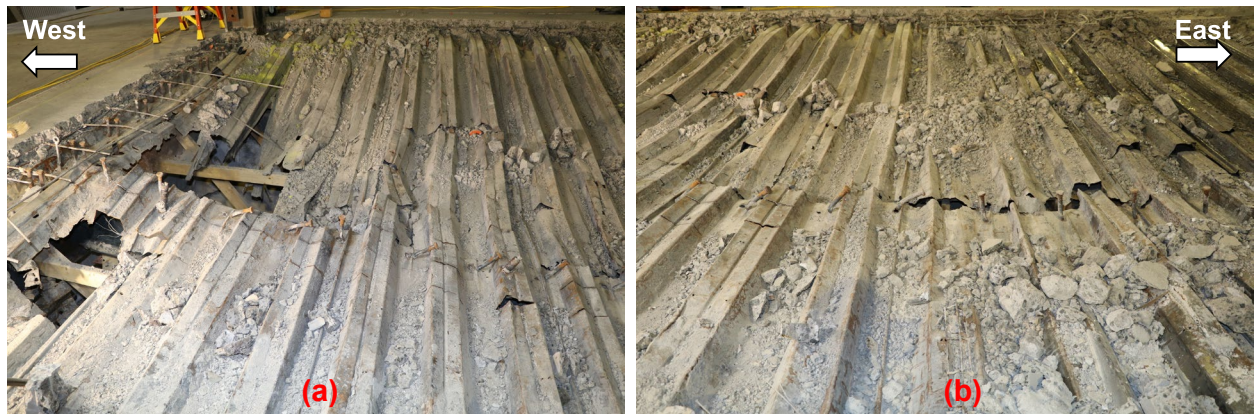
**Fig. 76.** Post-test photographs of steel deck ruptures (a) at the west side; (b) at the mid-span.

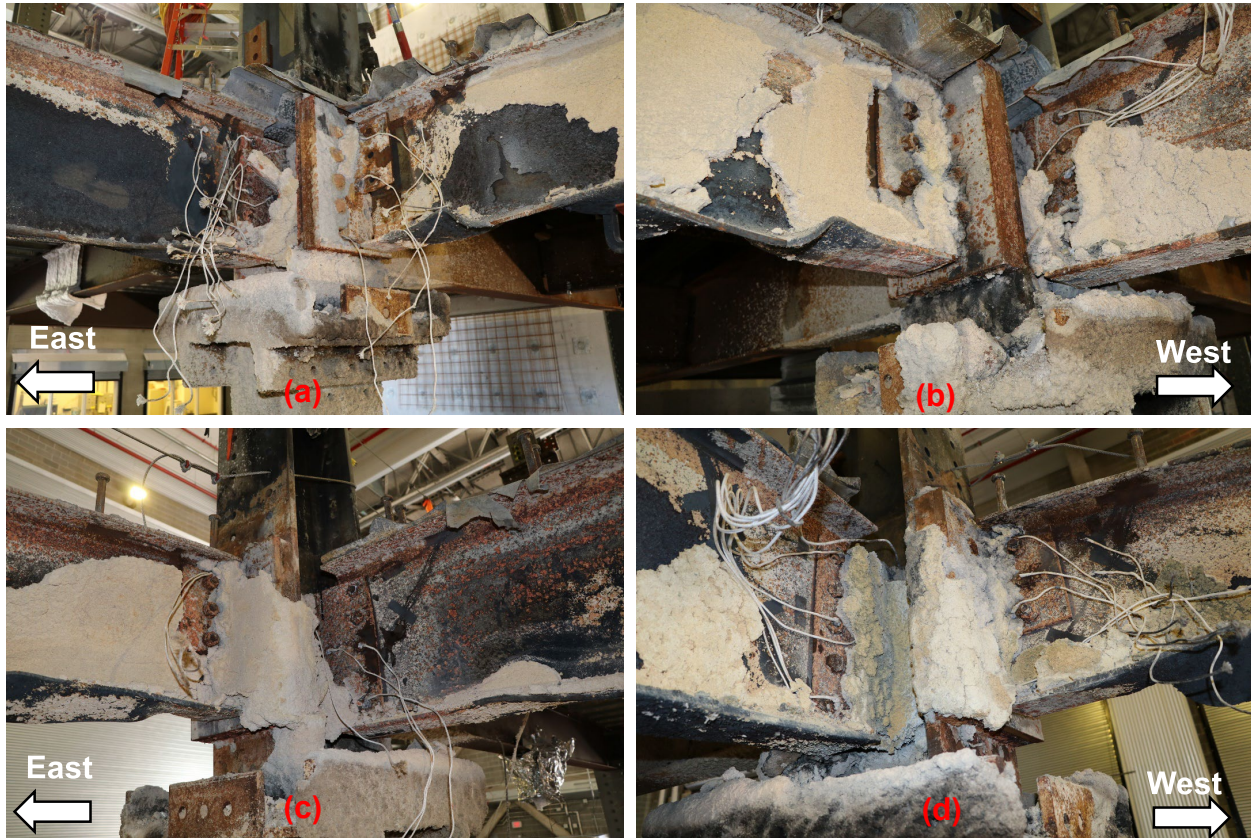
**Fig. 77.** Post-test photographs of test bay connections (a) at the north east corner; (b) at the north west corner; (c) at the south east corner; (d) at the south west corner of the test bay.
