Residential Home Performance Contracting Round Robin Guidelines

Michael Lubliner Rick Kunkle David Hales Melinda Spencer Washington State University Energy Program

April 2014

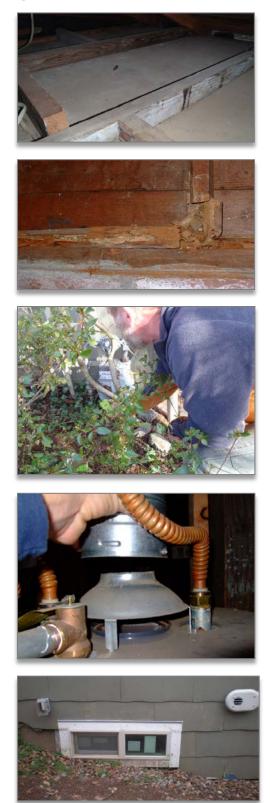
Figure B-5. Audit Observations at Portland Home

No insulation in attic above laundry – five auditors

Dry rot at sill plate – three auditors

Gas leak at meter – two auditors

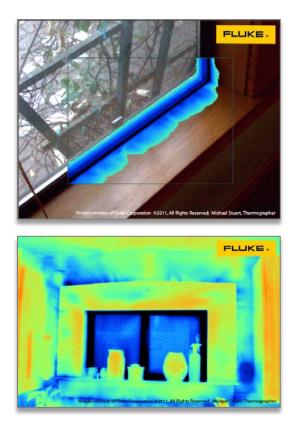
Air infiltration around window

Cool air infiltration around kitchen window trim and interstitial air flow in adjacent wall

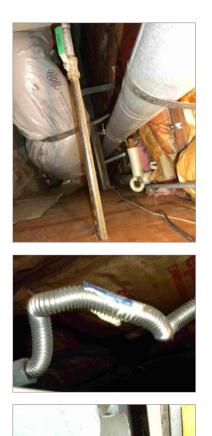
The atmospherically drafted 80% gas furnace is in the crawlspace, vents into a separate flue with a very long horizontal run, the flue was disconnected at the furnace, the gas flex line was kinked, and both the flue and the furnace show extensive corrosion. The furnace is at the end of its service life and should be replaced for safety reasons. It failed BPI standards for spillage, draft, and CO. Images of combustion safety testing are provided in Figure B-9.

Corroded furnace vent

Corrosion inside gas furnace

Horizontal furnace vent run in crawlspace

Kinked gas line to furnace

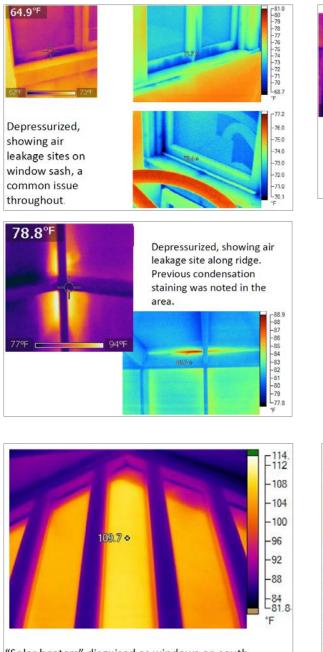
| Figure B-11. Infr | rared Inspection | of Berkeley Home |

"Solar heaters" disguised as windows on south gable wall at high solar noon.

Depressurized, showing air leakage sites on boarded ceiling, a common issue throughout.

Normal pressures (top) and depressurized (bottom), showing uninsulated area on first floor and associated air leakage from crawlspace.

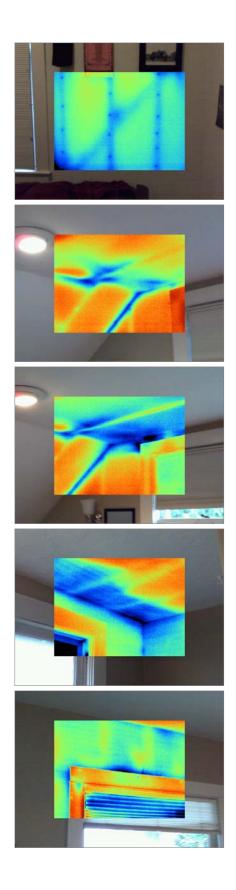
Insulation void in ceiling

Air leakage at wall plate

Uneven insulation in blocked wall

Cold spots in ceiling

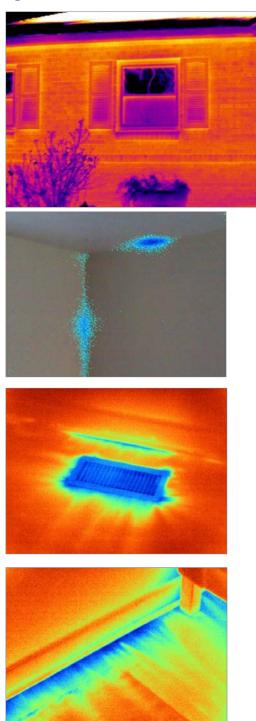
Figure C-10. Infrared Pictures of Seattle Site

Front of house showing uninsulated masonry wall

Insulation defects causing thermal bridging

Duct leakage-induced air infiltration at supply register

Blower door-induced air infiltration at sill plate

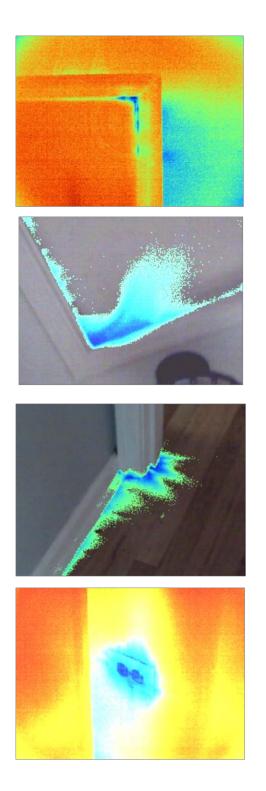
Blower door-induced infiltration at front door

Blower door-induced infiltration at attic hatch

Blower door-induced air leakage from crawl space on interior wall

Blower door-induced air leakage at electrical outlet
