NIST GCR 17-014

A Study on the Effect of Repeat Moderate Intensity Radiant Exposures on SCBA Facepiece Properties

July 2017

**A study on the effect of repeat moderate intensity
radiant exposures on SCBA facepiece properties**

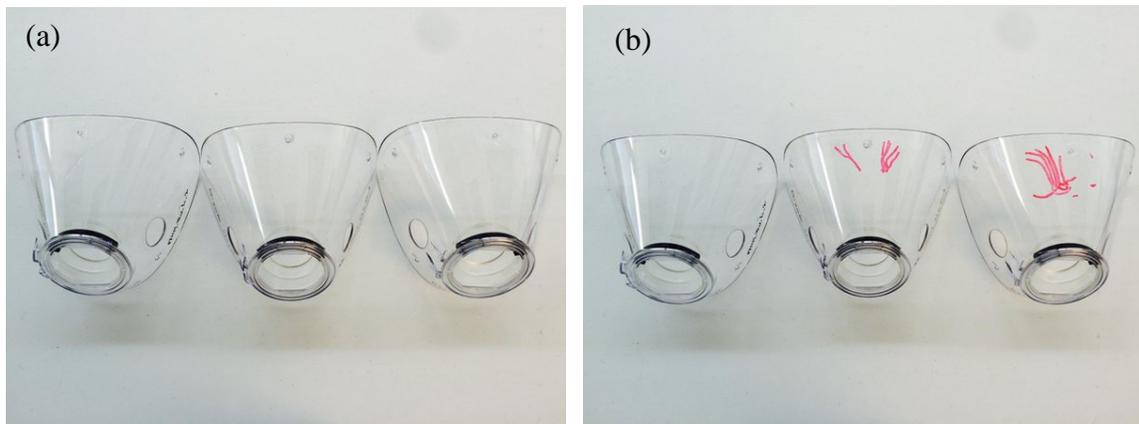
the facepieces that received a single exposure to 5 kW/m^2 flux were not visibly impacted. However, repeated exposures resulted in surface microcracks that began to appear at approximately 5-7 cycles and continued to grow through the exposures. While 3 separate masks were exposed to the 5 kW/m^2 exposure for 100 cycles, the damage never evolved past surface microcracking. The formation of bubbles that were sometimes identified by Putorti et al. at 5 kW/m^2 for a single 20 minute exposure did not occur in repeated exposures. Hole formation was also not experienced at the 5 kW/m^2 exposure level. Figure 18a shows visible light images of SCBA facepieces after 1, 10, and 100 5-minute exposures at 5 kW/m^2 . Damage is difficult to see with the naked eye from a distance. However, in Figure 18b, these indications of damage are highlighted after close inspection.

Figure 18: (a) SCBA facepiece exposed to 1, 10, and 100 cycles of 5 kW/m^2 . (b) Surface microcracking is highlighted by a marker.

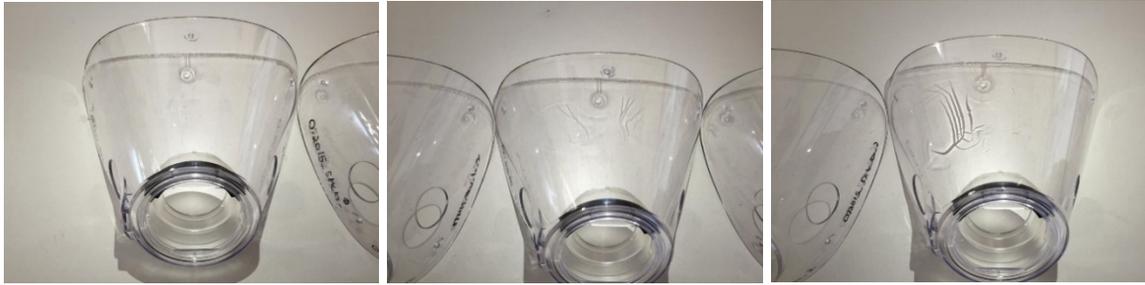
Figure 19: The same SCBA facepiece exposed to 1, 10, and 100 cycles of 5 kW/m², but imaged with a soft, broad illumination from a cell phone light, projecting a shadow of the damage on to a uniform, planar background.

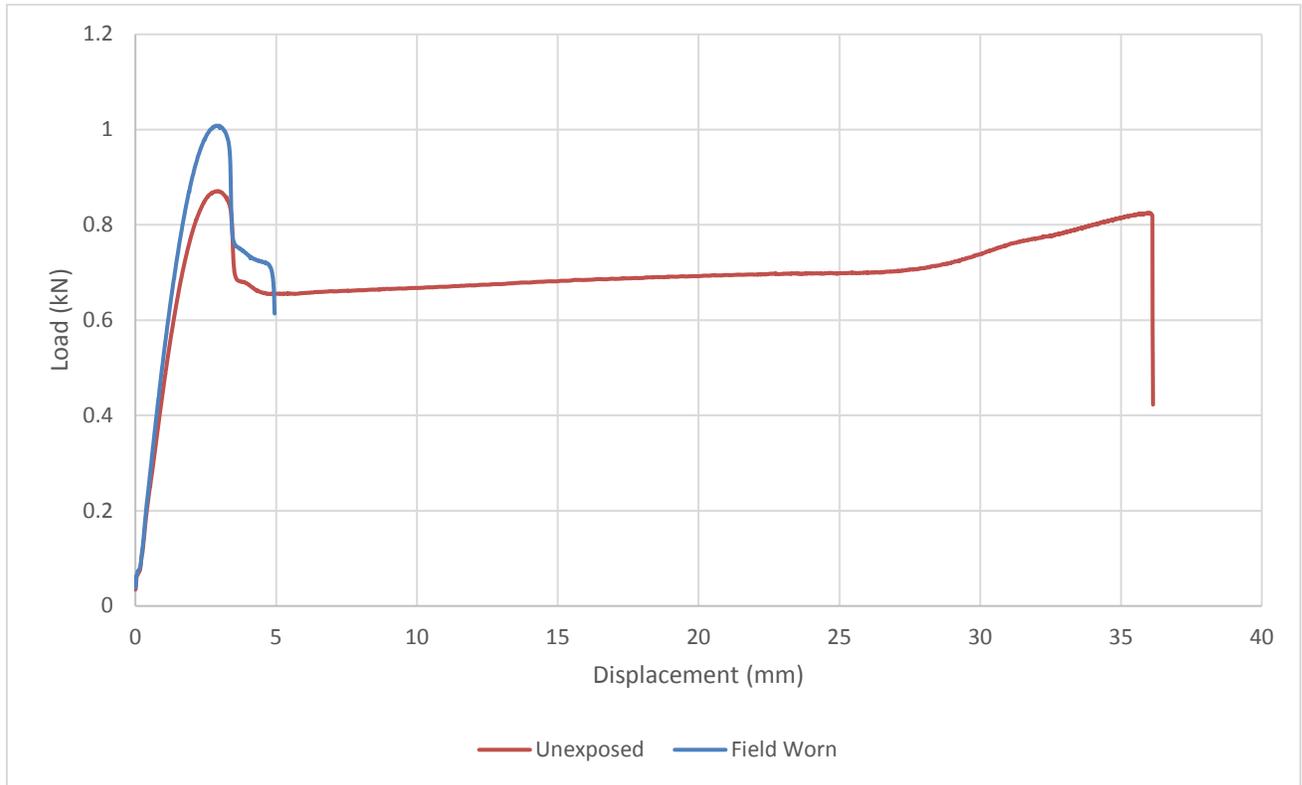
The measured reduction in ductility along with the increase in tensile strength suggests that the field worn samples and the central portion of the 100 cycle 5 kW/m^2 samples experienced an exposure that may have caused some level of embrittlement. These samples will absorb less energy prior to failure during a dynamic loading event. While the effect on the laboratory exposed samples are not quite as severe as the field worn samples, thermal degradation due to repeated exposures at levels well below the Lens Radiant Heat test are possible.

Figure 23: Load vs. Displacement for unexposed and field worn lens samples

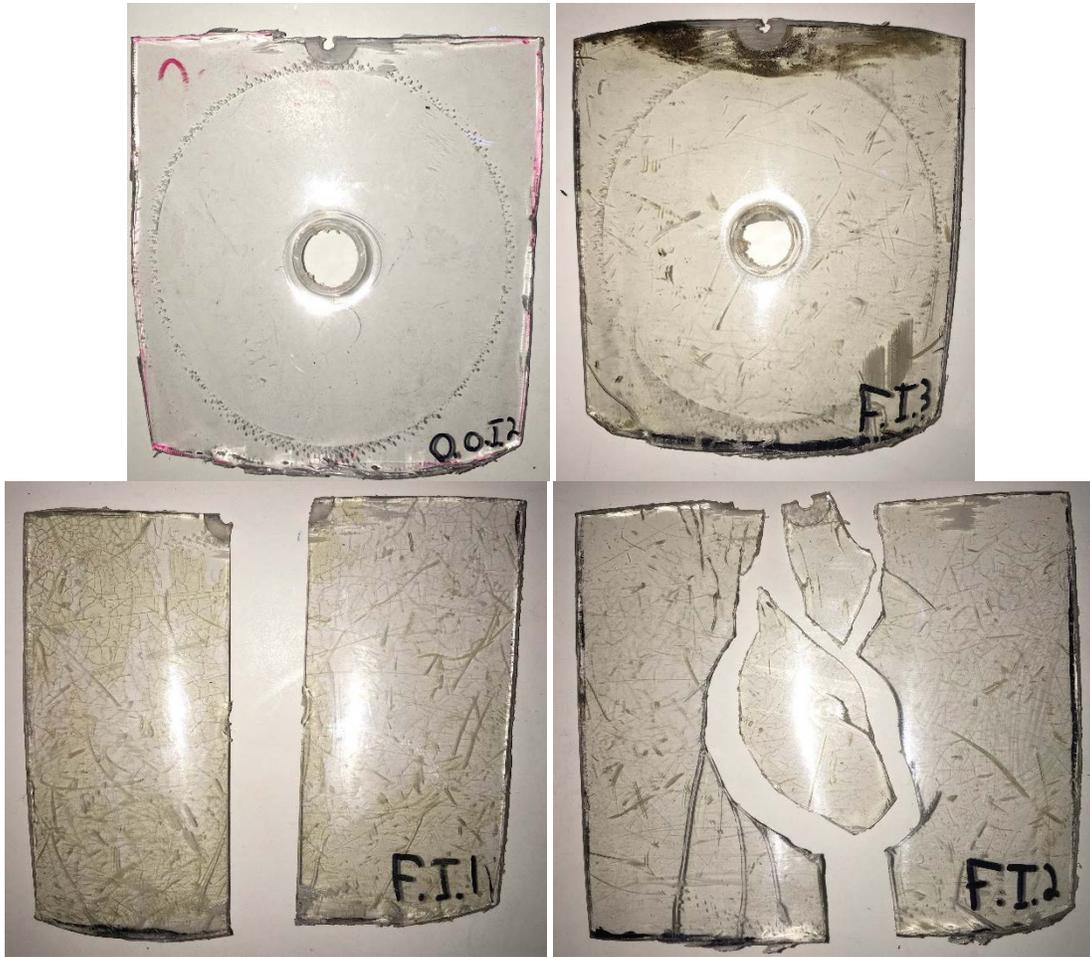
The variation in impact properties among the field worn samples may not be surprising, since the history of thermal exposures to these lenses cannot be accurately quantified. Qualitatively, the lenses that performed similarly to the unexposed samples had less visible thermal damage than those exhibiting decreased properties. Field samples 3-5 had minor surface cracking and abrasions, whereas samples 1 and 2 had subsurface cracking and severe crazing. Figure 25 shows the difference in post-impact damage between samples, as well as typical fracture patterns.

Figure 25: Impact specimen fracture patterns of samples extracted from the following lenses: unexposed (top left), surface damaged field worn (top right), thermally damaged field worn (bottom)

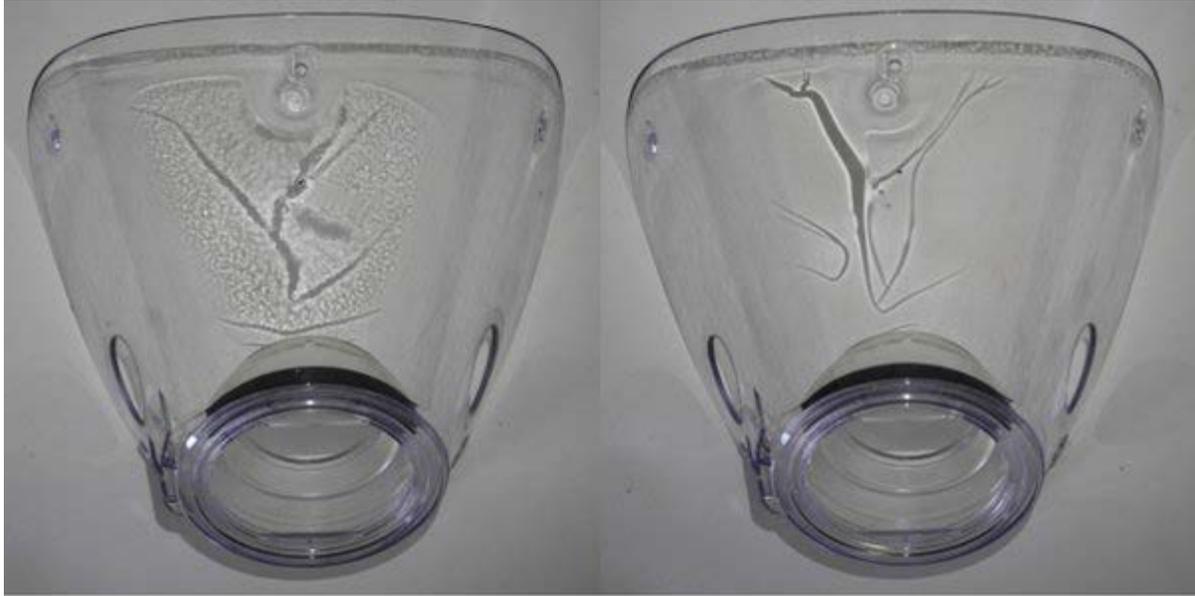
Figure 26: Post exposure damage for pilot samples exposed to short term (90 sec), high heat flux (10 kW/m^2). Mask on the left was rapidly cooled with a water mist, while that on the right cooled in ambient air.
