Investigations of Near-Edge Ballistic Impacts on Law Enforcement Body Armor

Kirk D. Rice, Amanda L. Forster, Michael A. Riley,
and Nicholas G. Paulter, Jr.

September 2014

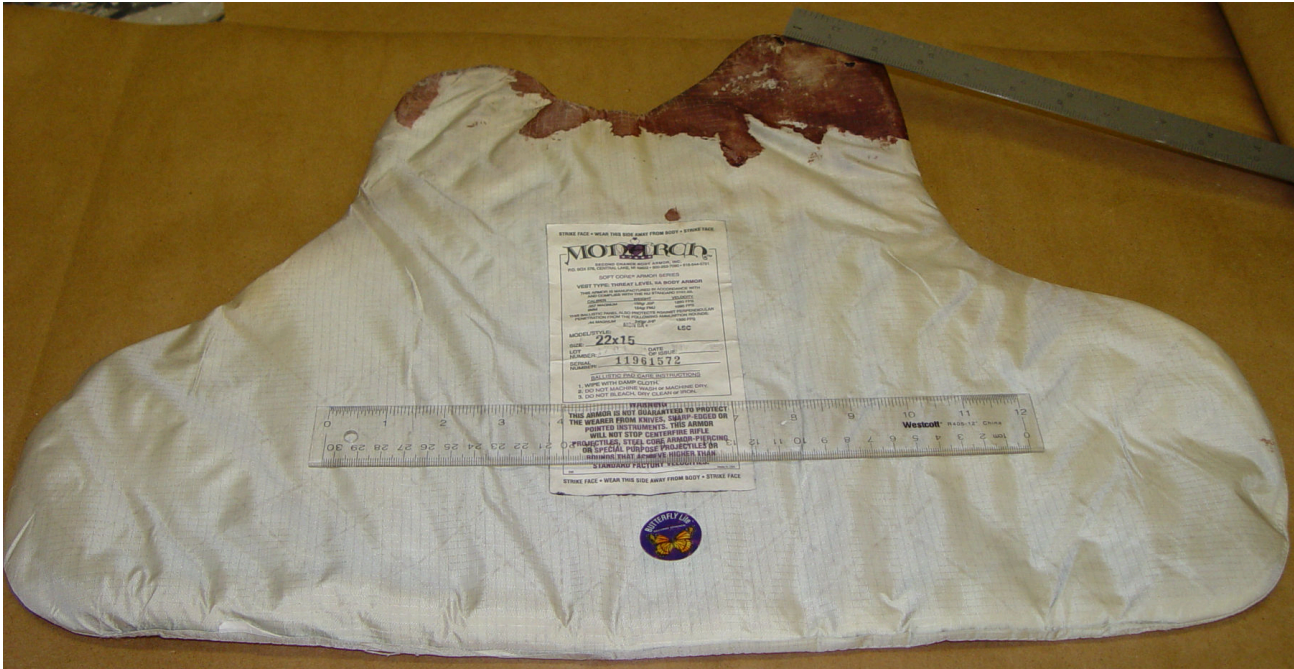
Figure 2.1: Strike Face (Front) of Panama City Beach Armor Ballistic Panel.

Although it was not documented in writing, it was understood from discussions with law enforcement personnel that the officer was leaning over to look into the vehicle at the time he was shot. The bullets impacted his armor high up on the left shoulder, between the neck scoop and where the armor terminates for the left arm. This can be observed in the photograph of the strike face of the armor panel in Figure 2.1.

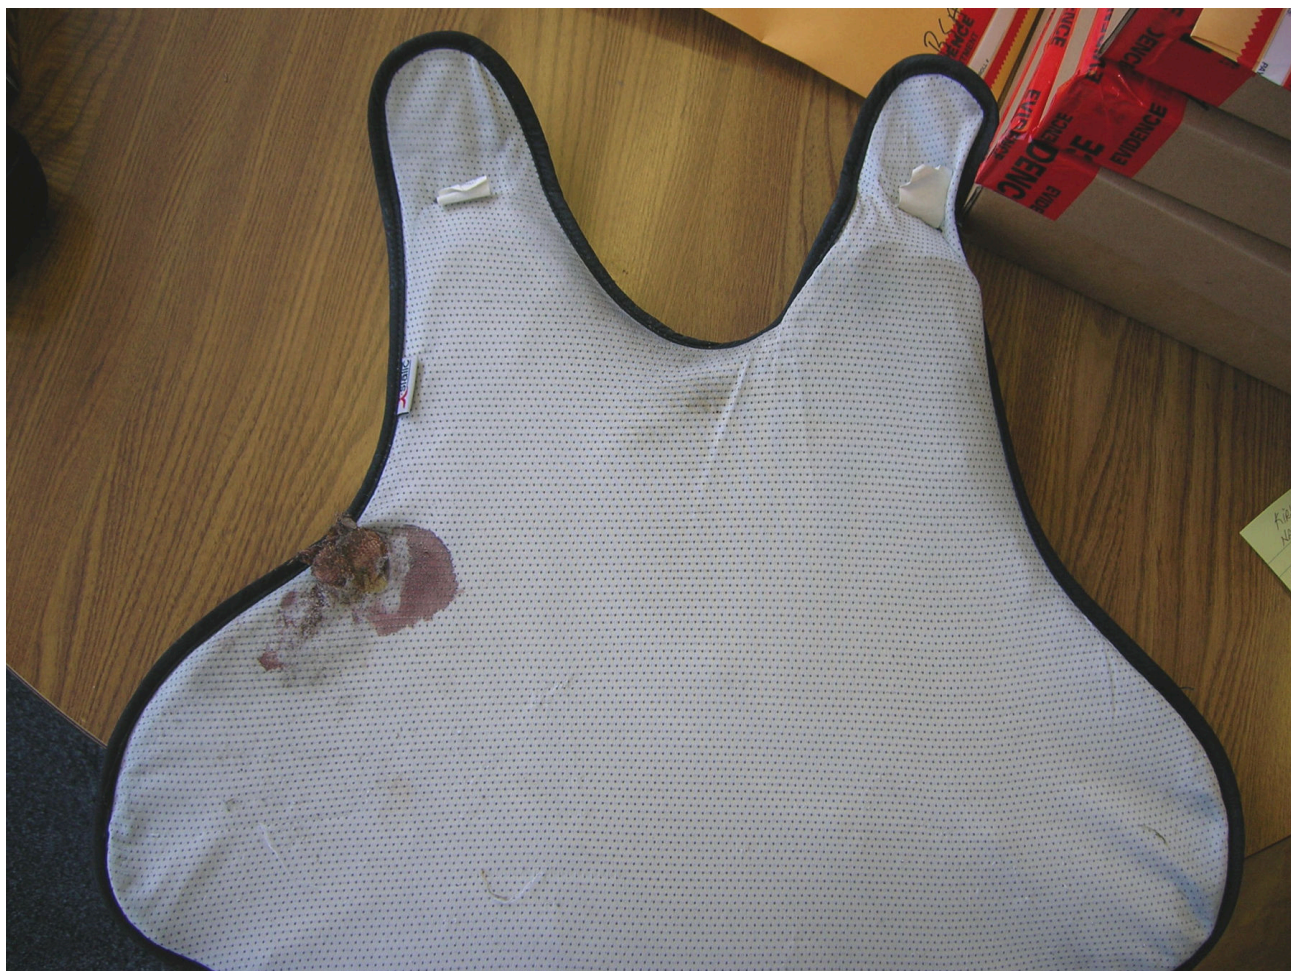
Figure 2.7: Body Side of Tampa Armor with Bullet Exit Hole Visible on Left Edge.
Photograph provided by Tampa Police Department

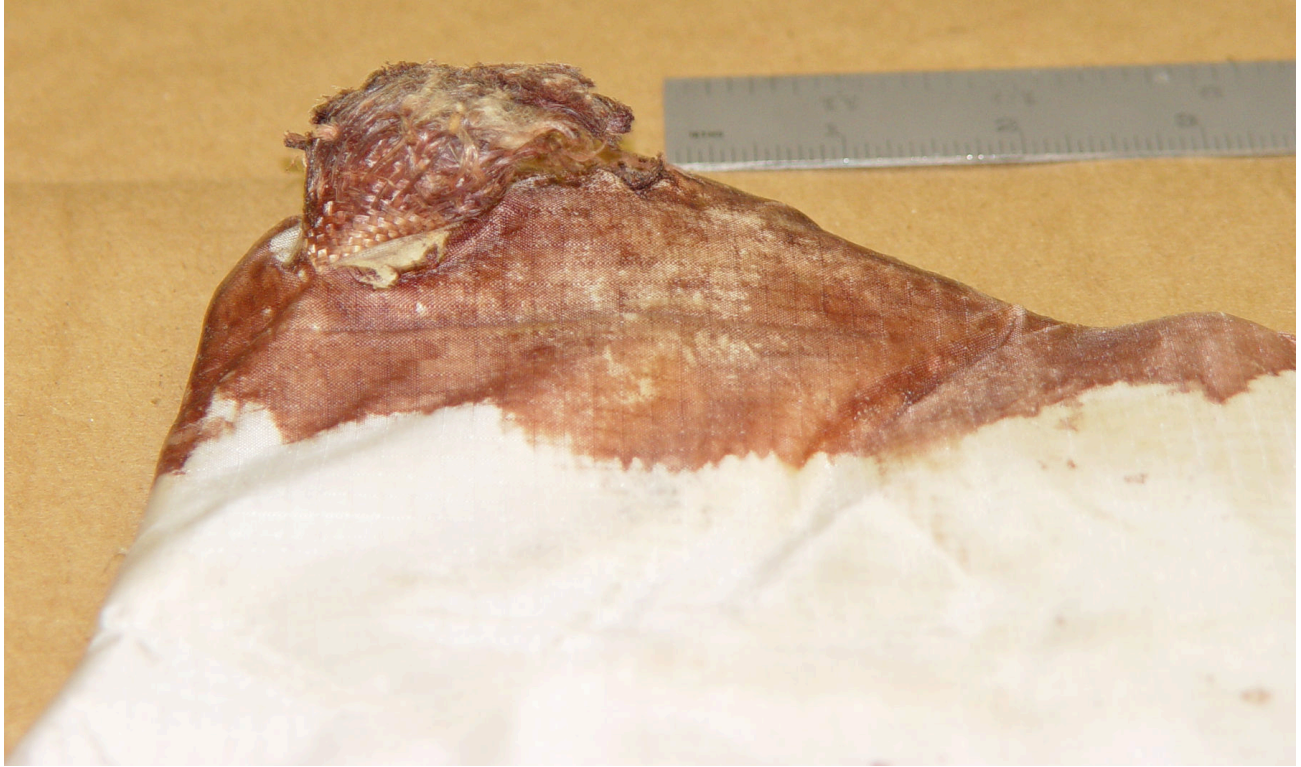
Figure 3.2: Exit Holes on Upper Left Shoulder of Panama City Beach Incident Panel.

The back of the incident panel revealed that the neck-side hole appeared to be relatively clean, with no indication of any material extruding out the back of the panel. The arm-side hole revealed a significant amount of extrusion, with a large tuft of ballistic fibers protruding, as can be observed in Figure 3.2. The extruded fiber lengths were generally between 13 mm (0.5 in) and 25 mm (1.0 in). The fibers formed a tightly clustered tuft of approximately 25 mm (1.0 in) diameter. The lack of any material extrusion from the neck-side hole suggests that little to no ballistic-resistant material was engaged by the bullet that perforated that location. When a perforation occurs in a typical laboratory test, ballistic-resistant material is driven rearward, causing some extrusion of the material through the armor panel cover and rupture of the panel cover. Evidence of ballistic-resistant material extrusion from the arm-side hole is an indicator that the bullet was engaged by the armor, but there appears to have been very little material available and a typical deformation cone would not have been able to form.

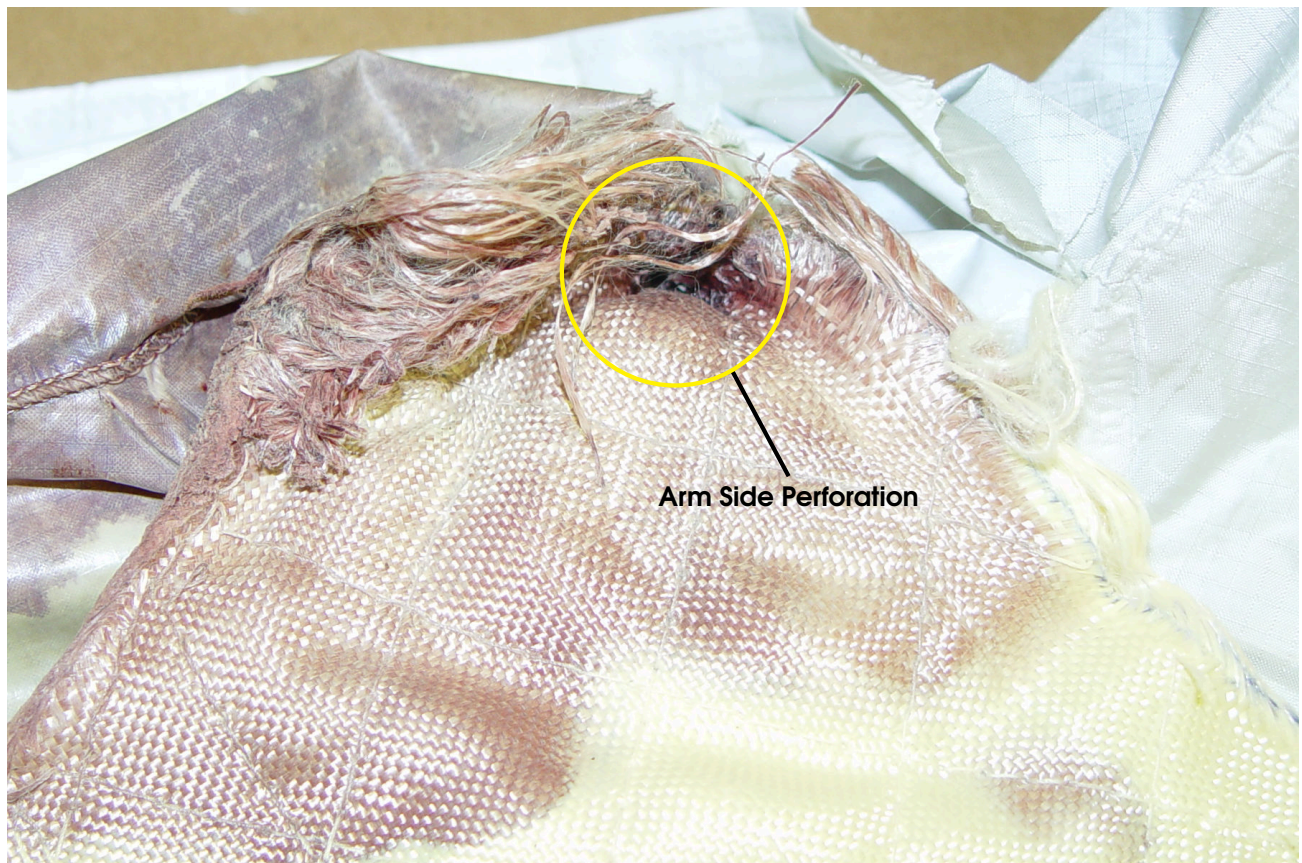
Figure 3.4: Damaged Area of Panama City Beach Incident Panel with Cover Removed.

Both shots were found to have engaged very little ballistic-resistant material that would have been bound together through the fabric weave and stitching used to construct the armor panel. Figure 3.4 shows how little ballistic-resistant material there was between the arm-side hole and the edge of the panel. A close examination of the arm-side hole revealed that the edge of the ballistic panel, proximal to the impact location, buckled and was extruded through the body side of the armor panel cover, allowing the bullet passage. The exact location of the neck-side hole in the ballistic-resistant material was difficult to determine with certainty, although it appears to have passed through the frayed and unraveled yarns at the extreme edge of the armor panel.

Generally, shots located very near an edge are unlikely to be stopped, simply because there is not enough ballistic fabric surrounding the impact location [34, 35]. This appears to be the condition that led to the perforations in this incident. The bullets that struck the armor engaged very little ballistic fabric, because they struck the armor panel at the extreme edge. There is no reasonable expectation that a conventional armor panel can perform satisfactorily when impacted in this region; therefore, the perforation of the armor at this location is not surprising.

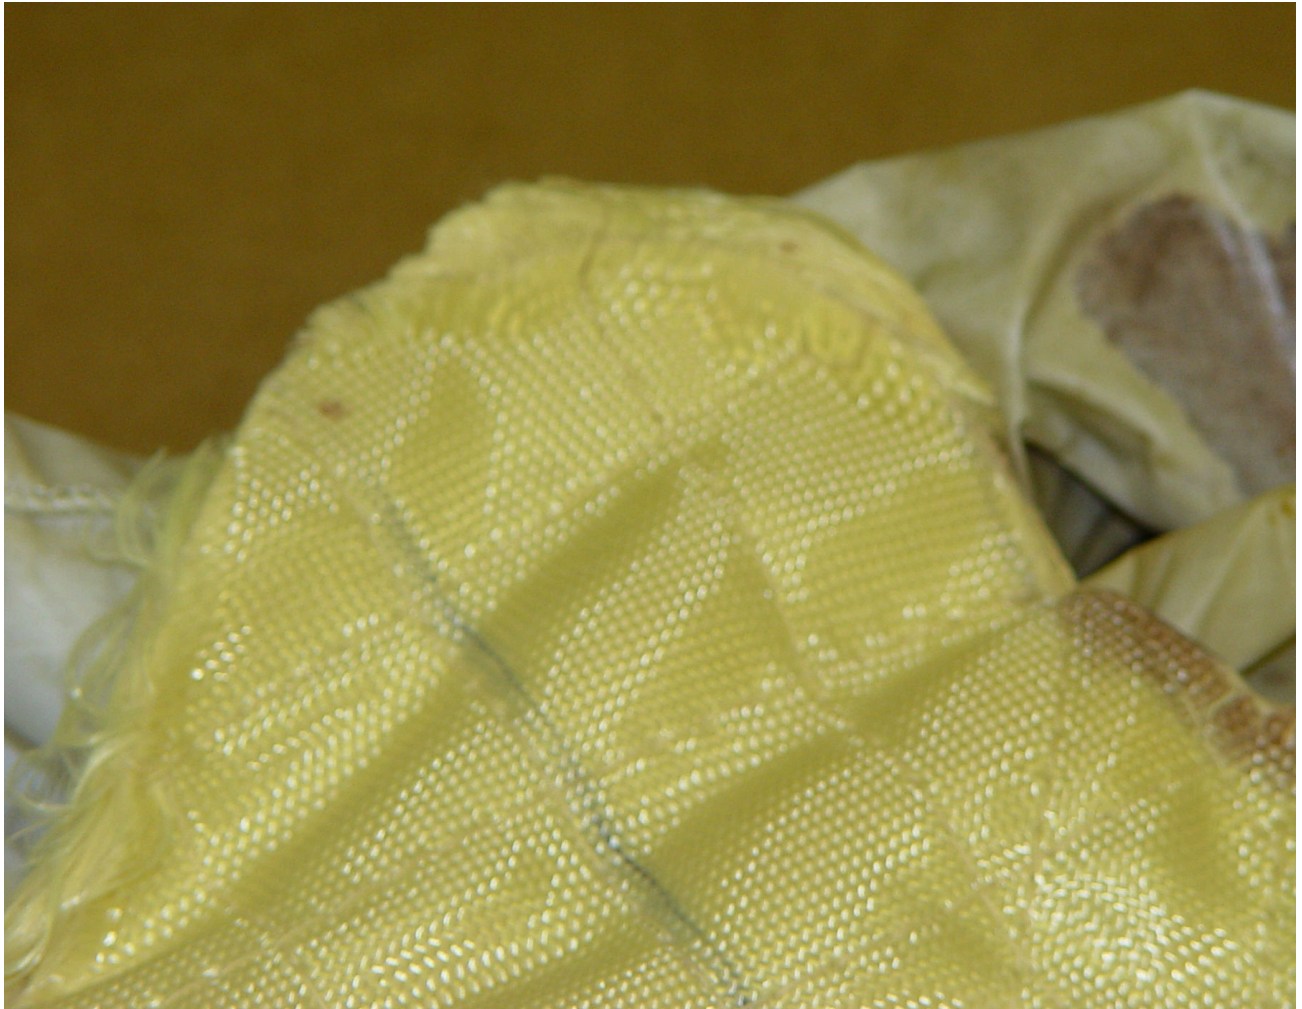
Figure 3.5: Unraveled Material on Panama City Beach Incident Panel Right Shoulder.

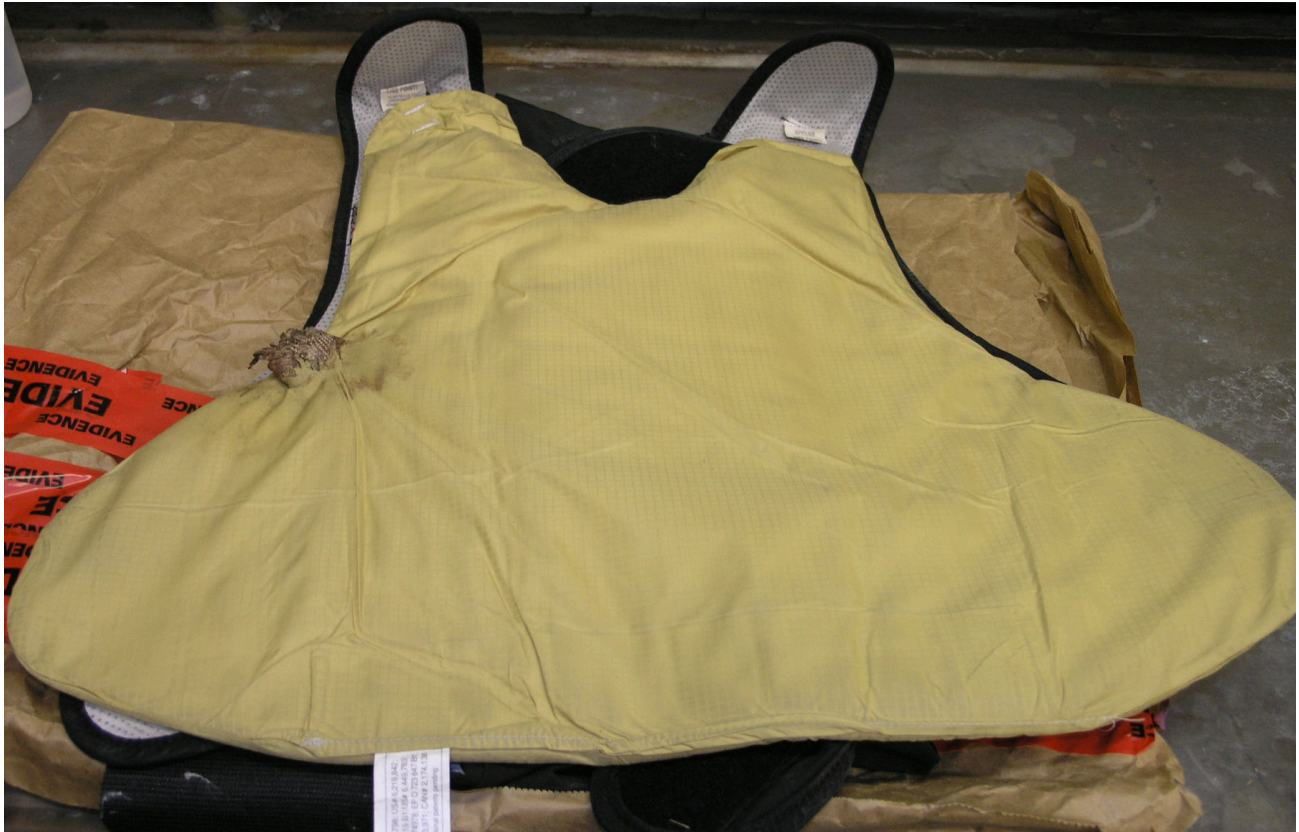
Figure 3.9: Body Side of Tampa Incident Panel with Bullet Exit Hole on Left Edge.

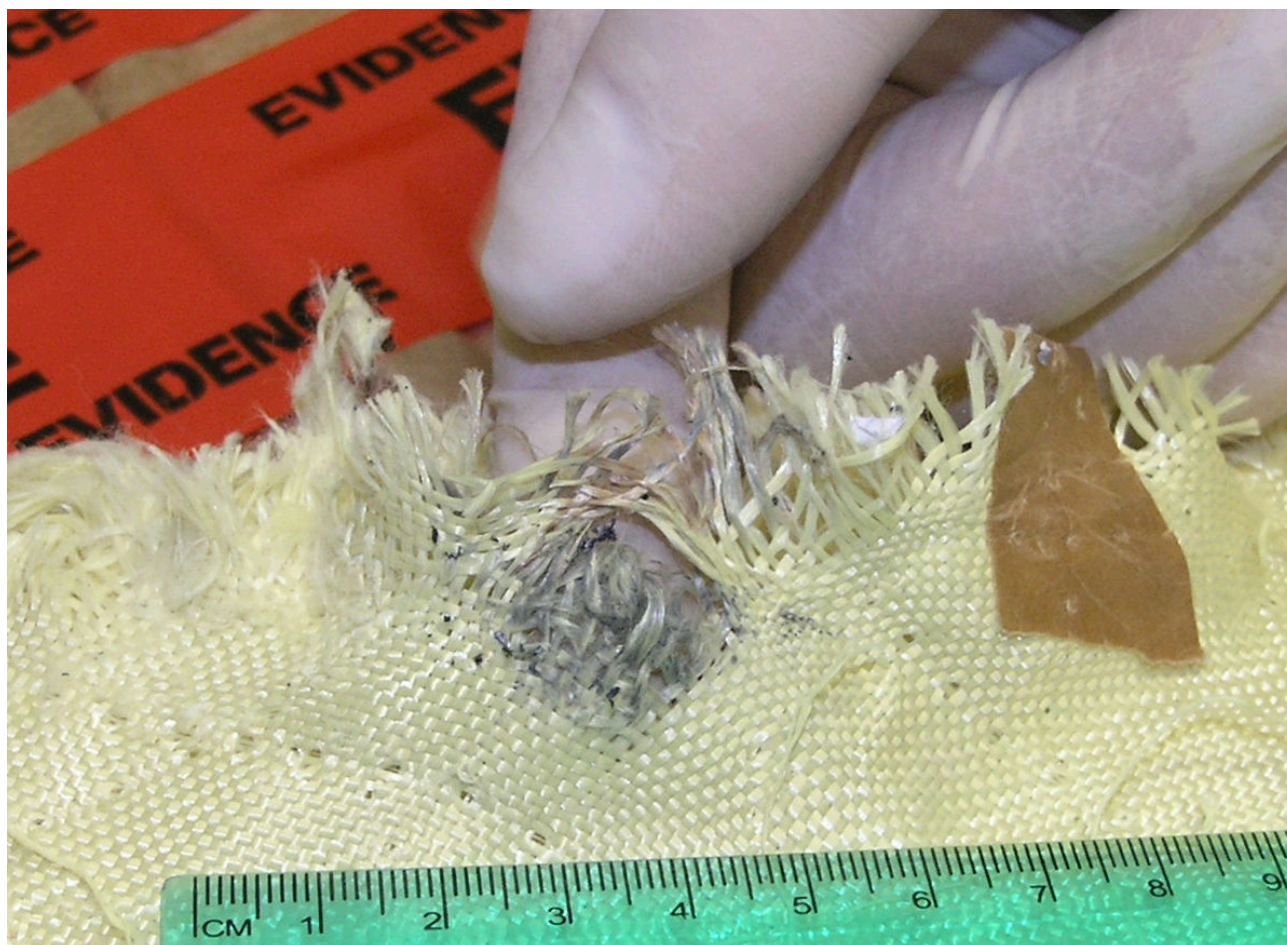
Figures 3.12 and 3.13 show the strike face (layer 1), with the ballistic-resistant material pulled flat to expose the bullet impact location. As shown in the photographs, only a small amount of woven material was available to stop or deflect the bullet at the bullet impact location. In Figure 3.13, the first layer of the ballistic-resistant material (the strike face) is separated from the underlying layers to expose the location where the bullet contacted the armor. Penetration into the first few layers is to be expected, and this type of damage is typical of

Figure 3.13: Incidence Location on Layer 1 of the Tampa Ballistic Material.
