NISTIR 8077

Investigation of PMU Response to Leap Second: 2015

August 2015

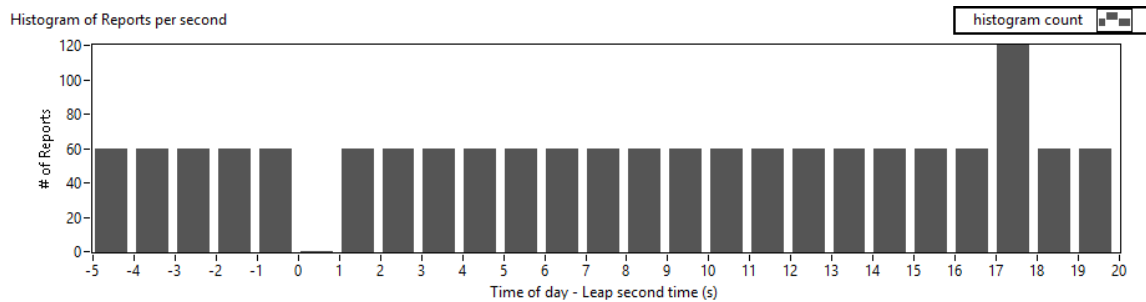
Figure 3: PMU ID1 Histogram of reports per SOC

Summary of PMU ID 1 Response: SOC 1435708799 never repeats (there is no TOD 23:59:60 represented). SOC 1435708816 repeats, so the SOC is unsynchronized with UTC for 17 seconds after the leap second occurs and becomes synchronized thereafter. PMU 1 did not set any time quality flag bits.

Figure 3 shows a histogram of the number of reports per TOD second versus TOD relative to the leap second for PMU ID1. There were no reports during the leap second, TOD 23:59:60. The SOC repeated 17 seconds after the start of leap second so there are 120 reports during that SOC.

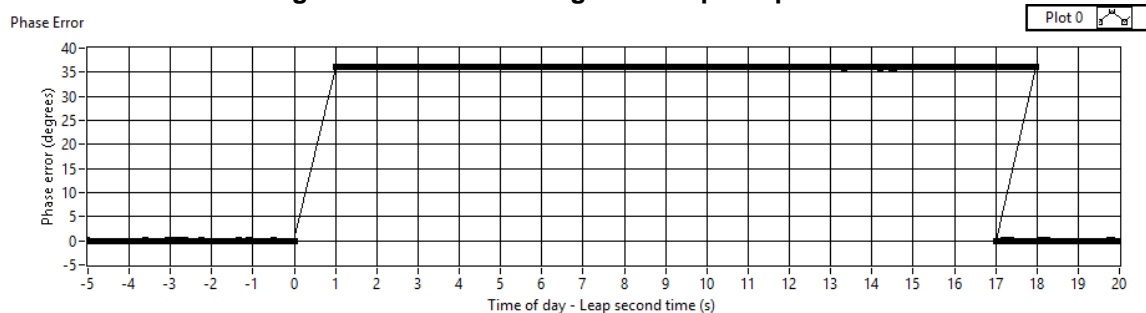
Figure 4: PMU ID 1 Phase Error at 59.9 Hz system frequency

Figure 4 shows the phase error in degrees for PMU ID 1. When each PMU report is aligned and compared with the actual input phase at the time of the PMU timestamp, the plotted phase errors result. The input signal was set to a steady state power system frequency of 59.9 Hz. Since the synchrophasor rotates at 36 degrees per second, a one-second error in reporting time will result in a 36 degree error in phase. There are no data between 0s and 1s because the PMU did not output any reports with a repeated SOC 1435708799 (TOD 23:59:60). There are two sets of data for the TOD from leap second (LS) +17 to +18 seconds.

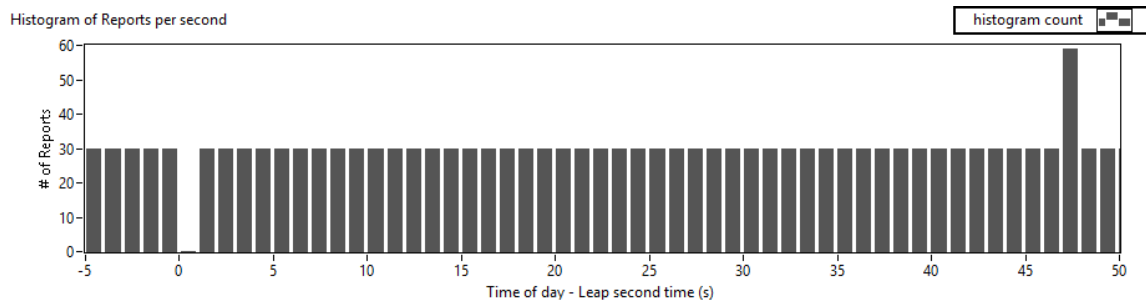
Figure 5: Histogram of Reports per SOC for PMU ID 2

Summary of PMU ID 2 Response: PMU did not repeat SOC 1435708799 and remained 1 second ahead of UTC for 47 seconds after leap second occurs, then returns to synchronization thereafter. No Time Quality bits were set.

Figure 5 shows a histogram of the number of reports per TOD second versus TOD relative to the leap second for PMU 2. There were no reports for Time of Day 23:59:60 because the PMU did not repeat the LS SOC. The SOC repeated the SOC 47.0 seconds after the start of leap second, so there are 60 reports during that time. Note that PMU ID 2 was configured for reporting rate of 30 frames per second.

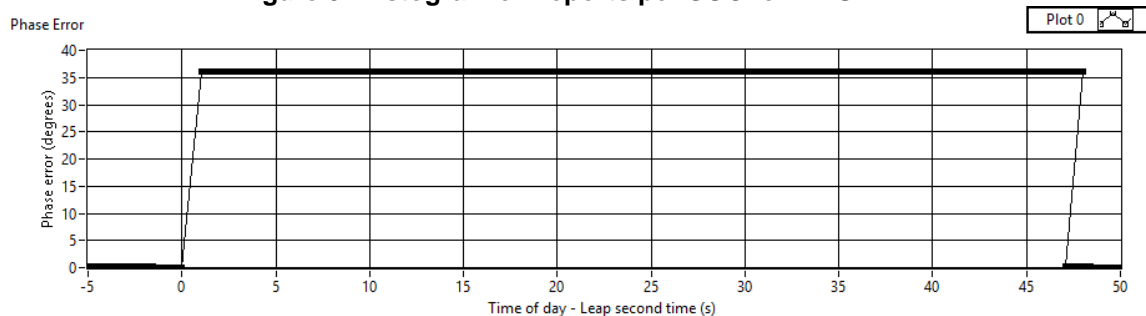
Figure 6: PMU ID 2 Phase Error

Figure 6 shows the phase error in degrees for PMU ID 2. When each PMU report is aligned and compared with the actual input phase at the time of the PMU timestamp the plotted phase errors result. The input signal was set to a steady state power system frequency of 59.9 Hz. Since the synchrophasor rotates at 36 degrees per second, a one-second error in reporting time will result in a 36 degree error in phase. There are no data between 0s (LS) and LS + 1s because the PMU did not output any reports with a repeated SOC 1435708799 (TOD 23:59:60). There are two sets of data for the time from LS + 47 to LS + 48 seconds.

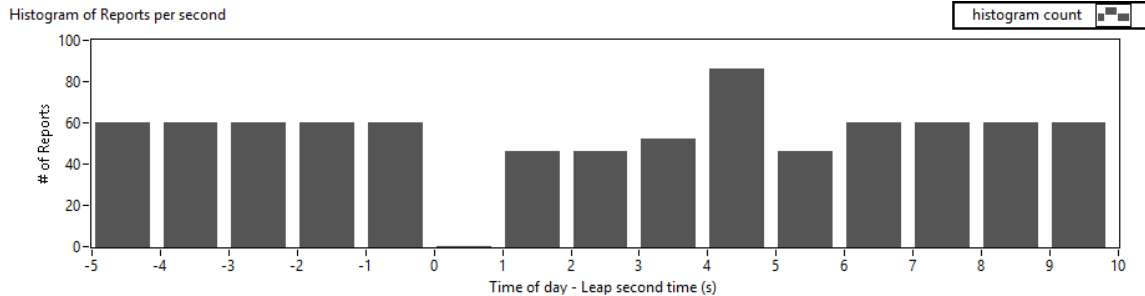
Figure 7: Histogram of reports per SOC for PMU ID 3

Summary of PMU ID 3 Response: PMU did not repeat SOC 1435708799; the Pending and Occurred bits are set at incorrect times; SOC was one second ahead of UTC for 4 seconds, then portions of SOC 1435708802 and 1435708802 are repeated; following the leap second, some SOC's had only 46 rather than 60 reports per second; the PMU continues to sporadically output 46 reports per second while primarily outputting 60 reports per second.

Figure 7 shows a histogram of the number of reports per TOD second versus TOD relative to the leap second for PMU ID 3. There were no reports during TOD 23:59:60 because the PMU did not repeat the LS SOC. Beginning one second after the leap second, the PMU only transmitted 46 reports for the following 3 seconds. However, following 00:00:03.8833, the PMU SOC skipped back to 00:00:02.9000; thus for 00:00:02 there were 50 reports but 4 of them occurred 1 second later. The SOC 00:00:03 had 88 reports (2 seconds worth of 46 reports per second minus the four reports from 00:00:02), then 00:00:04 had 46 reports. After that there were 60 reports per SOC for a while but the PMU began to sporadically output 46 reports per SOC for the following 8 days. After 8 days, the PMU was power cycled but continues to sporadically output 46 reports per SOC with 14 reports missing.

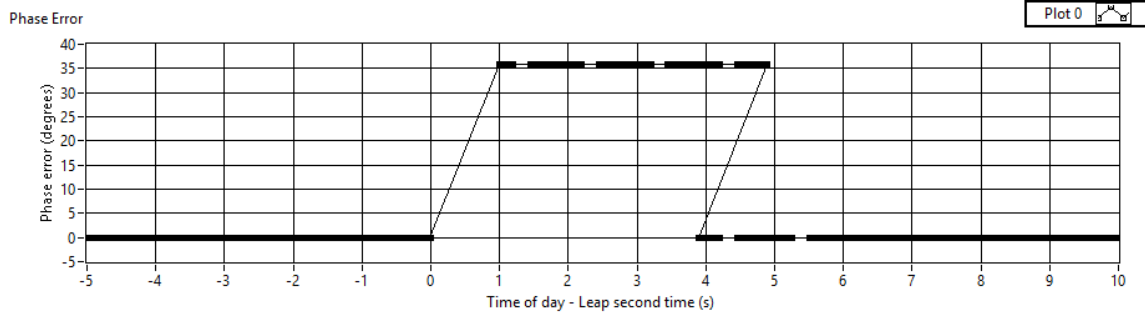
Figure 8: PMU ID 3 Phase Error

Figure 8 shows the phase error in degrees for PMU ID 3. When each PMU report is aligned and compared with the actual input phase at the TOD of the PMU timestamp the plotted phase errors result. The input signal was set to a steady state power system frequency of 59.9 Hz. Since the synchrophasor rotates at 36 degrees per second, a one-second error in reporting time will result in a 36 degree error will result in phase. Note that there are no data between 0s and 1s because the PMU did not repeat the LS SOC. There are two sets of data for the time from LS + 2.900 to LS + 4.900 seconds. Also, note also that there are gaps in the data from those seconds where only 46 reports were output.

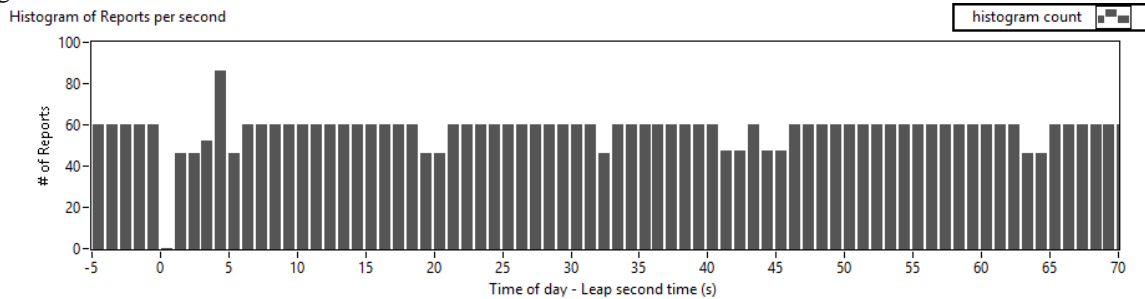
Figure 9: Histogram of reports per SOC for PMU ID 3 showing sporadic lost reports

Figure 9 shows how PMU 3 sporadically outputs 46 reports during some SOCs. The PMU continues to do this even though it has been shut down and re-started.

†† PMU ID 3 Beginning at the leap second and continuing at the time of writing, PMU ID 3 has sporadic periods where there are only 46 reports during a second. 14 reports are missing during these seconds.

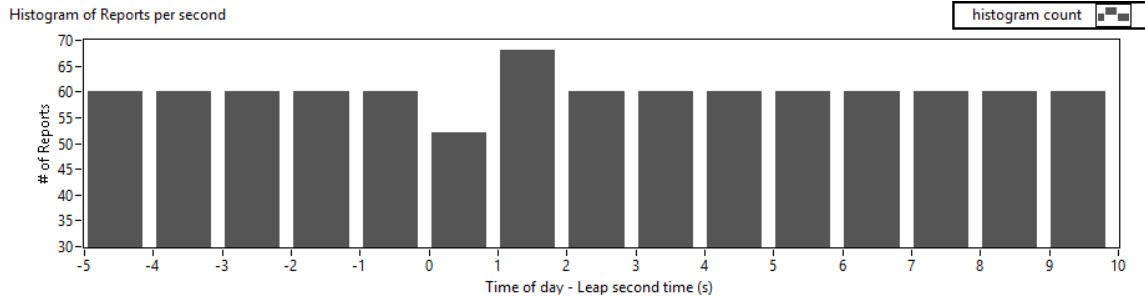
Figure 10: Histogram of reports per SOC for PMU ID 4

Summary of PMU ID 4 Response: SOC 1435708799 did not repeat immediately after TOD 23:59:59. After 8 reports with SOC 1435708800 (TOD 00:00:00) SOC changed back to 1435708799 (TOD 23:59:60); so for 0.15 seconds, the SOC was one second ahead of UTC. There were 52 reports during TOD 23:59:60. The leap second Pending flag was reset and the Occurred flag was set at 1.333 seconds after the leap second.

Figure 10 shows a histogram of the number of reports per TOD second versus TOD relative to the leap second for PMU ID 4. At the time of the leap second, instead of reporting TOD 23:59:60, the PMU rolled over to 00:00:00 for 8 reports then skipped back to 23:59:60.1333. There were 68 reports for TOD 00:00:00 and 52 reports for TOD 23:59:60 (8 of which occurred at the incorrect time).

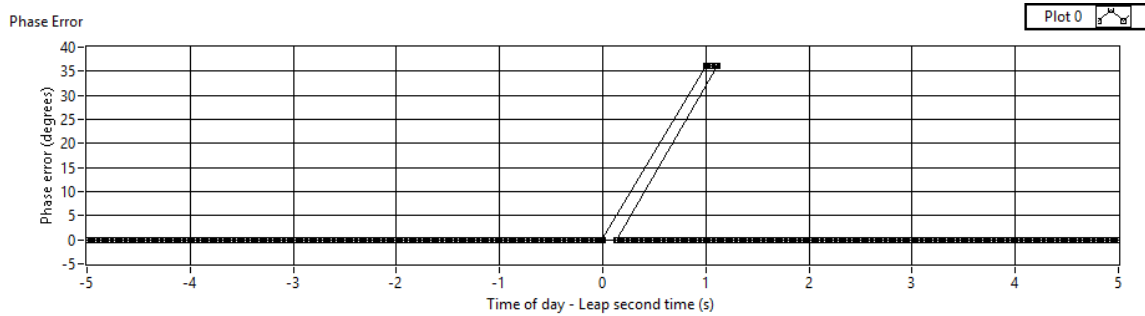
Figure 11: PMU ID 4 Phase Error

Figure 11 shows the phase error in degrees for PMU ID 4. When each PMU report is aligned and compared with the actual input phase at the time of the PMU timestamp the plotted phase errors result. The input signal was set to a steady state power system frequency of 59.9 Hz. Since the synchrophasor rotates at 36 degrees per second a one-second error in reporting time will result in a 36 degree error in phase. Note that there are no data between 0.0000 s and 0.1667 s because the PMU rolled over to 00:00:00 (1 second after Leap Second). After 7 reporting periods, the SOC skipped back to UTC time at 23:59:60.1667. There are two sets of data for the relative LS + 1.000 s to LS + 1.1667 s.

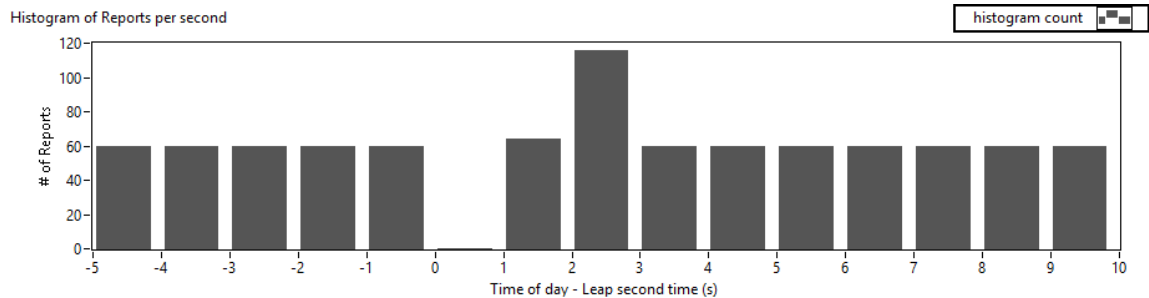
Figure 12: Histogram of reports per SOC for PMU 5

Summary of PMU ID 5 Response: LS bits did not get set. SOC 1435708799 did not repeat following TOD 23:59:59 and remained one second ahead of UTC for 1.933 seconds after LS but gets synchronized thereafter.

Figure 12 shows a histogram of the number of reports per TOD second versus TOD relative to the leap second for PMU ID 5. There are no reports for TOD 23:59:60 because the PMU did not repeat the LS SOC. The PMU rolled back the SOC by 1 second at 1.9333 seconds after LS so there are 64 reports for TOD 00:00:00 and 116 reports for TOD 00:00:01.

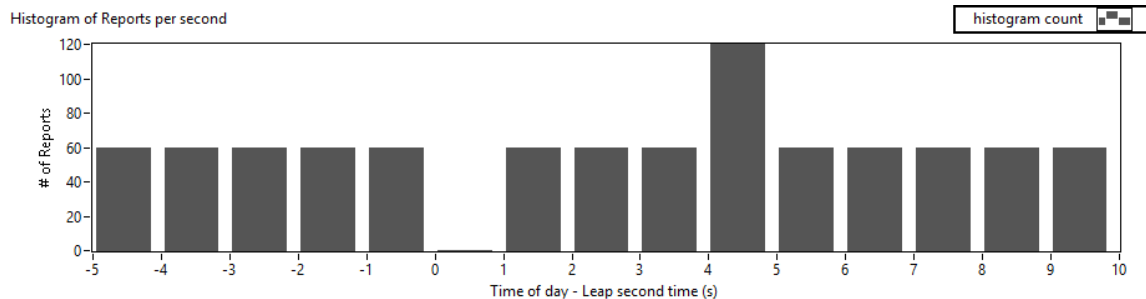
Figure 13: Histogram of reports per SOC for PMU ID 6

Summary of PMU ID 6 response: LS bits do not get set. SOC did not repeat after TOD 23:59:59 and remained 1 second ahead of UTC for 4 seconds after LS but gets synchronized thereafter.

Figure 13 shows a histogram of the number of reports per TOD second versus TOD relative to the leap second for PMU ID 6. The SOC repeated 4 seconds after the leap second so there are no reports for TOD 23:59:60 and 120 reports for TOD 00:00:03.

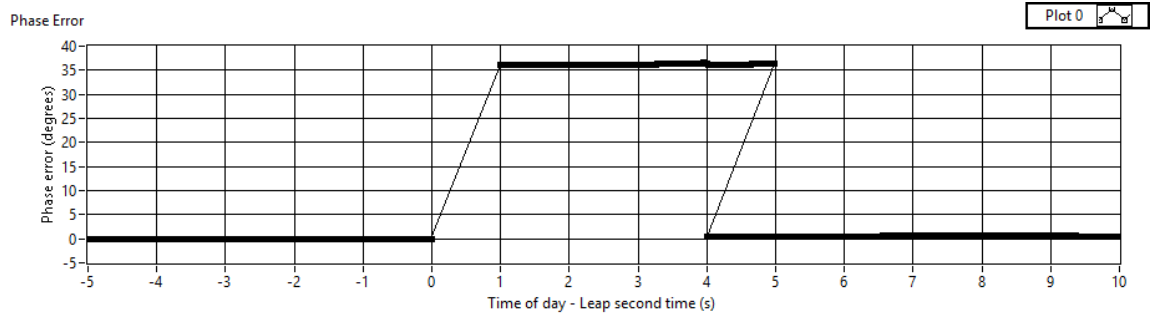
Figure 14: PMU ID 6 Phase Error

Figure 14 shows the phase error in degrees for PMU ID 6. When each PMU report is aligned and compared with the actual input phase at the time of the PMU timestamp the plotted phase errors result. The input signal was set to a steady state power system frequency of 59.9 Hz. Since the synchrophasor rotates at 36 degrees per second, a one-second error in reporting time will result in a 36 degree error in phase. Note that there are no data from LS to LS + 1 s because the PMU did not repeat the LS SOC. There are two sets of data for the LS + 4 to LS + 5 seconds.

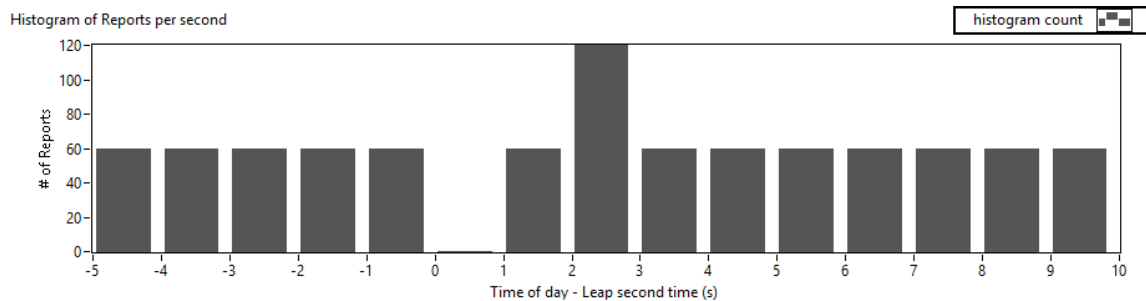
Figure 15: Histogram of reports per SOC for PMU ID 7

Summary of PMU ID 7 Response: LS flags do not get set. SOC did not repeat after TOD 23:59:59 and remained 1 second ahead of UTC for 2 seconds after LS but gets synchronized thereafter.

Figure 15 shows a histogram of the number of reports per TOD second versus TOD relative to the leap second for PMU ID 7. At 2 seconds after the LS, SOC repeats so there are no reports for TOD 23:59:60 and 120 reports for TOD 00:00:01

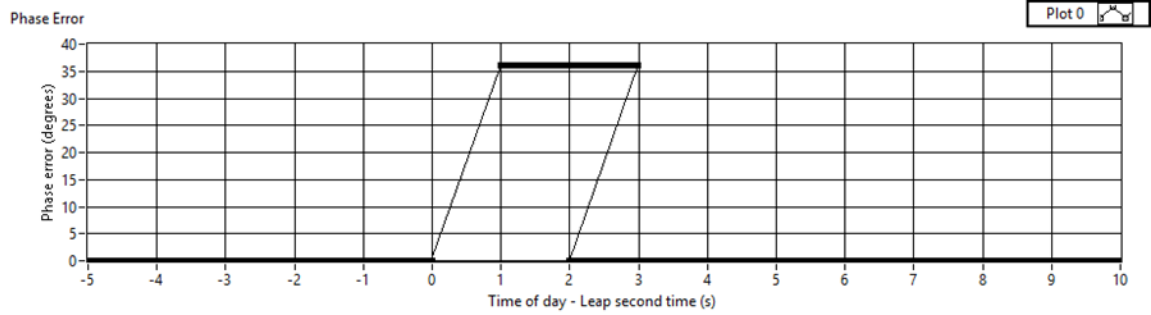
Figure 16: PMU ID 7 phase error

Figure 16 shows the phase error in degrees for PMU ID 7. When each PMU report is aligned and compared with the actual input phase at the time of the PMU timestamp the plotted phase errors result. The input signal was set to a steady state power system frequency of 59.9 Hz. Since the synchrophasor rotates at 36 degrees per second, a one-second error in reporting time will result in a 36 degree error in phase. Note that there are no data from LS to LS + 1 s because the PMU did not repeat the LS SOC. There are two sets of data for the LS + 2 s to LS + 3 s.

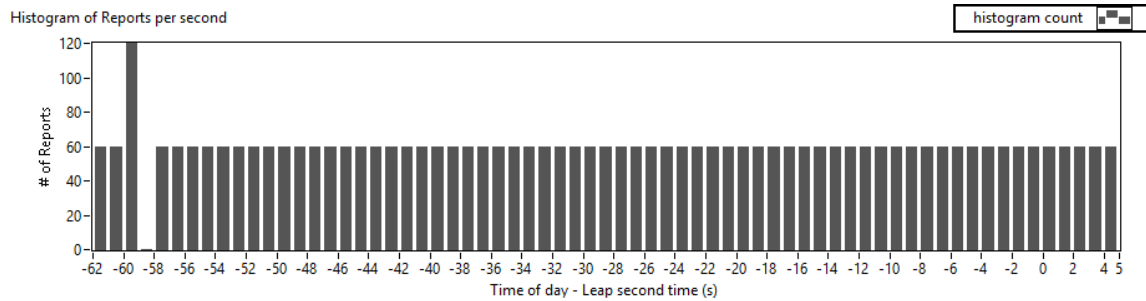
Figure 17: Histogram of reports per SOC for PMU ID 8

Figure 17 shows a histogram of the number of reports per TOD second versus TOD relative to the leap second for PMU ID 8. PMU ID 8 repeated TOD 23:59:00 at 59 seconds before the leap second then skipped forward from TOD 23:59:00.9833 to TOD 23:59:02.0000. This may be a result of the IRIG LSP having been set 1 second early. There are 120 reports for the second beginning one minute before leap second and none during the following second. Furthermore, PMU ID 8 did not skip back to TOD 23:59:60 at the appropriate time but rather skipped back by 2 seconds at one second after the leap second. At the end of the TOD 23:59:60 reports, the PMU then skipped ahead by one second to TOD 00:00:01.

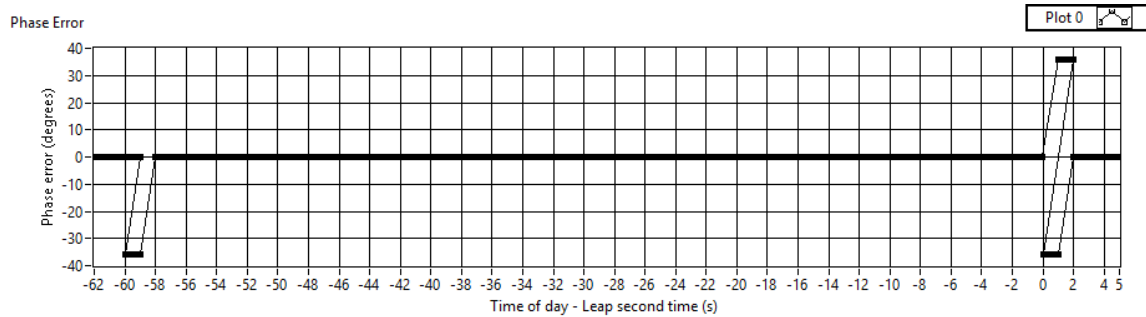
Figure 18: PMU ID 8 Phase Error

Figure 18 shows the phase error in degrees for PMU ID 8. When each PMU report is aligned and compared with the actual input phase at the time of the PMU timestamp the plotted phase errors result. The input signal was set to a steady state power system frequency of 59.9 Hz. Since the synchrophasor rotates at 36 degrees per second, a one-second error in reporting time will result in a 36 degree error in phase. The phase error plot shows the effect of skipping back by one second at relative LS - 59 seconds, then skipping ahead one second later. During the leap second, the histogram shows that there were 60 reports per second, but the phase error plot shows that for 2 seconds after LS the timestamps reported were incorrect. The reports from the time of leap second to 1 second after were actually taken 1 second late, thus there was a -36 degree error, then the SOC skipped ahead by 2 seconds causing one second of +36 degree error before returning back to synchronization with UTC.
