Interim Report on the Examination of Corrosion Damage in Homes Constructed With Imported Wallboard: Examination of Samples Received September 28, 2009

**D. J. Pitchure, R. E. Ricker,
M. E. Williams, and S. A.
Claggett**

Metallurgy Division,
Materials Science and
Engineering Laboratory,
National Institute of Standards
and Technology,
Gaithersburg, MD 20899-8553

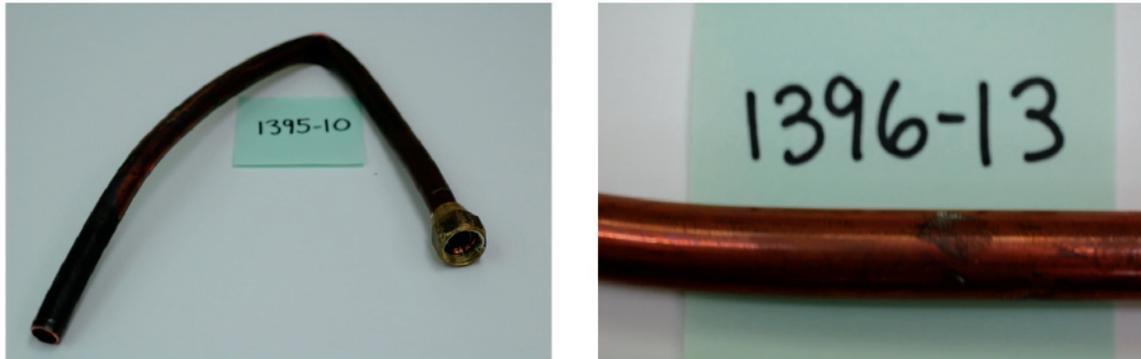
The lengths of copper tubing were discolored to varying degrees. This discoloration, which is illustrated in Fig. 1, was found to be due to the presence of a thin adherent layer of a black substance. This is clearly illustrated in Fig. 2 where the sample number has been scribed into the sample exposing fresh bare copper. The contrast in this figure is obvious. While this film adhered to the surface, physical contact would result in the transfer of a small quantity of a fine black powder from the film. In some cases, the discoloration was found to be very uniform, but in other cases it was irregular. The extent of discoloration varied with the thickness of the layer.

Fig. 1. Photographs of two representative samples of copper natural gas supply tubing.

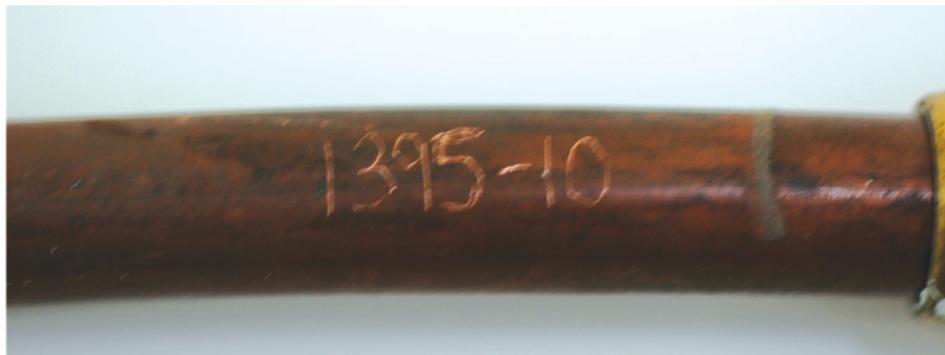
Fig. 2. Scribe marks illustrating the contrast between the color of bare copper and a sample of copper natural gas line tubing.

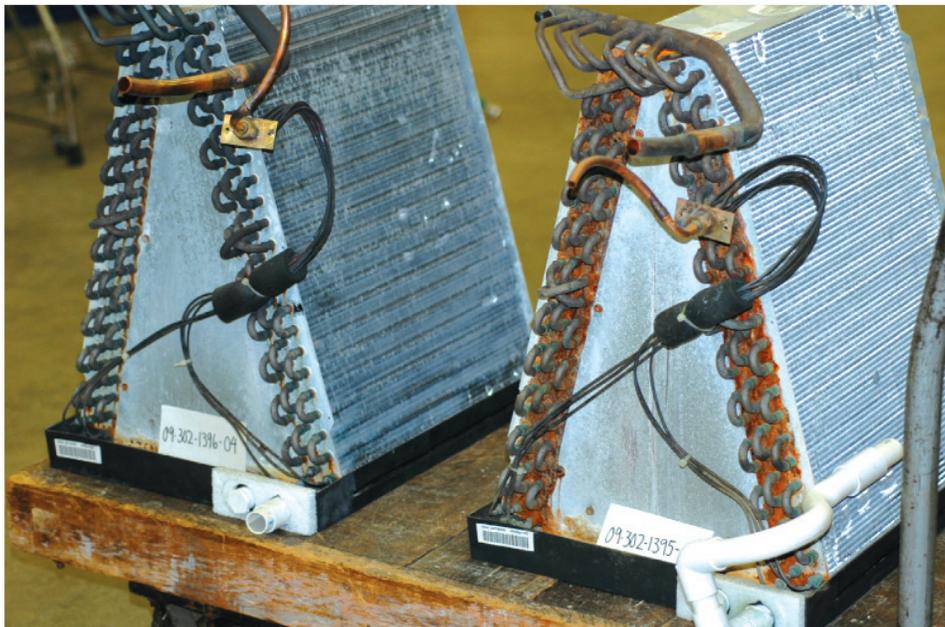
The air conditioner evaporator coils were also examined, Fig. 3. From the two coils in this figure it can be seen that all exposed copper surfaces have turned dark. These coils are constructed out of parallel lines of copper tubing placed through thin sheets of aluminum that serve as the heat transfer fins. The copper tubing is linked together by soldered U-bends to the ends of adjacent lengths of copper tubing. The end plates that hold this assembly in place are made out of galvanized steel. Copper manifolds and valves complete the assembly. Figure 4 is a close-up of the end plates and the U-bend region. In this figure, brown and orange corrosion products can be seen on the galvanized end plates, while black and green corrosion products can be seen on the copper tubing. The normal patina that forms on copper in the cyclically wet and dry environment of an air conditioner evaporator coil would be expected to contain copper (I) or copper (II) ions in oxides (black to brownish-red), carbonates (green to blue), sulfates (bright blue), and chlorides (greenish white to blue-green) [1,2]. Again, the black color was found to be due to the presence of a thin layer of a loose black powder.

Fig. 3. Photograph of the two air conditioner evaporator coils showing the black discoloration of the copper U-bends and corrosion of the end plate.

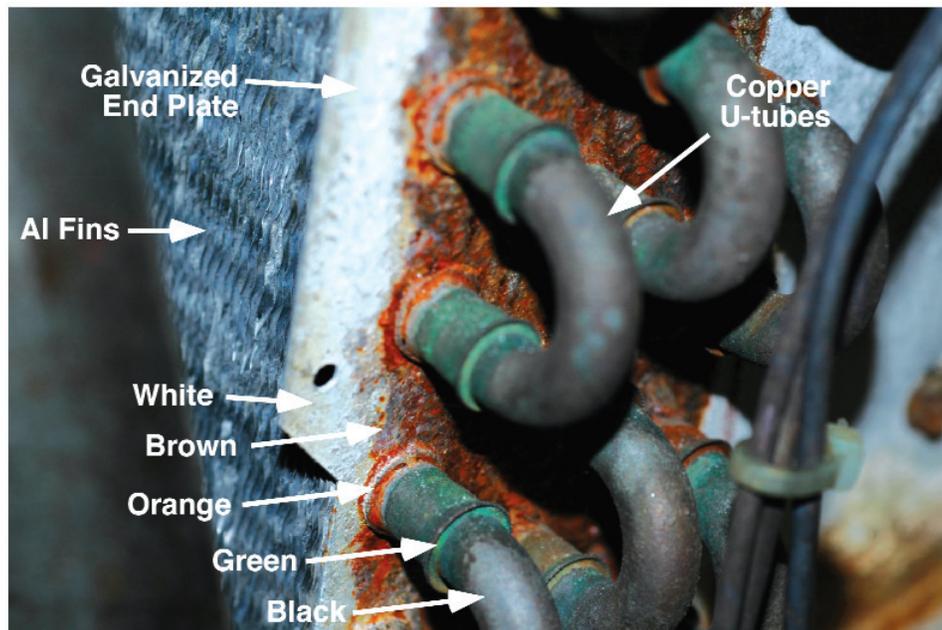
Fig. 4. Close-up photograph of the U-tubes and end plate of an air conditioner evaporator coil showing that there appears to be 5 colors associated with the corrosion products: white, brown, orange, green, and black.

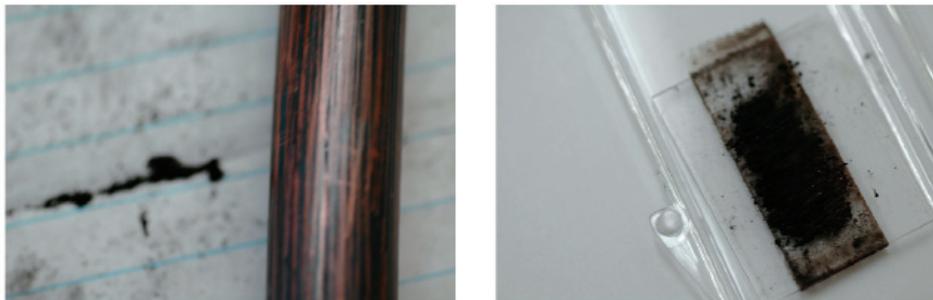
Fig. 5. Photographs of the scraped copper natural gas supply line and the slide holding the sample for x-ray diffraction.

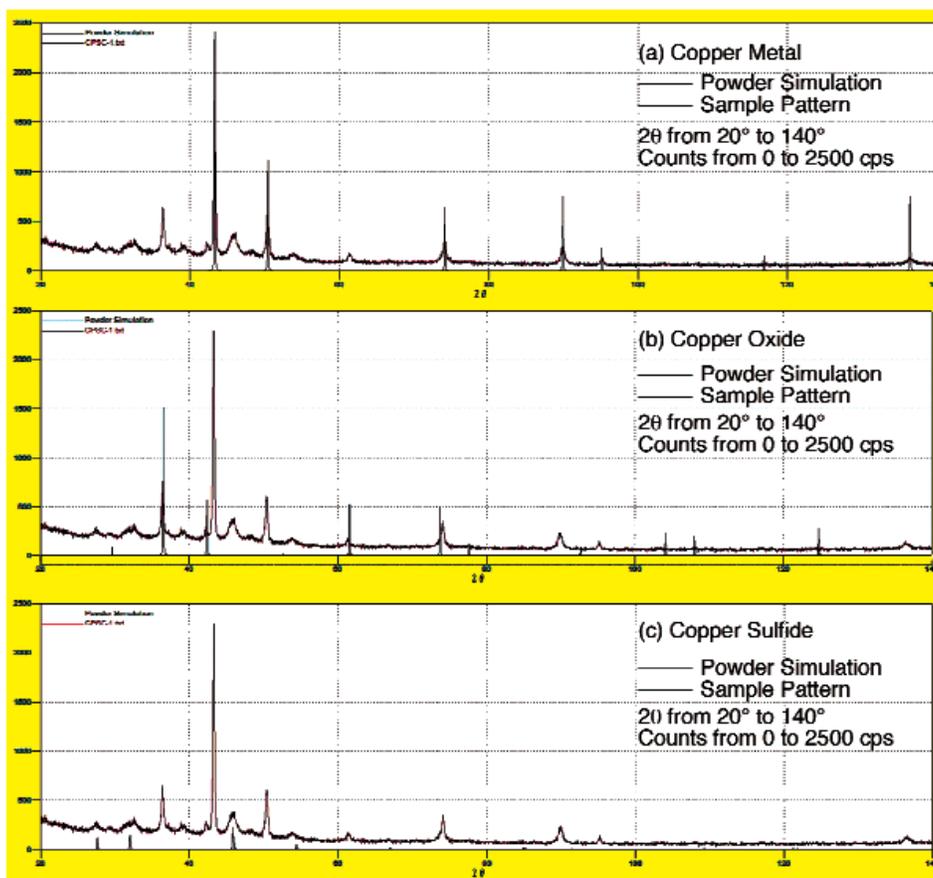
Figure 6 shows the results of these measurements in red along with the peak locations in black for copper metal (Fig. 6a), copper (I) oxide (Fig. 6b) and

copper (I) sulfide (Fig. 6c) as listed in the International Crystal Structure Database (ICSD). This figure shows that peaks corresponding to all three of these phases are present in the sample of scrapings from the surface of the copper natural gas supply line. Given that the sample was collected by scraping the surface of copper metal with a sharp razor blade, the peaks for copper and copper oxide were expected since copper is a soft metal compared to the steel of the razor blade and will normally form copper oxide when exposed to air. The third phase, copper sulfide (Cu_2S) is not a typical atmospheric corrosion product as the concentration of the reduced sulfur species, such as H_2S , required to form this product is usually very low under normal atmospheric conditions [1, 3-5]. Figure 7 is a summary of the XRD results showing that all but two small peaks, indicated by question marks, are accounted for by these three phases.

Fig. 6. Powder diffraction patterns for the sample of corrosion products scraped off a copper natural gas supply line (red) with, identified in black, the peaks for (a) copper, (b) copper (I) oxide (ICSD #38233), and (c) copper (I) sulfide (ICSD #95395).

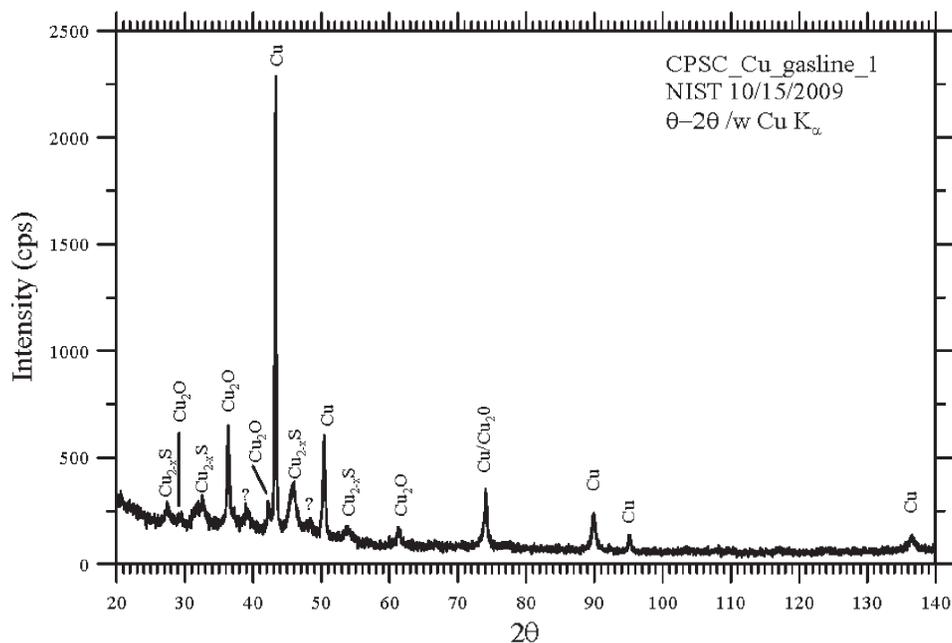
Fig. 7. Summary of peaks found in the corrosion product sample and their identification for showing that only two small peaks were unidentified by the three phases.

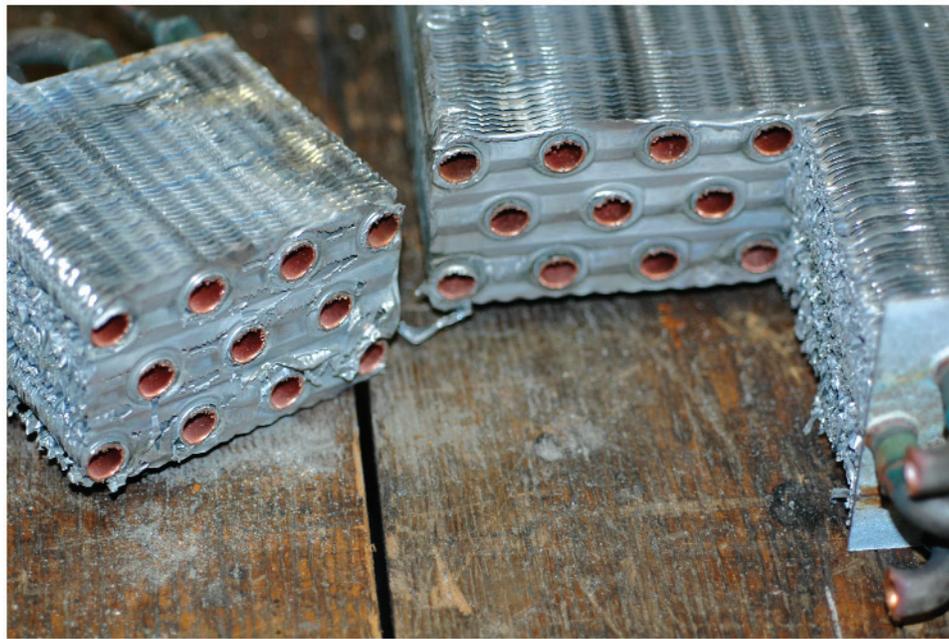
was sliced with a band saw as shown in Fig. 8 to expose these internal surfaces for examination of the copper. No evidence of localized attack was found, and the black corrosion product layer was not detected by visual examination.

Fig. 8. Air conditioner evaporator coil after slicing to allow for examination for corrosion damage between the aluminum sheets and the copper tubing.

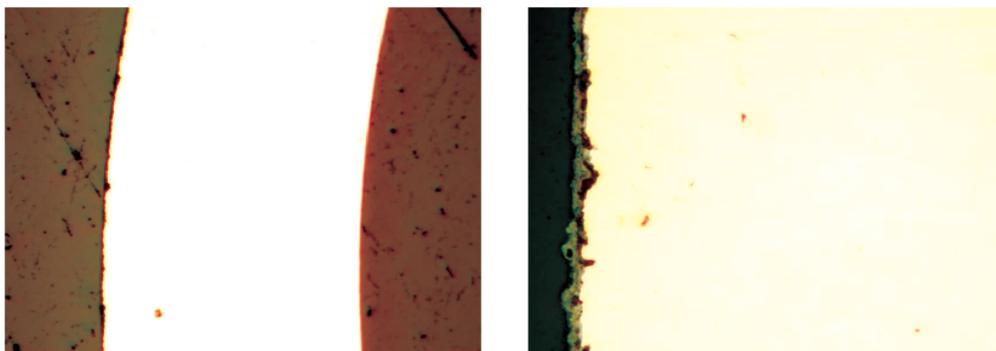
The thickness of the black corrosion product was measured using optical microscopy of samples prepared in cross section. For this analysis, samples of natural gas supply lines were cut, mounted in epoxy, and polished using standard metallurgical practice, exercising care to maintain the edge of the sample with the corrosion products in place. Figure 9 shows optical micrographs of this sample where the corrosion product layer varied from 5 μm to 10 μm thick.

Fig. 9. Optical micrographs of the wall of a copper natural gas supply line and the corrosion product layer at two magnifications (wall \approx 1.2 mm thick).
