NIST Special Publication 901

The January 17, 1995 Hyogoken-Nanbu (Kobe) Earthquake

*Performance of Structures, Lifelines, and Fire
Protection Systems*

Riley Chung, Team Leader and Editor

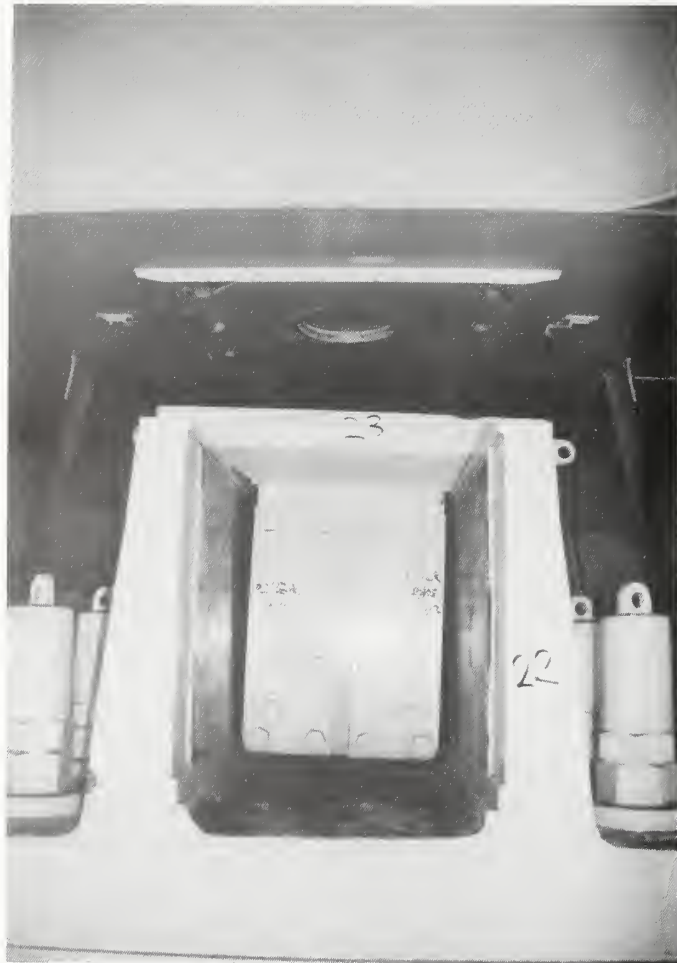
Figure 4.2.48 Failed wind shoe at Pier 187 of the Higashi-Kobe Bridge.

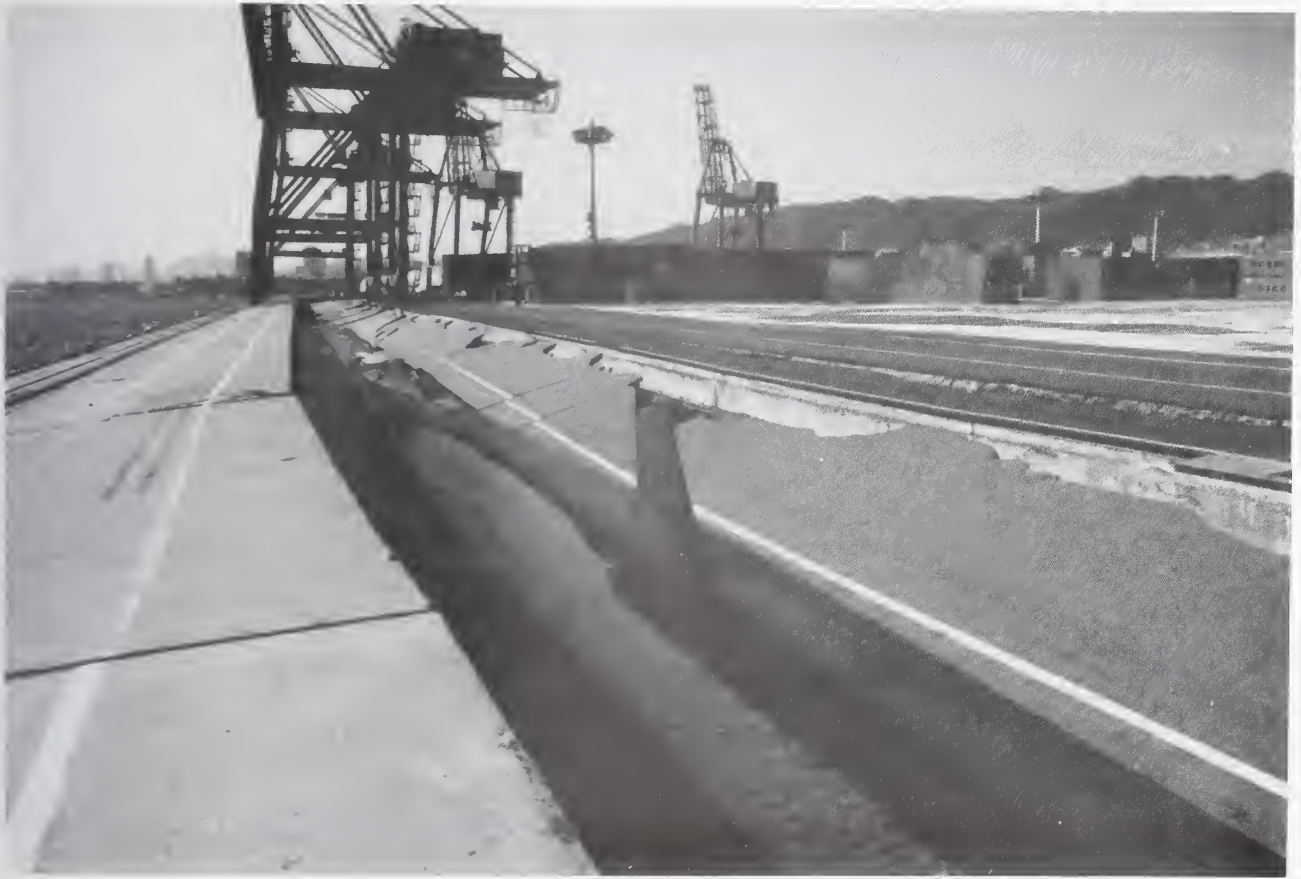
Figure 4.5.5 Damaged to Maya Wharf caused by liquefaction-induced lateral spreading. Downdropped block has formed behind quay wall where land has settled and moved outward. Landward side of block is the pile-supported rear crane rail. Photograph taken February 15, 1995.

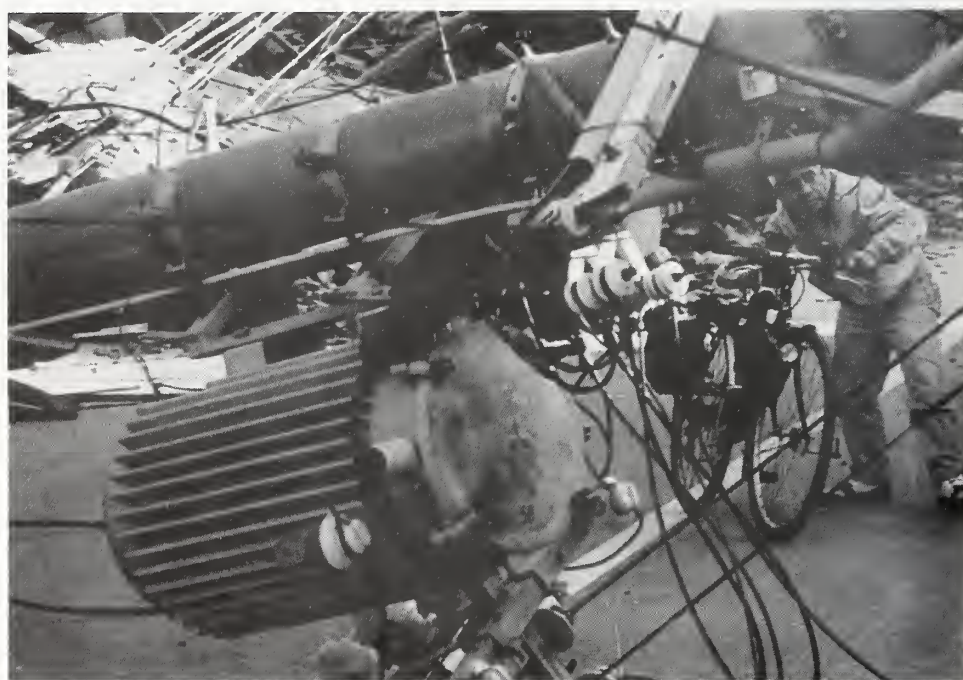
Figure 5.4.70 Fallen poles contributed to the disruption of traffic.

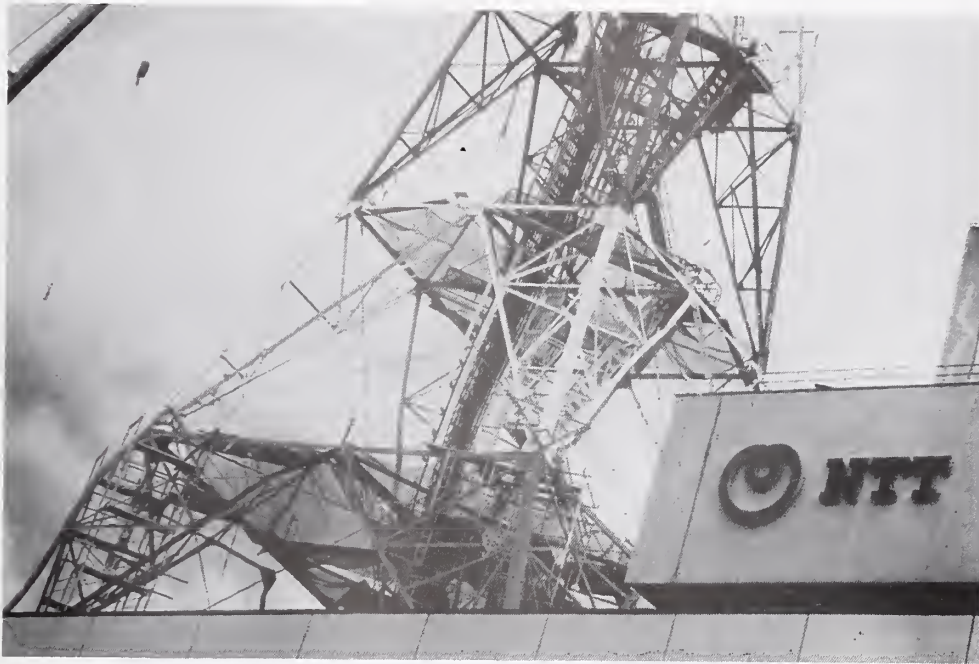
Figure 5.5.1 Microwave tower on top of a central office which was damaged and later removed.
