# TECHNOLOGIC PAPERS

No. 70

## DURABILITY OF STUCCO AND PLASTER CONSTRUCTION

(PROGRESS REPORT CONTAINING RESULTS  
OF INVESTIGATIONS UP TO APRIL, 1916)

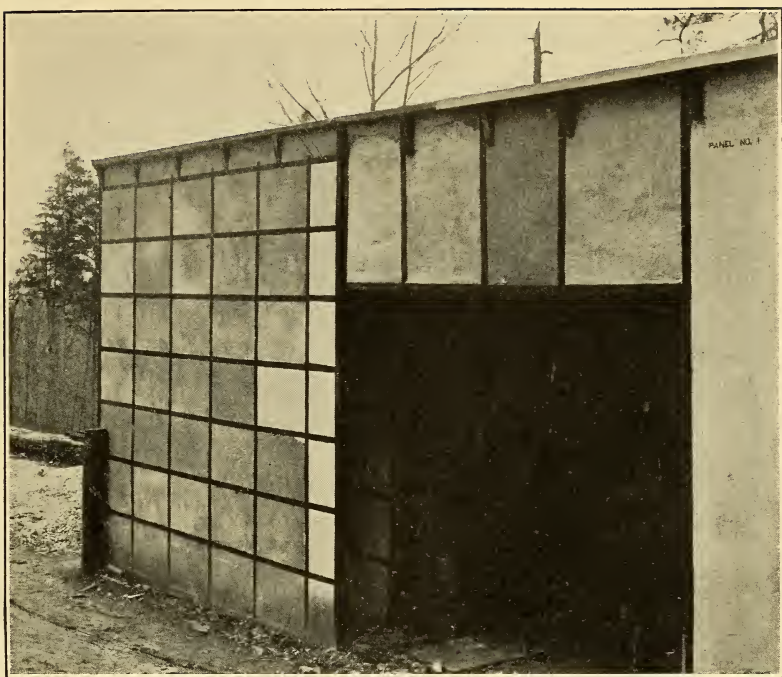
FIG. 1.—North wall of test panels erected in 1911

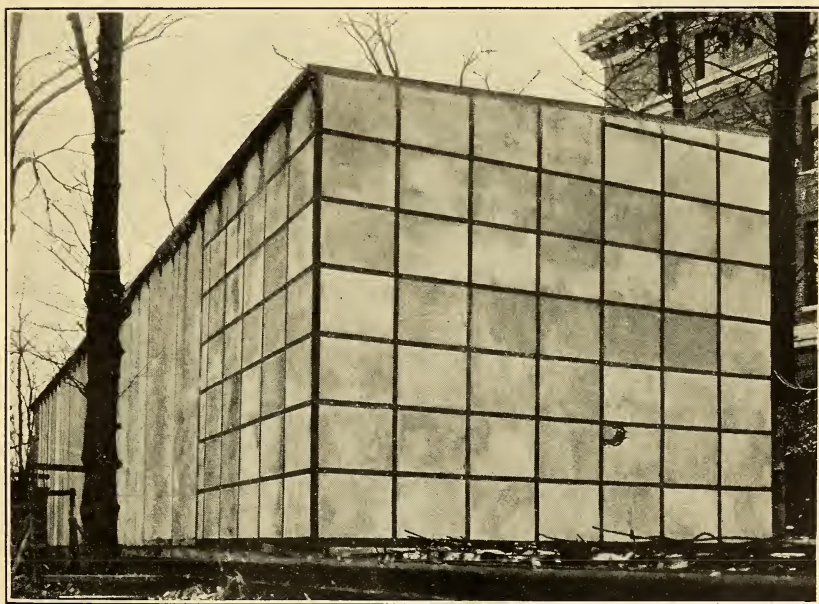
FIG. 2.—South and east walls of the test panels erected in 1911

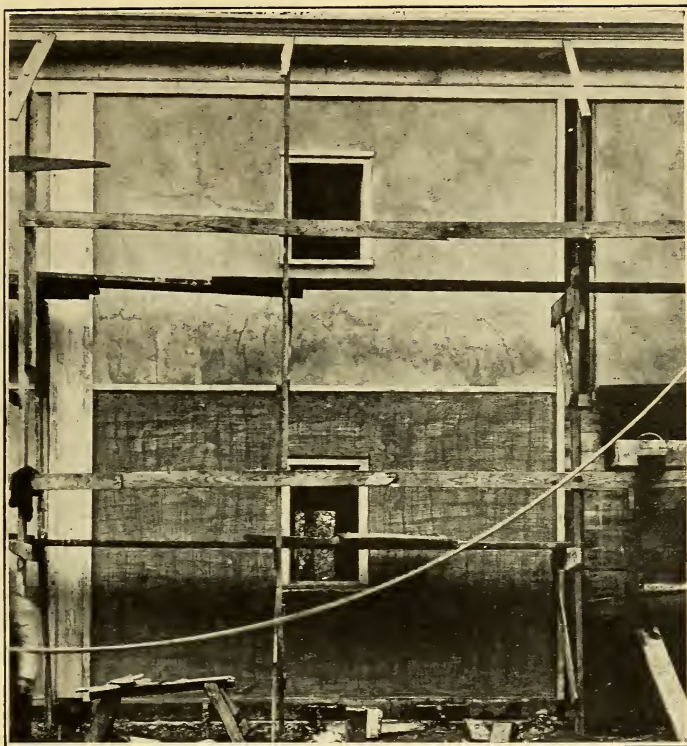
FIG. 9.—Panel No. 4 (upper) showing extensive body and structural cracks after spraying with water and allowing partially to dry. The photograph was taken November 18, 1915, about two weeks after the plastering of this panel was completed. The lower panel is No. 49, scratch coated only

applied morning of November 22, finish coat laid on morning of November 24, finished 2 p. m. (Fig. 9 shows this panel after application of scratch coat.)

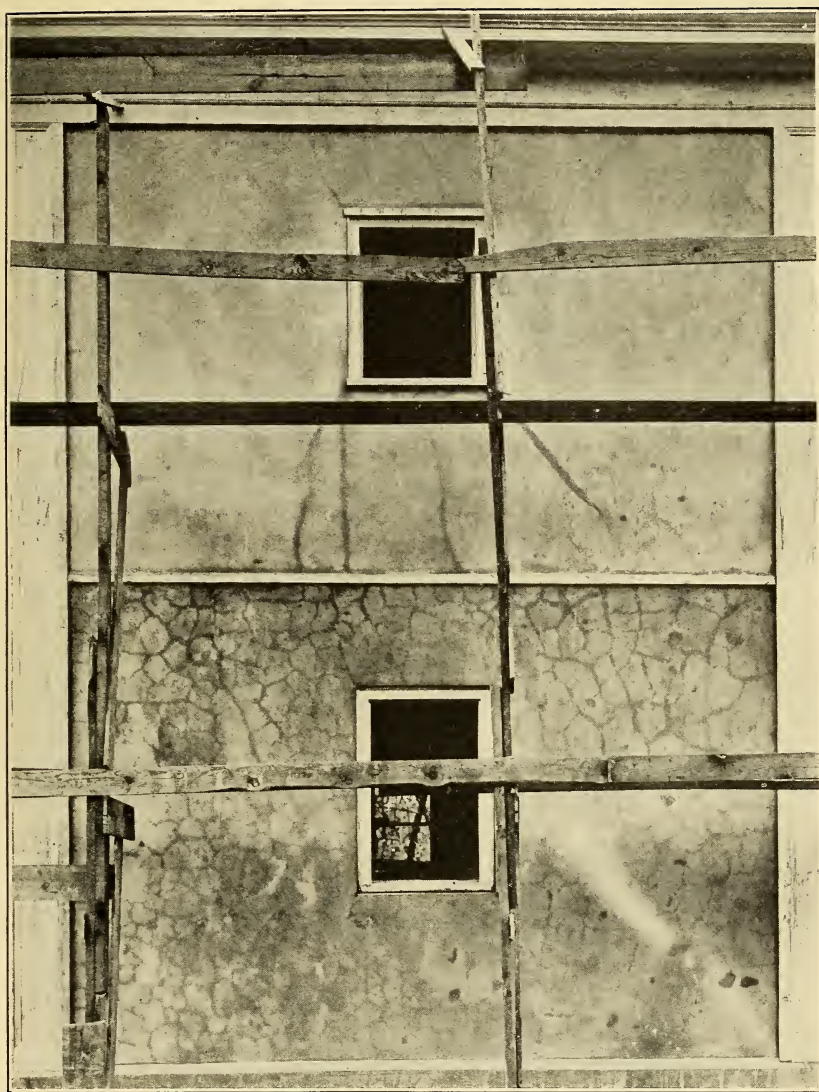
Remarks: Finished panel photographed November 18 with panel No. 31 (see Fig. 22), showing cracks radiating from window.

FIG. 22.—Map cracking (body cracks) on panel No. 31 (lower) and structural cracks on panel No. 1 (upper), after spraying with water and allowing partially to dry. This photograph was taken November 18, about three weeks after the plastering of these panels was completed
