> Fire Tests of Wood-Framed Walls and Partitions With Asbestos-Cement Facings

United States Department of Commerce National Bureau of Standards Building Materials and Structures Report 123

Nolan D. Mitchell

Building Materials and Structures Report 123 Issued May 10, 1951

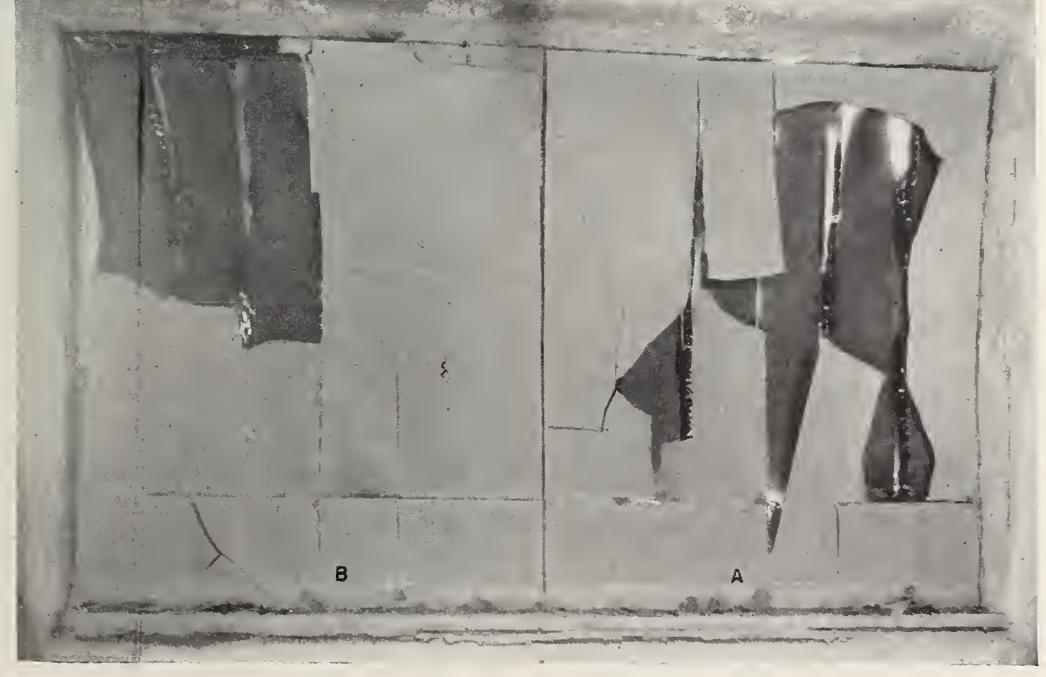
The limiting temperature rise of 250 deg F (139 deg C) on the unexposed face of this partition, test 1, was reached at 9 min for section B, and at 10 min for section A. The limiting rise of 325 deg F (181 deg C) at one point on the surface was reached at 10 min for both sections A and B. At a joint on the unexposed surface, where one sheet had bulged away from the stud, flames appeared at 27 min after the start of the fire. Glow, which was observed on the chair rail of section A at 36 min, developed into flame at 39 min. Other data for tests 1, 2, and 3 are shown in figure 3. Load failures of sections A and B occurred at 35 and 38 min, respectively.

Although buckling of the sheets on the fireexposed side pulled them loose from the nail heads for lengths up to 30 in. along a few studs, only two sheets broke up to the time that failure under load occurred (see fig. 5). Buckling of sheets on the unexposed side also pulled nail heads through in a few locations, but no breaks were observed in this test before the load failures. The deflections of the midpoints of the two sections A and B were 2.2 in. and 1.8 in., respectively, at 30 min after the start of the test.

FIGURE 5. Exposed side of asbestos-cement sheet-faced partition, no insulation, after failure under fire and load. Test 1.

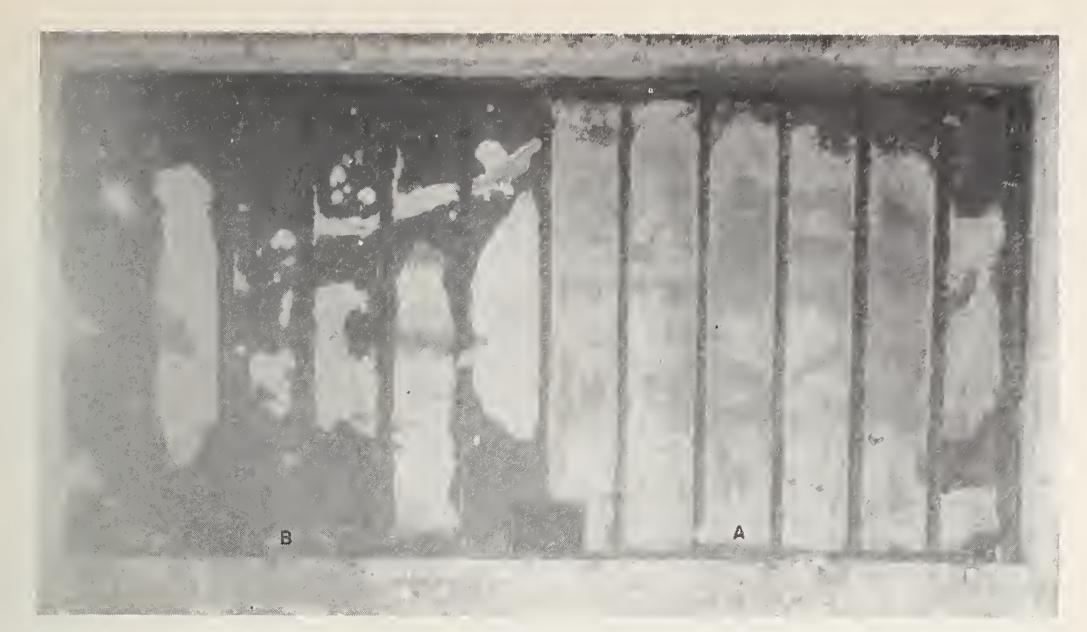
Fire and hose-stream test 3, made with a partition construction similar to that of test 2, resulted in the dislodgment of the sheets from the fire-exposed side when subjected to the impact of the hose stream after a 45-min exposure to fire. However, no hole through the partition developed nor did any other type of failure occur (fig. 6). Section A of this partition faced with %-in. gypsum boards and $\frac{3}{16}$ -in. asbestos-cement sheets is considered to have qualified for a fire-resistance rating of 1 hour, combustible for both load-bearing and nonloadbearing partitions. As a load-bearing partition, section B, with facings of ½-in.-thick gypsum wallboards and ³/₁₆-in. asbestos-cement sheets, by the same criterion qualified for the rating 1¼ hours, combustible, and as a nonload-bearing partition, $1\frac{1}{2}$ hours, combustible.

FIGURE 6. Exposed side of partition with gypsum sheathing under asbestos-cement sheets after 45 min exposure to fire followed by hose stream. Test 3.

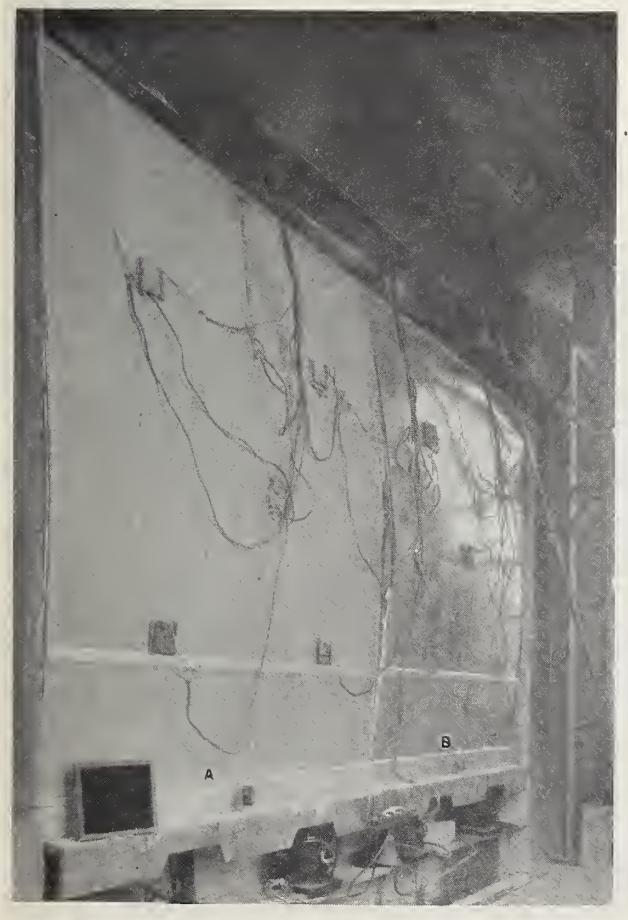
The partition in test 4 failed under load at 40 and 46 min for sections A and B, respectively. The limiting rise of surface temperatures was reached at 42 min at one point on section A, and the average rise on section B was reached at 46 min. The limiting rise of 250 deg F (139 deg C) as the average of five locations on the surface of section A occurred at 48 min. Glow was observed on the surface of section B at 46 min.

FIGURE 7. Unexposed side of partition with mineral-wool fill after failure under load. Test 4.

A partition of similar construction except for asbestos-paper lining on the edges of the stude of one section (test 5) failed in 1 min from impact of the hose stream following a 30-min exposure to fire. The impact of the stream forced the sheets off the countersunk nail heads of the unexposed surface, the sheets having been broken and dislodged very quickly from the fire-exposed surface on application of the stream. The depth of char observed on the edges of the studs toward the fire varied from $\frac{1}{2}$ to $\frac{7}{8}$ in., and was estimated to average about $\frac{3}{4}$ in. This resulted from a 30-min exposure of the wall to fire. No noticeable effect was observed in the asbestos paper on the edges of the studs, probably because the fire exposure was terminated before any limiting criterion of fire resistance was attained (see fig. 7).

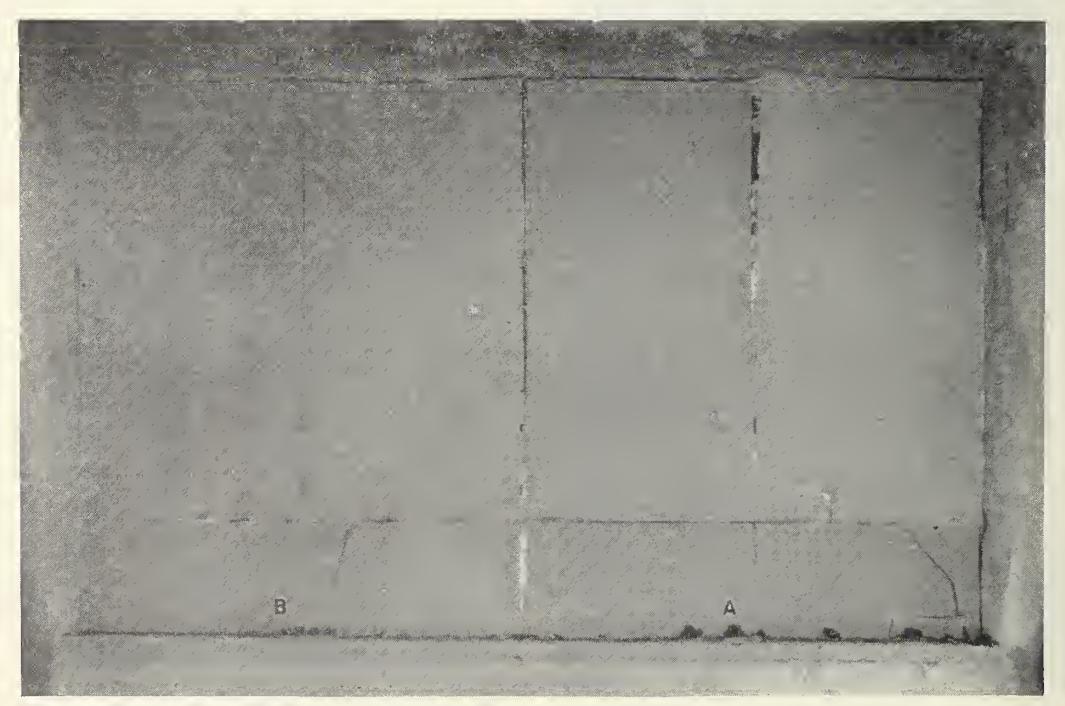
Failure by a temperature rise of 325 deg F (181 deg C) at one point of section A of the partition of test 6 occurred at 1 hr 19 min and on section B at 1 hr 22 min. The limiting rise of 250 deg F (139 deg C) as the average of five locations was reached at 1 hr 23 min on section A and at 1 hr 31 min on section B. Deflections of the midpoints of sections A and B toward the fire at 1 hr 25 min were 0.6 and 0.7 in., respectively. There was only minor cracking of the facing sheets on the unexposed surface. Figure 8 shows the face of the partition after 1-hr 32-min exposure to fire.

FIGURE 8. Partition with mineral-wool fill and gypsum-board strips on edges of studs. Fire-exposed face_after 1_hr 32 min. _Test 6.

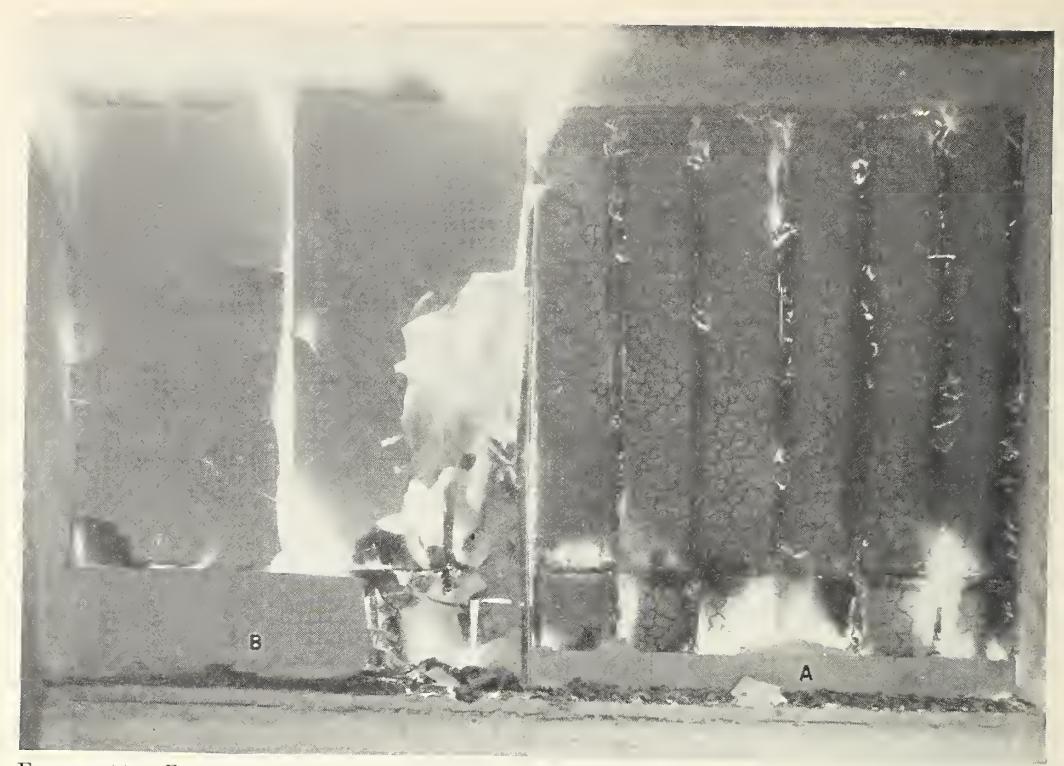
The wall having the interior facing of a composite insulated sheathing board and with no mineral-wool fill between studs, nor strips of gypsum-board lining the edges of the studs (test 8), failed in section B after a 32-min exposure to fire and in section A after a 34-min exposure (see fig. 11).

FIGURE 11. Fire-exposed face of wall with composite insulated sheathing board, no mineral-wool fill between studs. Test 8.

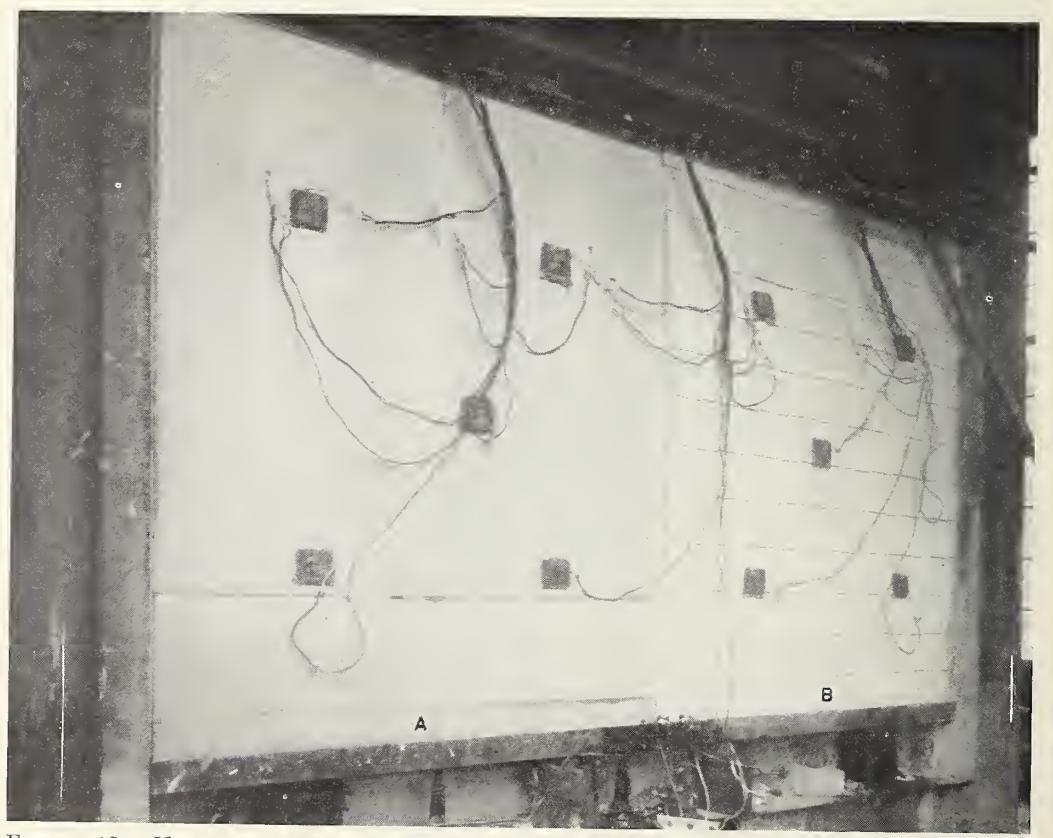
was charred in the 1-hr fire-exposure period. The deflection away from the fire of the midpoint of section B was 1.9 in. at 36 min, and of section A, 2.9 in. at 45 min (see fig. 12).

FIGURE 12. Unexposed face of wall with mineral-wool fill, after 42 min of fire endurance. Test 9.
