Influence of the Wash From Bronze on the Weathering of Marble

United States Department of Commerce National Bureau of Standards Building Materials and Structures Report 137

Daniel W. Kessler and Ross E. Anderson

Building Materials and Structures Report 137

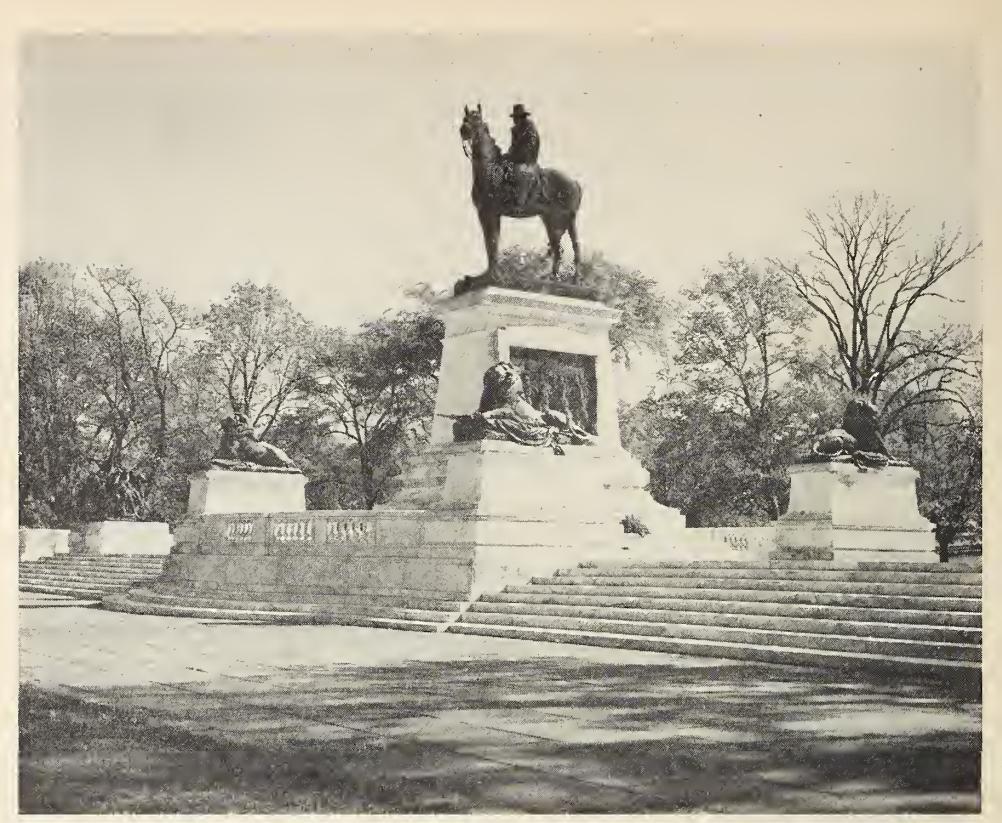
FIGURE 1. Grant Monument, Washington, D. C., from the southwest showing all but one of the bronze groups and the supporting marble.

Vermont White Marble: The Grant Monument (1922) shown in figure 1 consists of seven marble bases supporting large bronze figures. Several blocks have prominent brown stains, accompanied by cracking of the marble. The worst condition is shown in figure 3, but many blocks appear to be in good condition. The corner block under the south group is projecting considerably over the edge of the block below. This is believed to indicate that the injured block has undergone a swelling action.

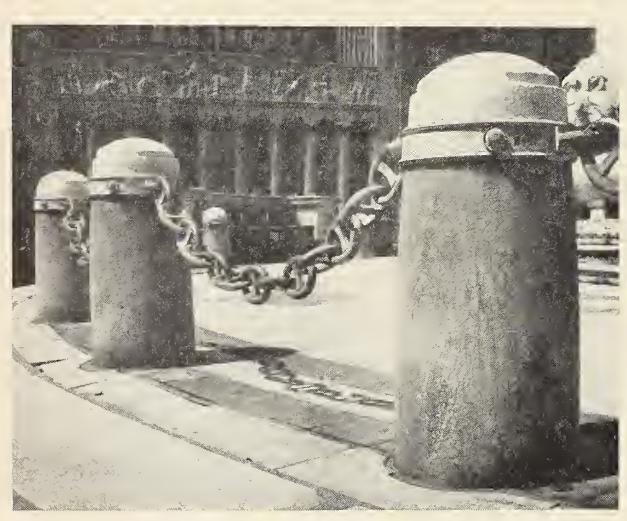
FIGURE 2. Marble posts surrounding the McKinley Monument at Buffalo, N. Y.

The marble below the bronze collars, forming an attachment for the chain, is badly cracked and discolored brown, whereas that part above the collars is not much changed.

The McKinley Monument, in Buffalo, N. Y. (1907), is surrounded by several marble posts, and near the top of each post is a bronze collar supporting a bronze chain. Figure 2 illustrates how seriously the marble is cracked. Above the collars the marble appears to be in good condition. When this structure was examined about 20 years ago, the brown stains were confined to a few inches below the collars, and incipient cracking was visible in these discolored areas. This seems to prove that the deterioration was caused by the bronze rather than some substance coming up from below.

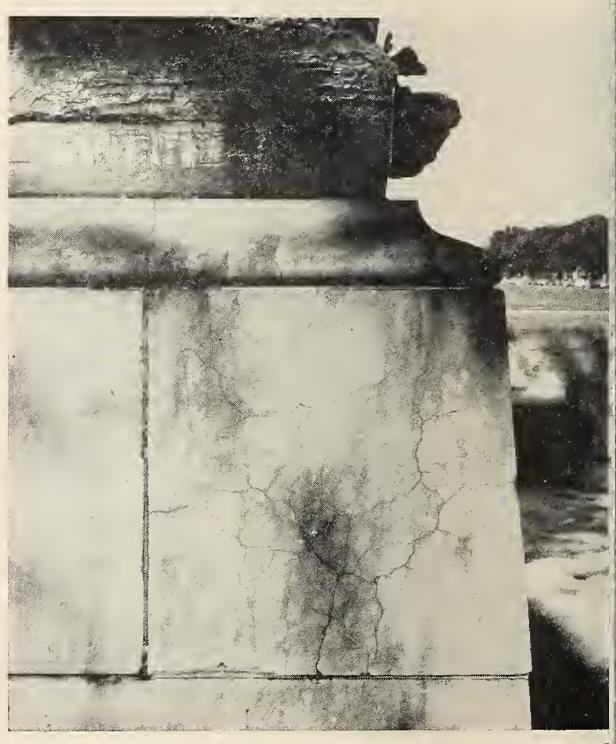
FIGURE 3. Block of badly cracked marble under the north statuary group of the Grant Monument showing the wors condition in this structure.

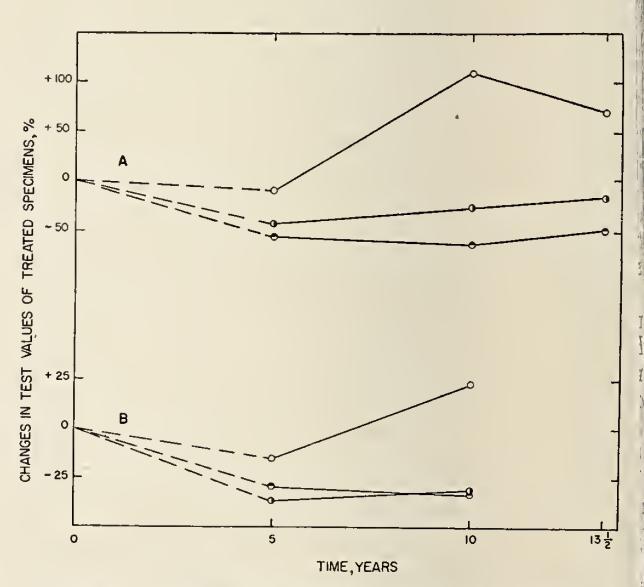
FIGURE 15. Changes in strength, abrasive hardness, and absorption of the treated specimens.

The treatment appeared to accelerate the weathering action rather than retard it. A, Not exposed to bronze; B, exposed to bronze; O, absorption; O, abrasive resistance ;O, flexural.
