# Fire Endurance of Open-Web Steel-Joist Floors With Concrete Slabs and Gypsum Ceilings

United States Department of Commerce  
National Bureau of Standards  
Building Materials and Structures Report 141

James V. Ryan and Edward W. Bender

Issued August 23, 1954

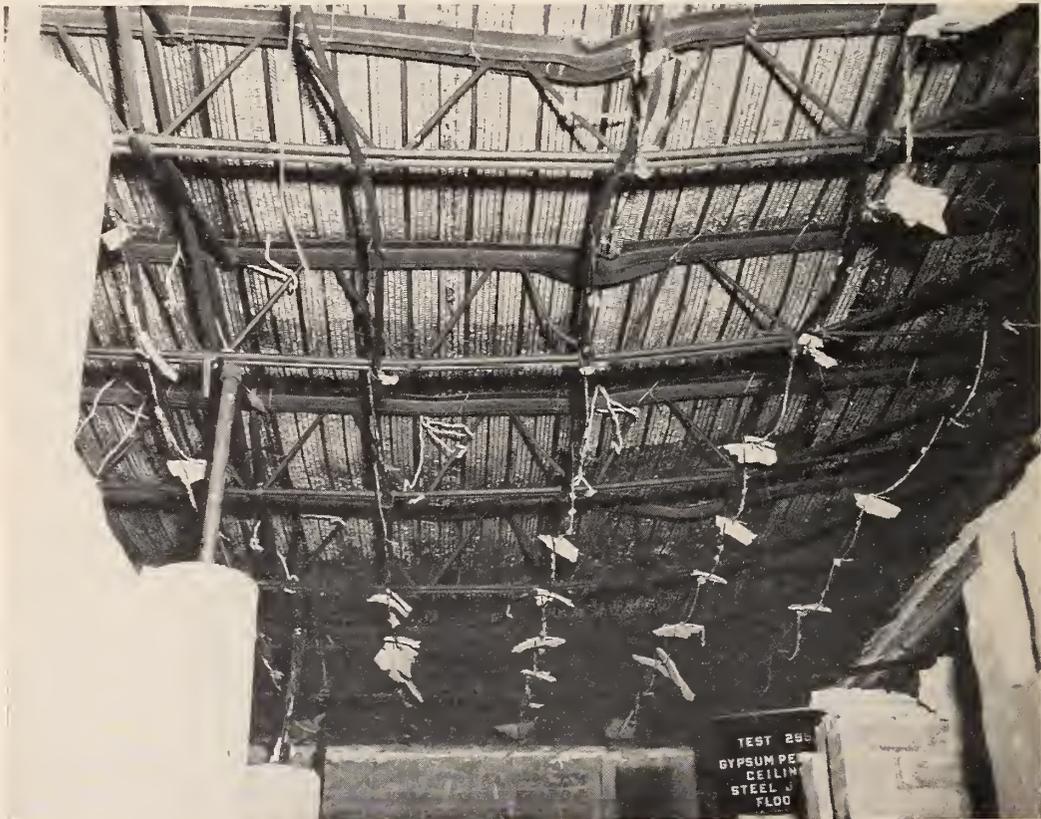
**Test 295.** Ceiling of 1 in. of plaster on 3/8-in. lath, same slab and joists as in test 287. At 2 min, white-coat plaster peeling from over half ceiling; 18 min, spot about 6-in.-diameter sagging; 27 min, half of above spot fell, another sagging 1 in.; 34 min, cracks along lines of lath joints over most of ceiling; 48 min, slight sag along crack; 1 hr 3 min, several cracks 1/8 in. wide, others less; 1 hr 26 min, offset of 1/4 in. along crack; 1 hr 36 min, sag of 2 in. at lath corner; 1 hr 36 1/2 min, about 5 ft<sup>2</sup> of ceiling fell; 1 hr 43 min, load removed, floor continued to deflect under deadweight, about one third of ceiling down; 1 hr 49 min, nearly all ceiling down, joists buckling; 1 hr 53 min, gas off.

FIGURE 6. Condition of joists after test 295 of specimen with unreinforced ceiling showing buckled joists.

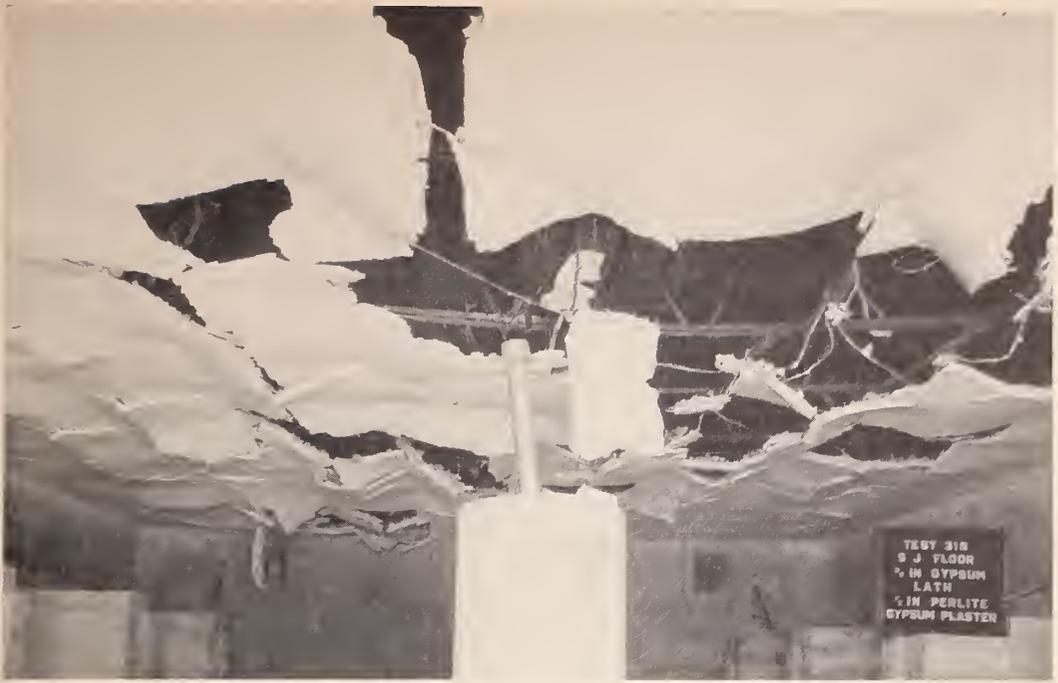
*Test 318.* Diagonal wires 11.3 in. apart, plaster ½ in. on ¾-in. lath. At 8 min, first crack; 15 min, smoke from single crack; 19 min, cracks partially outlined laths; 24 min, slight sagging along two cracks; 31 min, offset of ¼ in., some peeling of white coat; 35 min, entire ceiling surface had wavy appearance; 50 min, wavy appearance lessening except for 3-in. sag along two cracks; 1 hr 15 min, corner of lath and plaster sagging 1¾ in.; 1 hr 35 min, maximum crack width 1½ in., local sag as much as 4 in.; 2 hr 6 min, many cracks ½ to 2 in. wide, corners of lath and plaster hanging down 3 to 8 in., leaving openings about 6 and 10 in. square; 2 hr 27 min, about 2½ ft² of ceiling fell; 2 hr 47 min, load off; 2 hr 53 min, gas off.

Less than one-quarter of the ceiling fell during the test and subsequent cooling. Most of the joists were bent, a few buckled slightly, and the floor slab showed no appreciable cracking.

FIGURE 7. *Condition of ceiling after test 318 of specimen with diagonal wire reinforcing. One or two smoothly bent joists may be seen through the opening in the ceiling.*

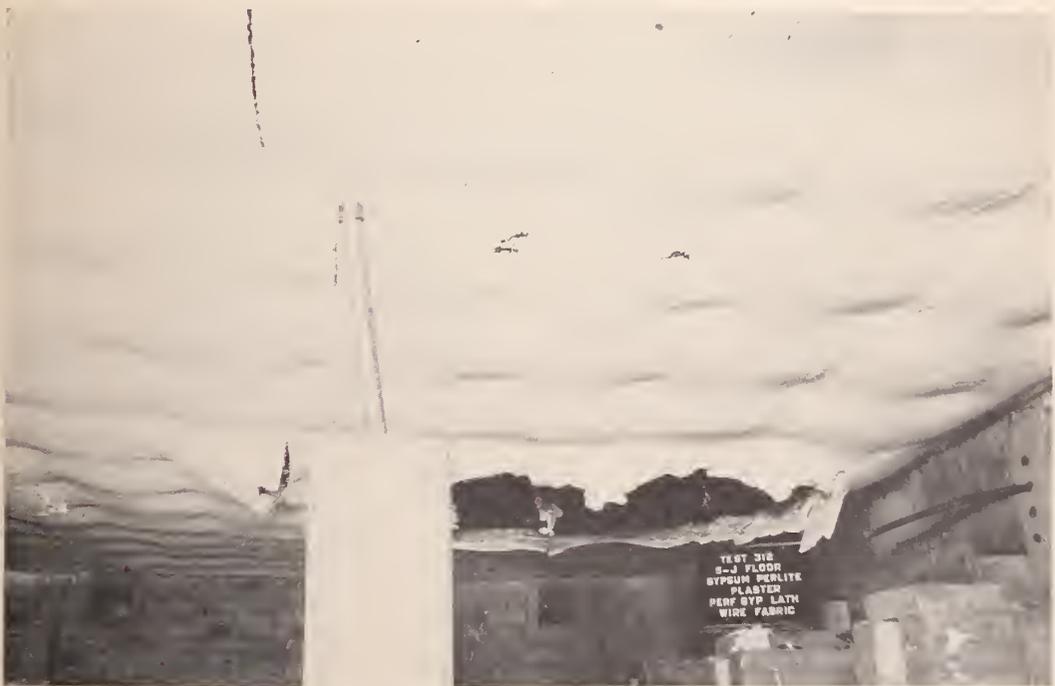
*Test 312.* Plaster  $\frac{1}{2}$  in. on  $\frac{3}{8}$ -in. lath. At 13 min, first crack; 27 min, short cracks outlined laths over part of ceiling; 1 hr, maximum crack width  $\frac{1}{16}$  in., length 3 ft, 1 hr 45 min, several parallel transverse bulges or sags of small depth, probably between lines of support for wire mesh; 2 hr 43 min, small edge cracks in floor slab, little change in ceiling; 3 hr, maximum crack width  $\frac{1}{8}$  in., length 6 ft; 4 hr, ceiling had developed 1 to 2 in. general sag; 5 hr, general sag of ceiling had developed into curve of 9-in. depth at center; 5 hr 20 min, local sag of  $\frac{1}{2}$  in. over area 3 ft in diameter; 6 hr 15 min, ceiling fell from 4-ft<sup>2</sup> area near center; 6 hr 27 min, load off; 6 hr 34 min, gas off, more ceiling down.

FIGURE 8. *Condition of ceiling in test 312, having hexagonal-mesh wire fabric, after 6½-hour exposure.*
