REPORT BMS43

Performance Test of  
Floor Coverings for Use in  
Low-Cost Housing: Part 2

PERCY A. SIGLER  
*and* ELMER A. KOERNER

ISSUED FEBRUARY 13, 1940

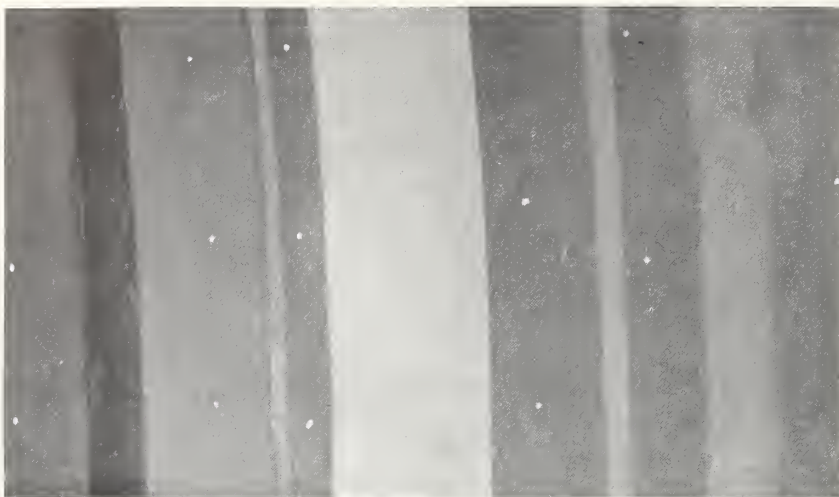
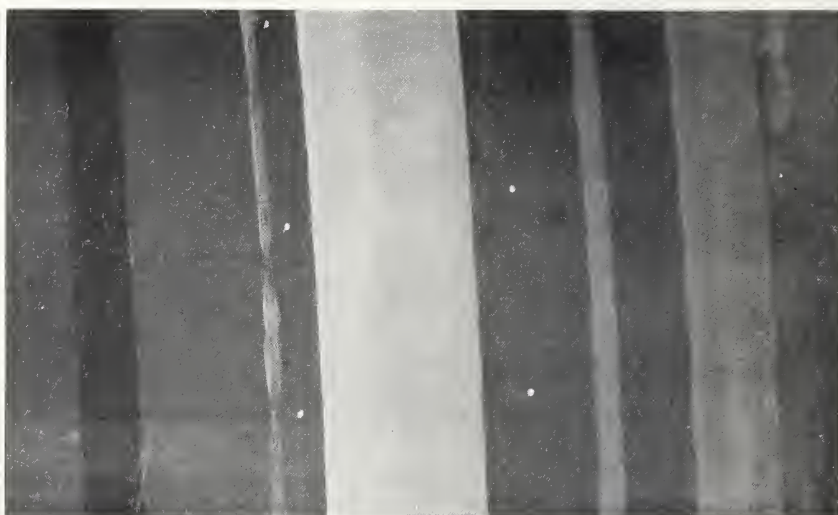
The  $\frac{1}{8}$ -in. green battleship linoleum, test panels 1L and 2L, showed very good performance (see figs. 2 and 3, and table 2). There was no evidence of failure in adhesion to the subfloors. On a wood subfloor, panel 2L, the linoleum was fractured slightly at one end by the steel-tired truck wheel (see fig. 3). On a concrete subfloor the linoleum was only slightly indented by the steel-tired truck wheel (see table 3).

FIGURE 2.— $\frac{1}{8}$ -in. battleship linoleum on concrete subfloor (test panel 1L).

FIGURE 3.— $\frac{1}{8}$ -in. battleship linoleum on wood subfloor (test panel 2L).

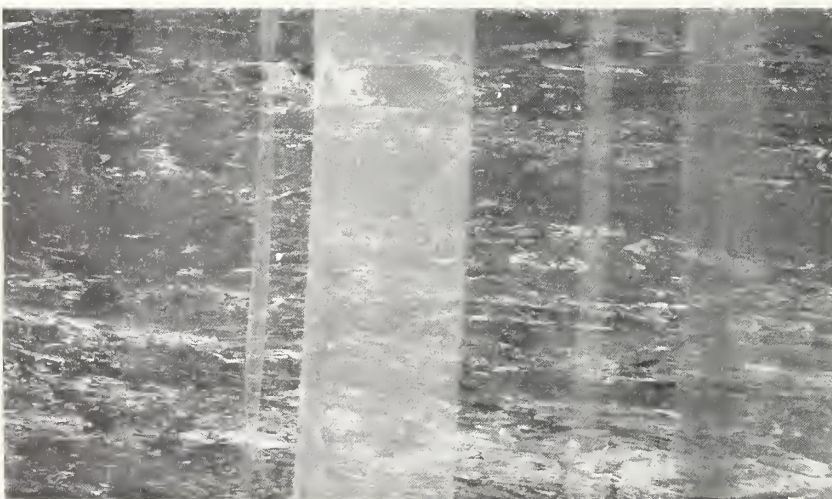
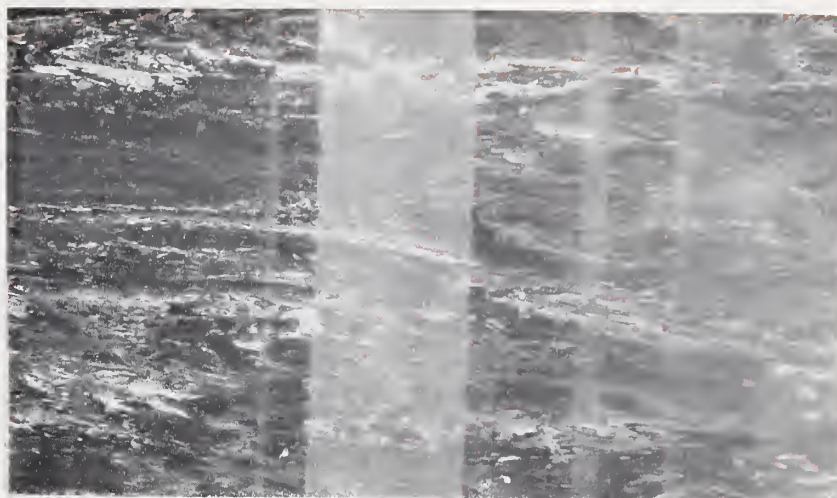
The  $\frac{1}{8}$ -in. sheet rubber, test panels 3L, 4L, 3R, and 4R, gave excellent performance (see figs. 4 and 5, and table 2). No failure occurred in adhesion to the subfloors except in panel 3L, where the casein-latex adhesive accumulated in rolls along the path of the steel-tired truck wheel, causing welts to form in the floor covering (see fig. 6). There was no evidence of fracture of the sheet rubber.

FIGURE 4.— $\frac{1}{8}$ -in. sheet rubber on concrete subfloor (test panel 3R).

FIGURE 5.— $\frac{1}{8}$ -in. sheet rubber on wood subfloor (test panel 4R).

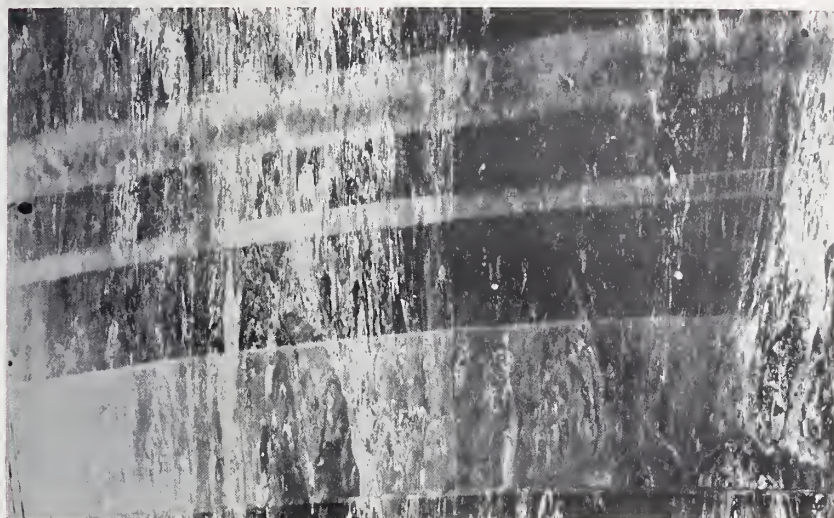
FIGURE 6.— $\frac{1}{8}$ -in. sheet rubber on concrete subfloor (test panel 3L).

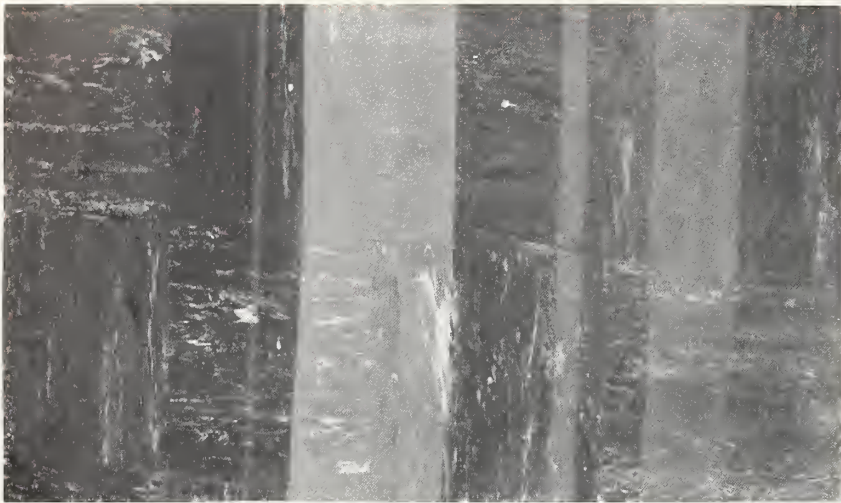
The  $\frac{1}{8}$ -in. rubber tile on a wood subfloor, test panels 6L and 6R, showed very good performance (see fig. 8), with no evidence of failure in adhesion to the subfloor or fracture of the rubber tile. On a concrete subfloor, test panels 5L and 5R, considerable failure in adhesion to the subfloor and fracture of the tile along the path of the steel-tired truck wheel were observed (see figs. 7 and 9). In test panel 5L there were also welts in the floor covering, caused by accumulations of the casein-latex adhesive (see fig. 9). The rubber tile was worn to a moderate degree by the abrasive action of the walking wheel (see table 2).

FIGURE 8.— $\frac{1}{8}$ -in. rubber tile on wood subfloor (test panel 9R).

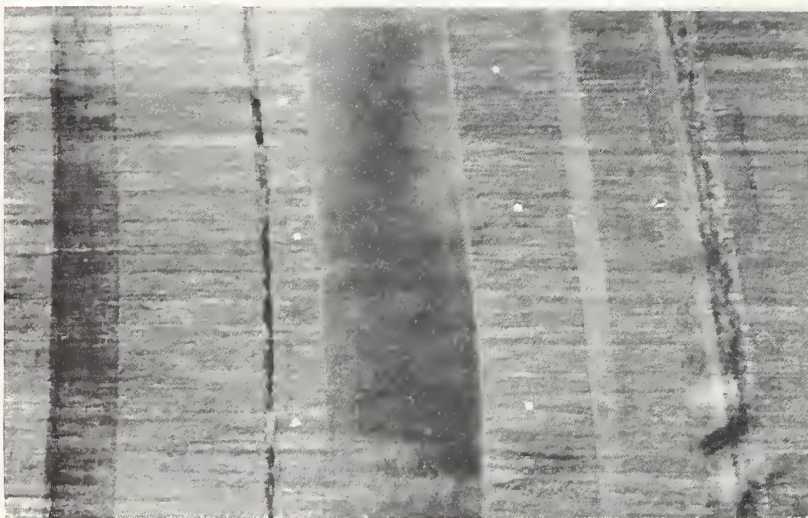
The nitrocellulose composition felt base, test panels 7L and 8L, withstood the severe test very well (see figs. 10 and 11). The only failure in adhesion to the subfloors was a few small blisters along the path of the steel-tired truck wheel in panel 7L (see fig. 10). On a wood subfloor with a dry lining felt the floor covering was moderately depressed and the

FIGURE 10.—Nitrocellulose composition felt base on concrete subfloor (test panel 7L).

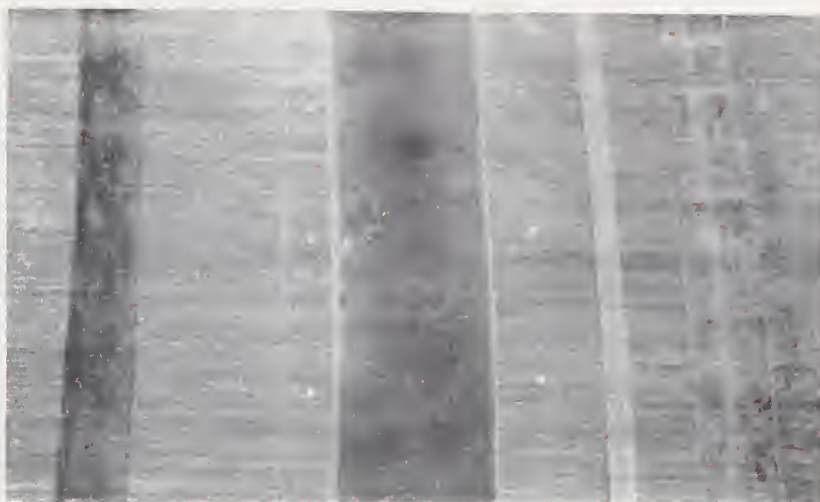
wearing surface was fractured slightly by the steel-tired truck wheel (see fig. 11). Upon removal of the test panel there was evidence of some separation in the dry lining felt along the path of the steel-tired truck wheel. The wearing surface was not worn through to the asphalt-saturated felt backing by the abrasive action of the walking wheel (see table 2). In general, the floor covering was still in serviceable condition at the end of the test.

FIGURE 11.—*Nitrocellulose composition felt base on wood subfloor (test panel 8L).*

The advisability of using dry lining felt in conjunction with felt-base floor coverings over wood subfloors is demonstrated by a comparison of figures 11 and 13. The use of a felt underlay will cause a felt-base floor covering to

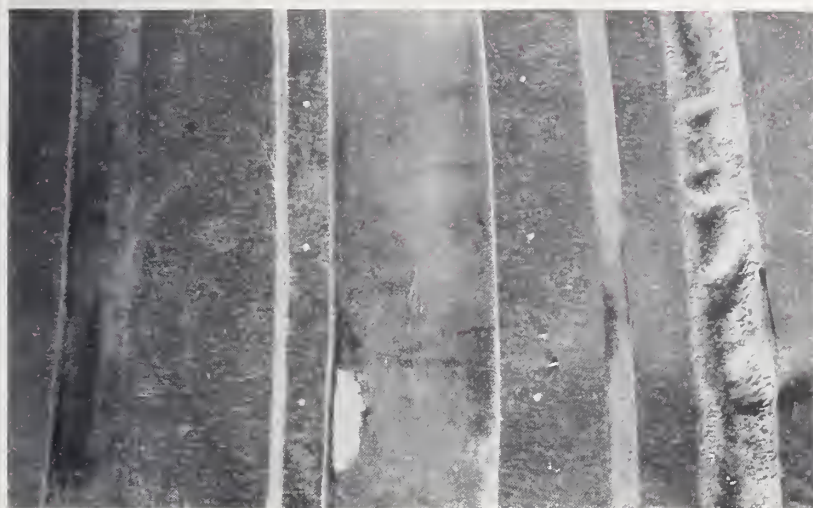
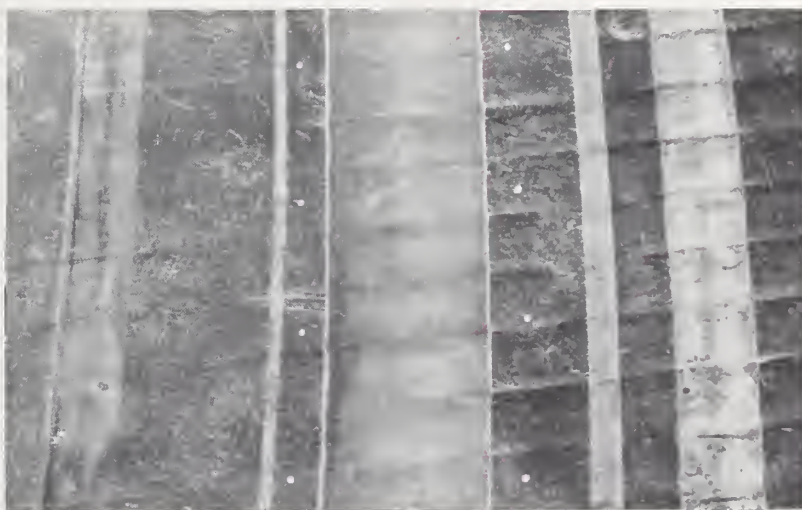
The pitch and resin mastie felt base,<sup>2</sup> test panels 7R and 8R, showed very poor performance (see figs. 12 and 13). The wearing surface was crumbled and completely worn through to the felt backing along the paths of the steel-tired truck wheel and the steel-wheel easter. The wearing surface was also worn through in spots by the abrasive action of the walking wheel in 1,700 cycles after the wheel had been covered with abrasive cloth, and was worn through over the entire path in 6,000 cycles. The total depth of wear is shown in table 2. The only failure in adhesion to the subfloors occurred as blisters along the path of the steel-tired truck wheel in panel 7R (see fig. 12). This failure, however, did not occur until after 43,000 cycles of the truck, by which time the surface of the floor covering was completely worn through to the felt backing.

FIGURE 12.—*Pitch and resin mastic felt base on concrete subfloor (test panel 7R).*

FIGURE 13.—*Pitch and resin mastic felt base on wood subfloor (test panel 8R).*

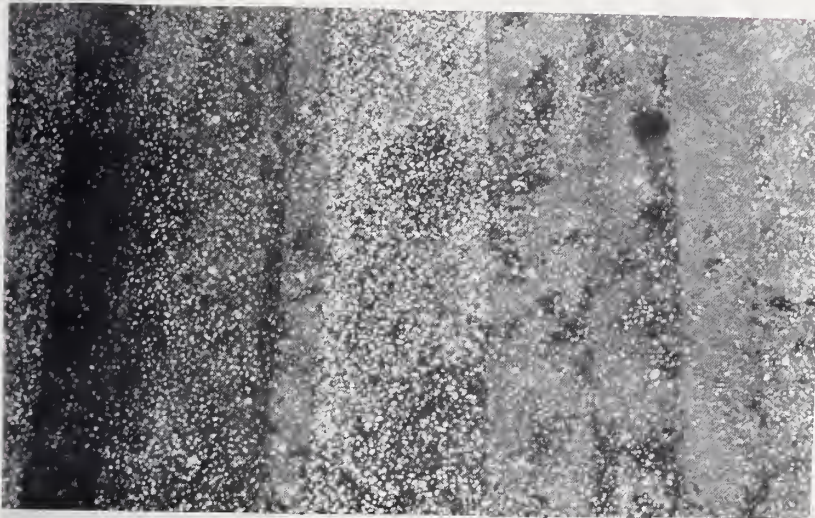
The  $\frac{1}{4}$ -in. alumina cement-latex monolithic floor, test panel 11L, was considerably depressed by the steel-tired truck wheel (see table 3). There was also evidence of some pitting and wear (see fig. 18). The floor was worn to a considerable degree by the abrasive action of the walking wheel (see table 2). There was no evidence of the floor cracking, even though it was installed over a cement-mortar fill only  $\frac{1}{2}$  in. thick.

FIGURE 18.— $\frac{1}{4}$ -in. alumina cement-later monolithic composition on cement-mortar subfloor (test panel 11L).

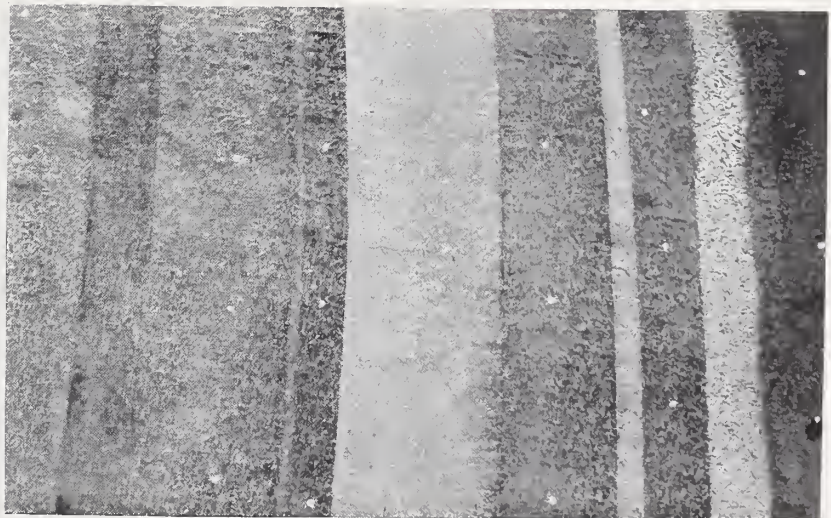
The  $\frac{1}{4}$ -in. magnesium-oxychloride monolithic floor, test panel 11R, was pitted and worn to a moderate degree by the steel-tired truck wheel (see fig. 19 and table 3). The floor was worn to an appreciable degree by the abrasive action of the walking wheel (see table 2). The cotton fibers showed as fuzz along the paths of the steel-tired truck wheel and the walking wheel (see fig. 19). Inasmuch as the subfloor consisted of a  $\frac{1}{2}$ -in. cement-mortar fill and not a solid concrete slab, it is not considered advisable to place too much significance on the cracks which appeared along the path of the steel-tired truck wheel and across the paths of the walking wheel and the steel-wheel caster (see fig. 19). Upon removal of the test panel the  $\frac{1}{2}$ -in. cement-mortar fill was also found to be cracked along the path of the steel-tired truck wheel. However, it was found possible to separate easily and completely the  $\frac{1}{4}$ -in. magnesium-oxychloride layer from the  $\frac{1}{2}$ -in. cement-mortar fill, which would indicate a poor bond for this type of material.

FIGURE 19.— $\frac{1}{4}$ -in. magnesium-oxychloride monolithic composition on cement-mortar subfloor (test panel 11R).

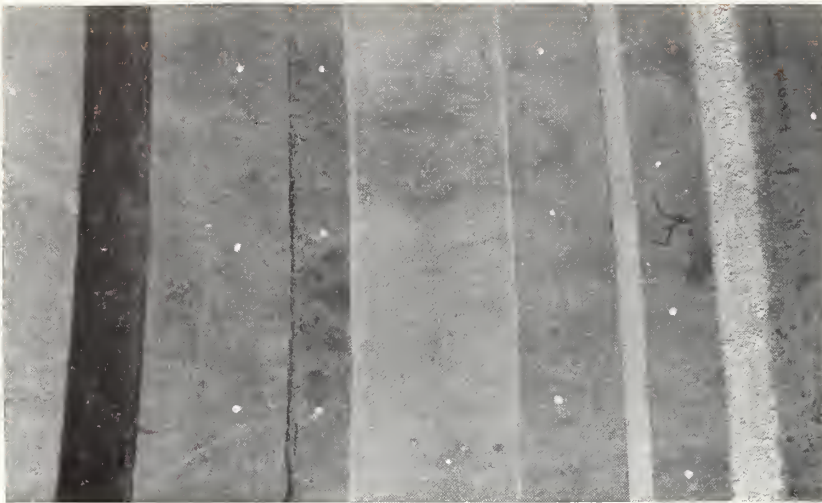
The  $\frac{3}{4}$ -in. magnesium-oxychloride monolithic floor, test panel 12L, was pitted and worn to a moderate degree by the steel-tired truck wheel (see fig. 20 and table 3). The floor was worn to an appreciable degree by the abrasive action of the walking wheel (see table 2). There was no evidence of the floor cracking. Upon removal of the test panel, bond to the chipped concrete subfloor was found to be very good.

FIGURE 20.— $\frac{3}{4}$ -in. magnesium-orychloride monolithic composition on concrete subfloor (test panel 12L).

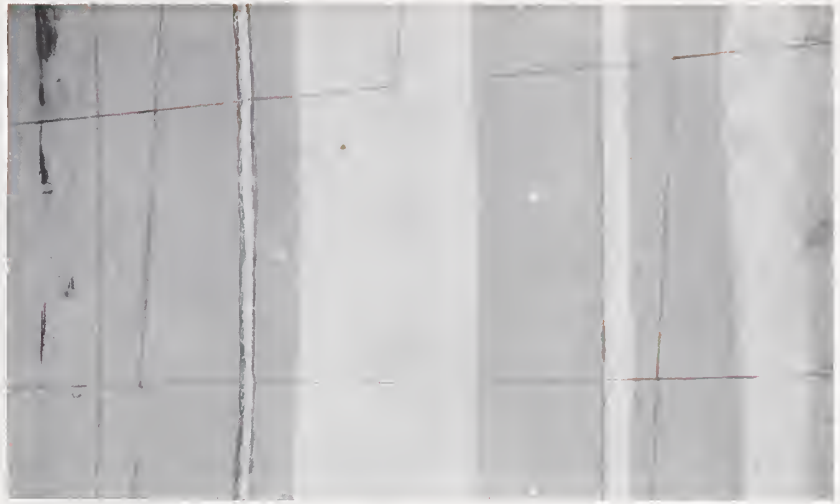
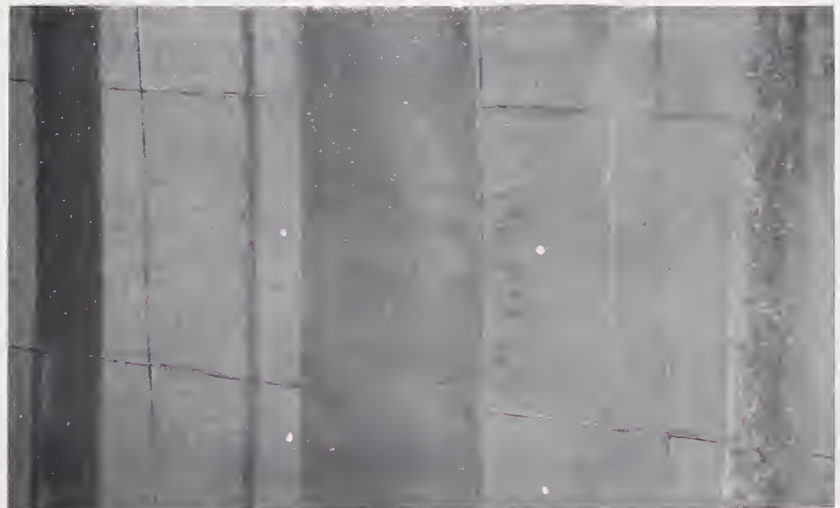
The  $\frac{1}{8}$ -in. and  $\frac{3}{16}$ -in. asphalt tiles, in general, did not stand up well in this test (see figs. 21 to 34 and table 2). With the exception of panels 15L and 15R, the tiles were badly broken and crushed by the steel-tired truck wheel. The tiles in panels 15L and 15R were pitted and

worn to a moderate degree (see figs. 23 and 25). All the tiles were appreciably worn by the abrasive action of the walking wheel (see table 2). On a wood subfloor the tiles were also fractured to a considerable degree by the walking wheel (see figs. 22, 24, 26, 28, 30, 32, and 34). The tiles in panels 15, 16, 17, and 18 showed a tendency to curl. On a wood subfloor with the clay type of asphalt emulsion, panels 16 and 18, there was evidence of considerable failure in bond and the tiles were fractured by the rubber-tired truck wheel (see figs. 24, 26, 28, and 30). In general, the asphalt tiles showed better performance over a concrete subfloor than over a wood subfloor, and the results indicate that complete contact with a firm and even subfloor is essential to prevent the tile from cracking under traffic.

FIGURE 23.— $\frac{3}{16}$ -in. asphalt tile, cumar-resin type, on concrete subfloor (test panel 15L).

FIGURE 25.— $\frac{3}{16}$ -in. asphalt tile, asphalt type, on concrete subfloor (test panel 15R).

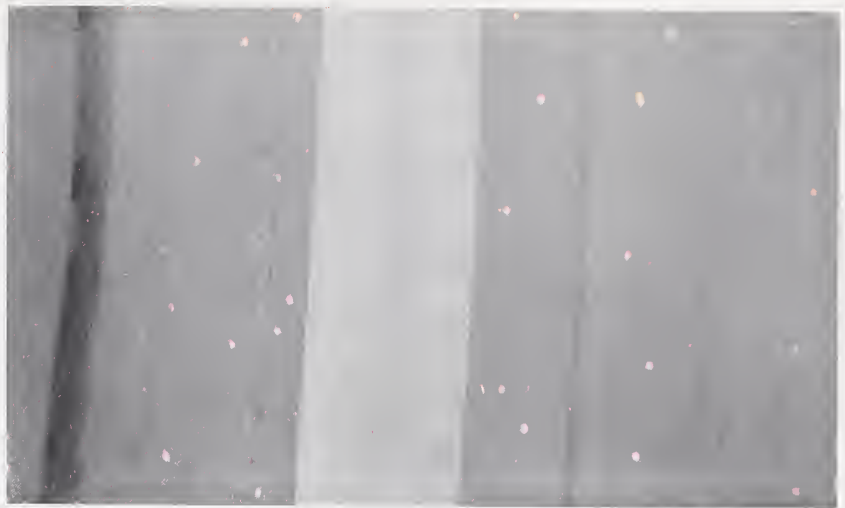
The  $\frac{1}{8}$ -in. brown battleship linoleum, test panels 1R and 2R, was in good condition after exposure to the additional test (see fig. 35 and tables 2 and 3). Along the path of the steel-tired truck wheel there was some failure in adhesion to the concrete subfloor in panel 1R and slight fracture of the linoleum at one end of panel 2R.

FIGURE 35.— $\frac{1}{8}$ -in. battleship linoleum on concrete subfloor (test panel 1R).

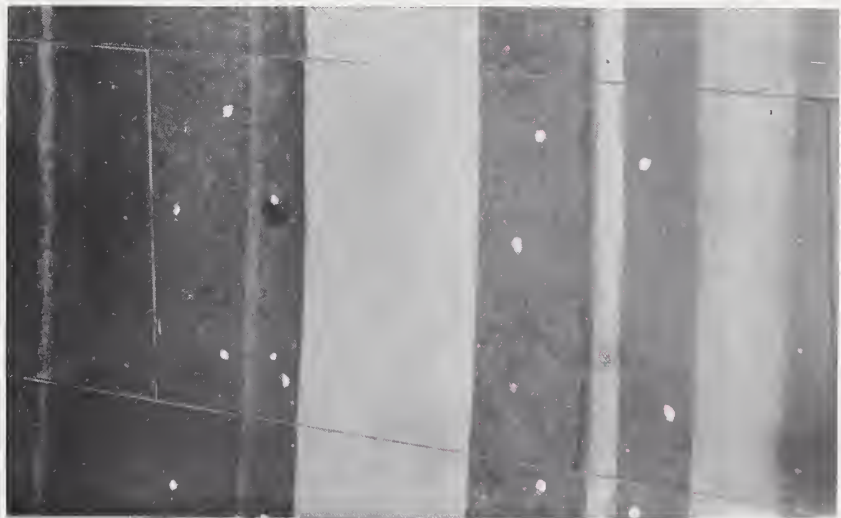
The  $\frac{1}{8}$ -in. pressed fiberboard, test panels 13R and 14R, was in unsatisfactory condition for additional service due to the total depth of wear caused by the abrasive action of the walking wheel during both series of tests (see fig. 37 and table 2). Bond to the subfloors was not complete, as determined by the chatter of the

FIGURE 37.— $\frac{1}{8}$ -in. pressed fiberboard on wood subfloor (test panel 14R).

fiberboards when tapped. On a wood subfloor fractures and separations in the fiberboard were observed along the path of the steel-tired truck wheel (see fig. 37). In panel 14R some of the nail heads were protruding to a slight degree.
