REPORT BMS68

Performance Test of Floor Coverings for Use in Low-Cost Housing: Part 3

PERCY A. SIGLER and ELMER A. KOERNER

ISSUED JANUARY 31, 1941

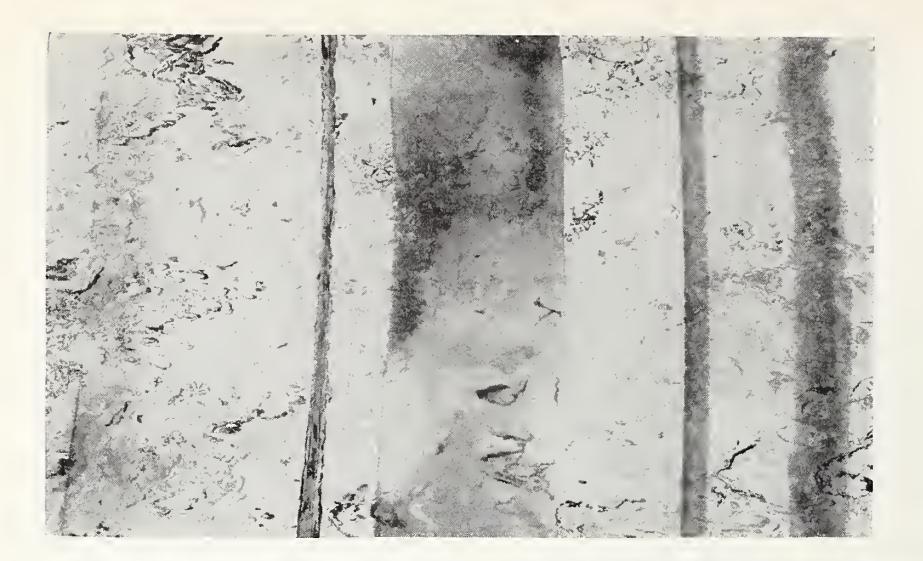
The $\frac{1}{2}$ -in. marbleized linoleums, panels 1L, 2L, 1R, and 2R, showed very good performance, with the possible exception of panel 2L (see figs. 3, 4, 5, and 6). In panel 2L a dry lining felt was used over the strip-wood subfloor. The action of the steel-tired truck wheel caused the dry lining felt to laminate, resulting in an appreciable fracture of the linoleum (see figure 4). In panel 2R, where an asphalt-saturated

FIGURE 3.—½-in. marbleized linoleum on concrete subfloor (test panel 1L).

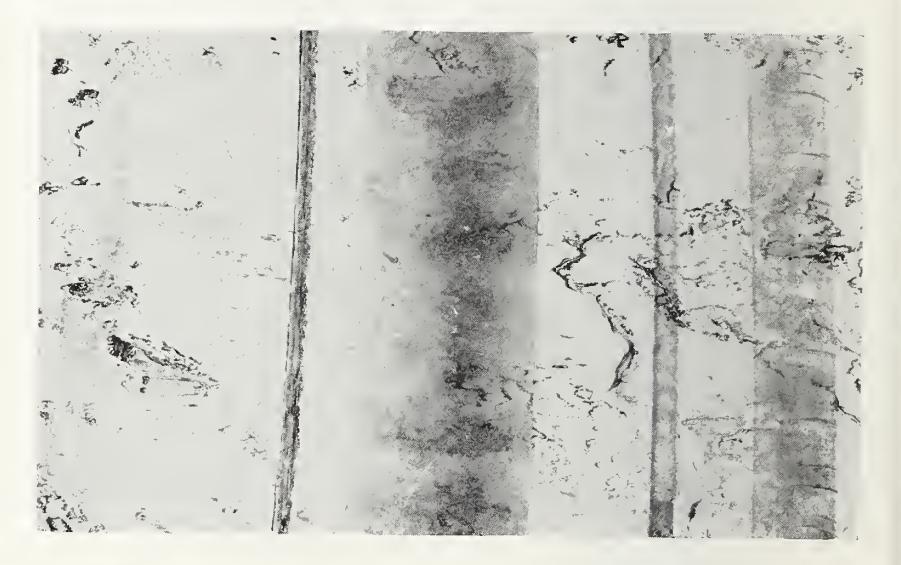
FIGURE 4.—½-in. marbleized linoleum on strip-wood subfloor (test panel 2L).

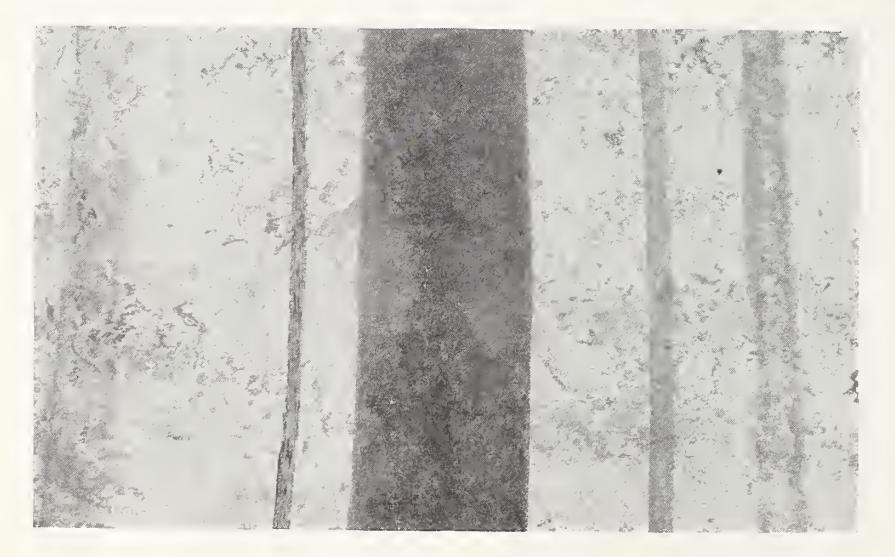
FIGURE 5.—1/8-in. marbleized linoleum on concrete subfloor (test panel 1R).

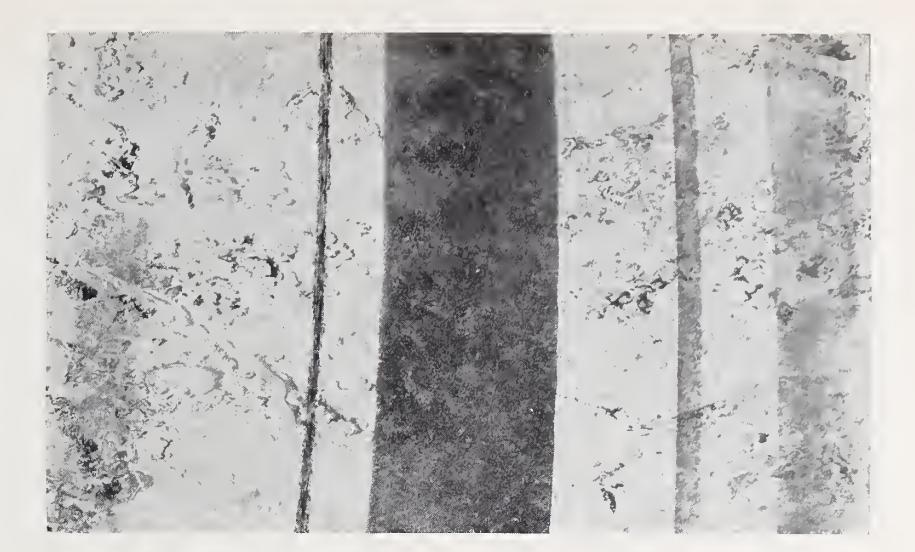
lining felt was used, there was no evidence of separation in the felt and the steel-tired truck wheel caused only slight fracture of the linoleum (see figure 6). The tan marbleized linoleum showed better resistance to abrasion than the white marbleized linoleum (see table 2).

FIGURE 6.—¹/₈-in. marbleized linoleum on strip-wood subfloor (test panel 2R).

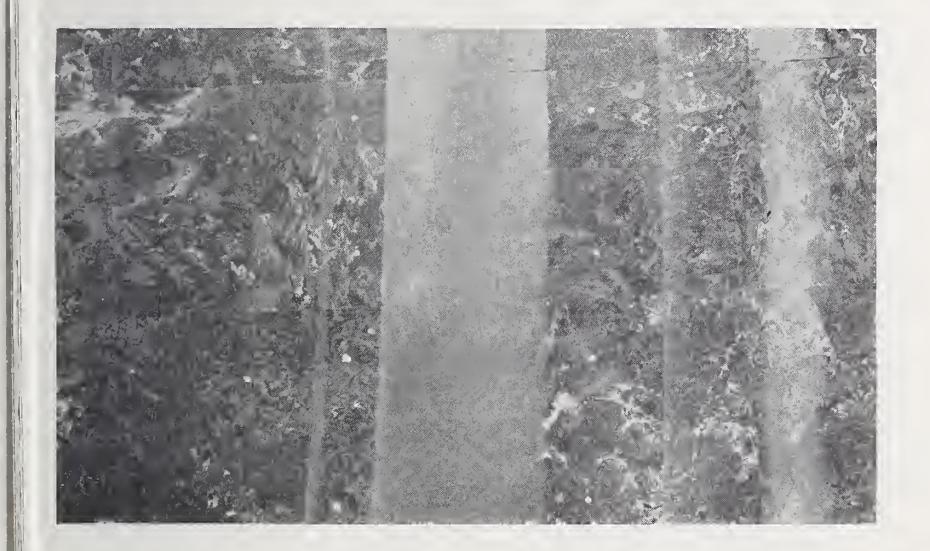
The $\frac{1}{2}$ -in. linoleum tile, panels 3R and 4R, gave very good performance, particularly with reference to abrasion (see figs. 7 and 8). On a concrete subfloor the tiles were fractured slightly by the steel-tired truck wheel.

FIGURE 7.— $\frac{1}{3}$ -in. linoleum tile on concrete subfloor (test panel $\frac{3}{8}$).

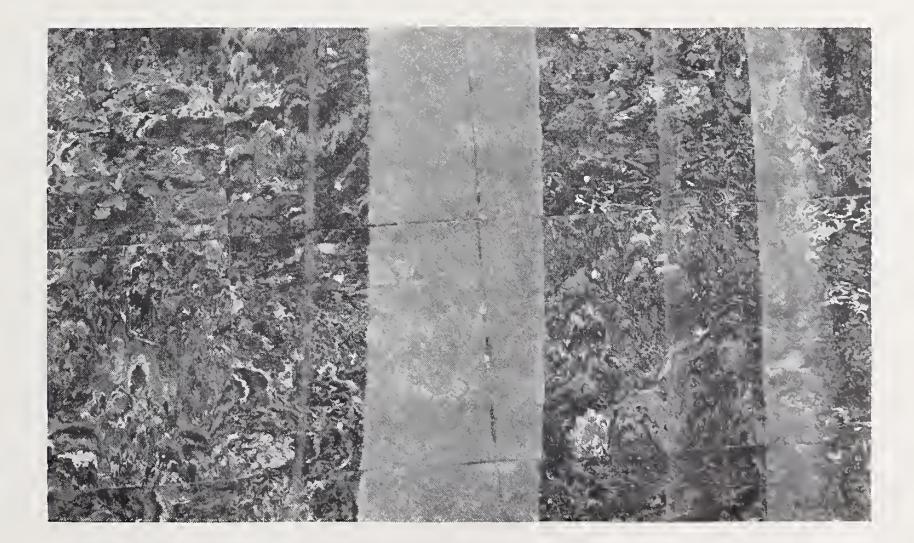
FIGURE 8.— $\frac{1}{6}$ -in. linoleum tile on strip-wood subfloor (test panel 4R).

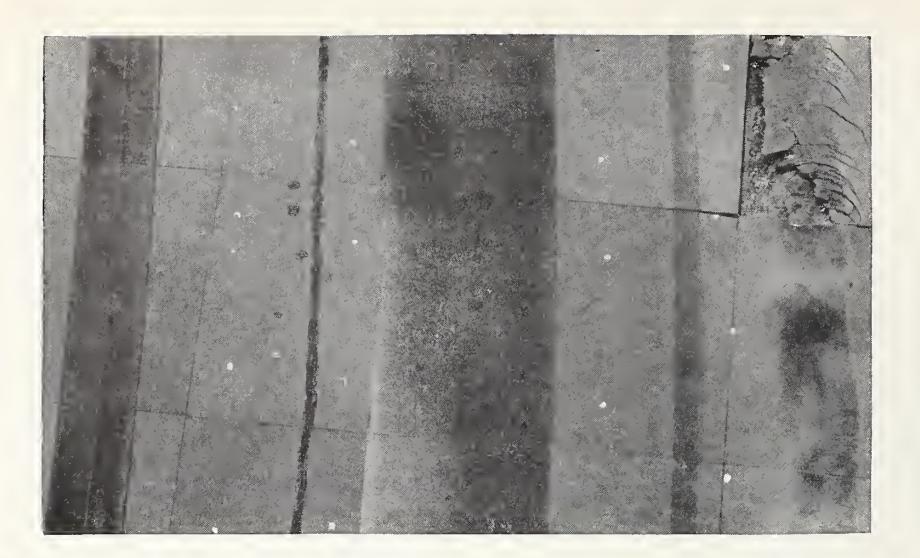
The ¹/₈-in. eork-composition tile, panels 3L and 4L, showed good performance except under the action of the steel-tired truck wheel, which fractured the tiles eonsiderably (see figs. 9 and 10). On a concrete subfloor, panel 3L, tiles along the path of the steel-tired truck wheel showed failure in bond and were fractured at an early stage of the test. They were replaced with new tiles at 1,240 eycles, which proved to be equally unsatisfactory. The tiles showed good resistance to abrasion.

FIGURE 9.—1/s-in. cork-composition tile on concrete subfloor (test panel 3L).

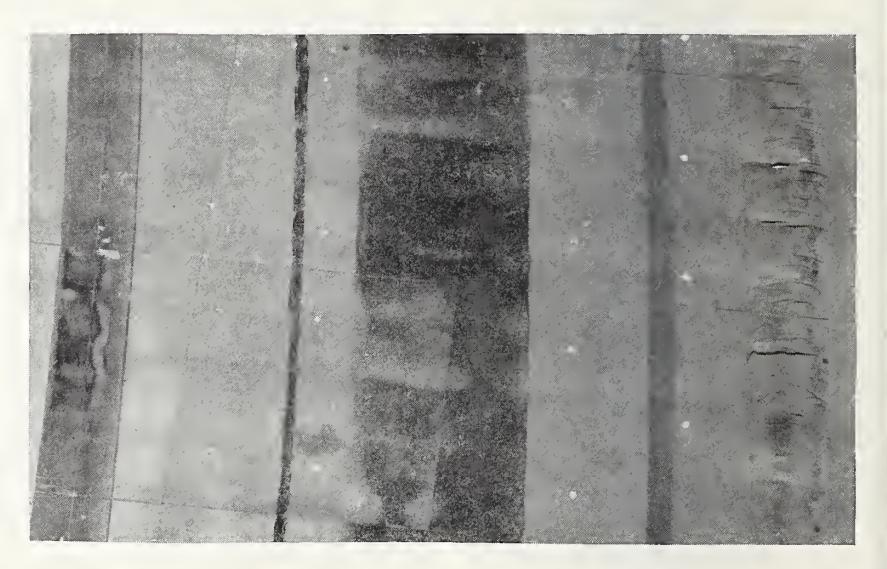
FIGURE 10.—½-in. cork-composition tile on strip-wood subfloor (test panel 4L).

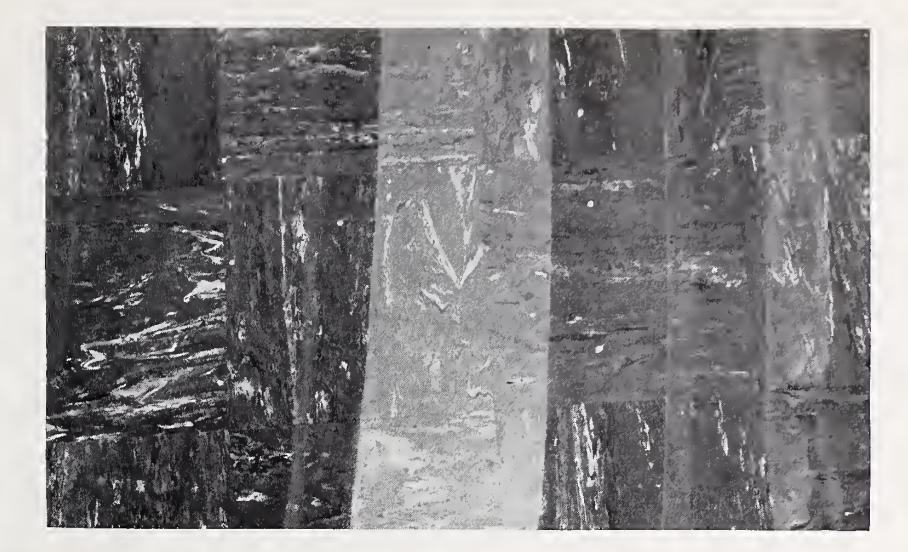
ance test [3]. These floor coverings on a concrete subfloor, panels 5L and 5R, gave very good performance. Along the path of the steel-tired truck wheel there were small welts in the floor eoverings, caused by accumulations of the adhesives (see figs. 11 and 12). The sheet rubber showed slightly better resistance to abrasion than the rubber tile (see table 2 in this report and table 2 in report BMS43).

FIGURE 12.— $\frac{1}{6}$ -in. rubber tile on concrete subfloor (test panel 5R).

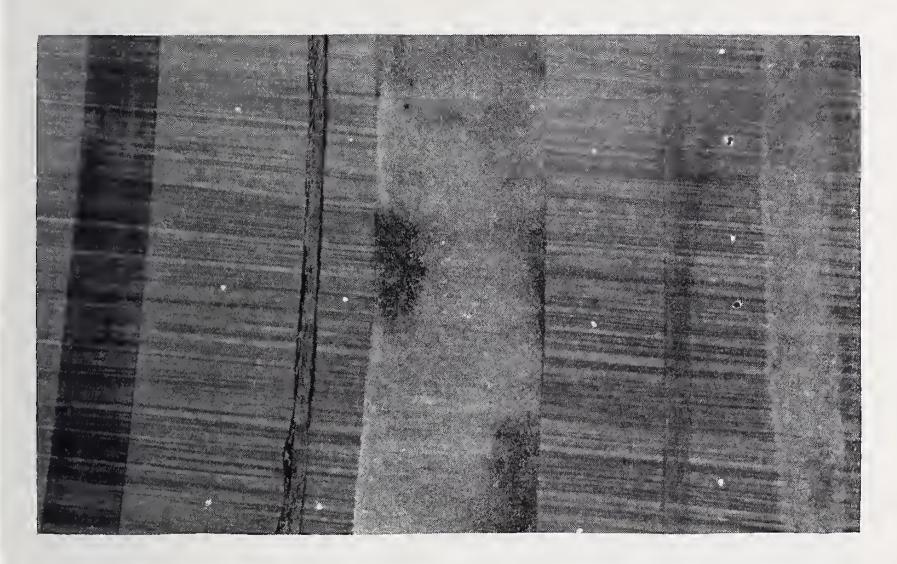
The jaspe linoleum, panel 6L, was an additional portion of a sample used in a previous performance test [2]. In the previous test, extensive failures in adhesion to the subfloors oceurred at an early stage of the test and the linoleum was in unserviceable condition at the end of the test. In the present test, with a different adhesive, there was no evidence of failure in bond and the floor eovering showed good performance (see fig. 13).

FIGURE 13.— $\frac{3}{32}$ -in. jaspe linoleum on concrete subfloor (test panel 6L).

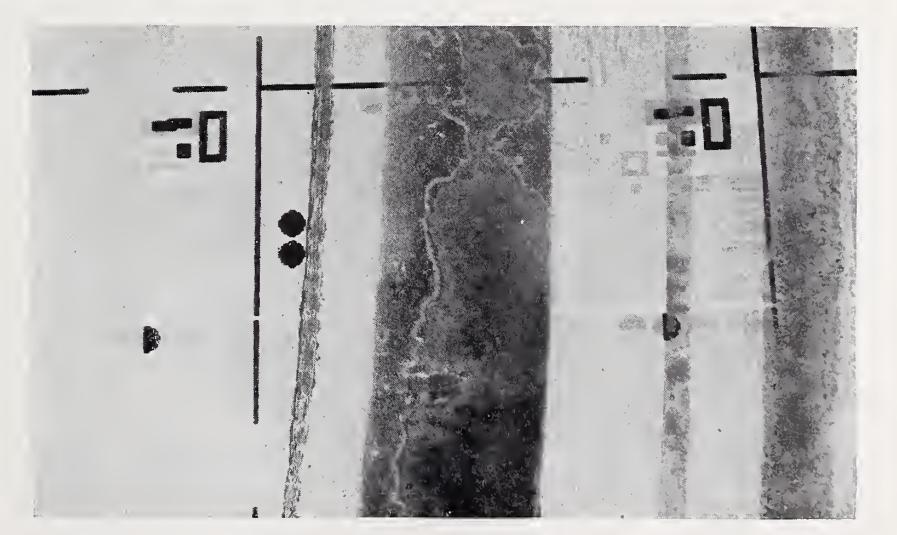
The felt-base floor eoverings with a wearing surface of enamel, panels 6R, 7R, and 8L, gave fair performance eonsidering the type of service for which they are designed. The floor eoverings were in unserviceable condition at the end of the test (see figs. 14, 15, and 16). On a Douglas fir plywood subfloor, panel \mathcal{SL} , the steel-tired truek wheel eaused eonsiderable depression and fracture in the floor eovering (see table 1 and fig. 16); otherwise the floor covering presented a more even surface than is usually obtained on a strip-wood subfloor. The enamel surfaces of the floor coverings were worn through in spots by the walking wheel in approximately 30,000 cycles, or 6,000 cycles after the wheel had been eovered with abrasive eloth. The total depth of wear is shown in table 2.

FIGURE 14.— $\frac{5}{64}$ -in. felt base, enamel wearing surface, on concrete subfloor (test panel 6R).

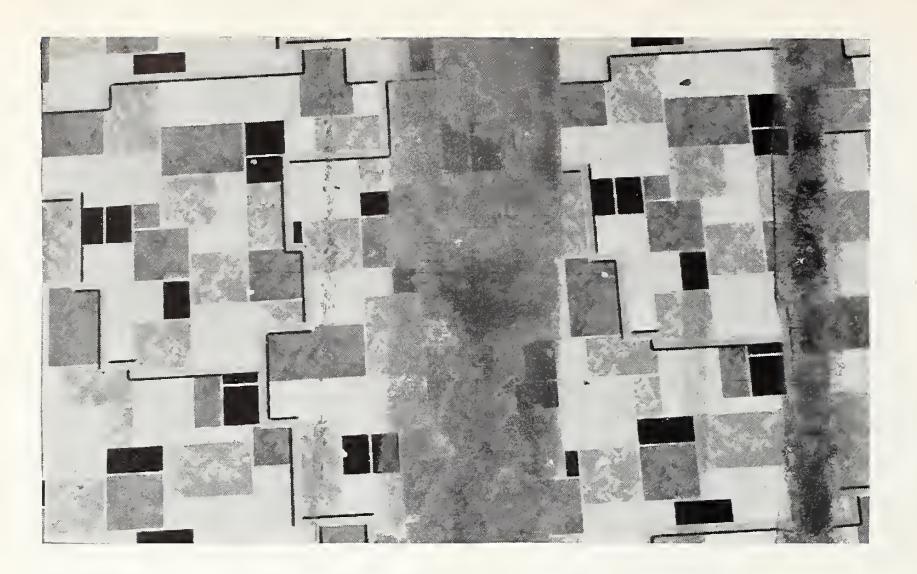
FIGURE 15.— $\frac{5}{44}$ -in. felt base, enamel wearing surface, on concrete subfloor (test panel 7R).

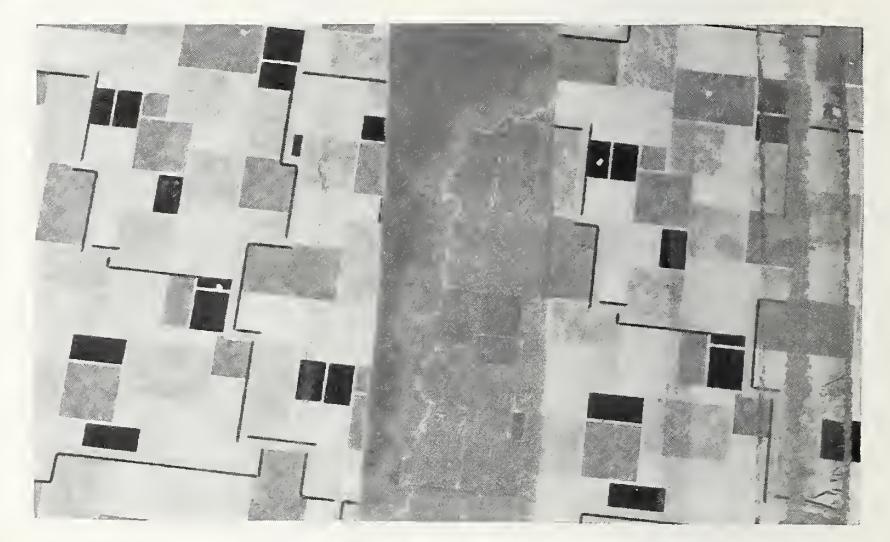
FIGURE 16.— $\frac{5}{64}$ -in. felt base, enamel wearing surface, on plywood subfloor (test panel 8L).

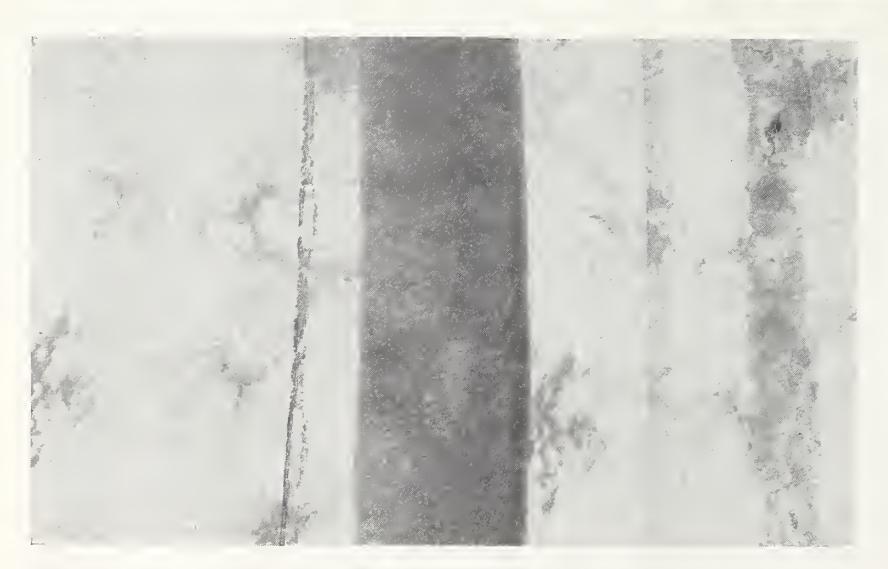
The felt-base floor eovering with a wearing surface eonsisting of a resin-treated eottonlinters sheet, panels 7L and 8R, withstood the test very well. Along the path of the steeltired truck wheel there was some failure in adhesion to the eonerete subfloor and slight fracture of the floor covering (see fig. 17). On a Douglas fir plywood subfloor, panel 8R, the steel-tired truek wheel eaused appreciable depression and slight fracture in the floor eovering (see table 1 and fig. 18). The wearing surface showed good resistance to abrasion.

FIGURE 17.— $\frac{5}{64}$ -in. felt base, resin treated cotton linters sheet wearing surface, on concrete subfloor (test panel 7L).

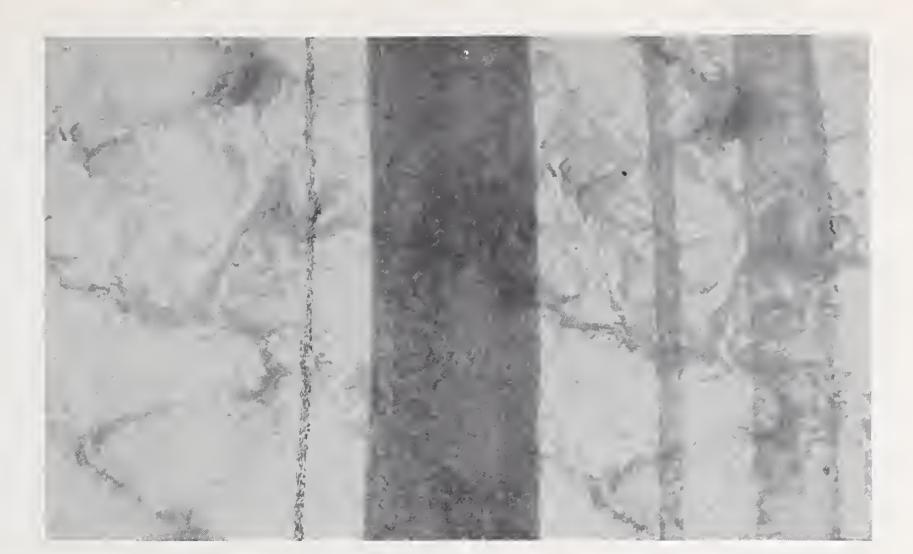
FIGURE 18.—5/4-in. felt base, resin treated cotton linters sheet wearing surface, on plywood subfloor (test panel 8R).

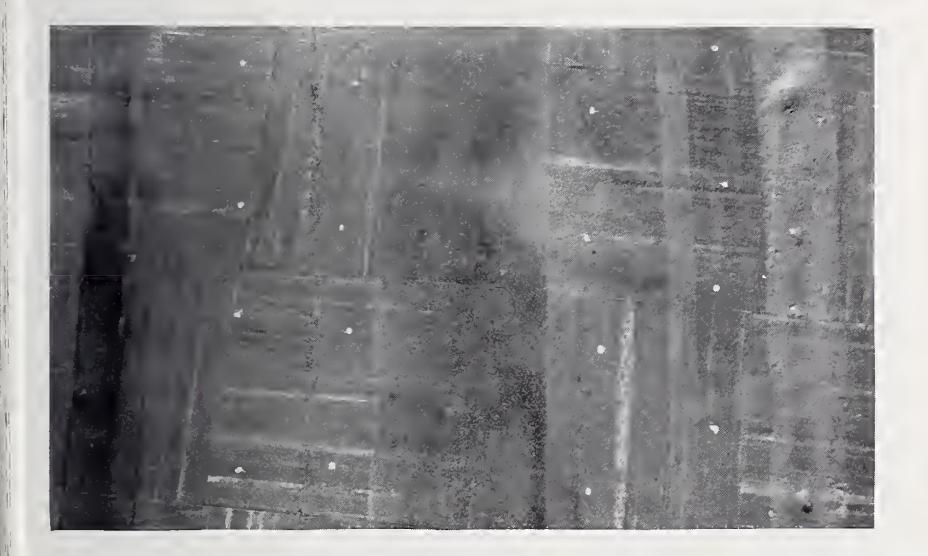
FIGURE 19.—%4-in. felt-base tile, cellulose nitrate composition wearing surface, on concrete subfloor (test panel 9L).

withstood the test very well, with the possible exception of panel 10L (see figs. 19, 20, 21, and 22). On a strip-wood subfloor with a dry lining felt, panel 10L, the steel-tired truck wheel caused separation in the lining felt and displaced some of the tiles (see fig. 20). On a strip-wood subfloor with no lining felt, panel 10R, the $\frac{7}{4}$ -in. tiles were moderately fractured by the steel-tired truck wheel (see fig. 22). Ridges caused by the strip-wood subfloor showed on the surface of the $\frac{7}{64}$ -in. tiles with no underlay whereas they did not show on the surface of the $\frac{5}{64}$ -in. tiles with a felt underlay (compare figs. 20 and 22). The wearing surface of the tiles showed good resistance to abrasion.

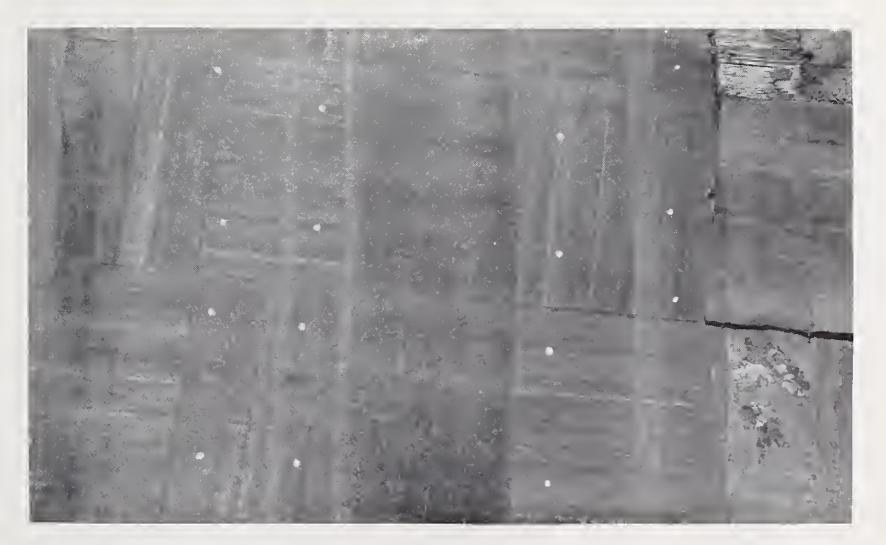
FIGURE 20.—5/64-in. felt-base tile, cellulose nitrate composition wearing surface, on strip-wood subfloor (test panel 10L).

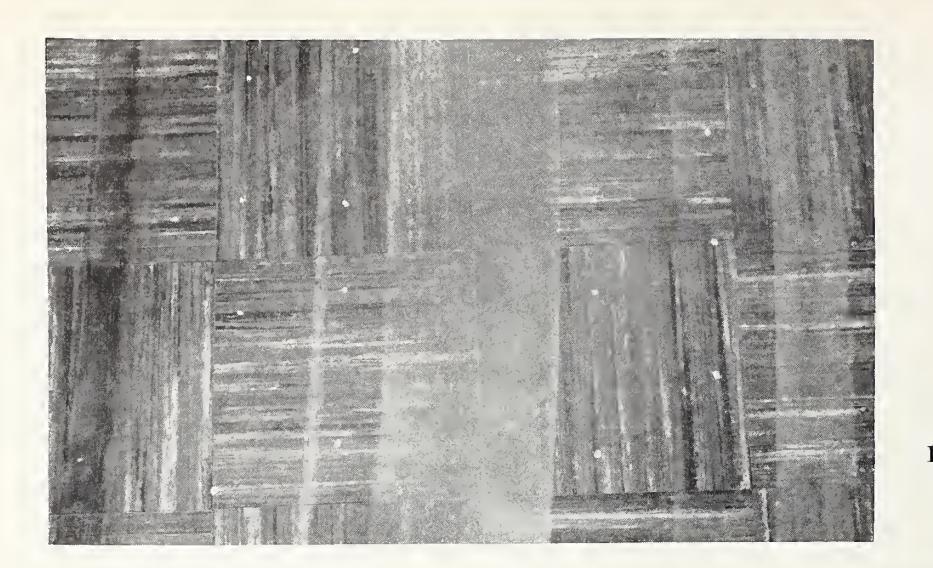
FIGURE 21.—%4-in. fell-base tile, cellulose nitrate composition wearing surface, on concrete subfloor (test panel 9R).

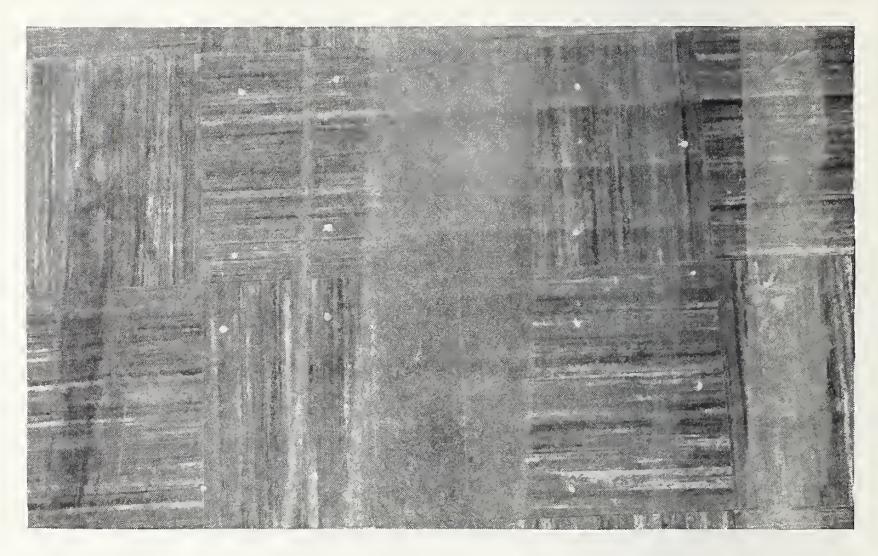
FIGURE 22.—‰4-in. felt-base tile, cellulose nitrate composition wearing surface, on stripwood subfloor (test panel 10R).

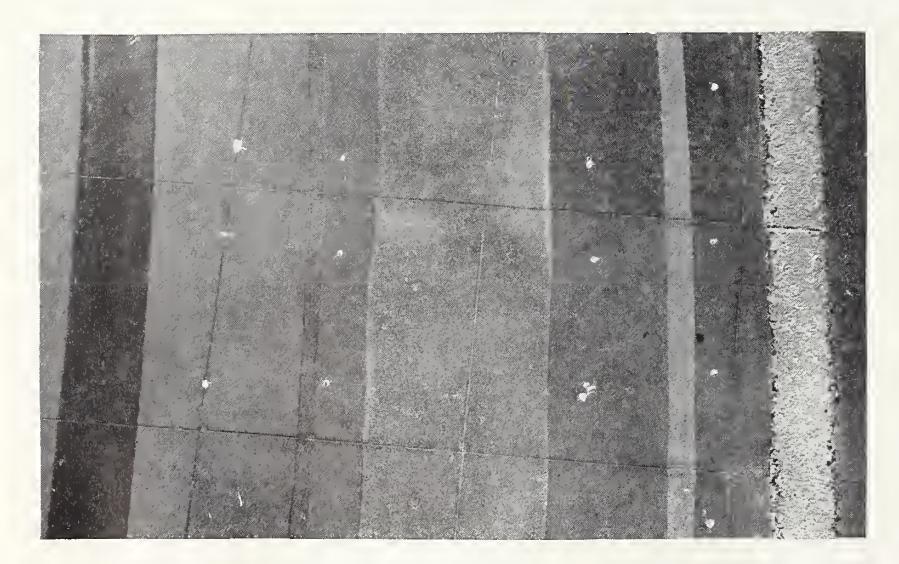
FIGURE 23.—½-in. asphalt tile on concrete subfloor (test panel 11L).

The ¹/₈-in. and the ³/₁₆-in. asphalt tiles showed fair performance on a concrete subfloor (see figs. 23, 24, 27, and 29). They were pitted and worn to a moderate degree by the steel-tired truck wheel (see table 1). The ¹/₈-in. asphalt tiles on Douglas fir plywood subfloors with no underlay, panels 12L and 12R, showed fair performance except under the action of the steel-tired truck wheel, which crushed the tiles completely (see figs. 25 and 26). The ³/₁₆-in. asphalt tiles on a strip-wood subfloor with an underlay of felt, panels 14L and 14R, did not stand up well in this test. The tiles were crushed by the steel-tired truck wheel and were fractured to an appreciable degree by the walking wheel (see figs. 28 and 30). In general, the asphalt tiles were worn to a moderate degree by the abrasive action of the walking wheel (see table 2).

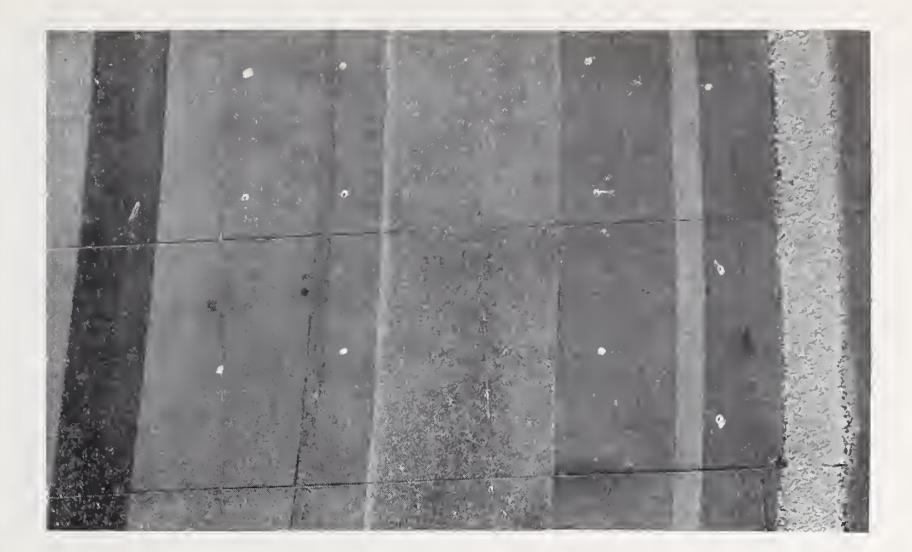
FIGURE 24.— $\frac{1}{6}$ -in. asphalt tile on concrete subfloor (test panel 11R).

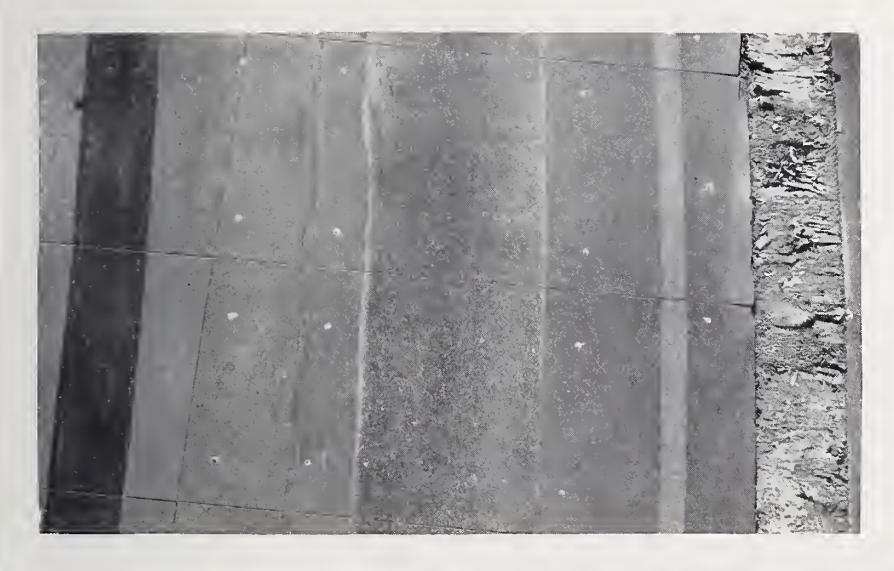
FIGURE 25.—1/8-in. asphalt tile on plywood subfloor (test panel 12L).

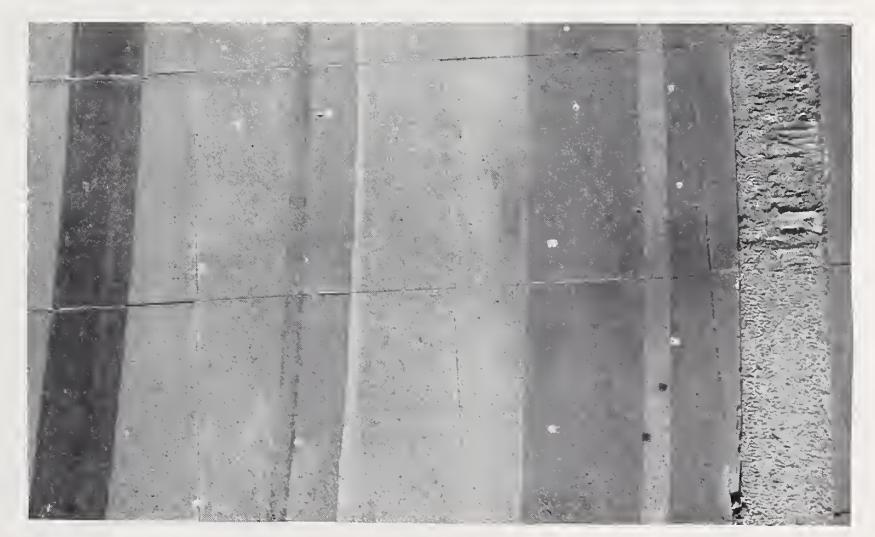
FIGURE 26.— $\frac{1}{8}$ -in. asphalt tile on plywood subfloor (test panel 12R).

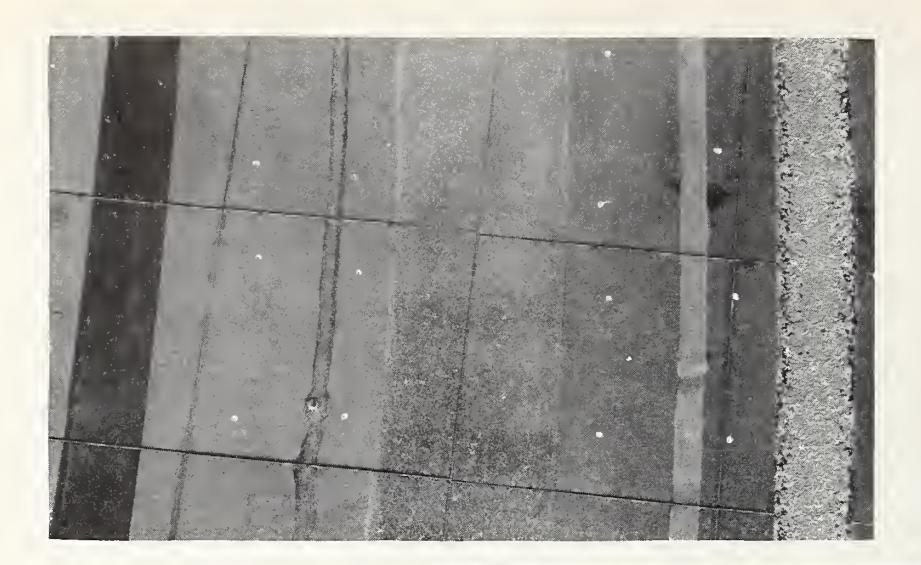
FIGURE 27.— $\frac{3}{16}$ -in. asphalt tile on concrete subfloor (test panel 13L).

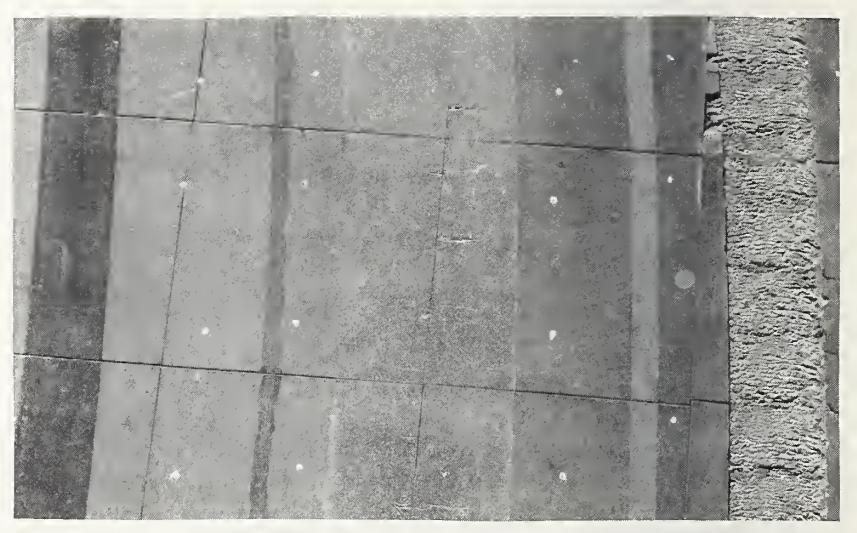
FIGURE 28.—¾6-in. asphalt tile on strip-wood subfloor (test panel 14L).

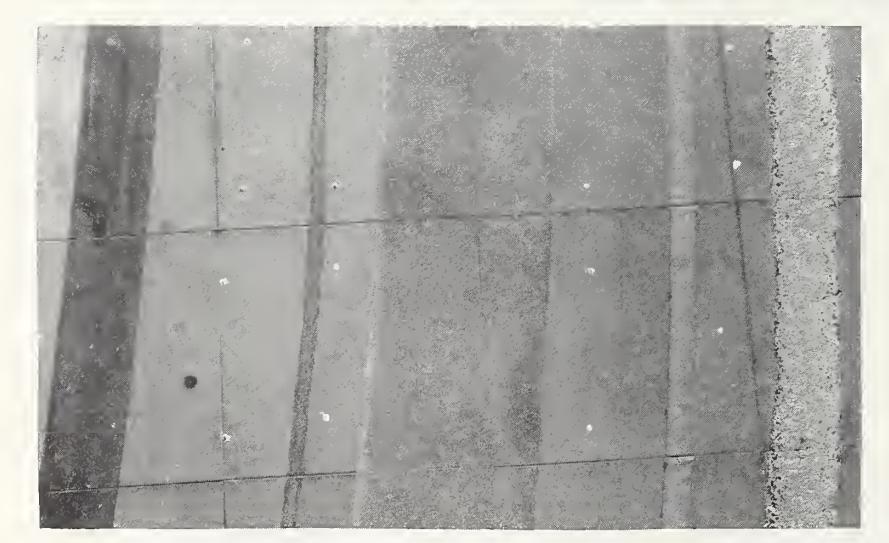
FIGURE 29.—¾6-in. asphalt tile on concrete subfloor (test panel 13R).

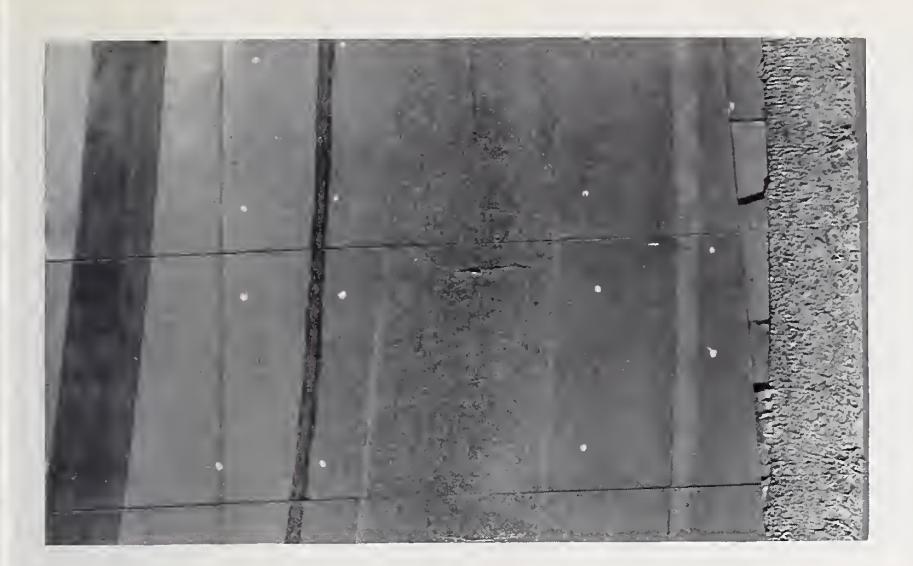
FIGURE 30.— $\frac{3}{16}$ -in. asphalt tile on strip-wood subfloor (test panel 14R).

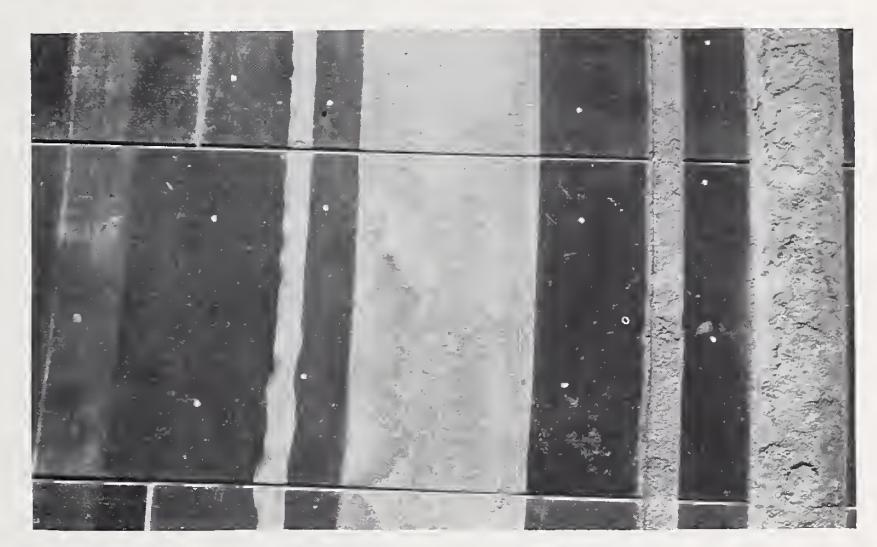
FIGURE 31.— $\frac{1}{4}$ -in. as phaltimpregnated fiberboard tile on concrete subfloor (test panel 15L).

The $\frac{1}{4}$ -in. asphalt-impregnated fiberboard tiles, panels 15L, 16R, and 15R, were in unserviceable condition at the end of the performance test. They were pitted and worn to a considerable degree by both the steel-tired truck wheel and the steel-wheel caster (see table 1 and figs. 31, 32, and 33). The painted surface of the tiles was worn through by the walking wheel in approximately 30,000 cycles, or 6,000 cycles after the application of the abrasive cloth. The total depth of wear is shown in table 2.

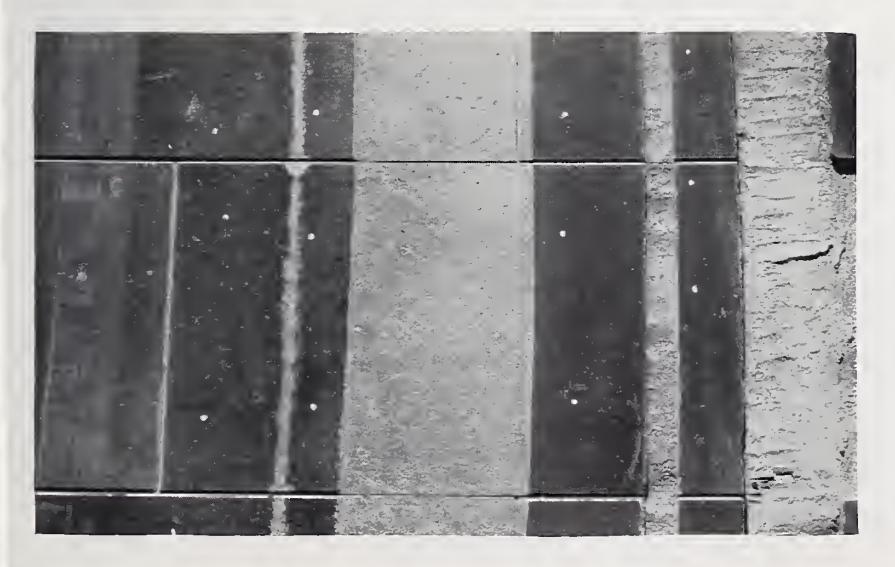
FIGURE 32.— $\frac{1}{4}$ -in. asphaltimpregnated fiberboard tile on plywood subfloor (test panel 16R).

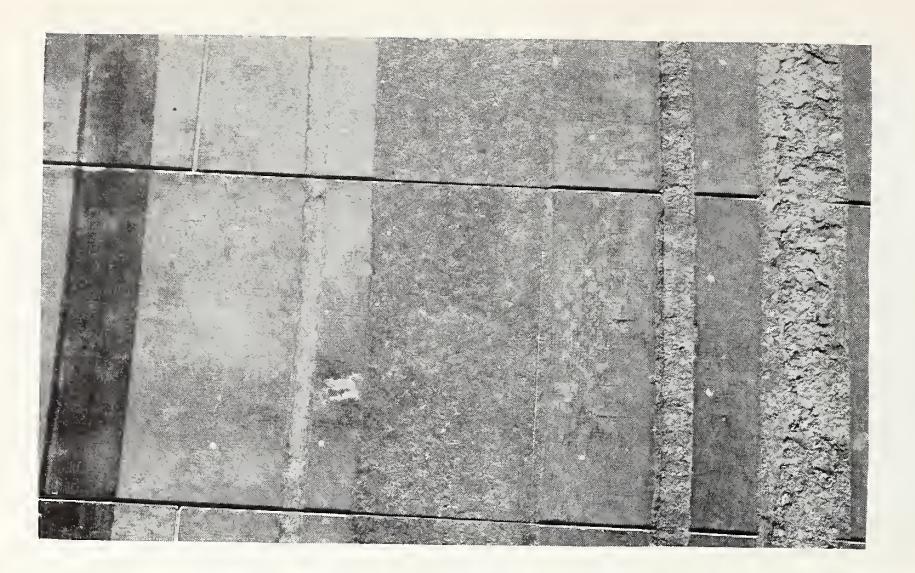
FIGURE 33.— $\frac{1}{4}$ -in. asphalt-impregnated fiberboard tile on concrete subfloor (test panel 15R).

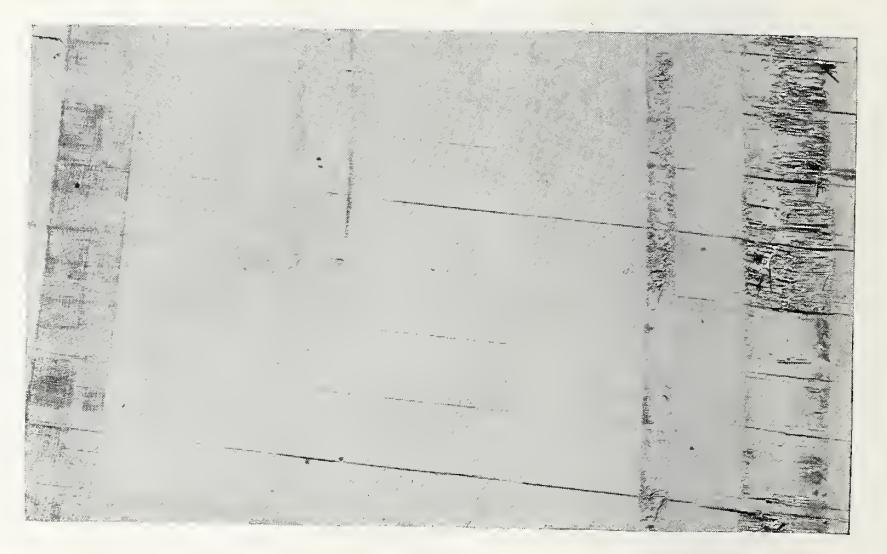
FIGURE 34.—²⁵/₃₂-in. strip Douglas fir on wood sleepers (test panel 16L).

The strip Douglas fir, panel 16L, was in unsatisfactory condition at the end of the test. The flooring was indented and splintered to an appreciable degree by both the steel-tired truck wheel and the steel-wheel caster (see table 1 and fig. 34). The Douglas-fir strip flooring showed poor resistance to abrasion.

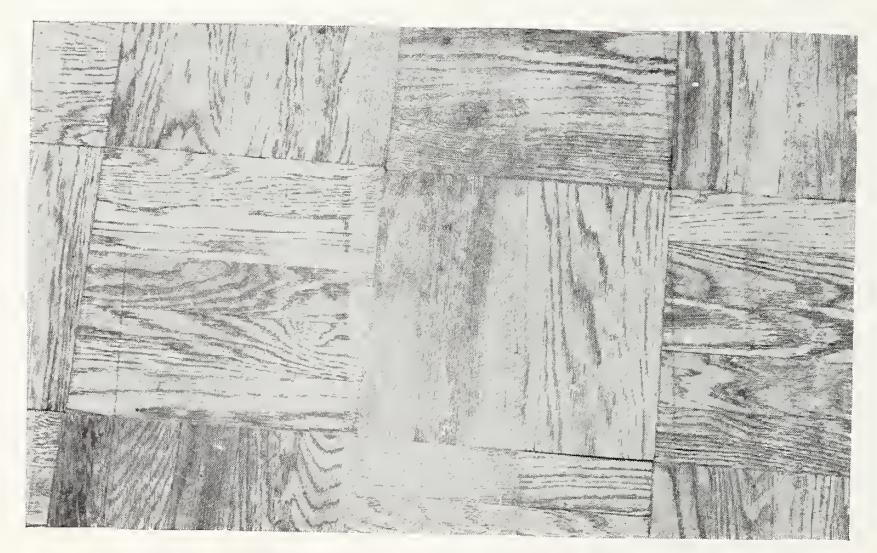
FIGURE 35.—½-in. white-oak unit-block on concrete subfloor (test panel 17L).

The white-oak and the red-oak unit-blocks, panels 17L and 18L, showed good performance. The unit-blocks were moderately compressed, and were fractured or splintered to a slight extent, by the steel-tired truck wheel (see table 1 and figs. 35 and 36). There was no evidence of failure in bond to the subfloors, although the individual strips in the unit-blocks showed a slight tendency to warp. The white-oak unitblocks showed slightly better resistance to abrasion than the red-oak unit-blocks (see table 2).

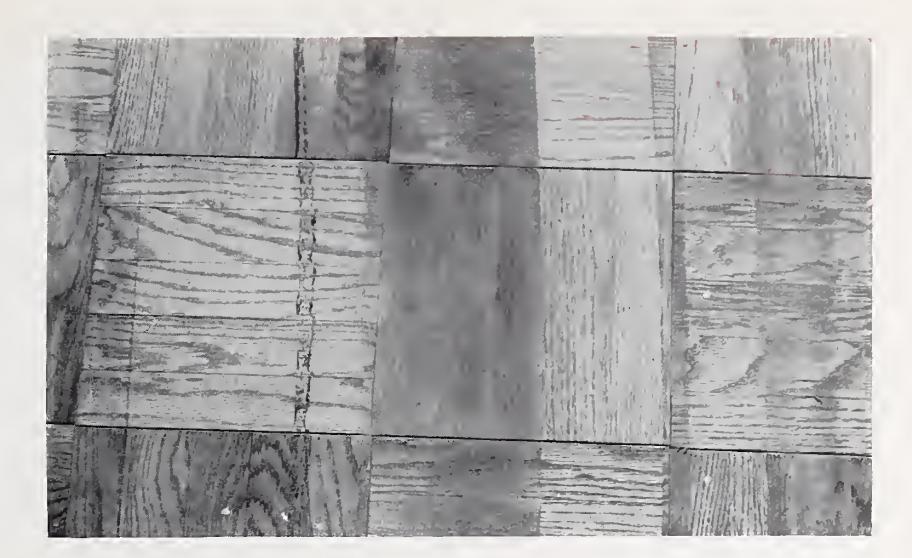
FIGURE 36.—½-in. red-oak unitblock on strip-wood subfloor (test panel 18L).

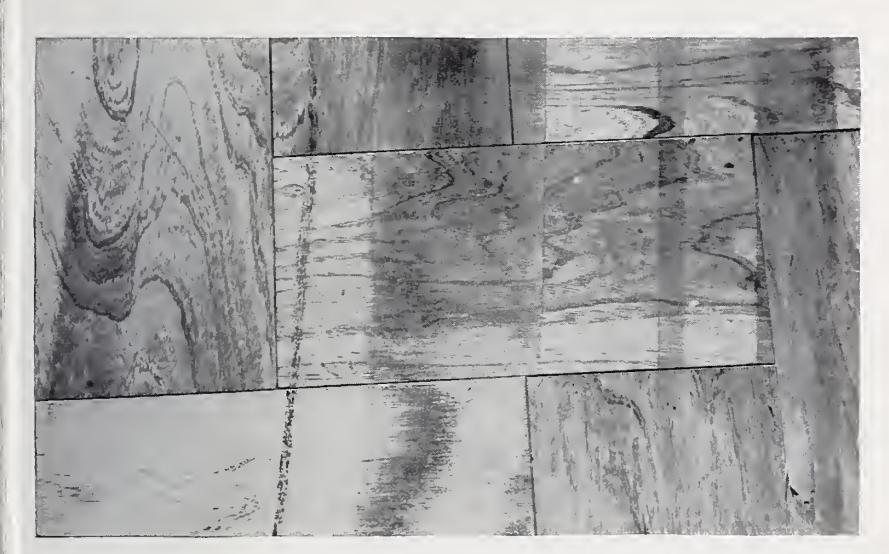
FIGURE 37.— $\frac{1}{2}$ -in. rock-elm plywood tile on concrete subfloor (test panel 17R).

The $\frac{1}{2}$ -in. and the $\frac{3}{8}$ -in. Rock-elm plywood tiles, panels 17R and 18R, were in good condition at the end of the test. The tiles were

moderately compressed by the steel-tired truck wheel (see table 1). There was no appreciable fracturing or splintering of the tiles (see figs. 37 and 38). The ½-in. tile showed better resistance to abrasion than the ¾-in tile (see table 2). The ½-in. tiles showed a slight tendency to warp, and they were not in complete contact with the concrete subfloor over the entire area of the test panel. The ¾-in. tiles laid over a ¼-in. rubberized sisal-fiber mat were held together very well by the metal dowel pins but were noisy when walked upon.

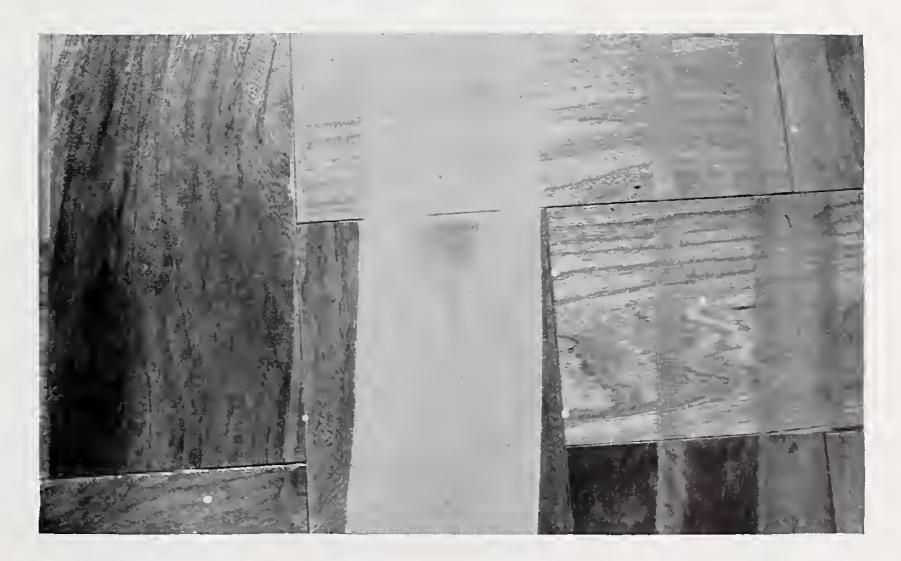
FIGURE 38.—¾-in. rock-elm plywood tile on fiber mat and strip-wood subfloor (test panel 18R).

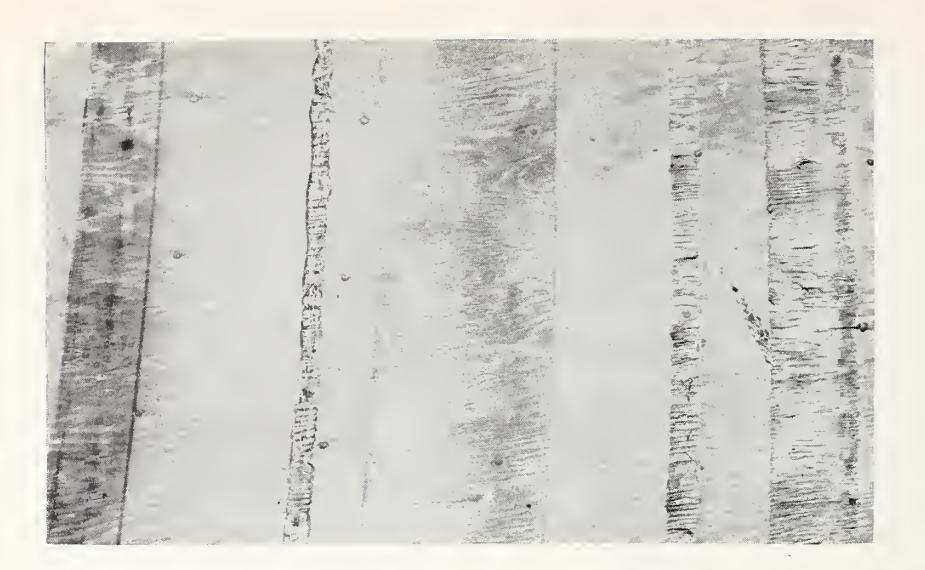
FIGURE 39.—½-in. Douglas-fir plywood on strip-wood subfloor (test panel 19L).

The $\frac{1}{2}$ -in. Douglas-fir plywood, panel 19L, remained in fair condition throughout most of the test, although at the end it was in unsatisfactory condition. The plywood was indented and splintered to an appreciable degree by both the steel-tired truck wheel and the steel-wheel easter (see table 1 and fig. 39). The splintered condition did not oeeur until near the end of the test. The Douglas-fir plywood showed fair resistance to abrasion (see table 2).

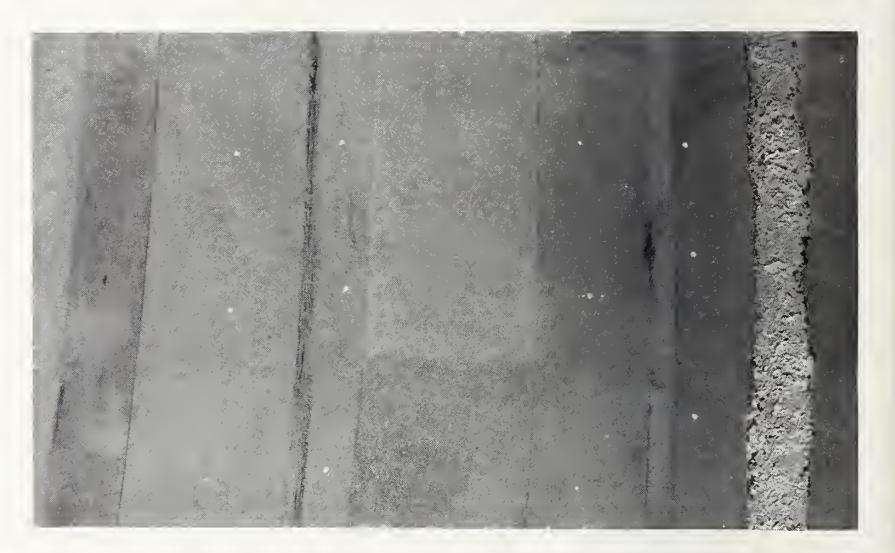
The $\frac{1}{2}$ -in. magnesium-oxychloride composition floor reinforeed with expanded metal, panel 19R, did not show satisfactory performance on a strip-wood subfloor. The floor was pitted and worn appreciably by the steel-tired truck wheel (see table 1 and fig. 40). A fine crack developed in the floor along the entire path of the walking wheel (see fig. 40). The floor showed only fair resistance to abrasion (see table 2).

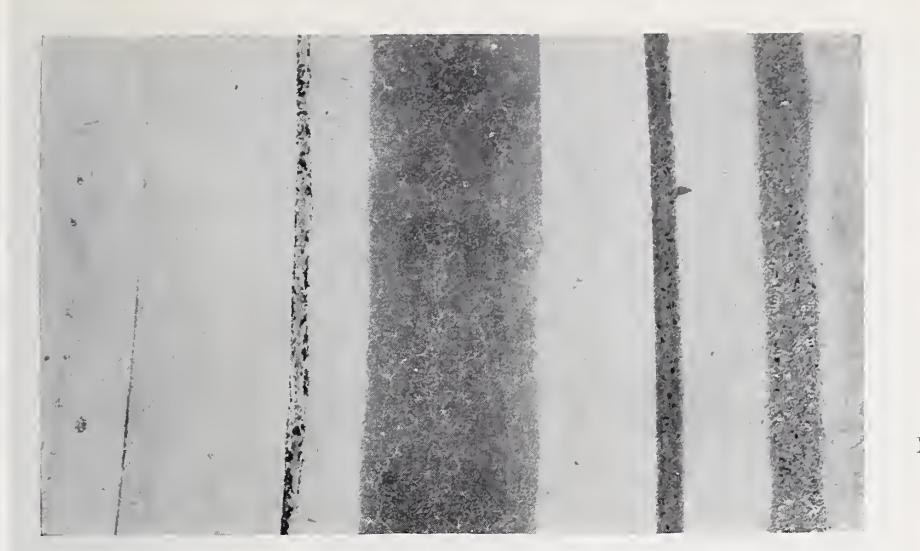
The 1-in. element-mortar topping, panel 20L, showed good performance. The topping was pitted and worn to a slight degree by the steeltired truck wheel (see table 1 and fig. 42). The fine cracks showing along the path of the walking wheel are due to internal shrinkage of the topping. The topping showed fair resistance to abrasion (see table 2).
