NBSIR 73-140

Fire Endurance Test of Plywood-Faced Exterior Walls for Single Family Housing

March 1973

Final Report

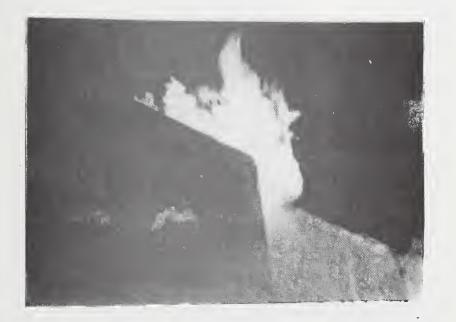
During the test when the flame penetration, shown in Figure 7, occurred at 47 min of test time, the gas supply to the burners was discontinued and thermocouples were disconnected; however, the combustion of the assembly continued. Figure 9 shows the complete burning of the single wall, while the double wall was still providing a barrier to flame penetration.

Since the flame-through occurred at the top of the vertical joint of the assembly and then spread downward, the intended comparison of the two adjacent stud spaces with and without fire stop could not be clearly obtained.

Figure. 7 Location of the flame through.

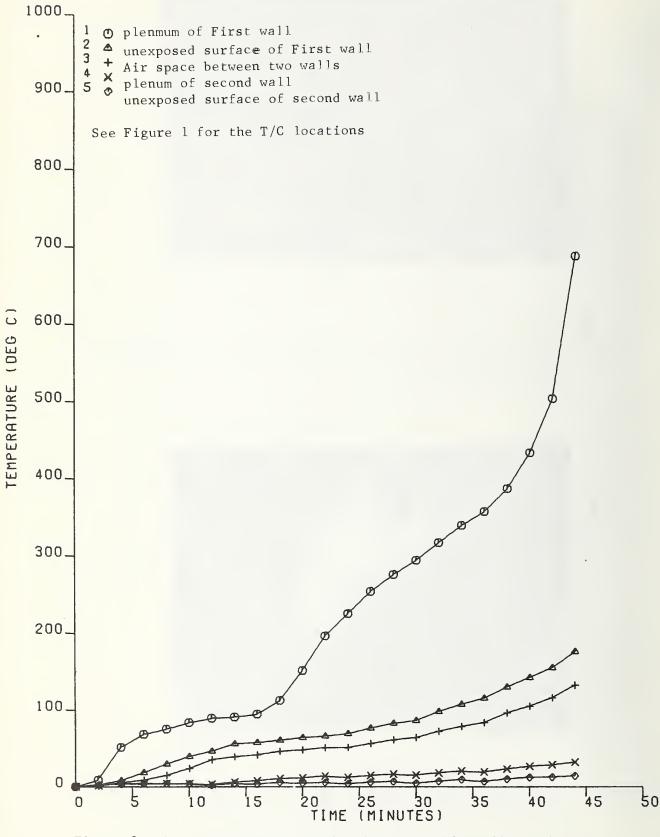
Figure 8. Average Temperature Rise Across Double Wall Panel For Test

The average temperature rise of the unexposed surface of the double wall at 43 min was 15°C (27°F). The average unexposed surface temperature rise and average temperature rise vs. time across the double wall are shown in Figure 8. A comparison of the average temperature rises of three groups of thermocouples on the unexposed surface of the first wall is shown in Figure 5. The three groups of thermocouples consisted of (1) 4 surface thermocouples under pads on the double wall side; (2) 4 thermocouples without pads on the double wall side; (3) 4 surface thermocouples under pads on the single wall side.

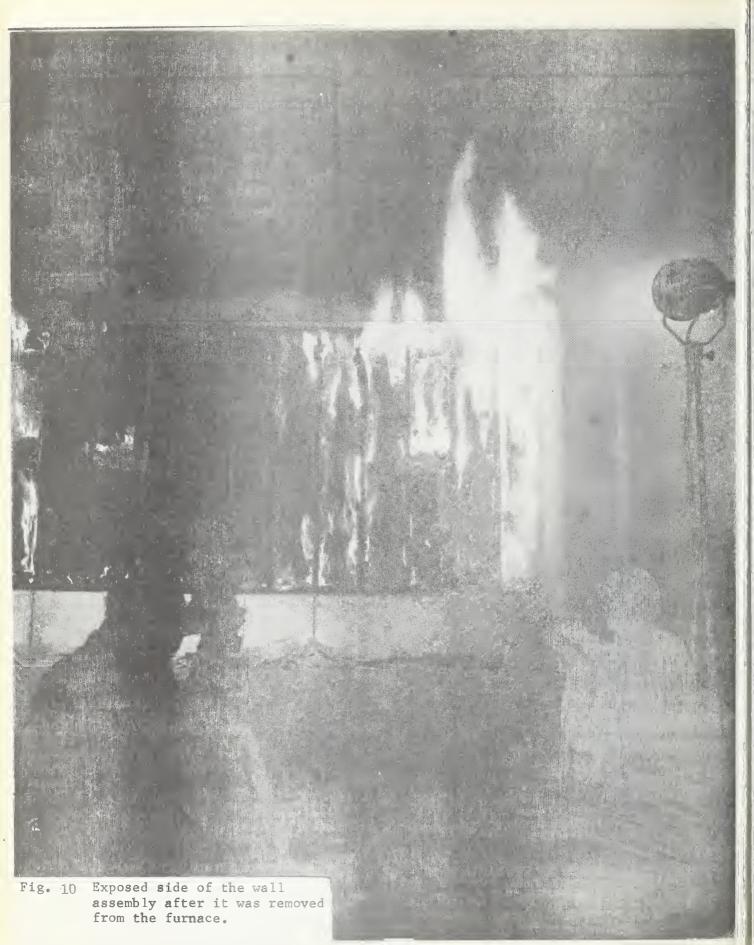
Figure 9, taken at 55 min of test time, shows burning of the single wall portion. Some flame and gray smoke are visible at top of the double wall portion. Flame penetration had taken place at the top of the double

wall portion, but had not yet penetrated to the unexposed surface of the double wall. The failure time of the double wall portion was estimated to be 1 hr 02 min when the unexposed gypsum board was losing contact with the wood studs. Figure 10, taken at approximately 1 hr 15 min of test time, shows the exposed side of the assembly after it was moved from the furnace while water was being applied from a fog nozzle.

Fig. 9 Complete burning as a gle wall while the sexpose of the double
