# NBSIR 73-167 Fire Endurance Test of a Roof/Ceiling Construction of Paper Honeycomb and Gypsum Board

Final Report

# Fire Endurance Test of a Roof/Ceiling Construction of Paper Honeycomb and Gypsum Board

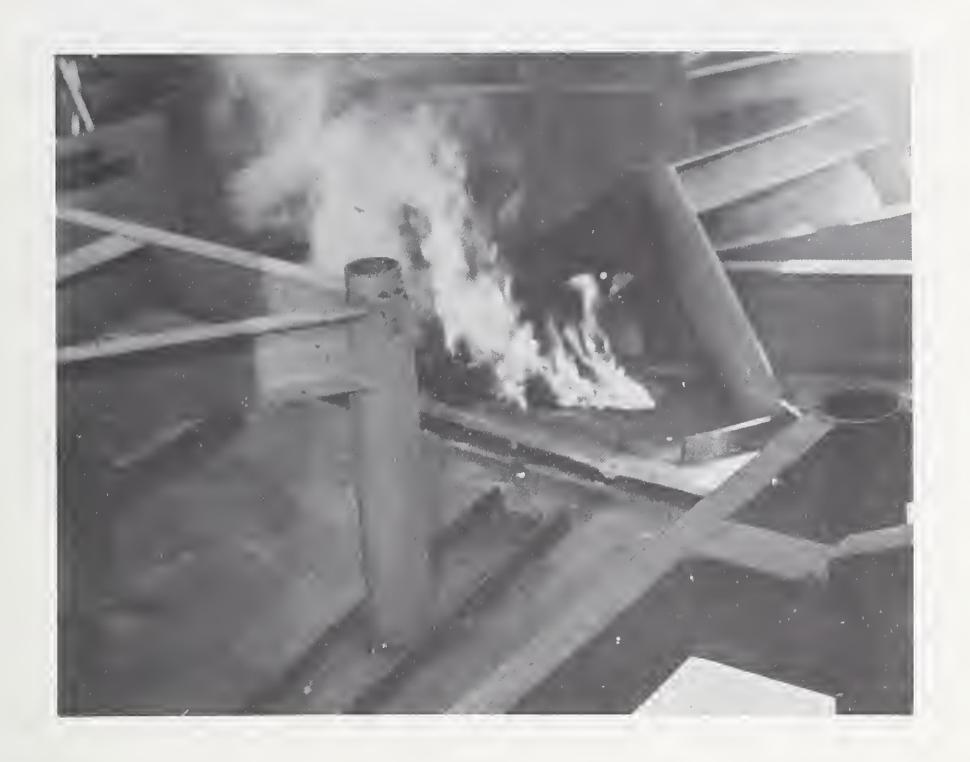
Figure 6. Flame through near center, with local load failure.

Failure occurred at an observed time of 37 min. 50 sec. by flamethrough at the unexposed surface through a joint in the gypsum boards of one of the panels. A local load failure occurred about 10 sec. later at the site of the flame penetration.

The local distintegration of the gypsum board under one of the loading members probably accelerated by the burnout of the supporting core, provided the opening for the initial breakthrough of flame to cause failure. Effects of the fire exposure on the underside of the specimen can be seen in figures 8 and 9.

- 37:50 Flame-through occurring at the point where the gypsum board was failing under a loading point (see Figure 6).
- 38:00 Pieces of the upper layer of gypsum board at this loading point falling into the furnace (a local load failure).

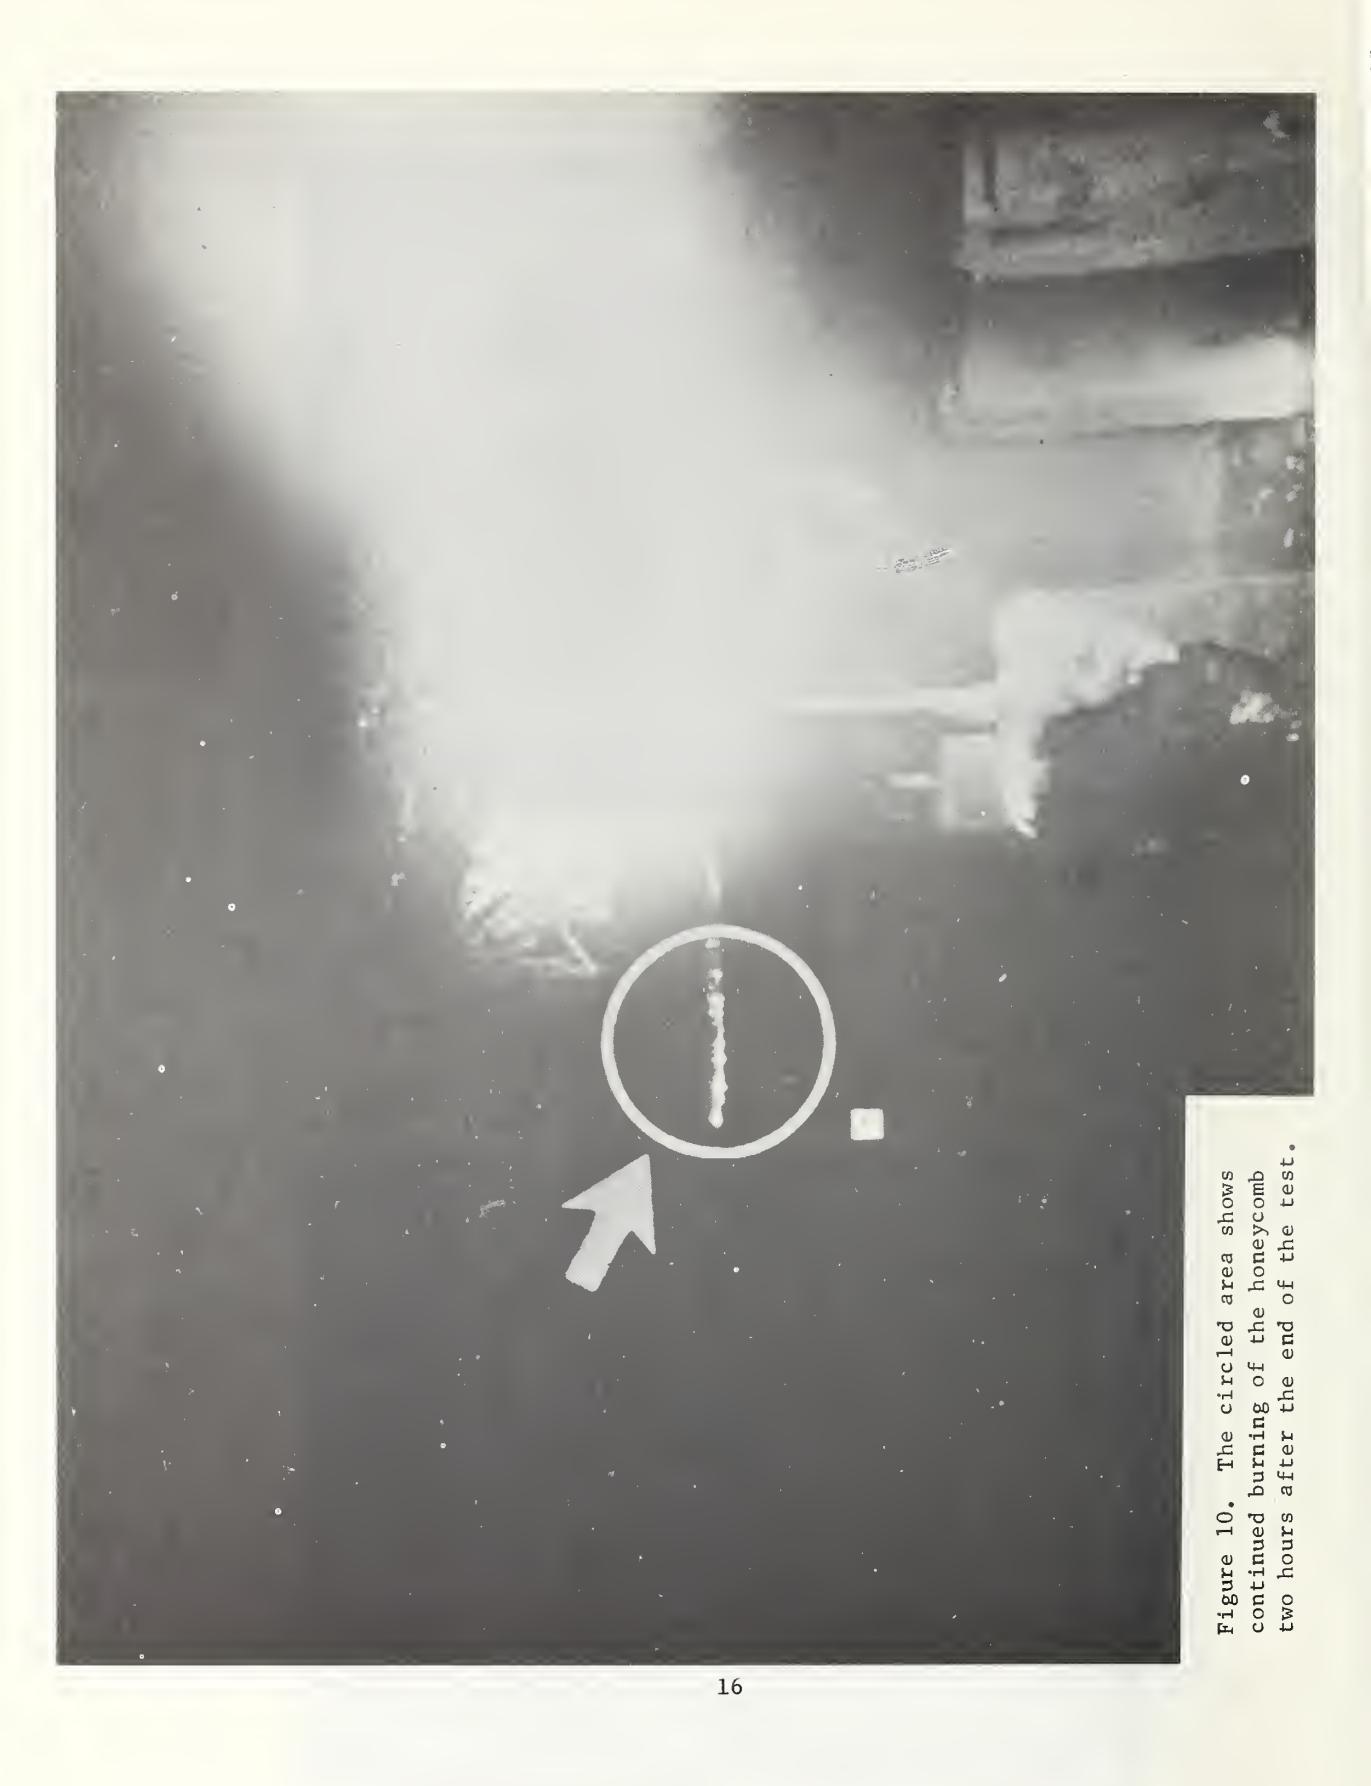
The flame retardant treatment said to have been applied to the paper honeycomb core apparently did little or nothing to prevent its destruction when exposed to fire. After test, the paper honeycomb core continued to smolder for several hours with occasional eruption into open flaming. Figure 10 shows flaming of the core material two hours after application of a water spray from a fog nozzle at the conclusion of the fire exposure.
