NBSIR 73-173

# Fire Endurance Tests of Double Module Walls of Gypsum Board and Steel Studs

April 1973

Final Report

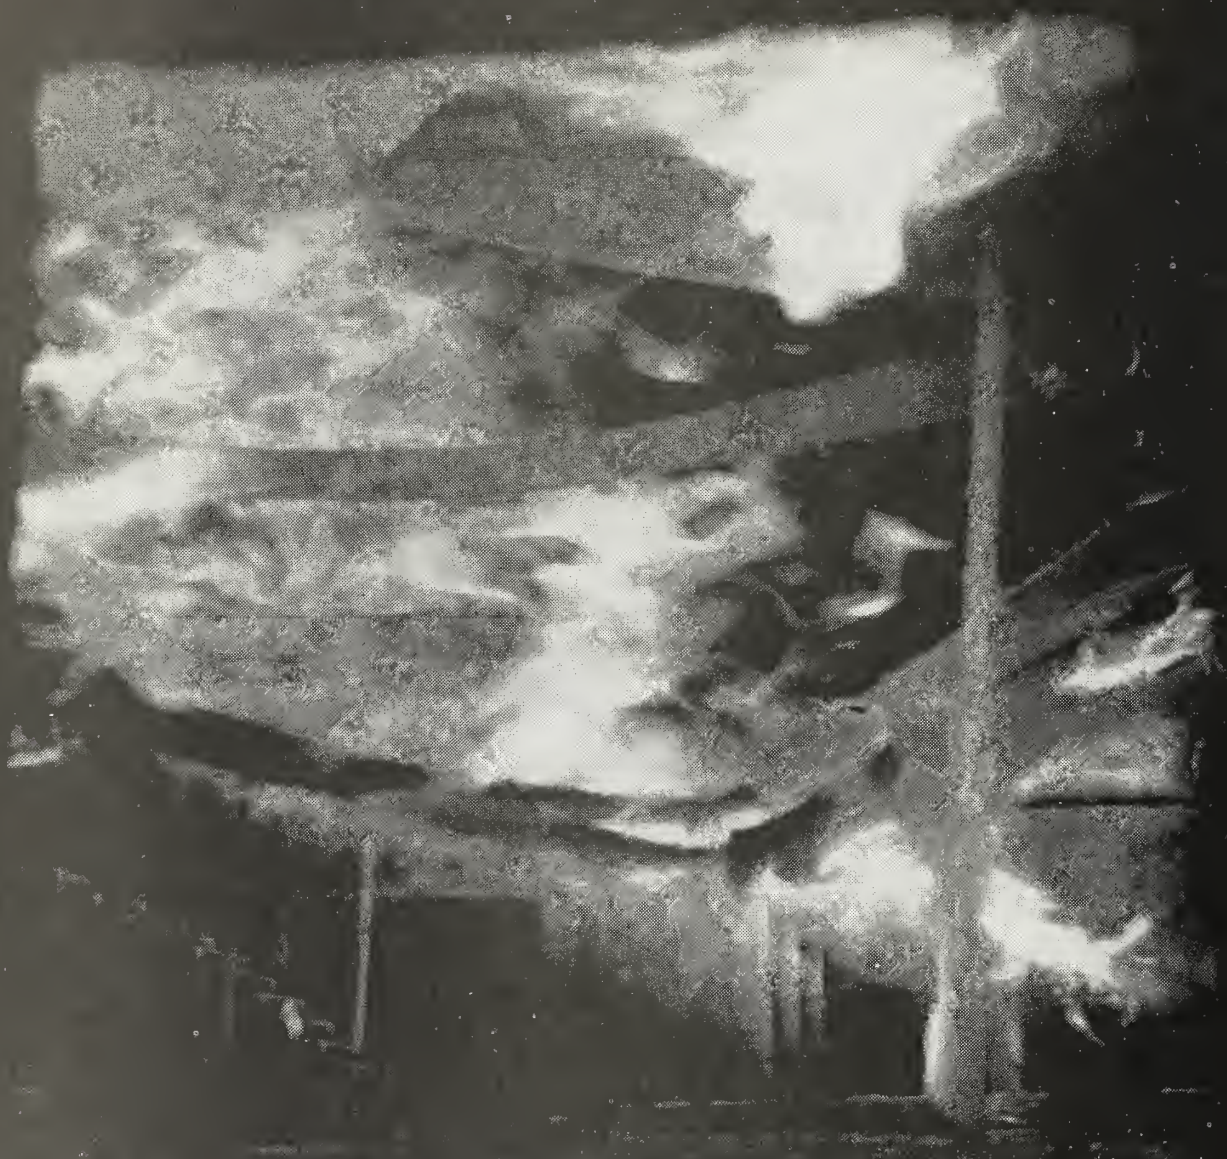
appeared in a fire exposed board at 21 minutes, and in all boards on the fire side by 34 minutes, with visible buckling. By 41 minutes, just prior to failure, there was considerable falling away of the fire exposed board, exposing the studs in the inner wall (fire-exposed). At 58 minutes the boards of the inner wall had fallen away sufficiently to allow full exposure of the inner face of the outer wall. Just prior to failure of the outer wall, there was considerable opening of board joints with consequent rapid buckling of the studs.

An examination of the walls after the tests indicated that the "C" type studs of the first test specimen twisted in failure, probably because of their asymmetry, while the tubular studs of the second test specimen exhibited simple buckling, which left the welds intact (Figures 12 and 13, respectively). The studs were changed to the tubular shape for the second test specimen to provide higher strength without increase in wall thickness. An alternate method of obtaining a higher fire endurance level with the "C" type studs would be by the use of additional layers of gypsum board.

Figure 12 - First Test Specimen, Exposed Side Near End of Test, Studs Twisted

From the results of these tests, it can be seen that a single layer of 5/8-inch Type "X" gypsum board will not provide protection to "C" type steel studs from failure under load for a one hour fire endurance period. Besides the applied load, critical factors include the size and shape of the studs and the quality of the gypsum board joints. In these tests a particular source of weakness appeared to be the joints between the gypsum boards where the filling compound was either quickly destroyed or loosened, allowing rapid heat transmission to the studs. This suggests that a better practice would be the use of a two layer construction, with application of the boards staggered to eliminate direct heat access to the steel through joints.

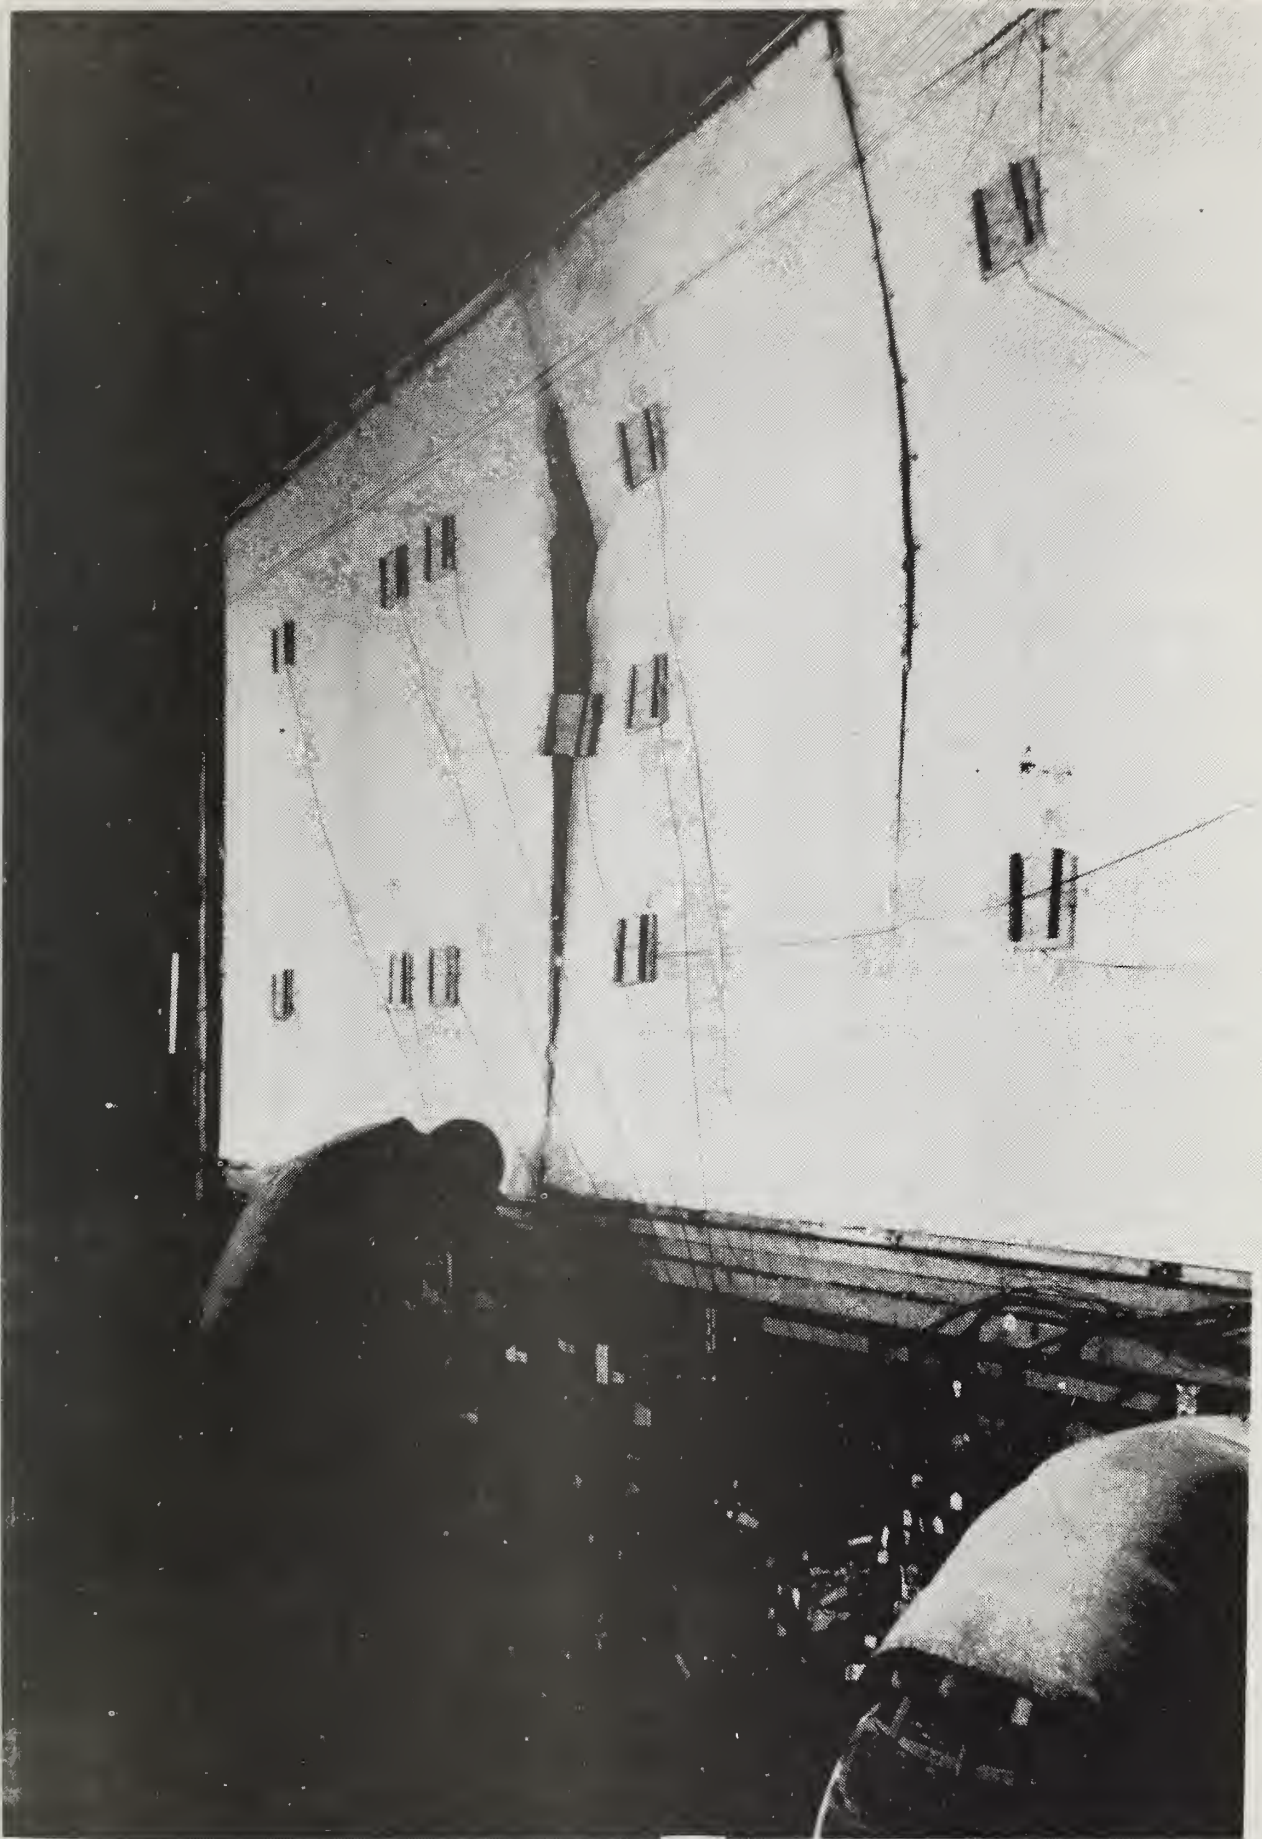
Visual observations indicated flaming occurred at the joints on the fire-exposed surface at 3 minutes. Cracks in the boards appeared at 23 minutes and by 34 minutes had opened to about 3/8 inch. At 48 minutes an end panel began to disintegrate, exposing the fiber glass insulation. By 1 hour the studs of the exposed wall were bowing toward the fire leading to load failure at 1 hour 7 minutes. By 1 hour 20 minutes enough of the wall next to the fire had fallen away to expose a considerable portion of the second wall. After this there was progressive opening of the joints of the second wall, on the side toward the fire

Figure 13 - Second Test Specimen, After Test, Showing Buckling of Unexposed Wall
