NBSIR 73-263

Fire Endurance Tests of Unprotected Wood-Floor Constructions for Single-Family Residences

July 1973

Final Report

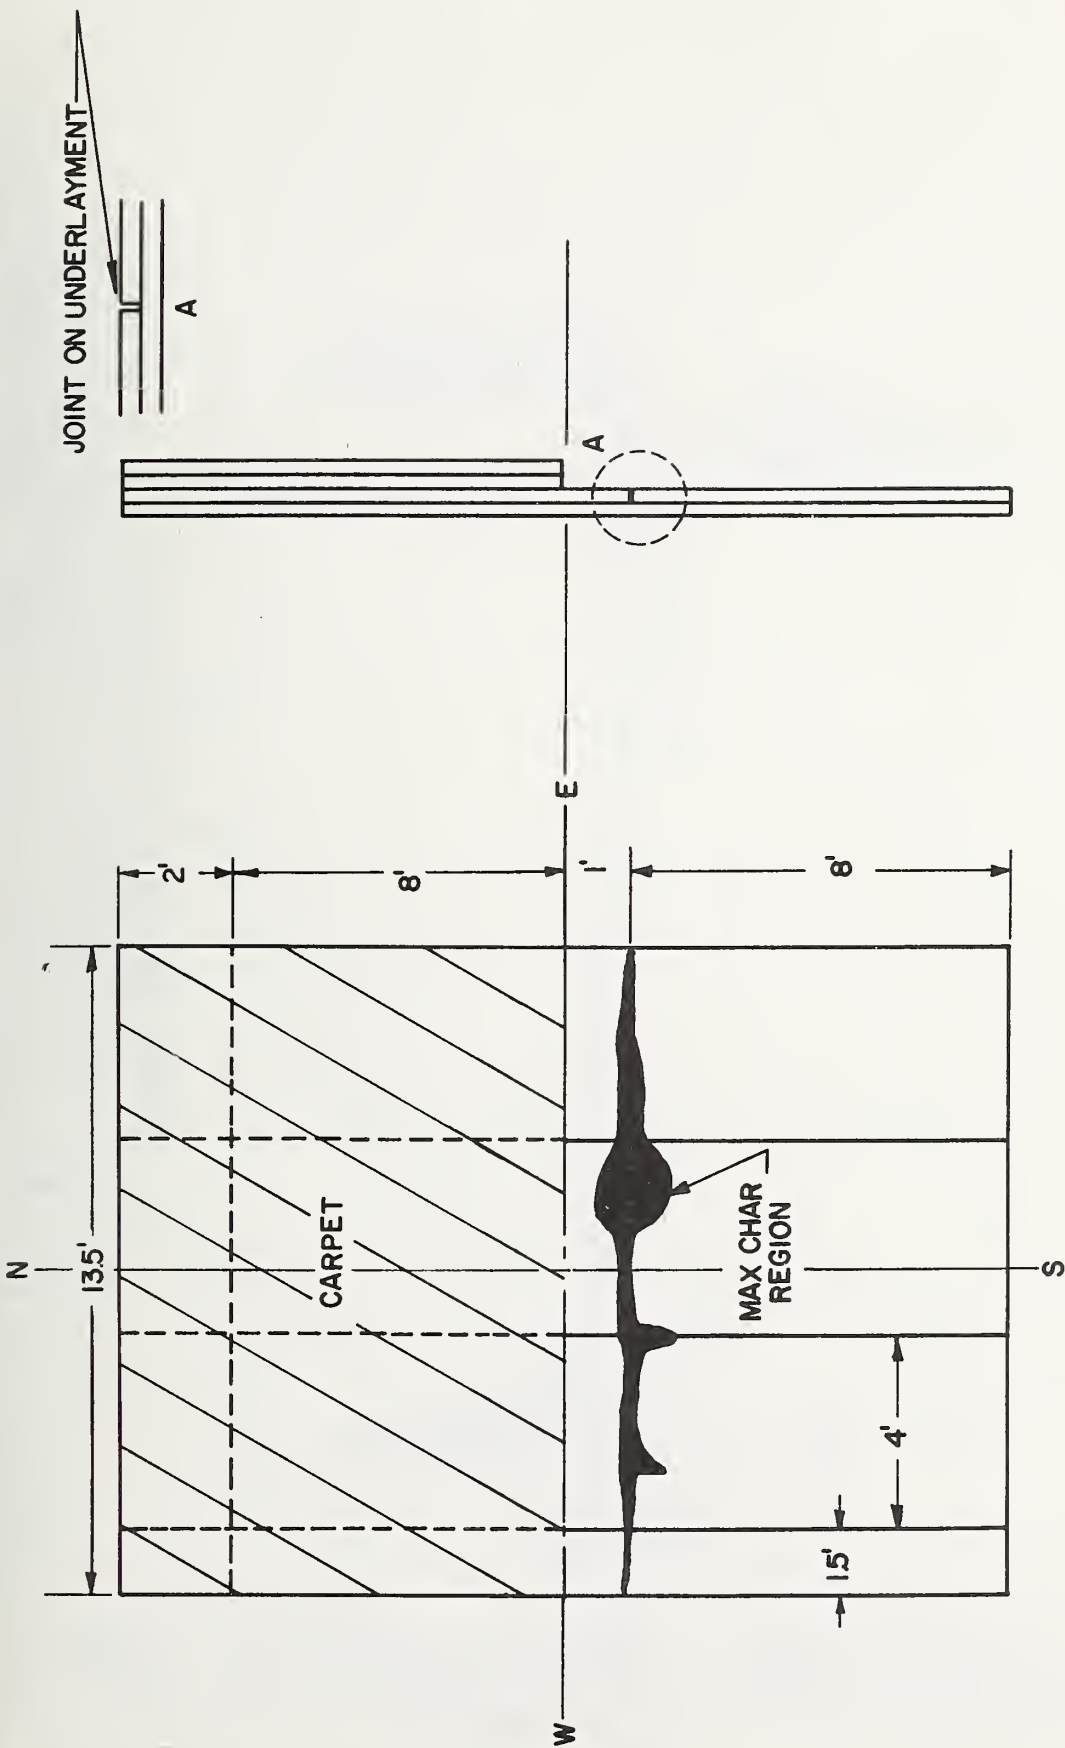
FIGURE 10. Char Region on Unexposed Surface after Test #L-1

Flame penetration near the center at the joint between the two sheets of plywood in the upper layer of the "bare" floor was observed at 13 min:30 sec. The location where flaming occurred and the associated charred region is shown in figure 10. There was also a load failure, as evidenced by the inability to maintain hydraulic pressure at 11 min:38 sec.

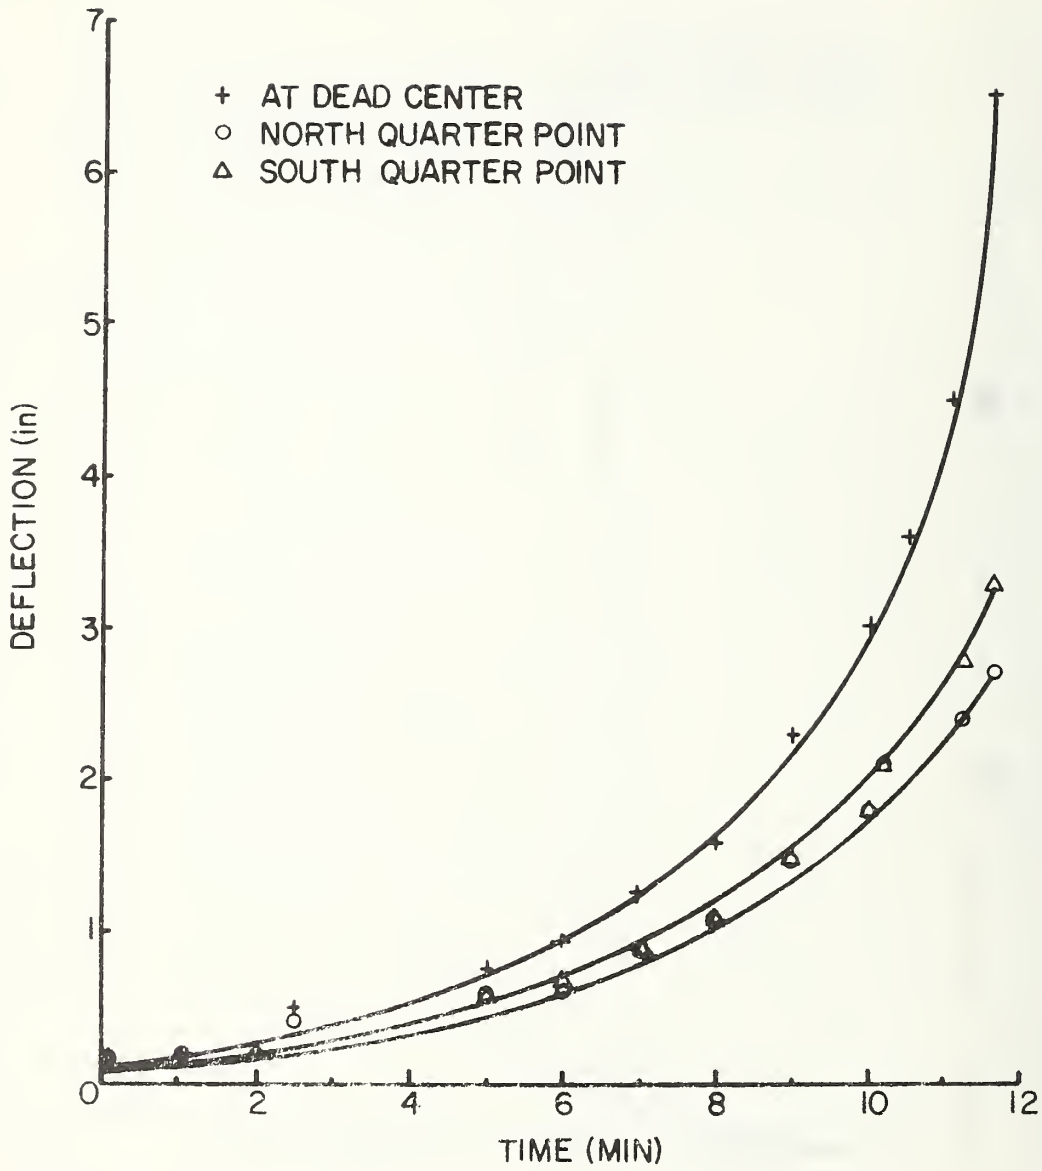
FIGURE 13. Deflection Measurements Test #L-1

The deflection increased steadily to 6.5 in. at 11 min:38 sec when the load could not be maintained as shown in figure 13. Deflections are tabulated in Table 3, Appendix I.

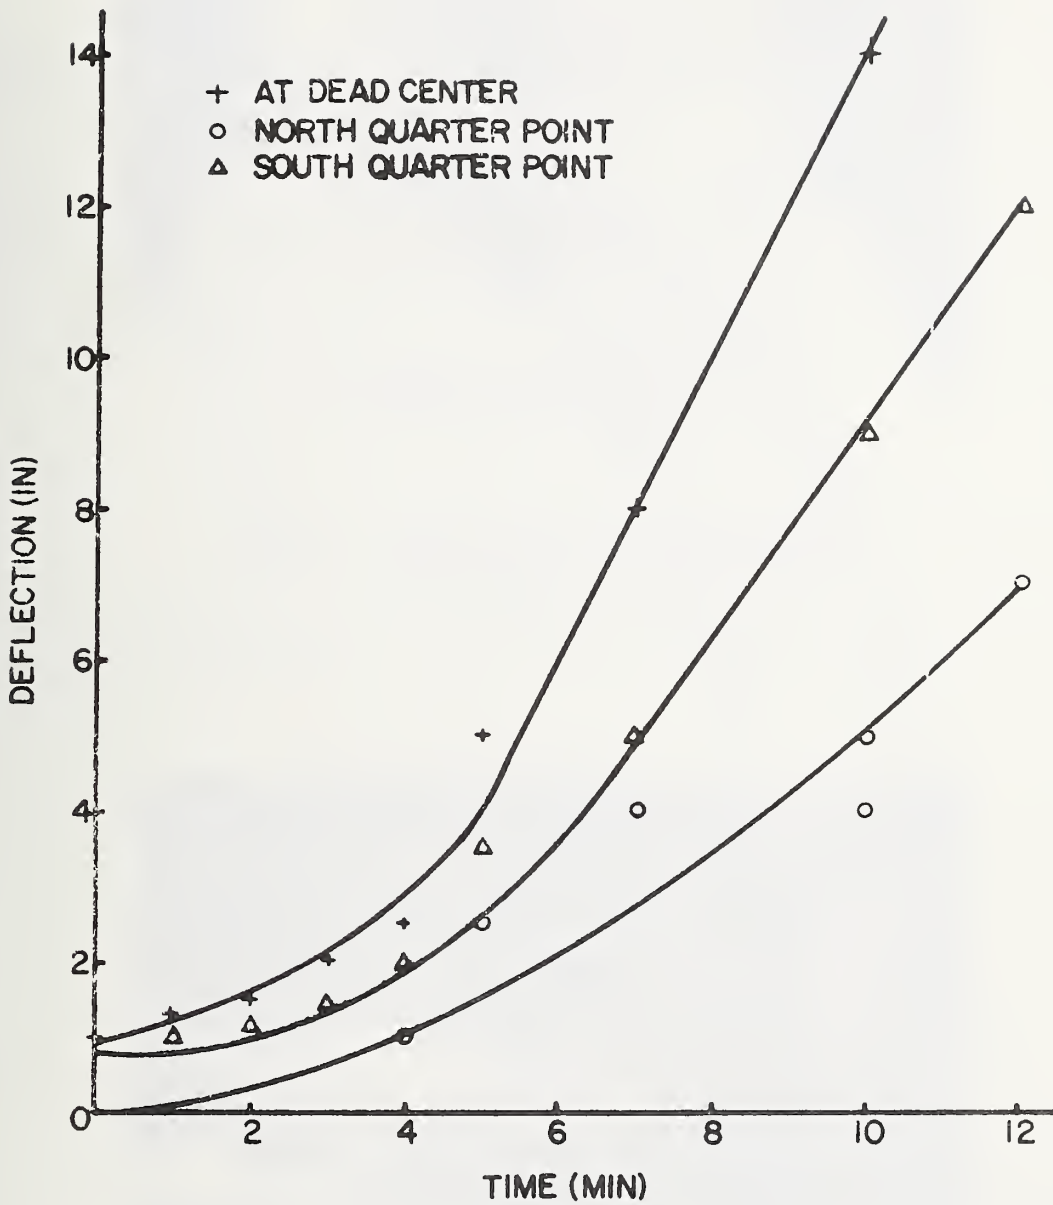
FIGURE 16. Deflection Measurements, Test #L-2

The deflections are tabulated in Table 4, Appendix I and shown graphically in figure 16. The deflection increased rapidly and the floor broke through at 13 min.

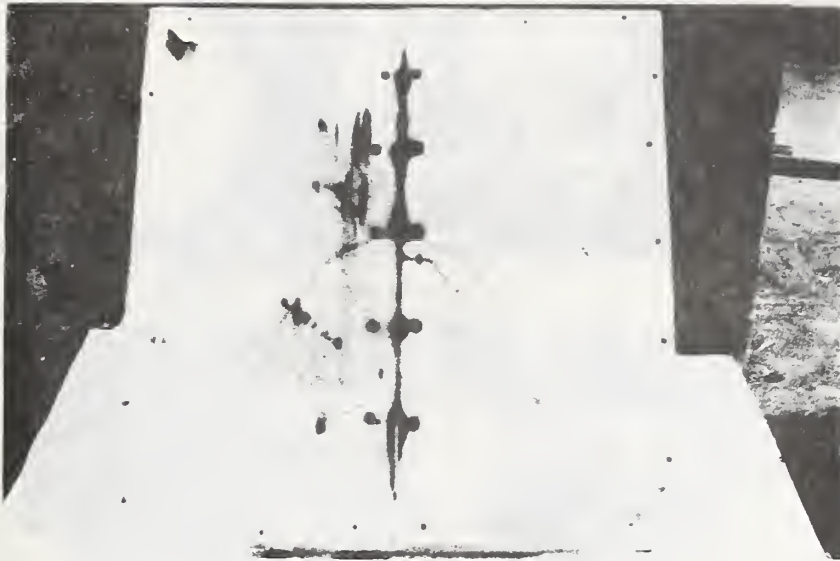
Fig. 18. Flame Through and Associated Char Region Test #S-3

The time 12 min:45 sec. to reach flame through was considerably decreased compared to test #S-2. As indicated in the test observations, it took about four minutes to produce a definite flame through after the subfloor burned out in test #S-2 but only one half a minute in test #S-3. The flame through was primarily through the 1/8 in. joint separation provided in the construction.
