NATL INST. OF STAND & TECH  
11107 101881

NIST  
PUBLICATIONS

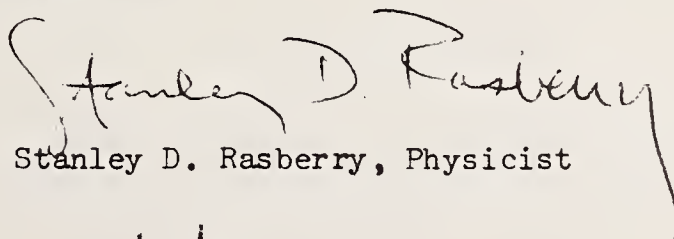
Stanley D. Rasberry, Physicist

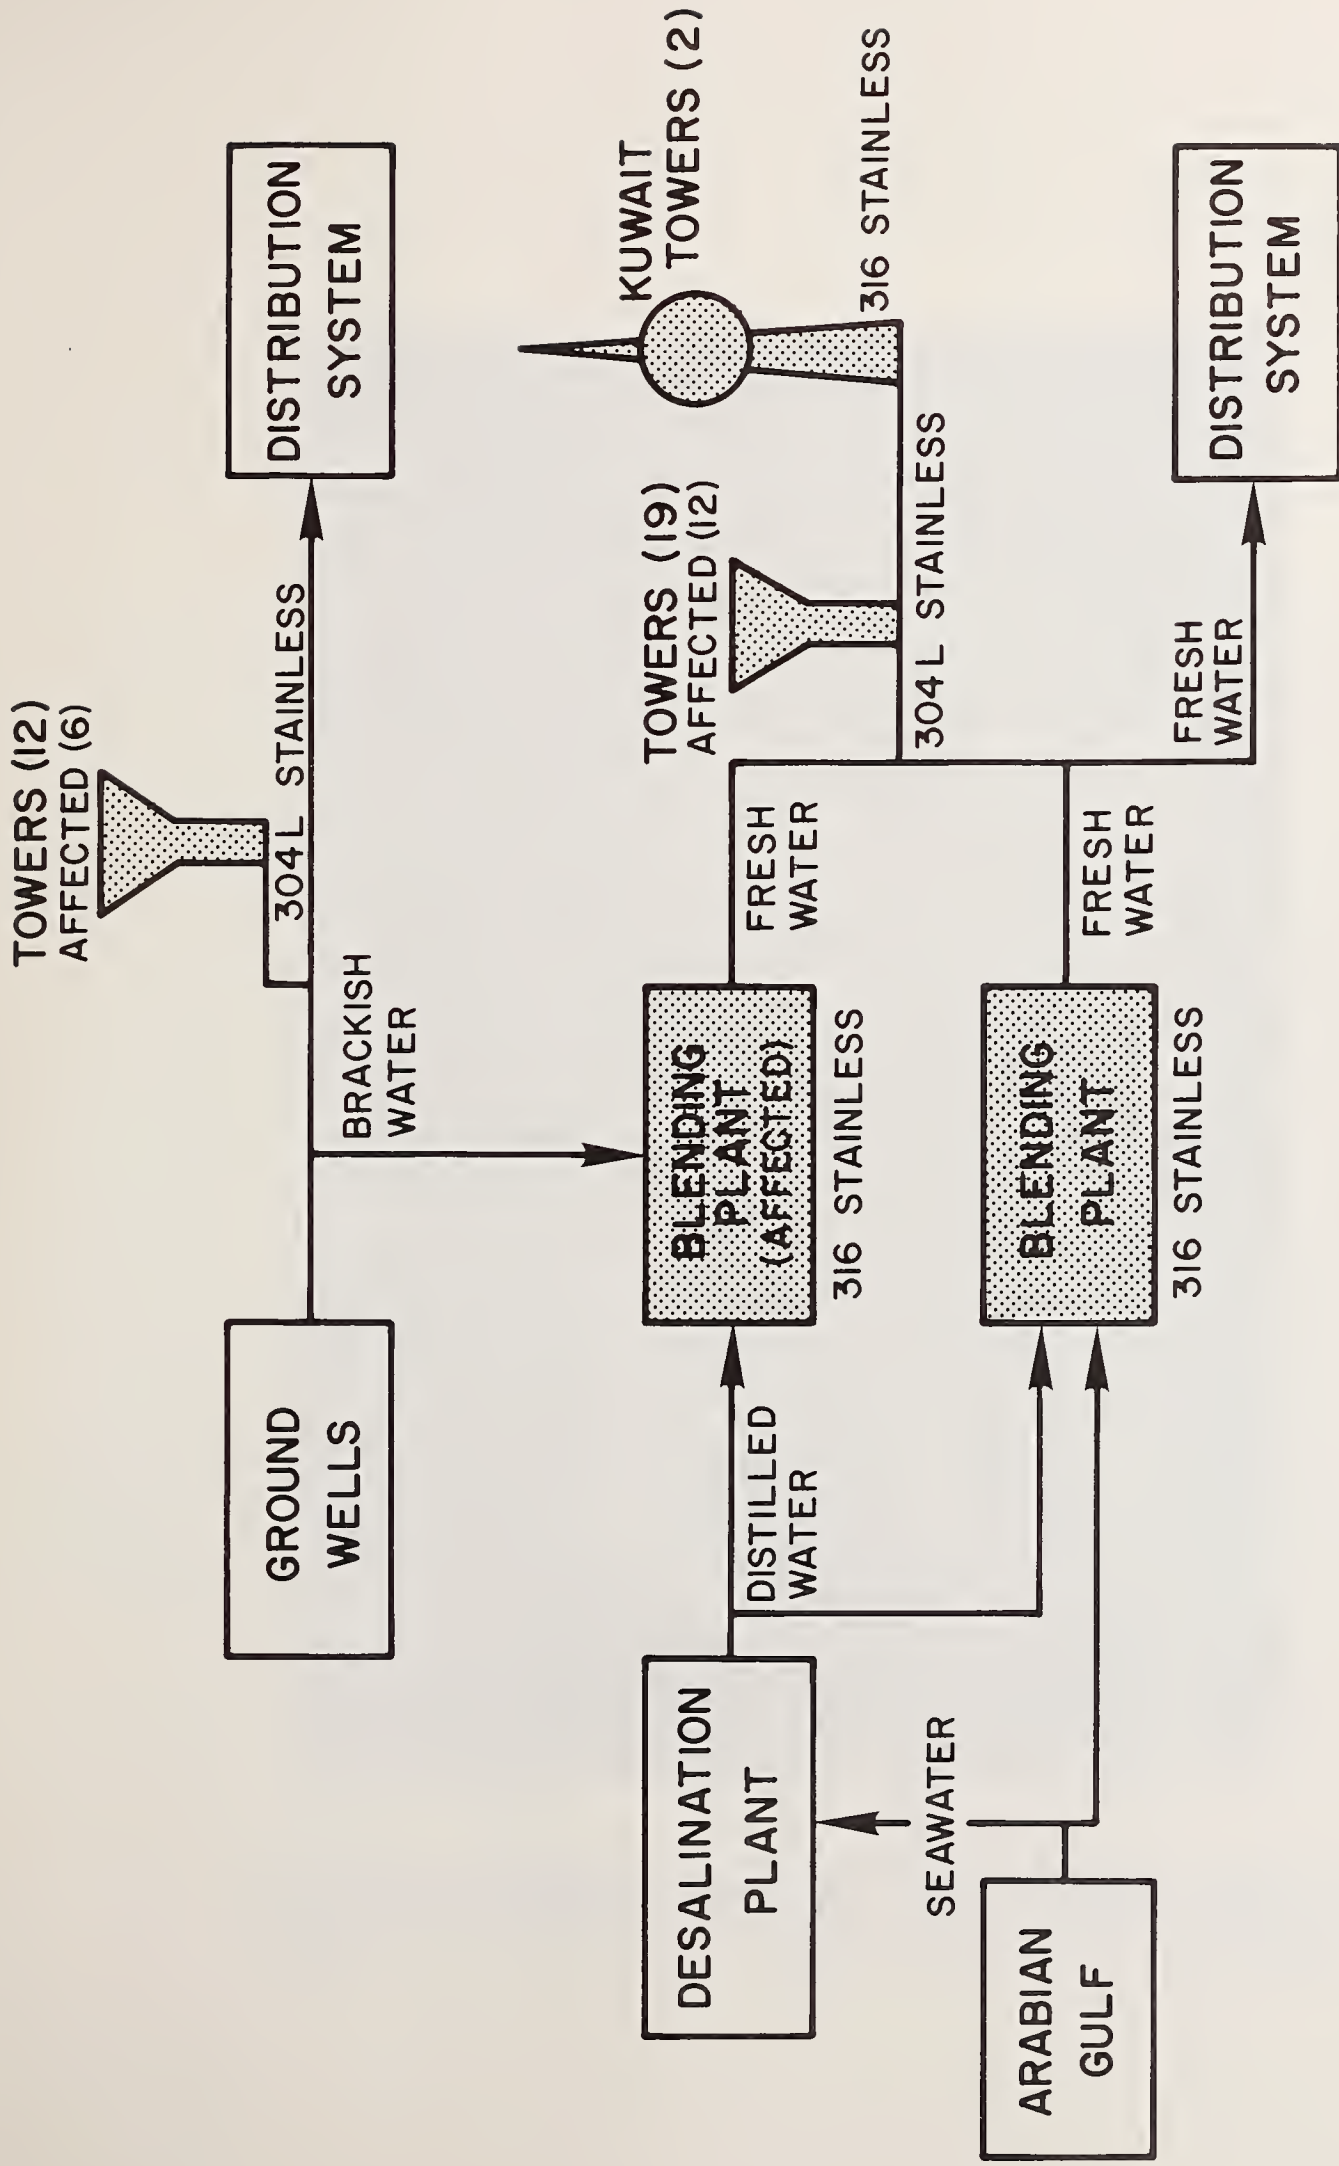
(1) Solutions air saturated, then sealed after NaOCl was added.  
 (2) Saturated calomel reference electrode.  
 (3) Lower E<sub>C,S</sub> indicates greater susceptibility to pitting attack under the conditions tested.  
 (4) The smaller the difference E<sub>C,S</sub>-E<sub>R</sub>, the greater the chances of pitting attack; where E<sub>R</sub>>E<sub>C,S</sub> pitting will occur.  
 (5) Attack occurred on specimen with crevice, but attack did not take place under crevice.  
 (6) Potentiostatically polarized to +600 mV vs SCE for 30 minutes.

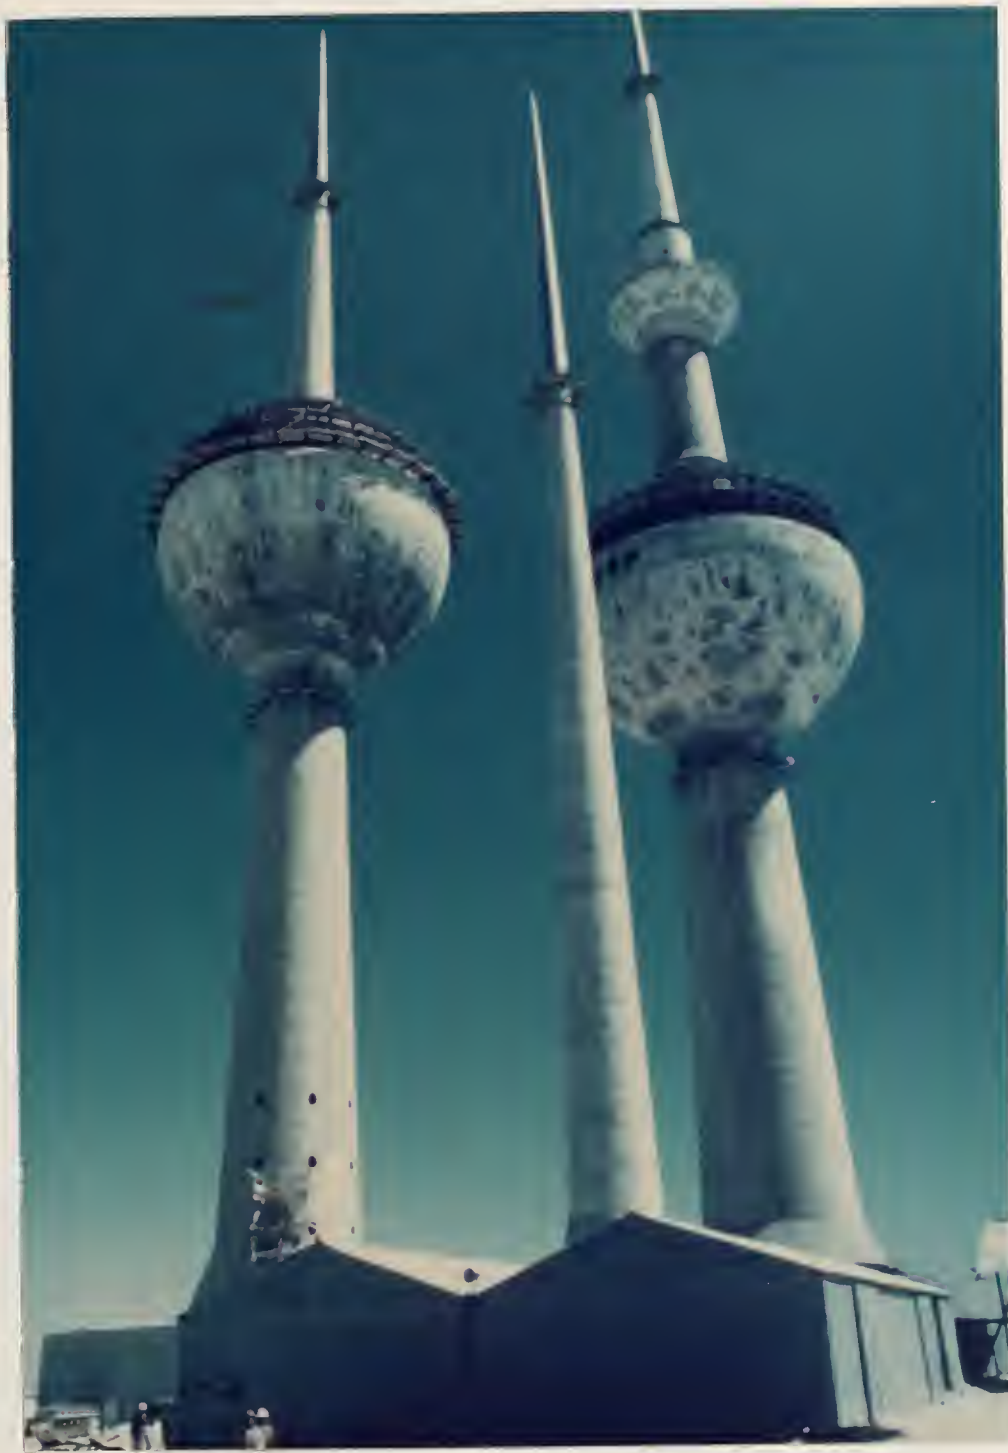
Figure 2. Kuwait Towers, site D-6, water storage towers, and visitors' center as of April 1973. Stainless steel type 316 pipes installed and protected externally with polyethylene.

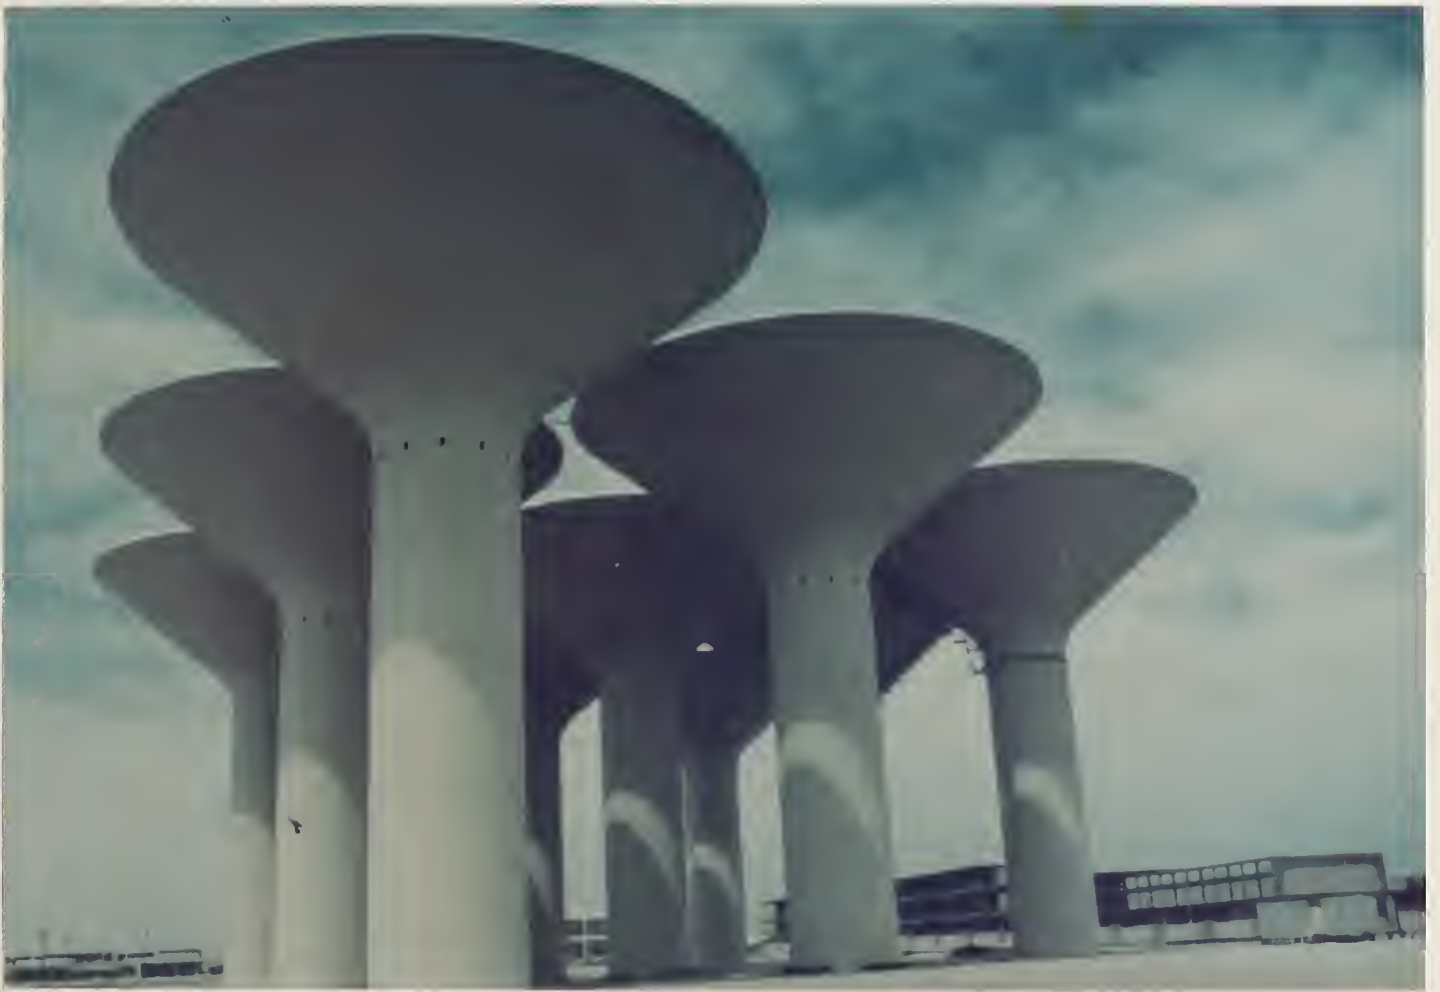
Figure 3. Towers site D-1. Stainless steel type 304L pipes perforated at time of inspection in April 1973.

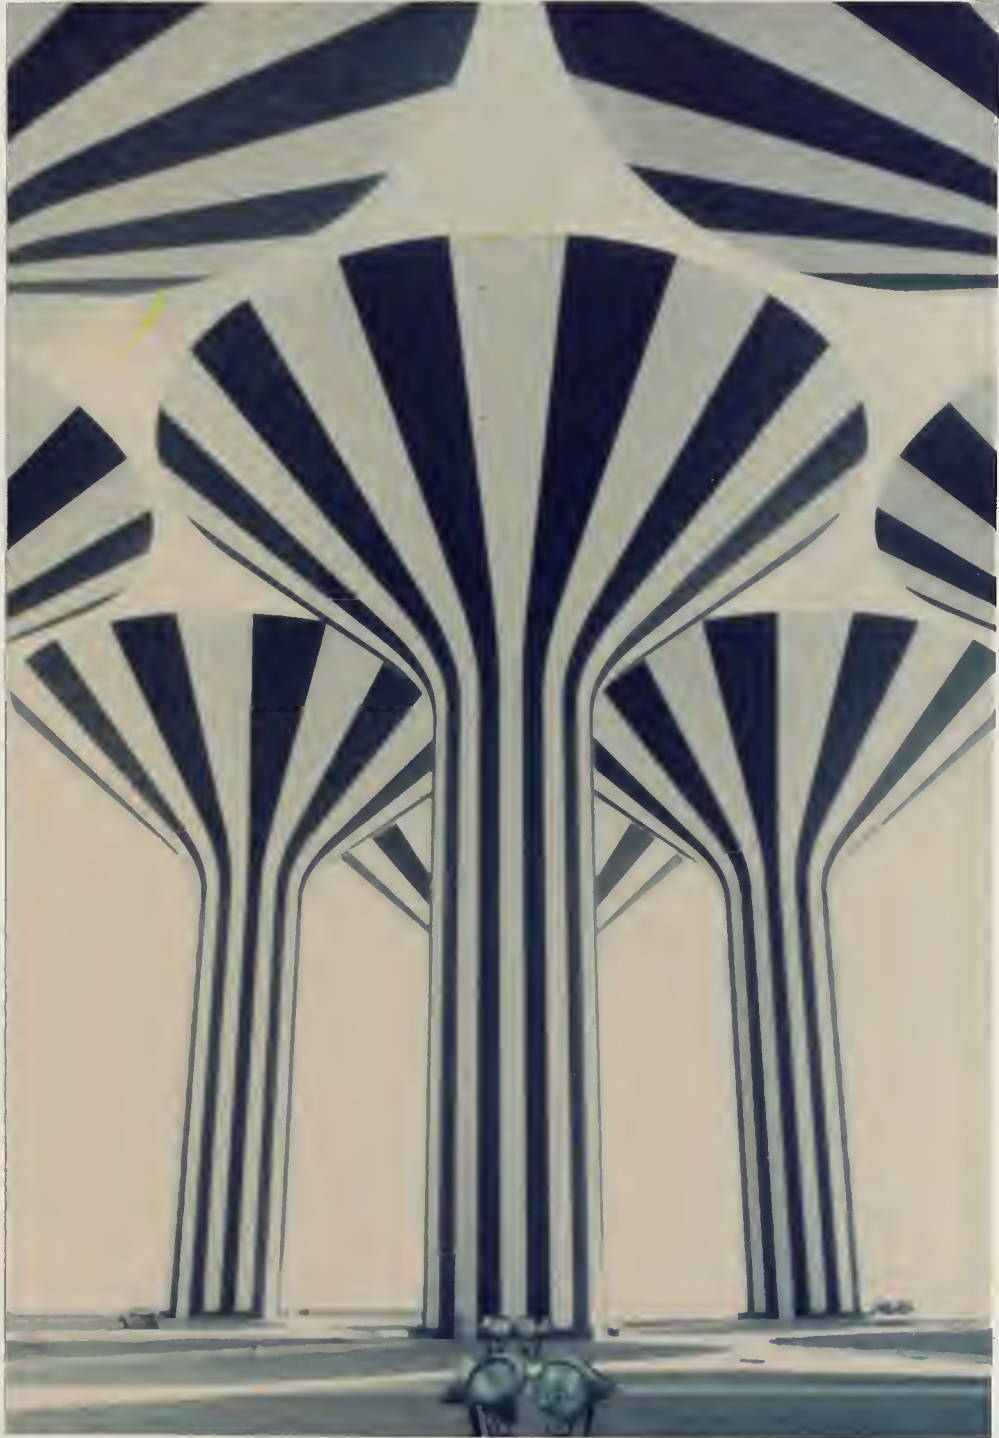
Figure 4. Towers site D-2. Stainless steel type 304L pipes perforated at time of inspection in April 1973.

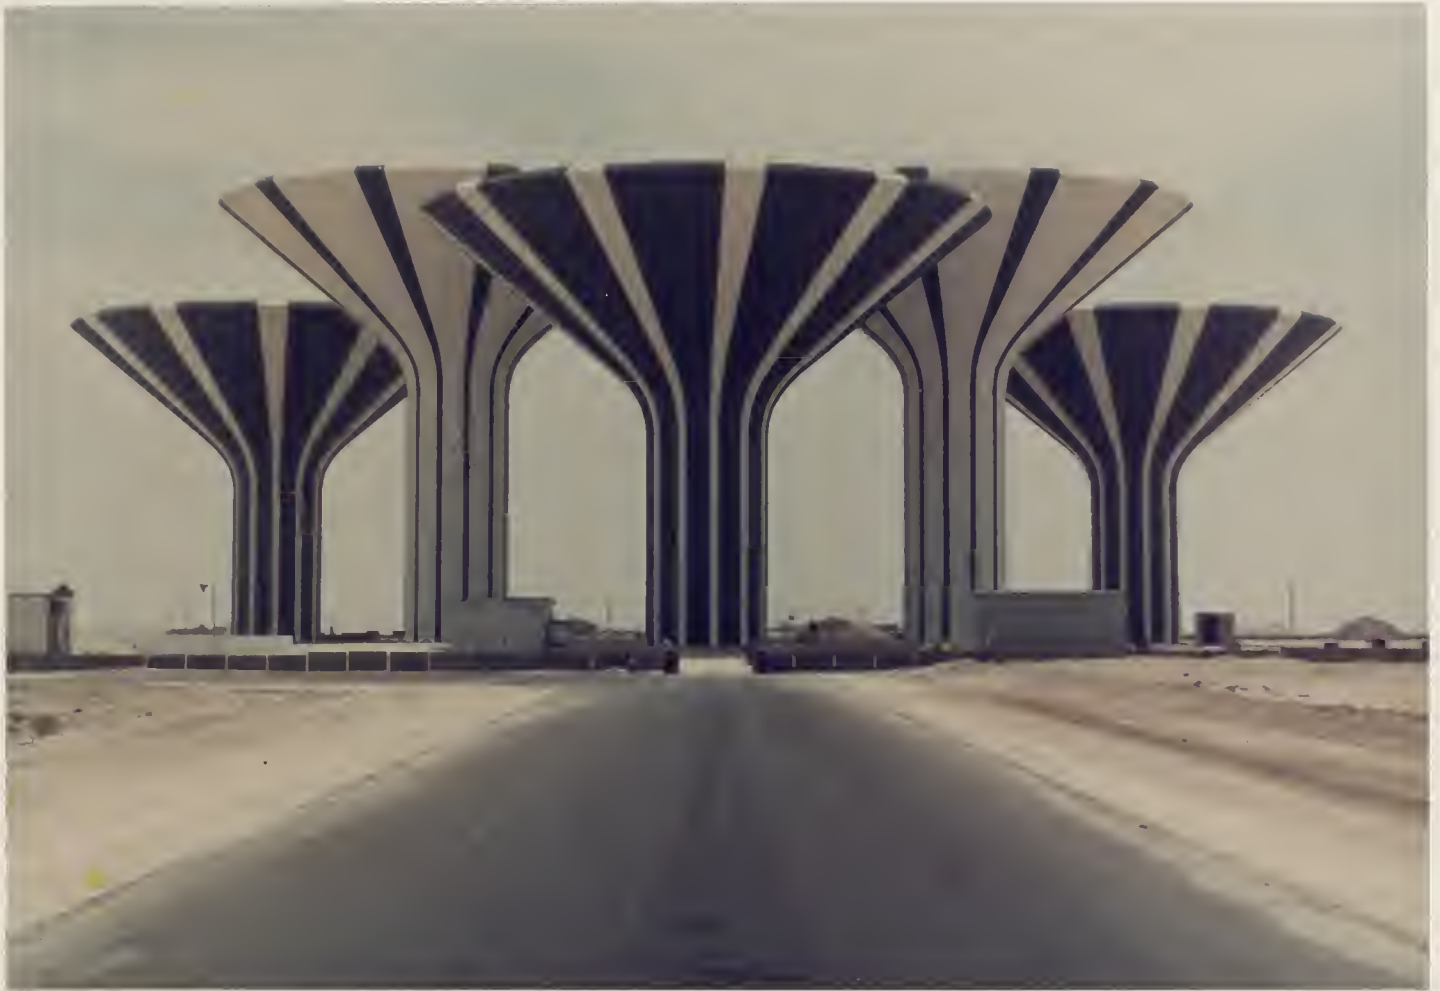
Figure 5. Towers site D-5. Stainless steel type 304L pipes in fairly good condition at time of inspection in April 1973. (Small 2-3 mm rust deposits inside pipe.)

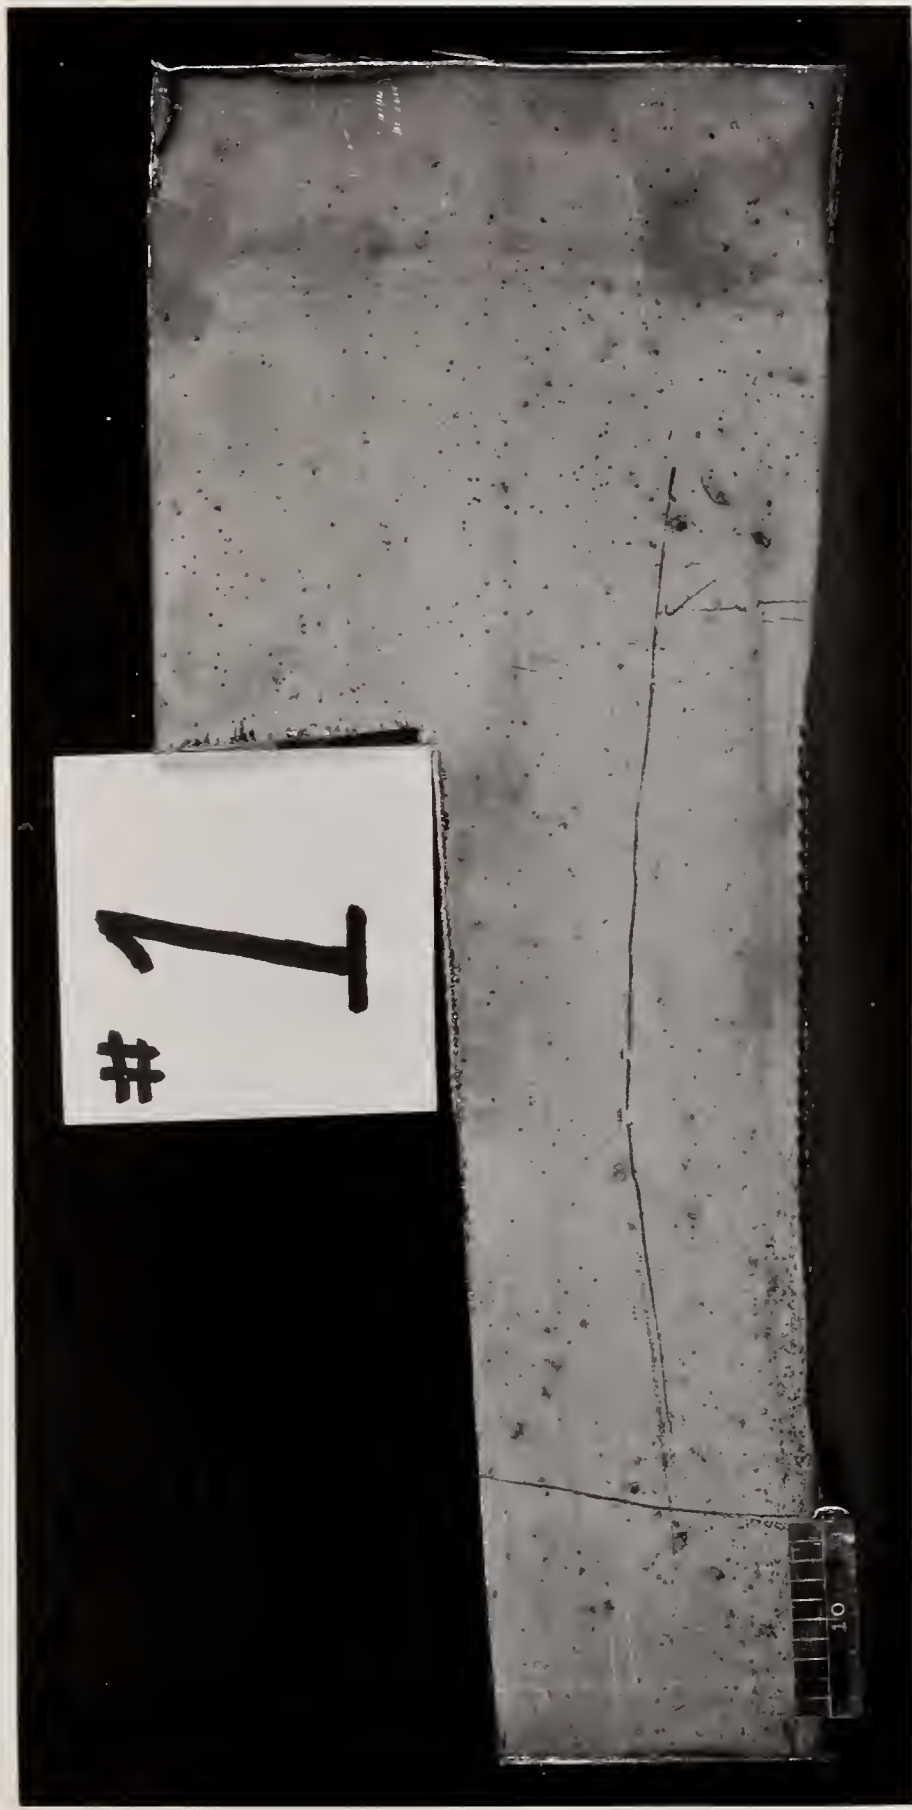
Figure 6. Interior view of stainless steel (type 316) specimen 1 removed from site D-6 (Kuwait Towers). The specimen is shown minus the pieces removed for chemical analysis. The pipe from which this specimen was removed was in storage exposed to the atmosphere at site D-6. Marker at lower left is 1 inch (2.54 cm) long.

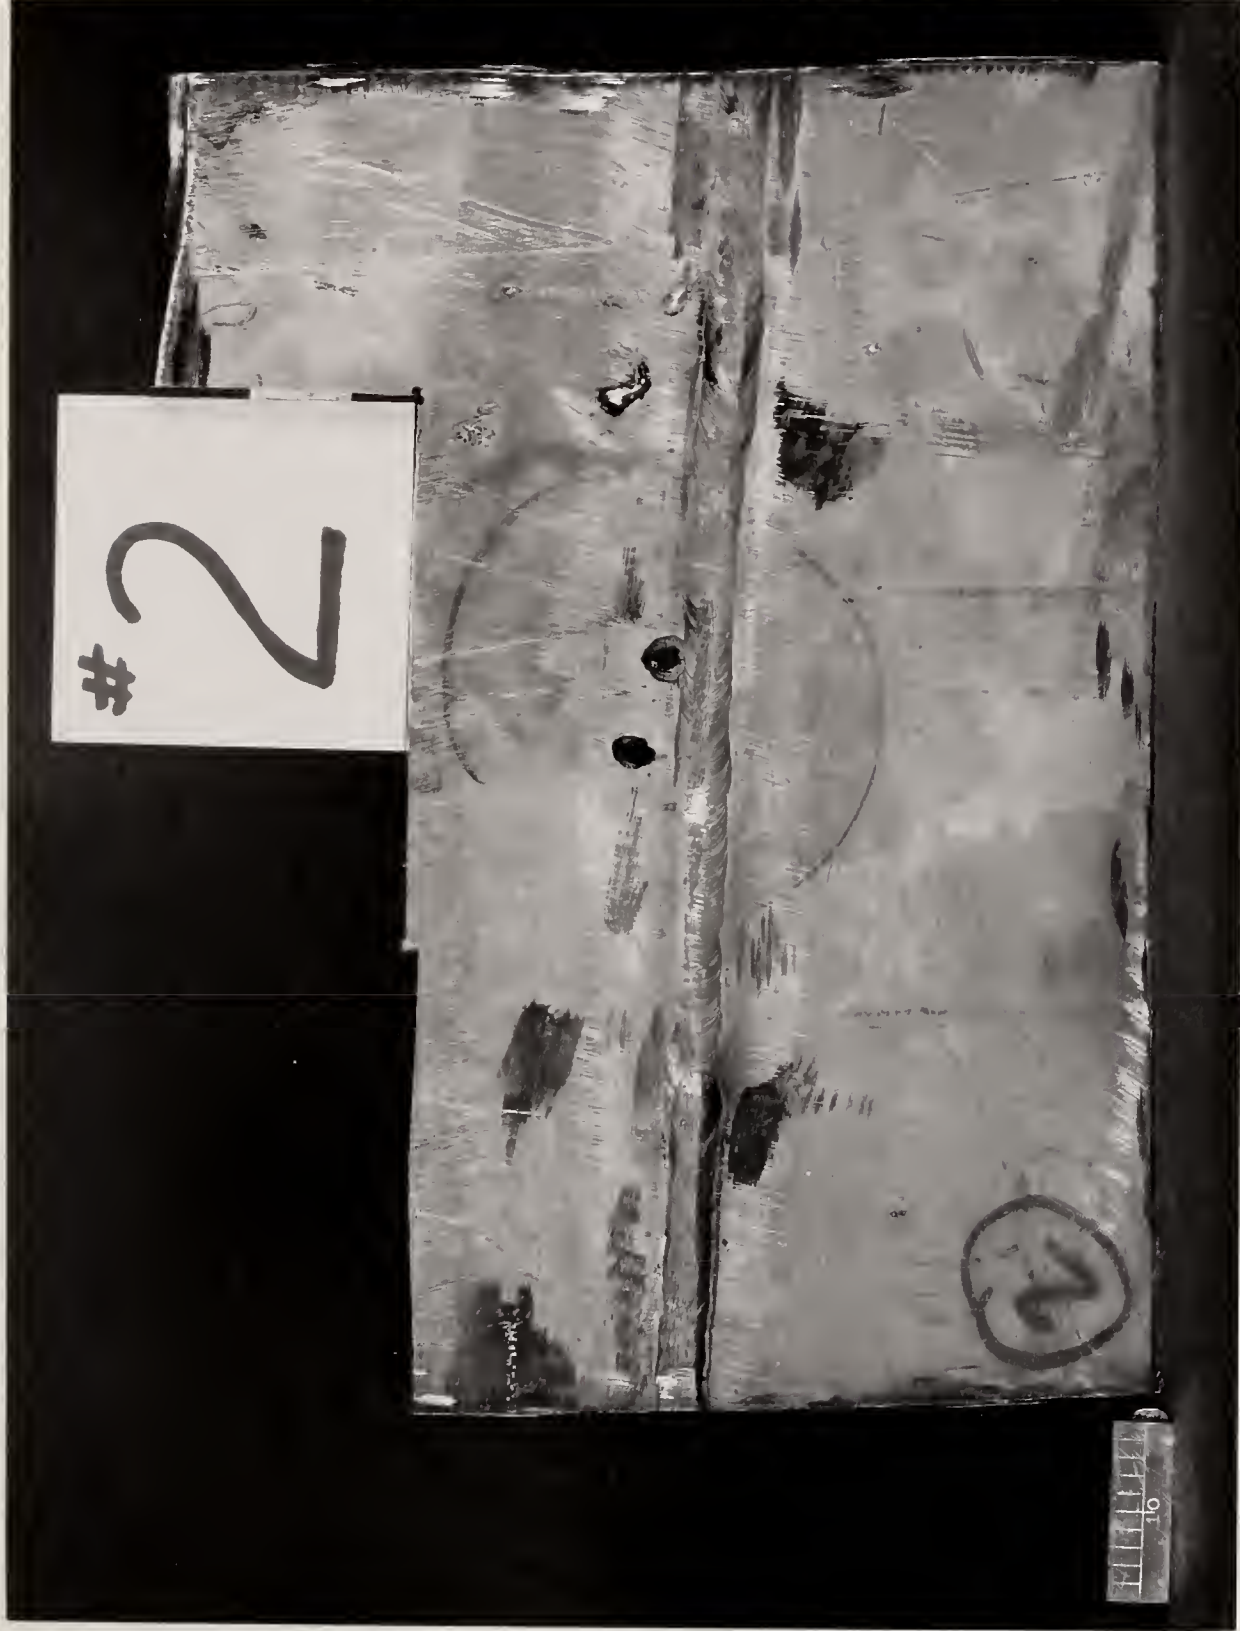
Figure 7. Interior view of stainless steel (type 304L) specimen 2 removed from the 1000 mm pipe at site D-2 (Towers). Note penetrating pits near weld at center of piece. The specimen is shown minus the pieces removed for chemical analysis. Marker at lower left is 1 inch (2.54 cm) long.

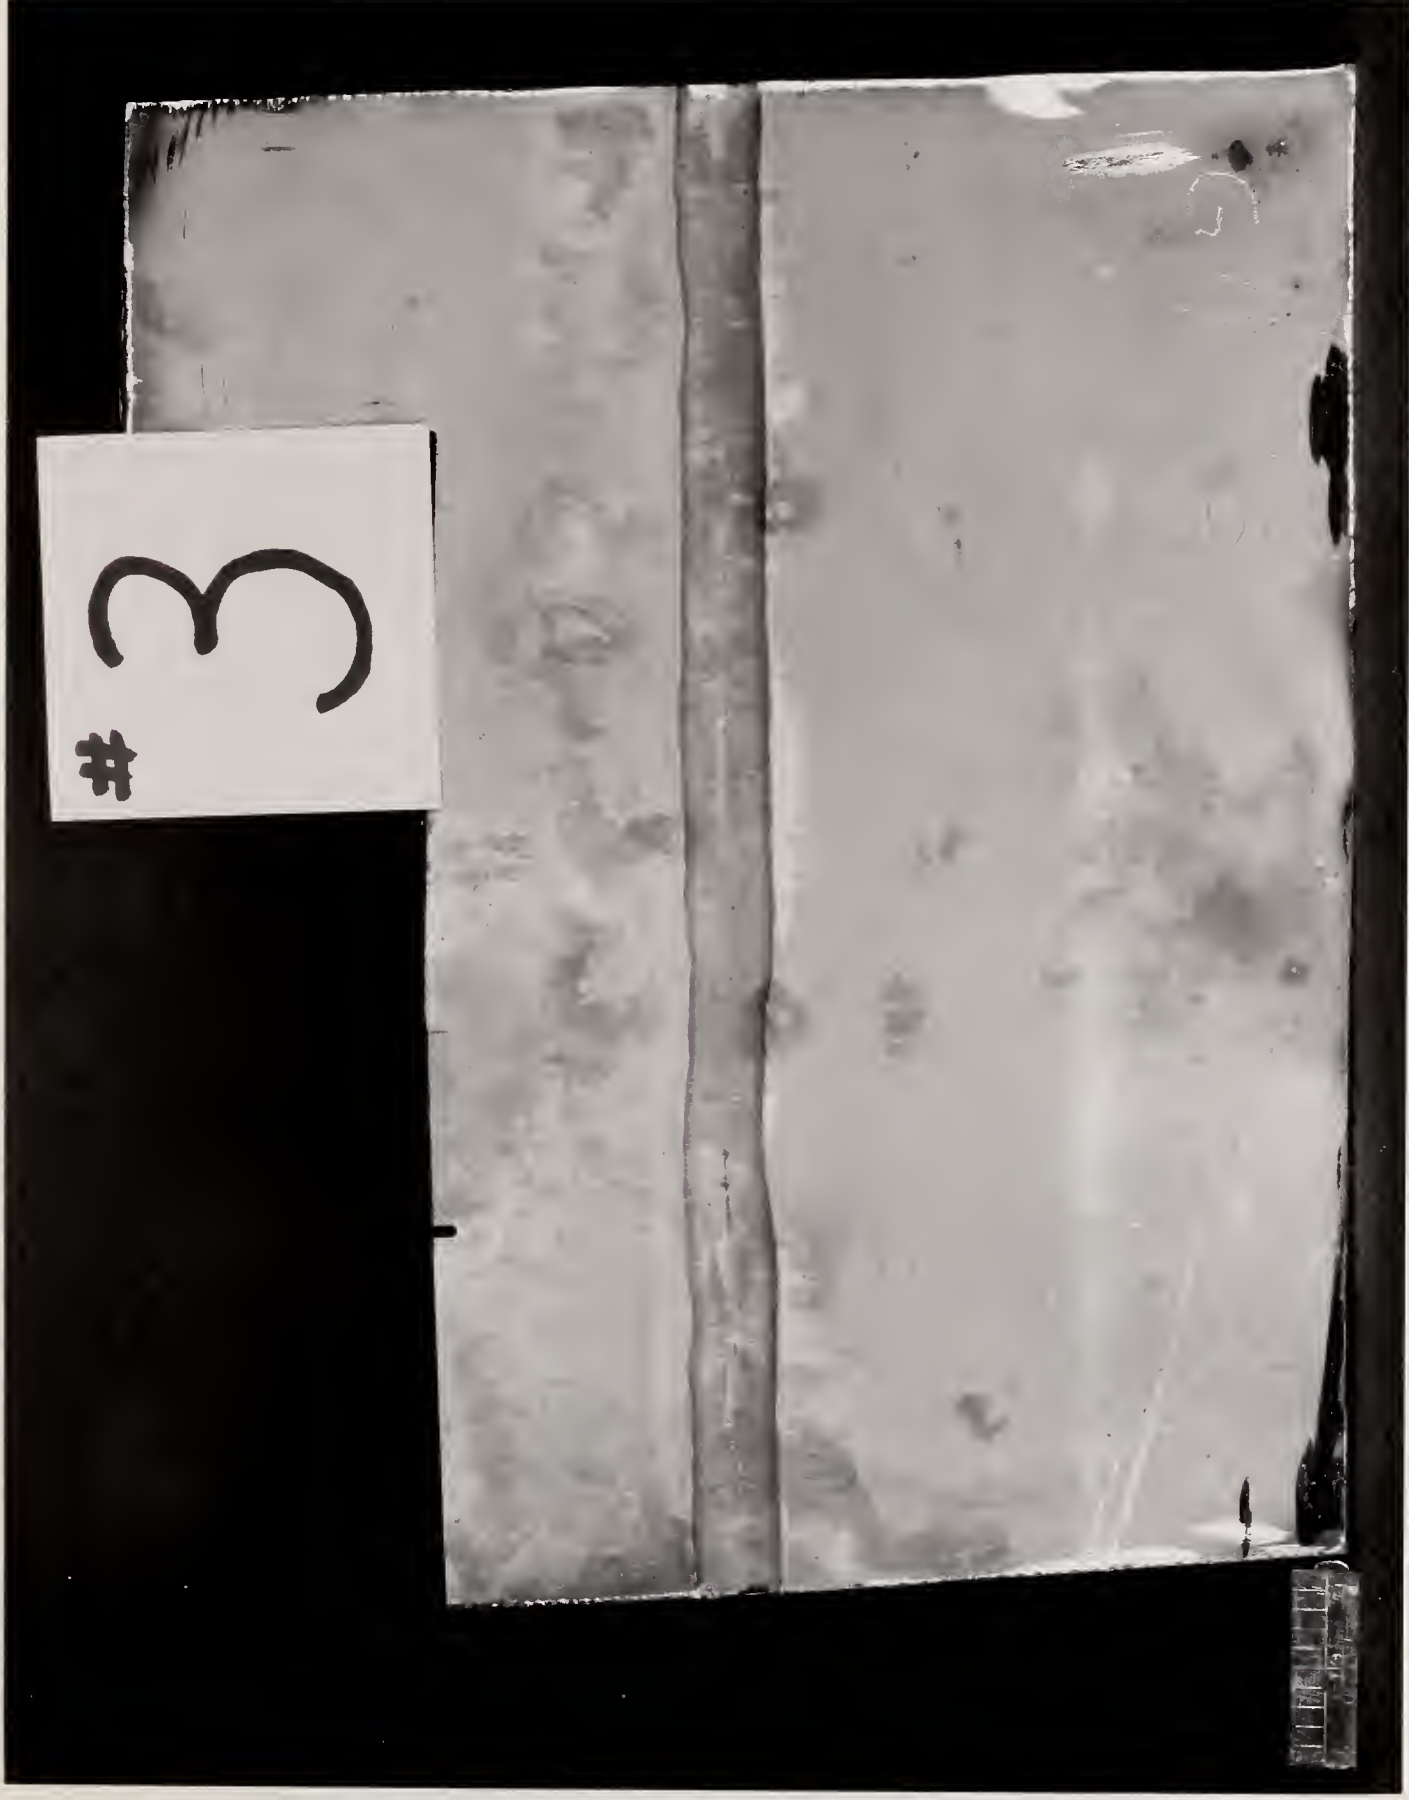
Figure 8. Interior view of stainless steel (type 304L) specimen 3 removed from the 1000 mm pipe at site D-2 (Towers). The specimen is shown minus the pieces removed for chemical analysis. Marker at lower left is 1 inch (2.54 cm) long.

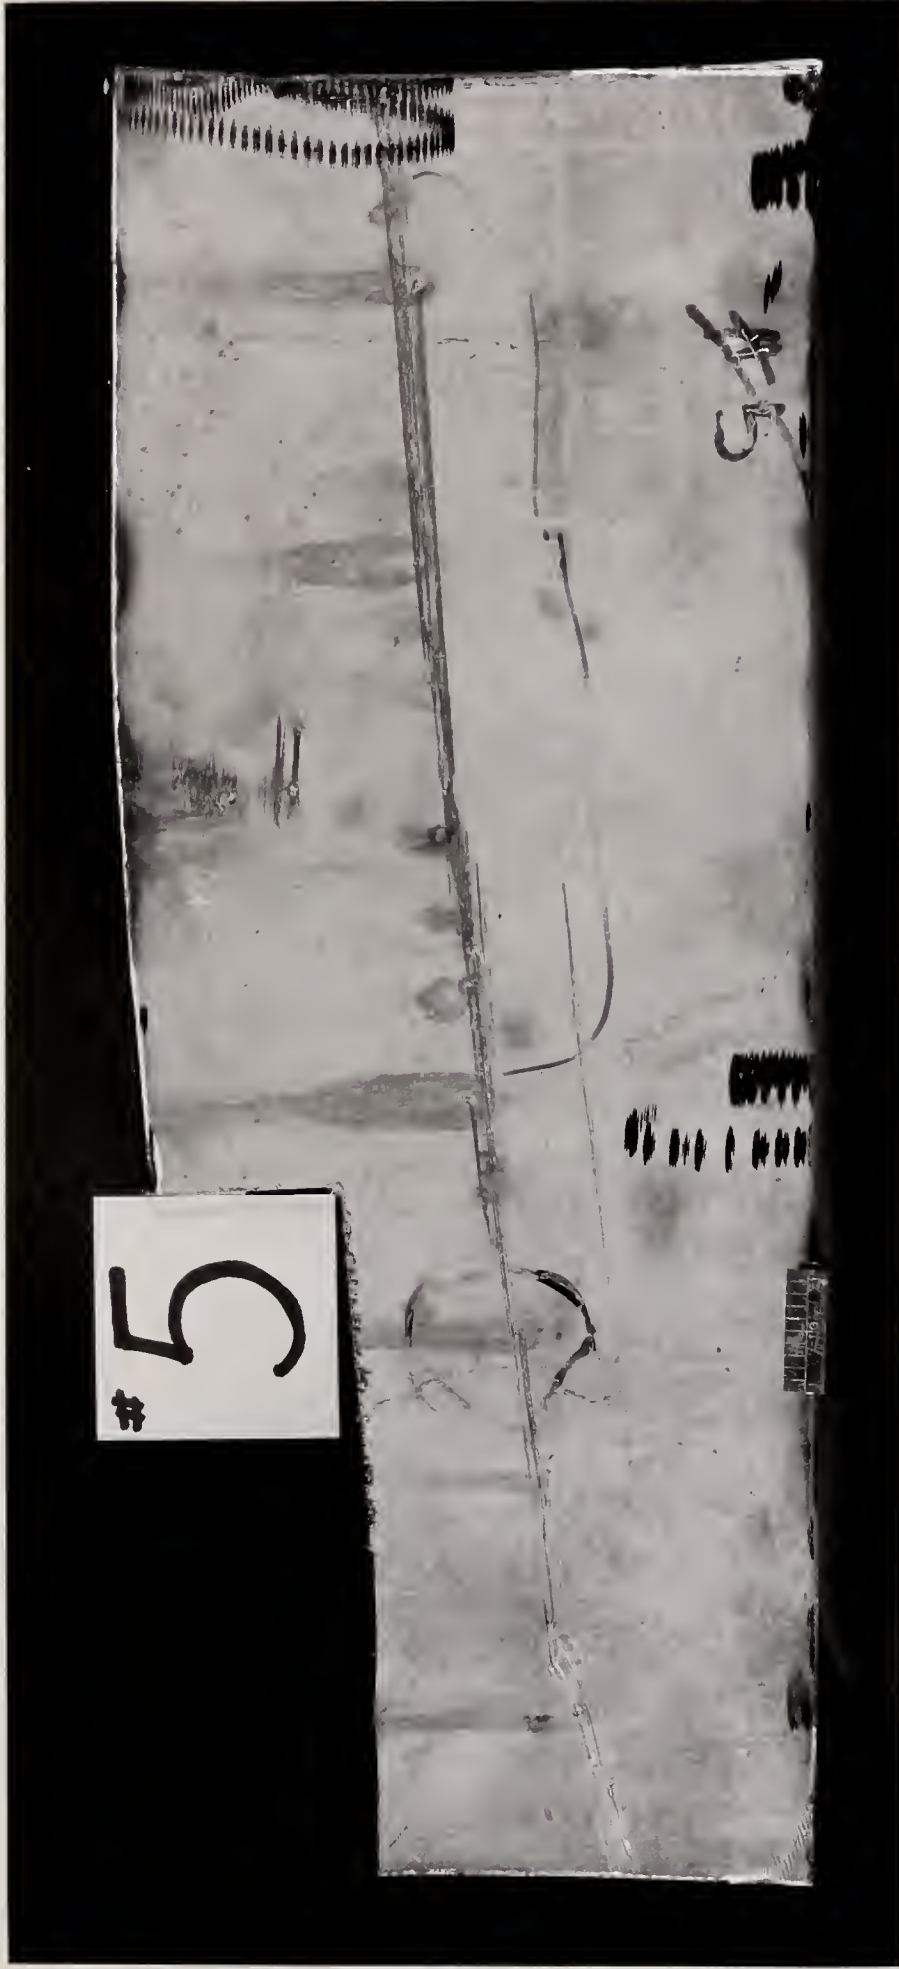
Figure 9. Interior view of stainless steel (type 304L) specimen 5 removed from the 1000 mm pipe at site D-2 (Towers). Note scratch with small pits along center of piece. The specimen is shown minus the pieces removed for chemical analysis. Marker at lower left center is 1 inch (2.54 cm) long.

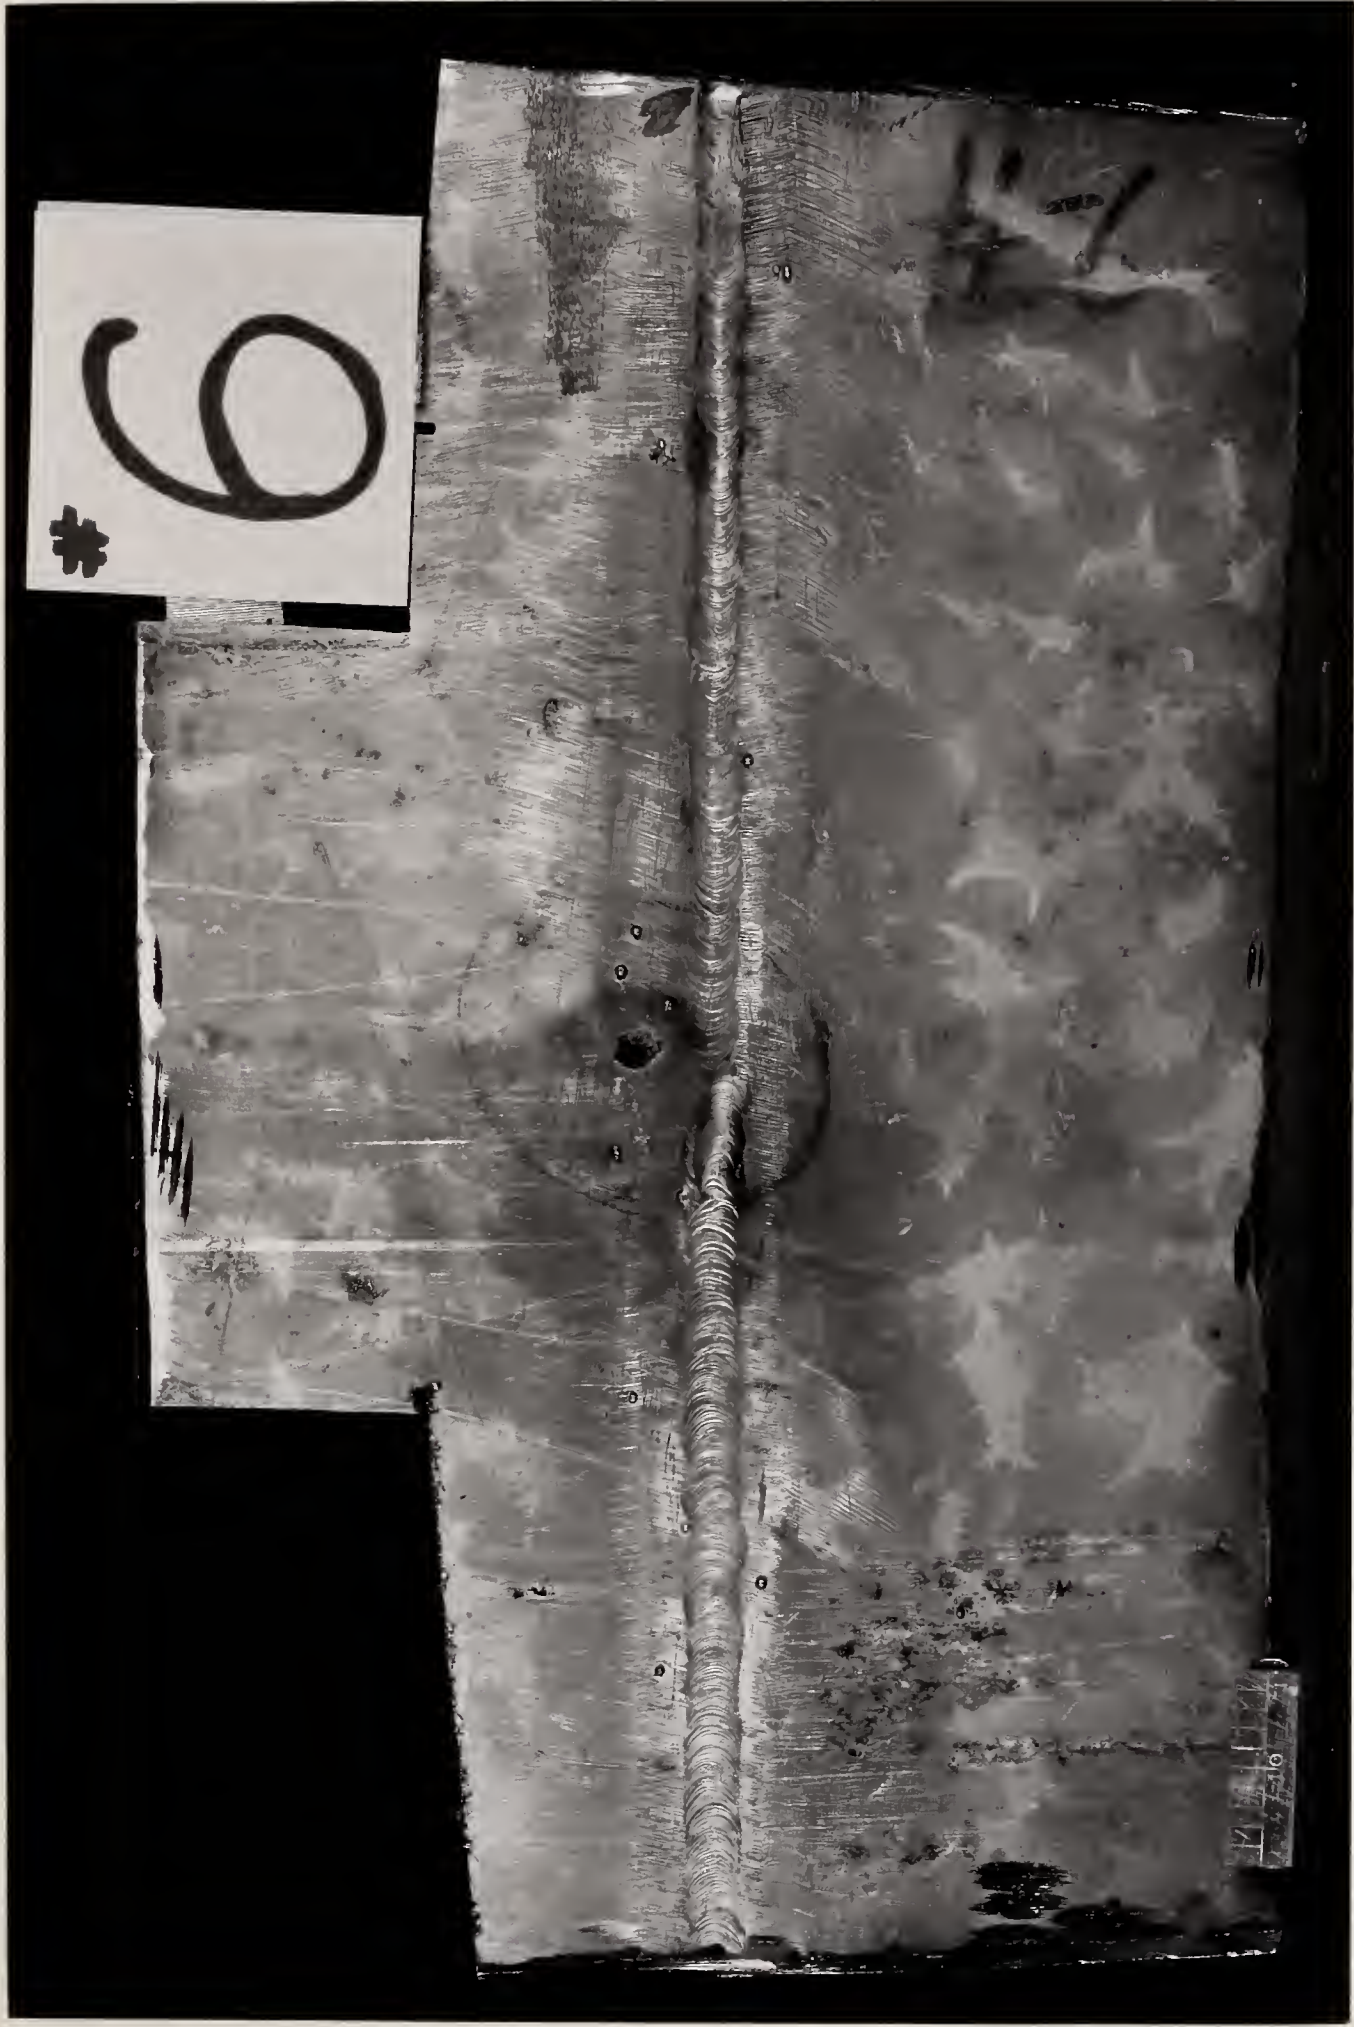
Figure 10. Interior view of stainless steel (type 304L) specimen no. 6 removed from the 1000 mm pipe at site D-2 (Towers). Note penetrating pit near weld at center of piece. The specimen is shown minus the pieces removed for chemical analysis. Marker at lower left is 1 inch (2.54 cm) long.
