NATL INST. OF STAND & TECH  
11107 101881

NIST  
PUBLICATIONS

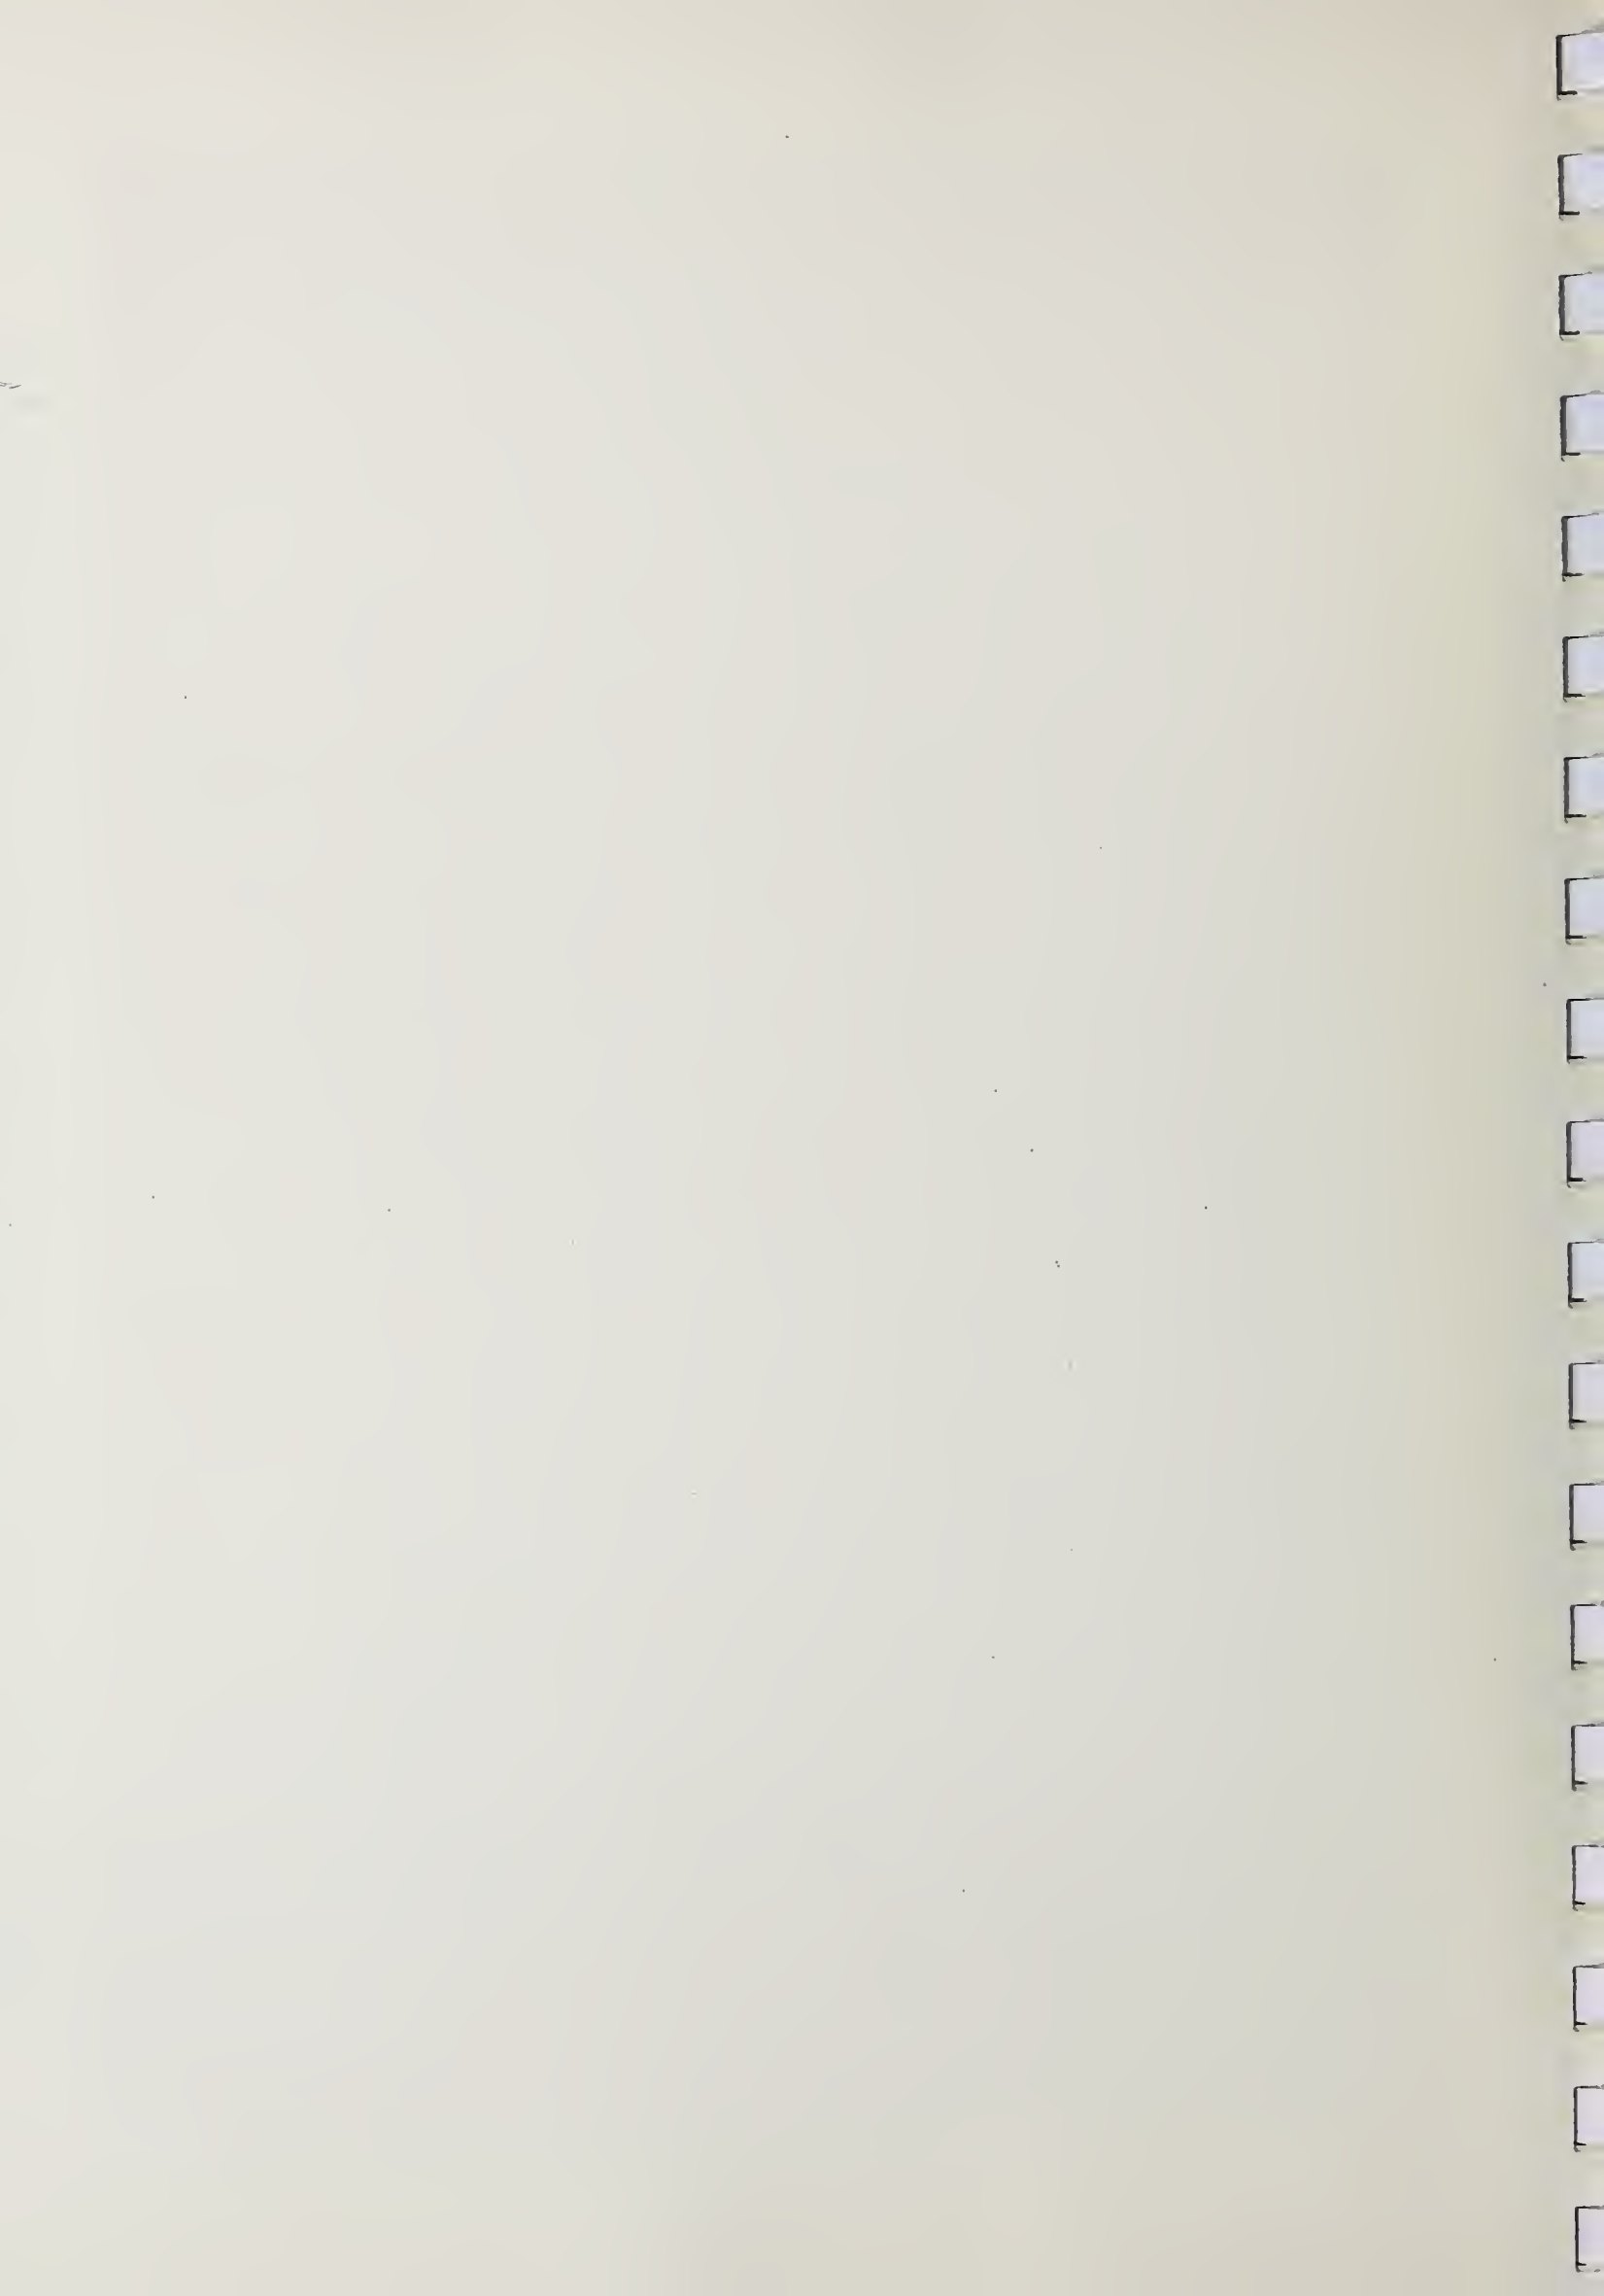
Figure 10. Interior view of stainless steel (type 304L) specimen no. 6 removed from the 1000 mm pipe at site D-2 (Towers). Note penetrating pit near weld at center of piece. The specimen is shown minus the pieces removed for chemical analysis. Marker at lower left is 1 inch (2.54 cm) long.

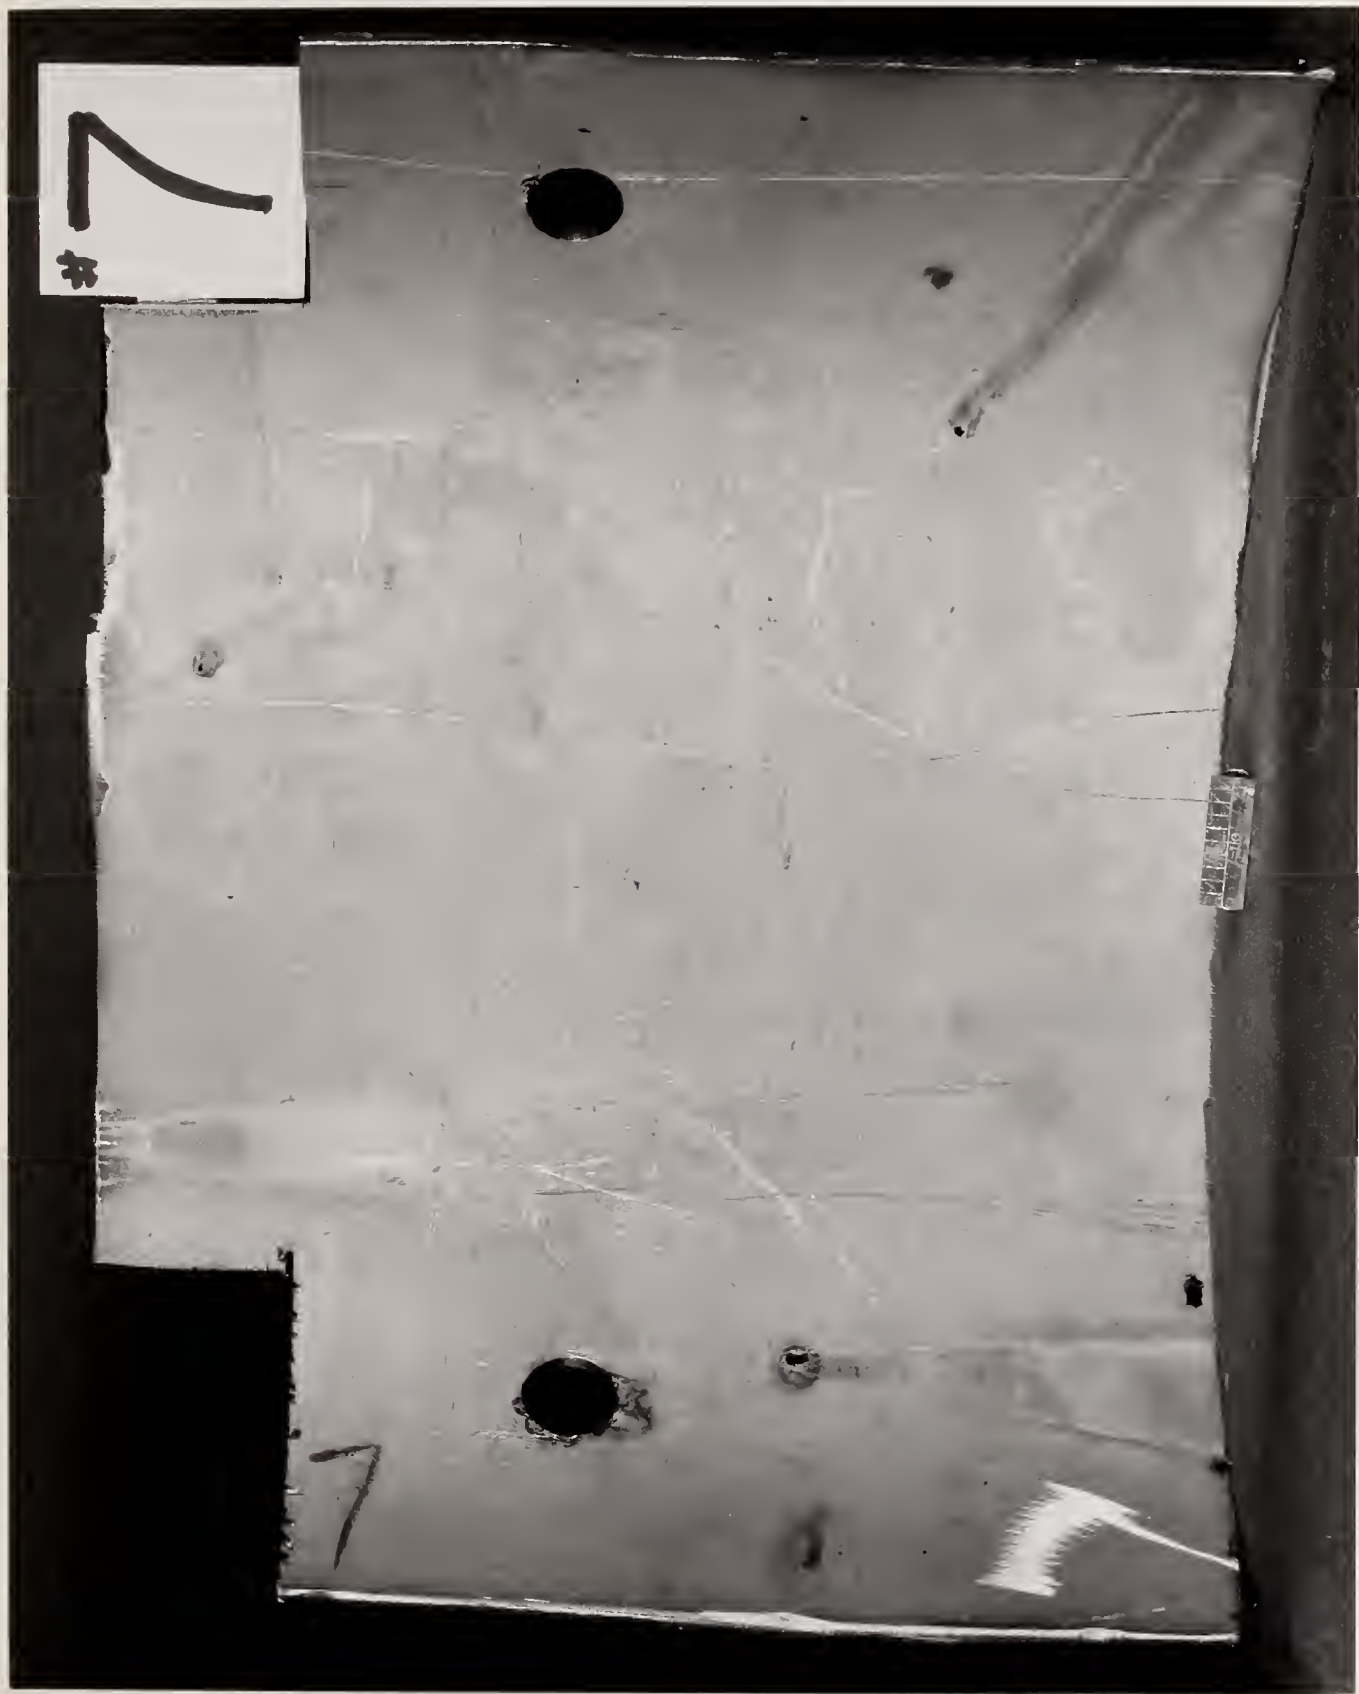
Figure 11. Interior view of stainless steel (type 316) specimen 7 removed from site P (Blender). This specimen shows an example of pitting initiated on the inside surface of the pipe. The specimen is shown minus the pieces removed for chemical analysis. Marker at bottom left is 1 inch (2.54 cm) long.

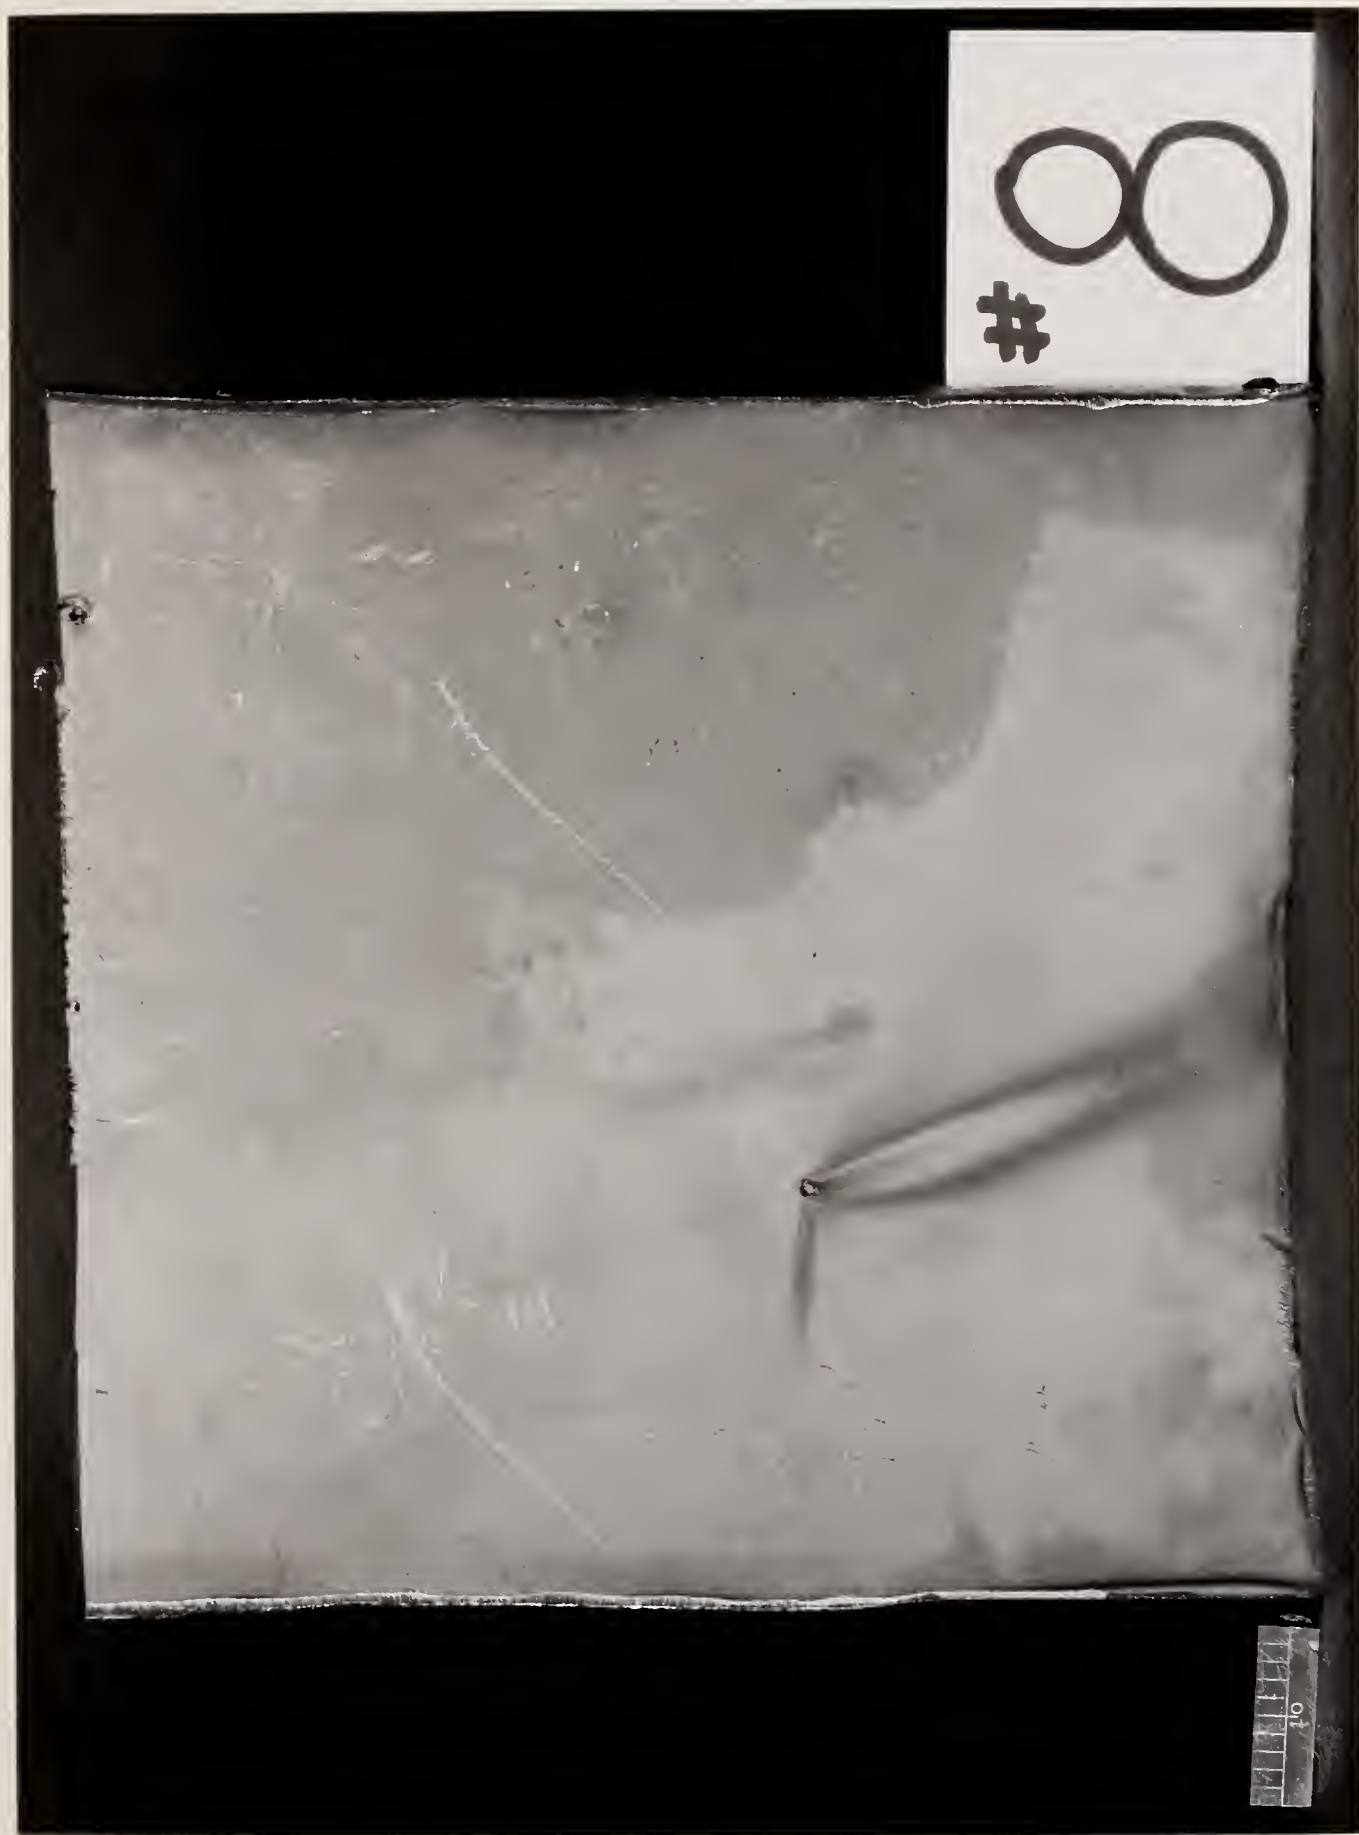
Figure 12. Interior view of stainless steel (type 316) specimen 8 removed from site P (Blender). This specimen shows an example of pitting initiated on the inside surface of the pipe. The specimen is shown minus the pieces removed for chemical analysis. Marker at bottom left is 1 inch (2.54 cm) long.

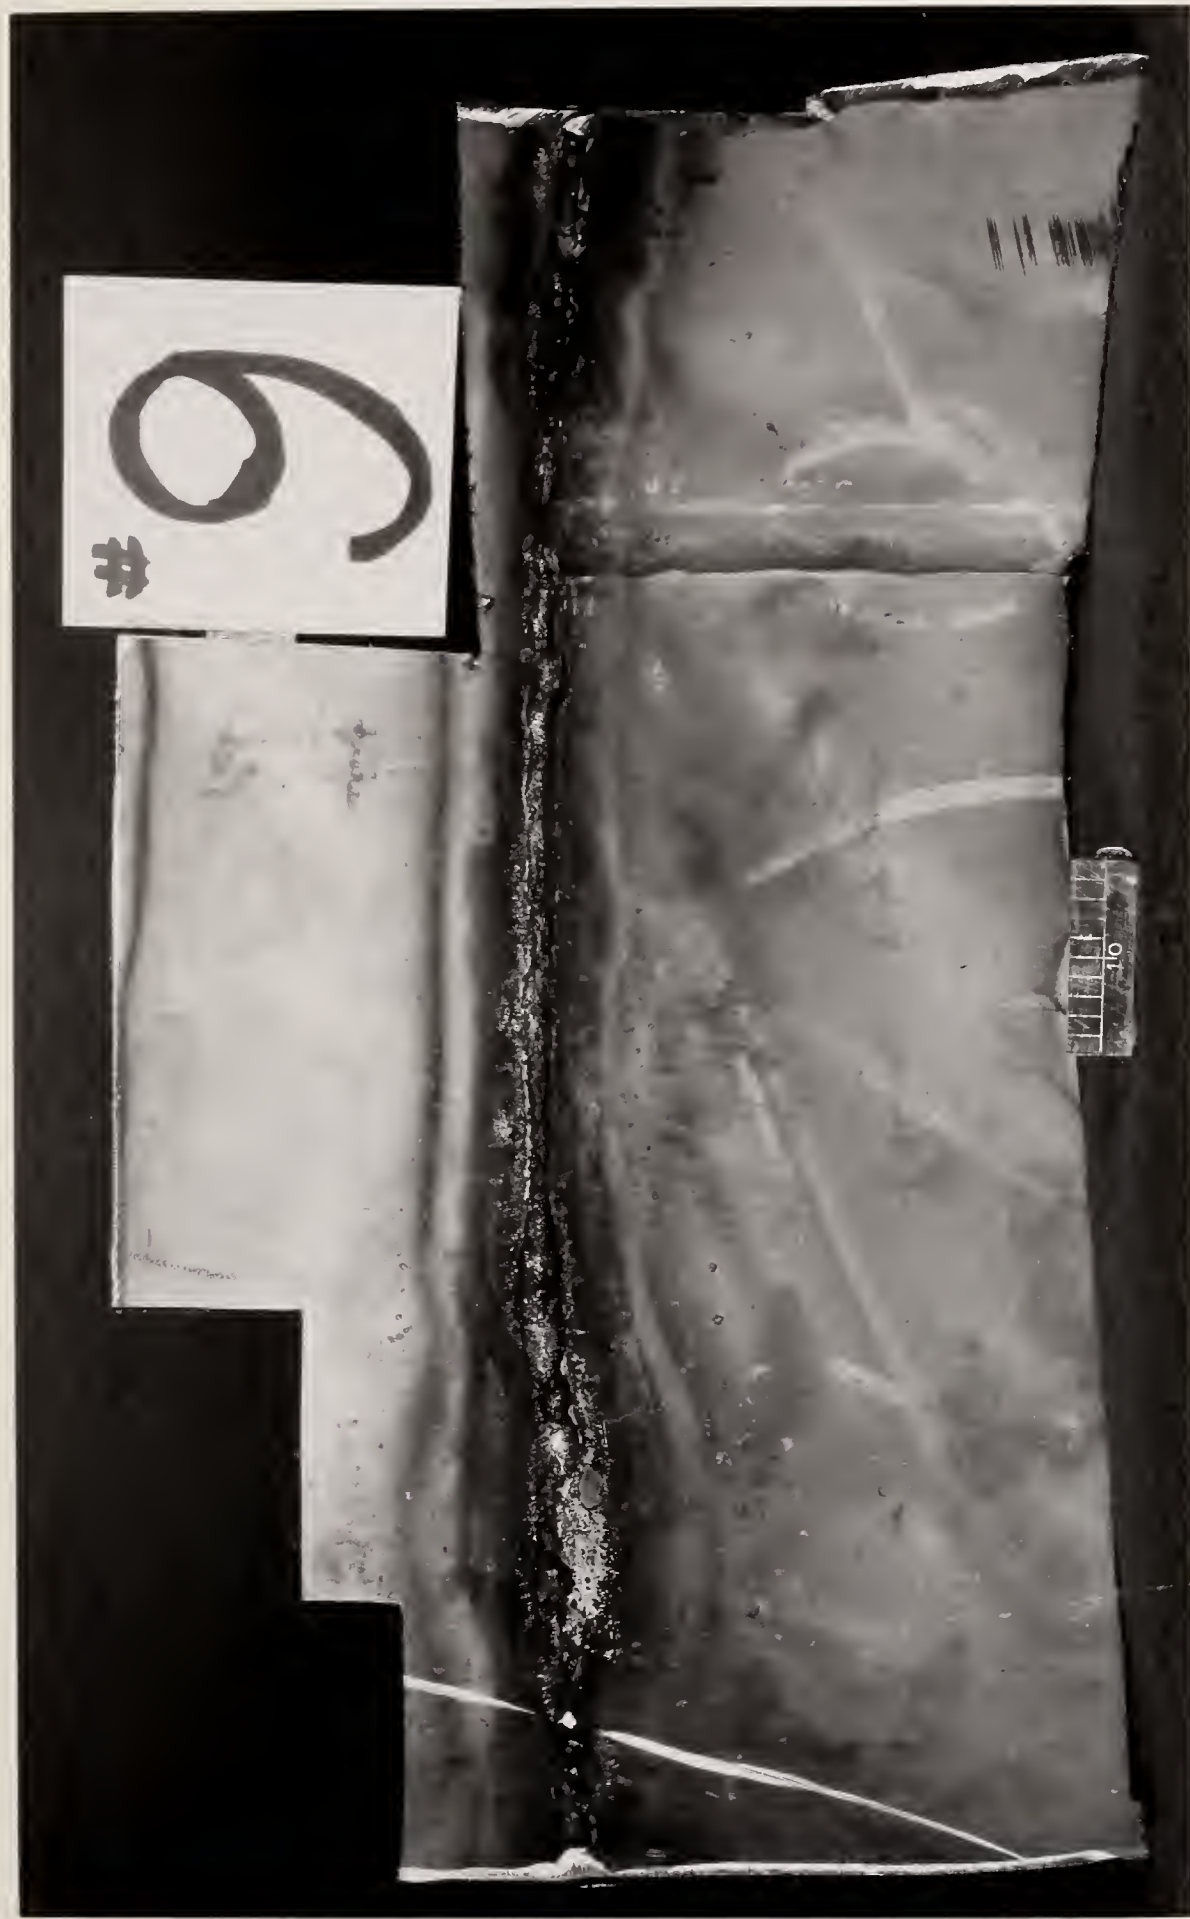
Figure 13. Interior view of stainless steel (type 316) specimen 9 removed from site P (Blender). Several small pits (initiated on the inside surface) were found adjacent to weld on this specimen. The specimen is shown minus the pieces removed for chemical analysis. Marker at bottom center is 1 inch (2.54 cm) long.

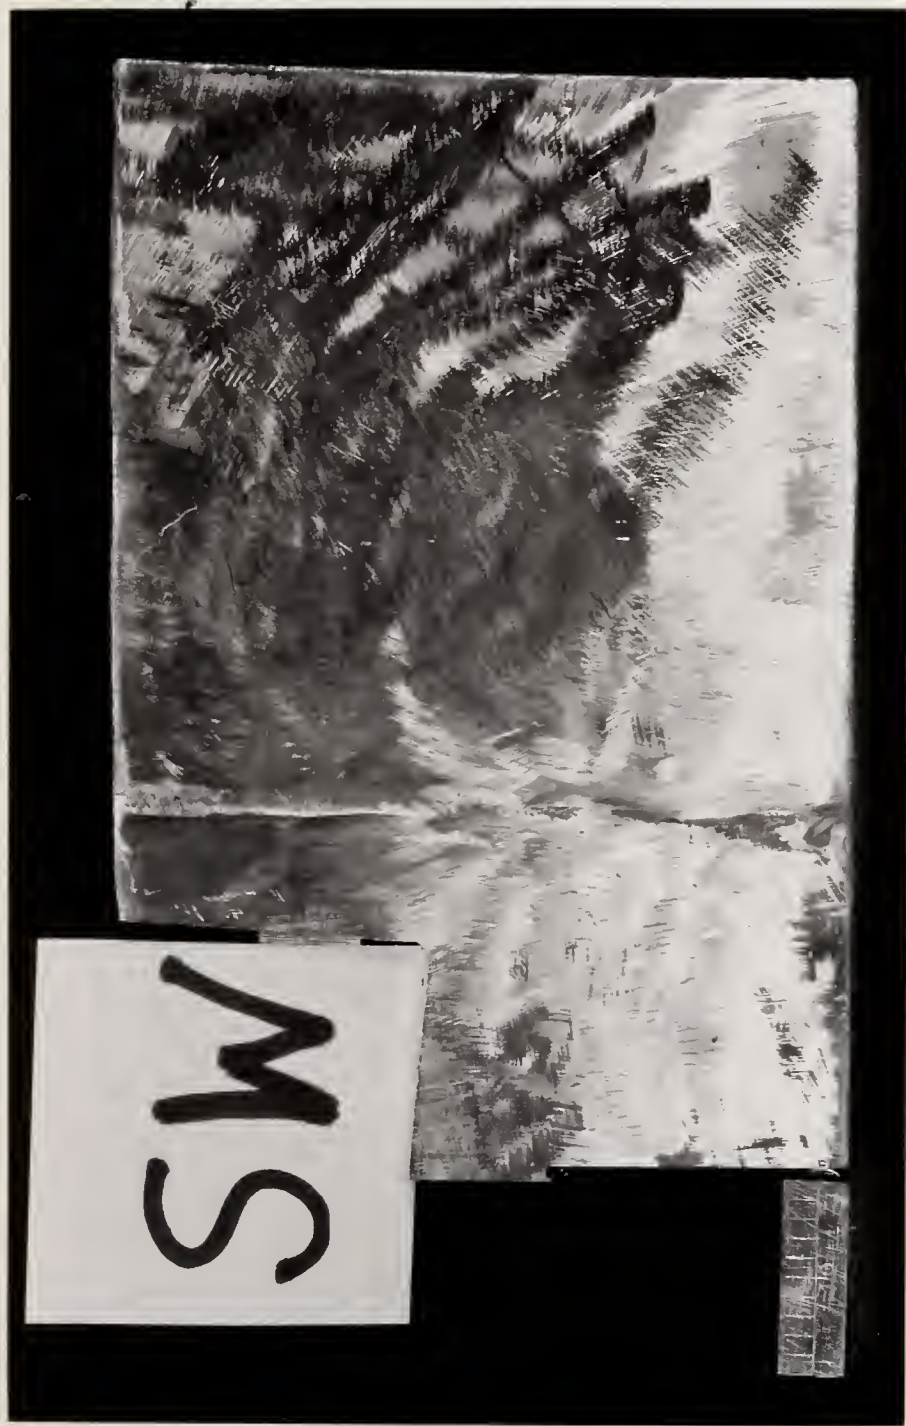
Figure 14. Interior view of stainless steel (type 316) weld specimen S.W. especially prepared by the contractor at site D-6 (Kuwait Towers) for NBS. The specimen is shown minus the pieces removed for chemical analysis. Marker at lower left is 1 inch (2.54 cm) long.

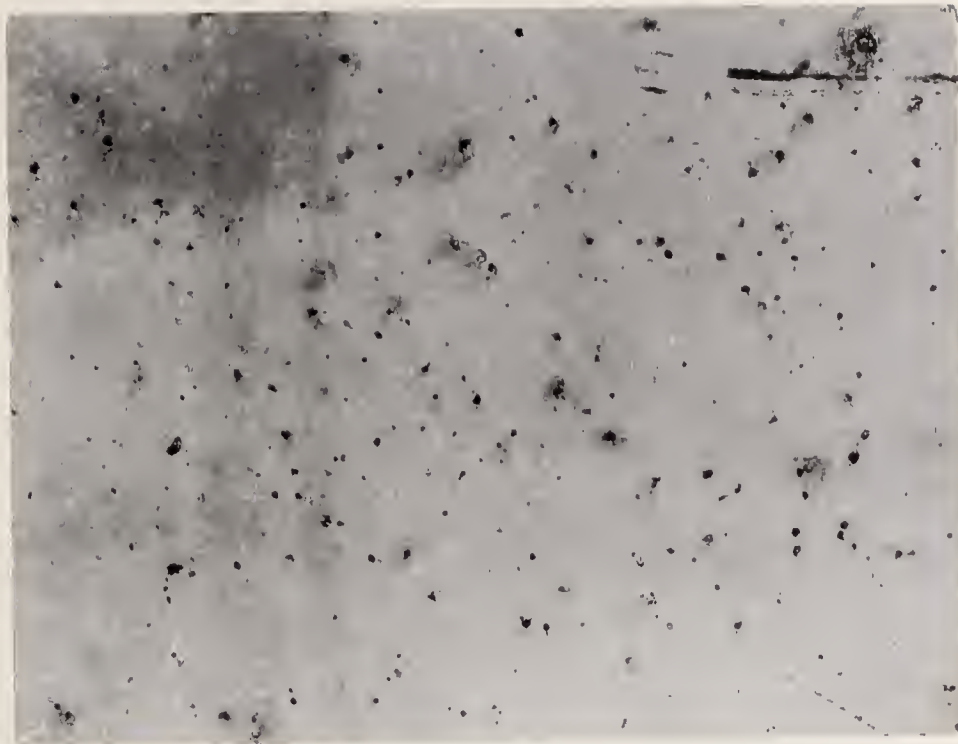
Figure 15. Enlarged view of an area of specimen 1 showing atmospheric pitting (dark spots). (304L) X2

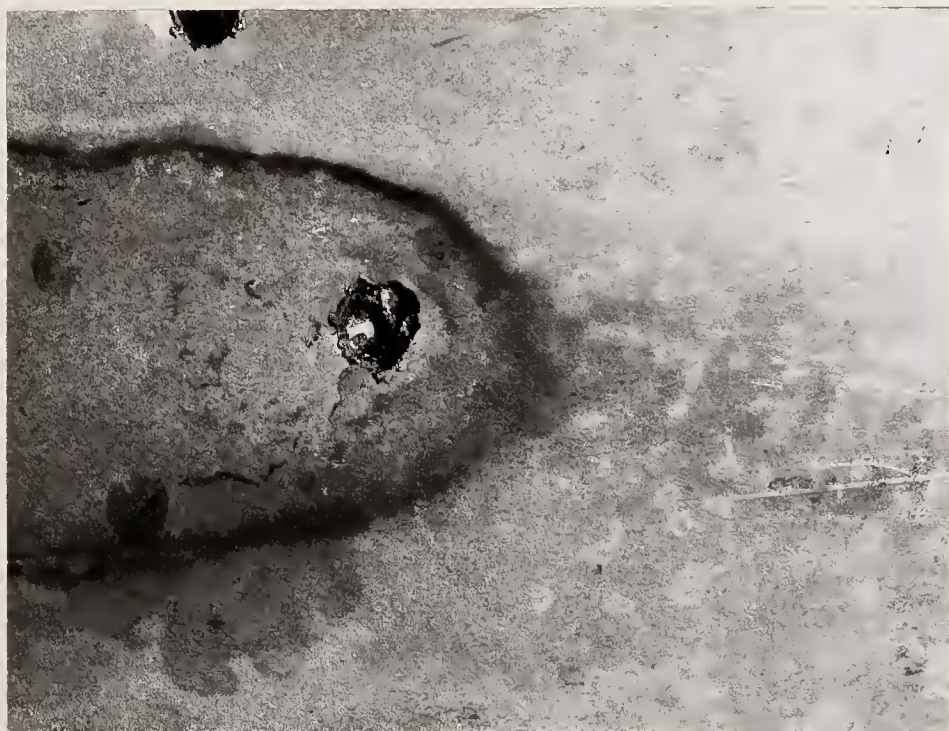
Figure 18. Enlarged view of area of outer surface of specimen 7 showing penetrating pit and oxide stain. (316) X2

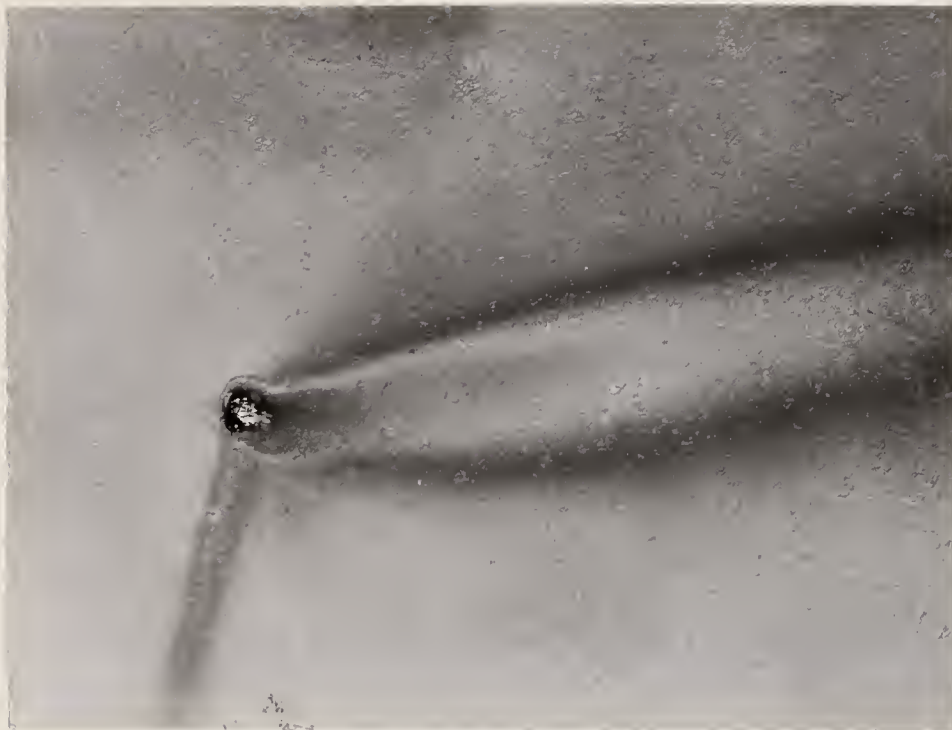
Figure 19. Enlarged view of area of inner surface of specimen 8 showing pit and oxide stain. (316) X2

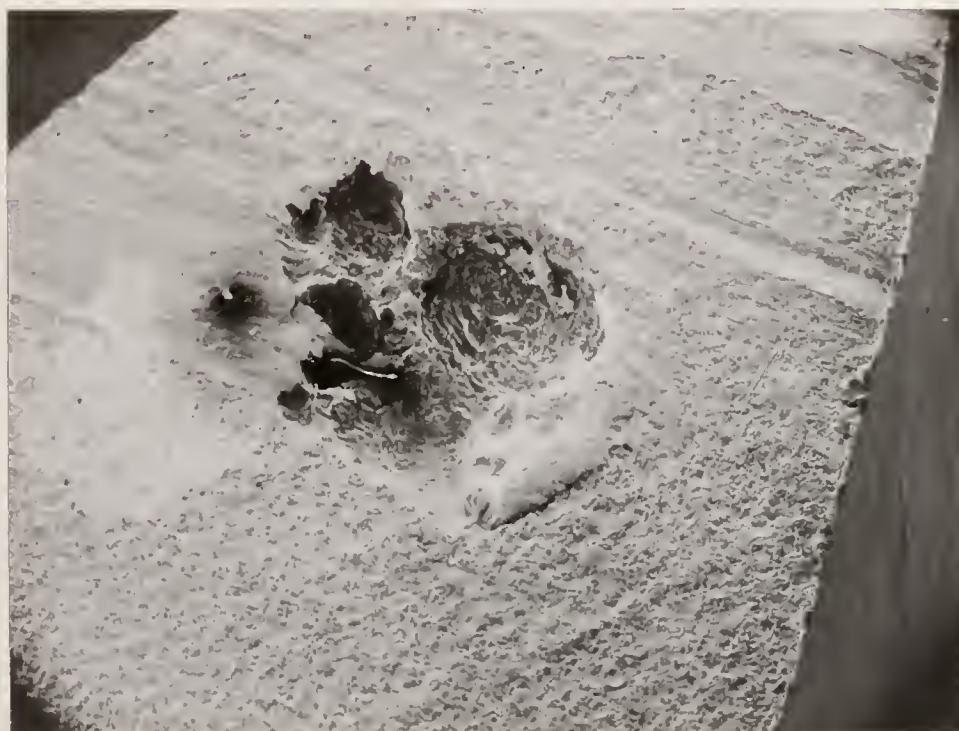
Figure 20. Scanning electron micrograph (SEM) of pit on specimen 5 shown in Fig. 17. (304L) X20

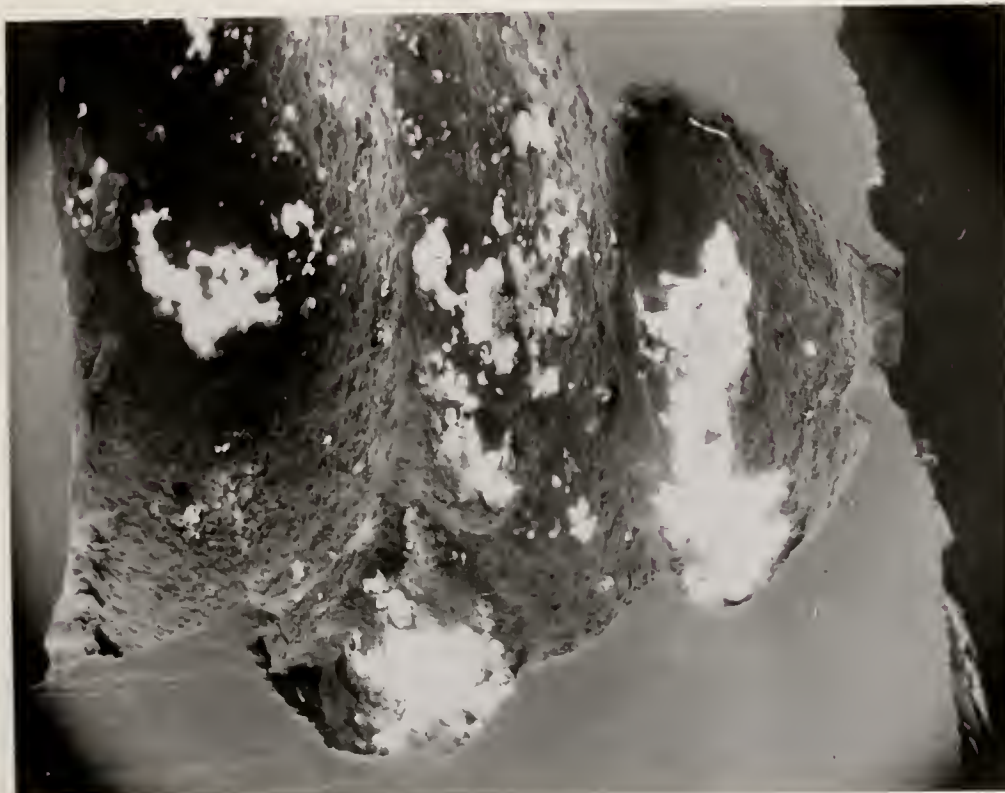
Figure 24. Cross section of one of the large pits near the weld in specimen 2 (see Fig. 16). White areas are corrosion product. (304L) SEM X16

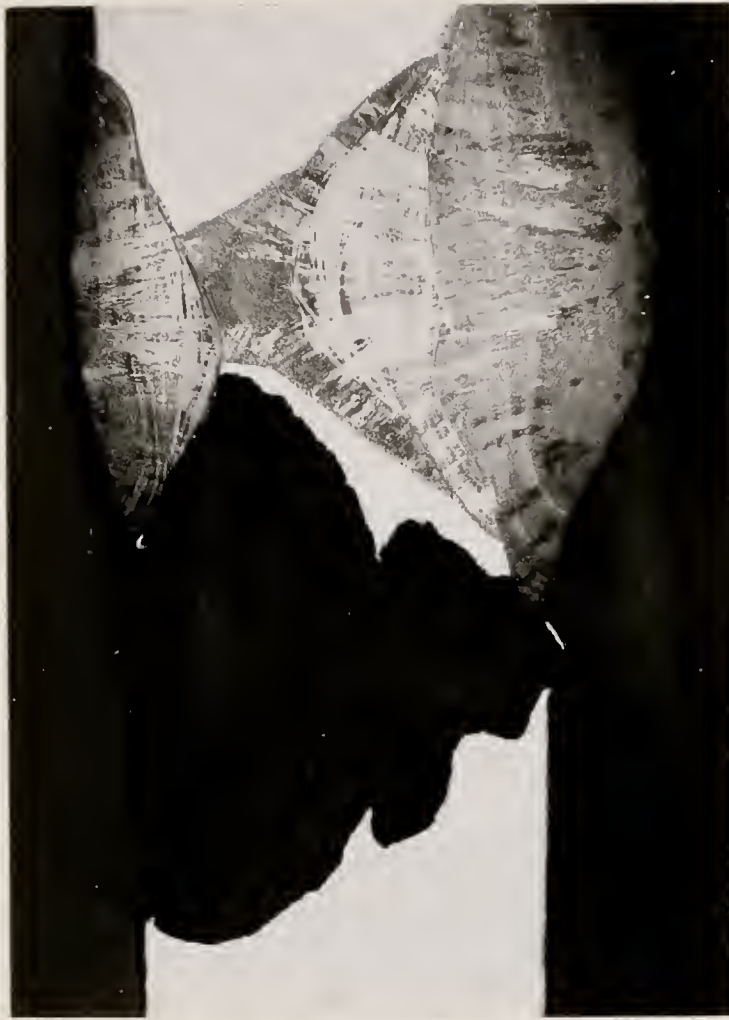
Figure 25. Cross section of the other half of pit shown in Fig. 24. Note relative resistance of weld metal to attack. (304L) Etched in 10% oxalic acid. X6

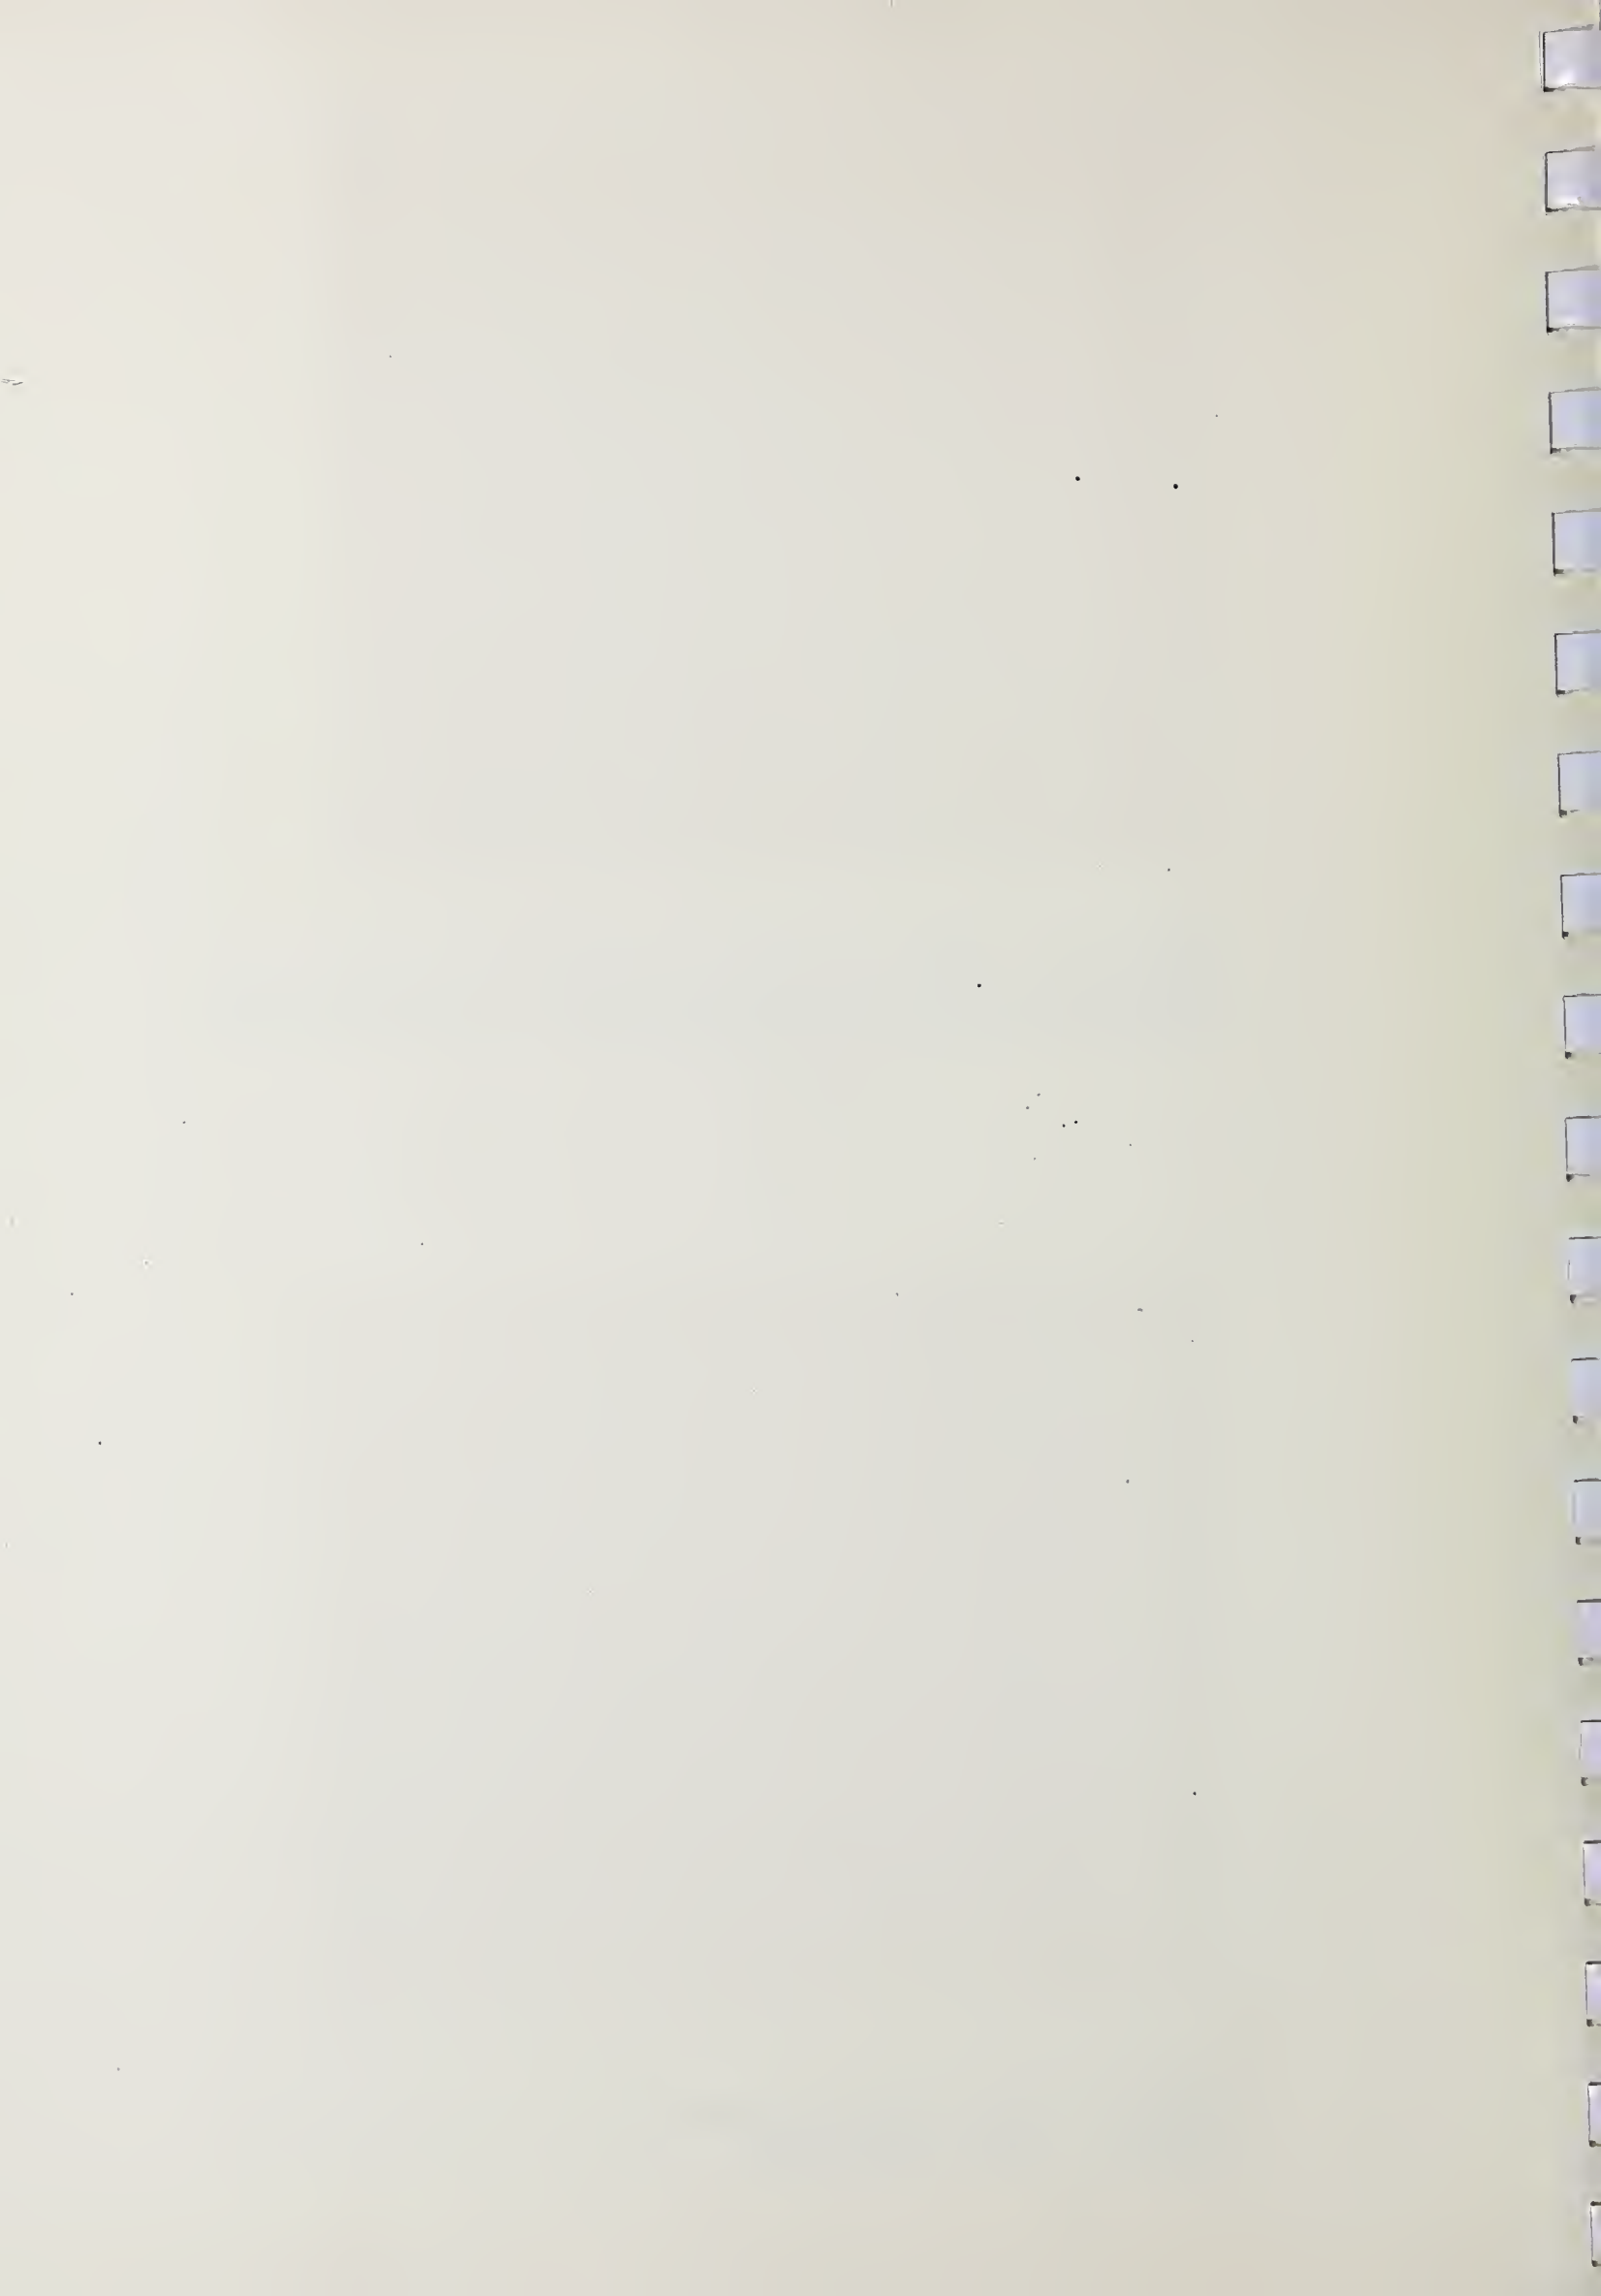
Figure 32. Area within pit shown in Fig. 31 showing faceting. (304L) SEM X400

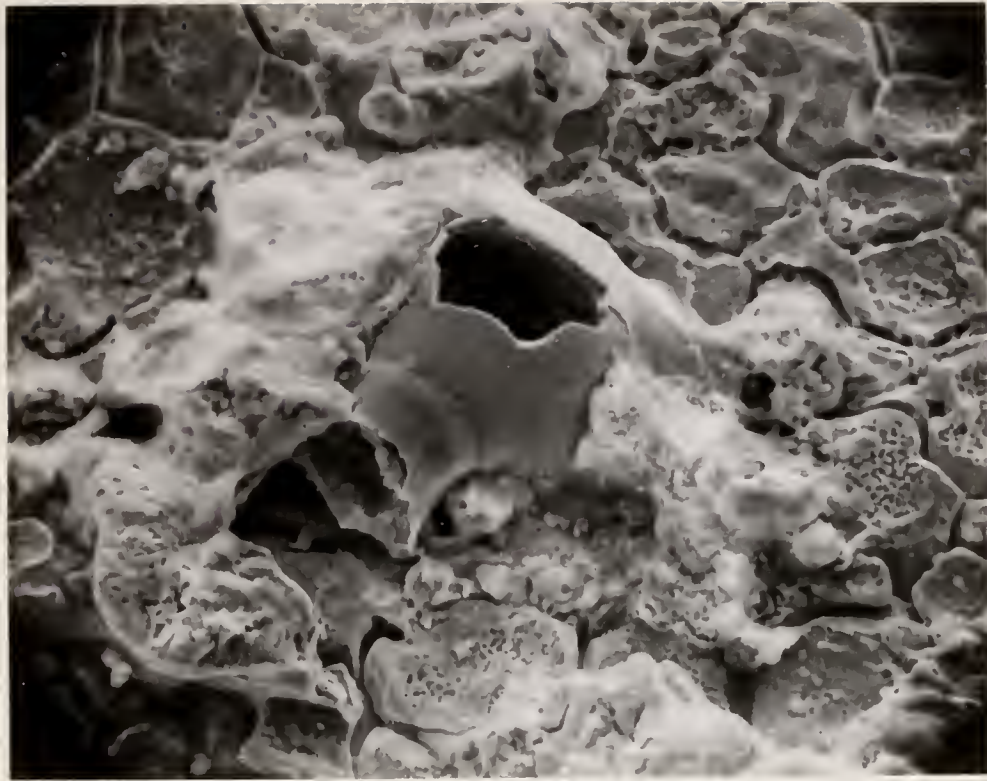
Figure 33. Microscopic view of one of the pits seen on specimen 1 in Figs. 6 and 15. Corrosion product is in form of barnacle-like incrustation. (316) SEM X500

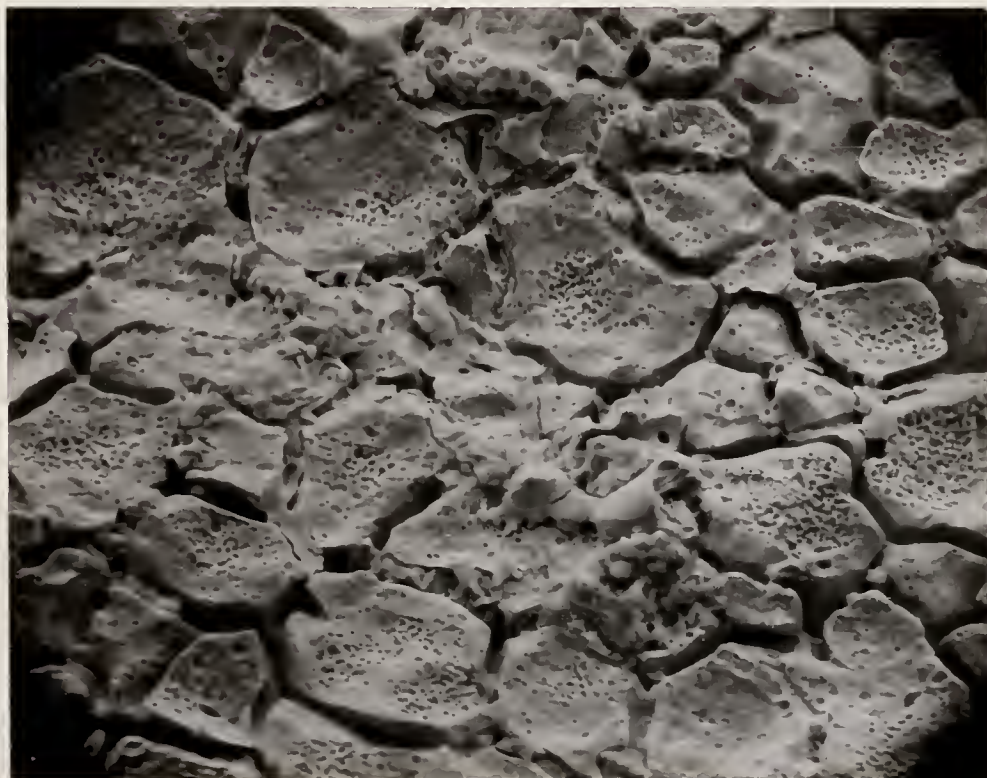
Figure 34. Identical area as shown in Fig. 33 with most of corrosion product removed. Some attack other than intergranular effect is present. (316) SEM X500
