NATL INST. OF STAND & TECH  
11107 101881

NIST  
PUBLICATIONS

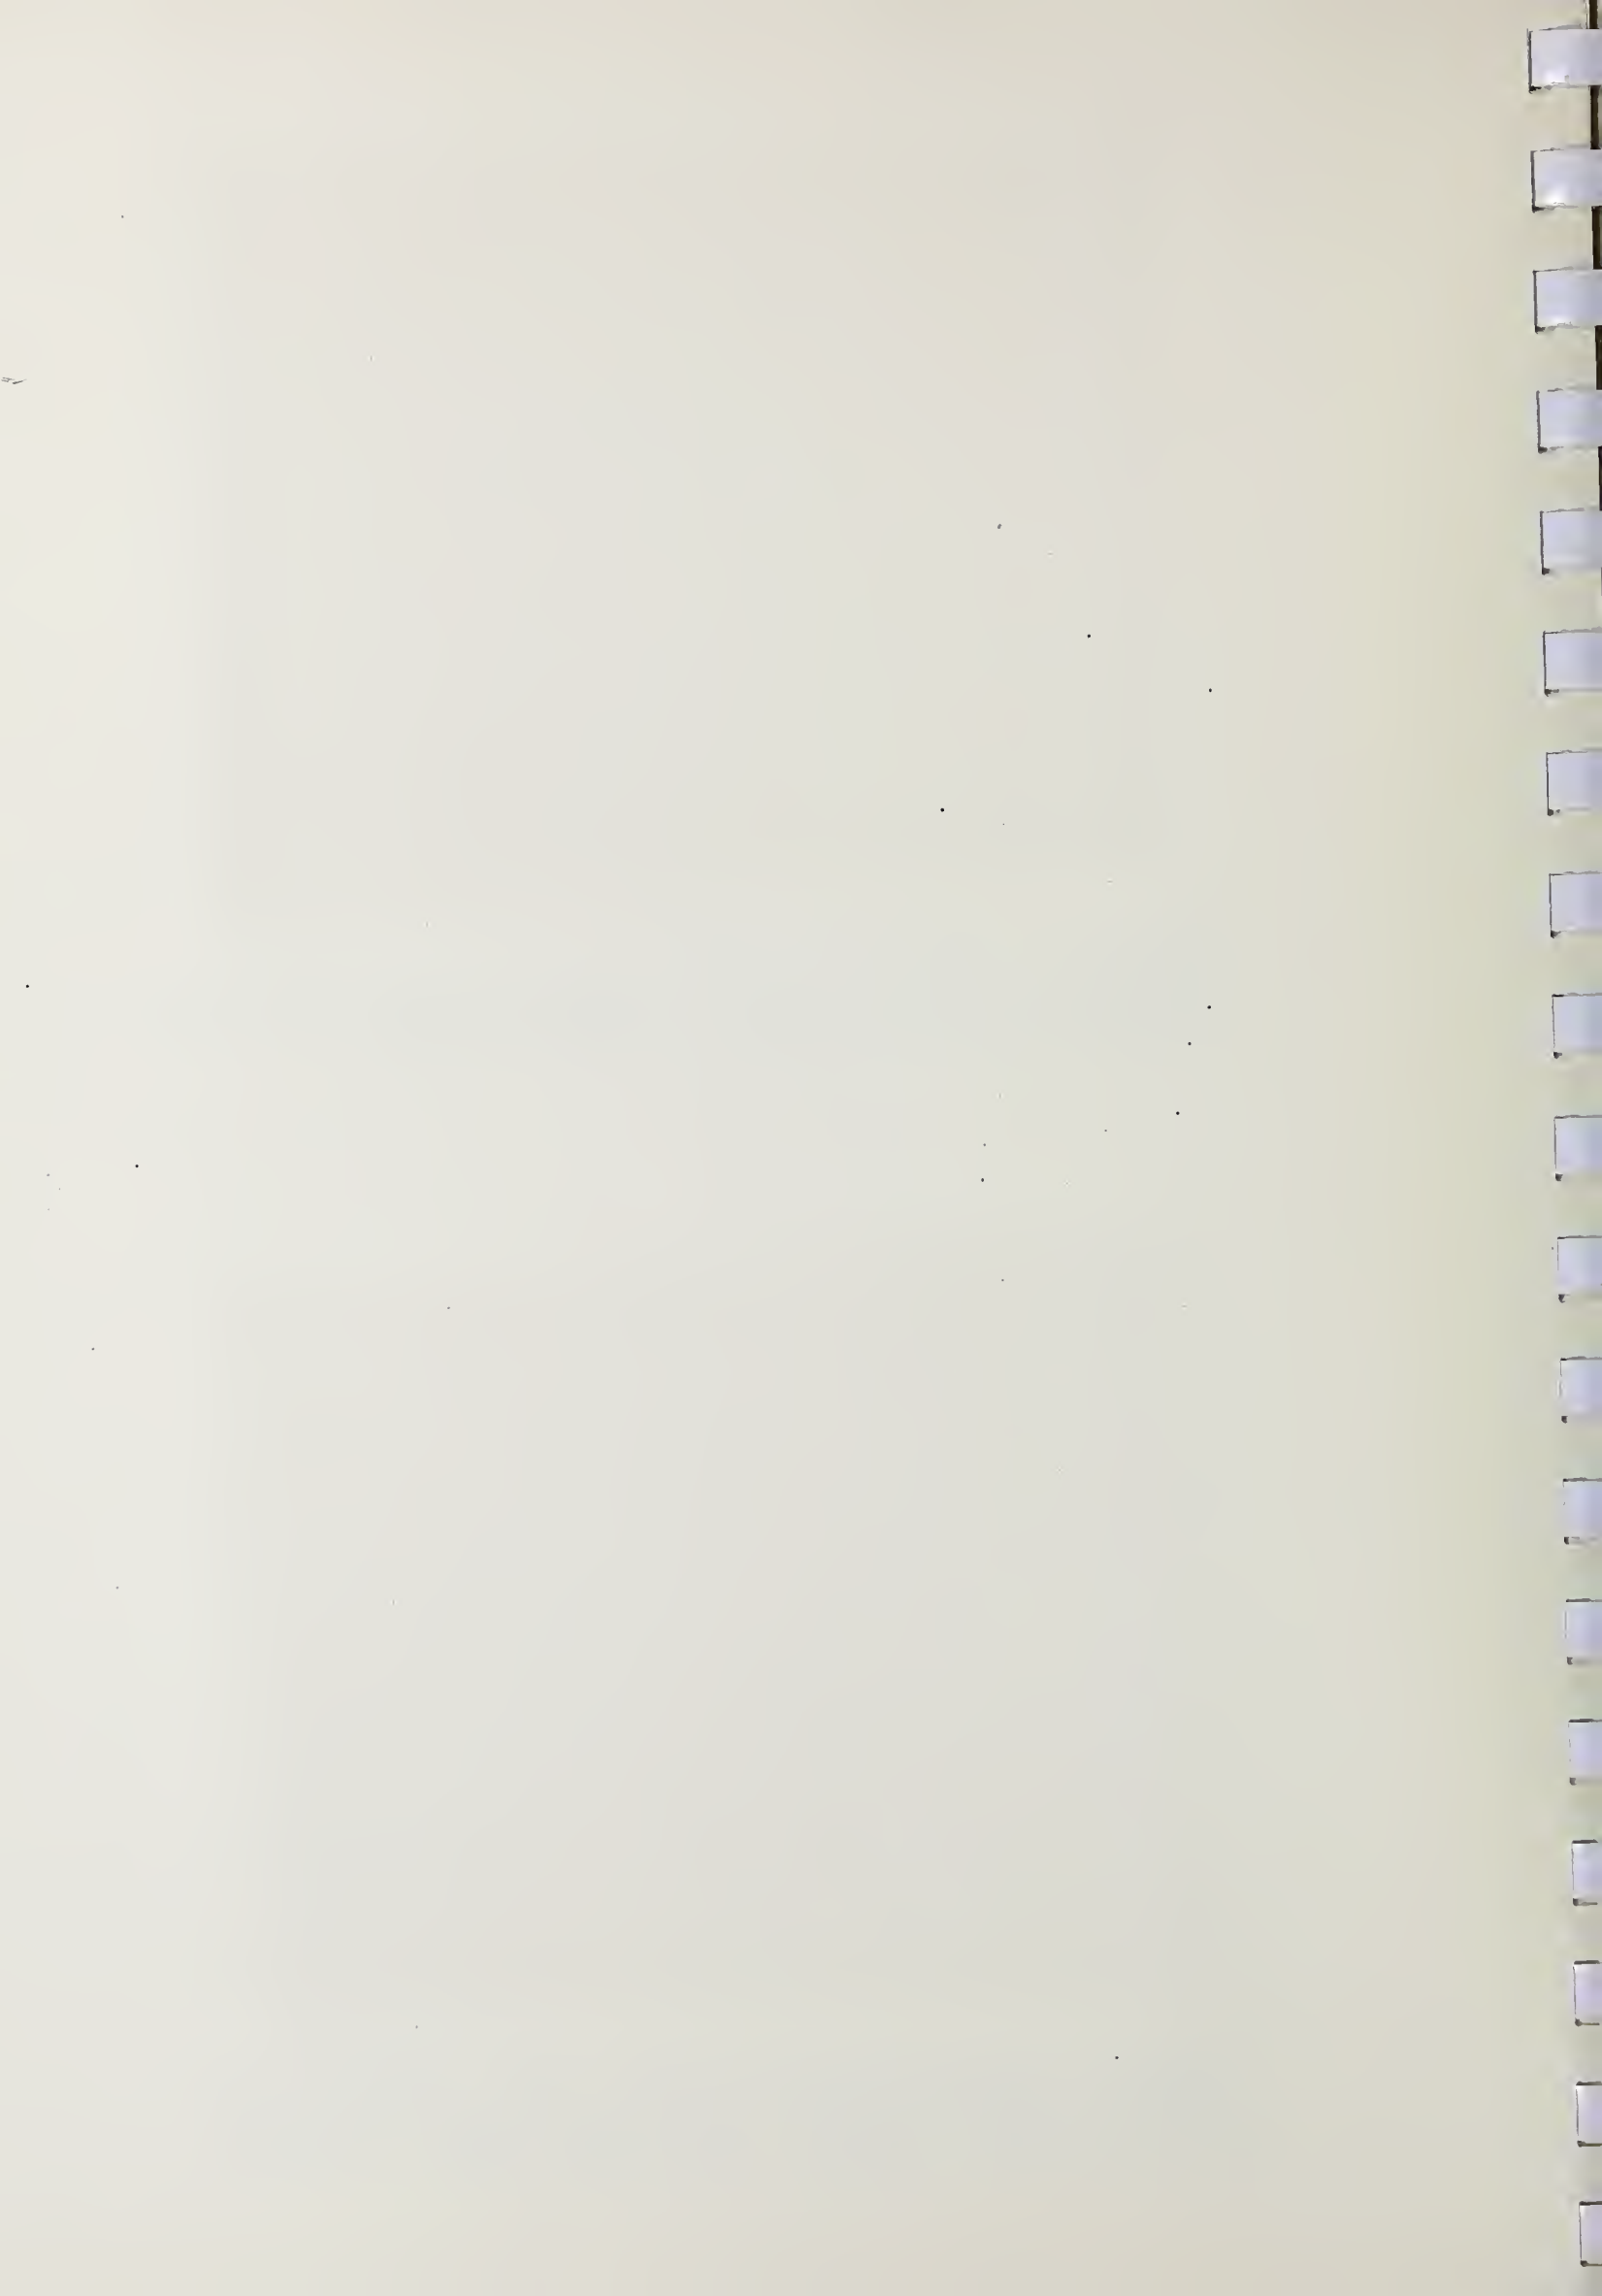
Figure 34. Identical area as shown in Fig. 33 with most of corrosion product removed. Some attack other than intergranular effect is present. (316) SEM X500

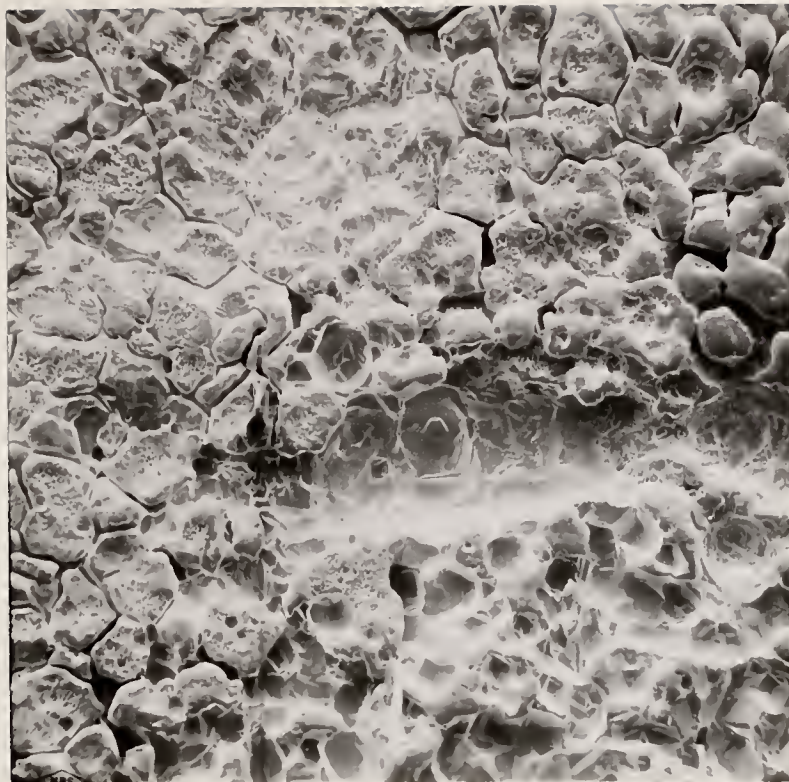
Figure 35. Area of specimen 1 in which grains of metal are missing from surface. (316) SEM X240

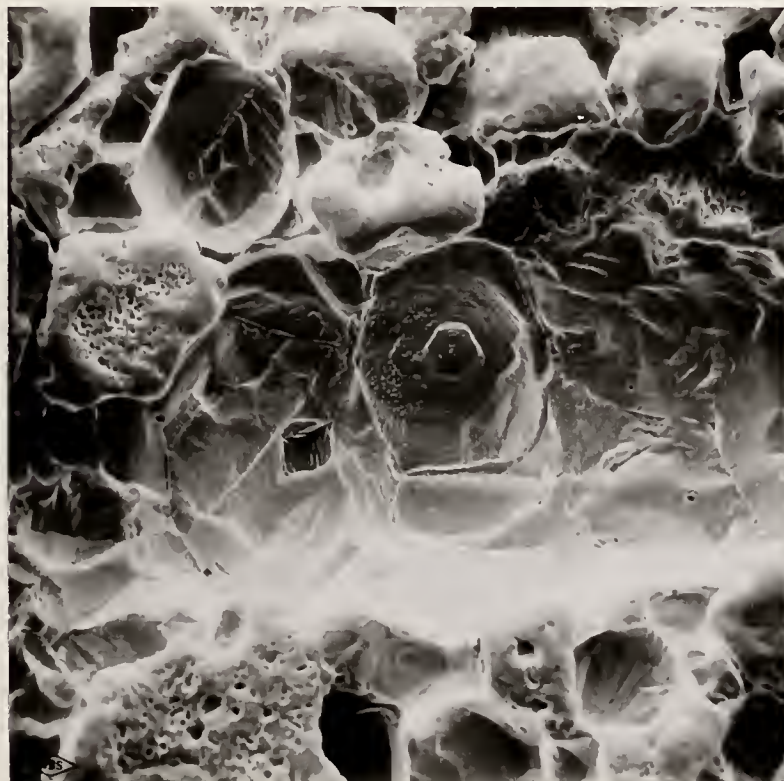
Figure 36. Area within attacked region shown in Fig. 35. Note faceting, etch pitting, and grain boundary delineation. (316) SEM X600

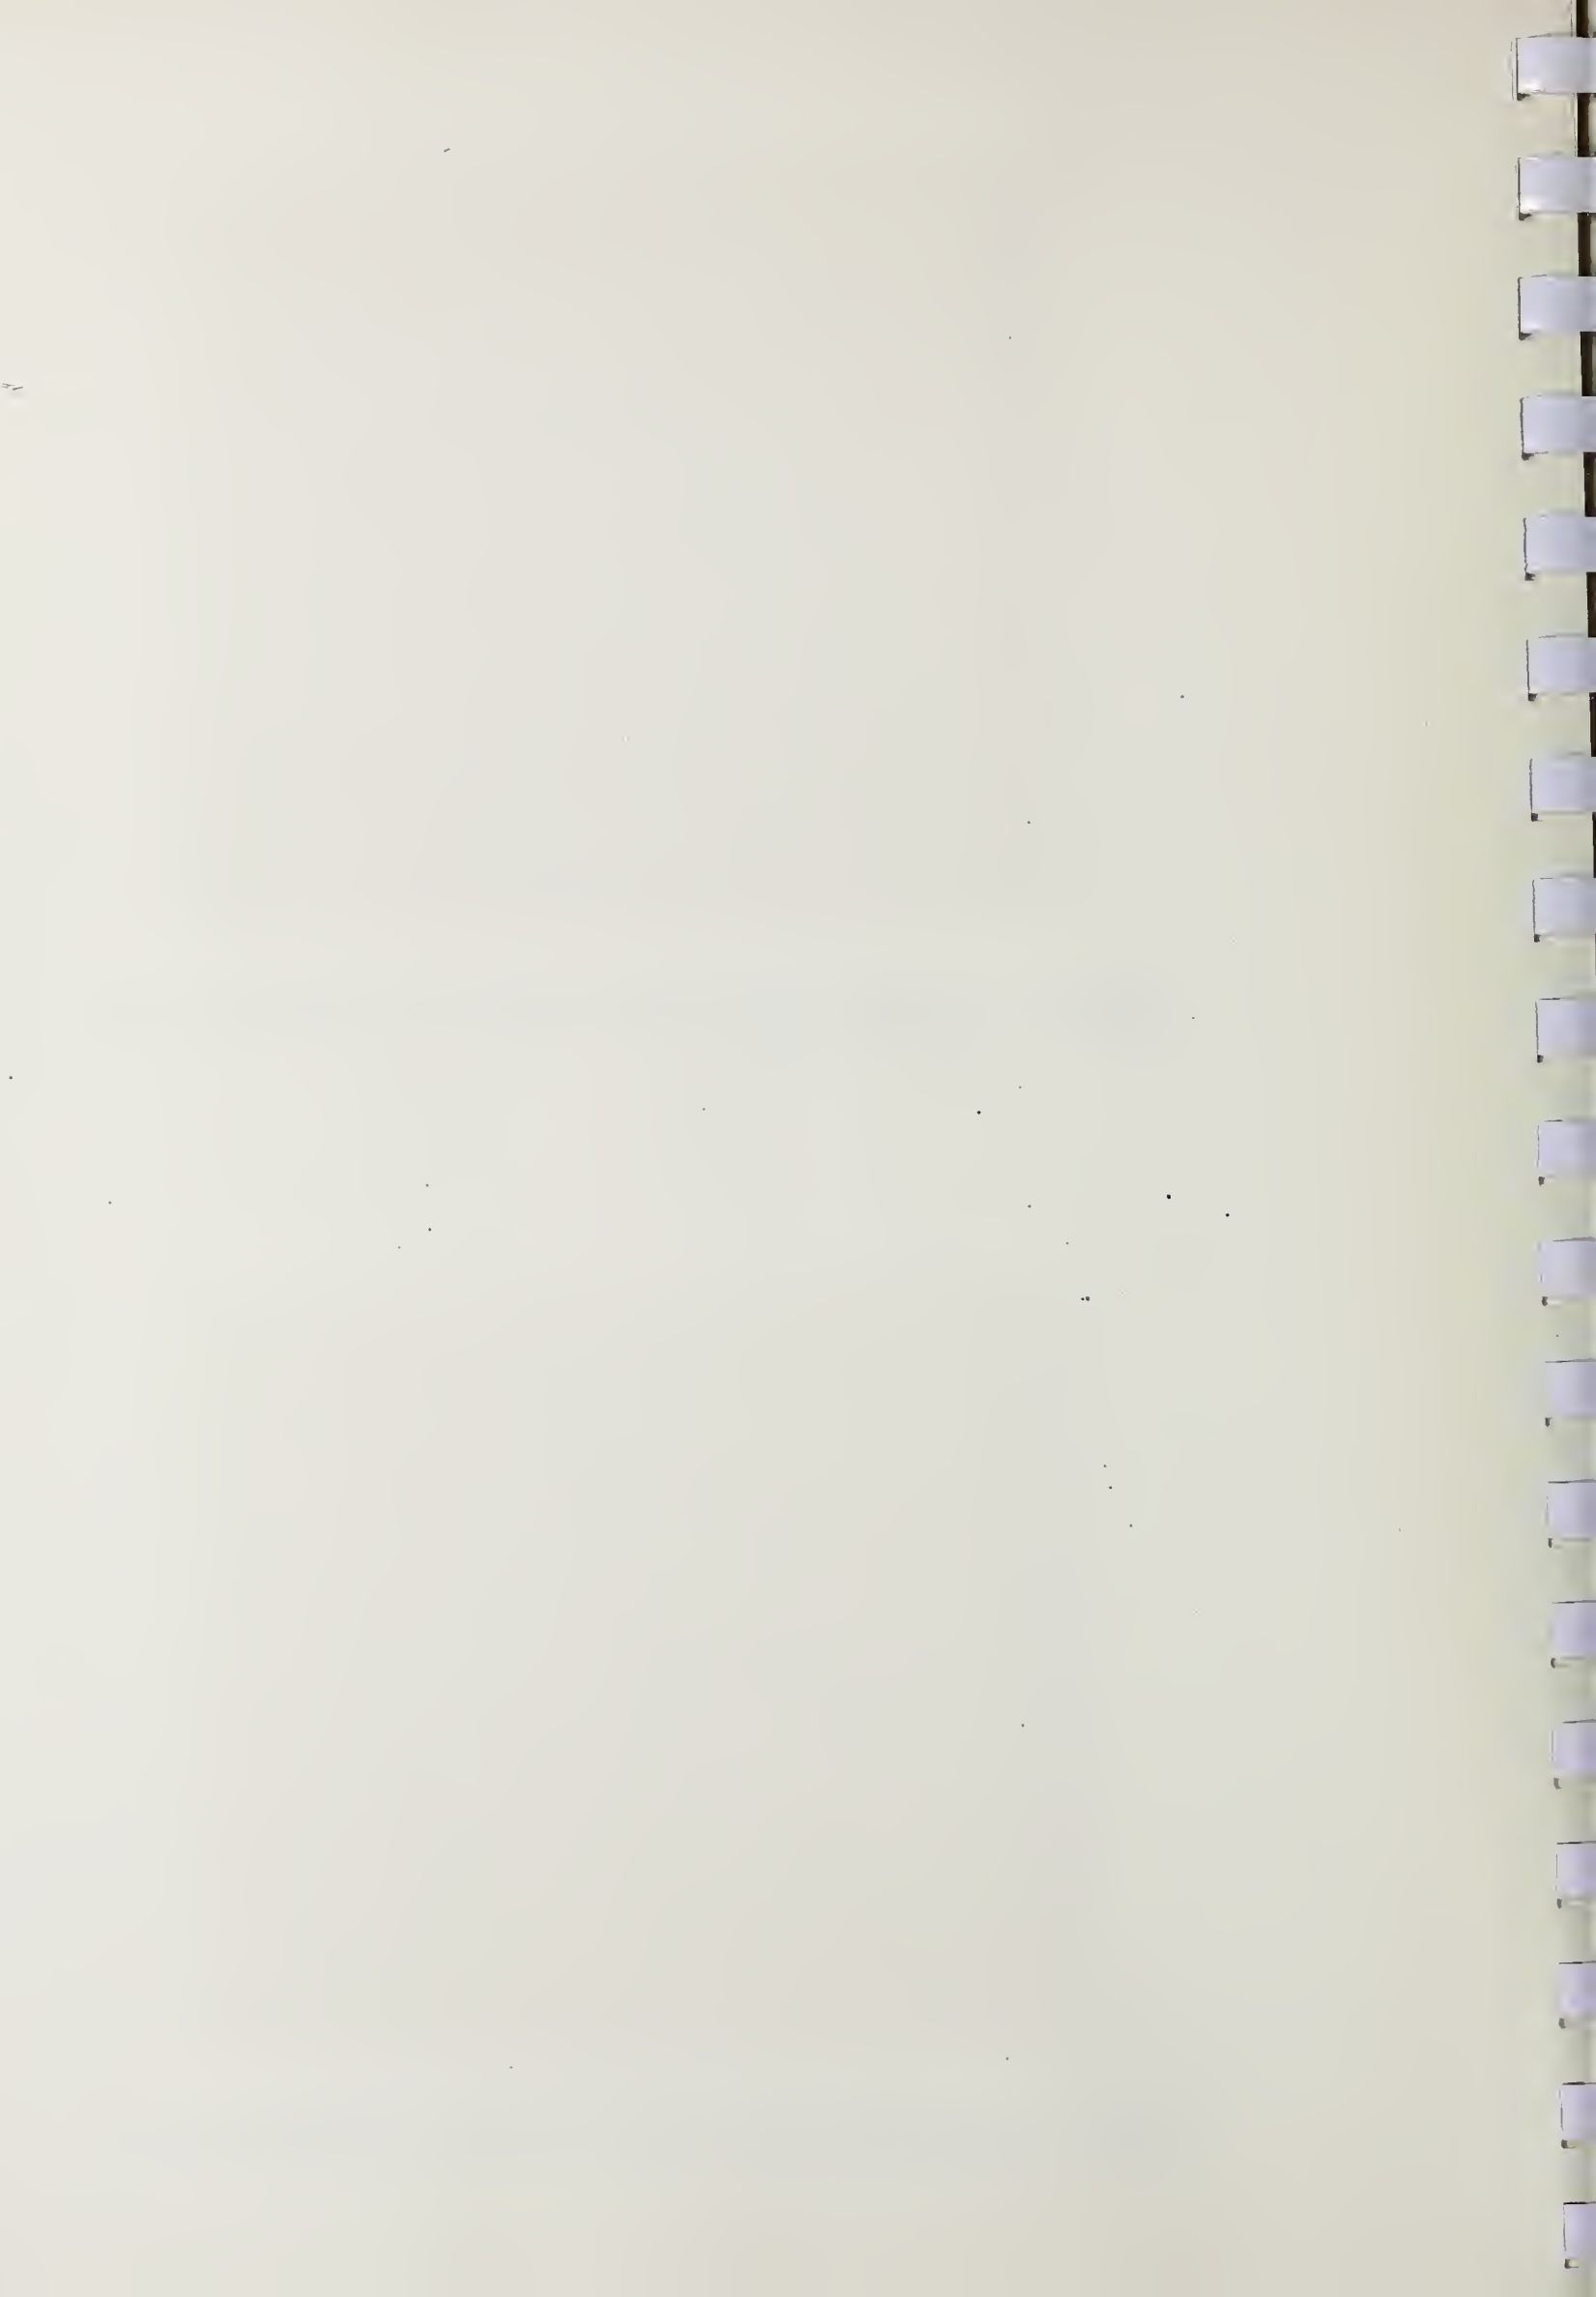
Figure 42. Typical area of outer surface of specimen 8 from site P. (316) SEM X600

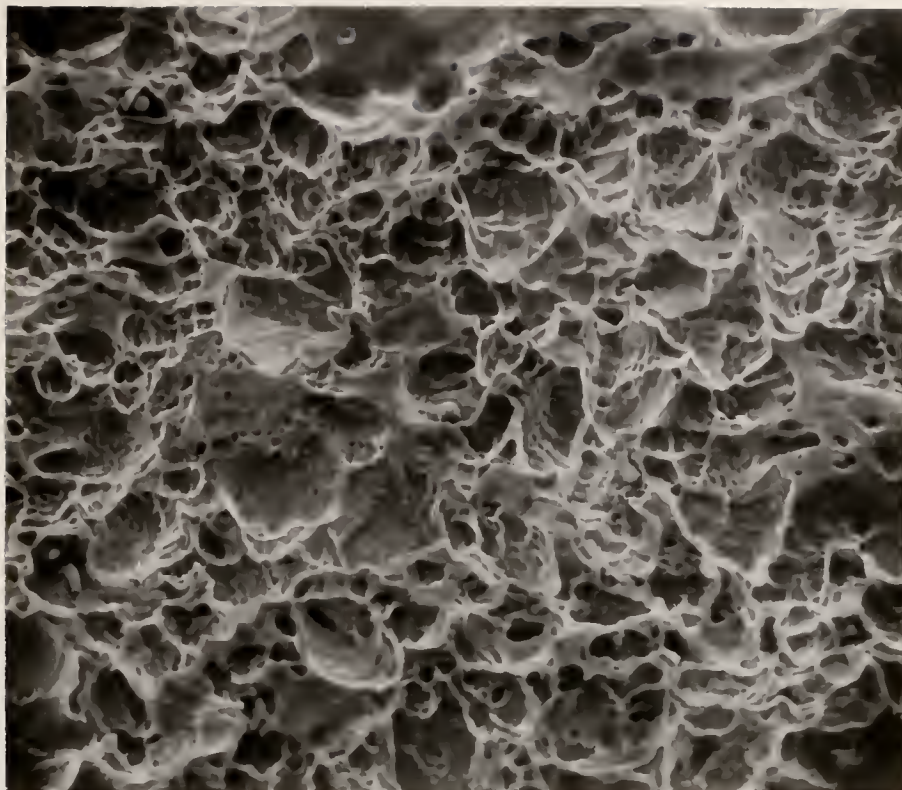
Figure 43. Typical area of surface of NBS storeroom stock type 304 stainless steel. SEM X600

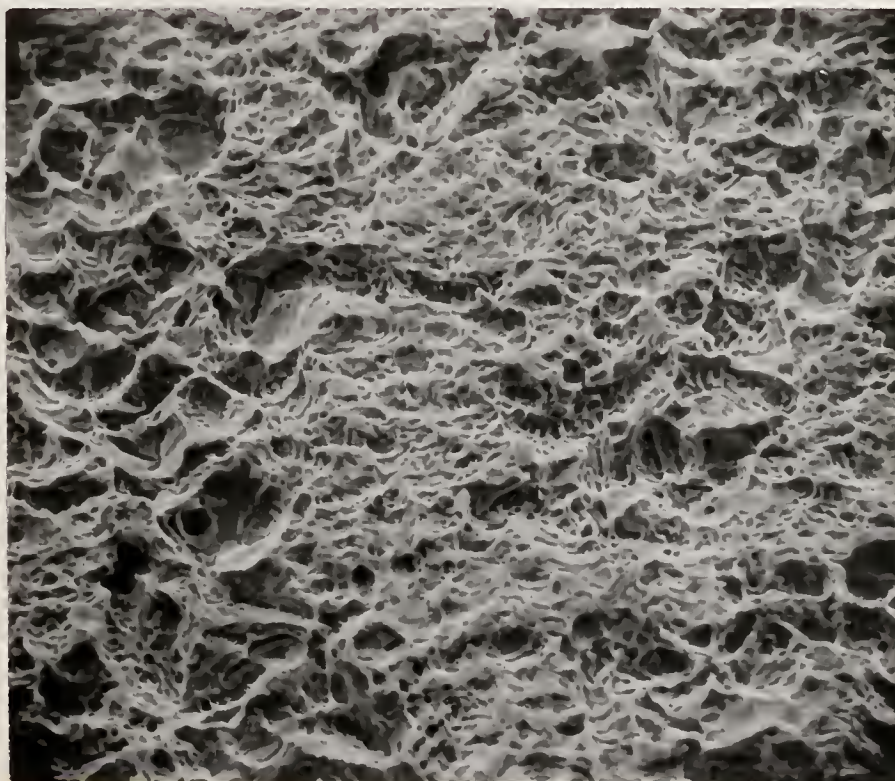
Figure 44. Typical area of surface on other side of 304 piece shown in Fig. 43. SEM X600

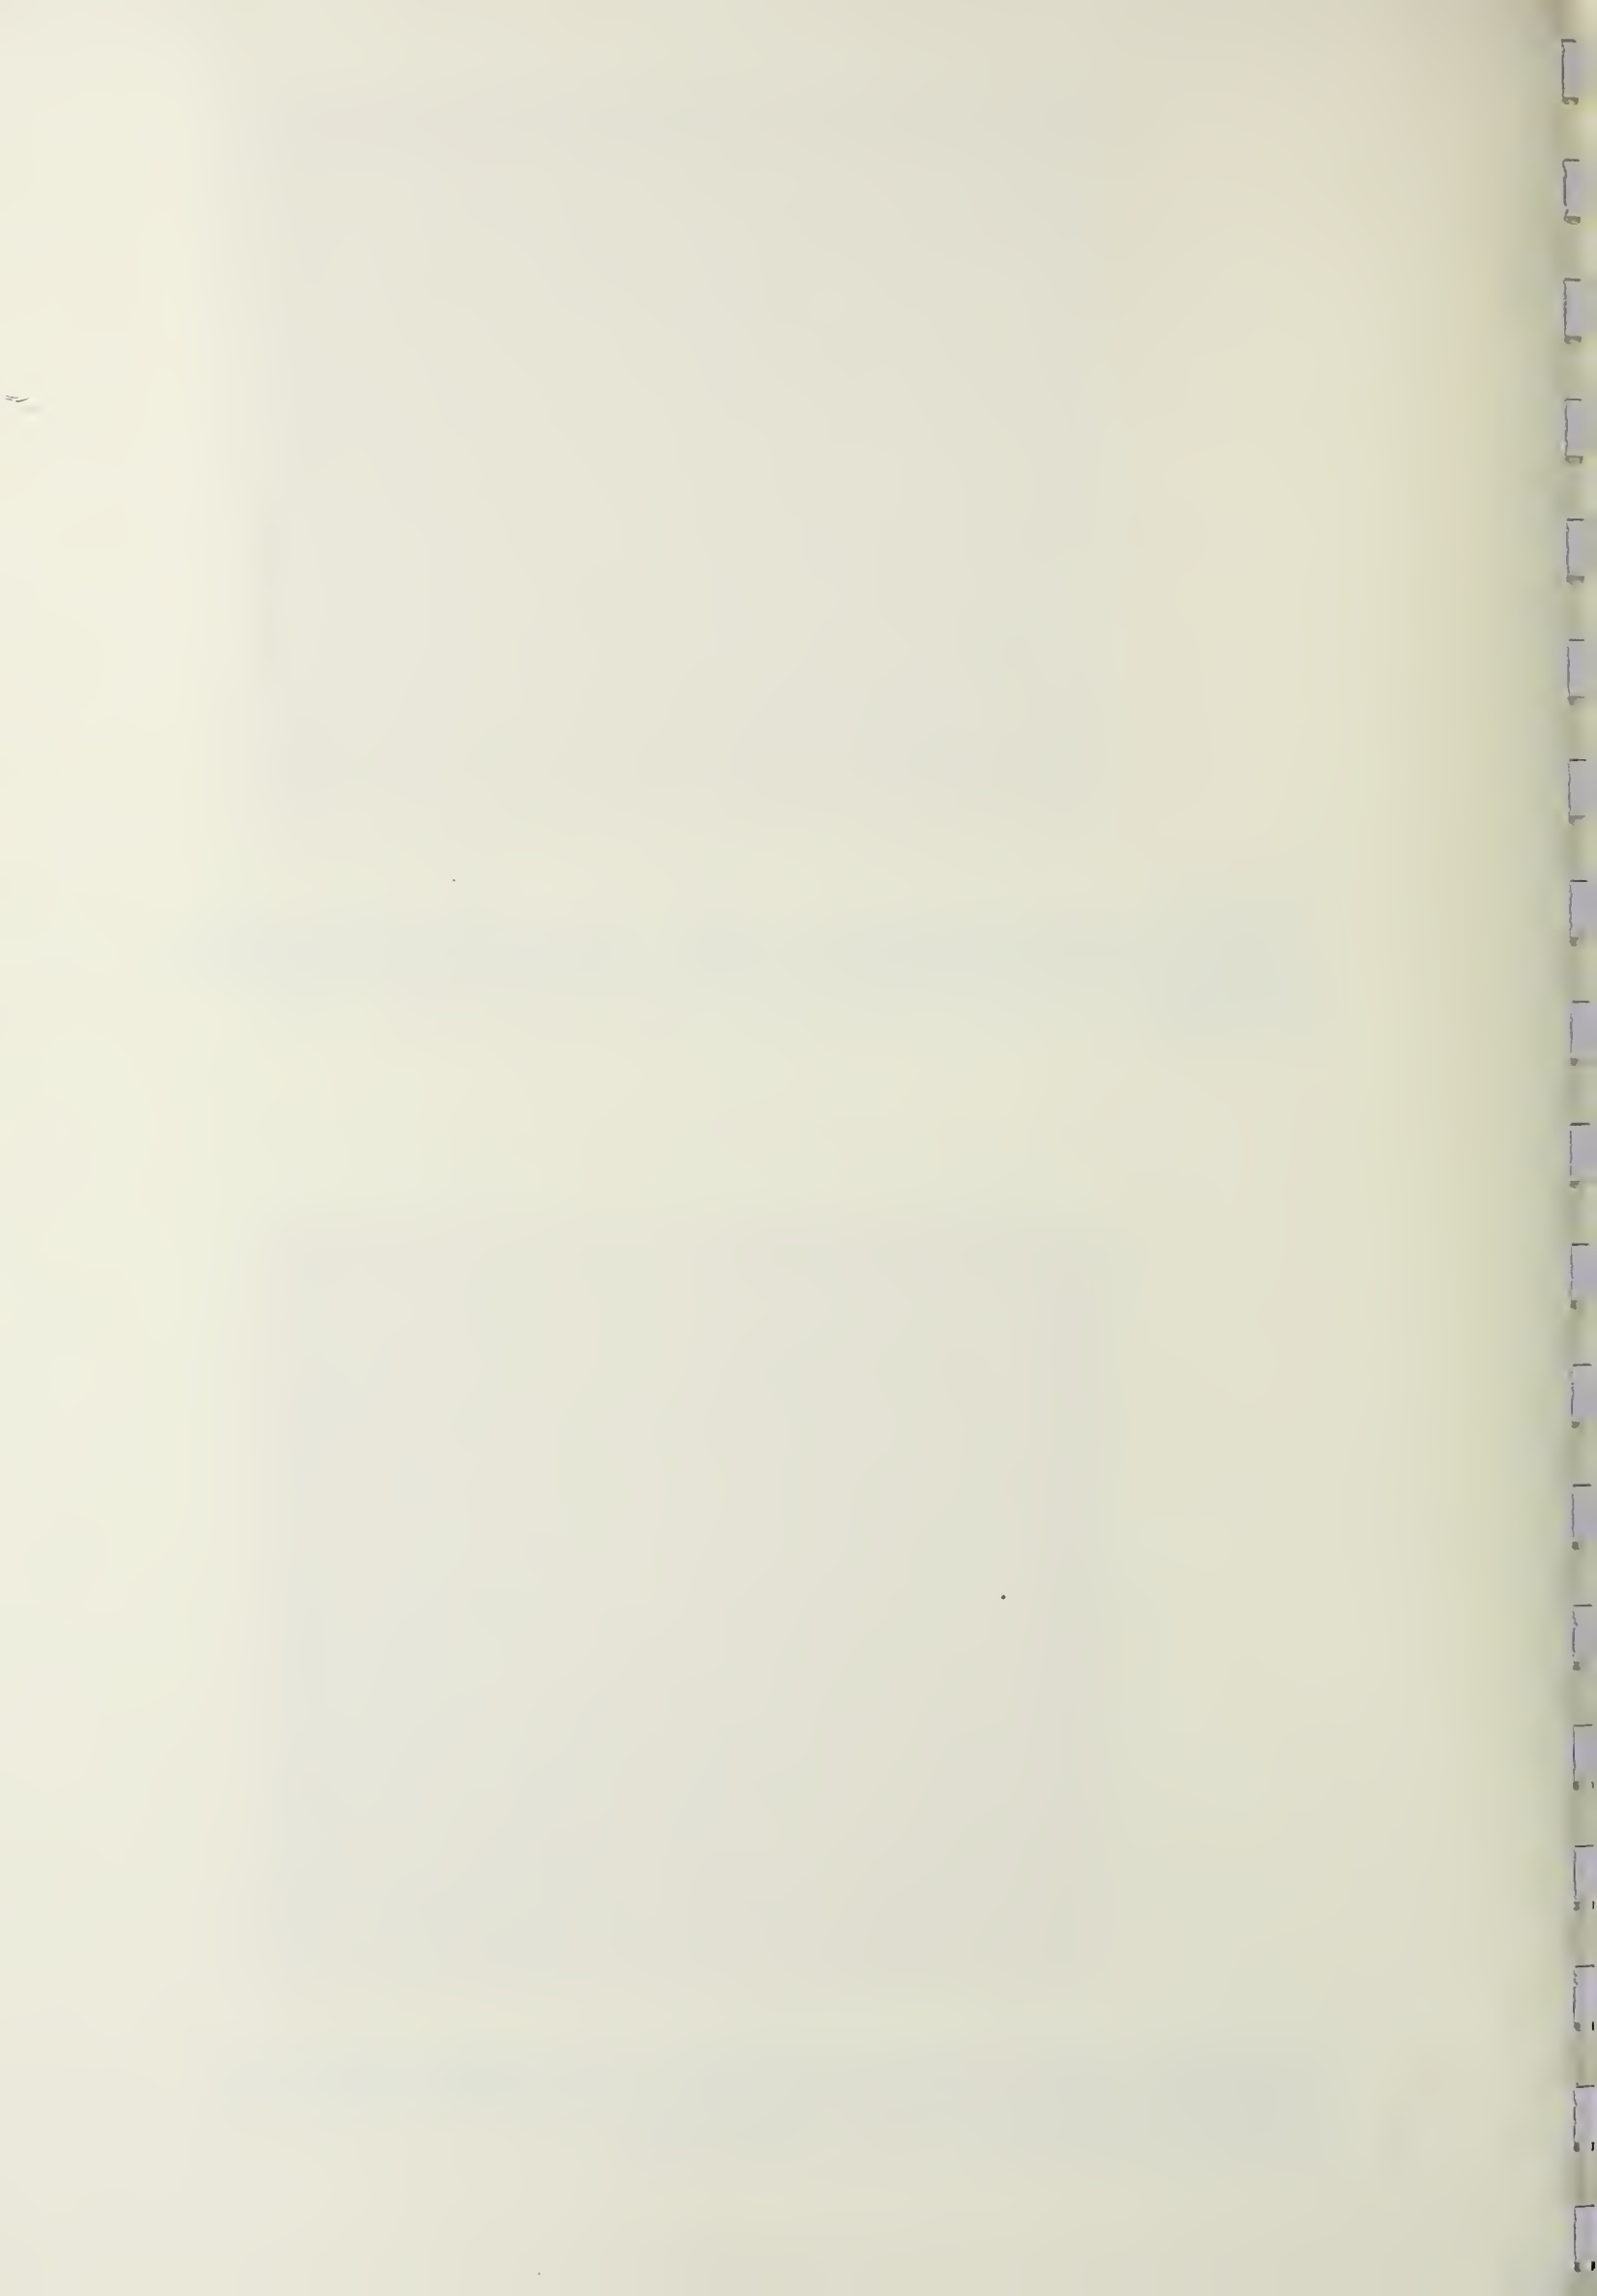
Figure 60. Area on specimen 1 after 5-day "rubber band" test in potable water +4 ppm  $\text{Cl}_2$  at  $50^\circ\text{C}$ . Note faceting and grain boundary delineation. (316) SEM X1000

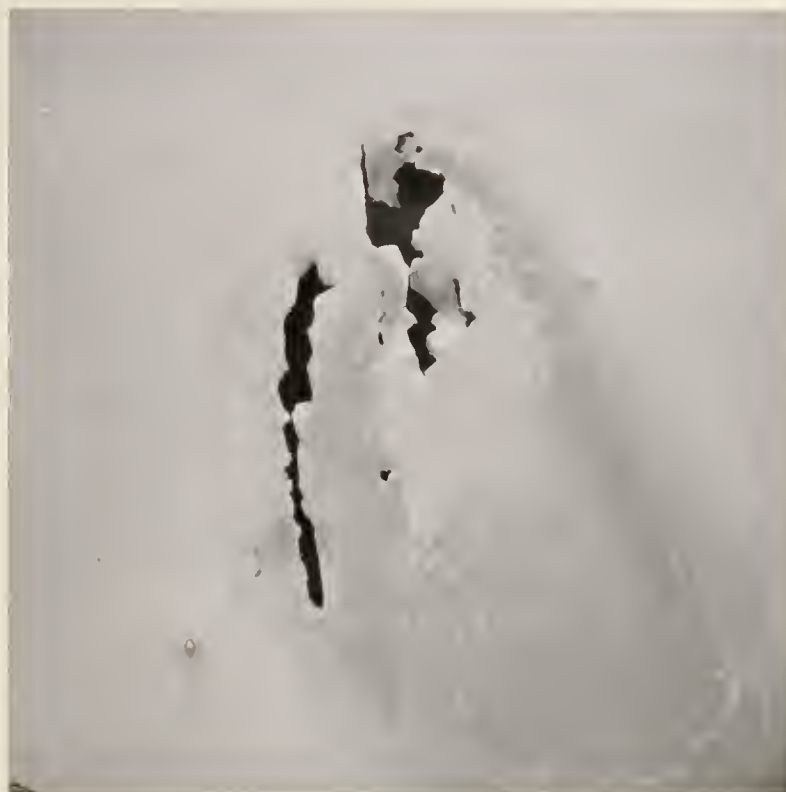
Figure 61. Surface of specimen 1 after 30-minute exposure to brackish water. Specimen was polarized to +600 mV vs SCE. Attack has undercut surface as in actual failure (see Fig. 29 and 30). (316) SEM X210

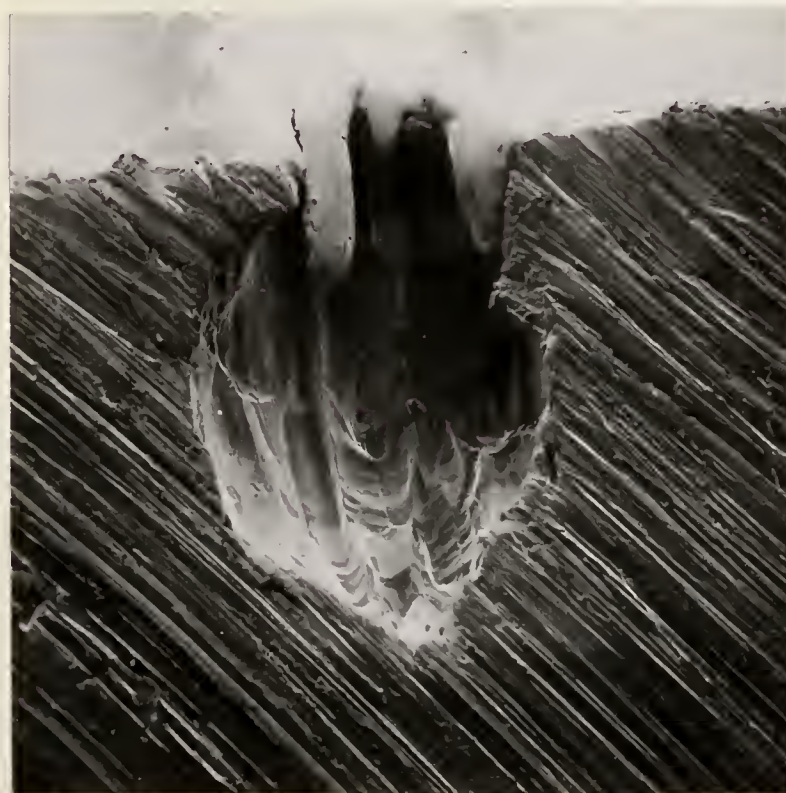
Figure 62. Cross section of pit shown in Fig. 61. Undercutting nature of pitting is shown. (316) SEM X200

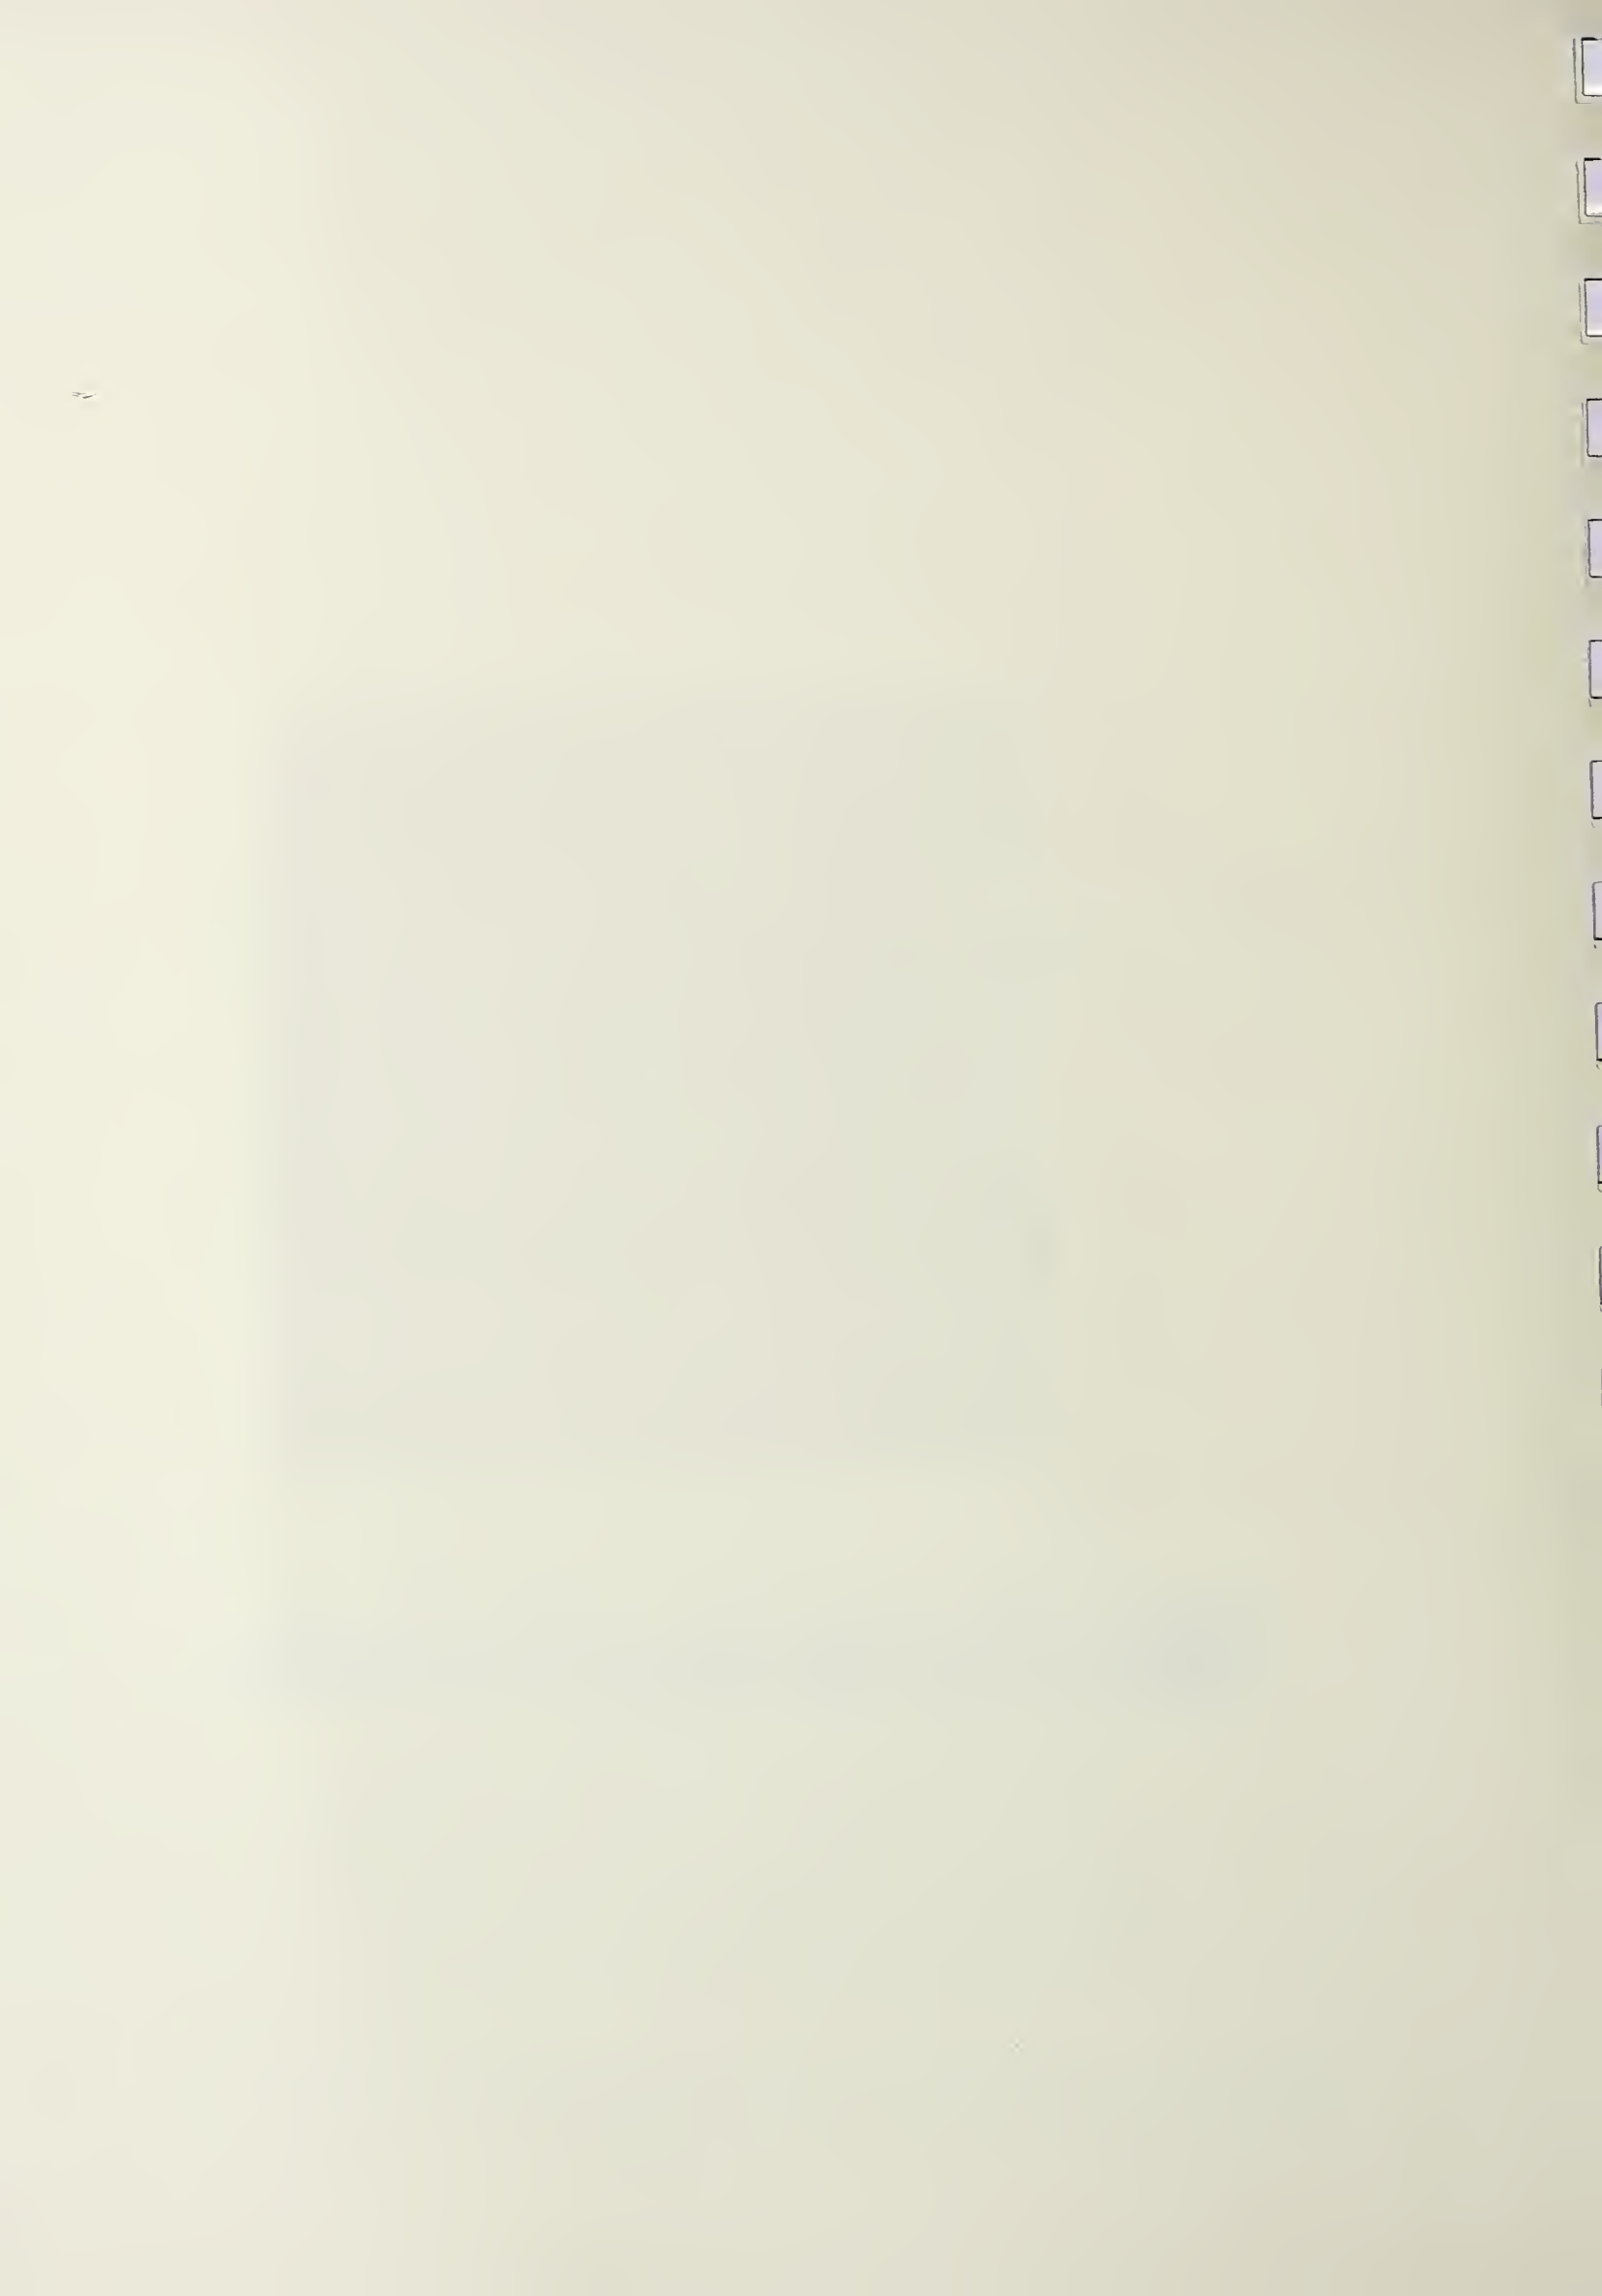
U.S. DEPT. OF COMM. BIBLIOGRAPHIC DATA SHEET	1. PUBLICATION OR REPORT NO. NBSIR 74-429	2. Gov't Accession No.	3. Recipient's Accession No.
4. TITLE AND SUBTITLE Corrosion of the Stainless Steel Piping in the Kuwait Water Supply System		5. Publication Date 1974	6. Performing Organization Code
