NBSIR 74-579 (?) Metallographic Examination of Cylinder Barrels Made From Aluminum Alloy (A-356) Sand Castings

September 1974

Failure Analysis Report

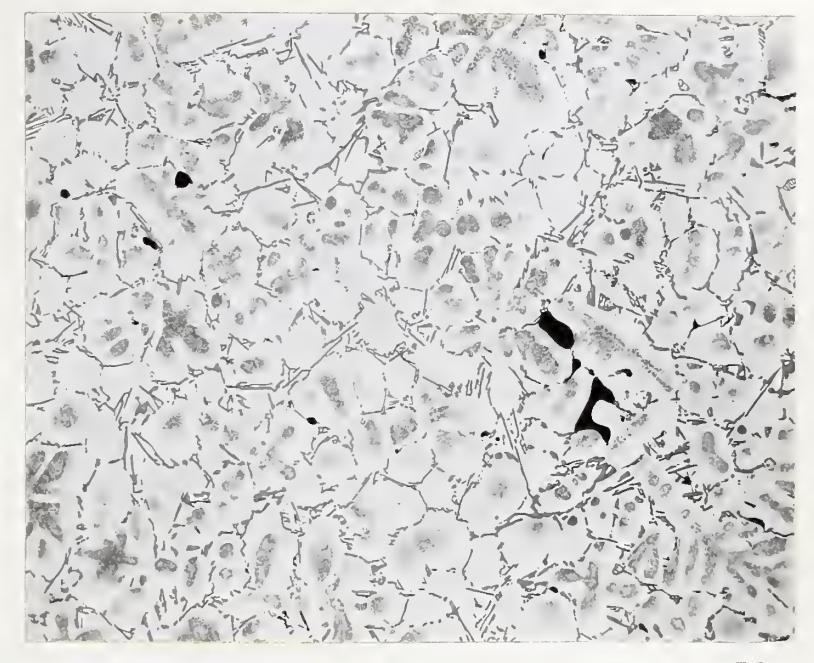
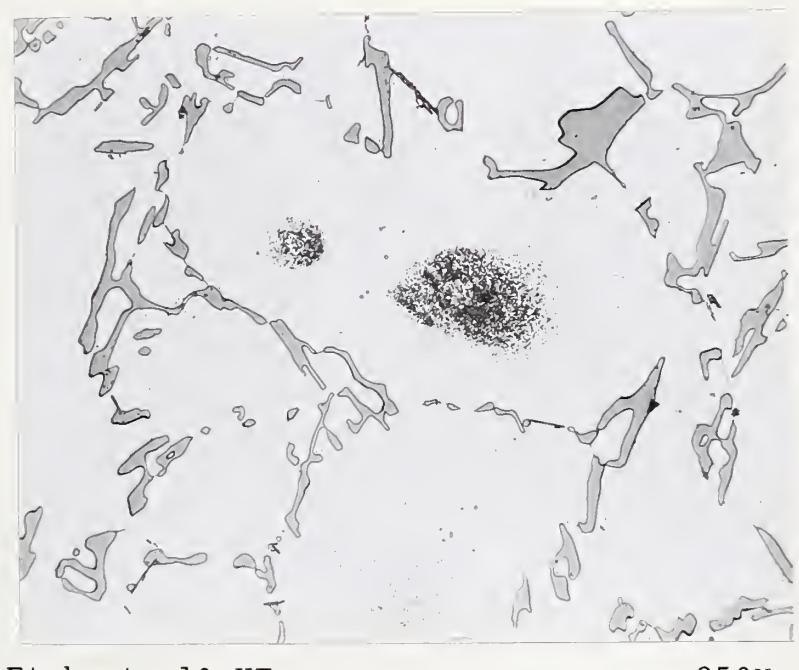
A close-up of one of these features, e.g., Figure 4, has a "pepper-like" appearance. The eutectic silicon network solidifies when the casting solidifies, whereas the Mg₂Si particles form in the solid state during aging. For convenient reference below, a summary of the eutectics which may form in A-356 alloy appears in Table II.

- 250X
- Figure 1. Solution-treated and aged microstructure of A-356 casting alloy. (a) Regions of primary aluminum solid solution (white), network of eutectic silicon particles in the interdendritic regions (gray), interdendritic shrinkage pores (black) and clusters of Mg2Si particles (apparent smudges in primary aluminum). (Ohio material: Specimen Number 8107-1.) (b) Close-up of Mg2Si particles, and eutectic silicon platelets. (Ohio material: Specimen Number 8040-1.)

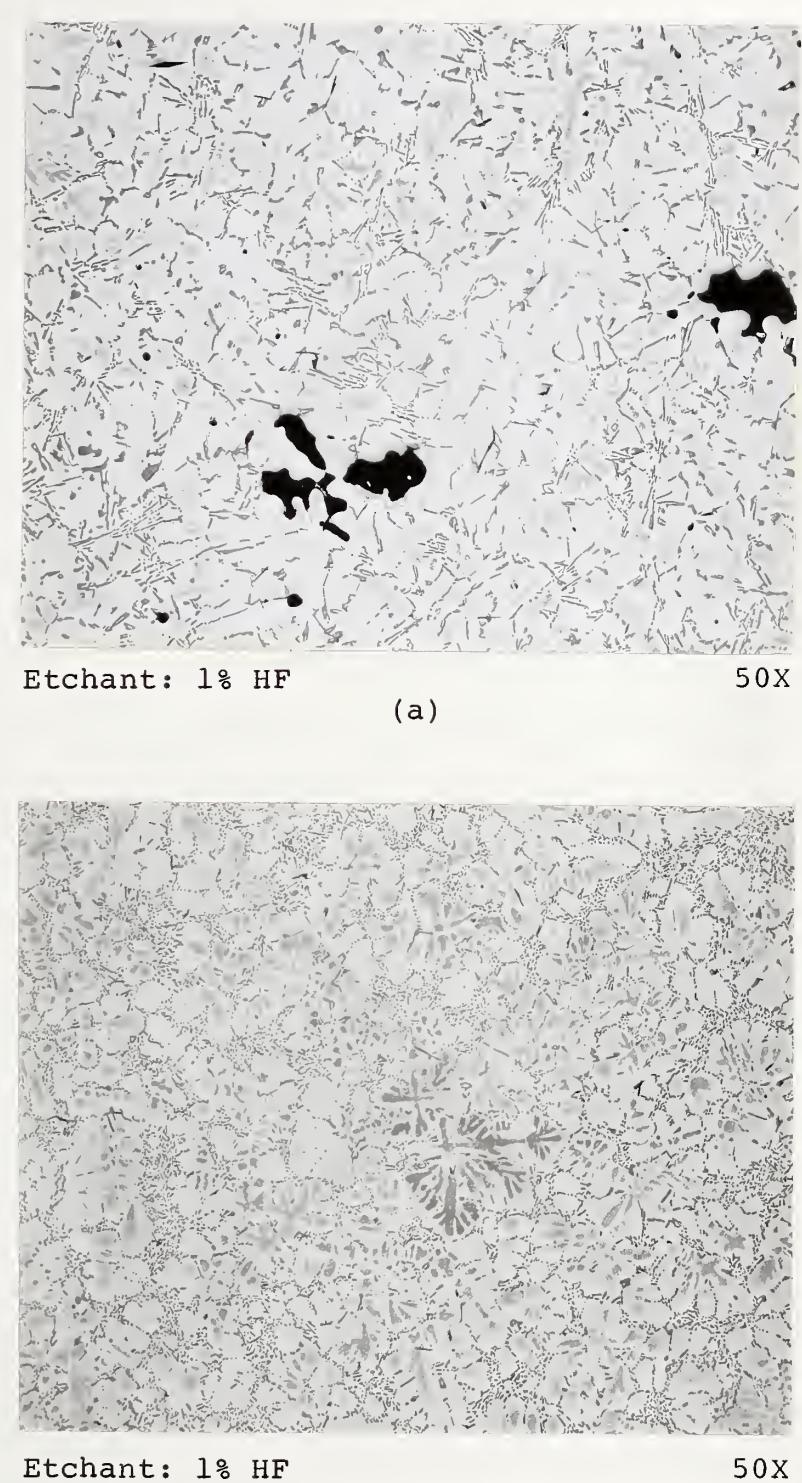
The microstructure characteristic of Ohio material appears in Figure 2a, and that characteristic of Wellman material appears in Figure 2b. There is a noticeable difference in the porosity, which shows up as the black regions in each photomicrograph. The pore size appears larger, and the number of pores appears greater in the Ohio material. The cause of this difference in the porosity of the two castings is not clear. The rounded dendrite arms of primary aluminum solid solution projecting into the larger pores of the Ohio material, and the location of these pores, suggest that they are interdendritic shrinkage cavities. The location and shape of the smaller pores in the Ohio material suggest that they may be gas pores.

Comparison of Figures 2a and 2b indicates that the microstructure is coarser in the Ohio material than in the Wellman material, i.e., on the average, the white patches of primary aluminum solid solution and the eutectic silicon particles are coarser in the Ohio material than in the Wellman material. This difference is possibly due to the difference in solidification rates, for it is well known that a cast microstructure becomes finer as the solidification rate increases.³ However, influences on the scale of the microstructure related to the maximum temperature reached during solution heat treatment (see Section III-D) and to sodium additions (see Section III-E) should not be overlooked.

- Figure 2. Comparison of typical microstructures in solutiontreated and aged A-356 casting alloys. (a) Ohio material: (Specimen Number 8107B, cut from tensile (b) Wellman material: (Specimen Number 4032A, bar.) cut from tensile bar.)

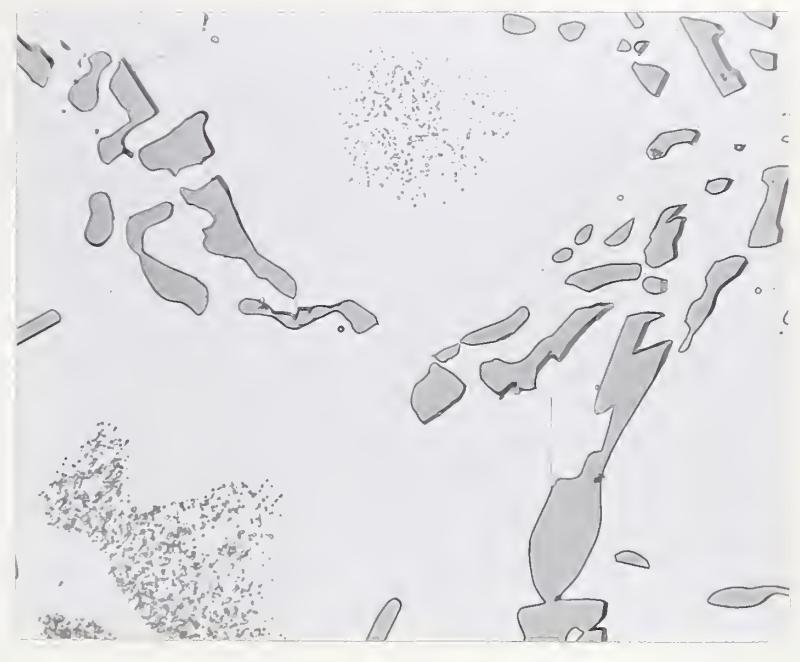
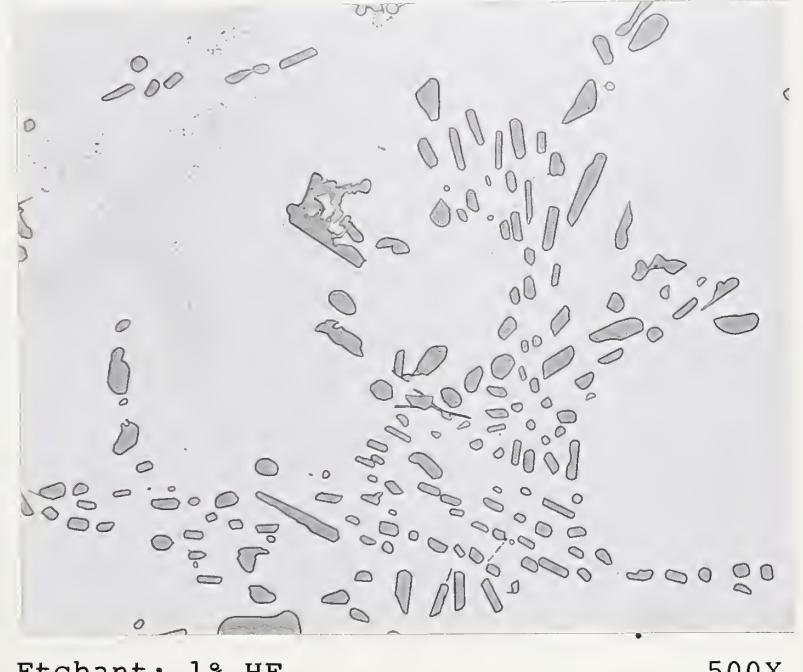
Figures 3a and 3b compare eutectic silicon particles in Ohio and Wellman material, respectively. Not only are the eutectic silicon particles in the Ohio material larger than those in the Wellman material, they are also plate-like, whereas those in the Wellman material are rod-like. (This point is discussed further in Section III-E.) Furthermore, comparison of Figures 3a and 3b indicates that the eutectic silicon network is more continuous in the Ohio material than in the Wellman material. This point can be verified by placing an imaginary line through several silicon particles in the interdendritic regions, then determining the number of intercepts with aluminum solid solution for a fixed line length. On the average, there will be fewer intercepts in the Ohio material than in the Wellman material. This latter feature of microstructure, i.e., the continuity of the eutectic silicon particles in the interdendritic region, is important in the analysis of cracks and the loss of ductility. Essentially, the brittle silicon particles represent an easy-tofracture phase in the microstructure, and the greater the continuity of the eutectic silicon network, the easier a crack can propagate throughout the microstructure. This point will be discussed further in Section III-B.

- 500X
- Figure 3. Comparison of eutectic silicon particles in solution-treated and aged A-356 casting alloys. (a) Ohio material: (Specimen Number 8040B-1.) (b) Wellman
 material: (Specimen Number 4032A.)

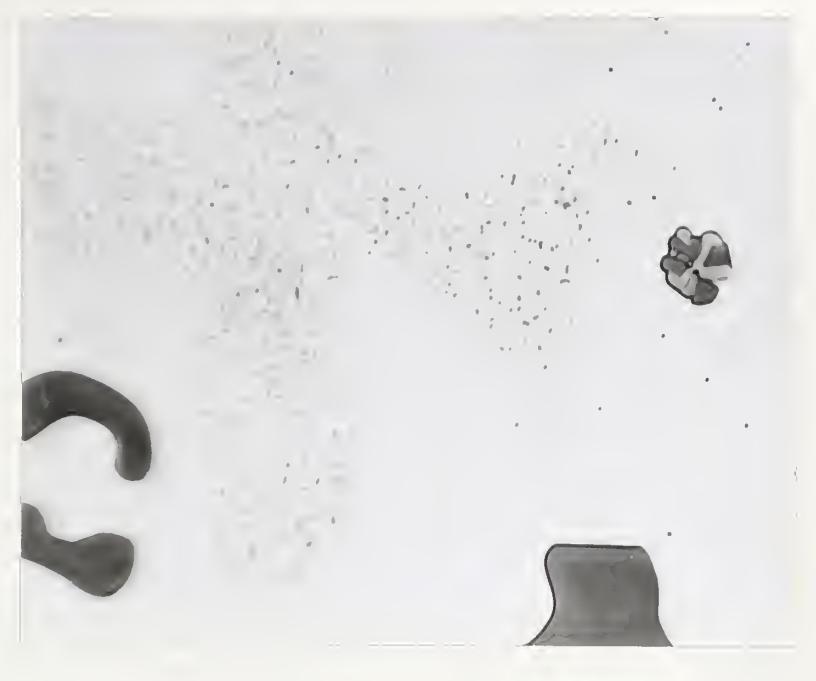
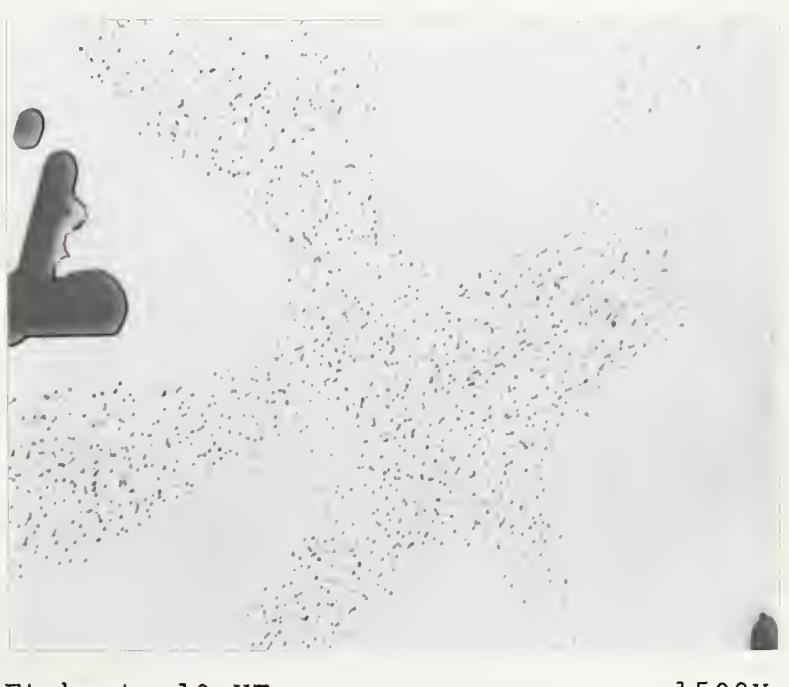
The "pepper-like" regions of Mg₂Si appear in the Ohio material as shown in Figure 4a and in the Wellman material as in Figure 4b. Mg₂Si is also evident in Figures 2a and 2b as the dendrite shapes which appear in the regions of primary aluminum solid solution. The size and distribution of Mg₂Si particles seems to be quite similar in both the Ohio and Wellman materials. This observation is consistent with the results of tensile and hardness tests, which showed no significant differences in the yield stresses and hardnesses of the Ohio and Wellman materials. Yield stresses appear in Table I. Furthermore, average hardnesses, as determined by placing a Knoop indenter in the primary aluminum solid solution, were 110 and 106, respectively, for Ohio and Wellman material. These hardness values convert to Rockwell-B values of 53 and 49. A typical hardness impression appears at the top-left in Figure 2a.

Figure 4. Comparison of Mg₂Si particles in solution-treated and aged A-356 casting alloys. (a) Ohio material: (Specimen Number 8107B, cut from tensile bar.) (b) Wellman material: (Specimen Number 4032A, cut from tensile bar.)

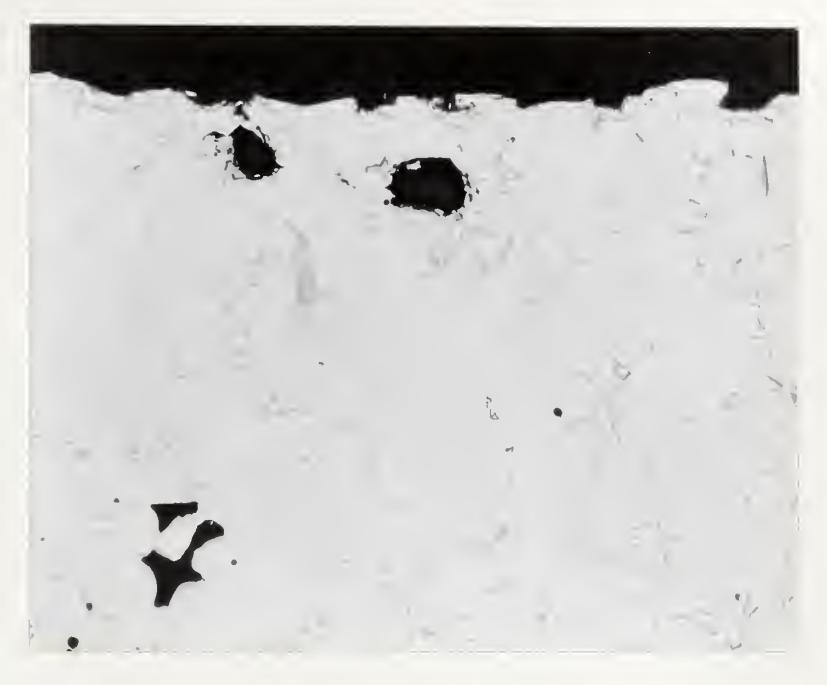
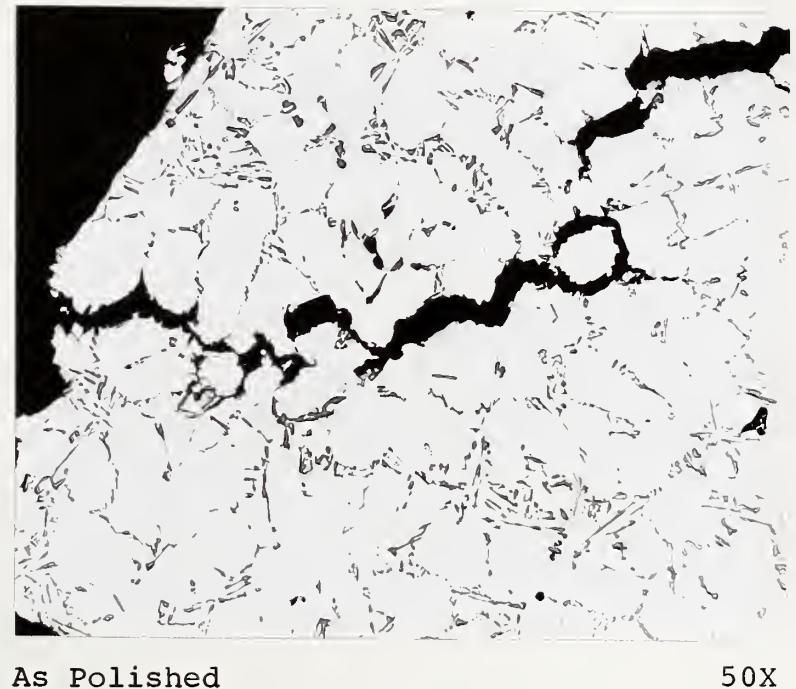
Natural cracks are defined as cracks which were found in the castings. Natural cracks found in various specimens taken from Ohio material almost always followed a path through the silicon-rich interdendritic regions, as shown in Figures 5a and 5b. The crack in Figure 5a is near a specimen surface and runs between two dark regions which may be sand particles trapped in the casting. This is the only near surface crack of this type which was found. The crack in Figure 5a appears at higher magnification in Figure 6. The tendency for a crack to follow a path through the silicon-rich interdendritic regions is evident in the similarity between the wandering nature of the crack path on an as-machined surface, Figure 7, and that of the crack path in Figure 5b.

It is evident from Figures 5 and 8 that the ease with which a crack can advance throughout the microstructure increases as the continuity of the network of eutectic silicon particles increases, since the silicon particles are a brittle (and relatively weak) phase. The difference in this feature of microstructure between the Ohio and Wellman material, as discussed in Section III-A, is probably the cause of the higher frequency of cracking and the anomalously-low mechanical properties of the Ohio material as reported by NOL. Probably the large interdendritic shrinkage pores in the Ohio material, which were pointed out in Section III-A, facilitate the nucleation of cracks in the interdendritic regions. As mentioned in Section I-A, initial analysis of these materials at NOL suggested that cracking and anomalously low mechanical properties were somehow related to eutectic melting. However, it is not obvious that the features of microstructure in the Ohio material suspected of causing cracking and anomalously-low mechanical properties, namely, a nearly-continuous network of large eutectic silicon platelets in the interdendritic regions and large interdendritic pores, are a consequence of the overheating which causes eutectic melting. (See Section III-D for a discussion of eutectic melting.)

Natural crack paths in Ohio material. (a) Near surface and between two rounded black features thought to be embedded particles of sand. (Specimen Number 8040-1.) is 4_{LSO} for Figure 5. (b) Edge-on view of crack near drilled hole. (Specimen cut from casting near drilled hole.)

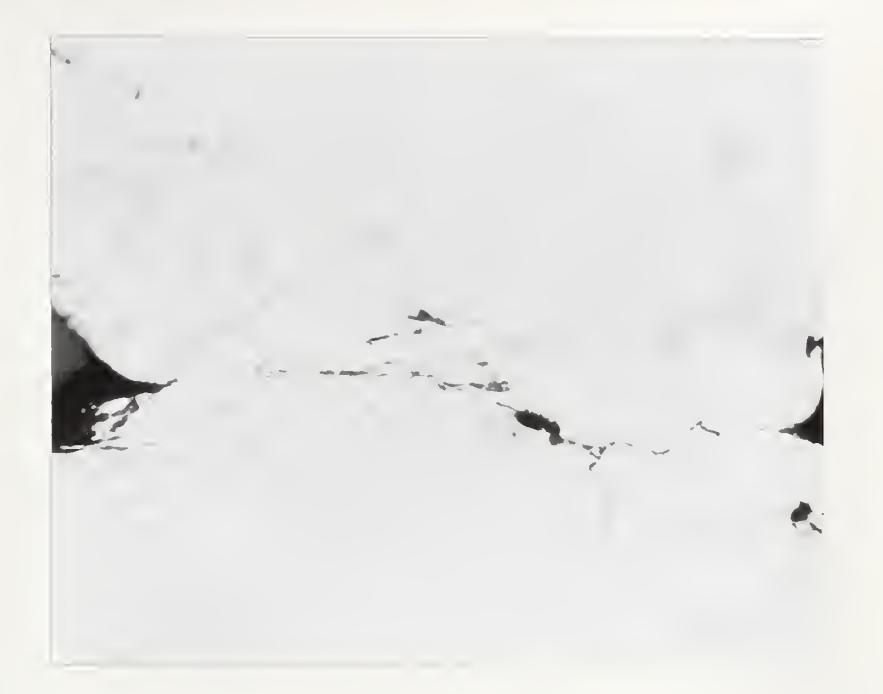
Figure 6. Close-up of near-surface crack appearing in Figure 5a. (Ohio material: Specimen Number 8040-1.)

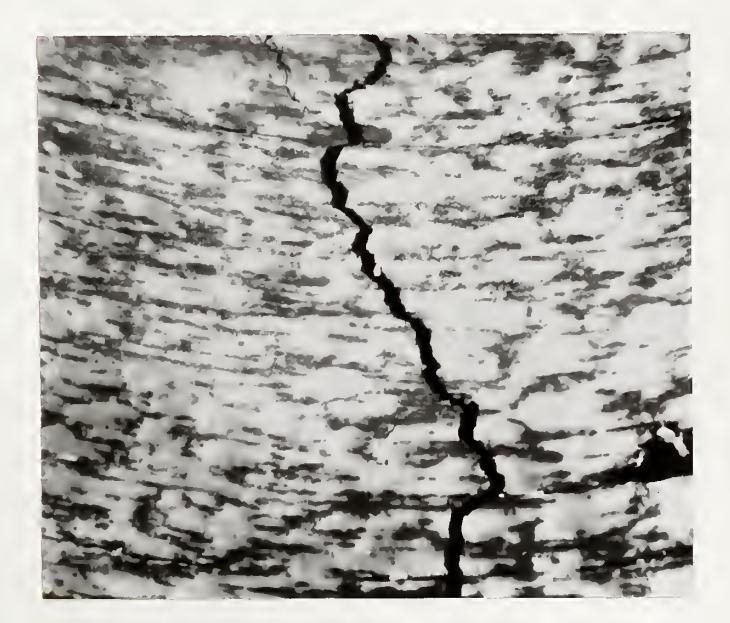
Figure 7. Typical crack path on as-machined surface. View of the interior of a sectioned hole which was drilled to accommodate a pin. (Ohio material: Specimen cut from casting near drilled hole.)

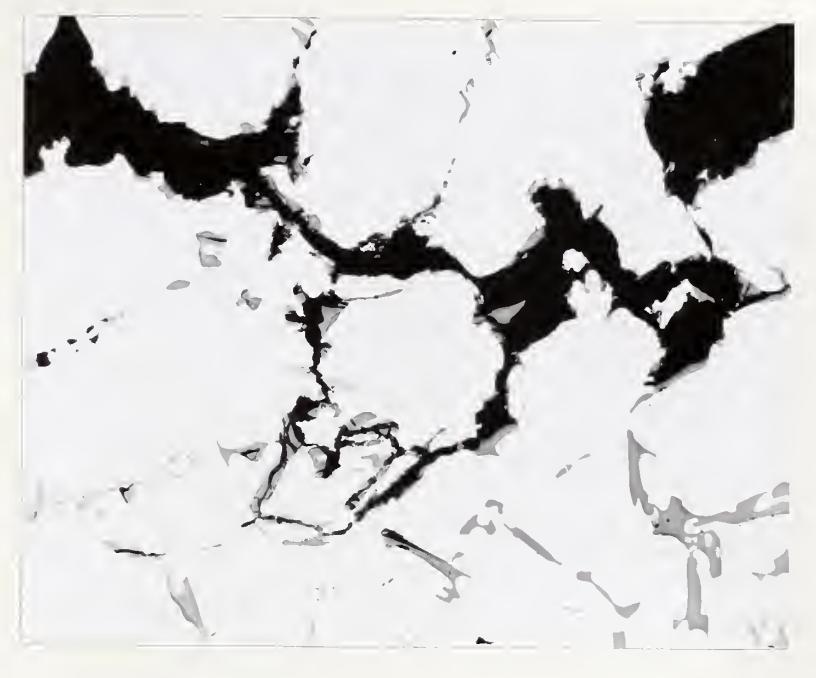
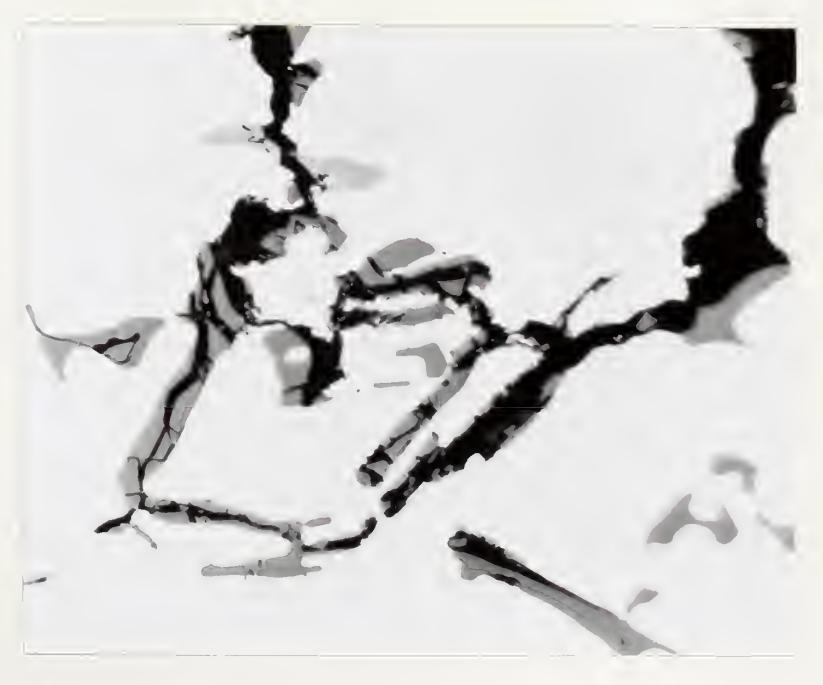
Figure 8 shows examples of eutectic silicon particles adhering to both surfaces of a natural crack. This feature was observed along the entire crack length. The presence of silicon particles along the crack edge suggests that the crack propagated by fracturing any silicon particles which it could reach. Indeed, the secondary branches of the main crack appearing in Figure 8a show the fracture of silicon particles. This fracture process is vividly illustrated at higher magnification in Figure 8b. The force which propagated the crack probably came from residual stresses in the casting, as well as from applied stresses accompanying machining operations and/or test firings.

Figure 8. Examples of how crack path follows eutectic silicon particles in Ohio material. (a) Primary crack and associated secondary cracks. (b) Close-up of secondary crack showing fracture of silicon particles. (Specimen cut from casting near drilled hole.)

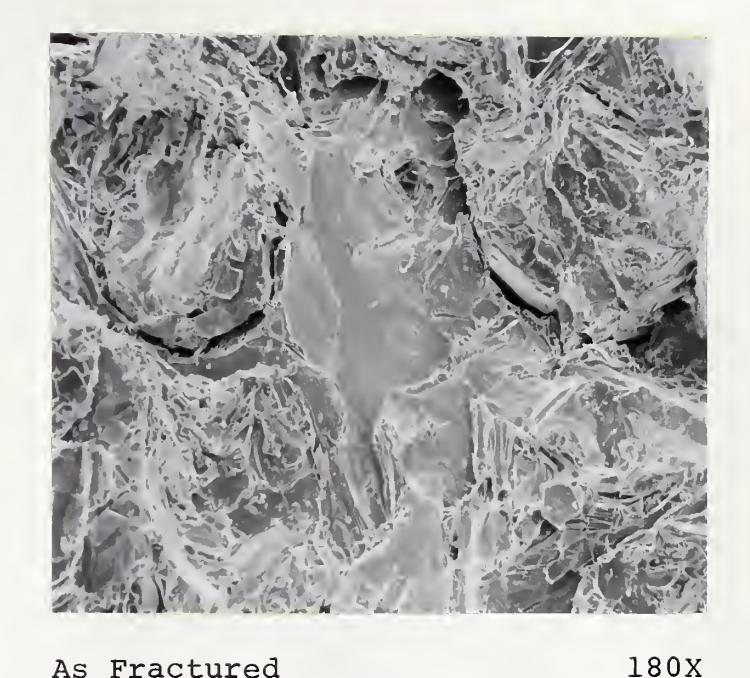
The fracture surfaces of the natural crack were viewed in the SEM. The fracture surfaces exhibited numerous cleavage facets, as is clear from Figures 9a, 9b, and 9c. Observations with the stereographic viewer confirmed that most topographic features on these fracture surfaces were cleavage facets. Very little evidence of dimpled rupture was found.

Since Figure 8 shows silicon particles on both surfaces of the natural crack, it may be inferred from Figures 8 and 9 that the crack propagation mode was principally via cleavage of the brittle and relatively weak silicon particles. The angular voids which appear in Figures 9 probably resulted when silicon particles were pulled out at some stage of the fracture process. The rounded voids appearing in the top left quadrant of Figure 9b probably resulted from the interdendritic shrinkage which occurred during the initial solidification of the casting. The shadowy features appearing in these voids are thought to be dendrite arms of the primary aluminum solid solution.

Figure 9. SEM views of the fracture surface of a natural crack in Ohio material. (a) Large cleavage facet. (b) Interdendritic shrinkage pores, and cleavage facets. (Specimen cut from casting near drilled hole.)

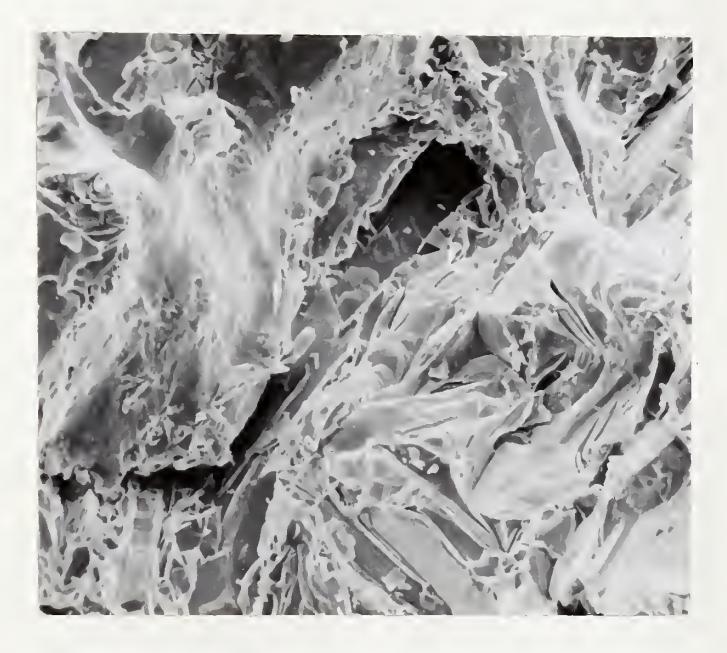
Figure 9c. Voids due to pull-out of silicon particles, and cleavage facets. (Ohio material: Specimen cut from casting near drilled hole.)

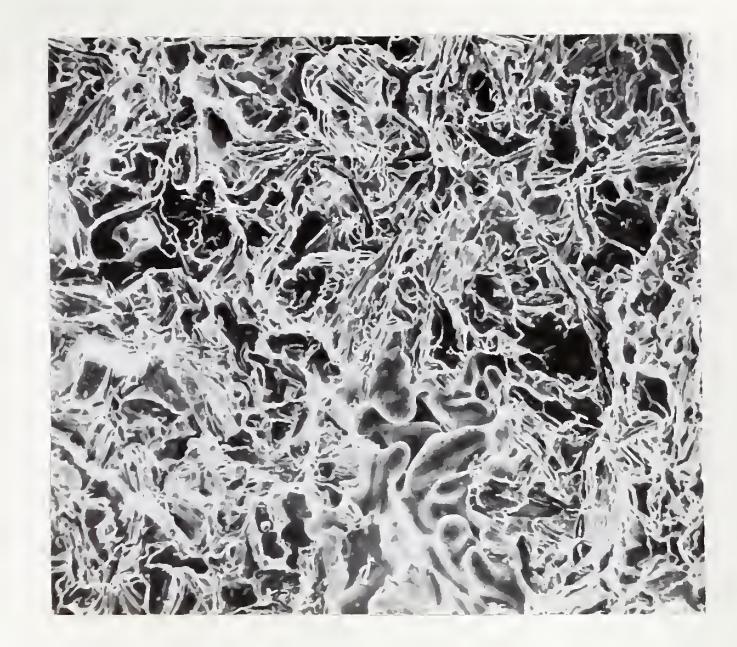
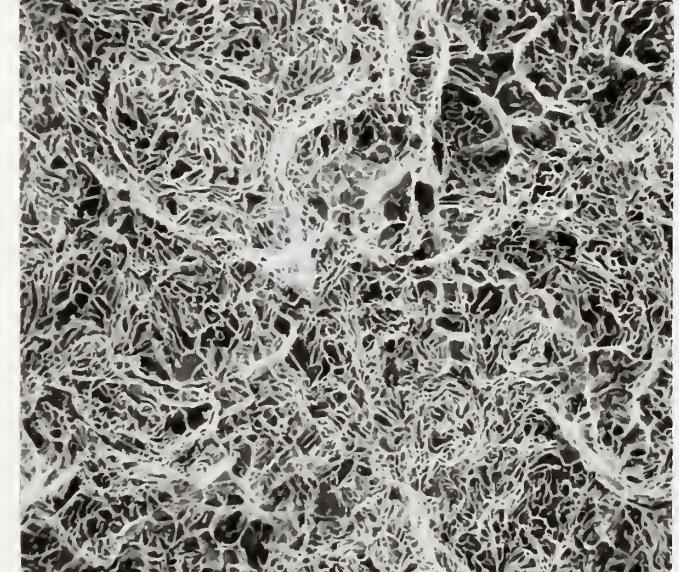
Figure 10 shows the fracture surfaces of a tensile bar machined from each foundry's castings. SEM results appear in Figures 10a and 10b, and optical microscopy results appear in Figures 10c and 10d. The polygonal regions in Figures 10a and 10b are interpreted as evidence of cleavage facets. The larger scale of the microstructural features in the Ohio material as compared to the Wellman material, a feature already noted in Section III-A, is also evident from comparison of Figures 10a and The region of rounded features appearing in the bottom 10b. center of Figure 10a is interpreted as an interdendritic shrinkage pore, with the rounded features presumed to be the arms of primary aluminum dendrites. The chief difference between the optical micrographs, Figures 10c and 10d, is that a larger number and larger size of bright facets appear on the tensile bar made from the Ohio casting. These facets are probably the same cleaved particles of silicon which were pointed out in the discussion of Figures 5, 8 and 9, in Sections III-B and III-C-1.

Figure 10. Fracture surfaces of tensile bars. (a) Cleavage facets and an interdendritic shrinkage pore in Ohio material, as viewed in SEM. (Specimen Number 8107B.) (b) Cleavage facets in Wellman material, as viewed in SEM. (Specimen Number 4032A.)

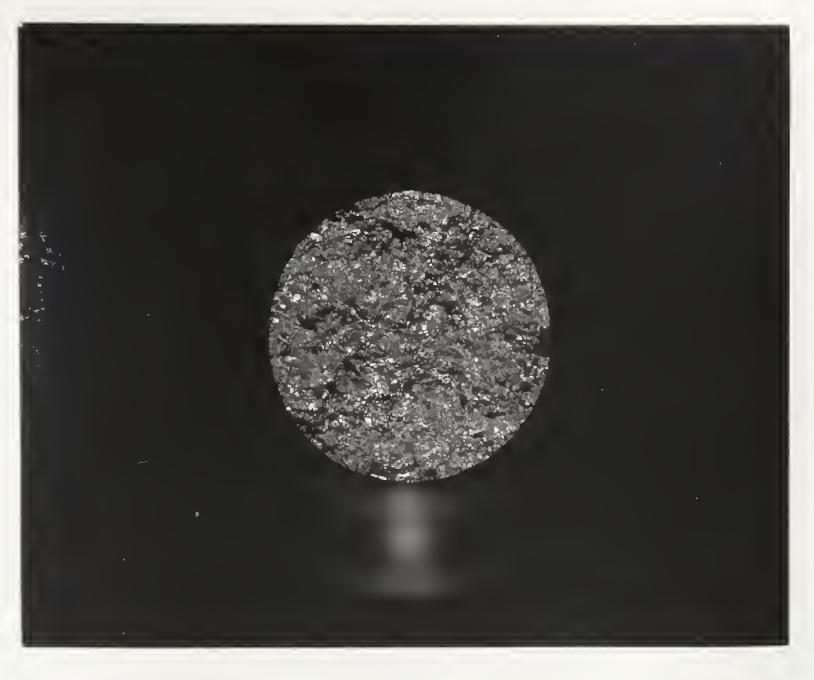
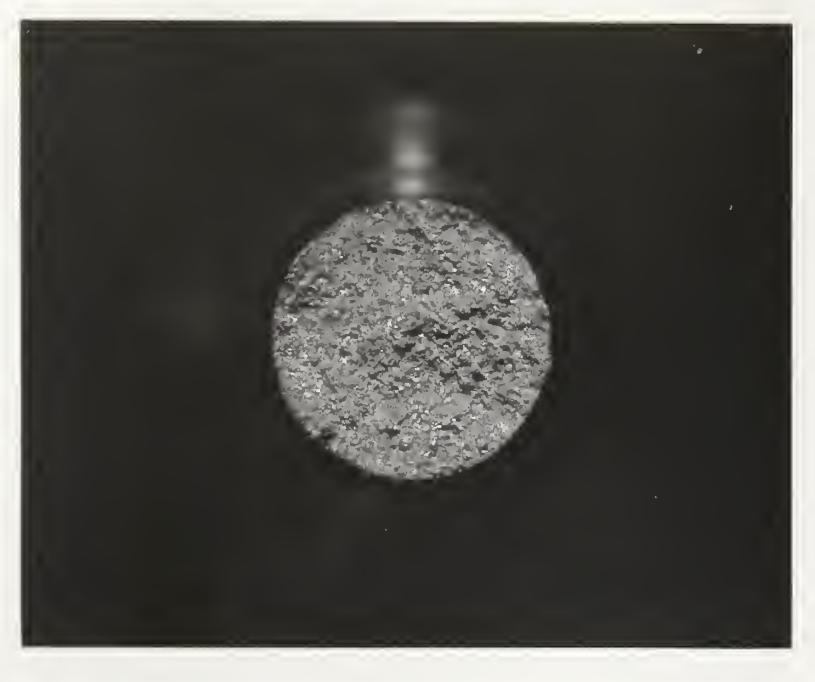
The presence of bright facets on the fracture surface of the tensile bar made from a Wellman casting, Figure 10d, suggests that cracks also propagate through silicon particles in this material if the stress is high enough (ultimate tensile stress is about 43,000 psi, as compared to about 35,500 psi for tensile bars from the Ohio casting, Table I). However, to reiterate, the main difference between the fracture surfaces in Figures 10a and 10b is the number and size of bright facets, not just their presence. This difference is easily seen on the fracture surface of tensile bars with the unaided eye, as well as with a low-magnification, hand-held magnifier.

Figure 10. Fracture surfaces of tensile bars. (c) Brightly reflecting cleavage facets in Ohio material. (Specimen Number 8107B.) (d) Faintly reflecting cleavage facets in Wellman material. (Specimen Number 4032A.)

- 2. Remove a small sacrifical specimen from a piece of hardware, fracture it and visually examine the fracture surface for bright facets. A large number of large-size facets would be cause for suspecting that the hardware would be susceptible to cracking. (See Section III-C-2.) Again, some development would be required so that effects on fracture surface facets due to different solidification rates near and remote from surfaces could be recognized.

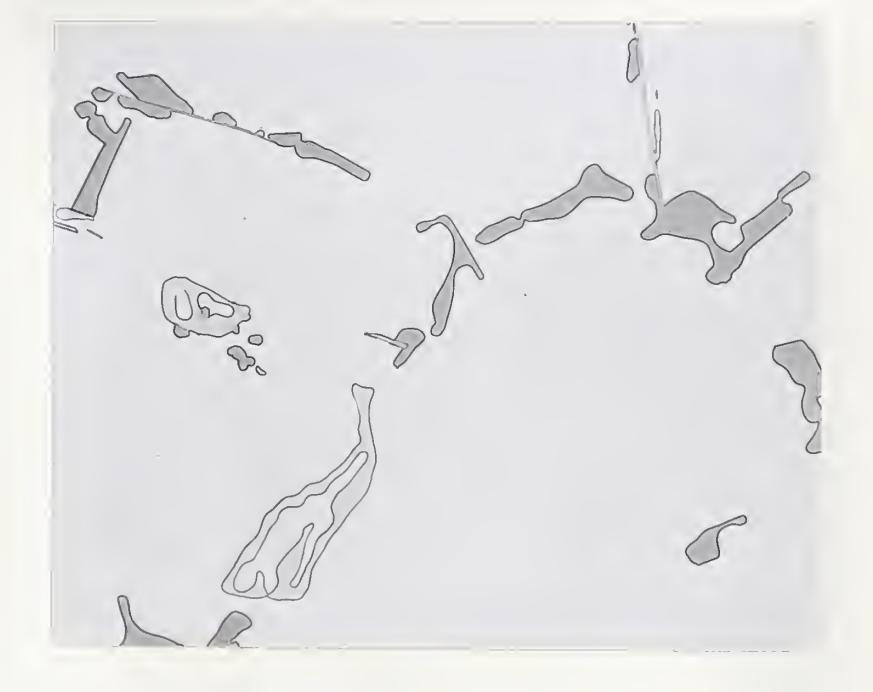
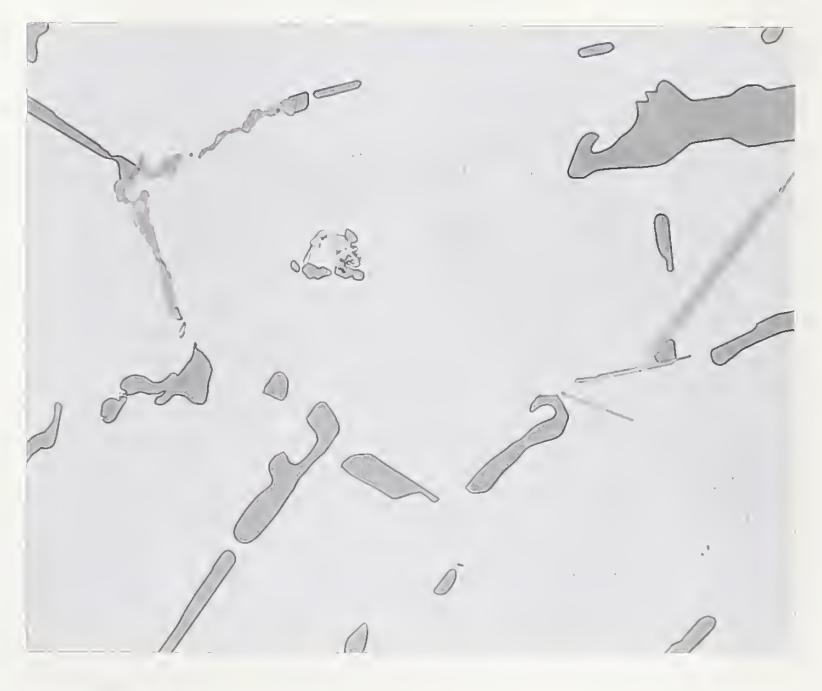
The type of rosette appearing in the middle of the primary aluminum solid solution in Figure 11a is usually regarded as resulting from solidification of the ternary eutectic, composed of aluminum solid solution, silicon solid solution and Mg₂Si. The expected three phases appear as white, light gray and dark gray regions of the rosette. Features thought to be the same ternary eutectic also appear in Figures 4a, 11b, and 11c although the rosette shape is not pronounced in Figure 11c.

The blade-like particles appearing in Figures 11 are thought to be Fe₂Si₂Al₉, a ternary phase of the Fe-Si-Al system.¹C Blades of Fe₂Si₂Al₉ were often observed to connect eutectic silicon particles in the Ohio material, e.g., see Figure 11a, upper left and upper right. Generally, there seemed to be more Fe₂Si₂Al₉ blades in the Ohio material than in the Wellman material. The reported iron analyses of castings from both foundries, < 0.05 wt. pct., is well below the 0.2% max. appearing in the specifications for A-356. Thus, embrittlement from iron bearing intermetallic compounds is not likely.

Figures 11a and 11b. Rosettes interpreted as evidence of ternary eutectic phases. Rosettes embedded in primary aluminum solid solution. The needle-like and blade-like particles are thought to be Fe2Si2Al9. (Ohio material: Specimen Number 8107B-1.)

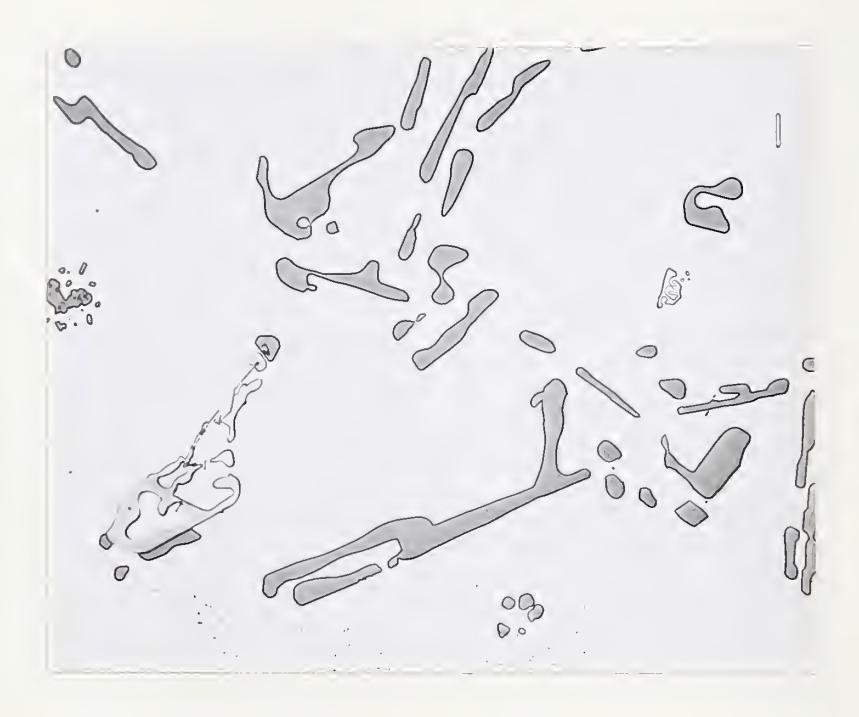
- 500X
- Figure llc. Non-rosette shaped regions thought to contain ternary eutectic phases. (Ohio material: Specimen Number 8107B-1.)

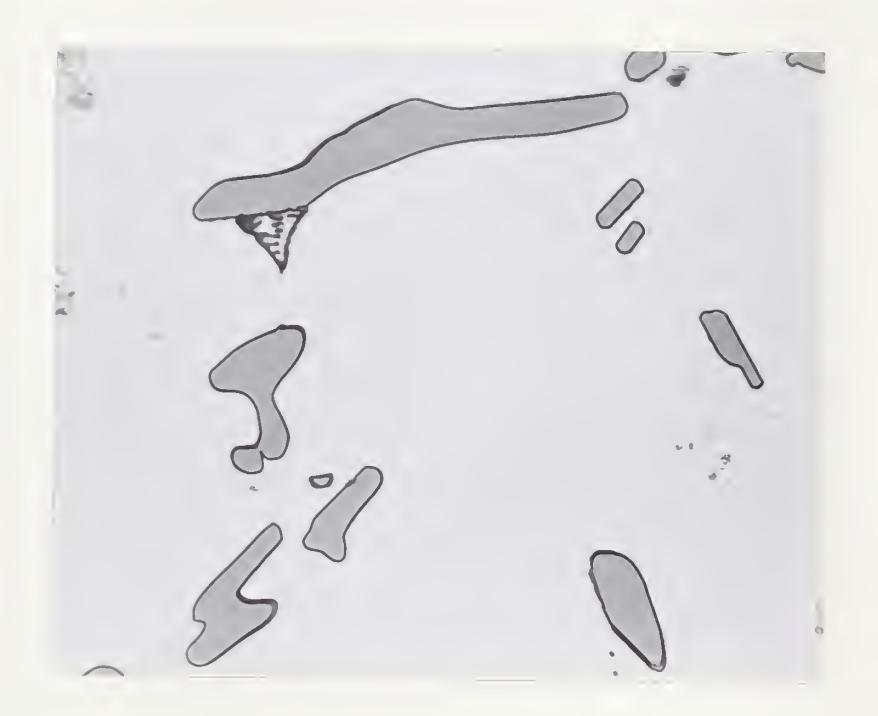
Figure 12 shows a microstructural feature of Ohio material, the triangular region projecting from a silicon particle, which is interpreted as evidence of melting of the binary eutectic. This eutectic is composed of the terminal aluminum solid solution and the terminal silicon solid solution, and the eutectic temperature is 1071°F.^{1b} Binary eutectic melting usually initiates at grain boundaries, and indeed, this is the case in Figure 12. The

expected two phases, etching lightly and darkly, show up clearly in the triangular region. The triangular shape, determined by surface tension, suggests that the binary eutectic melted while the surrounding material was solid. Furthermore, the smaller size of the phases in the triangular region, as compared to the size of the surrounding aluminum solid solution and silicon particles, also suggests that the binary eutectic melted while the surrounding material was solid. For example, the surrounding material could have acted as a heat sink to rapidly cool the triangular region and thereby produce the smaller particle size. It is possible that the melting occurred during a temperature excursion during the solution heat treatment of the Ohio material.

Triangular regions such as that appearing in Figure 12 were not detected in the Wellman material. The small size of the triangular region, and the fine particle size of the phases in it, makes detection of such regions extremely difficult. High magnification, e.g., 1000X, and extremely careful etching are required to reveal such regions.

Figure 12. Triangular regions interpreted as evidence of binary eutectic melting. (Ohio material: Specimen Number 8040B-1.)
