NBSIR 75-688

Performance of Mobile Homes - A Field Inspection Study

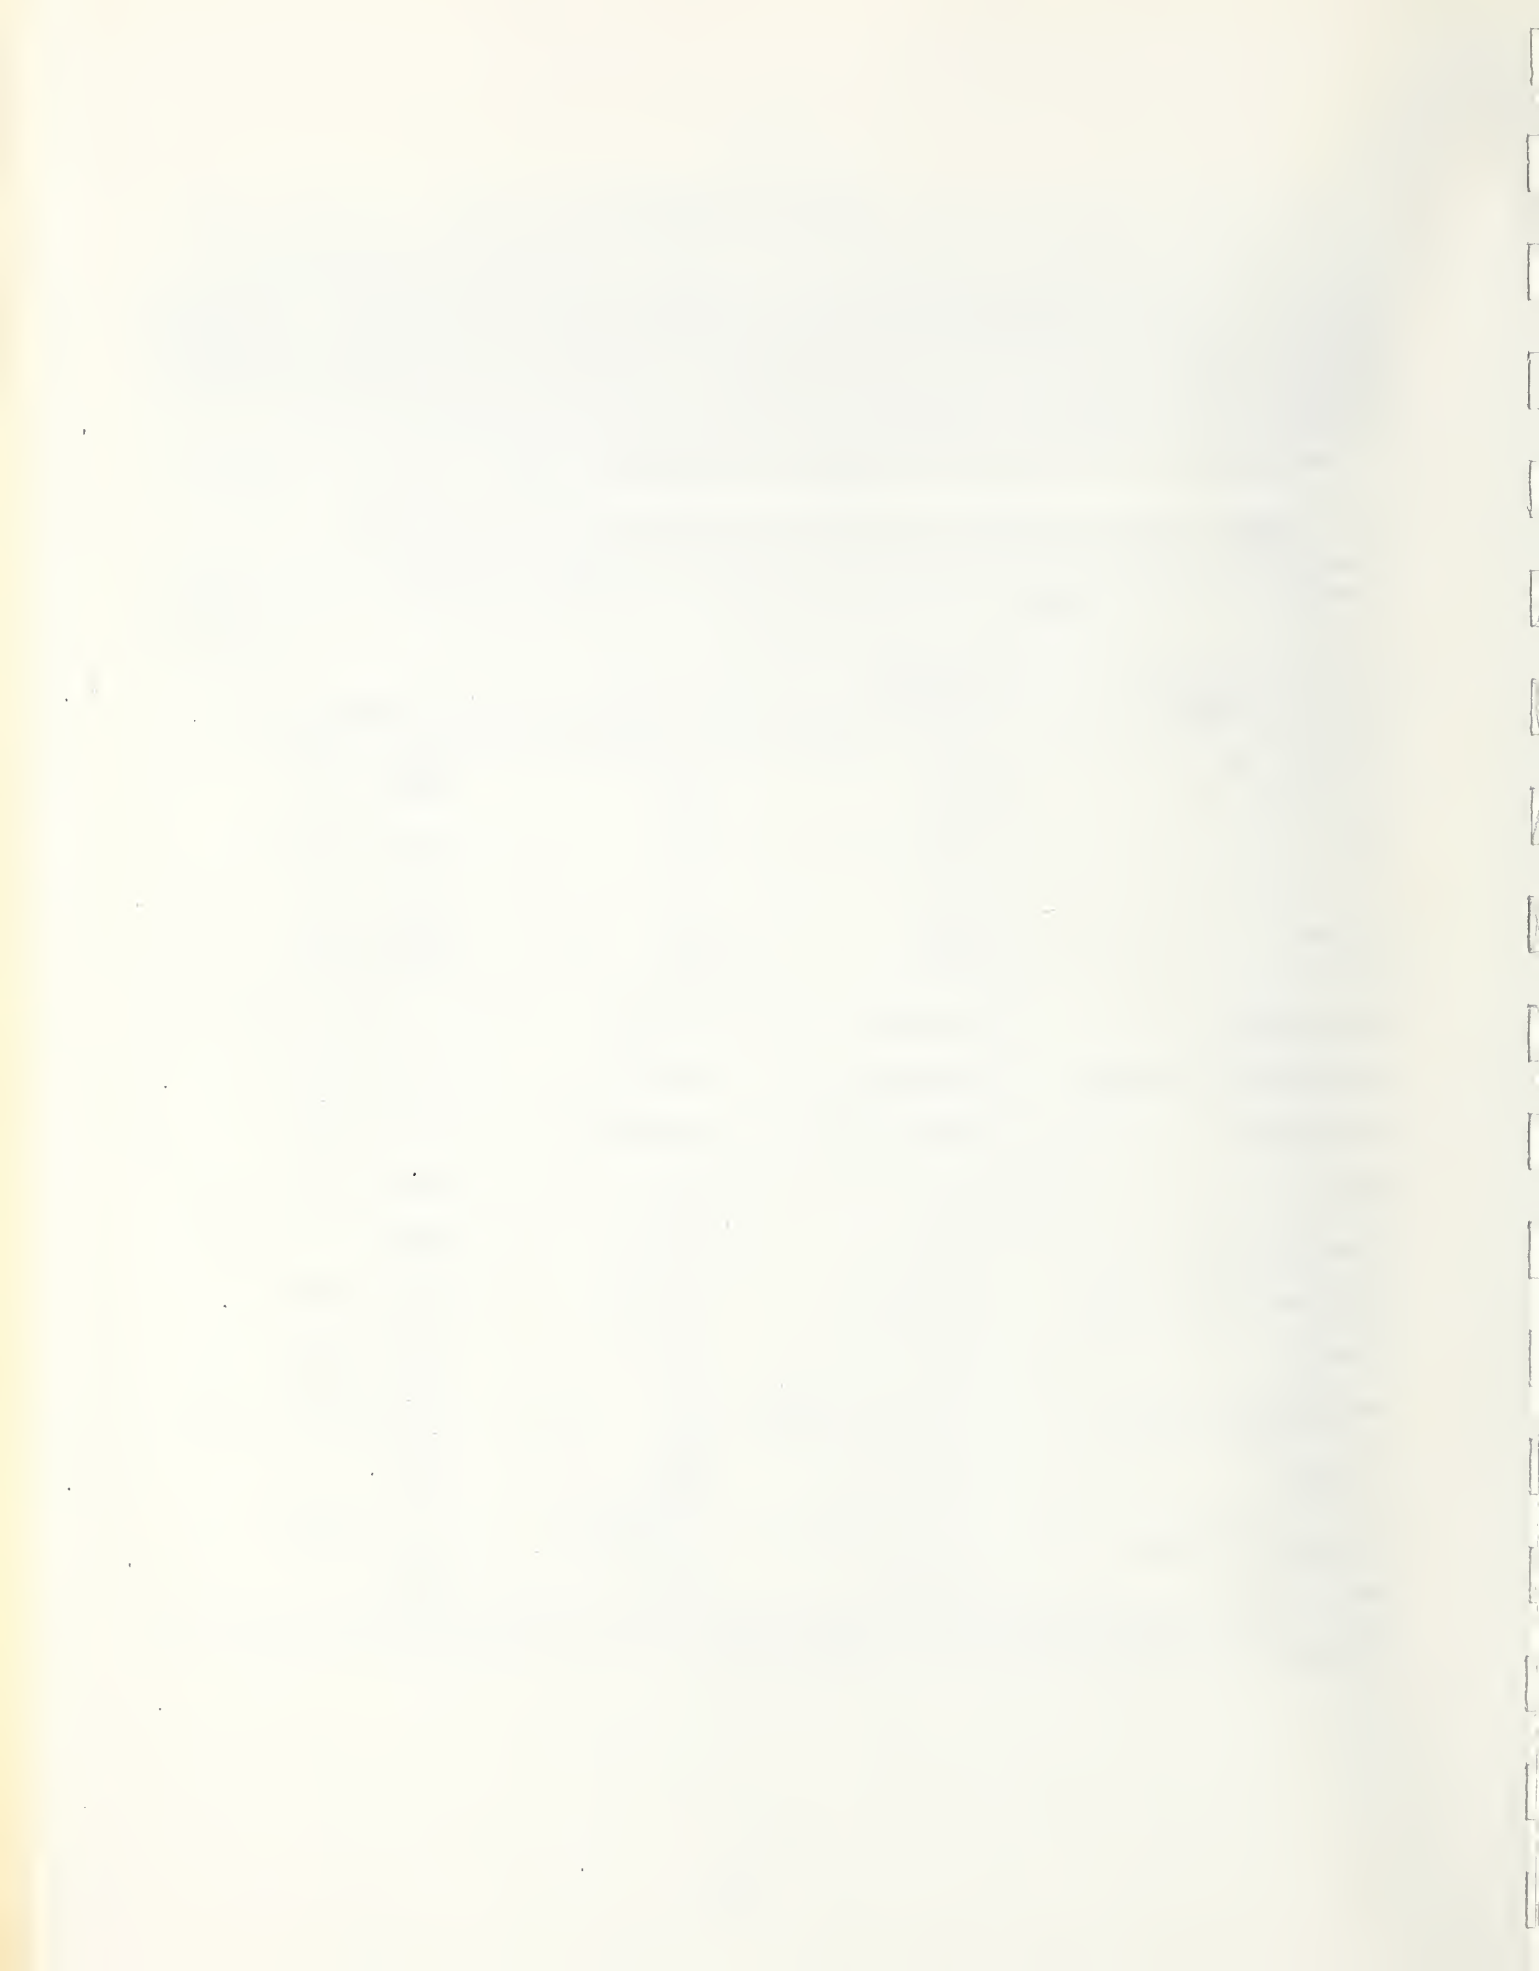
*Exact value; others are rounded to fourth place.

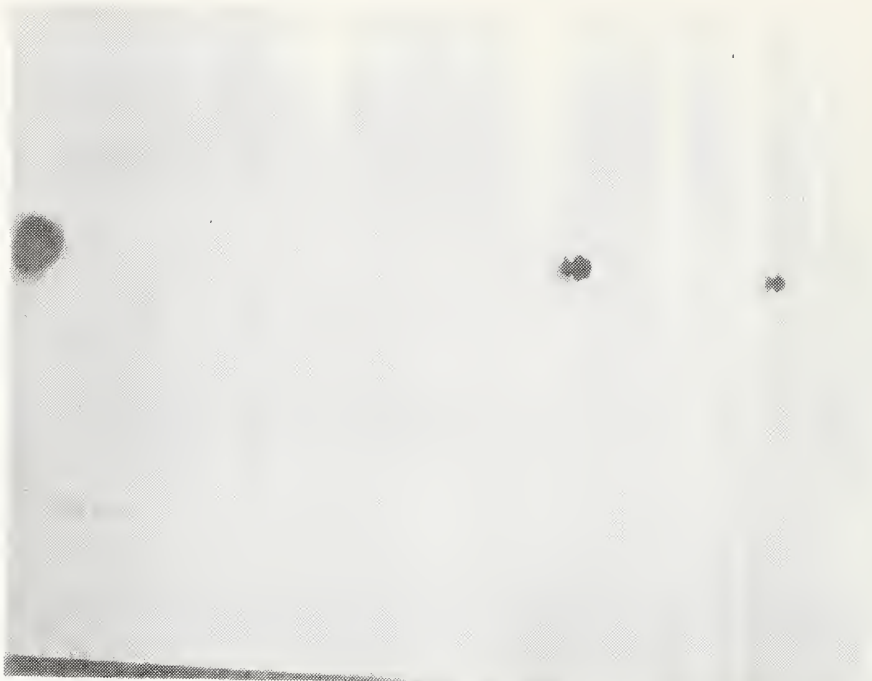
Figure C-1 Exterior Wall Fasteners Which Have Corroded and Worked Loose

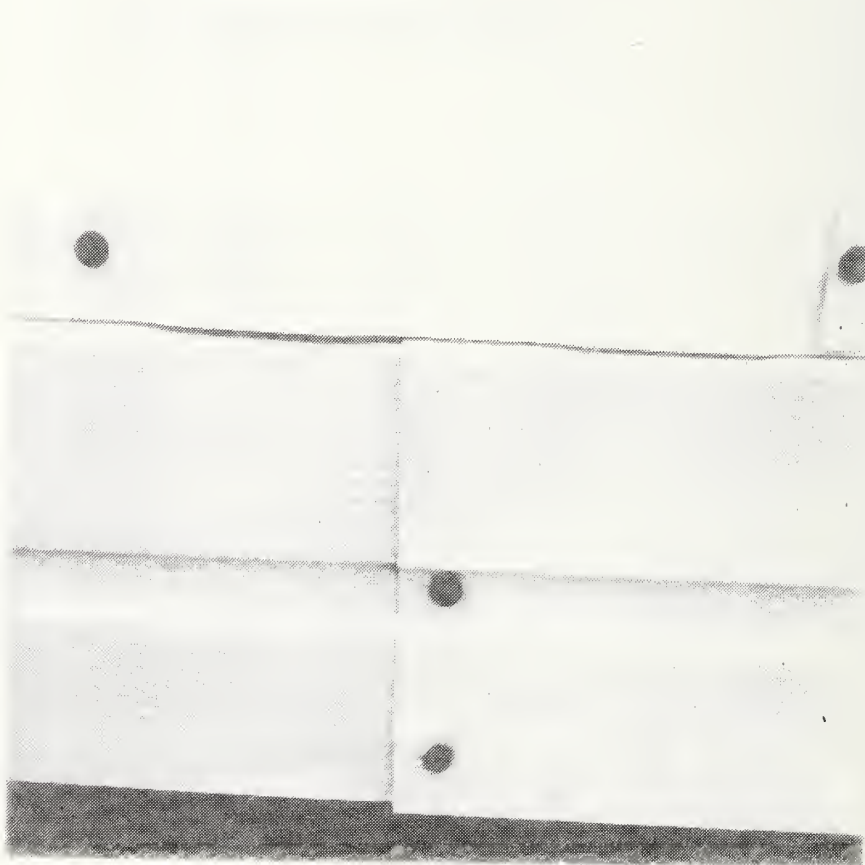
Figure C-2 Rusted Exterior Fasteners

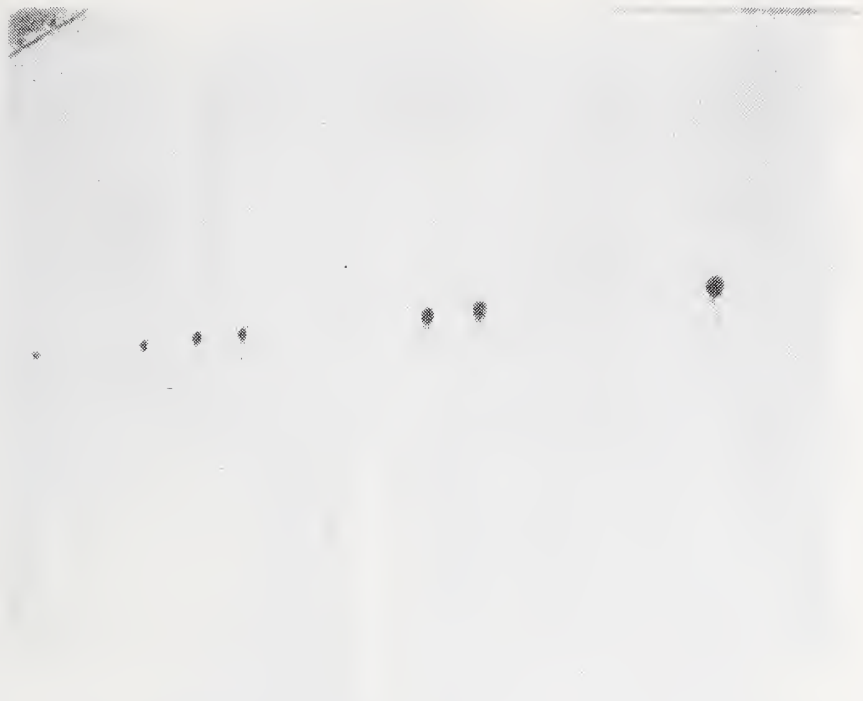
Figure C-3 Rusted Exterior Fasteners
Causing Staining of Siding

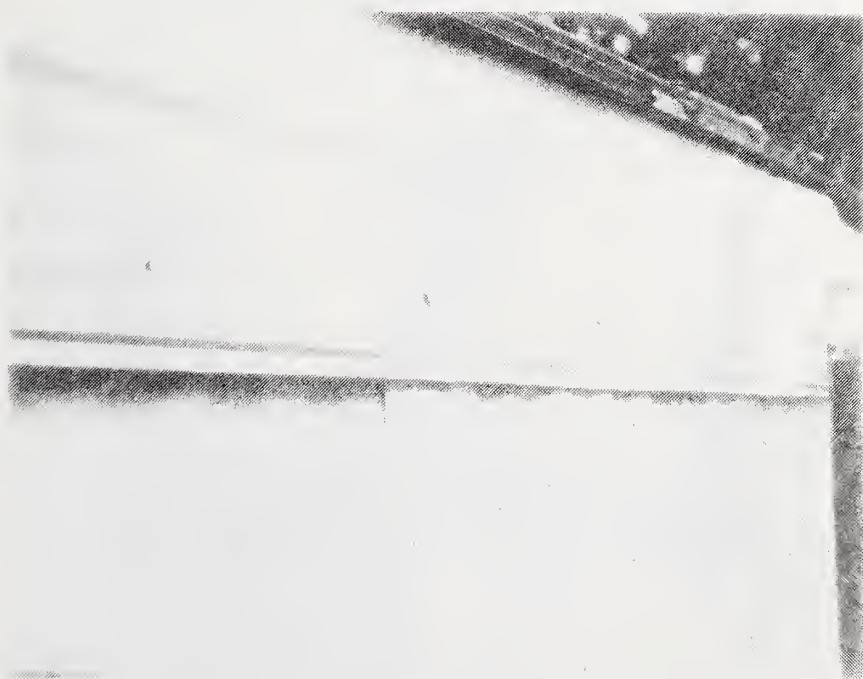
Figure C-4 Exterior Fasteners Pulled
Through Exterior Siding

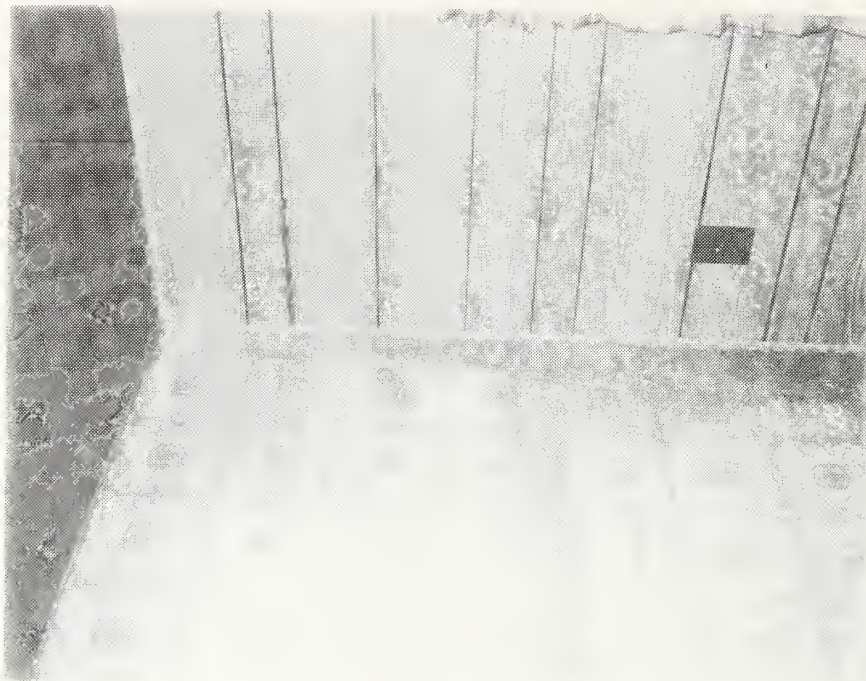
Figure C-5 Water Staining At Wall-Floor Due to Rain Leak Through Exterior Wall

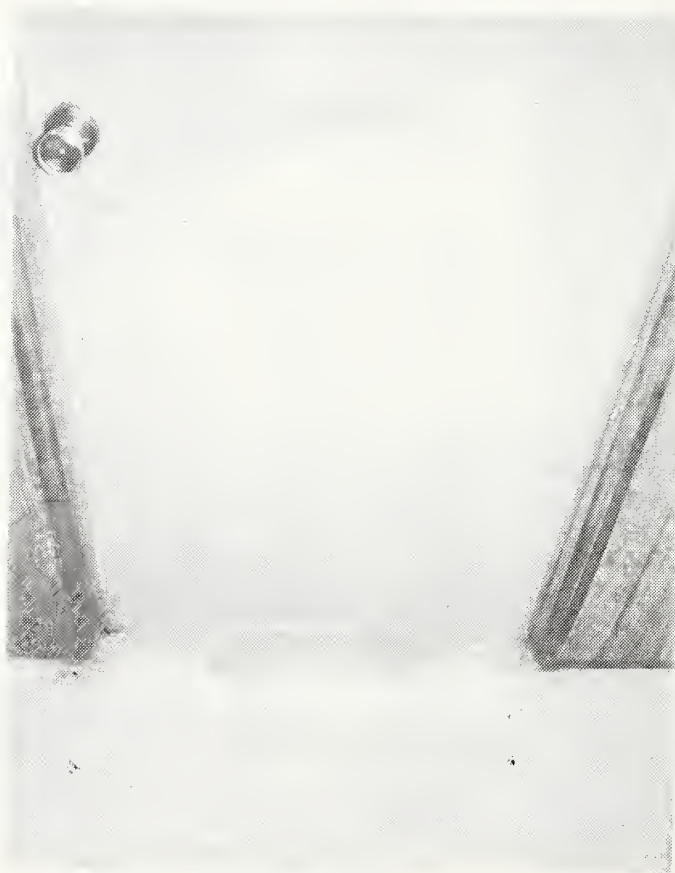
Figure C-6 Rain Leak Staining at Exterior Door

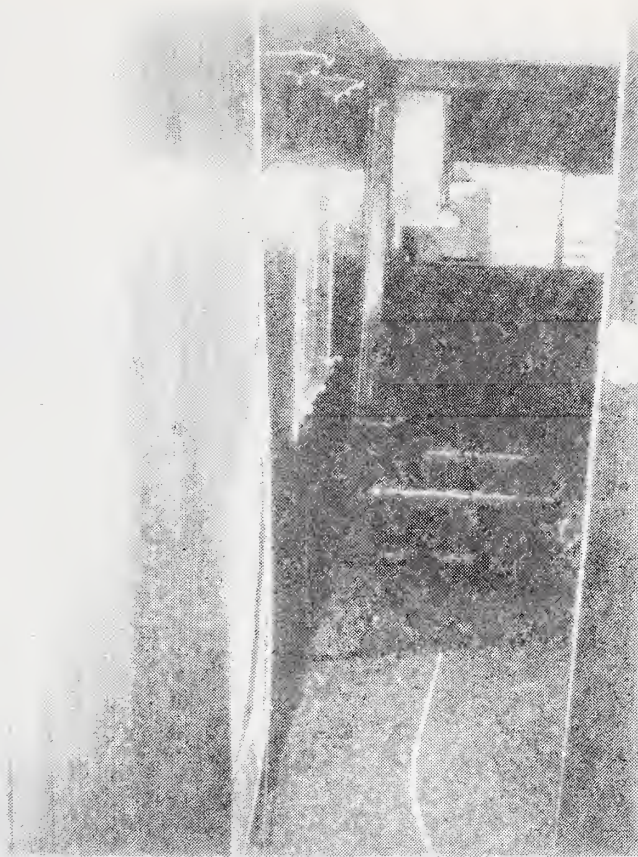
Figure C-7 Buckled Interior Wall Paneling on Exterior Wall Due to Water Penetration of Exterior Skin.

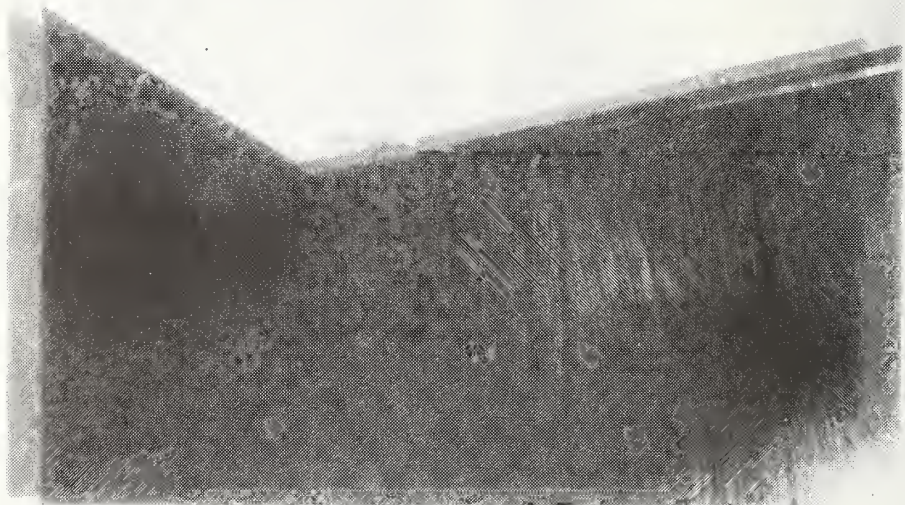
Figure C-9 Water Stained Ceiling Material
Due to Rain Leak

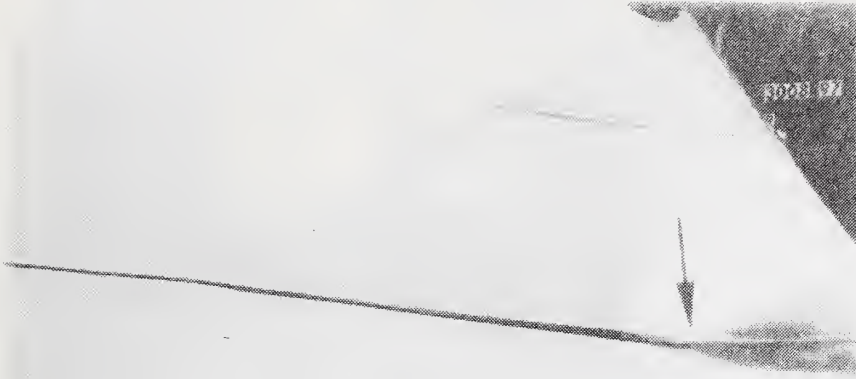
Figure C-10 Damaged Metal Roof Allowing Rain Leak With Resulting Damage Shown in Figure C-11

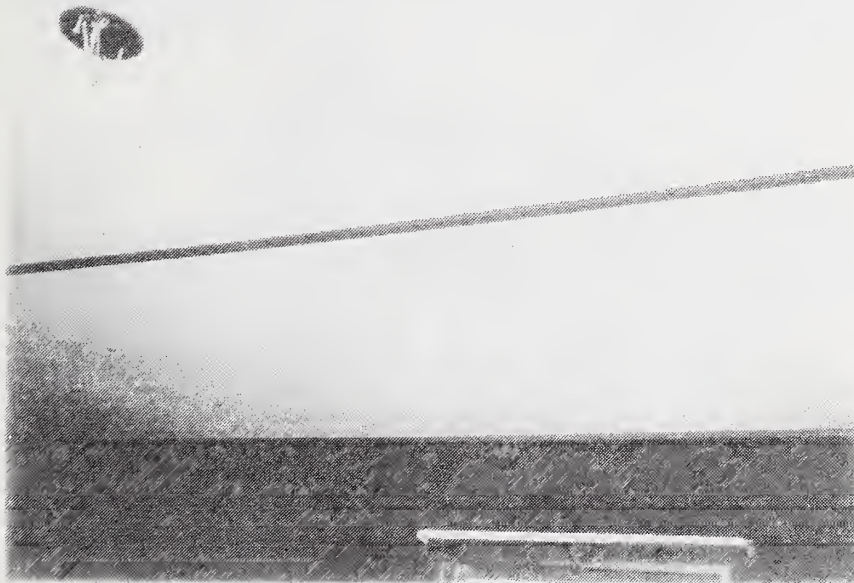
Figure C-11 Water Damage to Ceiling Due to Rain Leak at Roof Membrane Joint

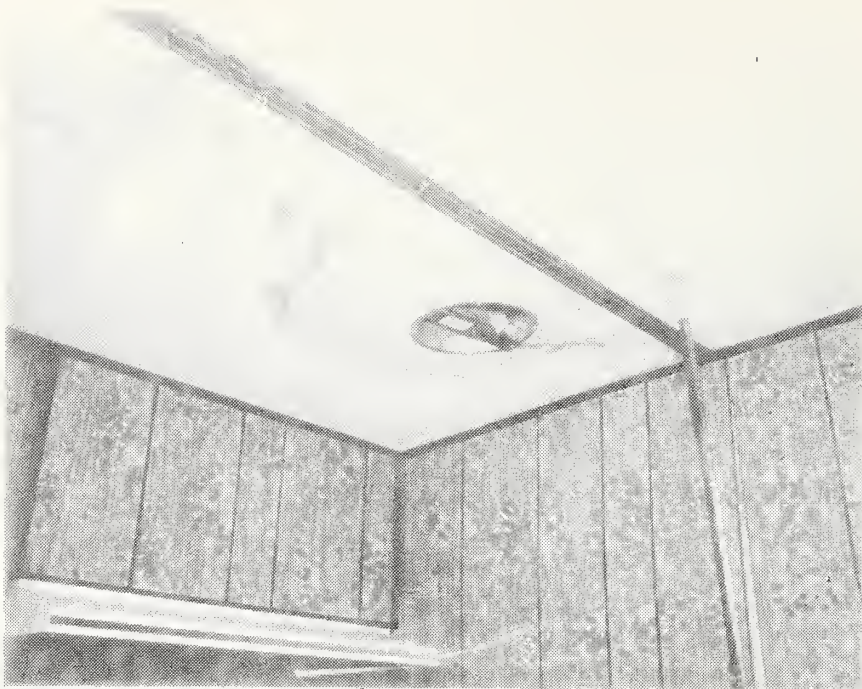
Figure C-12 Water Damage to Ceiling Due to Rain Leak at Vent Stack Penetration Through Roof

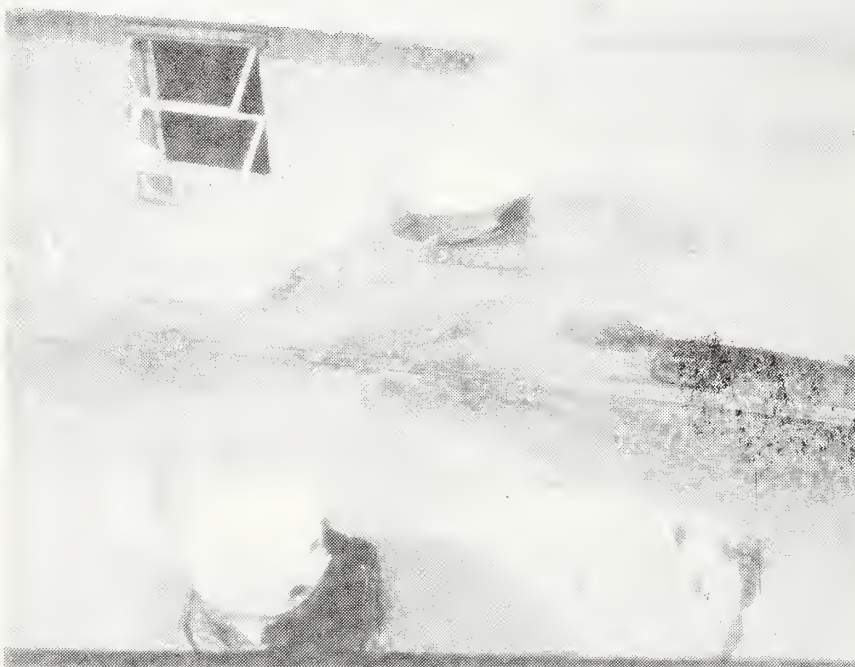
Figure C-13 Application of Coating Material to Vent Stack Penetration in Roof to Correct Rain Leak

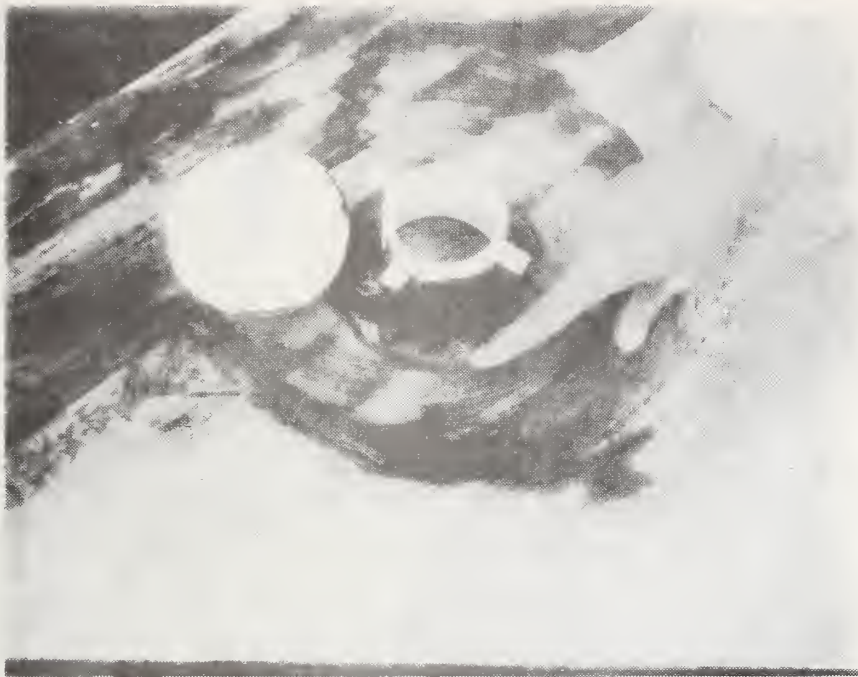
Figure C-14 Rain Leak at Flashing of Plumbing Vent Pipe

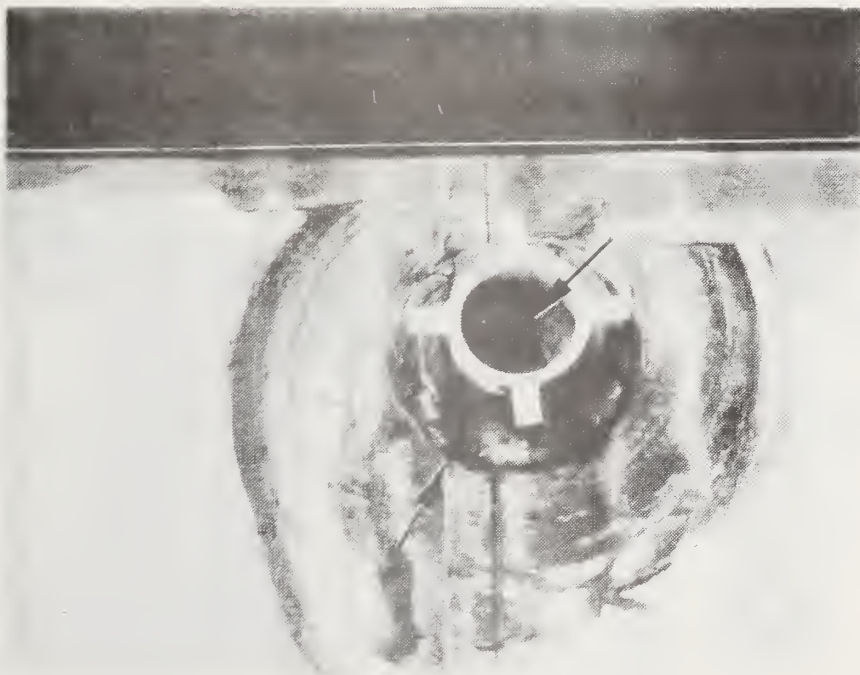
Figure C-15 Rain Leak at Plumbing Vent Pipe Flashing Located at Joint of Metal Roofing. Also, Vent Pipe Does Not Penetrate Roof Covering

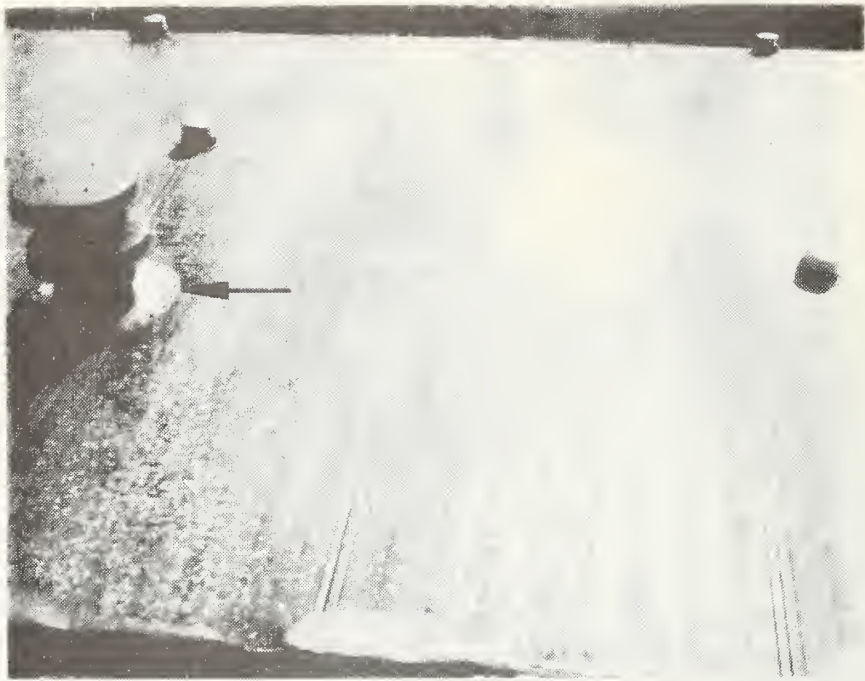
Figure C-16 Ungasketed Heating Vent Pipe Attached With Sheet Metal Screws to Metal Roofing

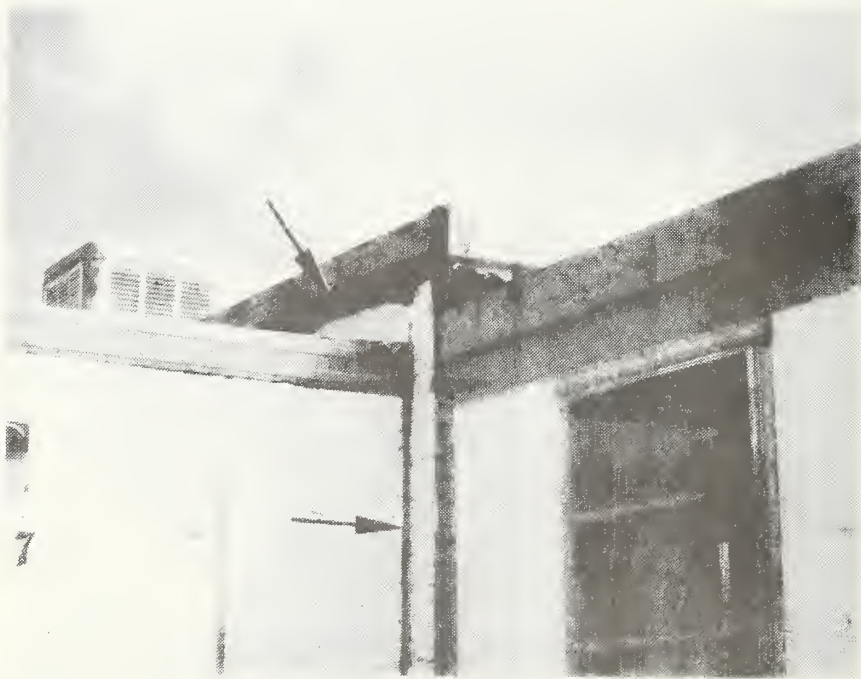
Figure C-17 Application of Coating Material to Repair Water Leak at Tip-out Joint

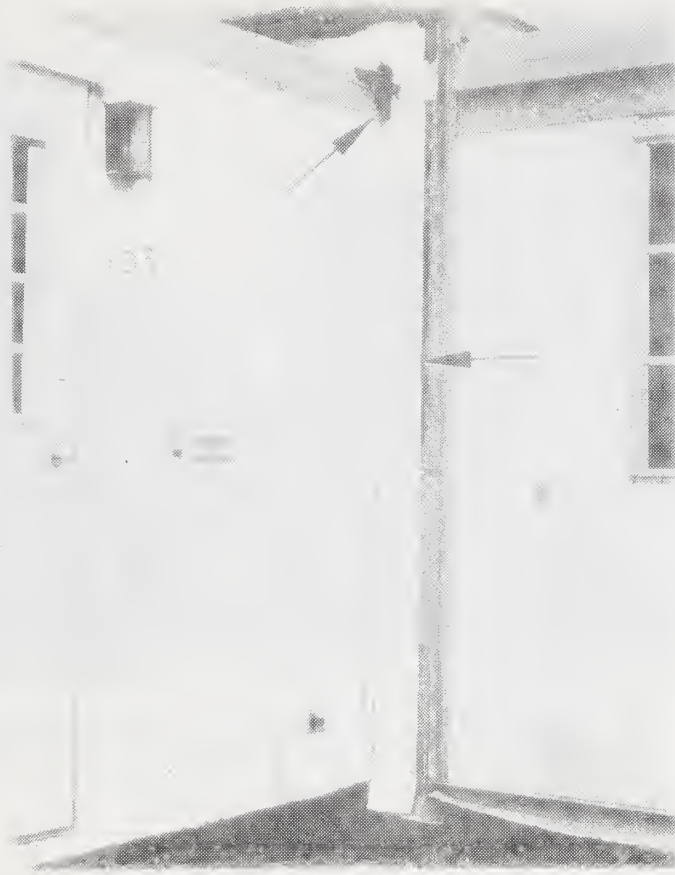
Figure C-18 Location of Rain Leak
at Tip-out Joint

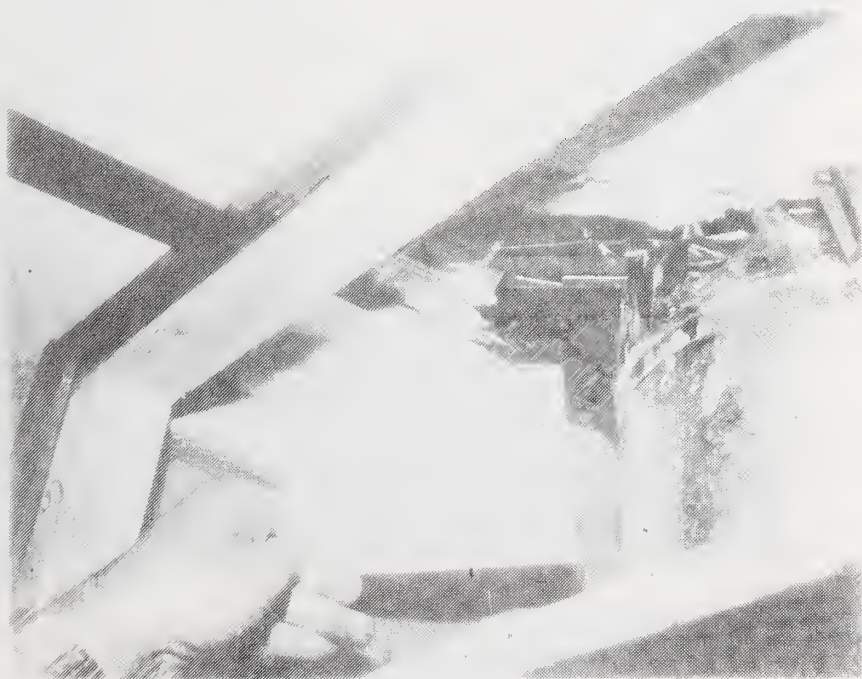
Figure C-19 Bowstring Roof Truss Cut for
Passage of Furnace Vent

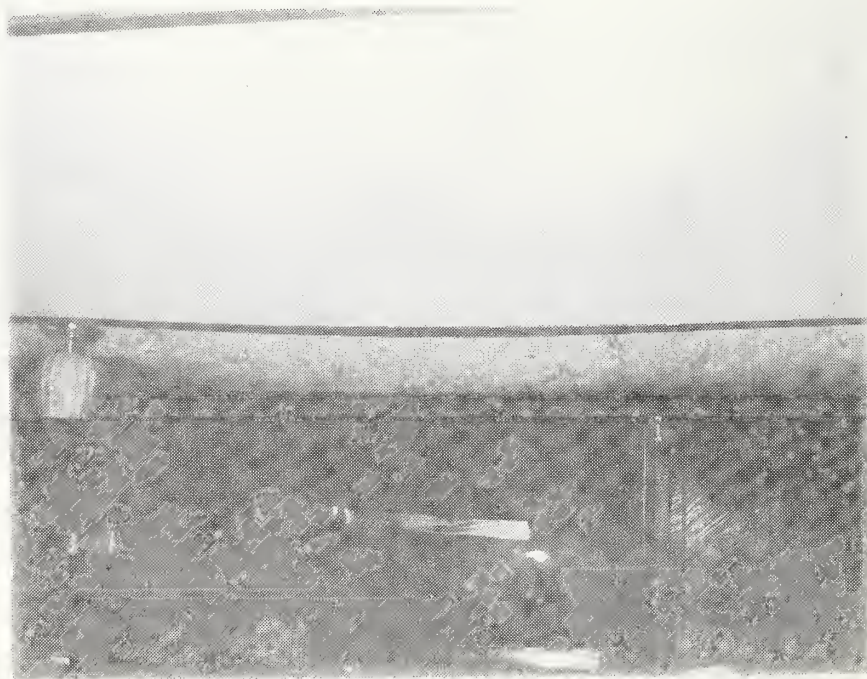
Figure C-21 Deflection of Ceiling Indicating Failure of Attachment to the Roof Truss

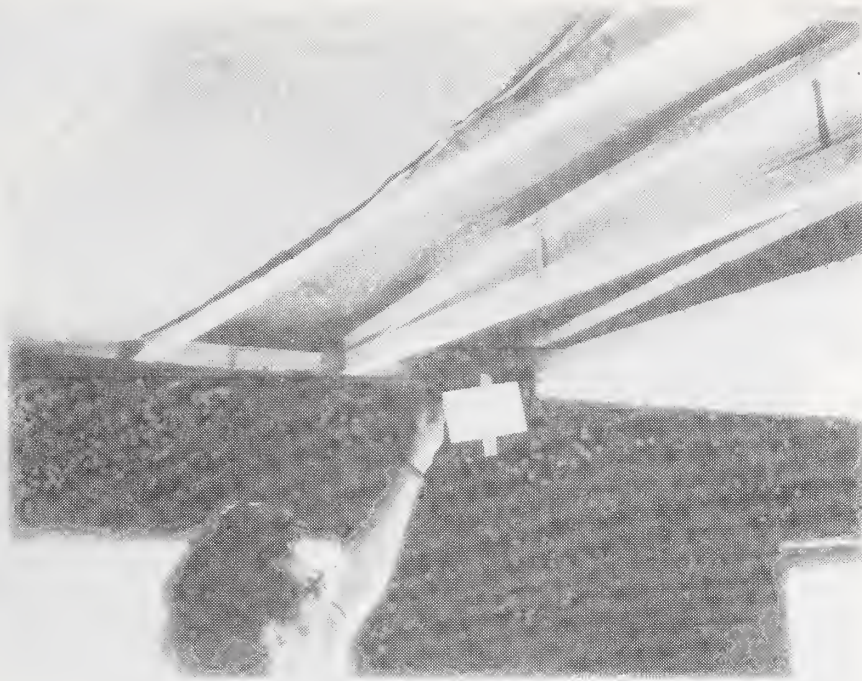
Figure C-22 Insulation Missing in Roof System. Note Metal Roofing Loosely Lying on Roof Truss Which Would Likely Result in "Roof Rumble" in Windy Condition

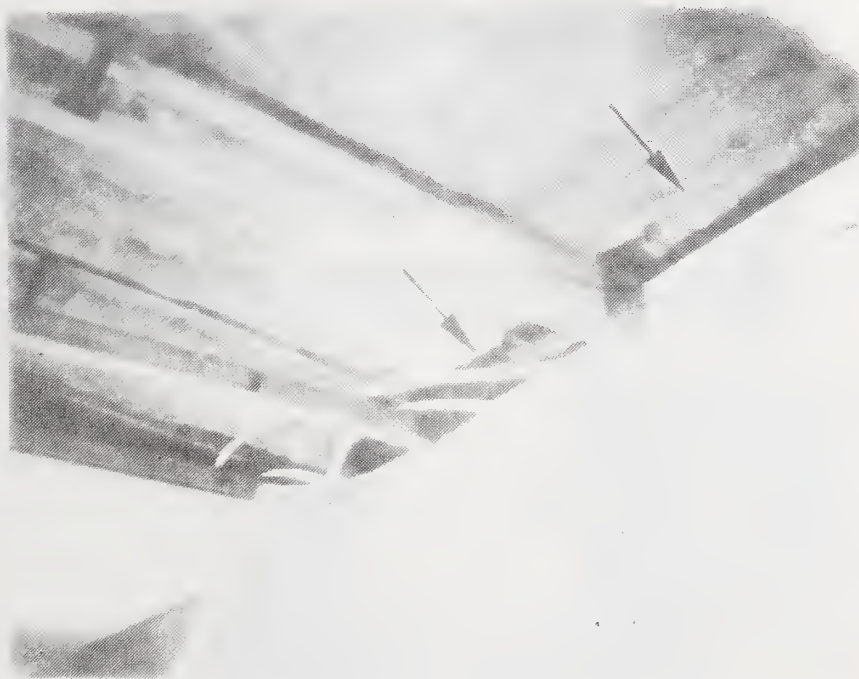
Figure C-23 Insulation Cut Short at Juncture of Roof Truss and Exterior Wall

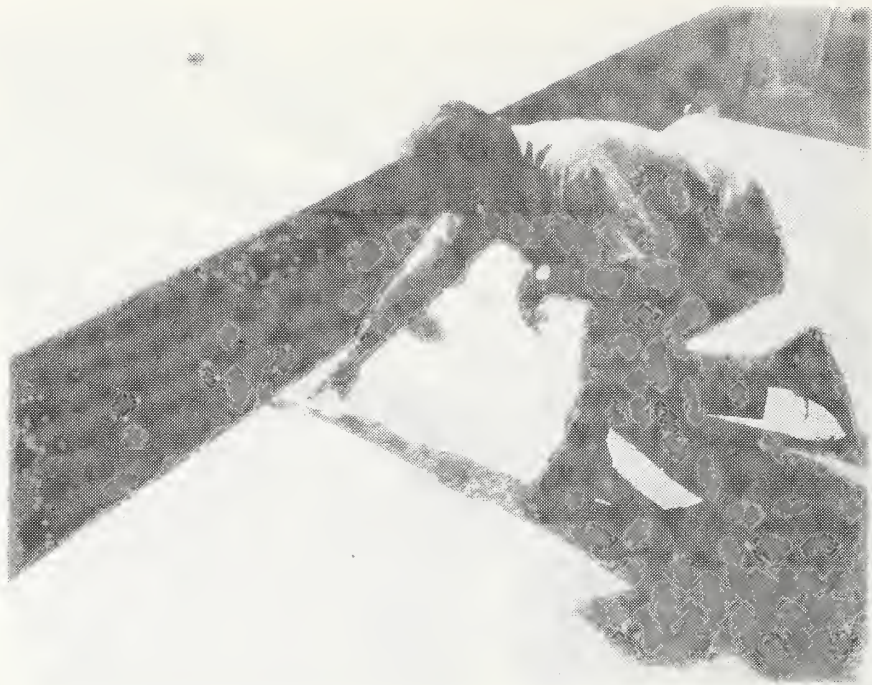
Figure C-24 Improperly Crimped Metal Membrane at Roof Edge

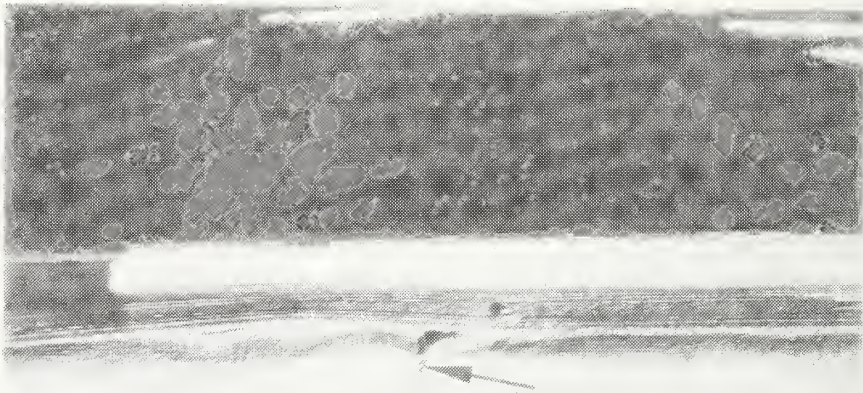
Figure C-25 Crack in Crimped Steel Roof Membrane—Water Leak Potential

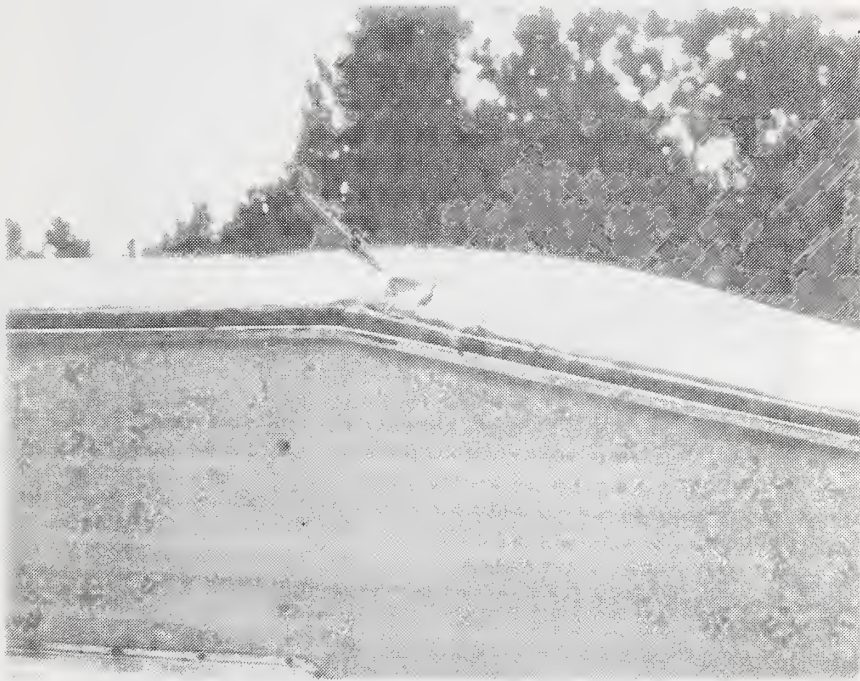
Figure C-26 Crimped Steel Membrane at Change in Slope of Roof

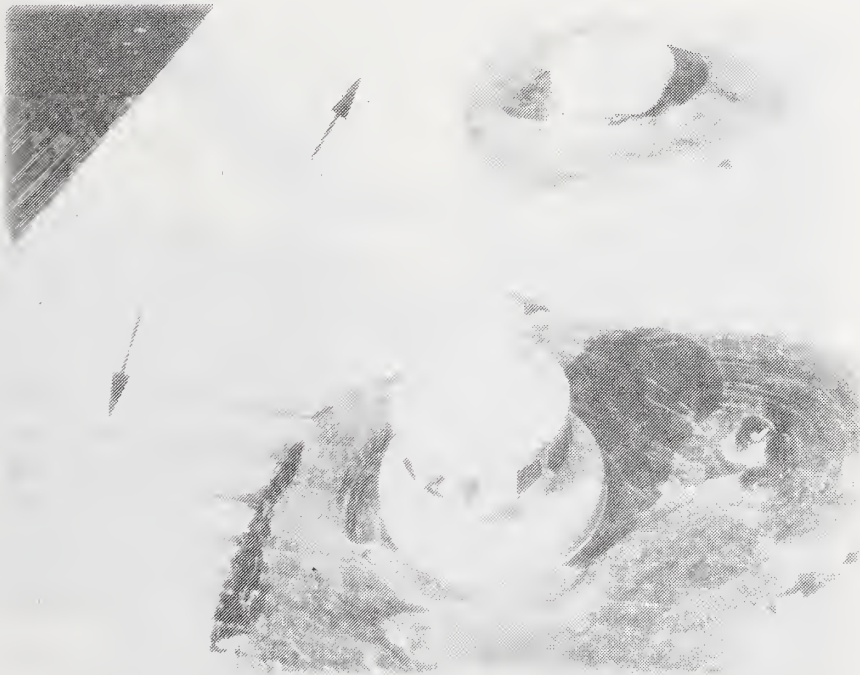
Figure C-27 Rusting Steel Roofing Membrane Near Roof Penetrations Which Have Been Coated With Roofing Sealant

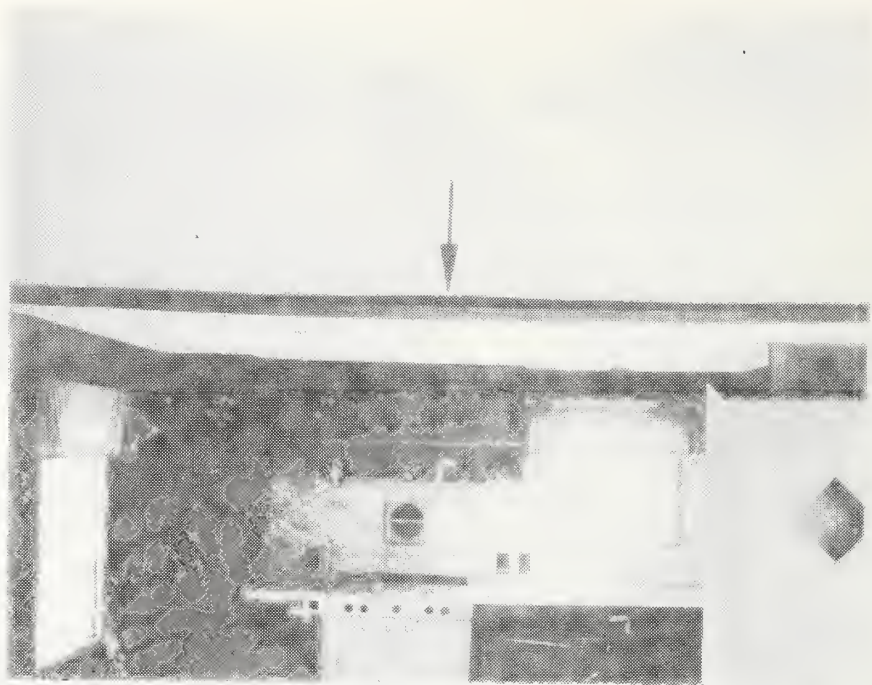
Figure C-28 Failure of Ceiling/Roof Truss Attachment
as Indicated by Sagging Ceiling

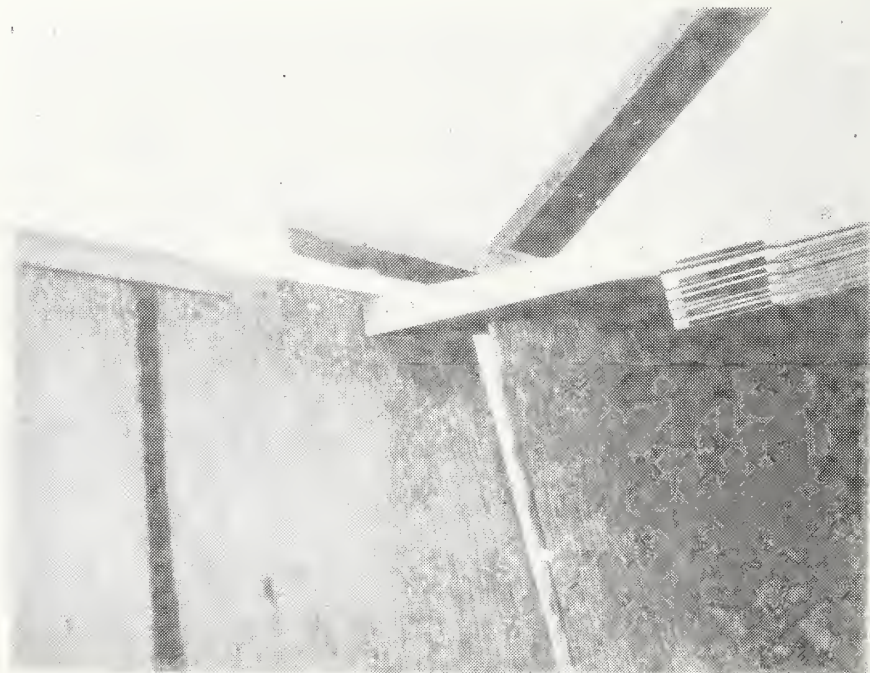
Figure C-29 Loose Interior Paneling to Wall Framing Attachment
At Intersection of Exterior Wall and Ceiling

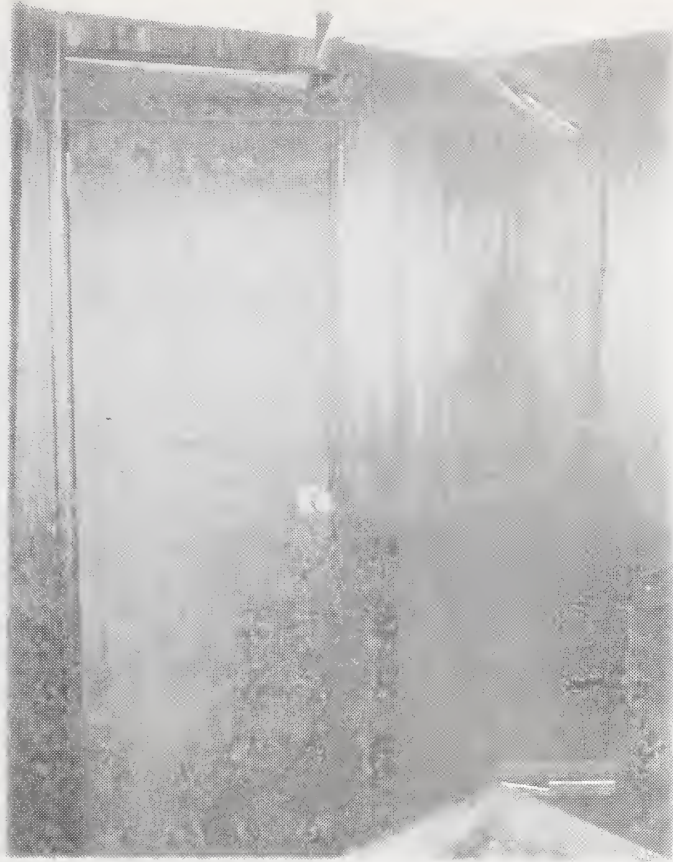
Figure C-30 Distortion of Interior Partition With Door - Due to Undercarriage Damage.

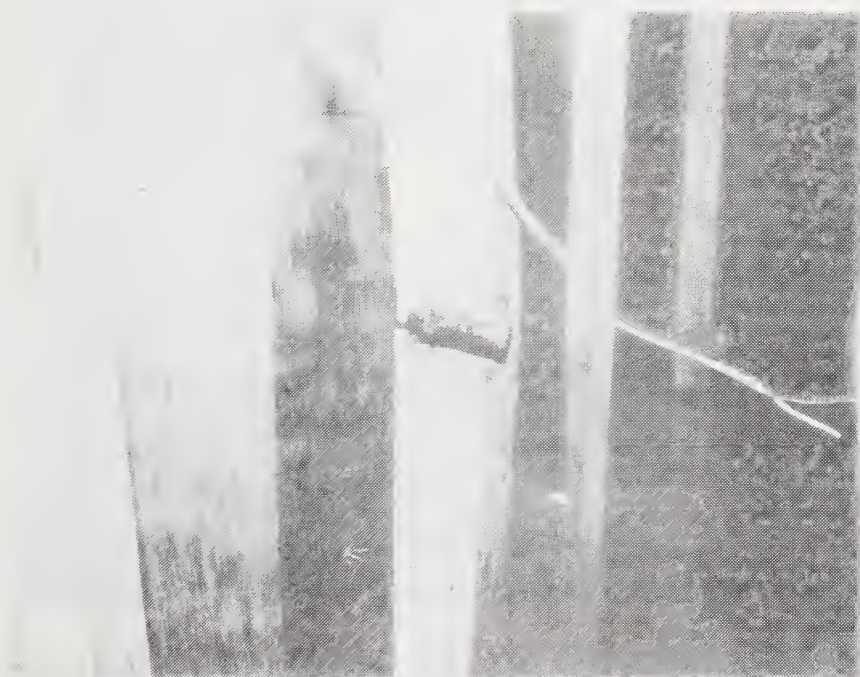
Figure C-31 Load Carrying Failure of Partition Wall Structural Member Due to Inferior Lumber Grade

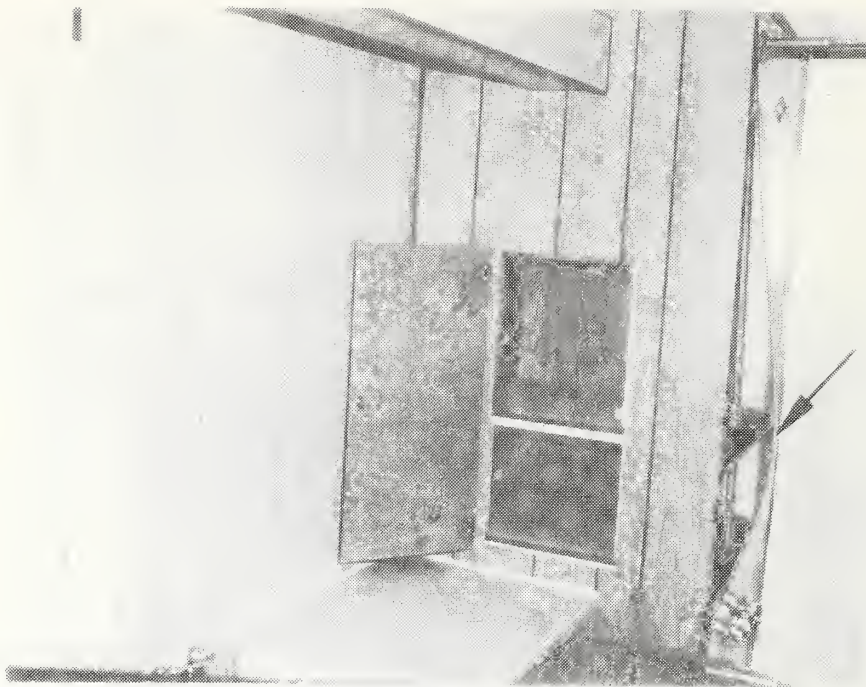
Figure C-32 Distortion of Shower Enclosure Wall Due to Effects of Moisture

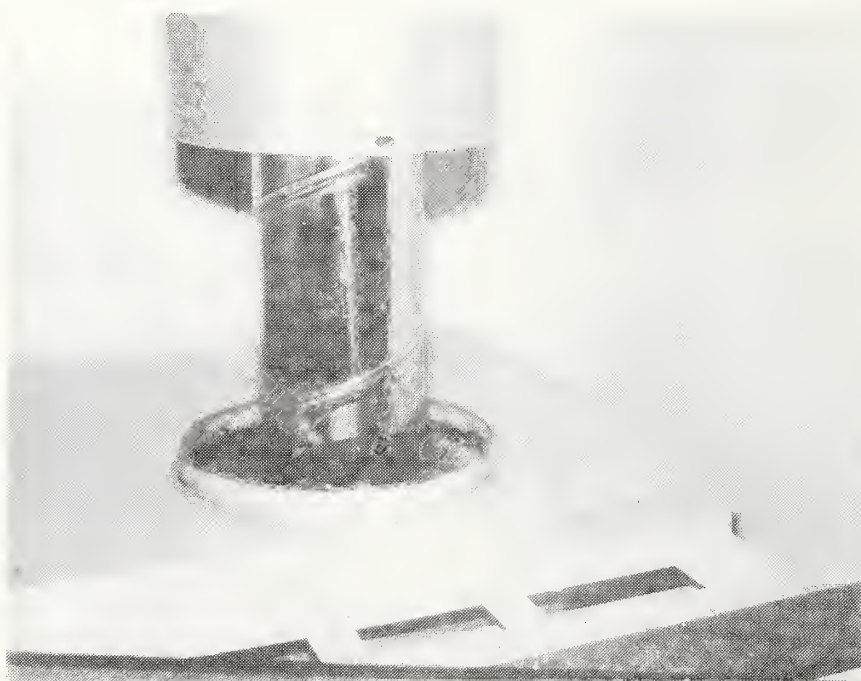
Figure C-33 Construction Detail - Gypsum Board Lining of Furnace Enclosure Wall

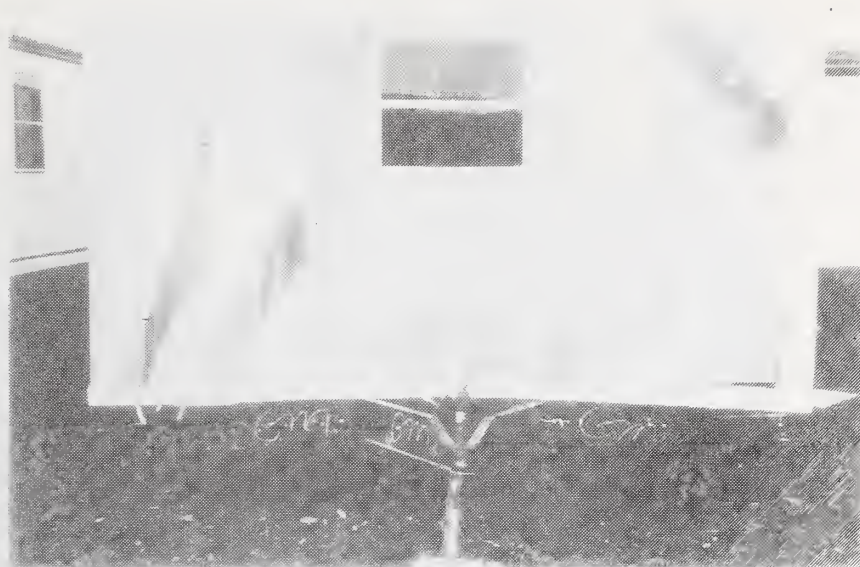
Figure C-34 A-Frame Assembly and Outrigger Failure
Resulting in Damage to Mobile Home - Exterior View.

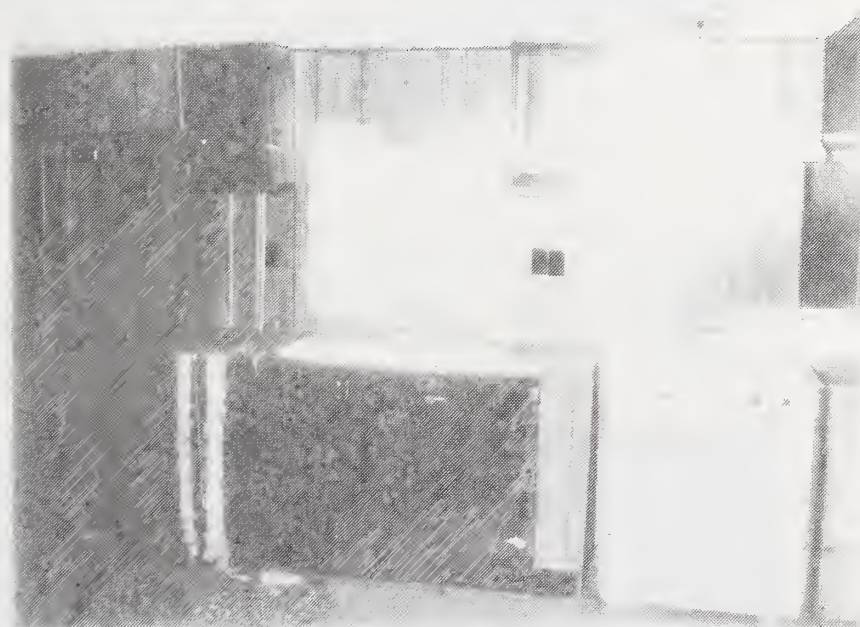
Figure C-35 Result of A-Frame Assembly and Outrigger
Failure - Interior View Looking Toward Tongue
End of Home Shown in Figure C-34.

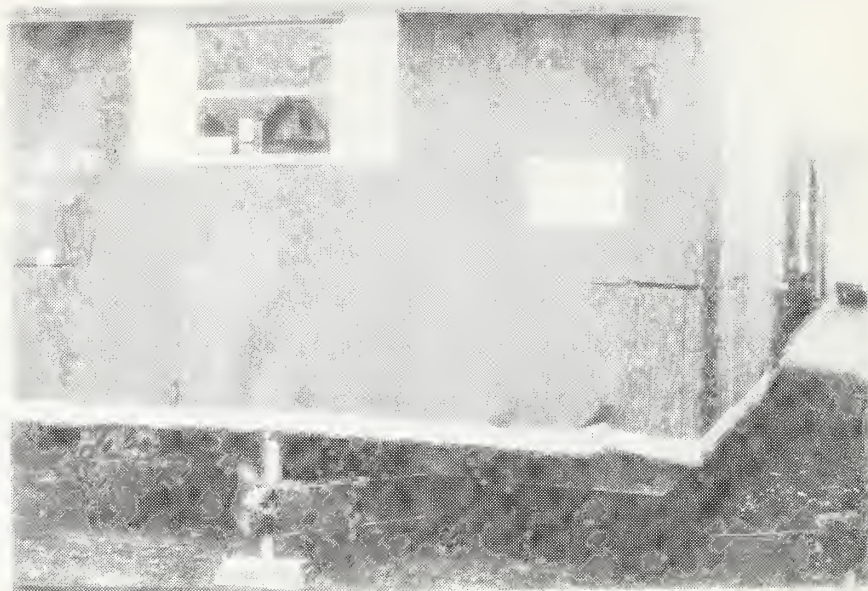
Figure C-36 A-Frame Assembly Failure

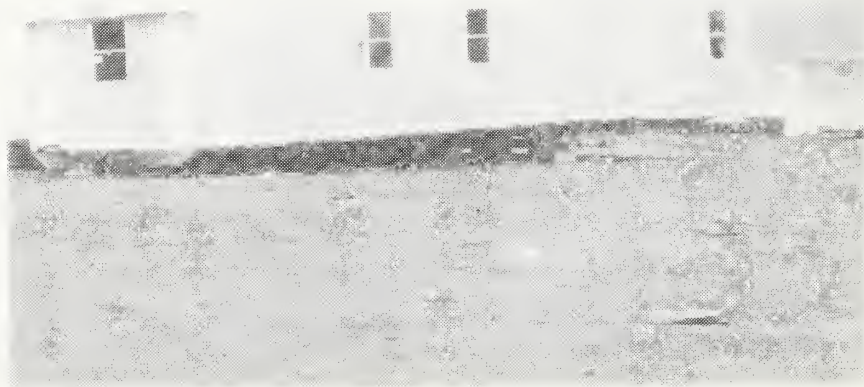
Figure C-37 Longitudinal Member Failure.
