NBSIR 75-688

Performance of Mobile Homes - A Field Inspection Study

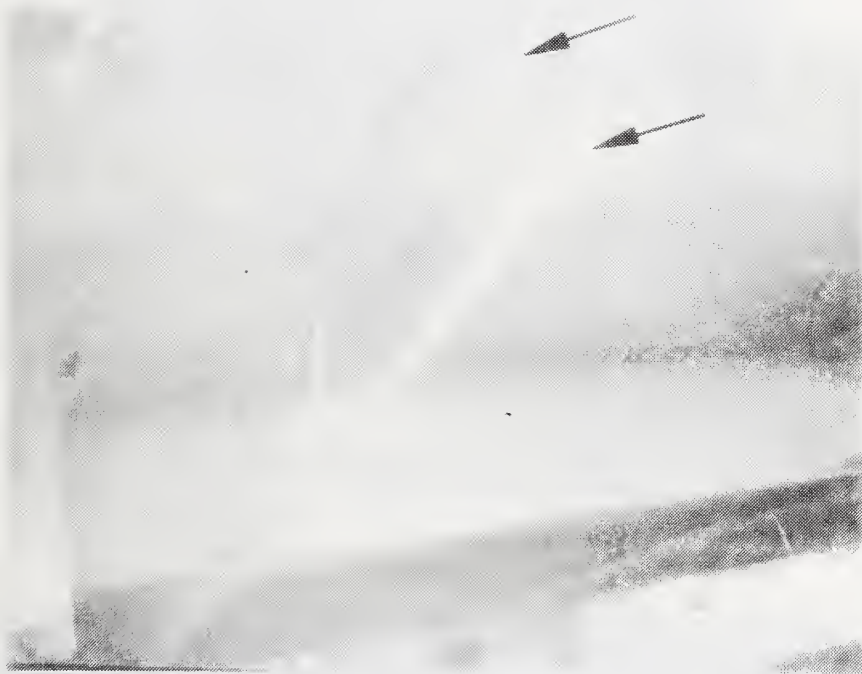
Figure C-38 View of Underside of Mobile Home -
Weld Failure of Open Web Outrigger.

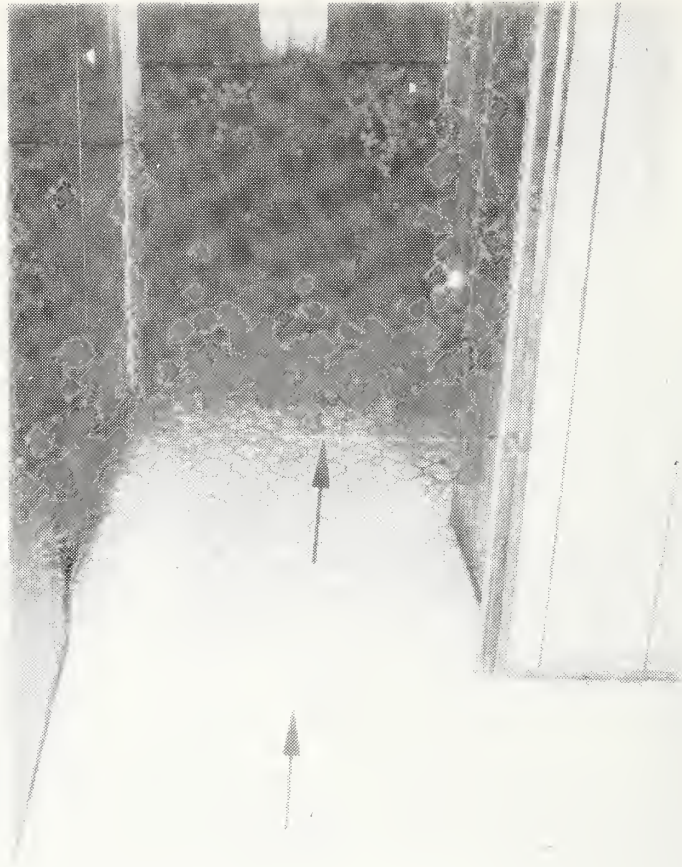
Figure C-39 Buckled Floor Covering at Joints
of Floor Sheathing

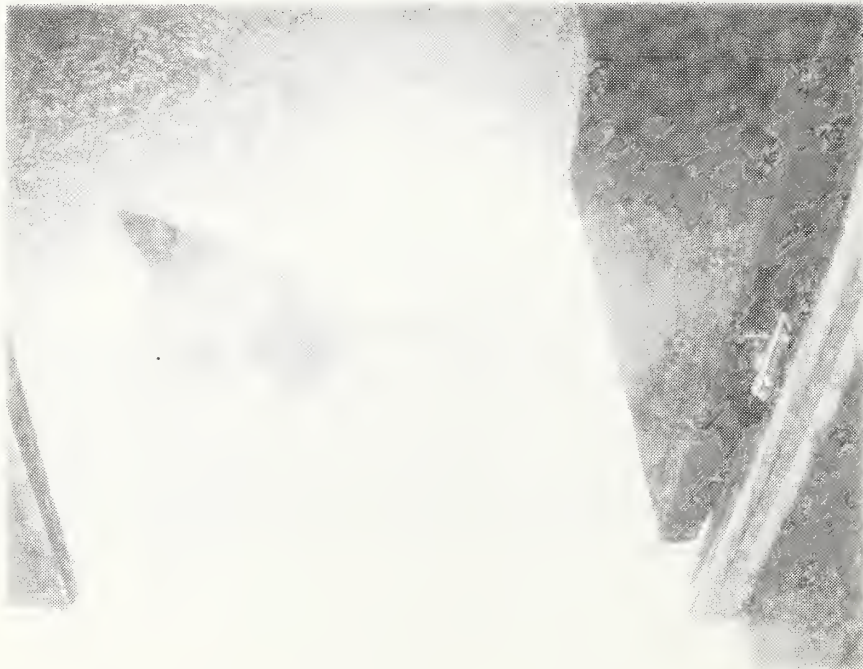
Figure C-40 Damaged Floor Covering at
Entrance to Bedroom

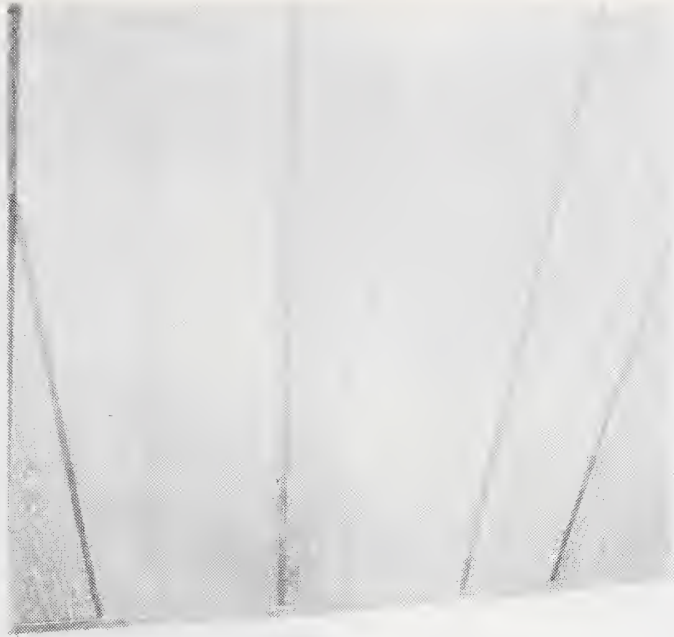
Figure C-41 Damaged Floor Covering

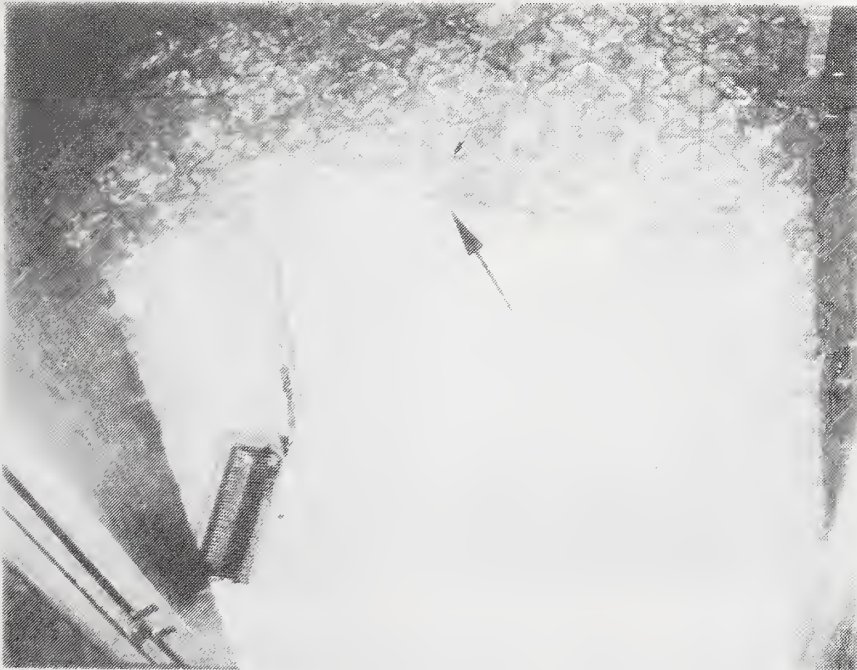
Figure C-42 Buckled Flooring and Covering Due to Distortion of Floor System Caused by Undercarriage Damage

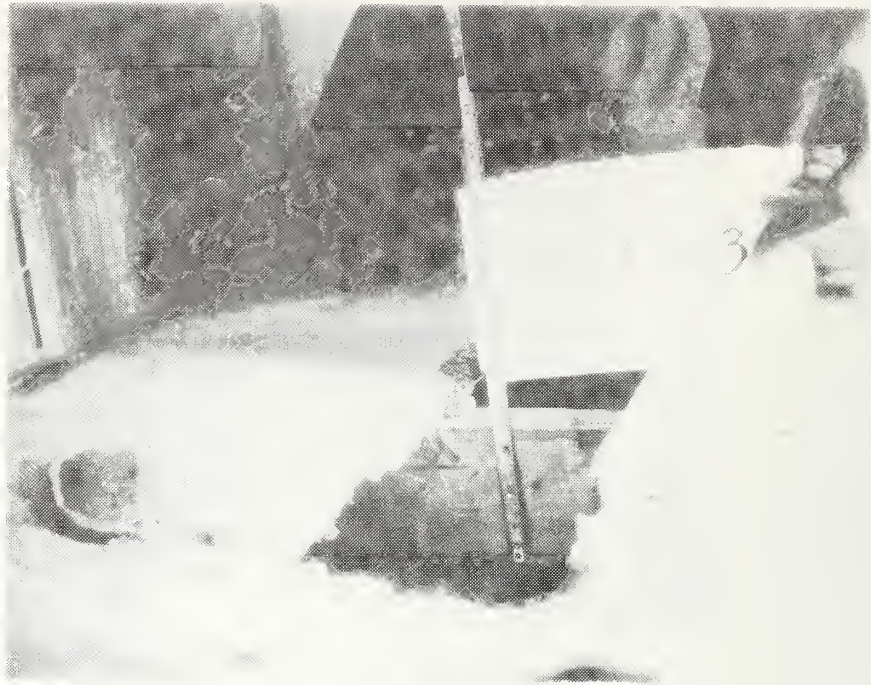
Figure C-43 Buckling of Particle Board Floor Decking
Due to Water Damage Caused by Plumbing Malfunction

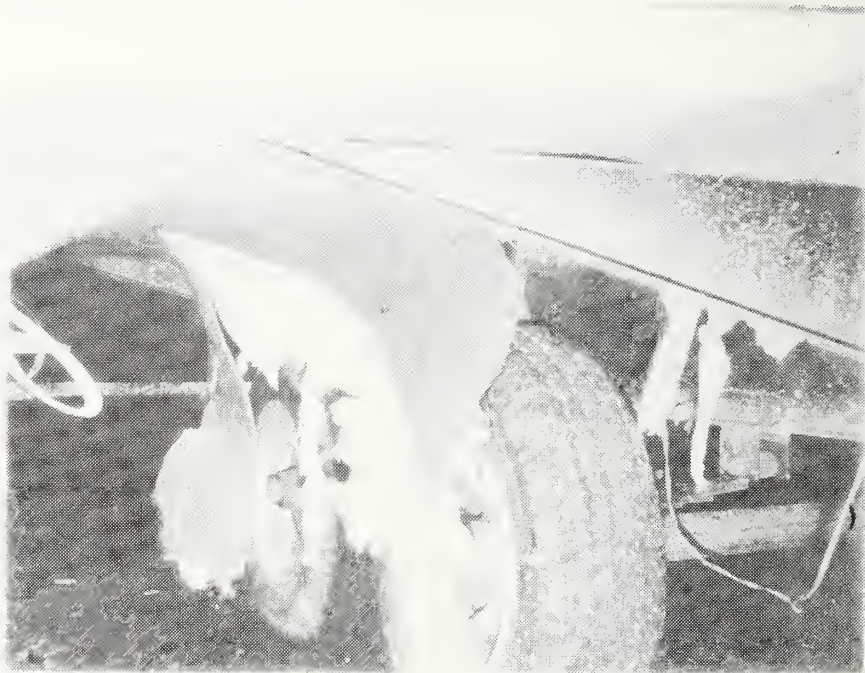
Figure C-44 Damage to Bottomboard on Underside of Mobile Home
Exposing Floor Insulation Resulting in Diminished
Rodent Resistance and Excessive Air Infiltration.

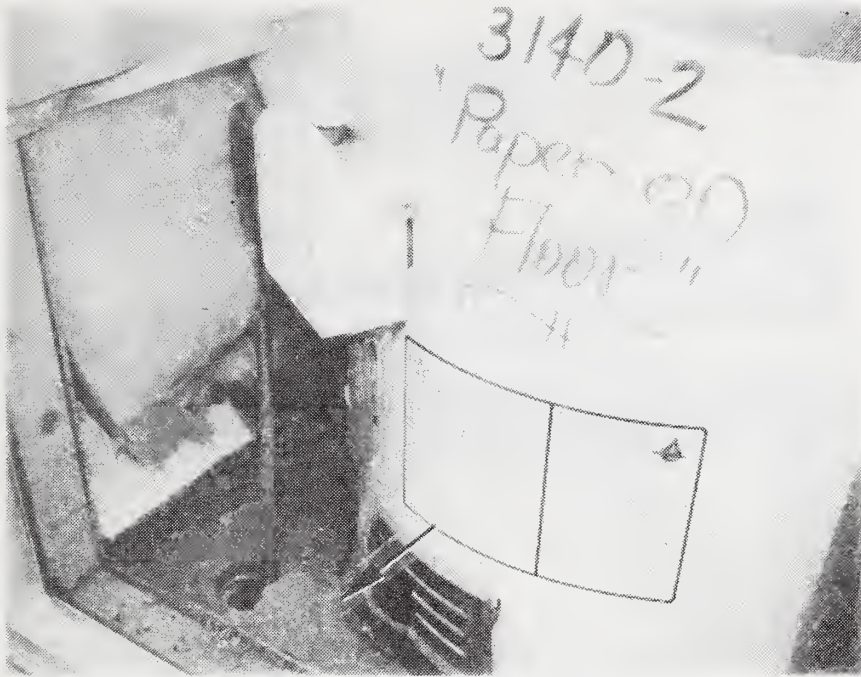
Figure C-45 Combustible Material on Hot Water Heater Compartment Floor

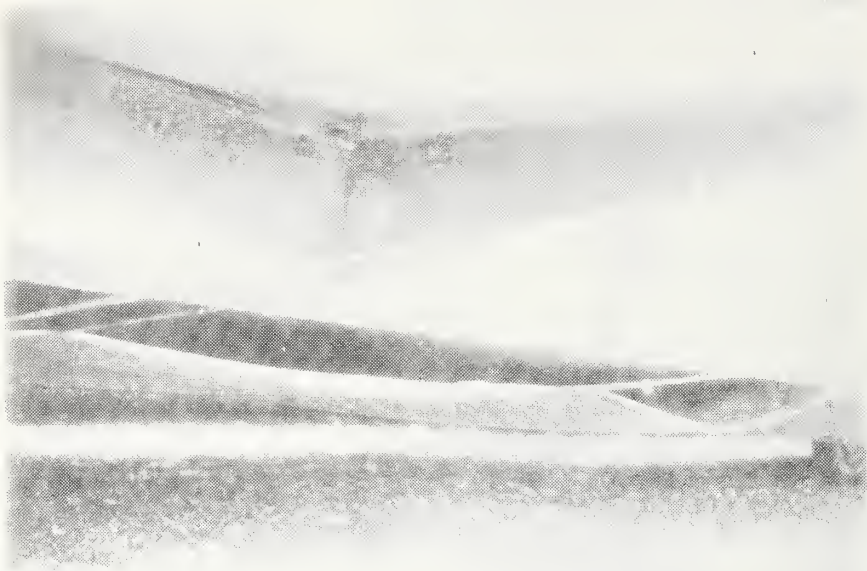
Figure C-47 Failure of Fastening of Bottomboard to Underside of Floor.

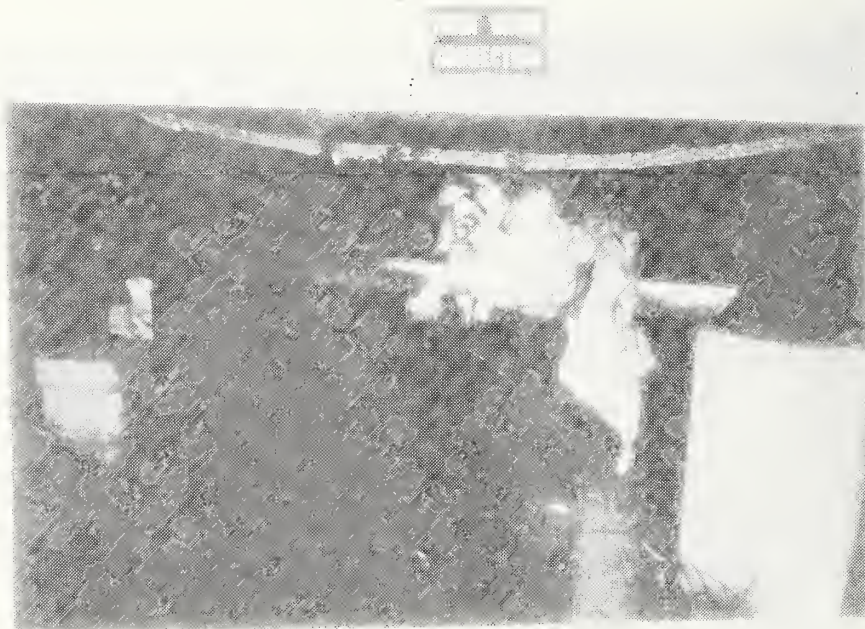
Figure C-48 Failure of Fastening of Bottomboard to Underside of Floor.

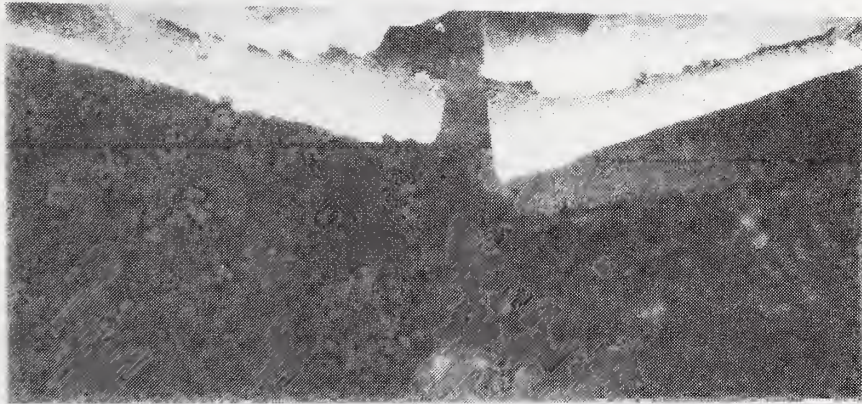
Figure C-49 Failure of Fastening of Bottomboard
to Underside of Mobile Home

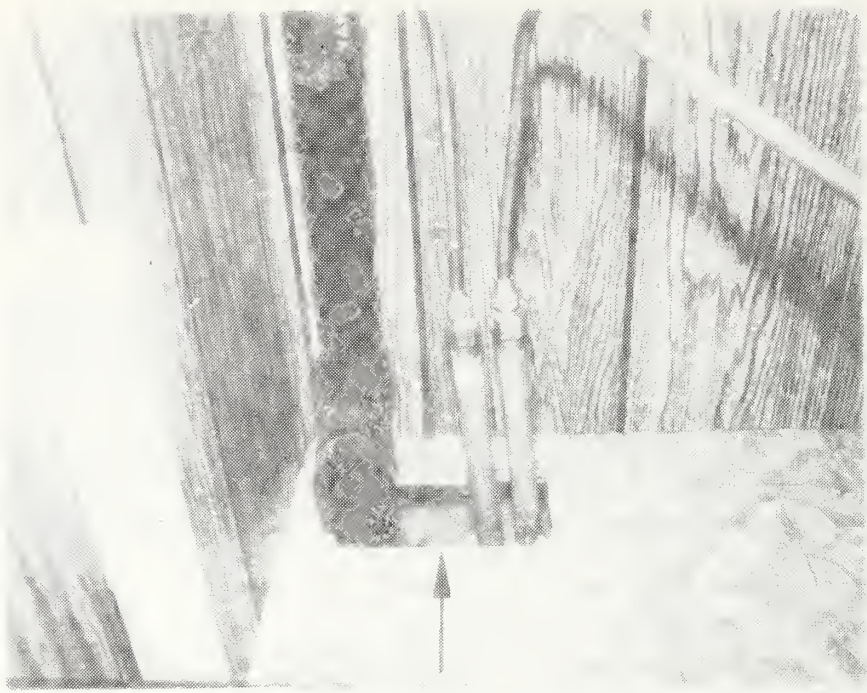
Figure C-50 Inadequate Rodent Resistance Due to Oversize Hole Cut for Passage of Plumbing Piping. No Attempt Was Made to Seal Holes.

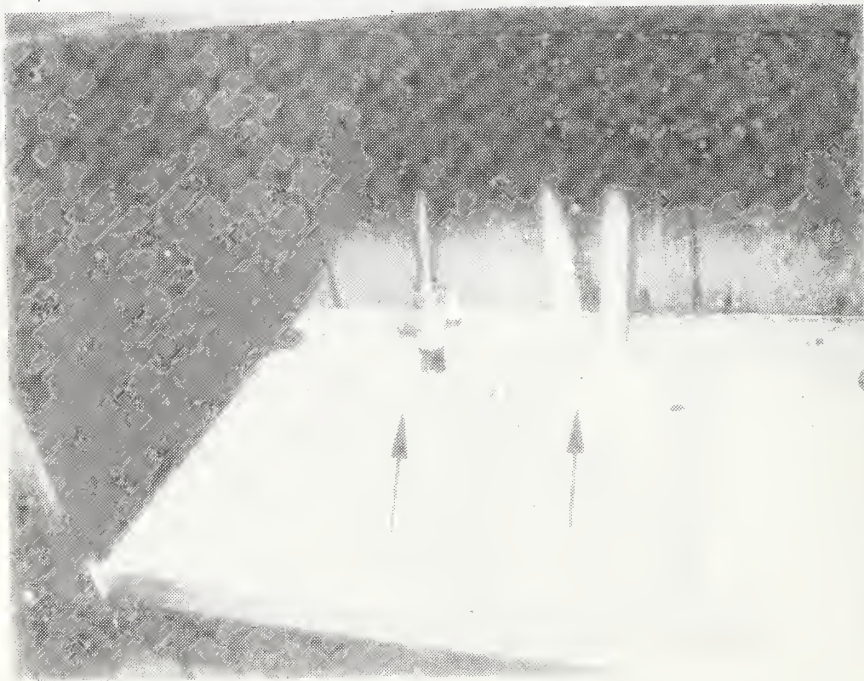
Figure C-51 Rodent Protection Was Provided at These Pipe Penetrations

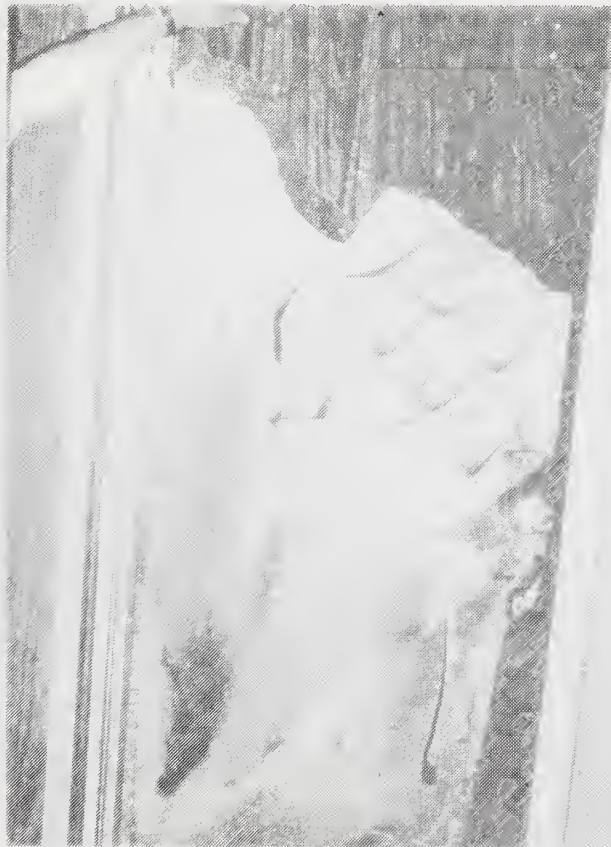
Figure C-53 Exterior Door Construction of Paper Honeycomb Core and Vegetable Fiber Board Skins. (This Mobile Home Had Been Abused and Experienced Exterior Water Damage)

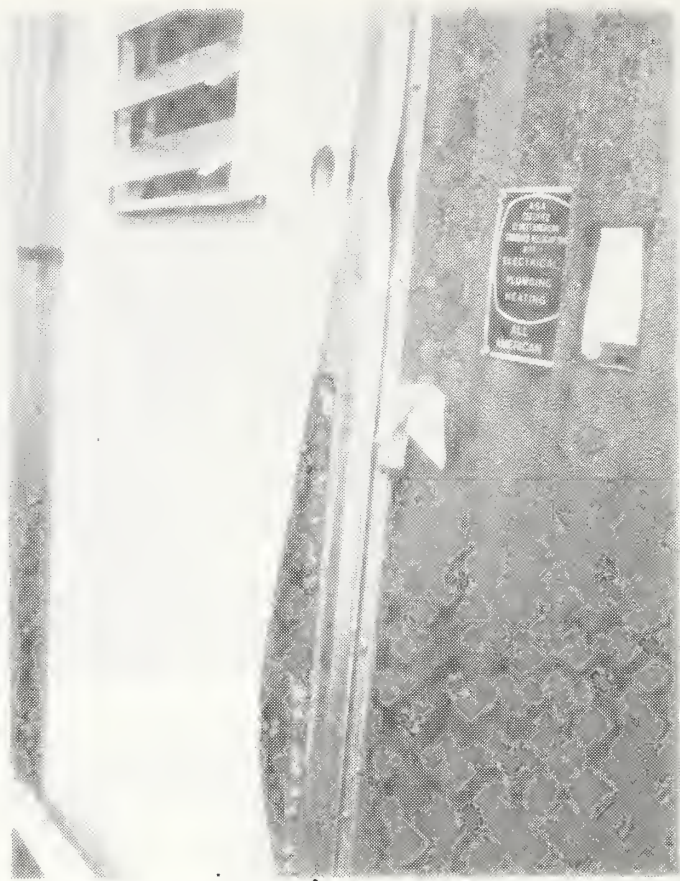
Figure C-54 Exterior Door Construction of Paper Honeycomb Core and Aluminum Skins - Exterior Skin Was Buckled.

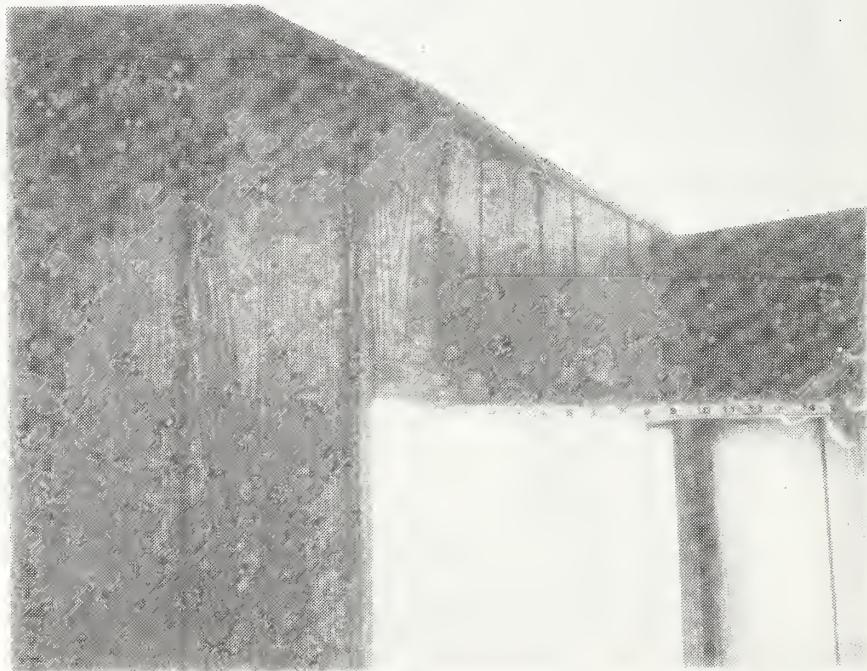
Figure C-55 Racked and Damaged Exterior Door Frame

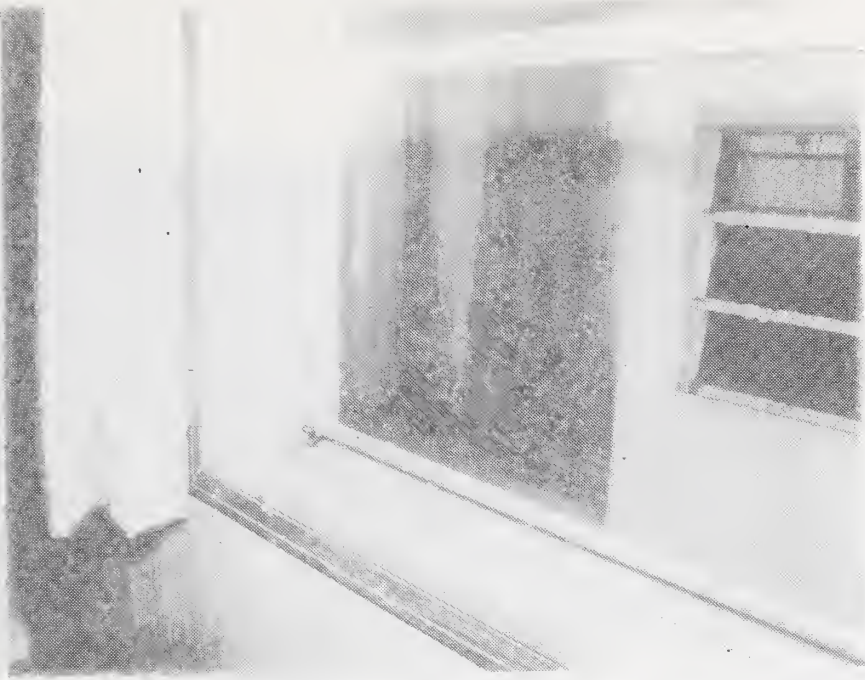
Figure C-56 Water Leak Through Closed Awning Type Windows (Interior Storm Windows)

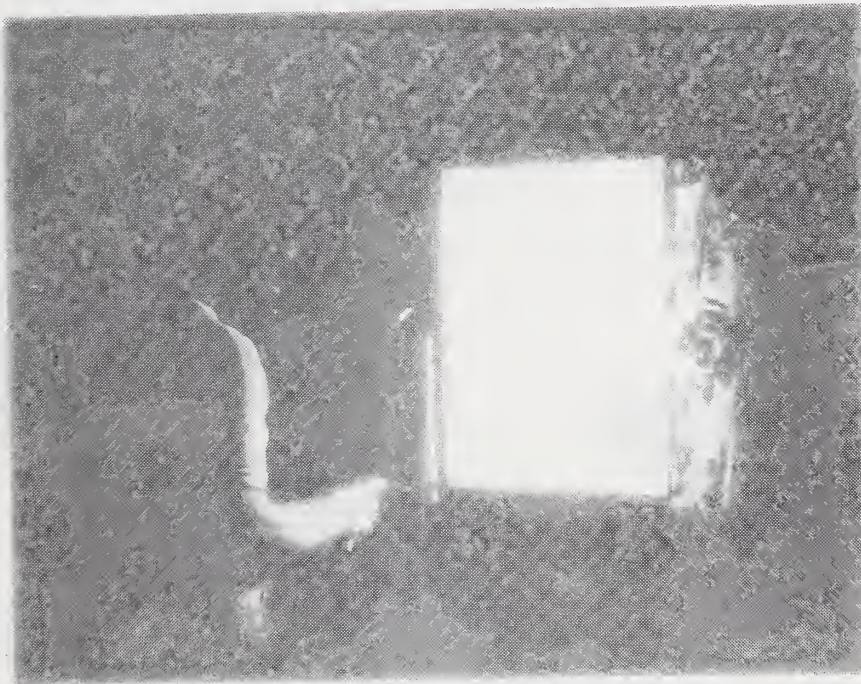
Figure C-57 Space for Air Leakage (Shows Light) Between Window and Wall Framing

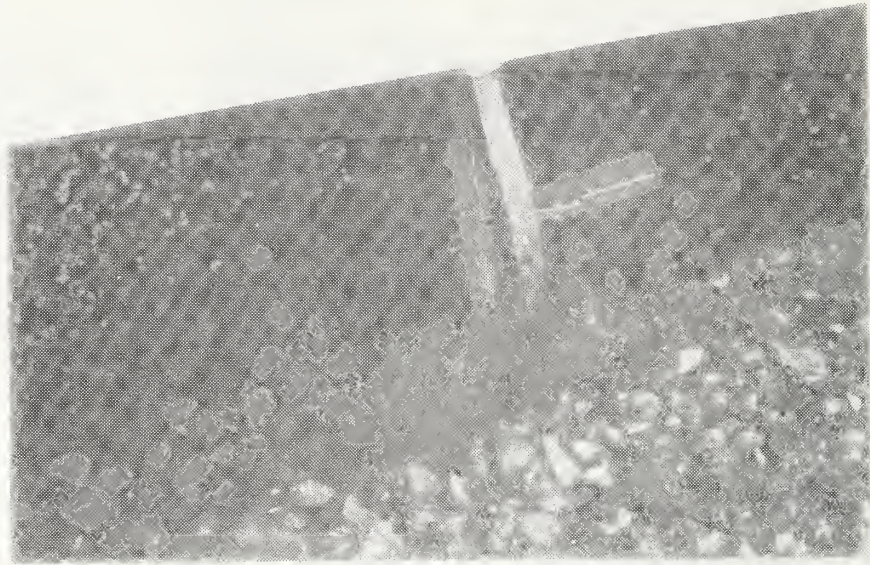
Figure C-58 Extensively Rusted Under-the-Skin Tie Down Strap

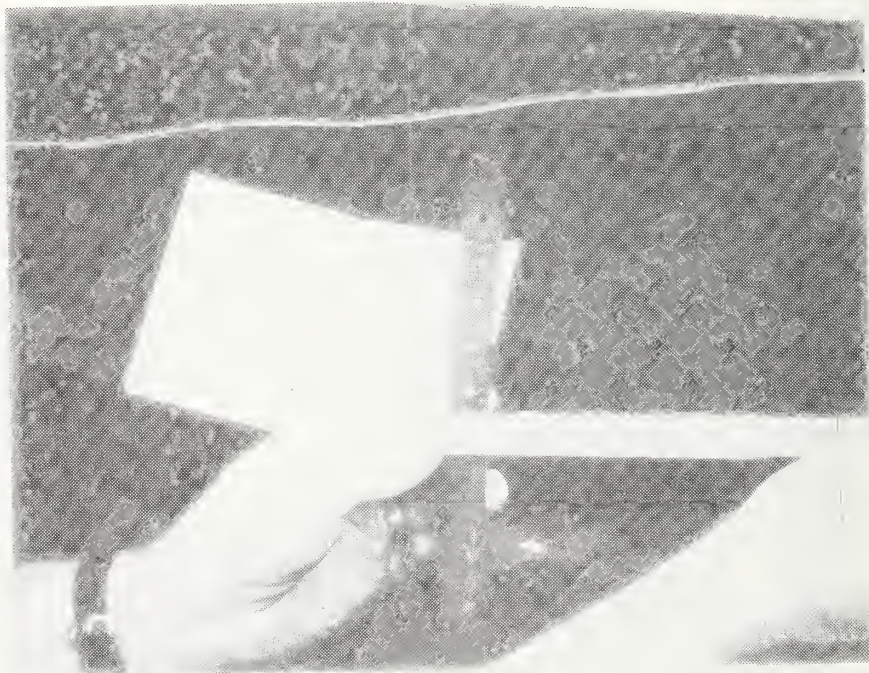
Figure C-59 Extensively Rusted and Undersized Under-the-Skin Tie Down Strap

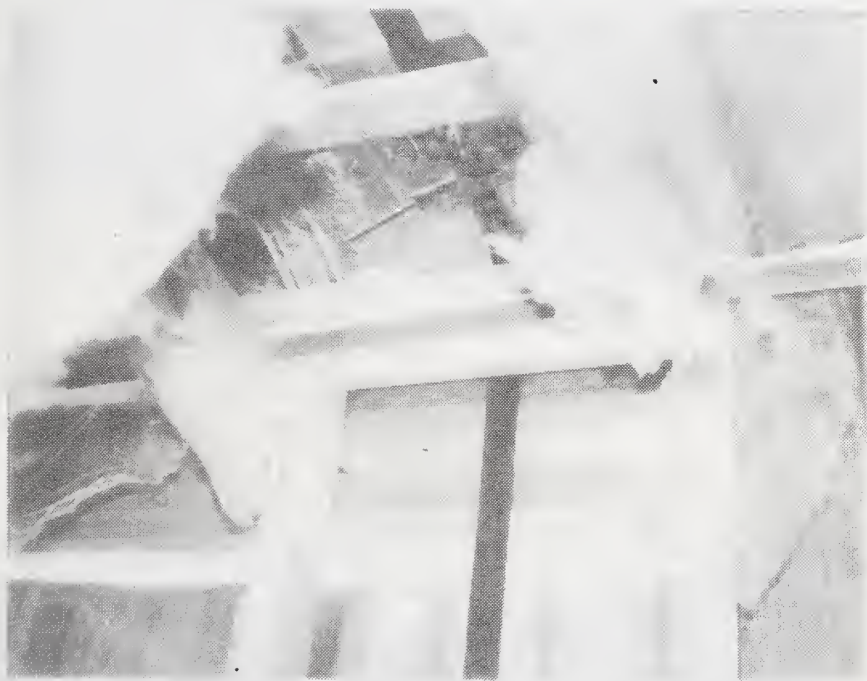
Figure C-60 Under-the-Skin Tie Down Strap Located Between Roof Trusses (Better Design Would Locate Tie Down Straps at Roof Trusses to Insure Load Transfer Between Walls).

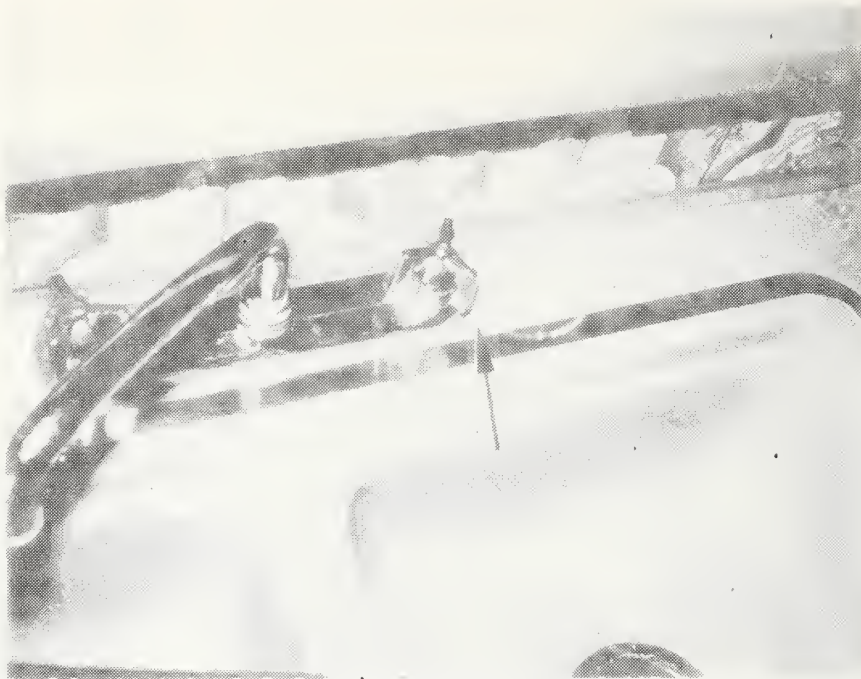
Figure C-61 Deterioration of Kitchen Counter Top Due to Water Leak at Faucet

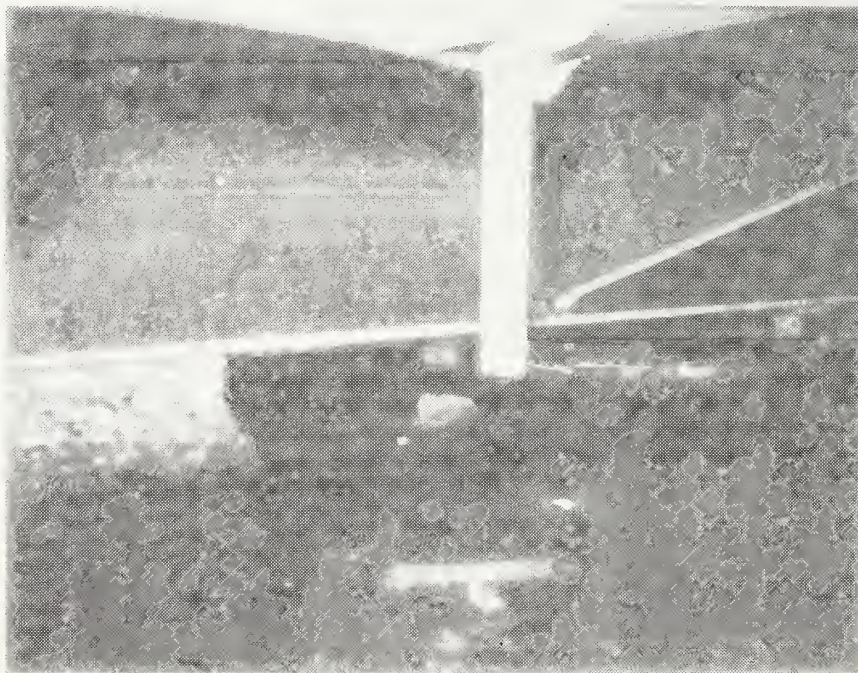
Figure C-62 Hot Water Heater Pressure Relief Overflow Pipe With Threaded End.

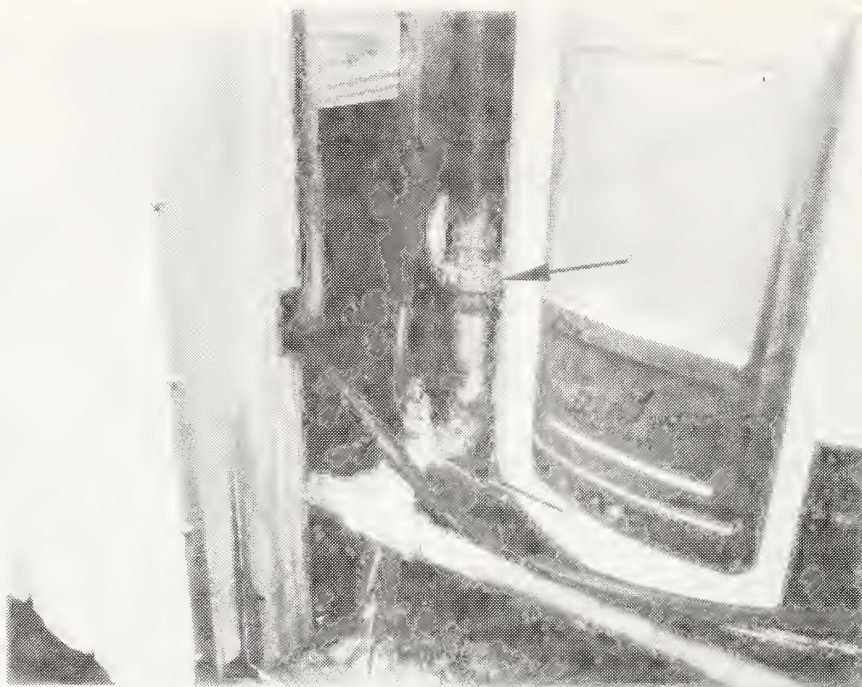
Figure C-65 Excessive Corrosion of Galvanized Steel Water Pipe in Hot Water Heater Compartment. Also, Electrical Cable Not adequately Supported

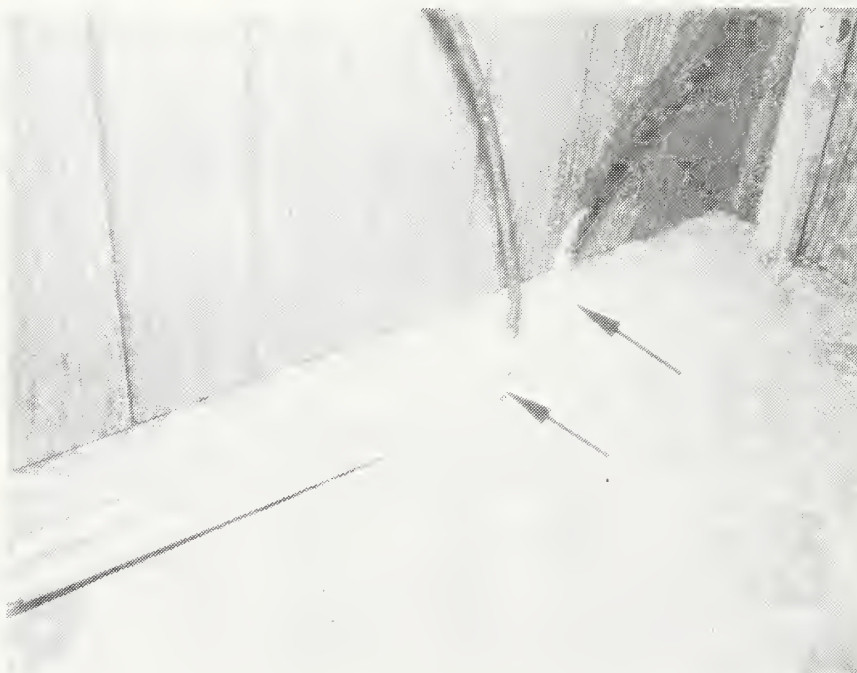
Figure C-66 Corrosion of Dissimilar Metals (Copper to Galvanized Steel) Used for Water Supply Under Bathroom Sink

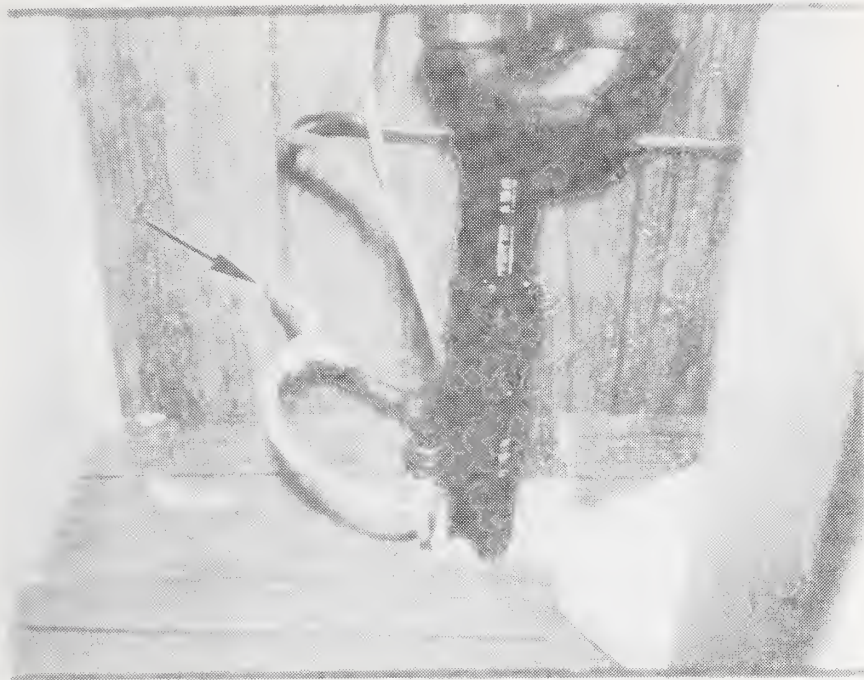
Figure C-67 Example of Poor Workmanship - Water Supply Piping and Electrical Wiring Passing Through the Same Undersize Wall Penetration

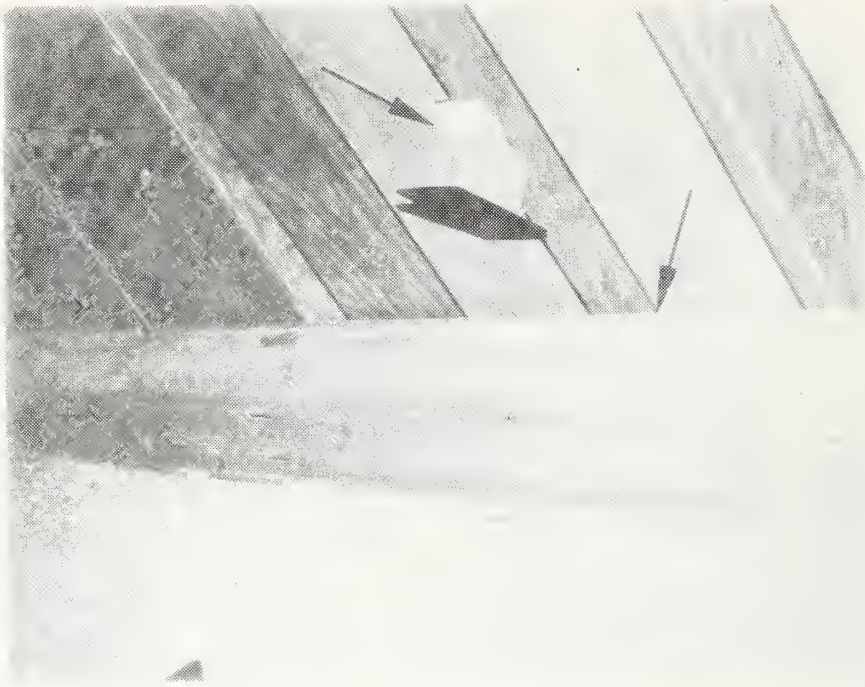
Figure C-69 Plumbing Pipe Running Along Inside Wall in Sleeping Quarters Covered With Lightweight Plastic Cover. Also, Electrical Box Inadequately Attached to Wall

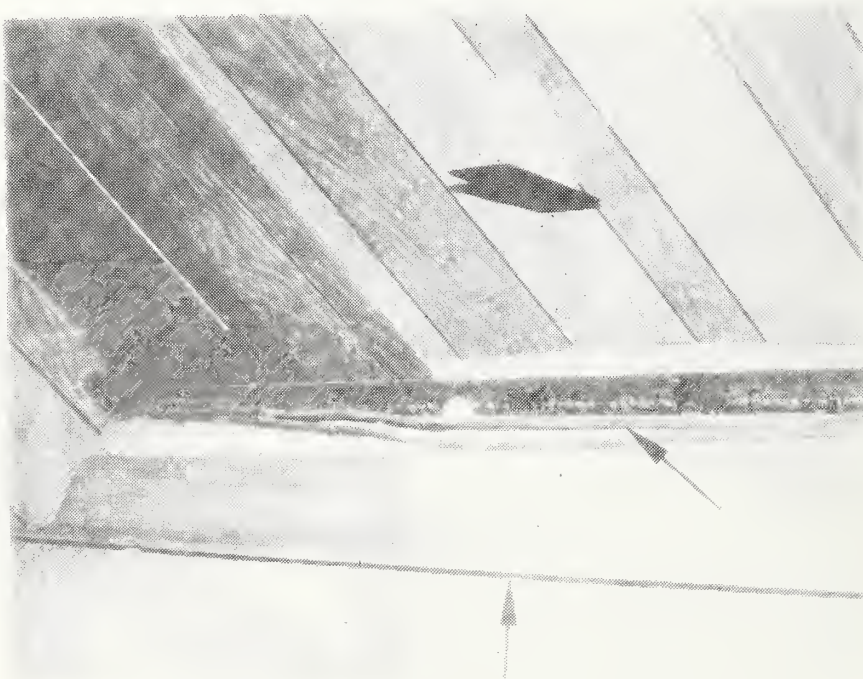
Figure C-70 Lightweight Plastic Pipe Cover Removed in Sleeping Quarters to Expose Plumbing Pipe Running Along Wall (See Figure C-69).

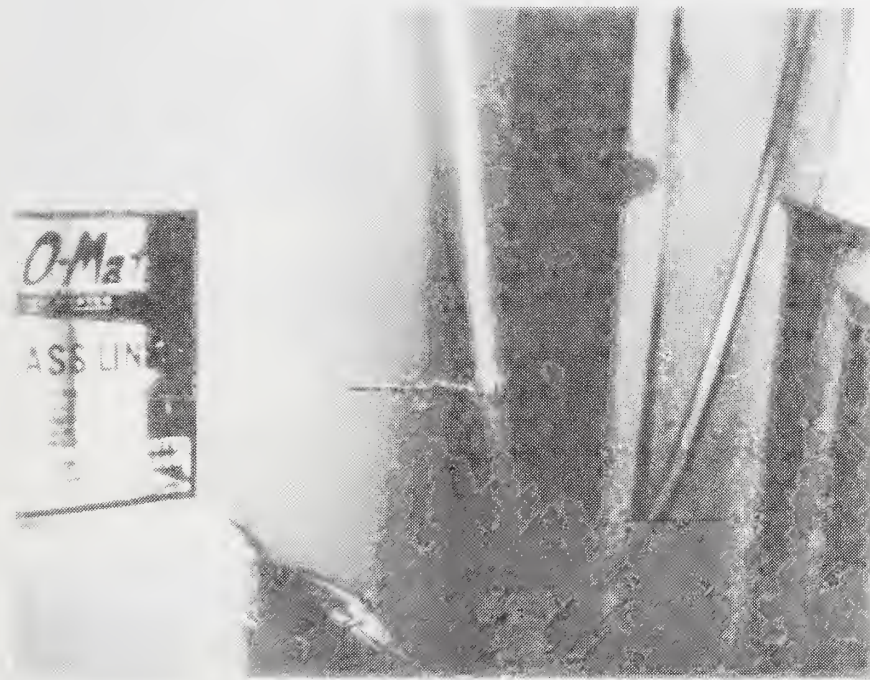
Figure C-75 Copper Water Supply Tubing Failure Due to Freezing in Hot Water Heater Compartment

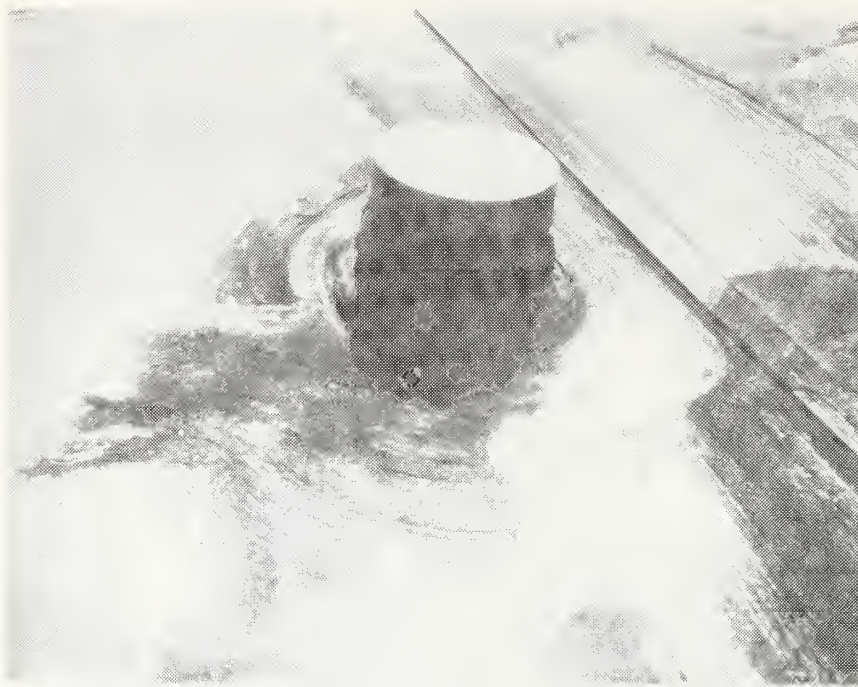
Figure C-76 Vent Cap on Roof Which is Not the Removable Type Required by ANSI A119.1 Standard

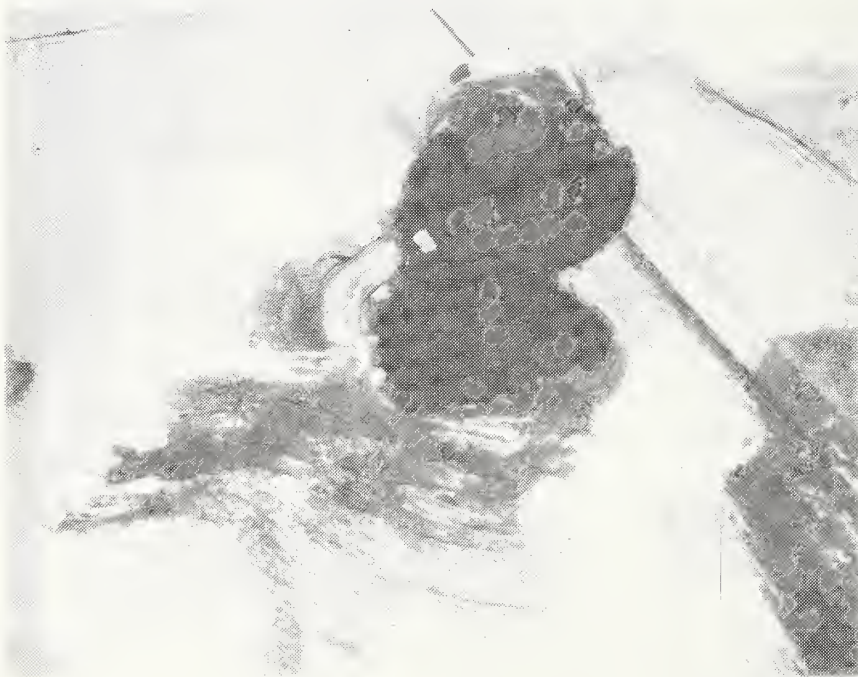
Figure C-77 Vent Cap Removal Damaged the Flashing.

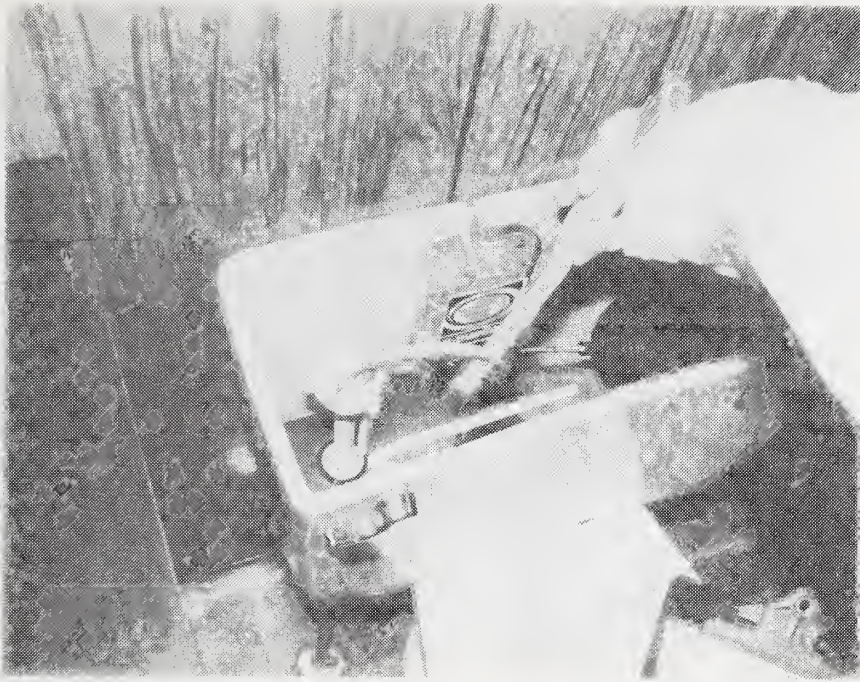
Figure C-78 Submerged Valve Flushing Device Which Could Allow Flush Tank Water to Back Flow Into The Potable Water Supply

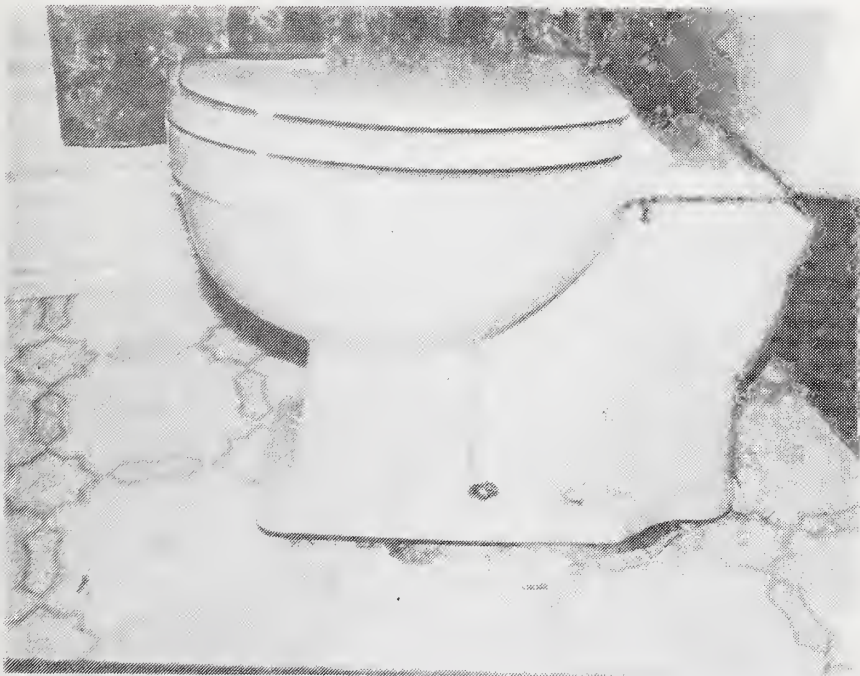
Figure C-79 Loose Toilet at Floor Connection.

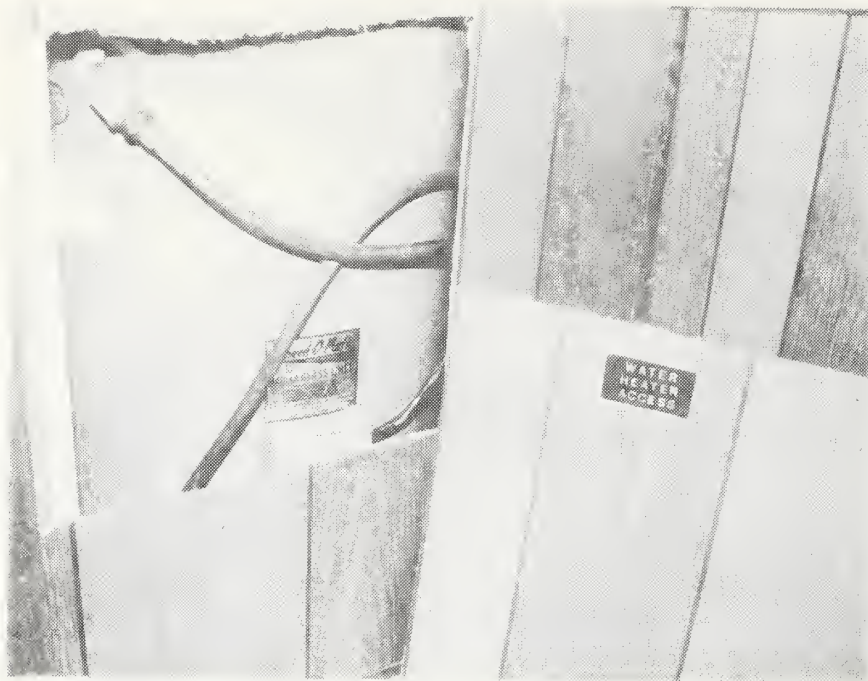
Figure C-80 Inadequate Hot Water Heater Access From Within Closet. Wall Paneling Would Have to be Removed to Replace Hot Water Heater

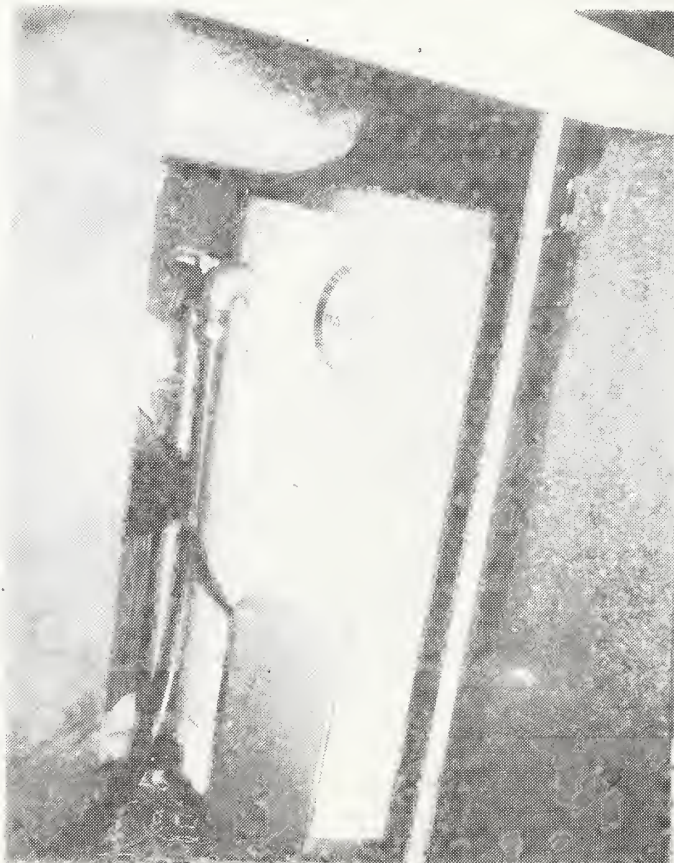
Figure C-81 Hot Water Heater Access Under Kitchen Cabinet. Kitchen Cabinetry would Have to be Removed to Replace Hot Water Heater

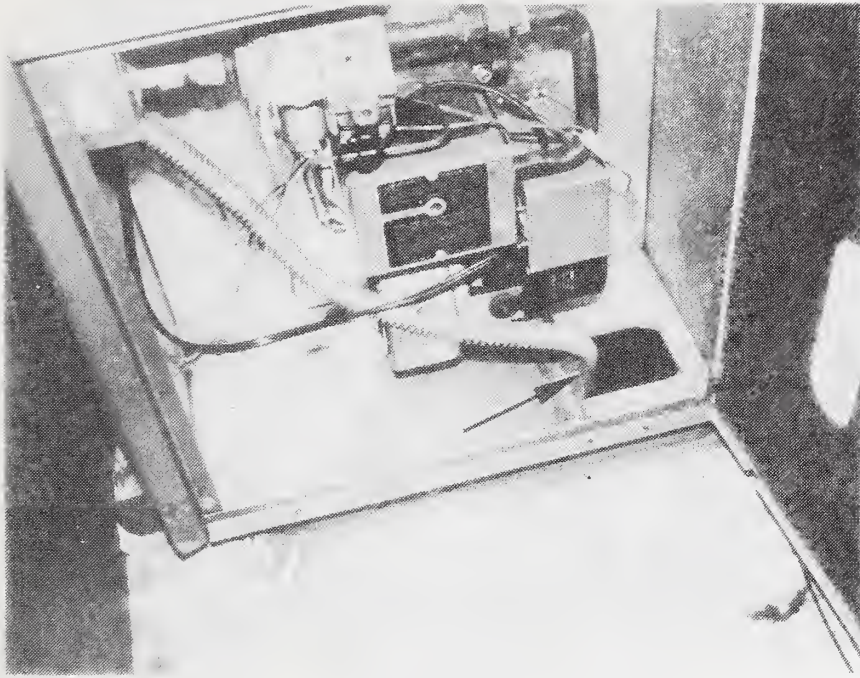
Figure C-82 Flexible Gas Connector on Furnace Through Floor to Gas Supply Piping

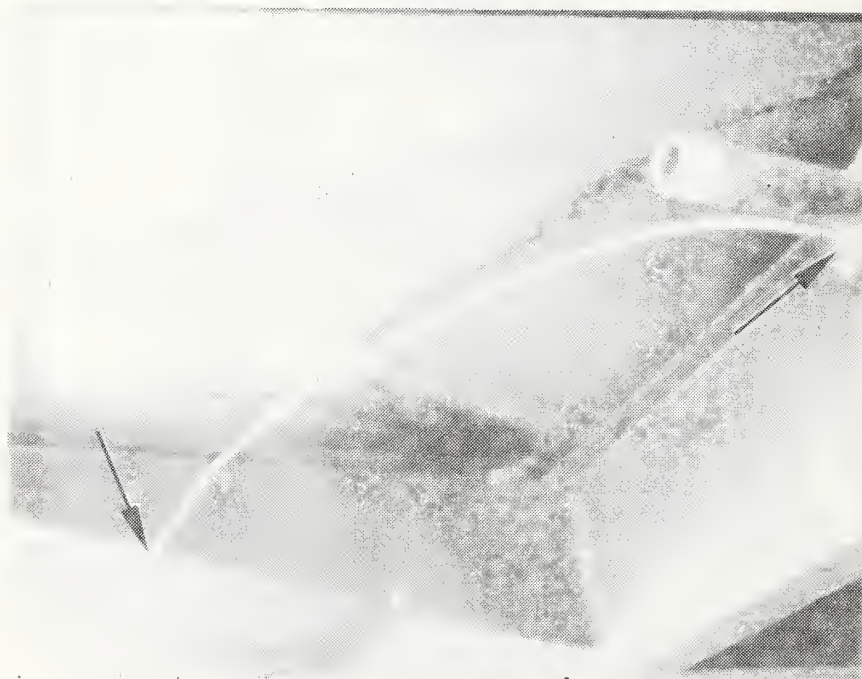
Figure C-85 Improper Grounding of Gas Supply Pipe to Mobile Home Frame

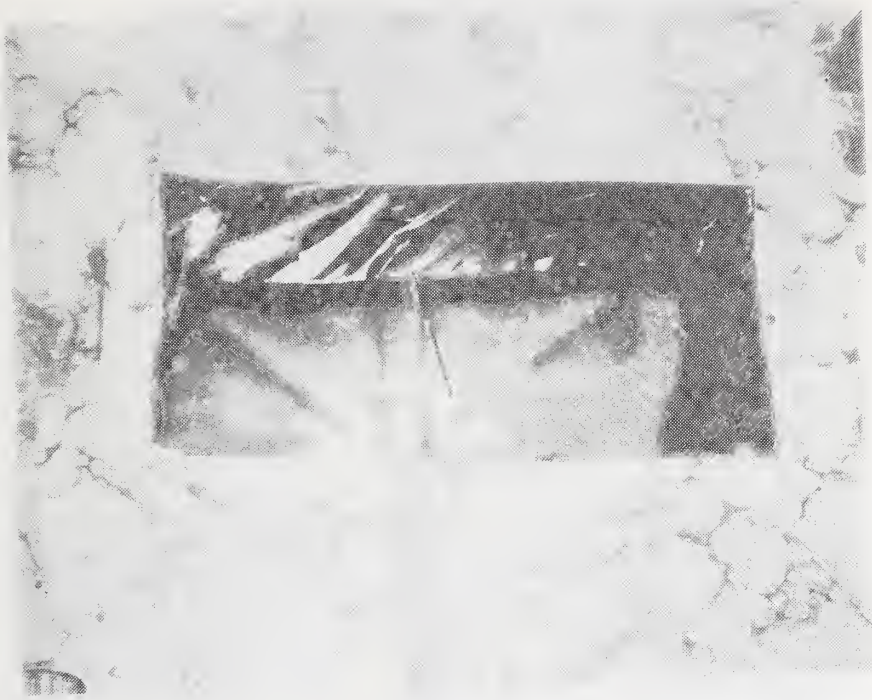
Figure C-86 Riser From Heat Duct in Floor to Register
Constructed of Fabric Material.

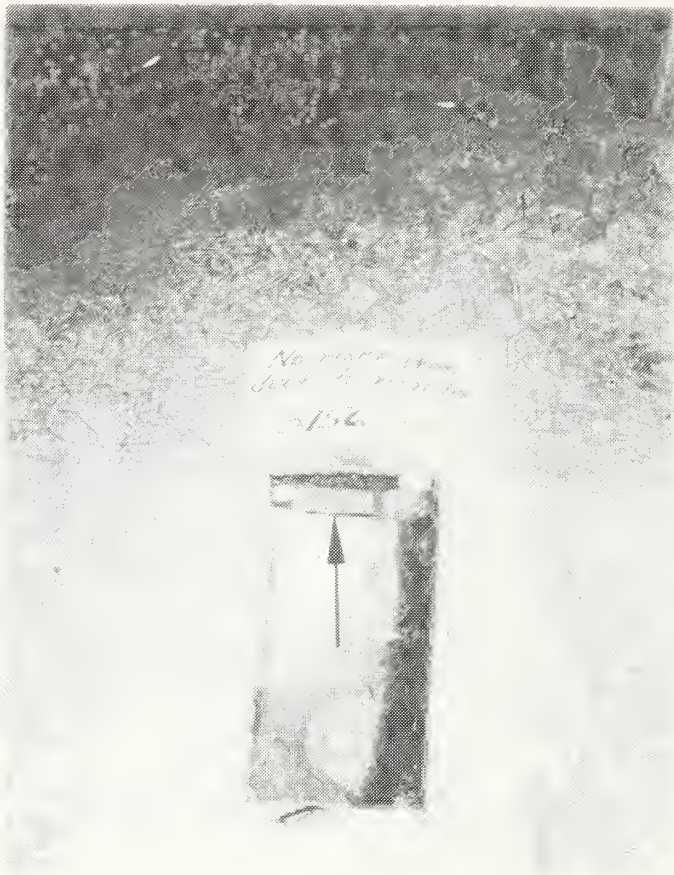
Figure C-88 Riser from Heat Duct to Floor Register Missing. Air Supply System Not Tight.
