NBSIR 75-688

Performance of Mobile Homes - A Field Inspection Study

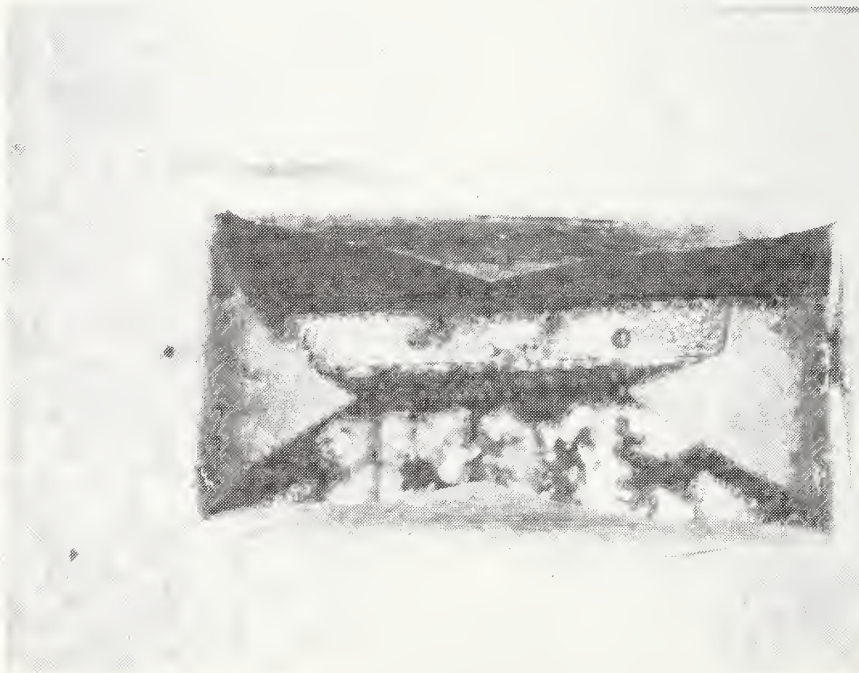
Figure C-89 Dirt and Flooring Material in Heat Duct Blocking Air Flow.

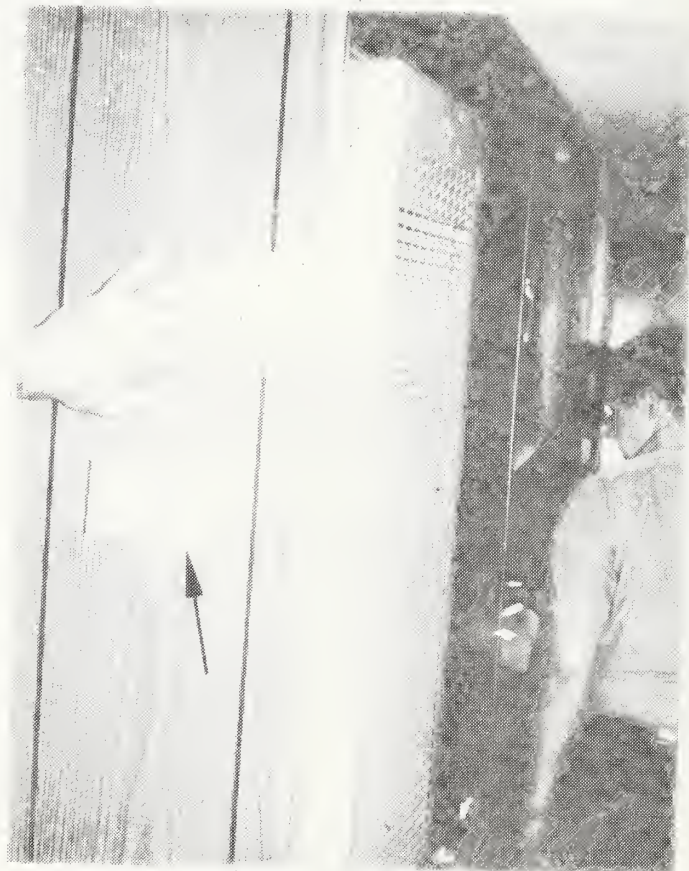
Figure C-92 Furnace Thermostat Located Adjacent to Furnace on Wall Common to Furnace Compartment Causes Problems of Temperature Control.

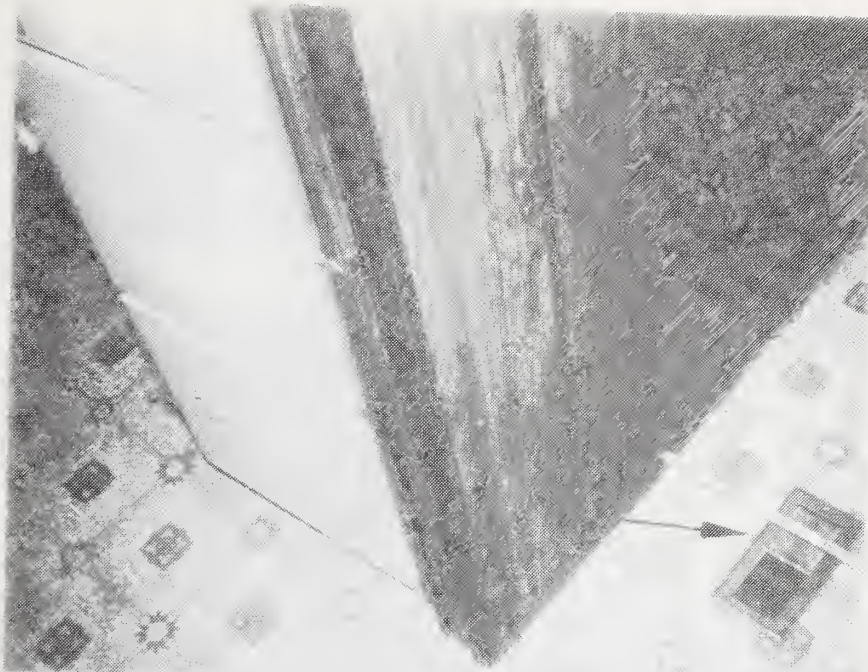
Figure C-93 Floor Register Located Eight Inches From Furnace Compartment Wall in Bedroom Creating Non-Uniform Distribution of Heat.

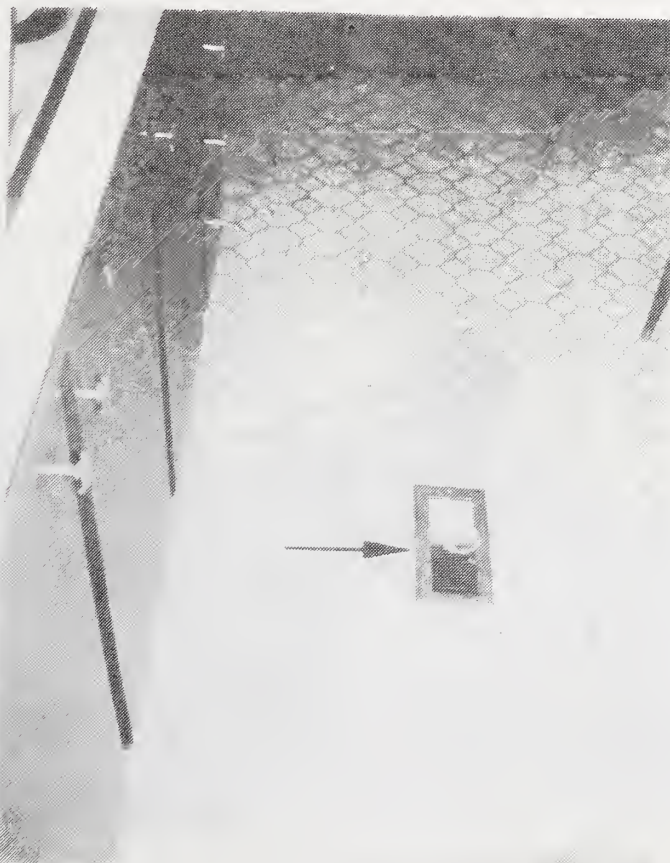
Figure C-94 Floor Register Location Adjacent to Kitchen Cabinets (high traffic area) constituting a Safety Hazard

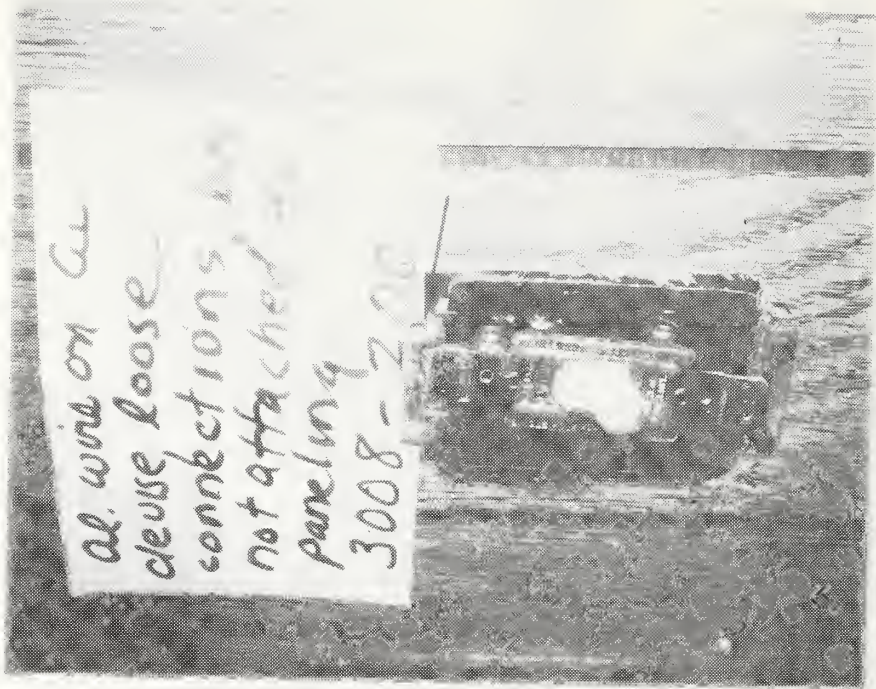
Figure C-95 Aluminum Wire Used With Copper Device

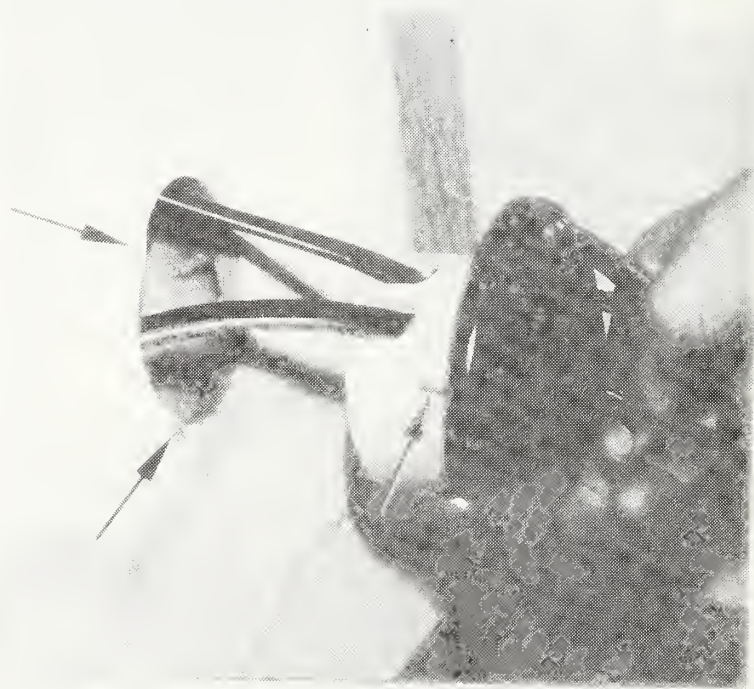
Figure C-96 Ceiling Fixture Inadequately Attached to Vegetable Fiberboard Ceiling Material.

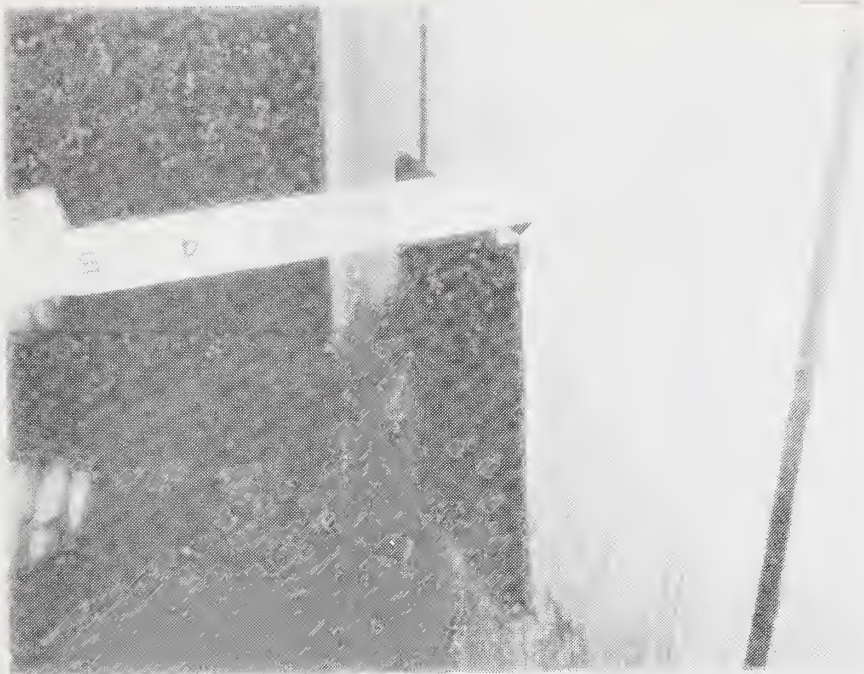
Figure C-97 Loose Receptacle Box Attached
Only to Wood Paneling

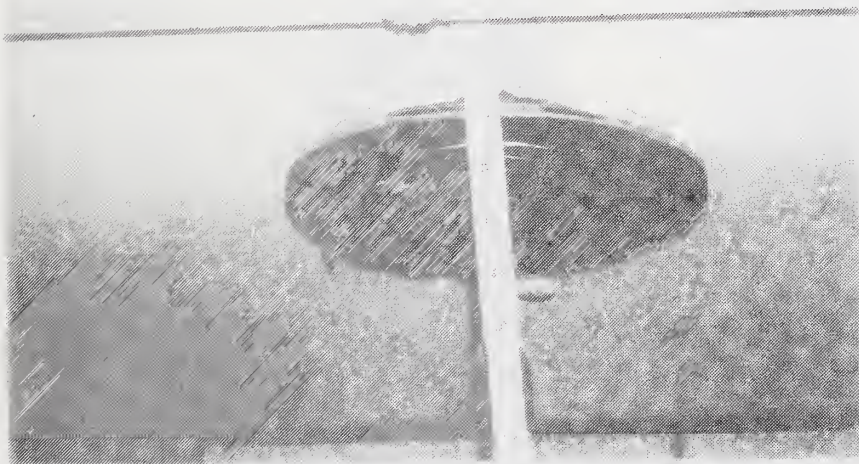
Figure C-98 - Loose Exhaust Fan In
Ceiling

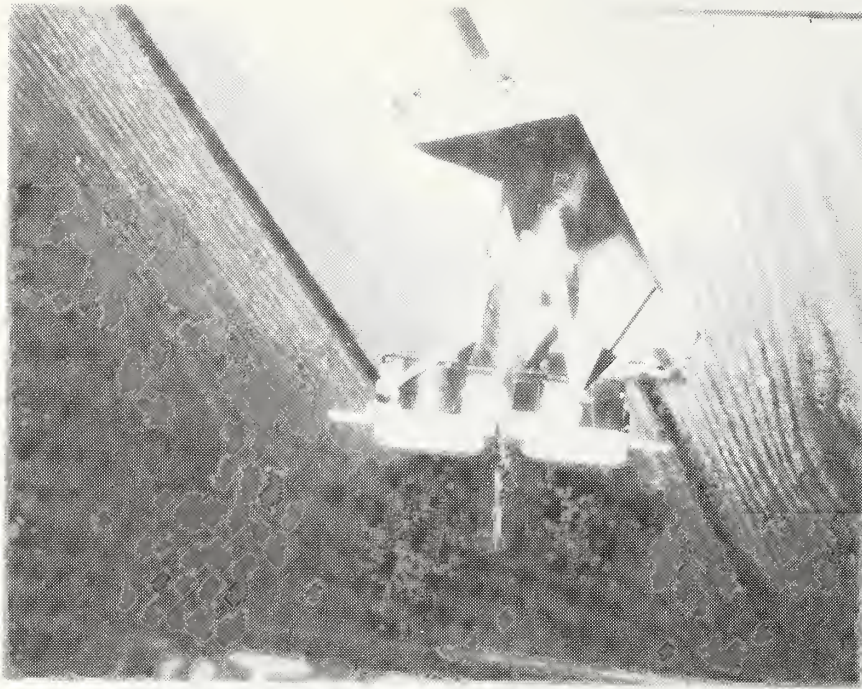
Figure C-99 - Overwrapped Aluminum
Wire in Wall Receptacle

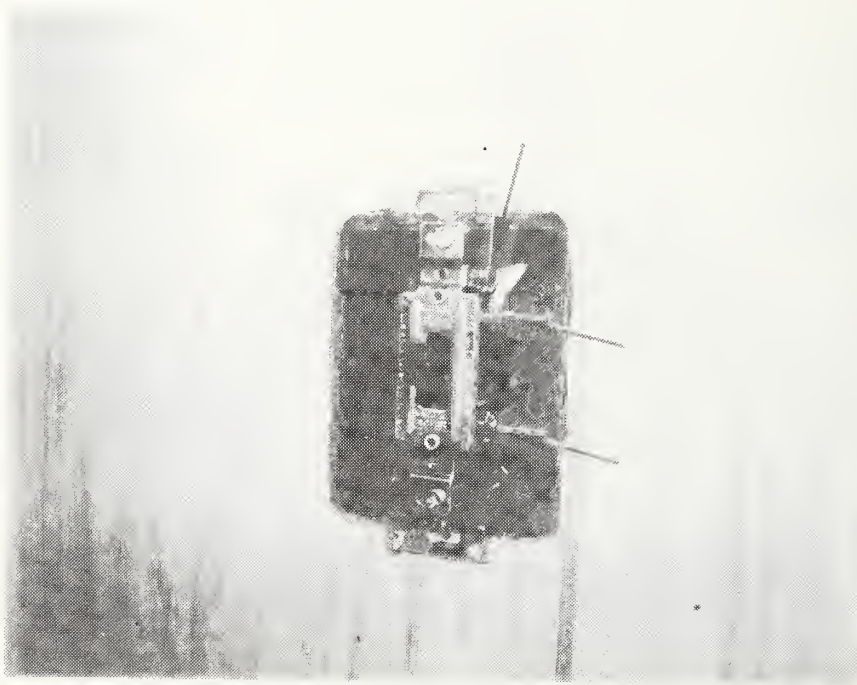
Figure C-100 - Loose Connections
(Copper Wire) in Wall
Switch

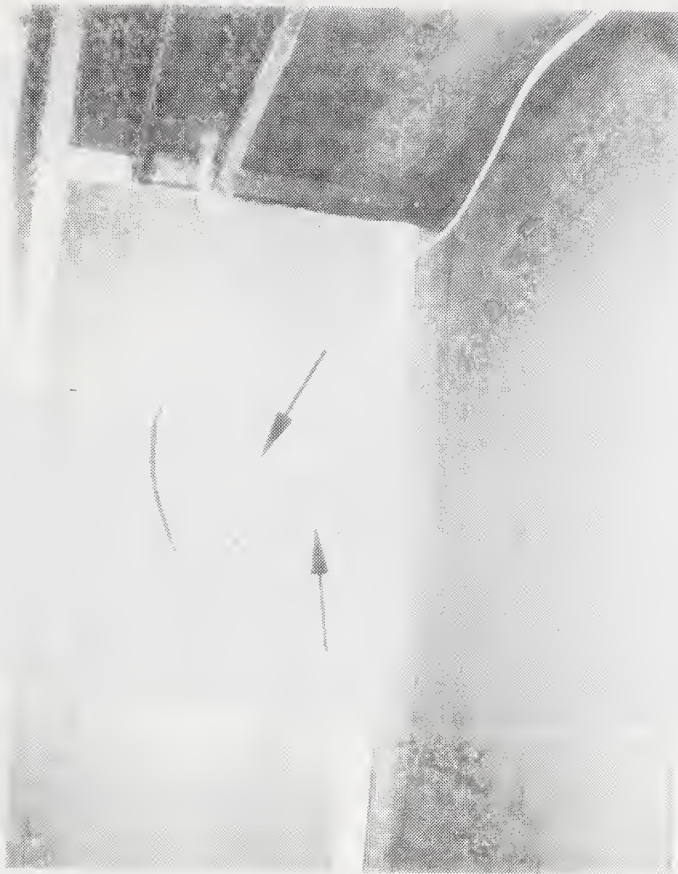
Figure C-101 Cable Inadequately Supported and Exposed in Bedroom Closet.

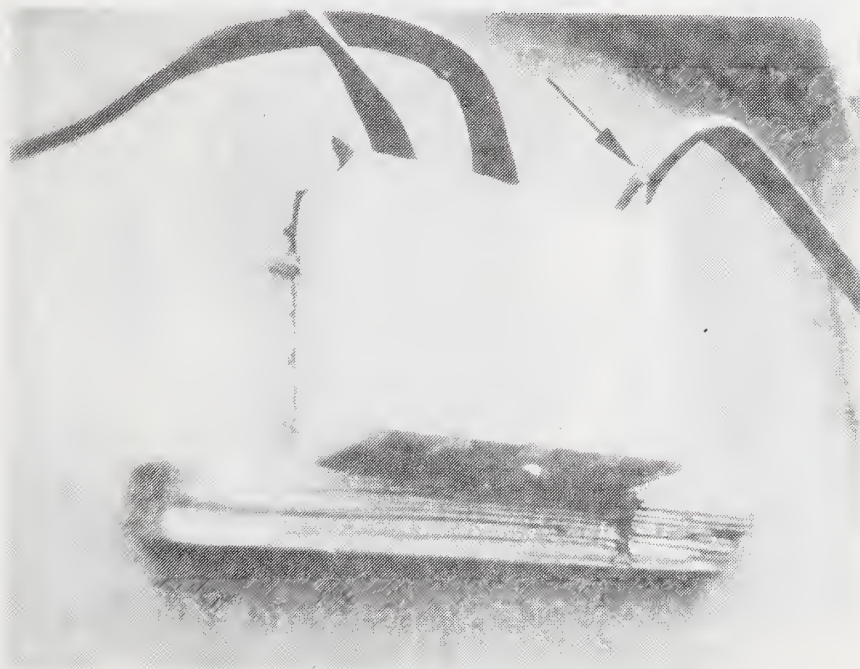
Figure C-102 - Cable Sheath Cut Short of Box 111

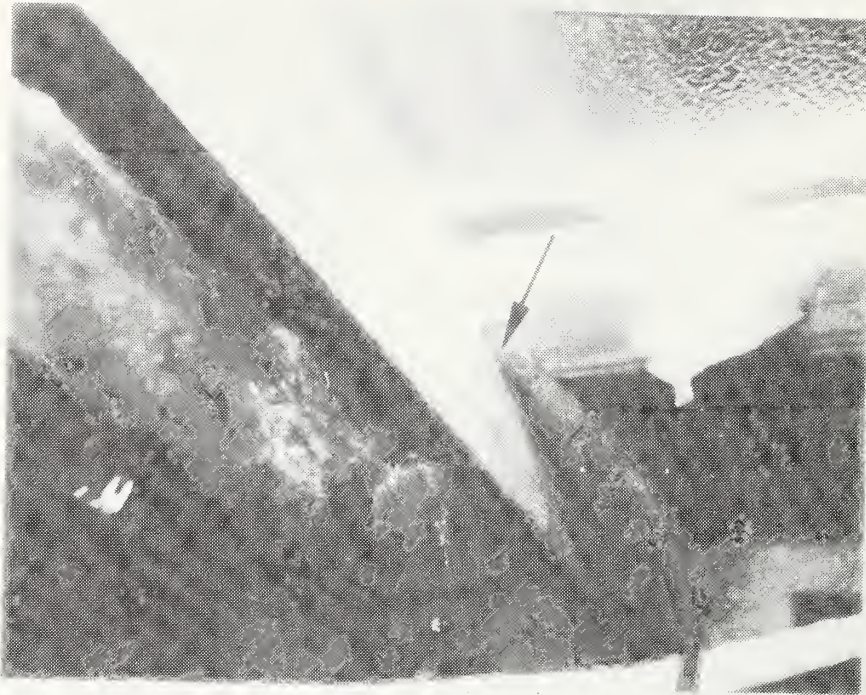
Figure C-103 Inadequate Electrical Cable Protection -
Cable Wedged Between Wall Stud and Belt Rail

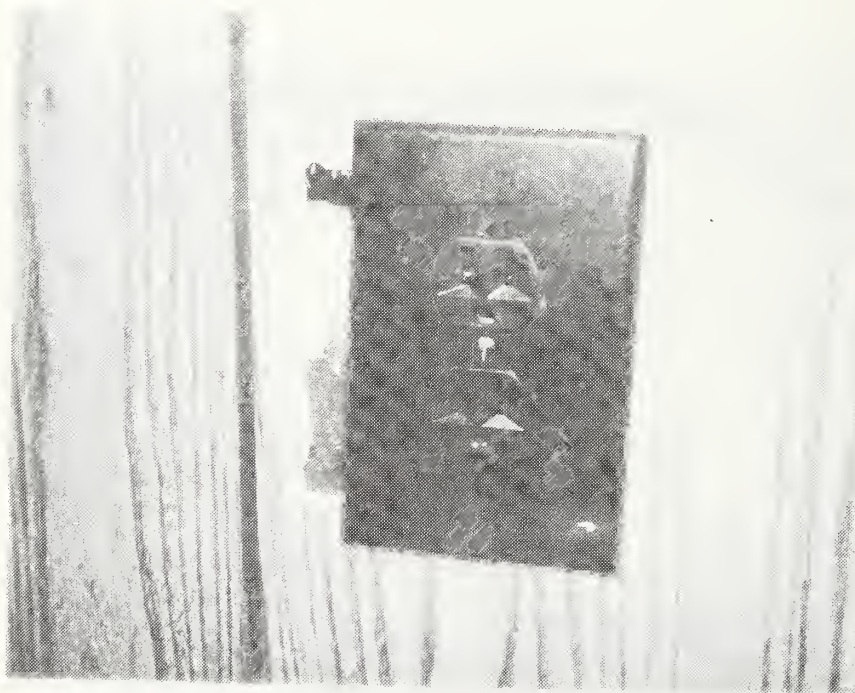
Figure C-104 Oversize Hole Cut for
Outlet Box Installation
