NBSIR 85-3158

Fire Performance of Interstitial Space Construction System

J. Randall Lawson

May 1985

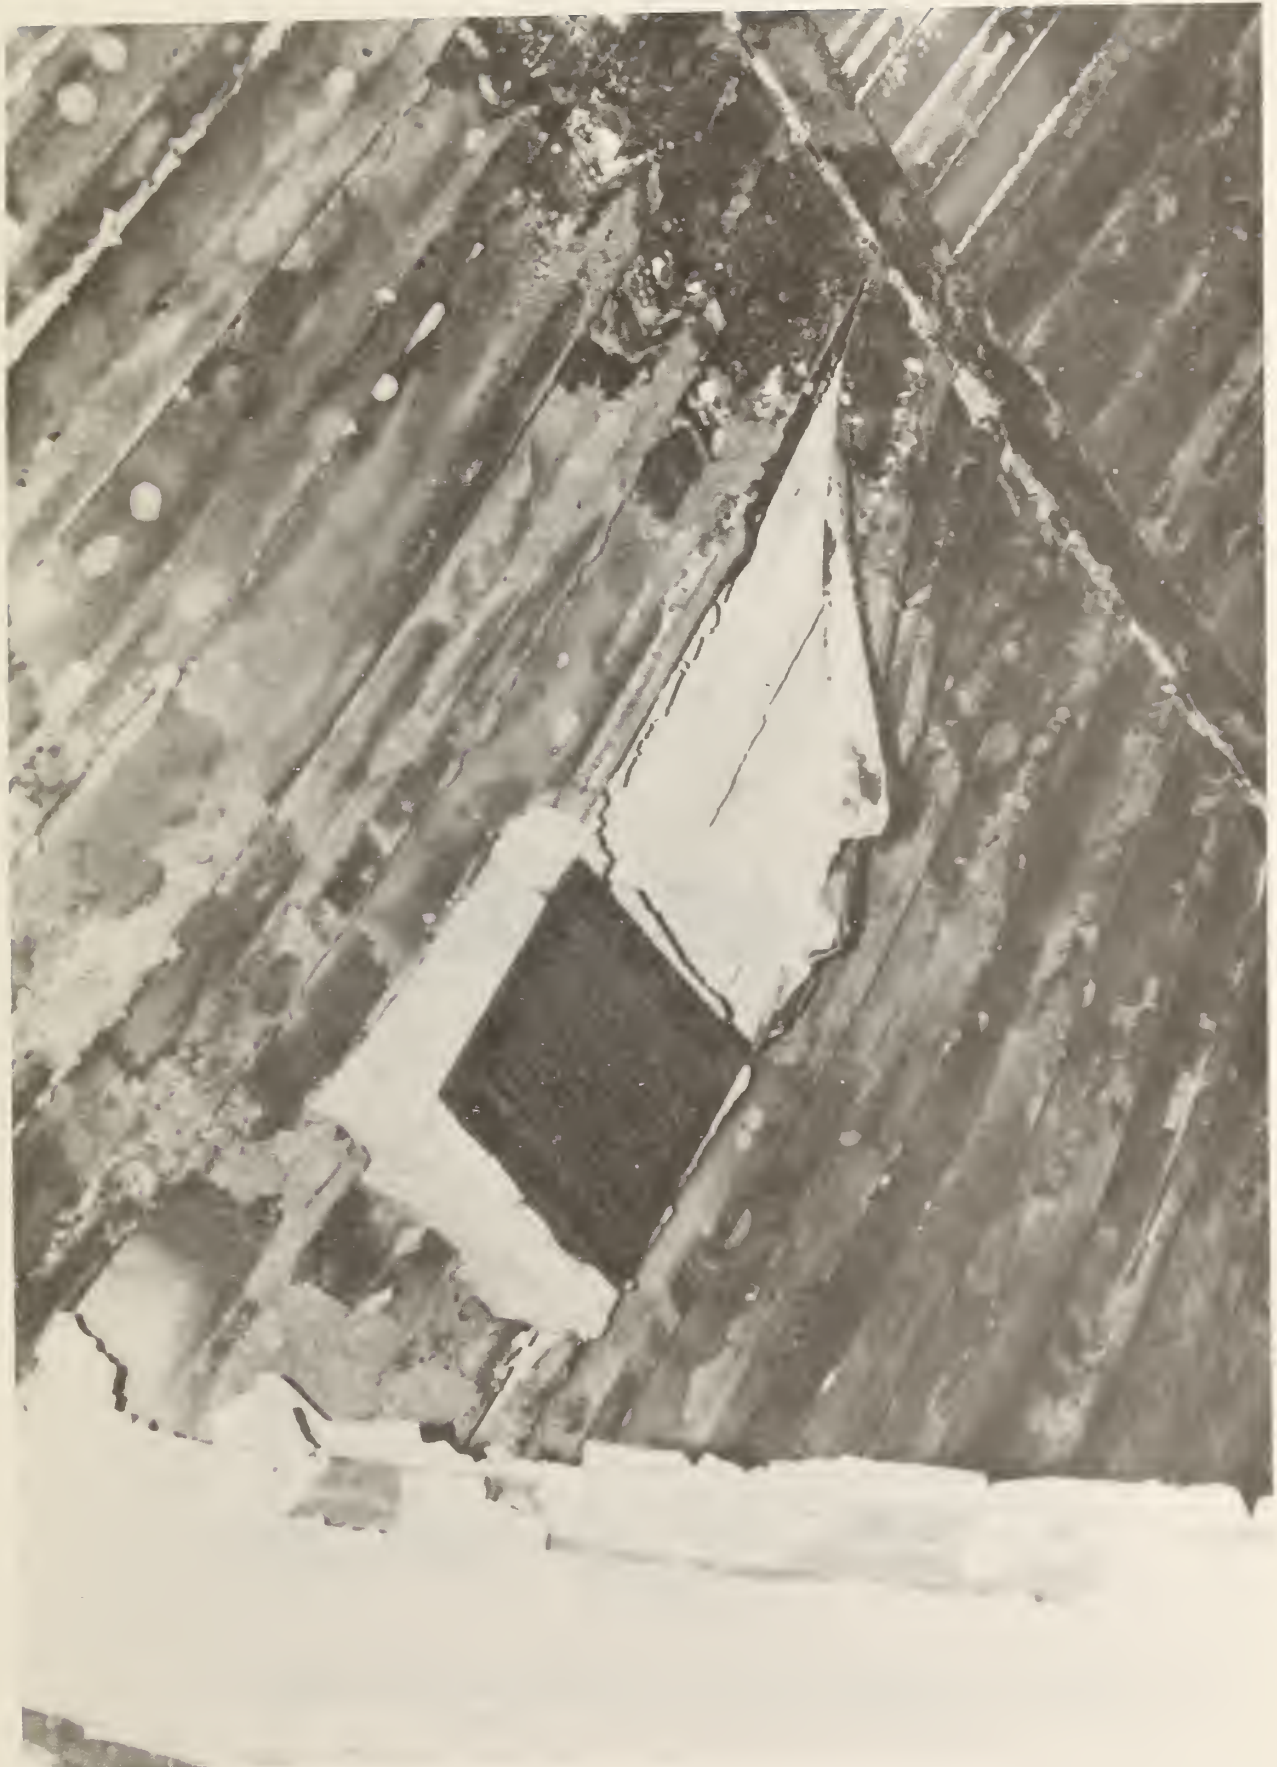
1. Most of the inside layer of gypsum board is still in place around the center column. The metal studs supporting the gypsum board on the column are still in place, figure 24.
2. The pier has spalled on the side exposed to the furnace burner. One piece of concrete approximately 2 inches deep and 6 to 8 inches in diameter has broken away from the pier.
3. The walk-on deck between the purlins has sagged. The metal flooring has dropped away from the concrete floor at one place near the return duct and is sagging approximately one foot below the bottom of the current floor level, figure 24.
4. About 75 to 85 percent of the fireproofing on all of the purlins has dropped off. Only three spots are left where fireproofing remains.
5. All of the firestop material is still in place at the duct penetrations.
6. No signs of burning were noted in the interstitial space.

Figure 24. Photograph showing bottom of walk-on deck after test 1

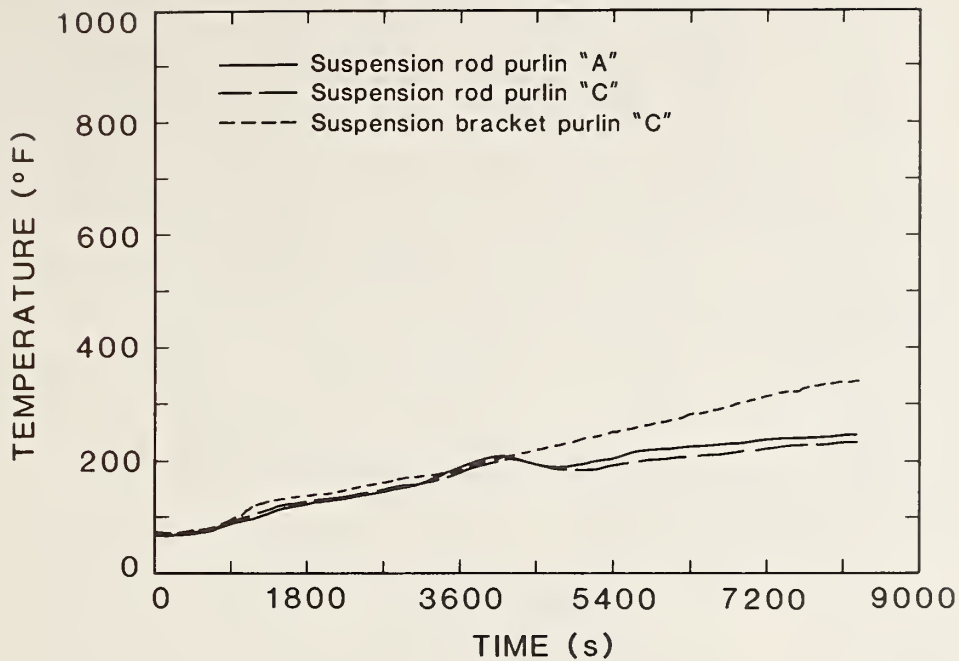
As stated earlier, temperature measurements were also made on two suspension rods and a steel tube bracket. Temperature plots for these construction elements are shown in figure 47. Each of these components performed well with temperatures remaining below 400°F. Figure 48 shows representative temperature data for the dummy air conditioning ducts. The large difference in surface temperatures between the supply and return ducts is attributed to the fact that the supply duct was wrapped with insulation, and the return duct was not. Figure 49 shows selected air temperature data in the interstitial space. Data obtained on deflections of the walk-on deck purlins are presented in figure 50. These deflection plots show that the purlins moved in various directions throughout the test. These data do not appear to accurately reflect the observed permanent upward bend experienced with each of the totally suspended purlins. Figure 51 illustrates an example of the 3 inch upward permanent set of purlin "C". The picture shows the suspension bracket. This unusual movement of the purlins has been studied, but no firm conclusions have been drawn. The behavior of these purlins resulted in

Figure 47. Temperatures for suspension rods and steel tube bracket, test 1

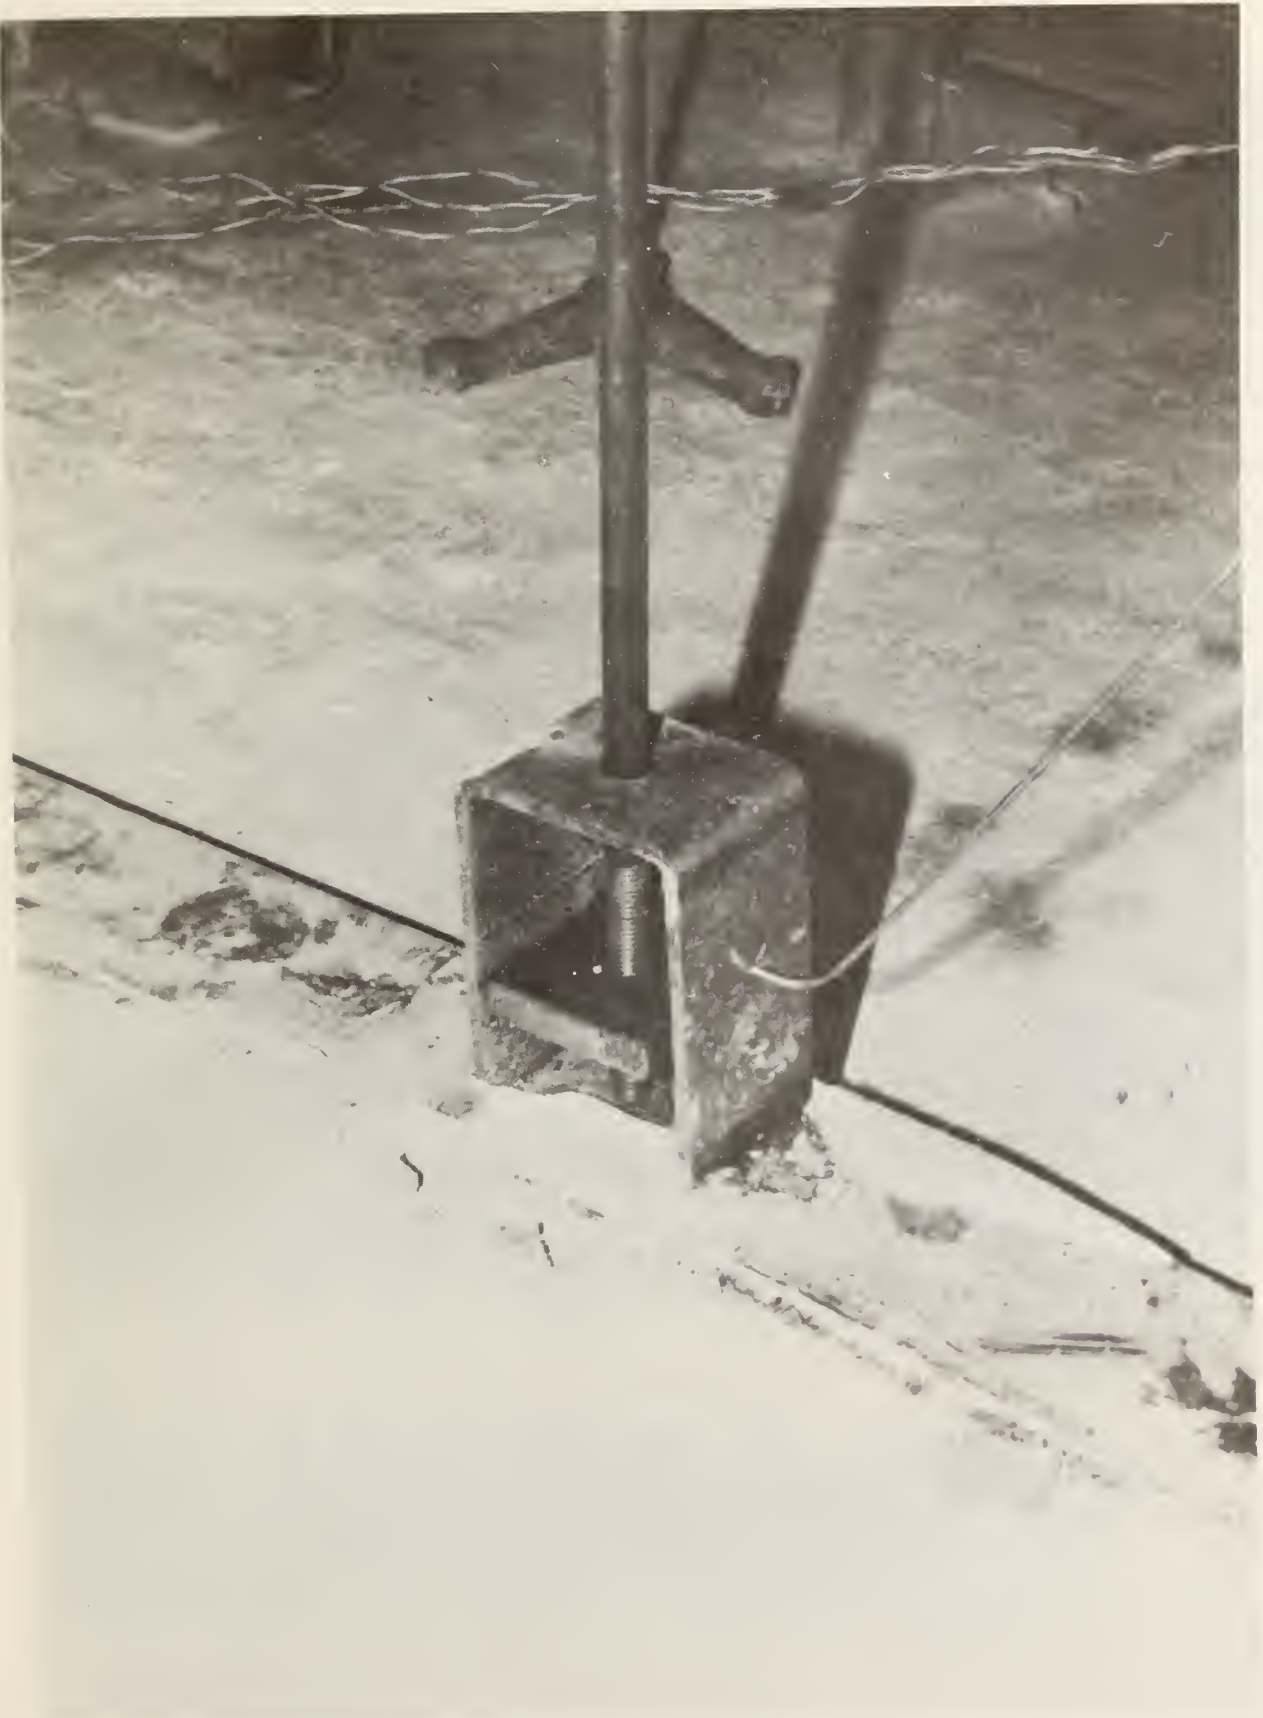
Figure 51. Photograph showing permanent upward set of suspended purlin, test 1

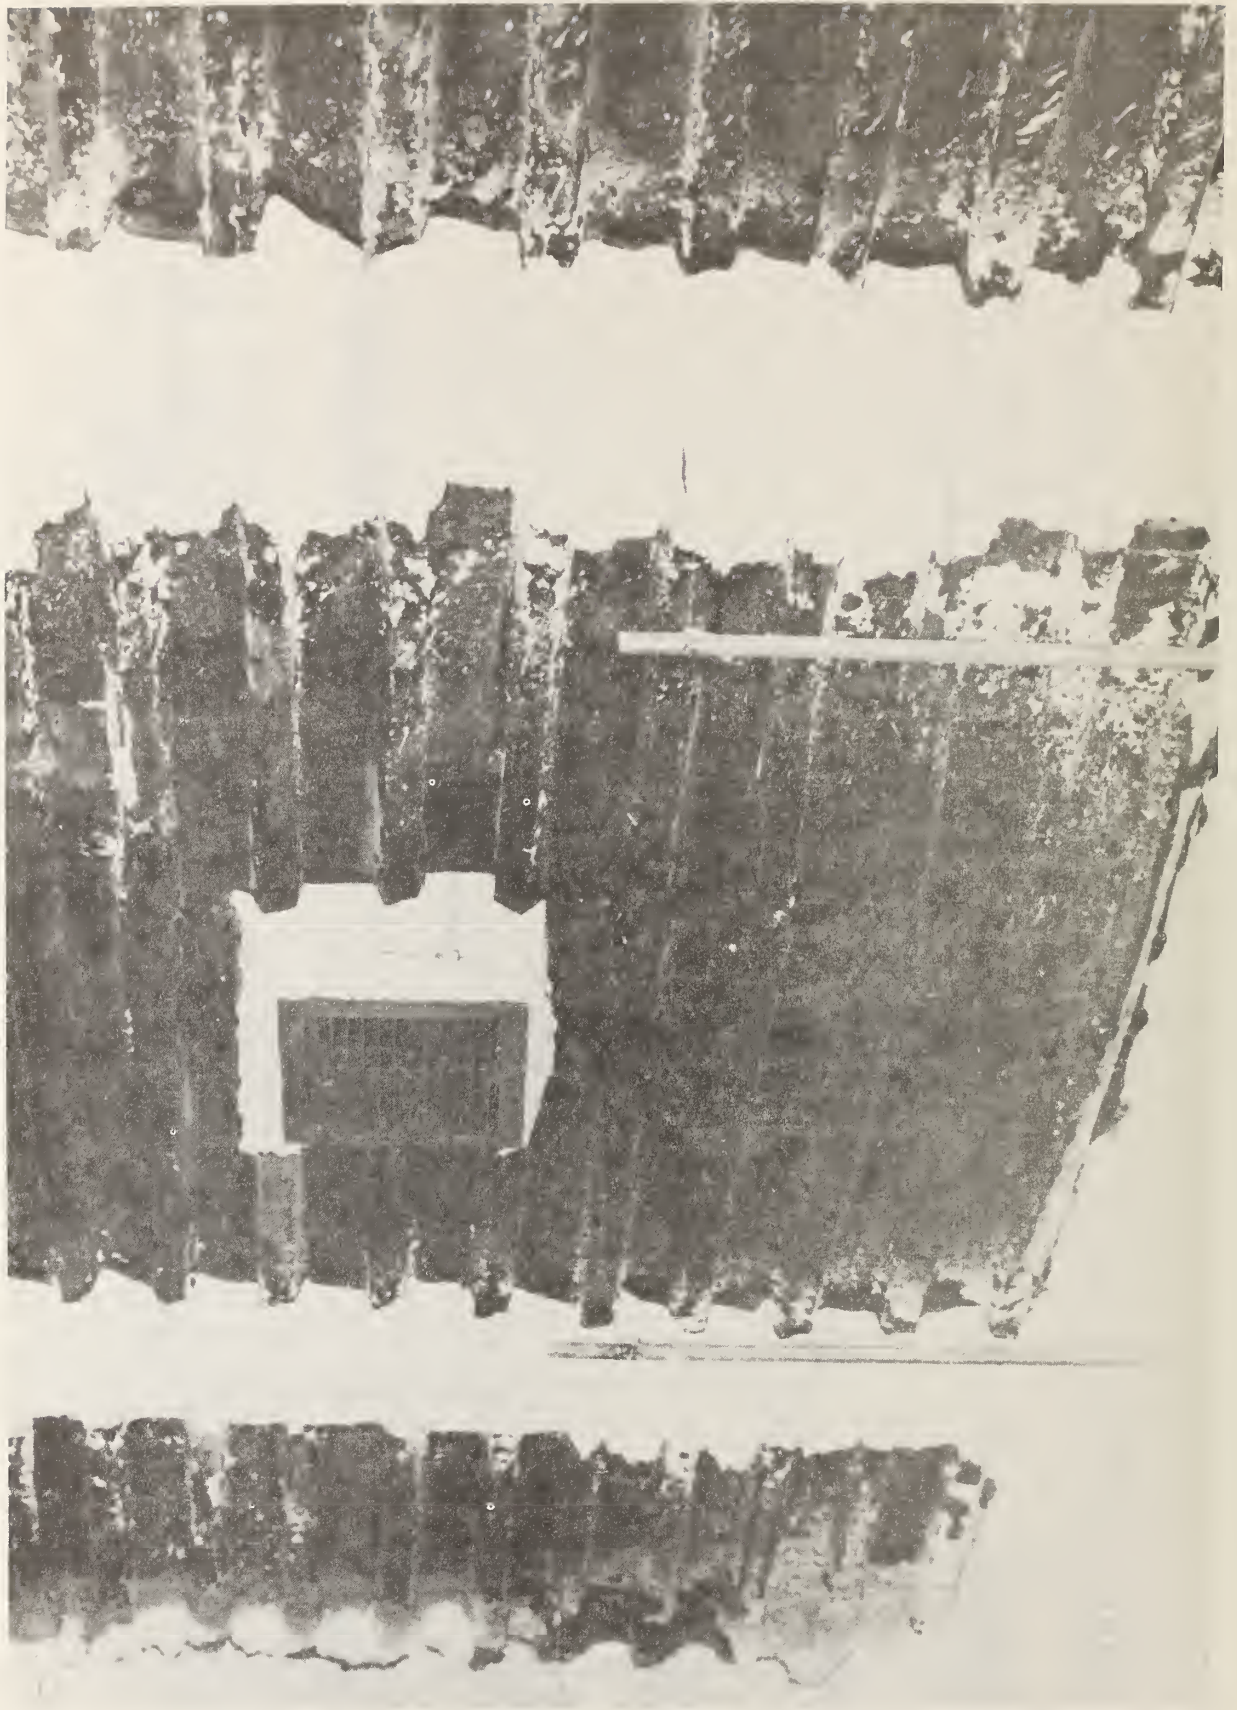
Figure 81. Photograph showing bottom of walk-on deck at end of test 2A

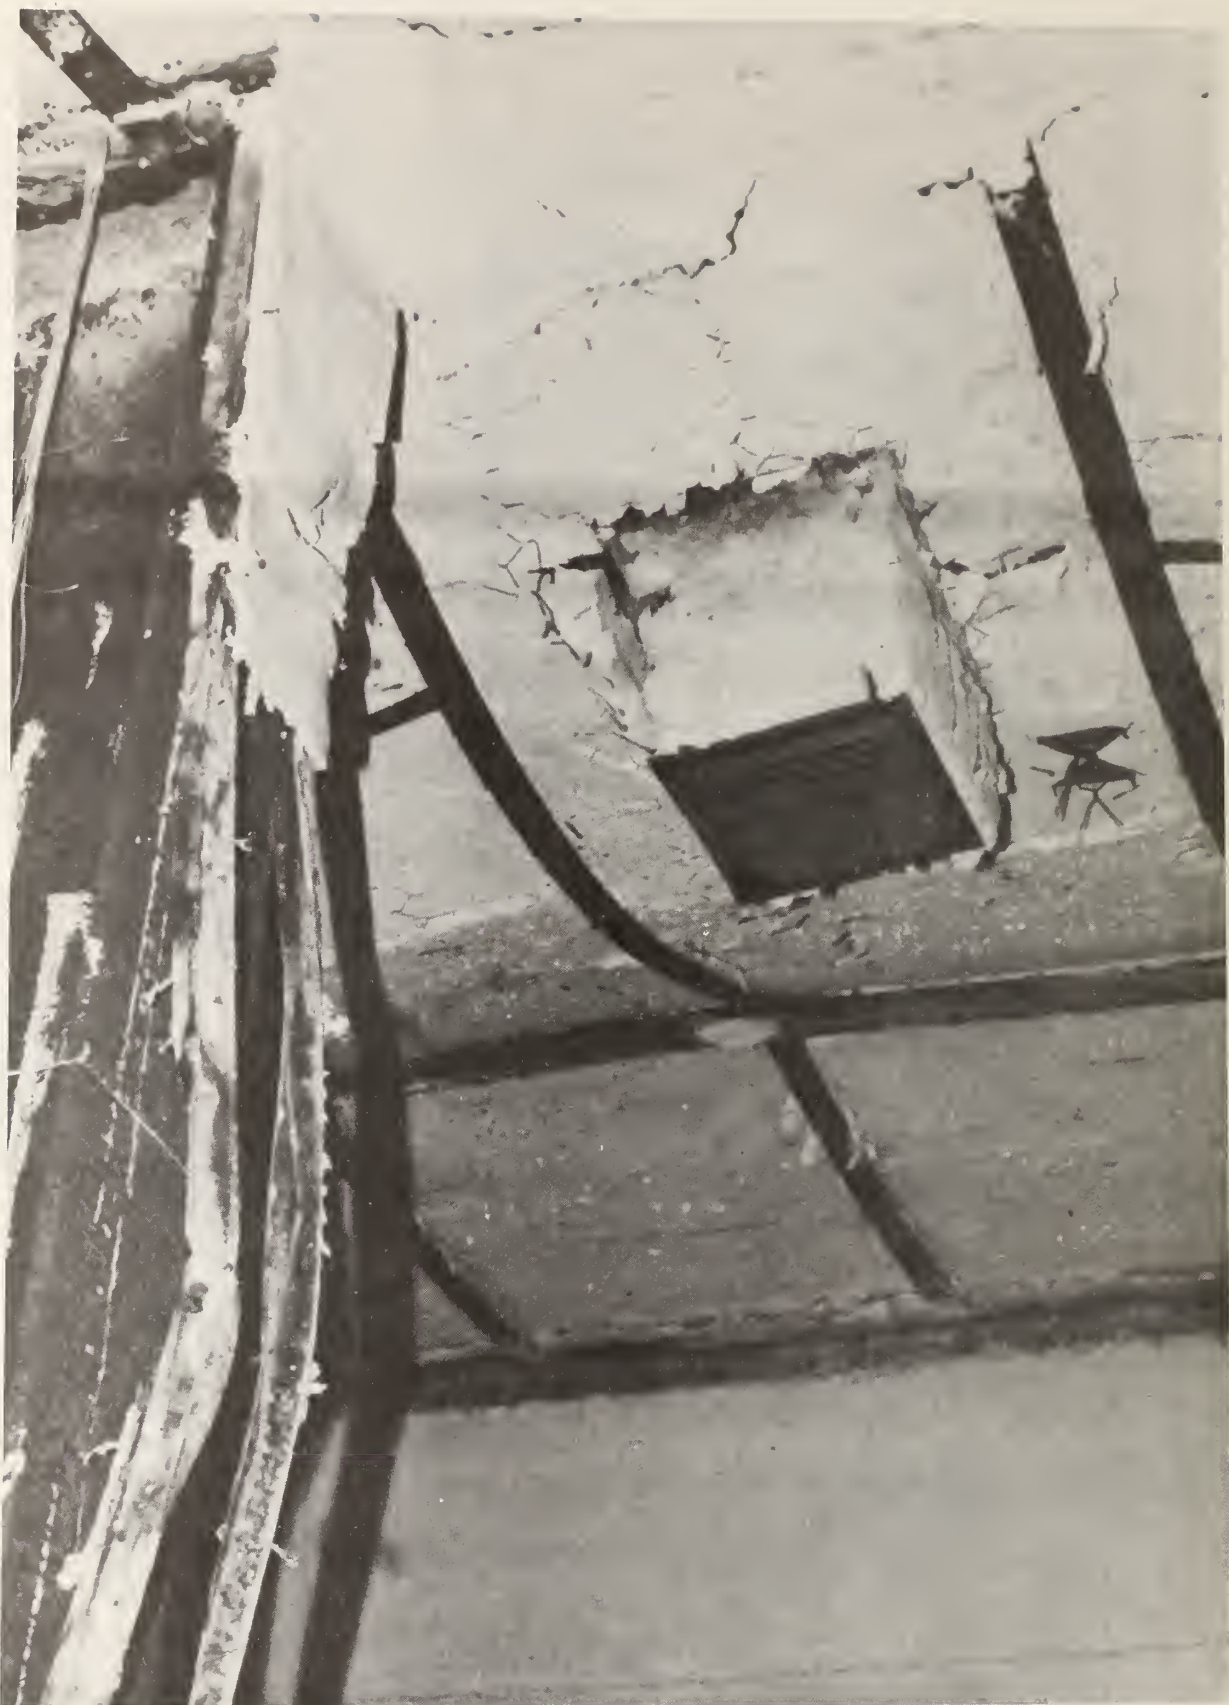
Figure 112. Photograph showing bottom of gypsum walk-on deck after test 3

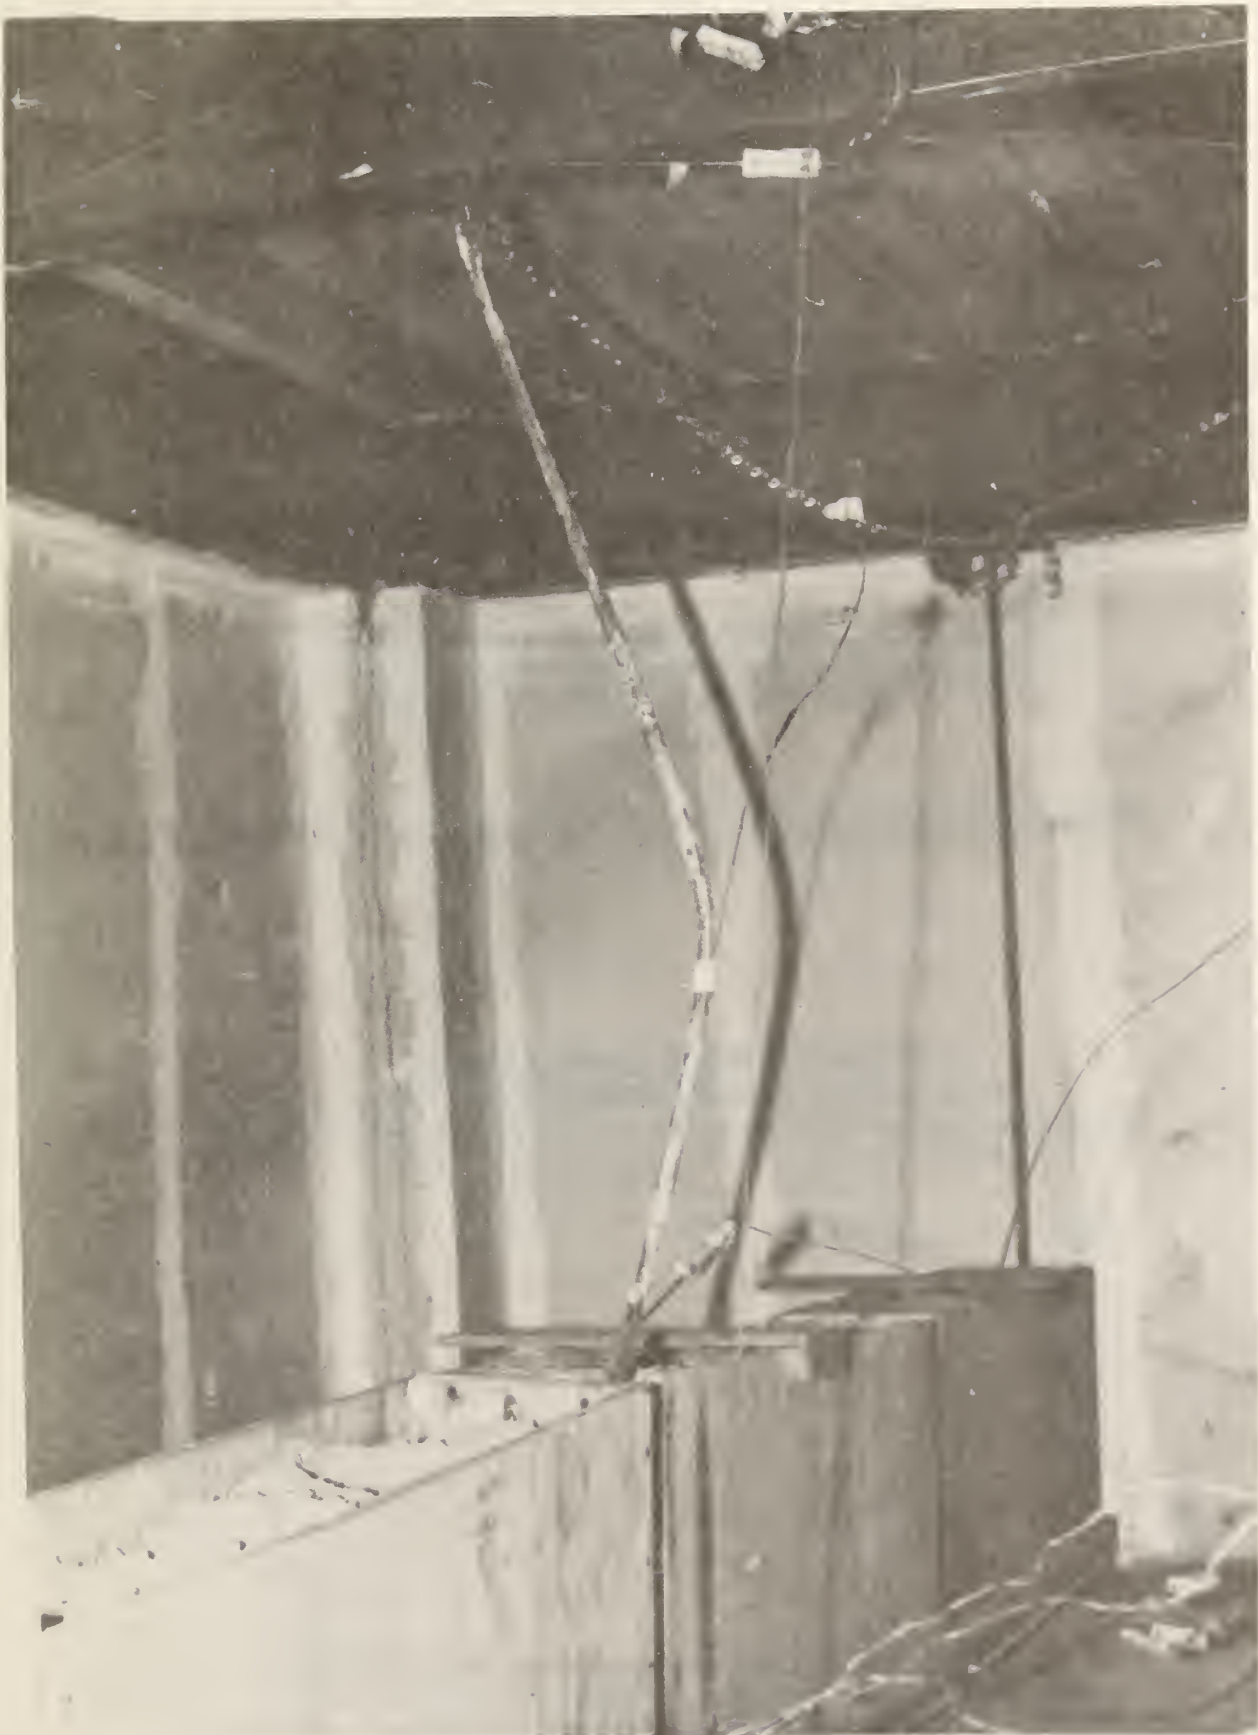
Figure 113. Photograph showing bent suspension rod in interstitial space, test 3
