NBSIR 87-3640

# Investigation of L'Ambiance Plaza Building Collapse in Bridgeport, Connecticut

Occupational Safety and Health Administration U.S. Department of Labor Washington, DC 20001

Issued September 1987

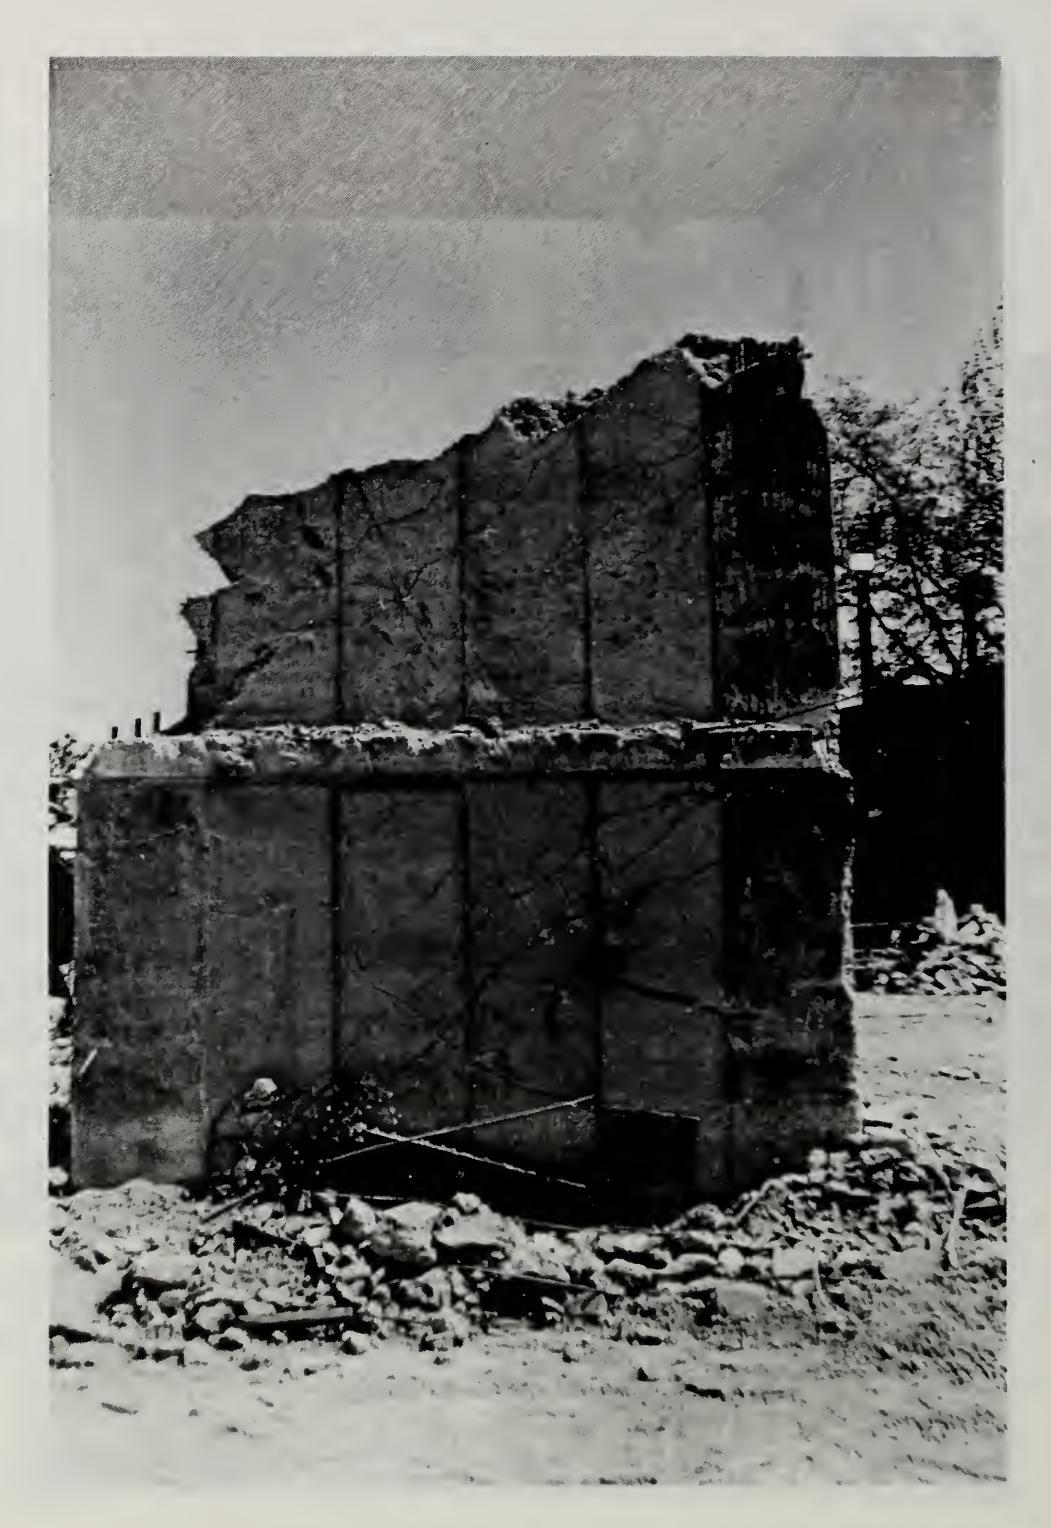
Figure 4.4.5 Diagonal tension crack in East tower shearwall - View to the South

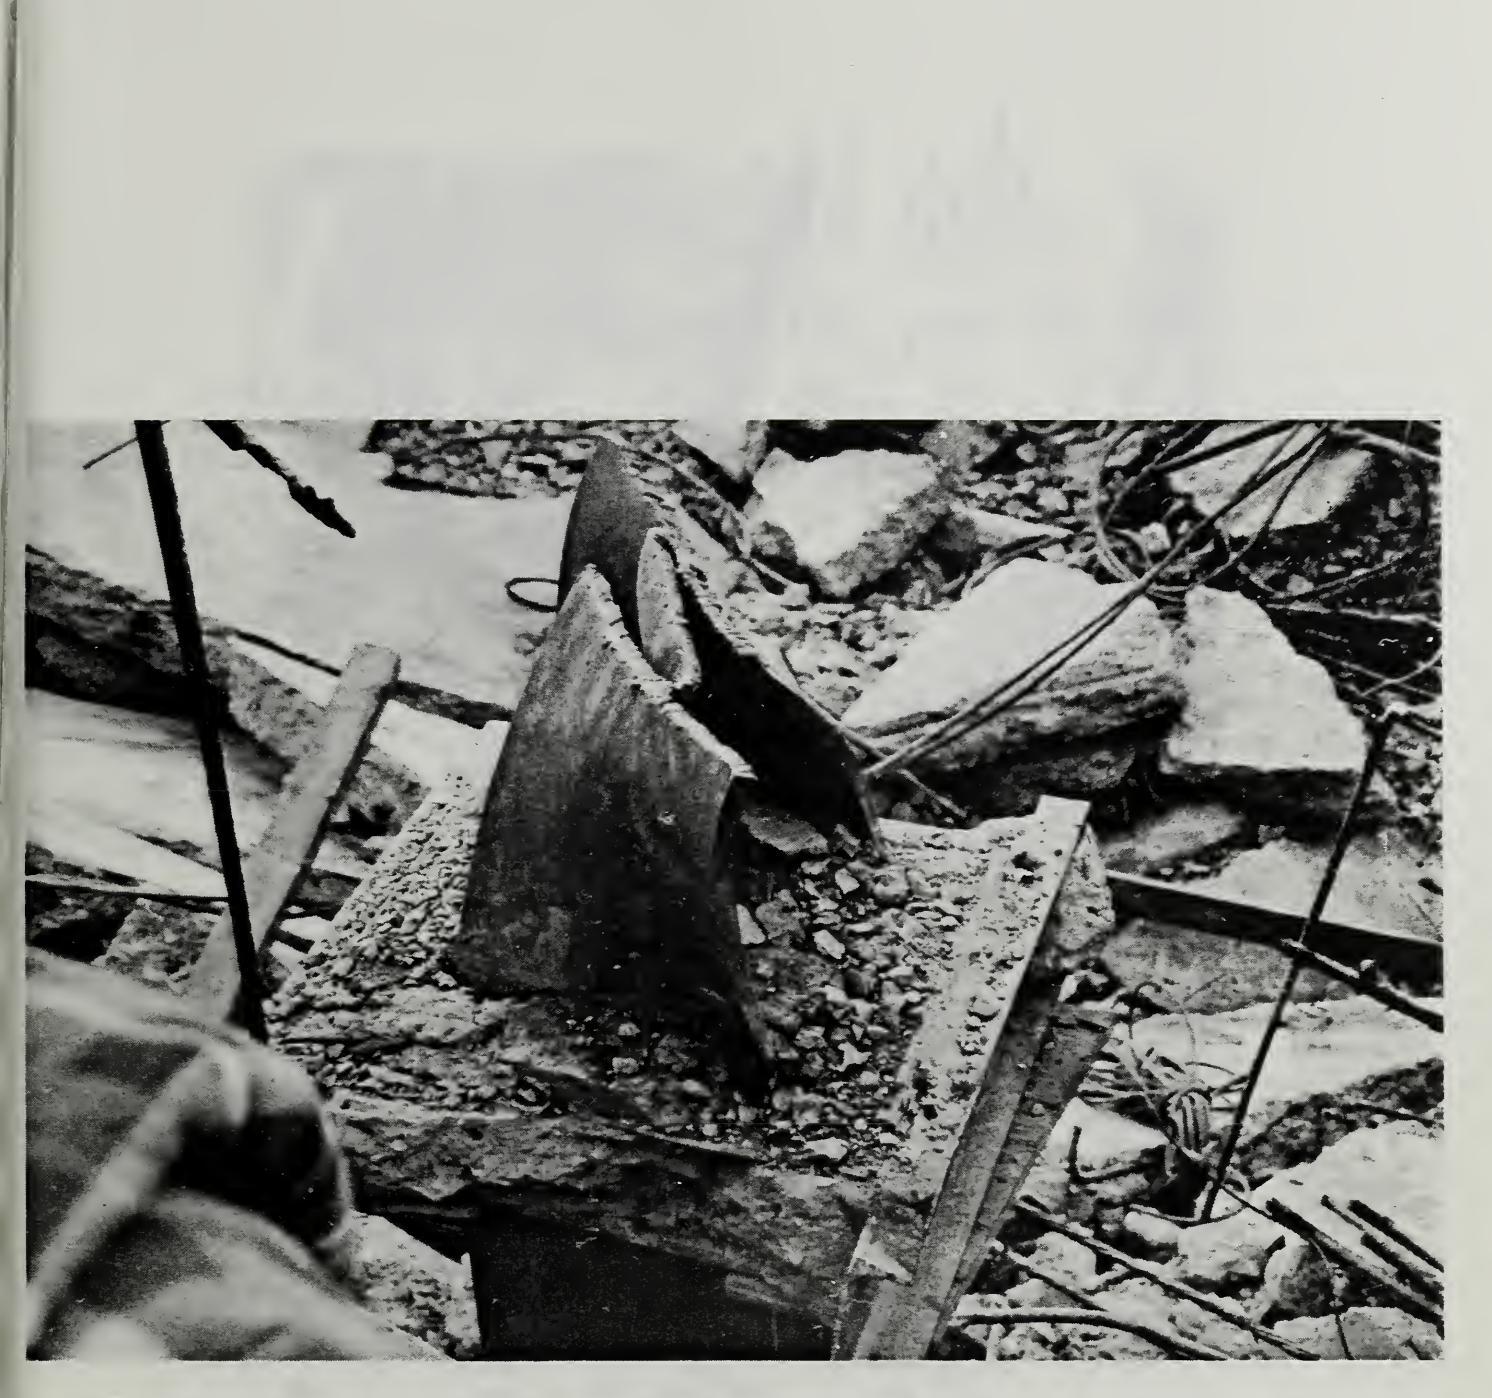
Figure 4.4.6 Twisting deformation of column in West tower

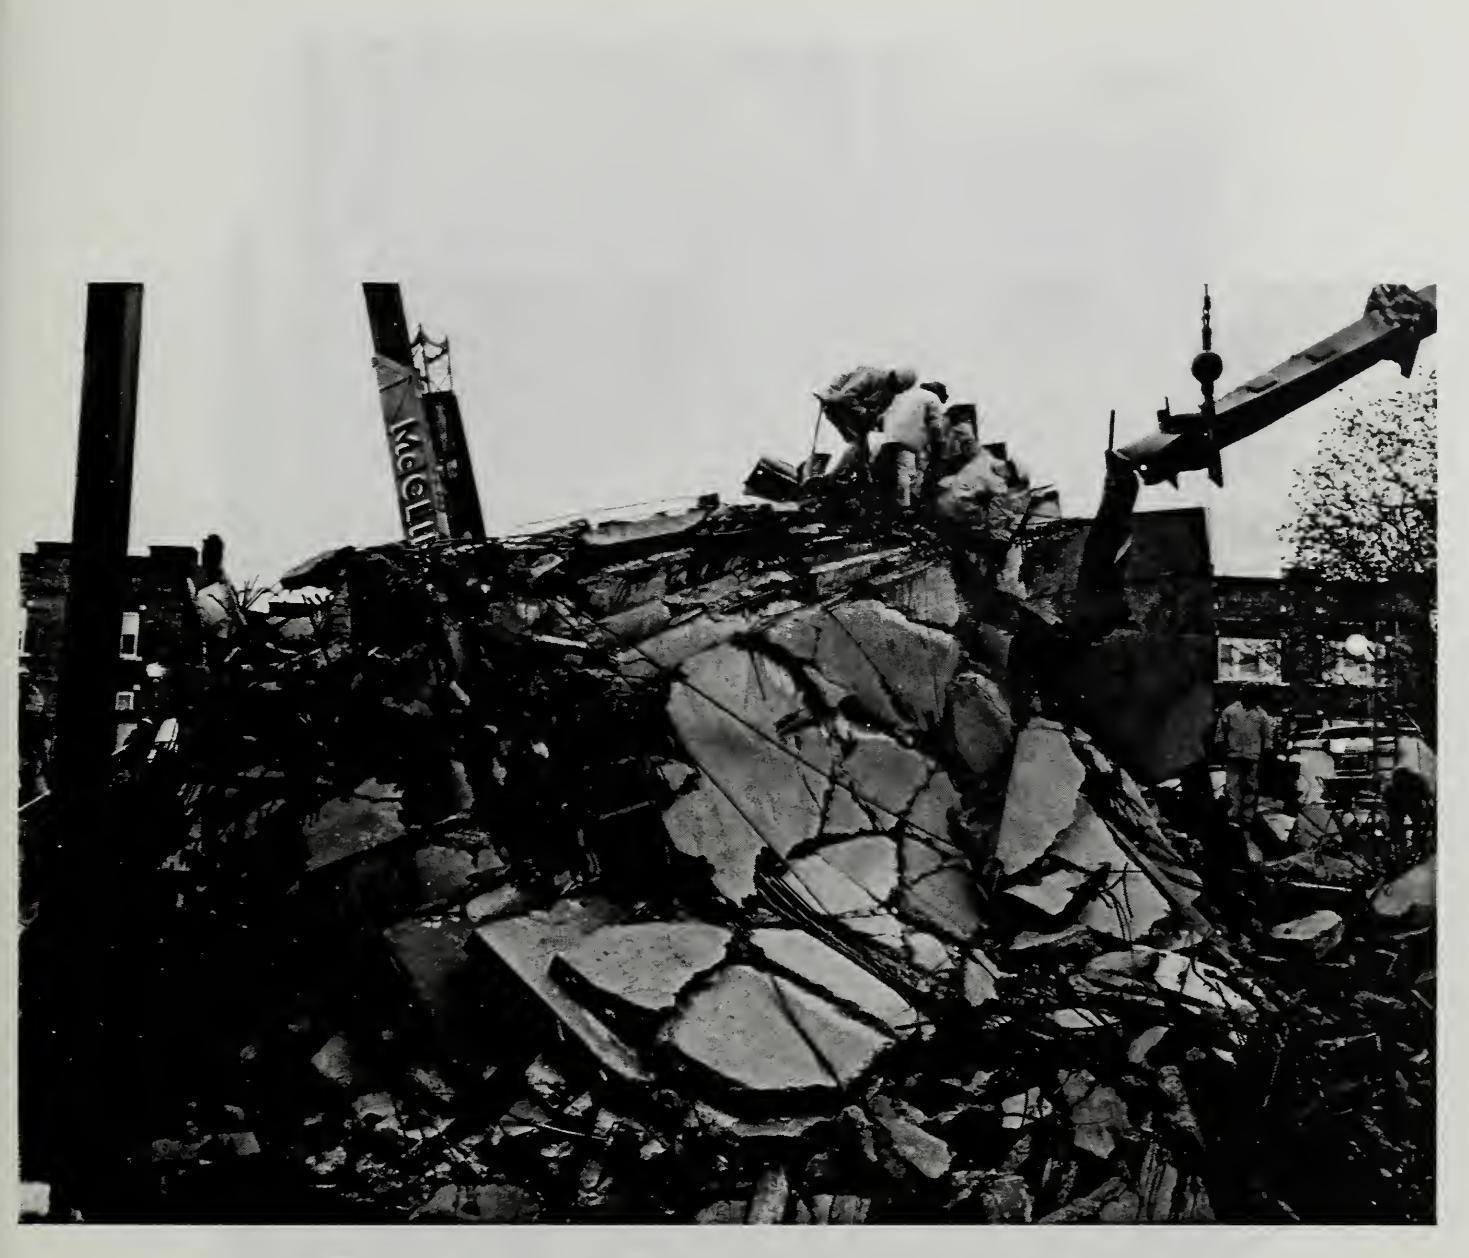
Typical crack patterns and broken floor slabs are shown in figures 4.4.16 and 4.4.17. Note the slabs broke into a number of small pieces. This would be expected once the post-tensioning is lost due to the lack of conventional reinforcing steel except in the vicinity of the columns.

Figure 4.4.16 Floor slab crack pattern

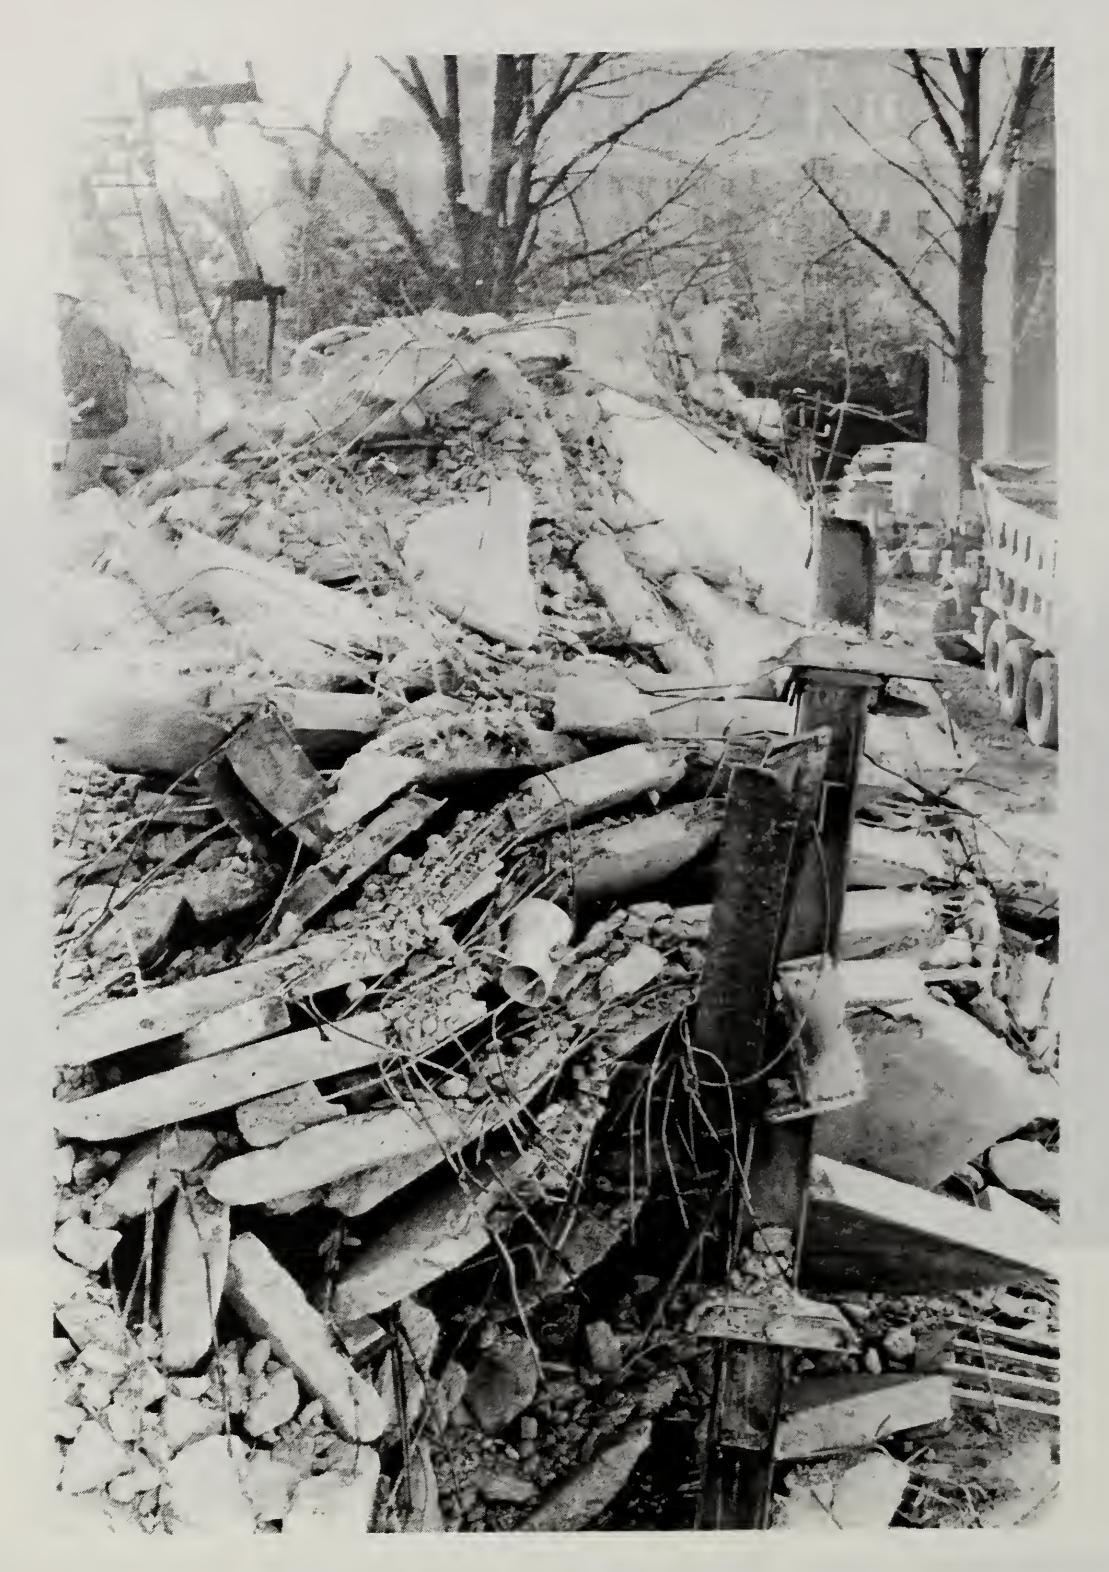
Figure 4.4.17 Broken floor slabs - View to the Southeast; column line H

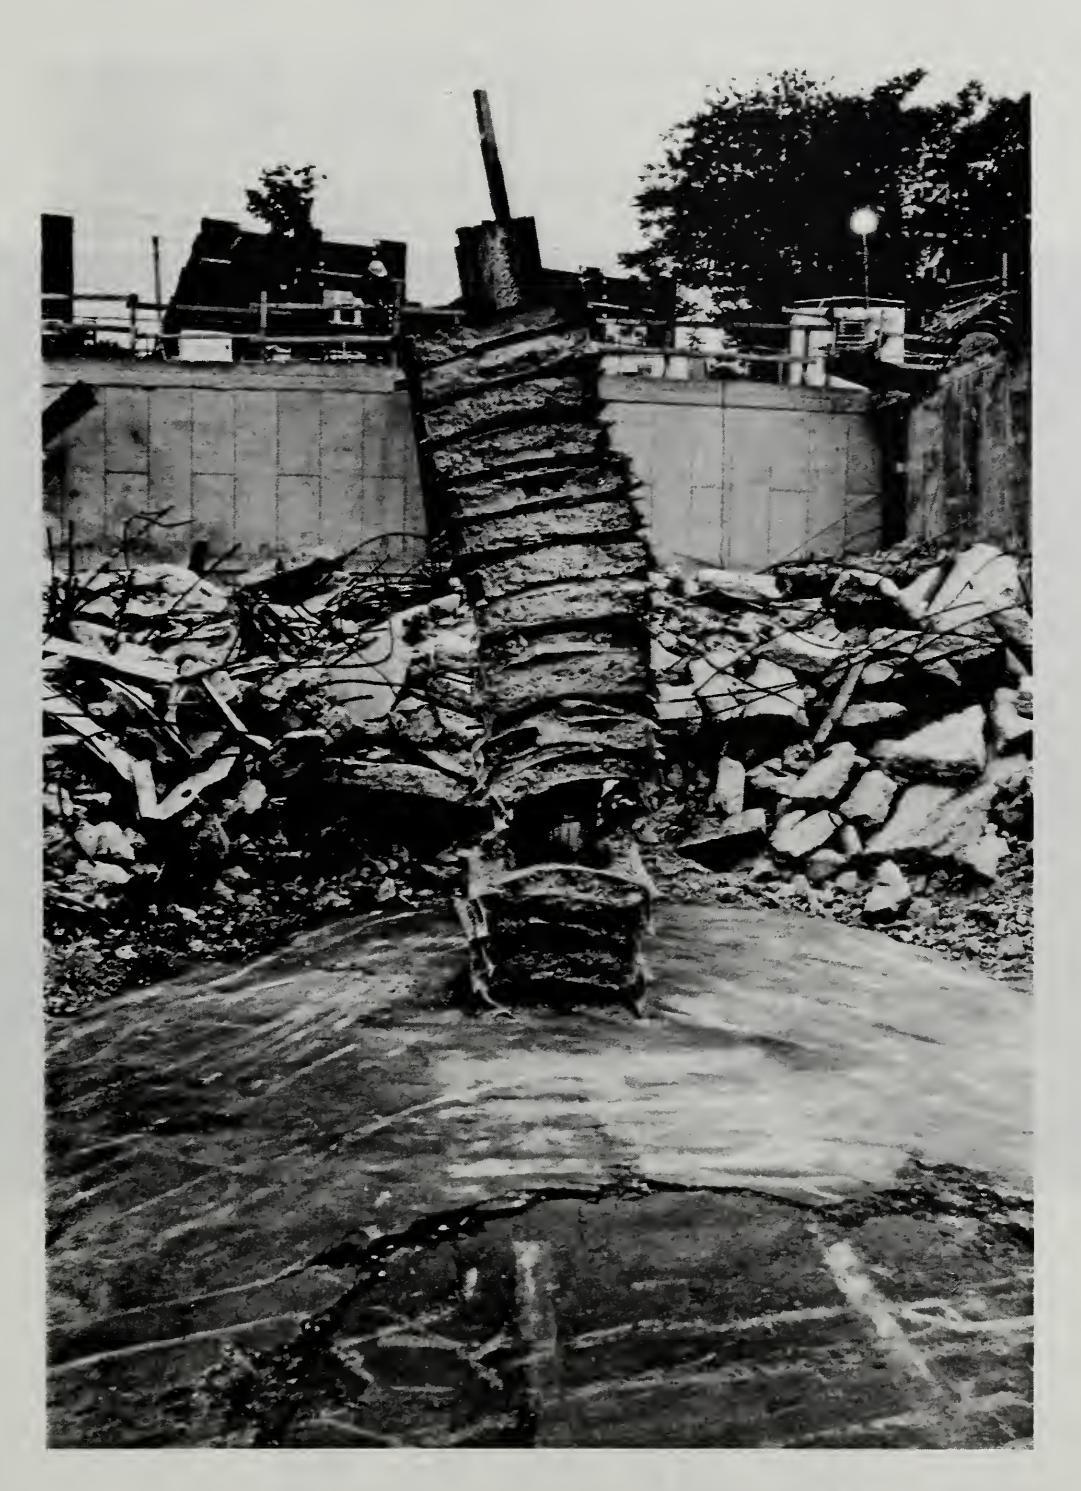
The deformations of the shearheads that occurred at various levels in the structure during the collapse are shown in the stack of shearheads in figure 4.4.18. The position of the shearheads in the photograph was not changed as the debris was removed. Note that sixteen shearheads came to rest at level E. The ten shearheads which had been located in the upper levels of the structure were relatively undamaged. Similar conditions were observed at most locations throughout the structure. This indicates that the shearheads in the upper levels of the building were not subjected to forces large enough to induce substantial inelastic deformations during the collapse. Two possible explanations are: (a) the post-tensioning in the slabs could have been lost early in the collapse and the slabs broke away from the shearheads, and/or (b) the wedges supporting the upper level slabs could have been dislodged or the weld blocks on the columns could have sheared off.

The deformations of the lower six shearheads in figure 4.4.18 indicate they were subjected to considerable force during the collapse. It would appear that the slabs in the lower levels remained whole or portions of the slabs remained attached to the shearheads because of the conventional bonded reinforcing. Enough force was transmitted to the shearheads to cause the shearhead to fail, to cause a punching shear type failure of the slab or to fail the welds between the weld block and the column or the welds between the wedges and the weld blocks. Each of these conditions occurred. Figure 4.4.19 illustrates a situation where the shearhead failed. Although the welds to the wedge and the column held, the shearhead was literally torn apart. Failure of the weld block welds and the welds of the wedges are discussed in Section 4.4.4. The locations of the shearheads along the height of the columns throughout the structure are shown in figure 4.4.20. In general, shearheads on the perimeter columns remained in place at the floor levels as the building collapsed. On the interior columns, however, the shearheads were dislodged and came together as shown in figure 4.4.18. Apparently the concrete slabs broke away from the shearheads around the perimeter leaving the shearheads in place. At the interior columns, the slabs exerted sufficient force to fail the shearhead-column connection. There was more conventional reinforcing in the slab at the interior columns than at the perimeter columns and it was located on all four sides of the column.

Figure 4.4.18 Deformation pattern of shearheads - column D10

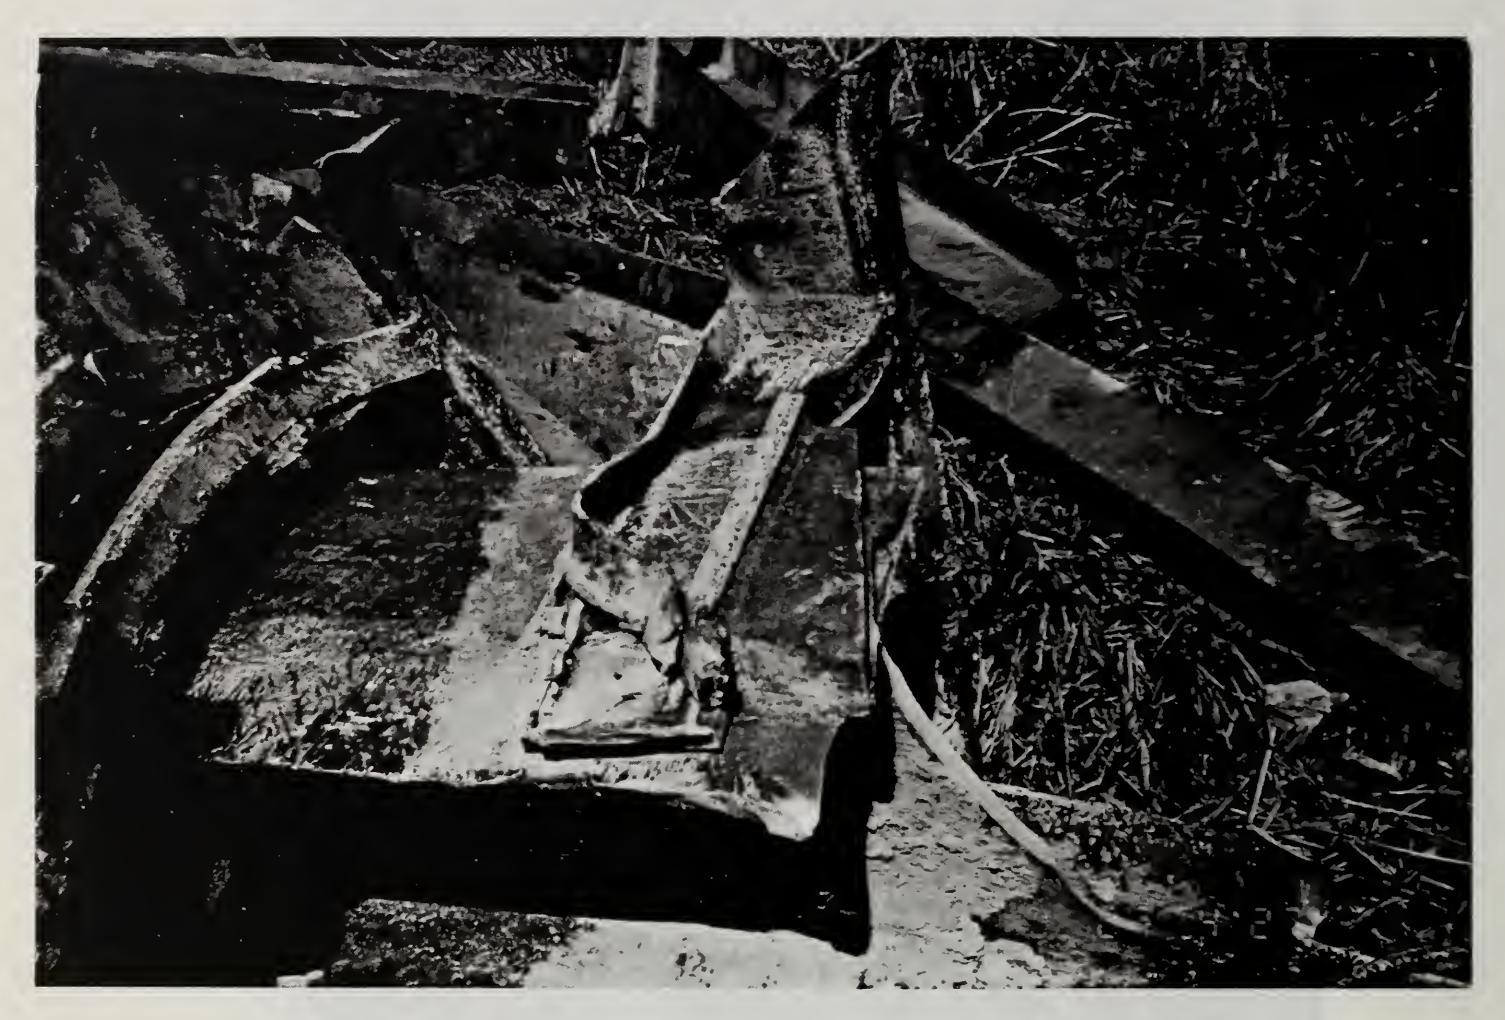
Figure 4.4.19 Failed shearheads

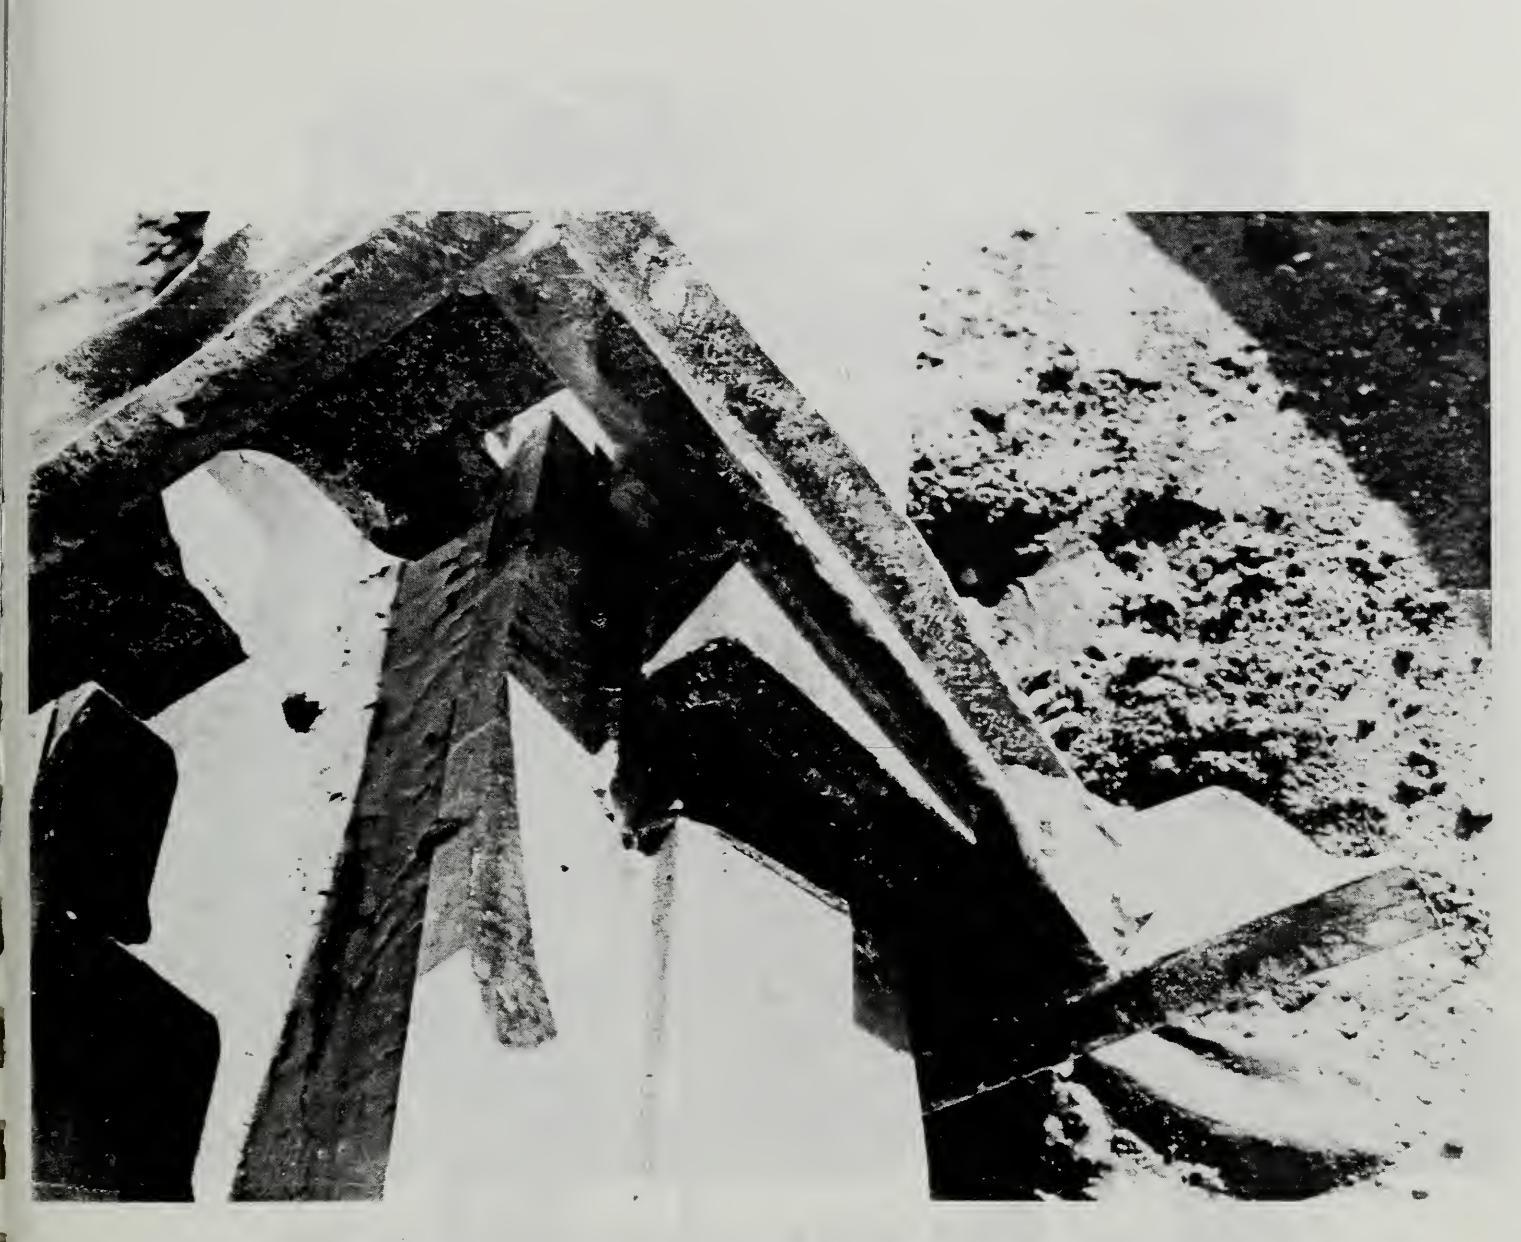
Some welds failed on the weld blocks as shown in figures 4.4.24, 4.4.25 and 4.4.26. The wedges were fully welded and these connections were obviously at slabs in the building which were in their final locations rather than parked temporarily. In the latter case, the wedges were only tack welded. Note the rotation of the wedge in figure 4.4.25. Note also the small shim on the bottom of the wedge. In all three figures, the wedge had pulled away from the column flange and the weld block. The welds do not appear to have fractured but rather the wedge separated from the weld, probably due to the lack of fusion.

Figure 4.4.24 Weld failure at weld block

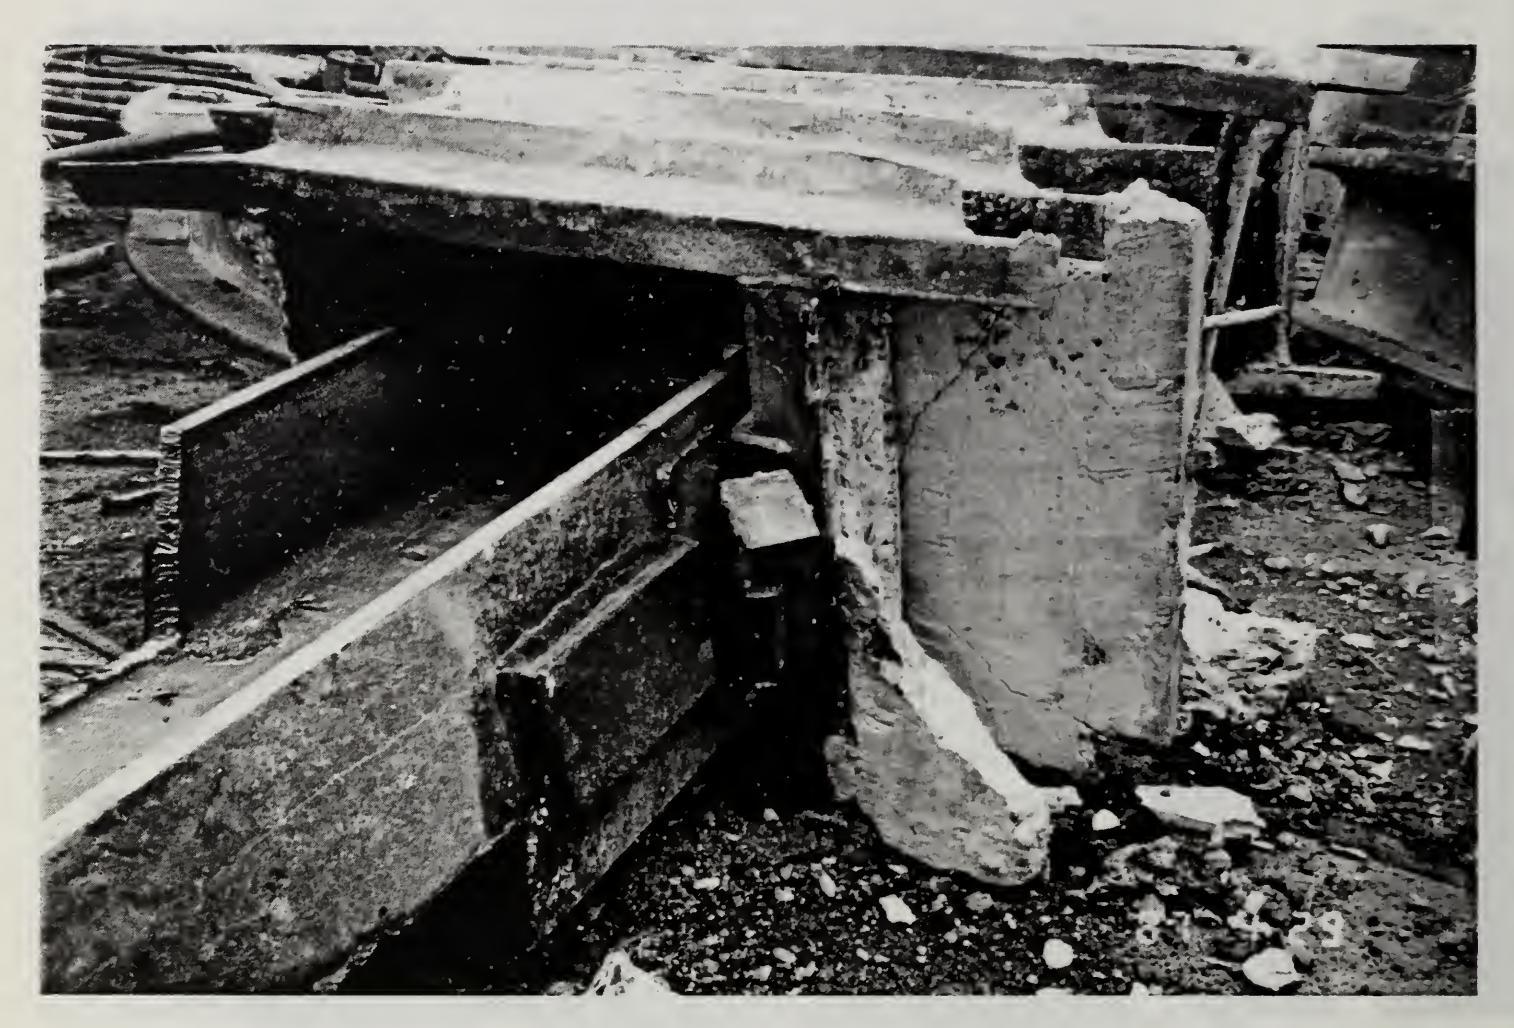
Figure 4.4.25 Weld failure at weld block with shim

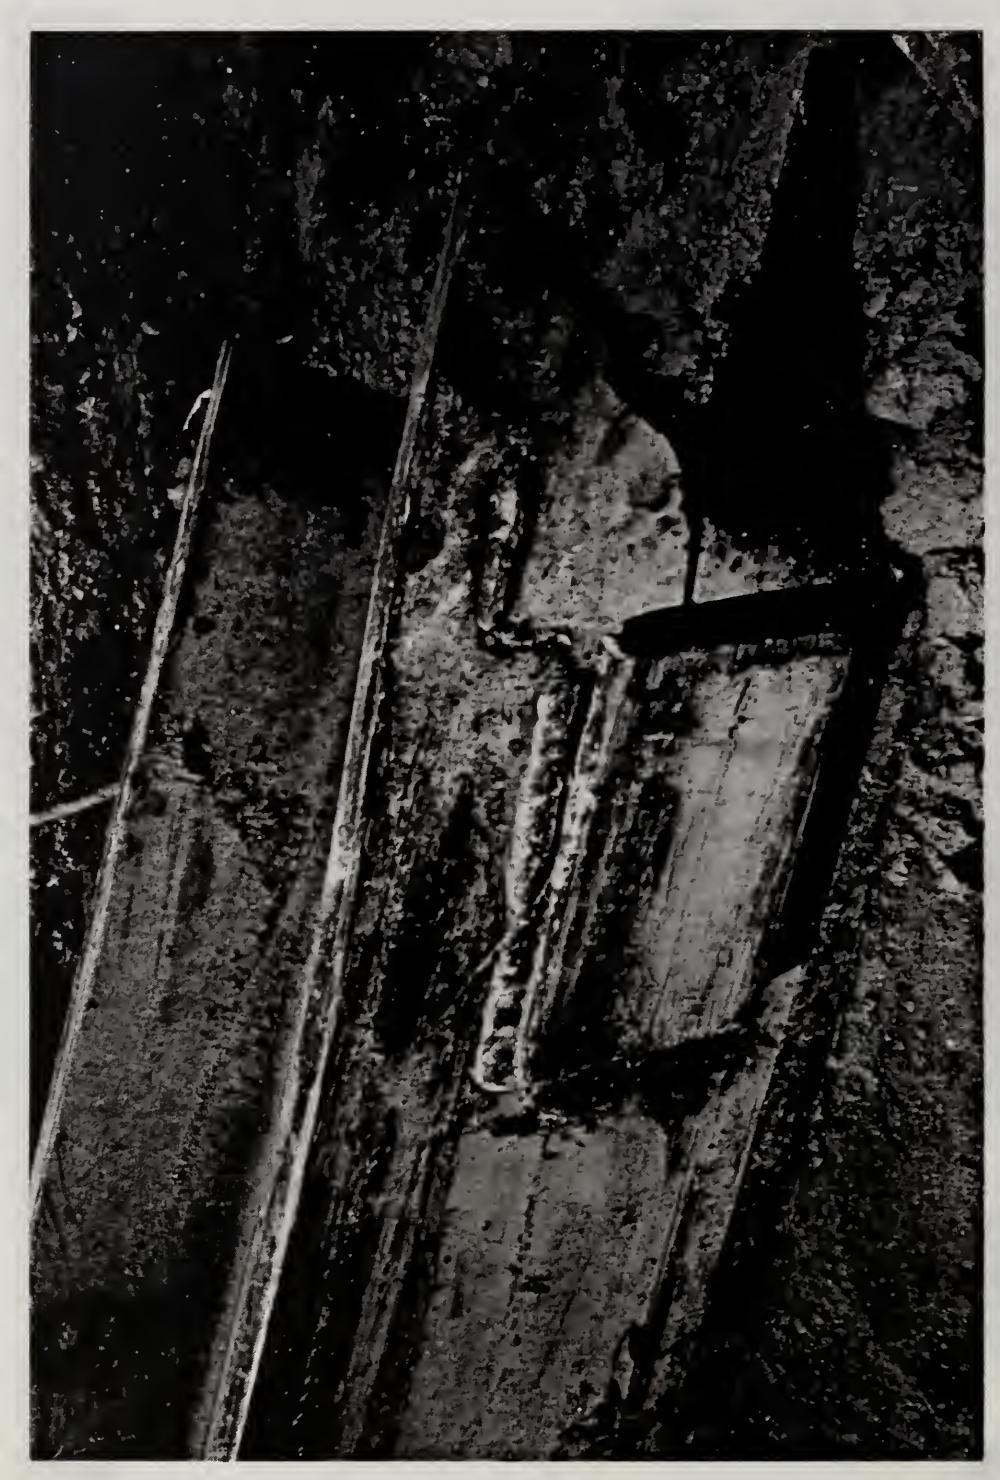
Failure of a weld on a weld block is shown in figure 4.4.27. A crack in the column flange can be seen at the top of the weld block (to the right in the photograph). This crack propagated under the weld block and through the weld block weld about half way down the weld block. Note the separation of the upper portion of the weld block from the column flange. Again there appears to be a lack of fusion between the weld and weld block at this location.

Figure 4.4.27 Weld block weld failure

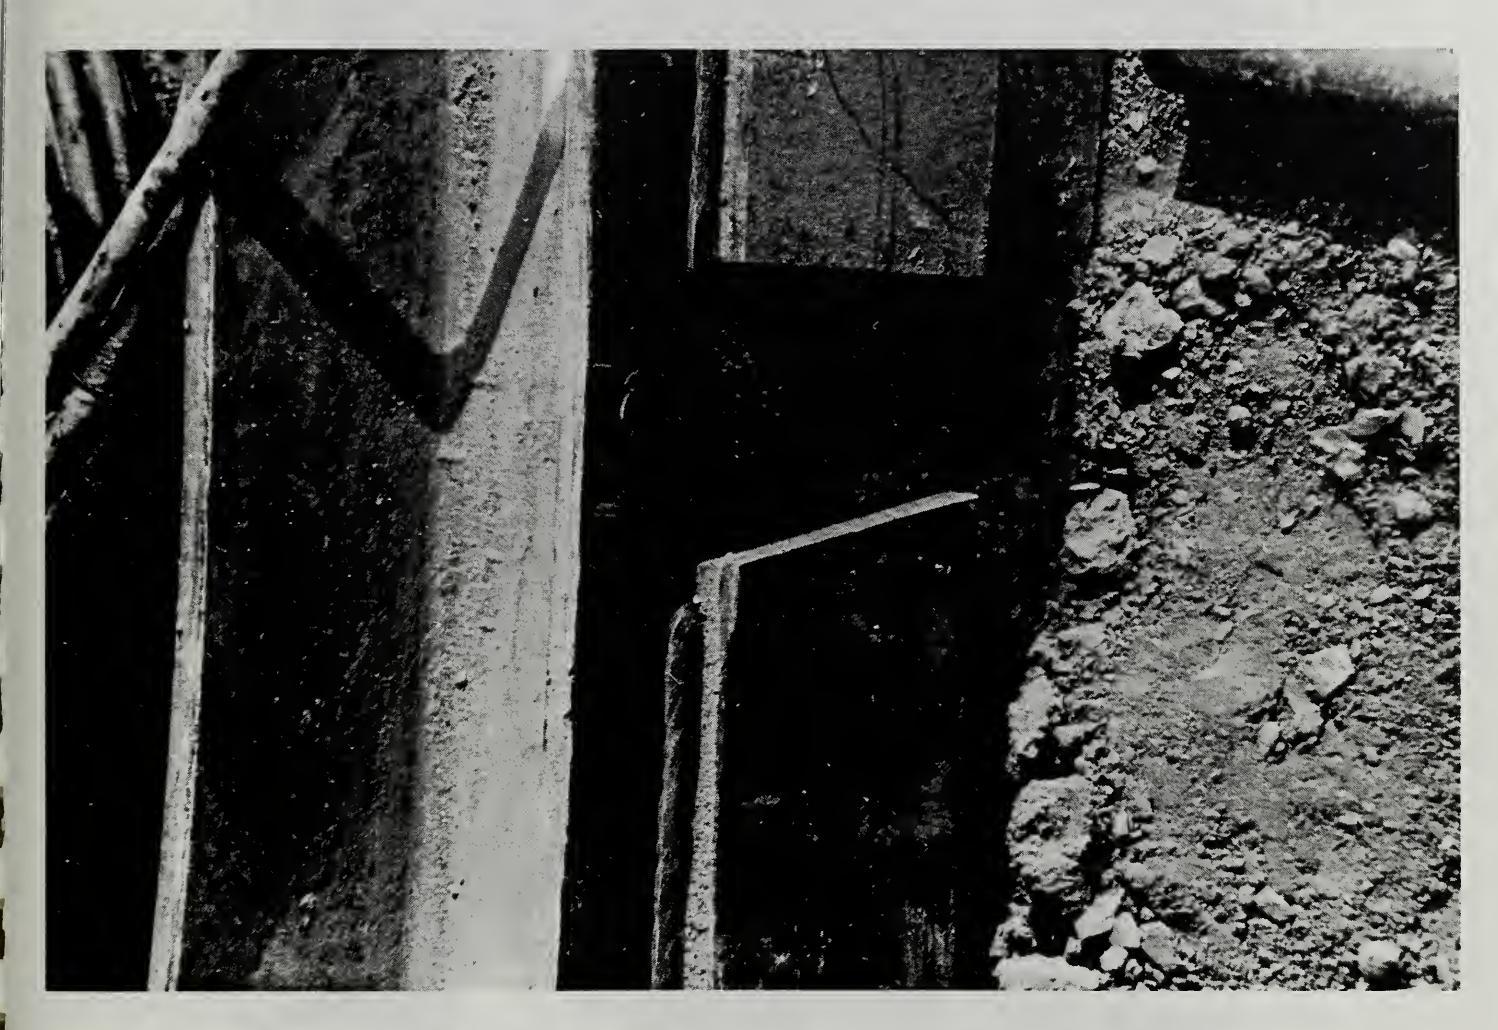
Figure 4.4.28 Failure of temporary weld at shearhead support

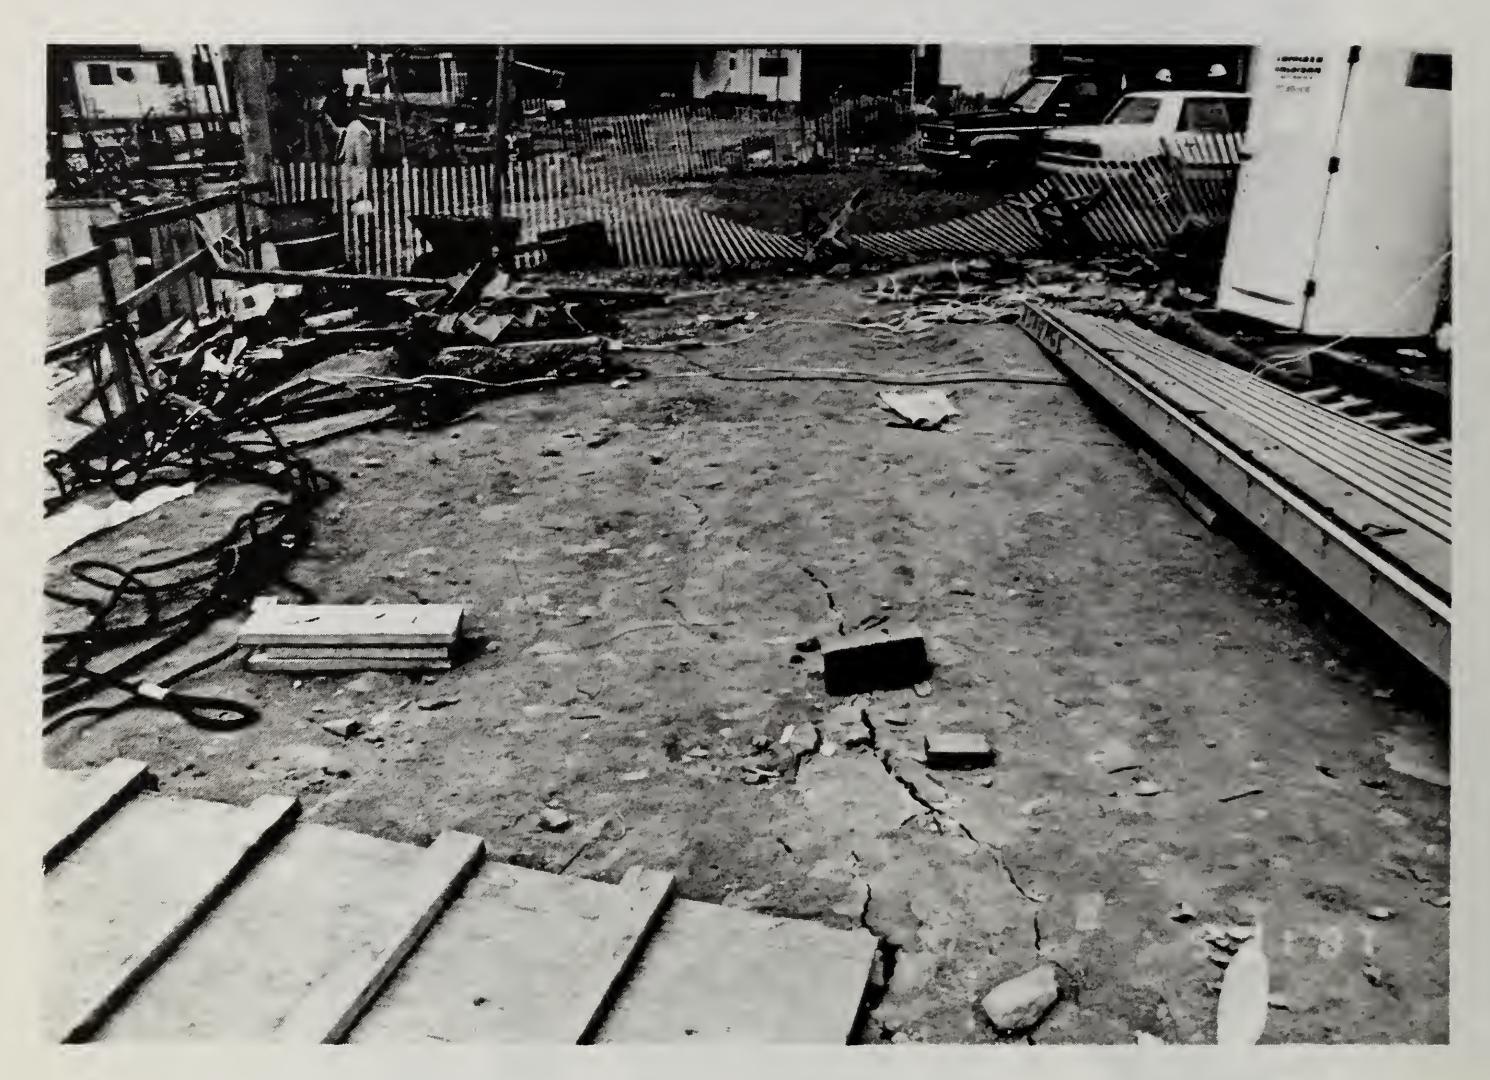
Figure 4.4.31 Tension cracks in backfill behind basement wall -North side of building

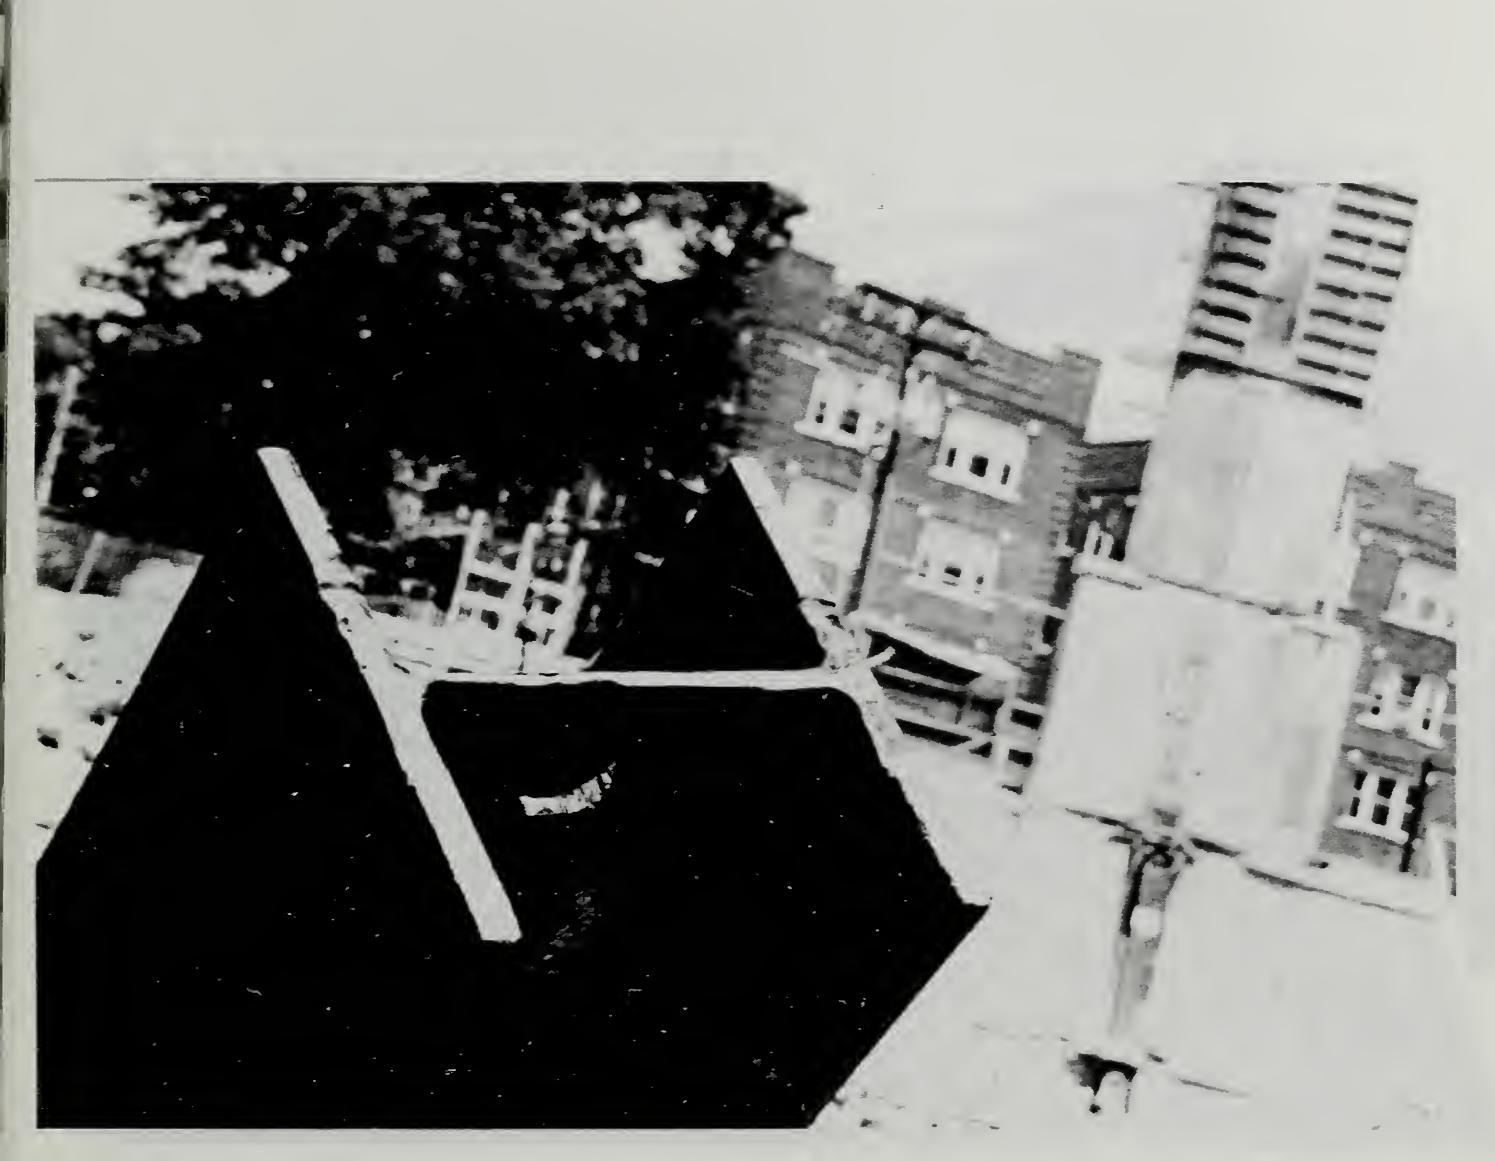
Figure 4.4.32 Typical indentation in top of column due to lifting jack

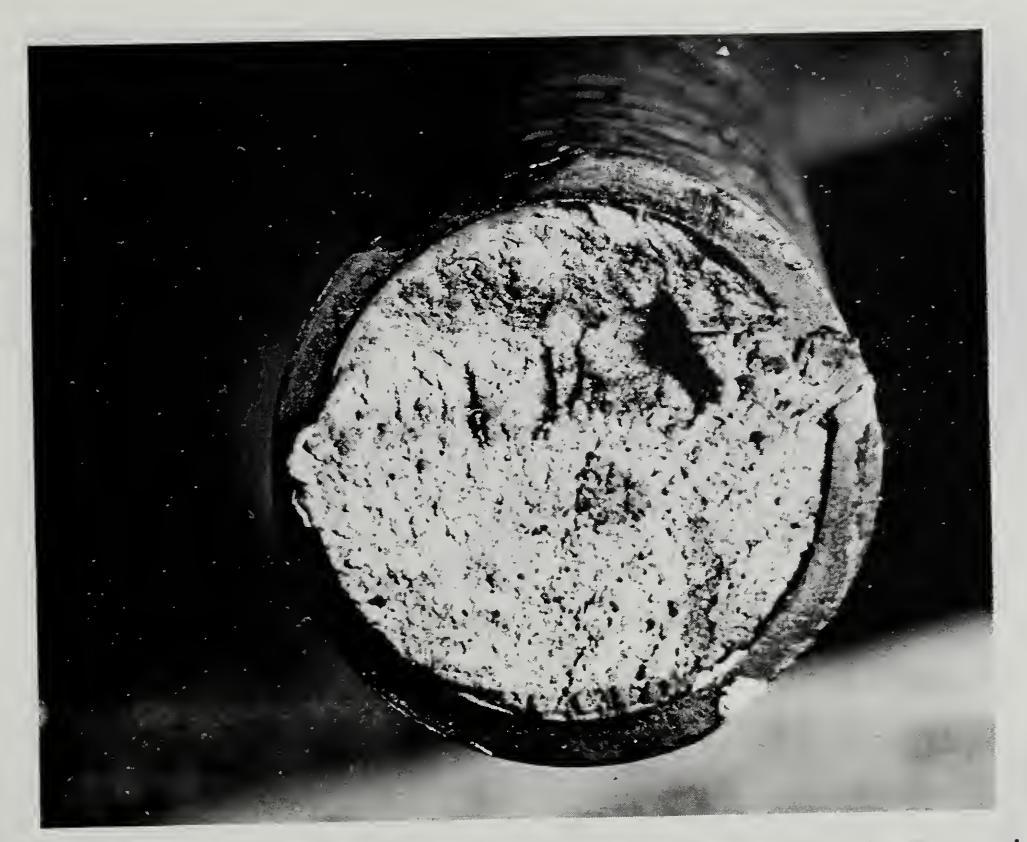
Figure 5.5.5 Fracture surface of jack rod, sample NBS 11-2(x 1)

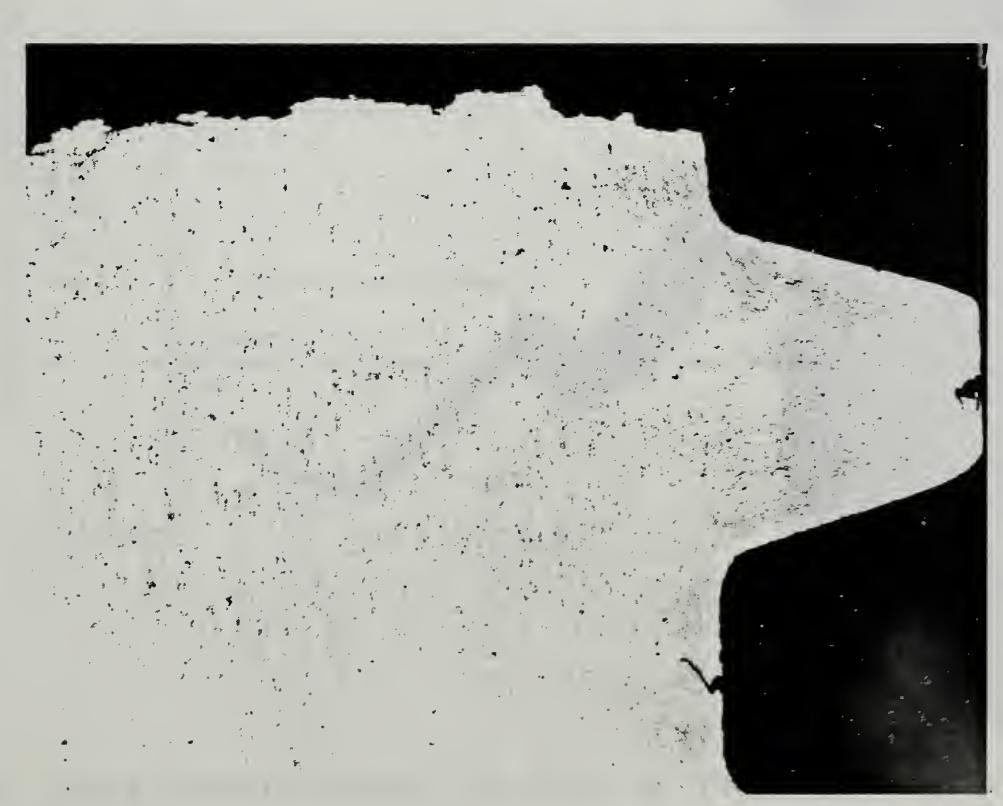
Figure 5.5.6 Fracture profile of jack rod, left, first thread adjacent to fracture (Sample NBS 11-2) (x 9)
