NBSIR 87-3640

# Investigation of L'Ambiance Plaza Building Collapse in Bridgeport, Connecticut

Occupational Safety and Health Administration U.S. Department of Labor Washington, DC 20001

Issued September 1987

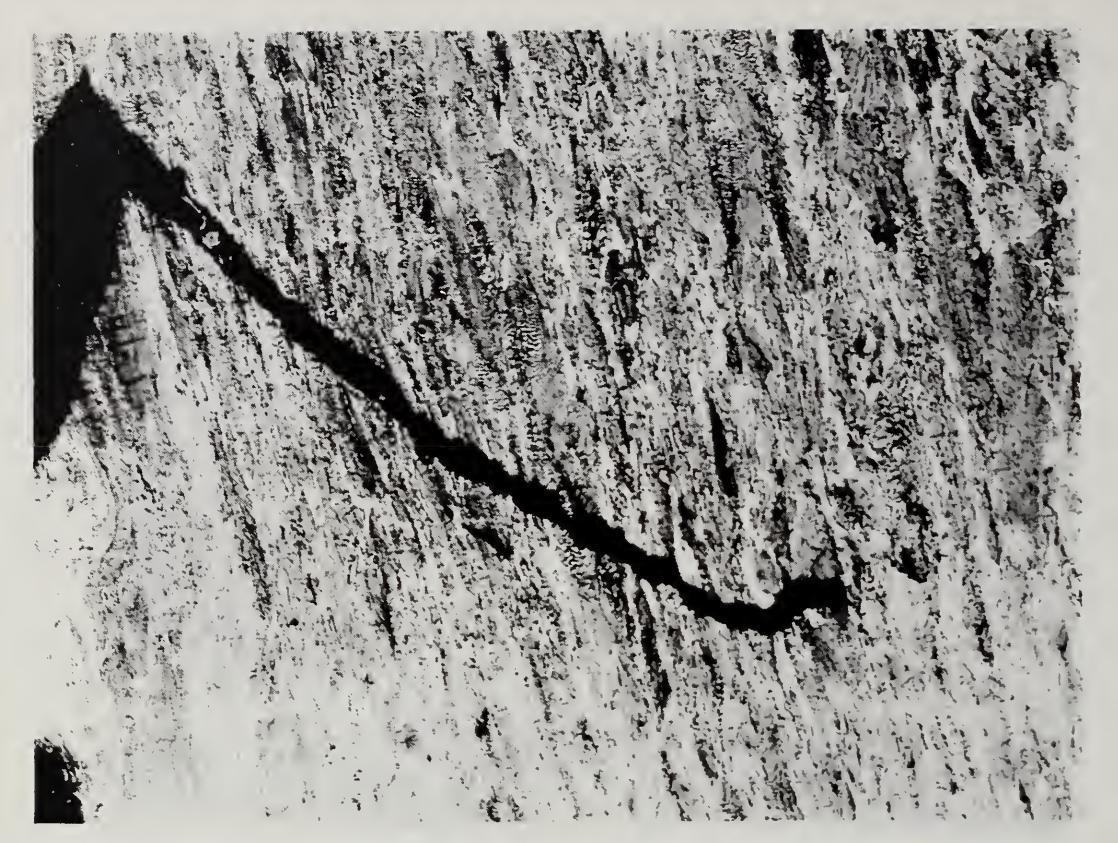
Figure 5.5.7 Lap seam at root of first thread removed from fracture of jack rod (Sample NBS 11-2) (x 500)

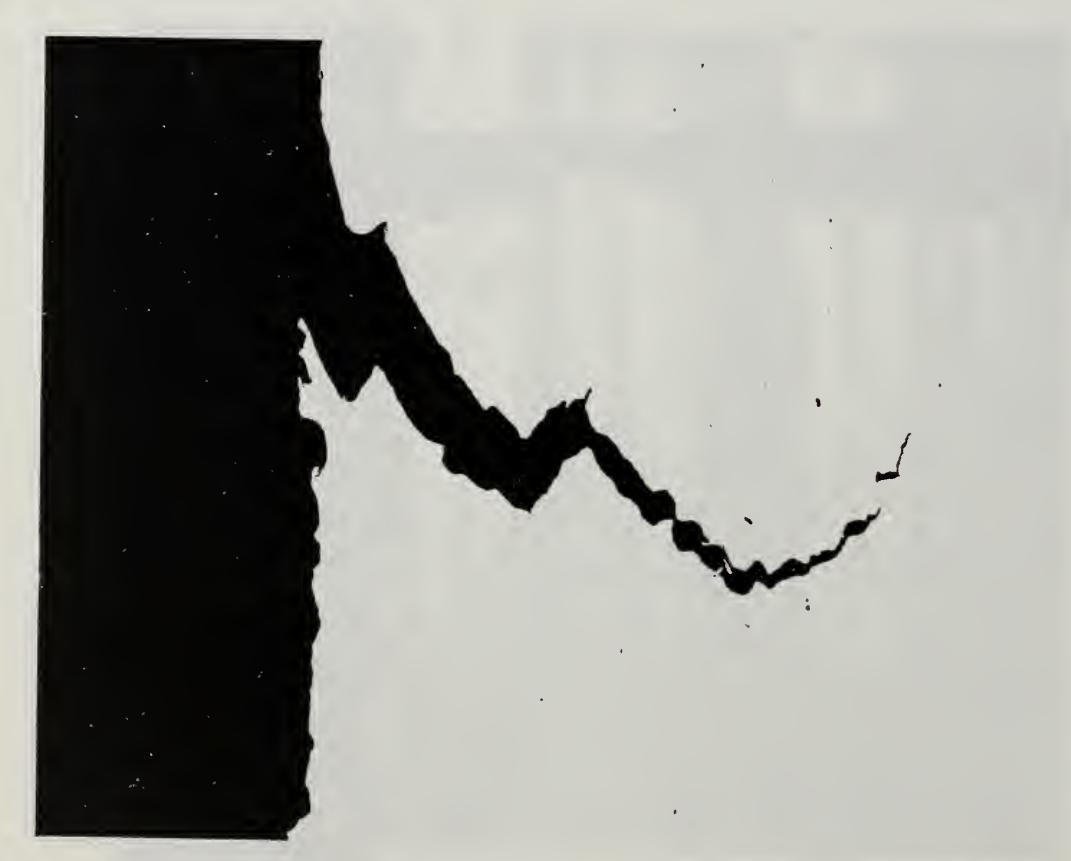
Figure 5.5.8 Lap seam at root of second thread away from fracture of jack rod. As polished (x 40)

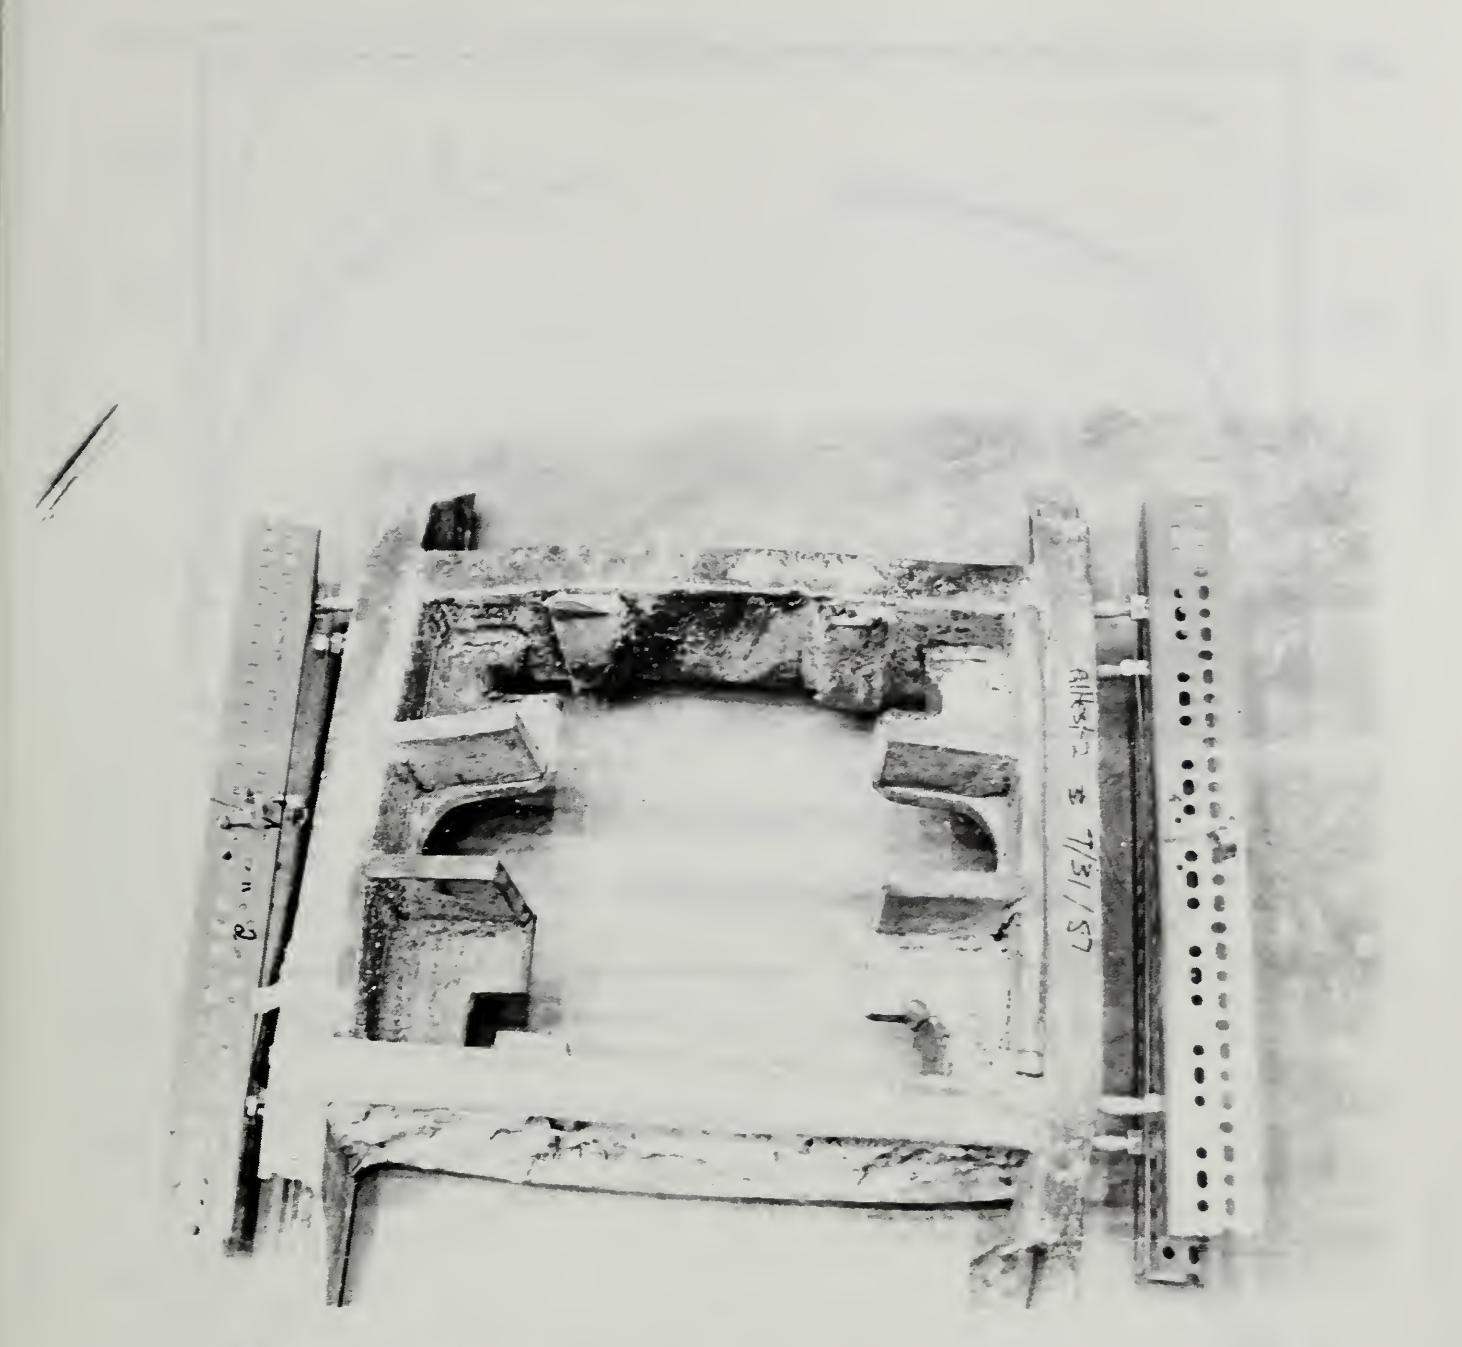
Figure 5.5.17 Shearhead No. 2 after failure showing rotation of lifting angles

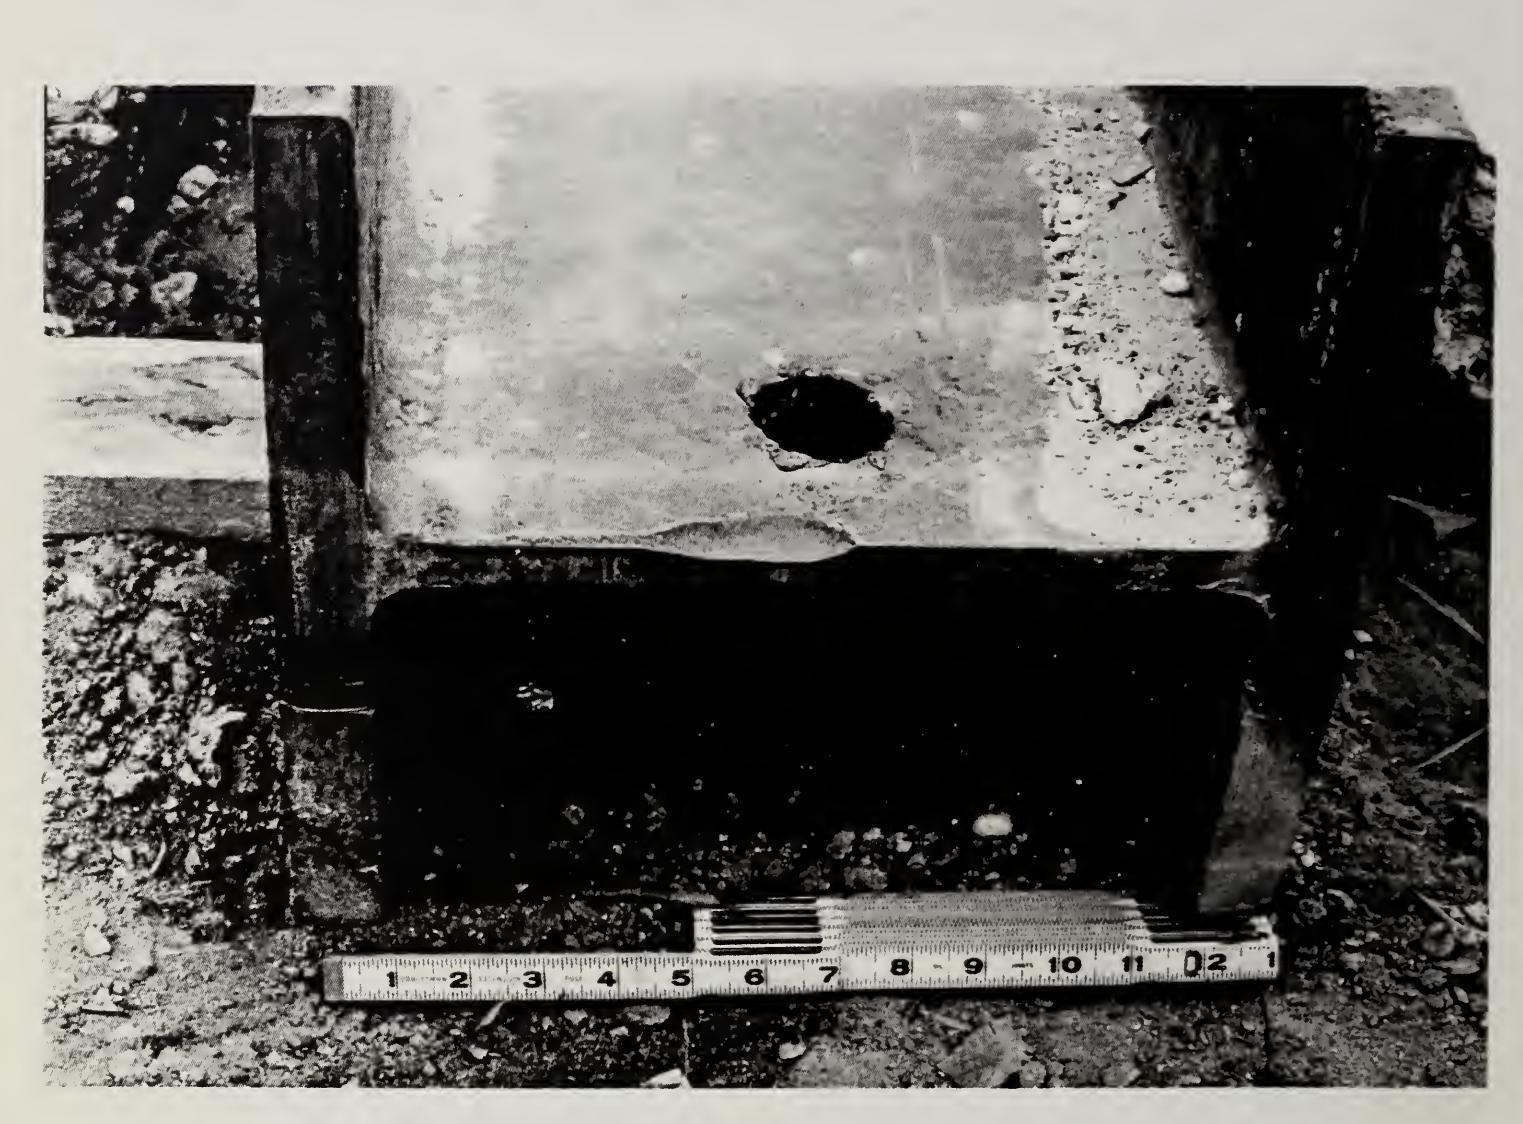
Figure 9.3.1 Indentation in top of column E4.8
