**NIST
PUBLICATIONS**

Examination of the Excessive Retained Austenite on the Surface of A Section of 17-7 Precipitation Hardening Stainless Steel

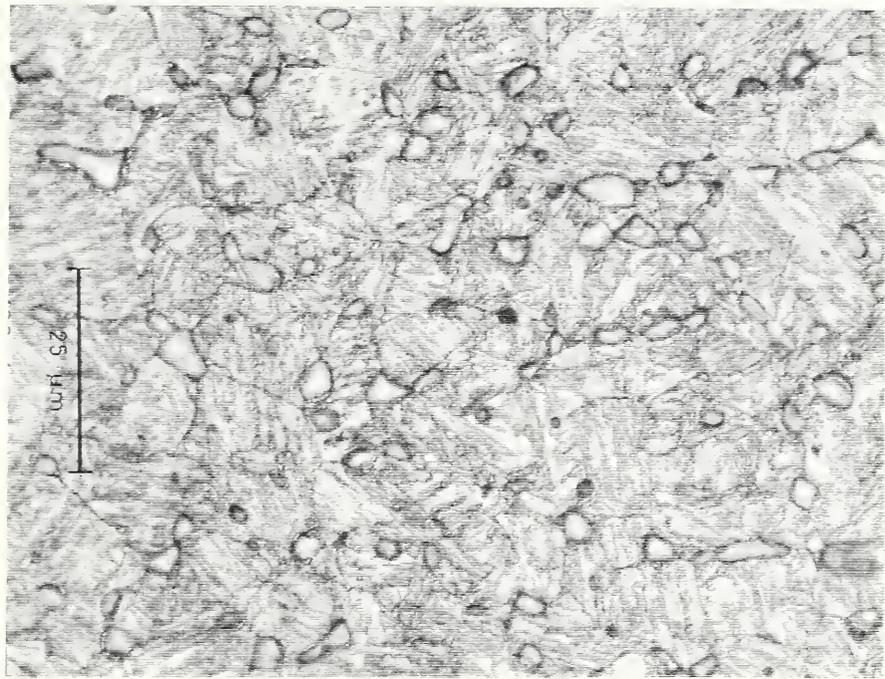
Figure 2. Photomicrographs of specimen NIST-Z1 after solution annealing, and austenite conditioning in vacuum at 1400 F for 90 minutes. The dark particles are the delta ferrite. Note the chromium carbide precipitates (arrows) surrounding the delta ferrite particles. Mag: (a) X1000, (b) X2000. Etch: Villela's

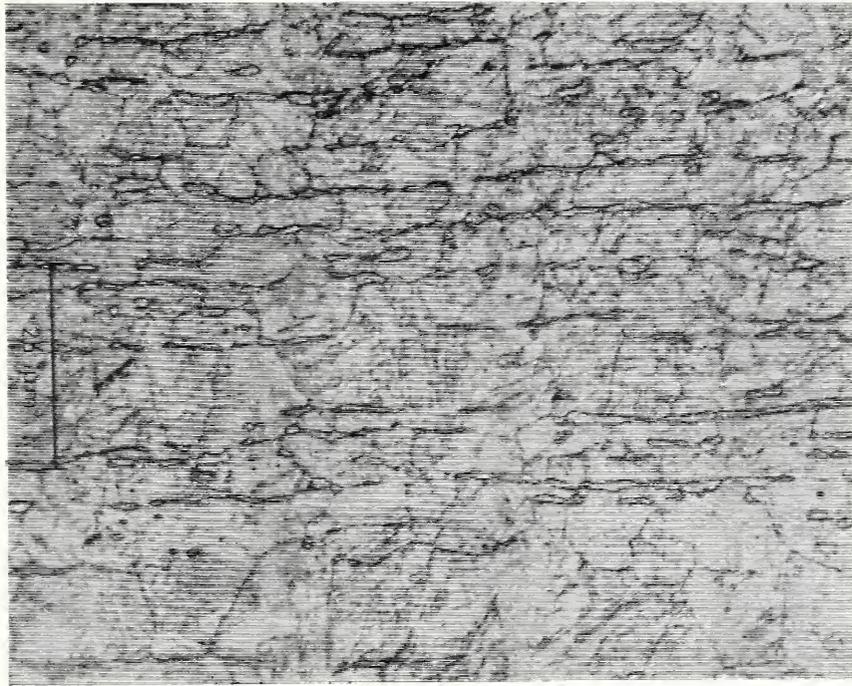
Figure 3. Photomicrographs of specimen NIST-Z1 after solution annealing, austenite conditioning, and precipitation hardening at 1050 F for 90 minutes. The needle-like dark particles are tempered martensite, and the grey particles, delta ferrite. The retained austenite is unresolvable.
Mag: (a) X1000, (b) X2000. Etch: Villela's

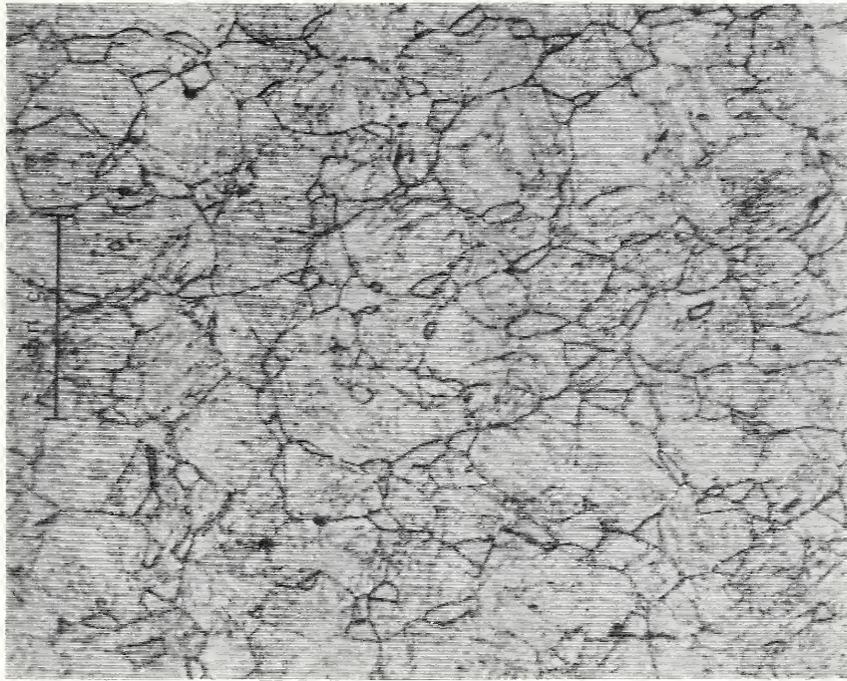
Figure 4. Photomicrographs taken near the center of specimen NIST-Y. The microstructure consists of stringers of delta ferrite and tempered martensite. The retained austenite is unresolvable. Mag: (a) X1000, (b) X2000. Etch: Vilella's

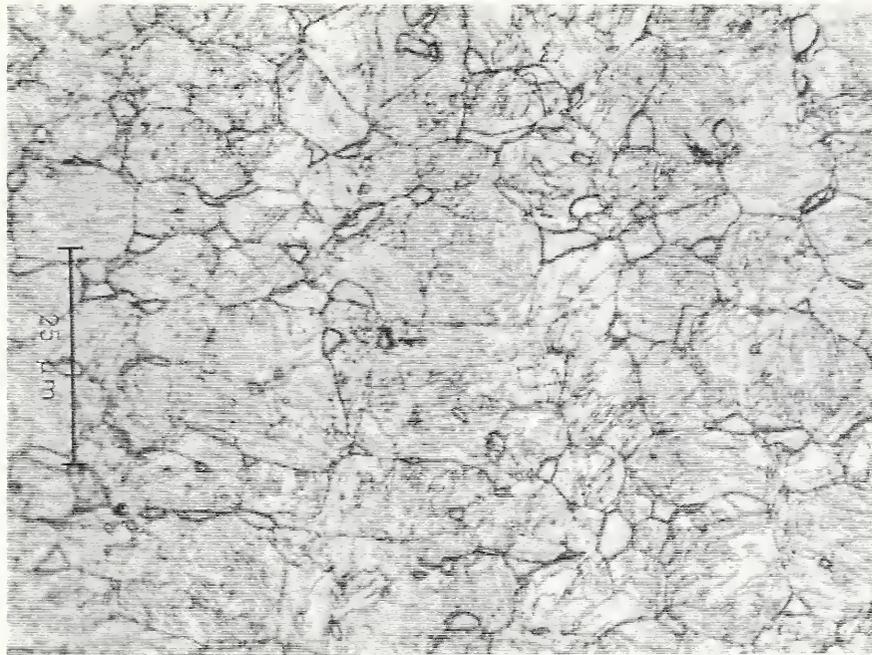
Figure 5. Photomicrographs taken near the center of specimen NIST-Z1. The section had failed after installation. Note the absence of delta ferrite in the microstructure as compared to NIST-Y. Tempered martensite (dark needles) and chromium carbides (arrows) were observed.
Mag: (a) X1000, (b) X2000. Etch: Villela's

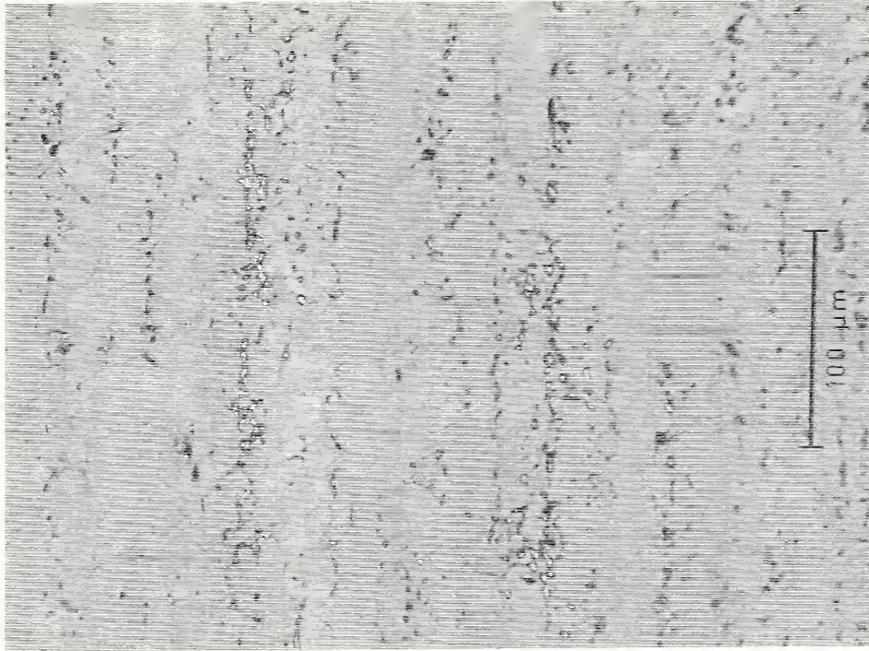
Figure 6. Photomicrographs taken near the center of specimen NIST -Z2. The Navy suspects that this sample is not acceptable for service. Note the absence of delta ferrite in the microstructure. Tempered martensite and chromium carbides were also observed. Mag: (a) X1000, (b) X2000. Etch: Vilella's

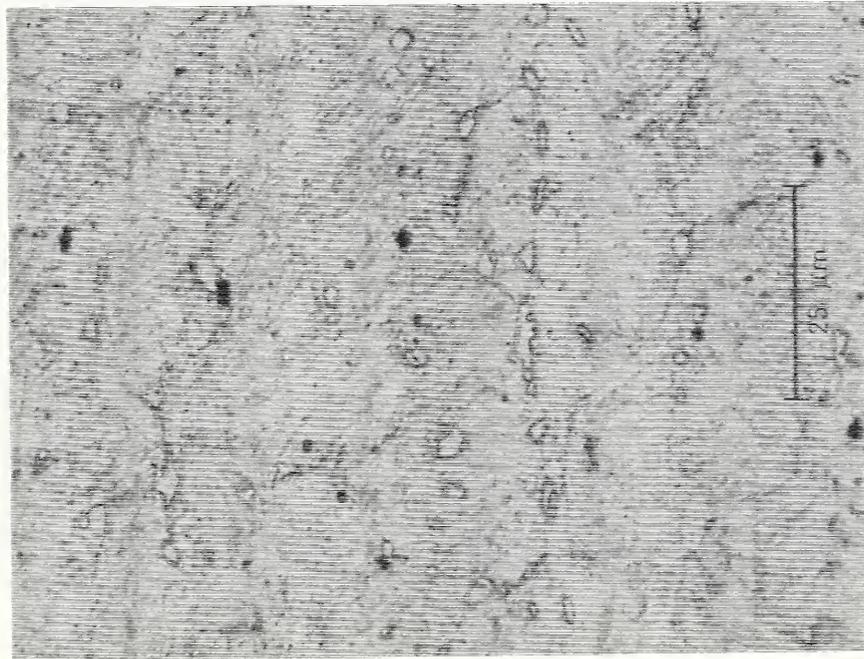
Figure 7. Photomicrographs of the "mishap" specimen. The microstructure consisted of tempered martensite (dark needles), delta ferrite (gray particles), and unresolvable retained austenite. Mag: (a) X250, (b) X1000. Etch: Villela's

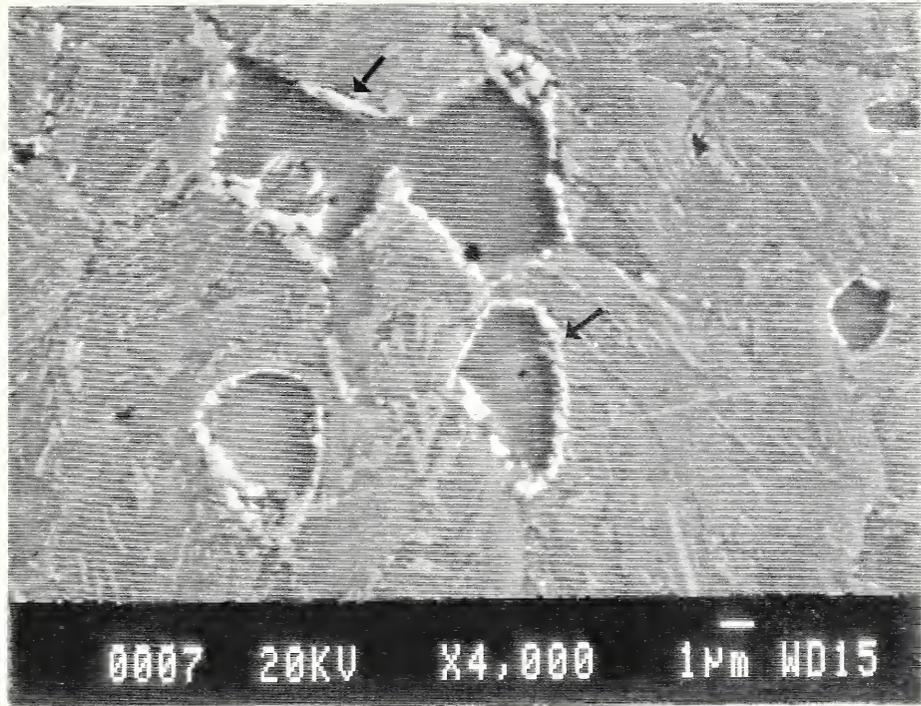
Figure 8. Photomicrographs of the "mishap" specimen taken in another area. The microstructure consisted of delta ferrite (round grey-like particles), tempered martensite, and carbides dispersed throughout the austenite matrix. Note the absence of chromium carbides around the delta ferrite.
Mag: Both X1000. Etch: Villela's

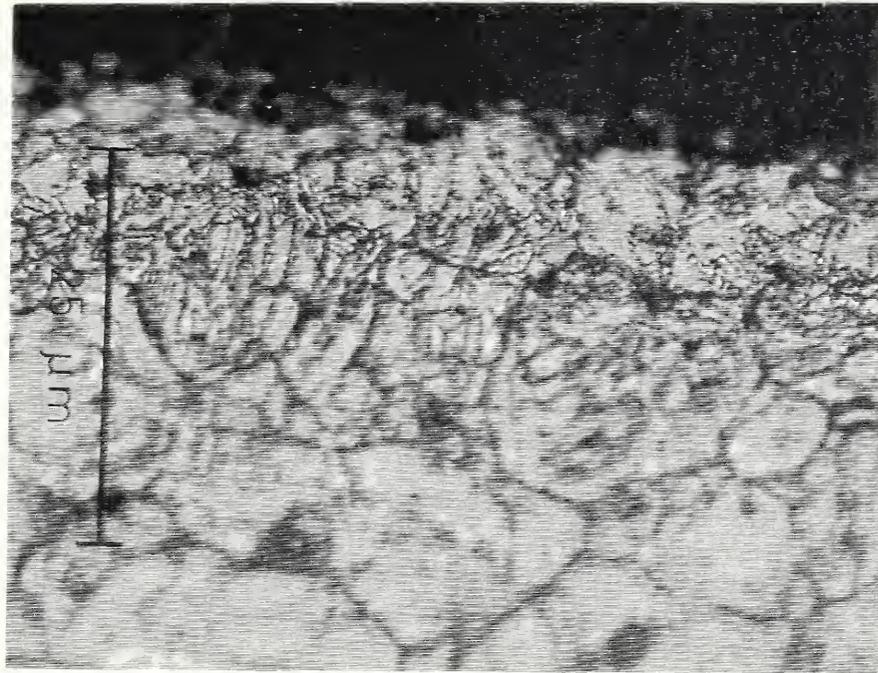
Figure 15. Photomicrographs of specimen NIST-Y taken near the surface (a), and center (b). There was no evidence of retained austenite on the surface, but some (arrows) was observed at the center. Mag: Both X2000. Etch: Vilella's
