NISTIR 7120

**Impact of Sprinklers on the Fire Hazard in Dormitories:
Day Room Fire Experiments**

June 2004

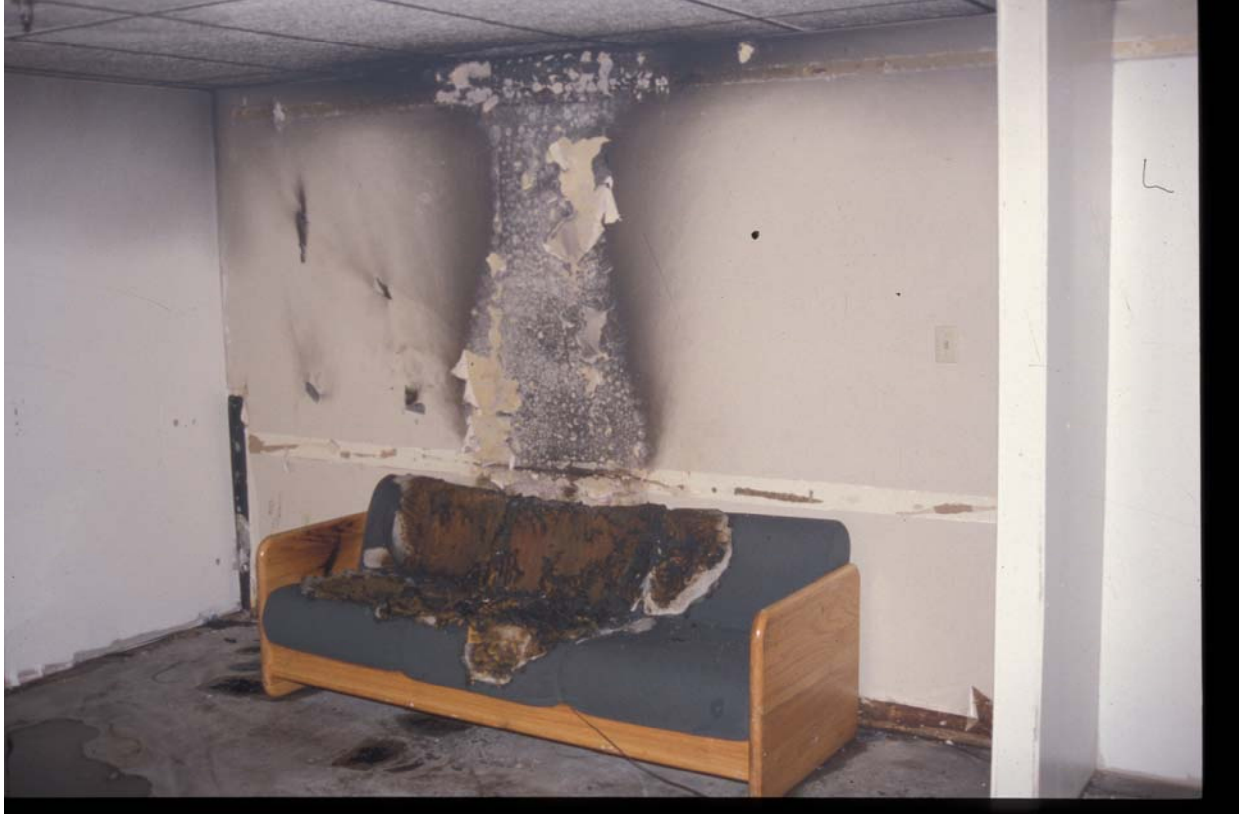
Figure 12. Photograph of day room after experiment 1.

350 s	Fire fighters enter building
360 s	Visibility improving
380 s	Turned off light in fire area
Post-Test	Fire damage limited to ignition sofa and the wall behind the sofa. Soot marks on ceiling tile. Other sofas were not involved in fire.

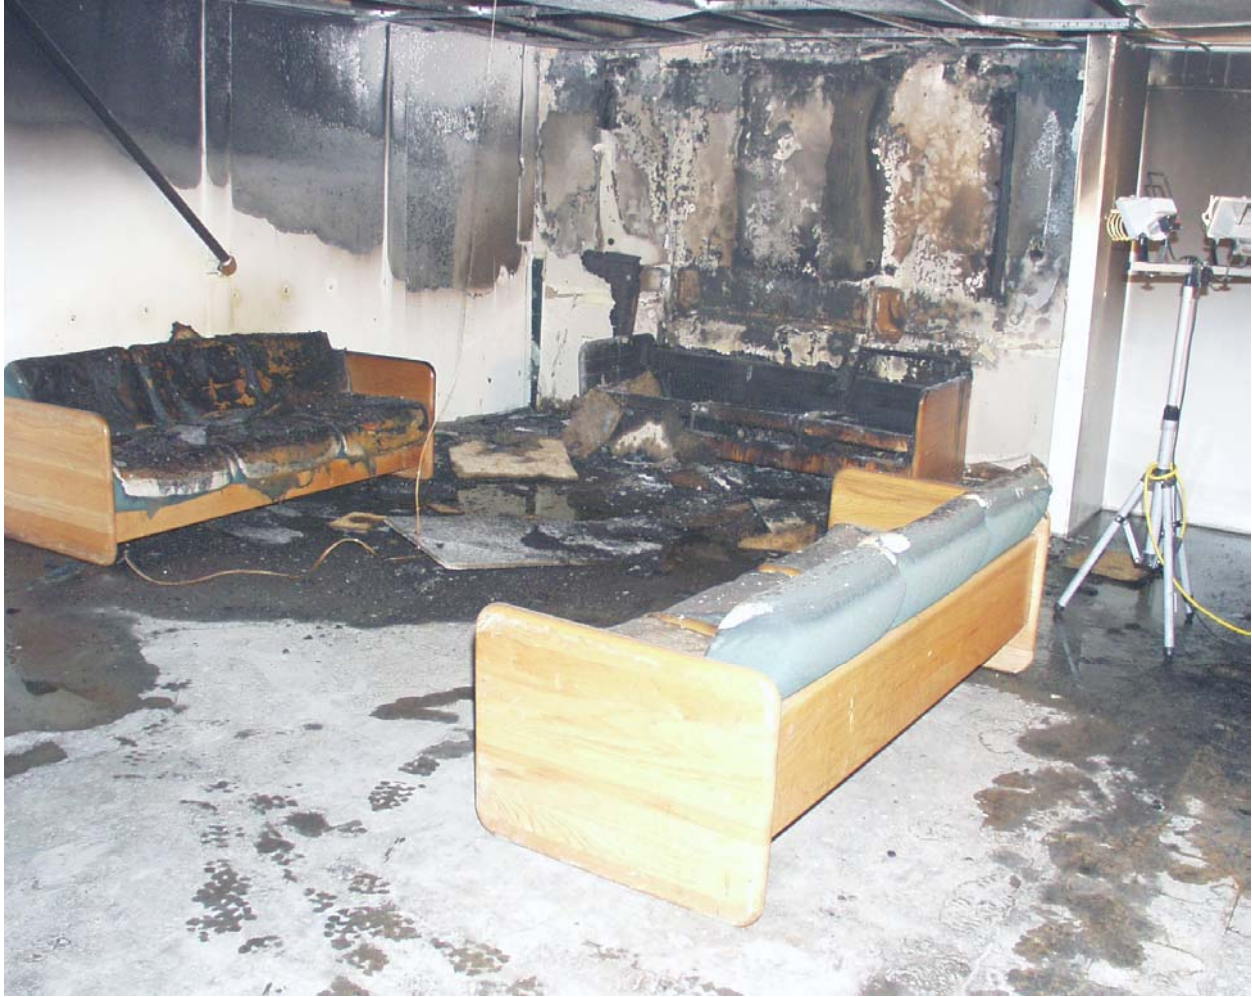
Figure 13. Photograph showing the day room after experiment 2.

Post Test All of the ceiling tile is burned or down on the floor with the exception of a row of tiles on the east end of the day room. All of the foam cushions have burned away completely. Significant burn damage to walls. Burn line in day room on east and south walls stops approximately 0.5 m above the floor. Fire damage (evidence of burning) in corridor limited to area across from day room with some extension to the east and west.

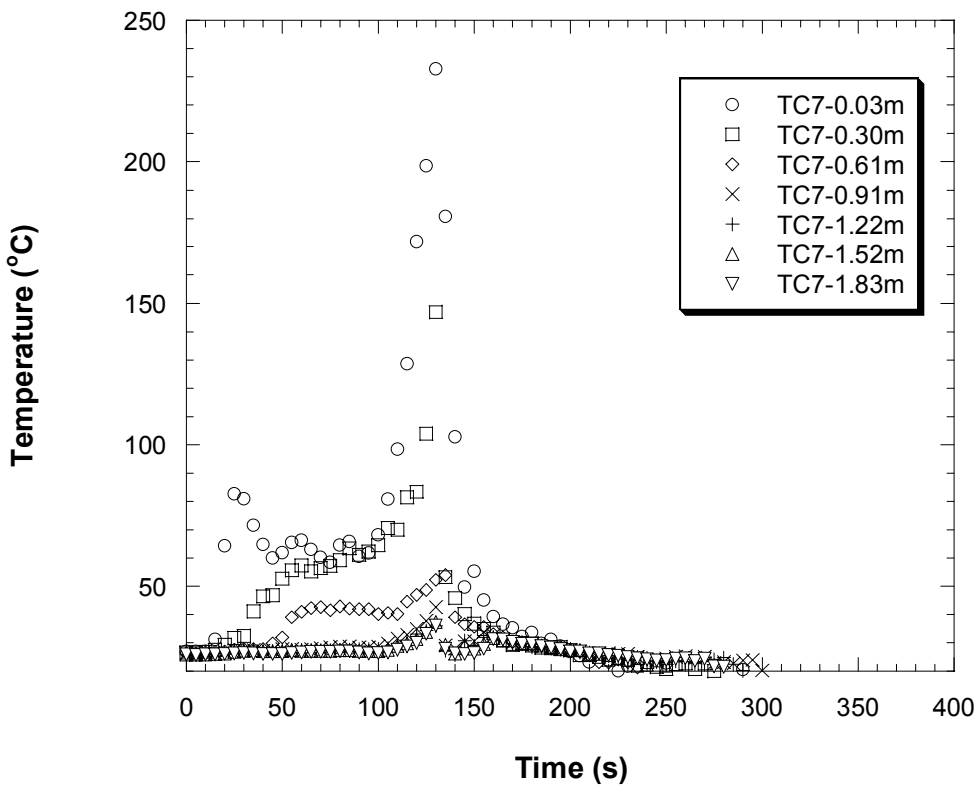
Figure 23 Experiment 1, dayroom temperatures, west side near ignition, TC array 7

In experiment 1, the sprinklered case, temperatures near the ceiling in the day room, thermocouple array 7, approach 245 °C (473 °F) just prior to sprinkler activation at 137 s, Figure 23. In the corridor adjacent to the day room, thermocouple array 6, the temperature near the ceiling exceeds 120 °C (248 °F) for approximately 10 s prior to sprinkler activation. At approximately 1.5 m (5 ft) above the floor in the corridor, the maximum temperature is approximately 50 °C (122 °F), Figure 22. The temperatures then decrease rapidly at the corridor positions to the east and west of the day room. At the west end of the corridor, the maximum temperature increase just below the ceiling is 20 °C (68 °F), Figure 28. At the east end of the corridor, the temperature increase is approximately 10 °C (50 °F), Figure 17. The thermocouple located 1.83 m below the ceiling in TC array 8, was not functioning and therefore is not shown in Figure 24.
