# NATIONAL BUREAU OF STANDARDS REPORT

10 320

FIRE ENDURANCE TESTS OF UNPROTECTED WOOD-FLOOR  
CONSTRUCTIONS FOR SINGLE-FAMILY RESIDENCES

May 10, 1971

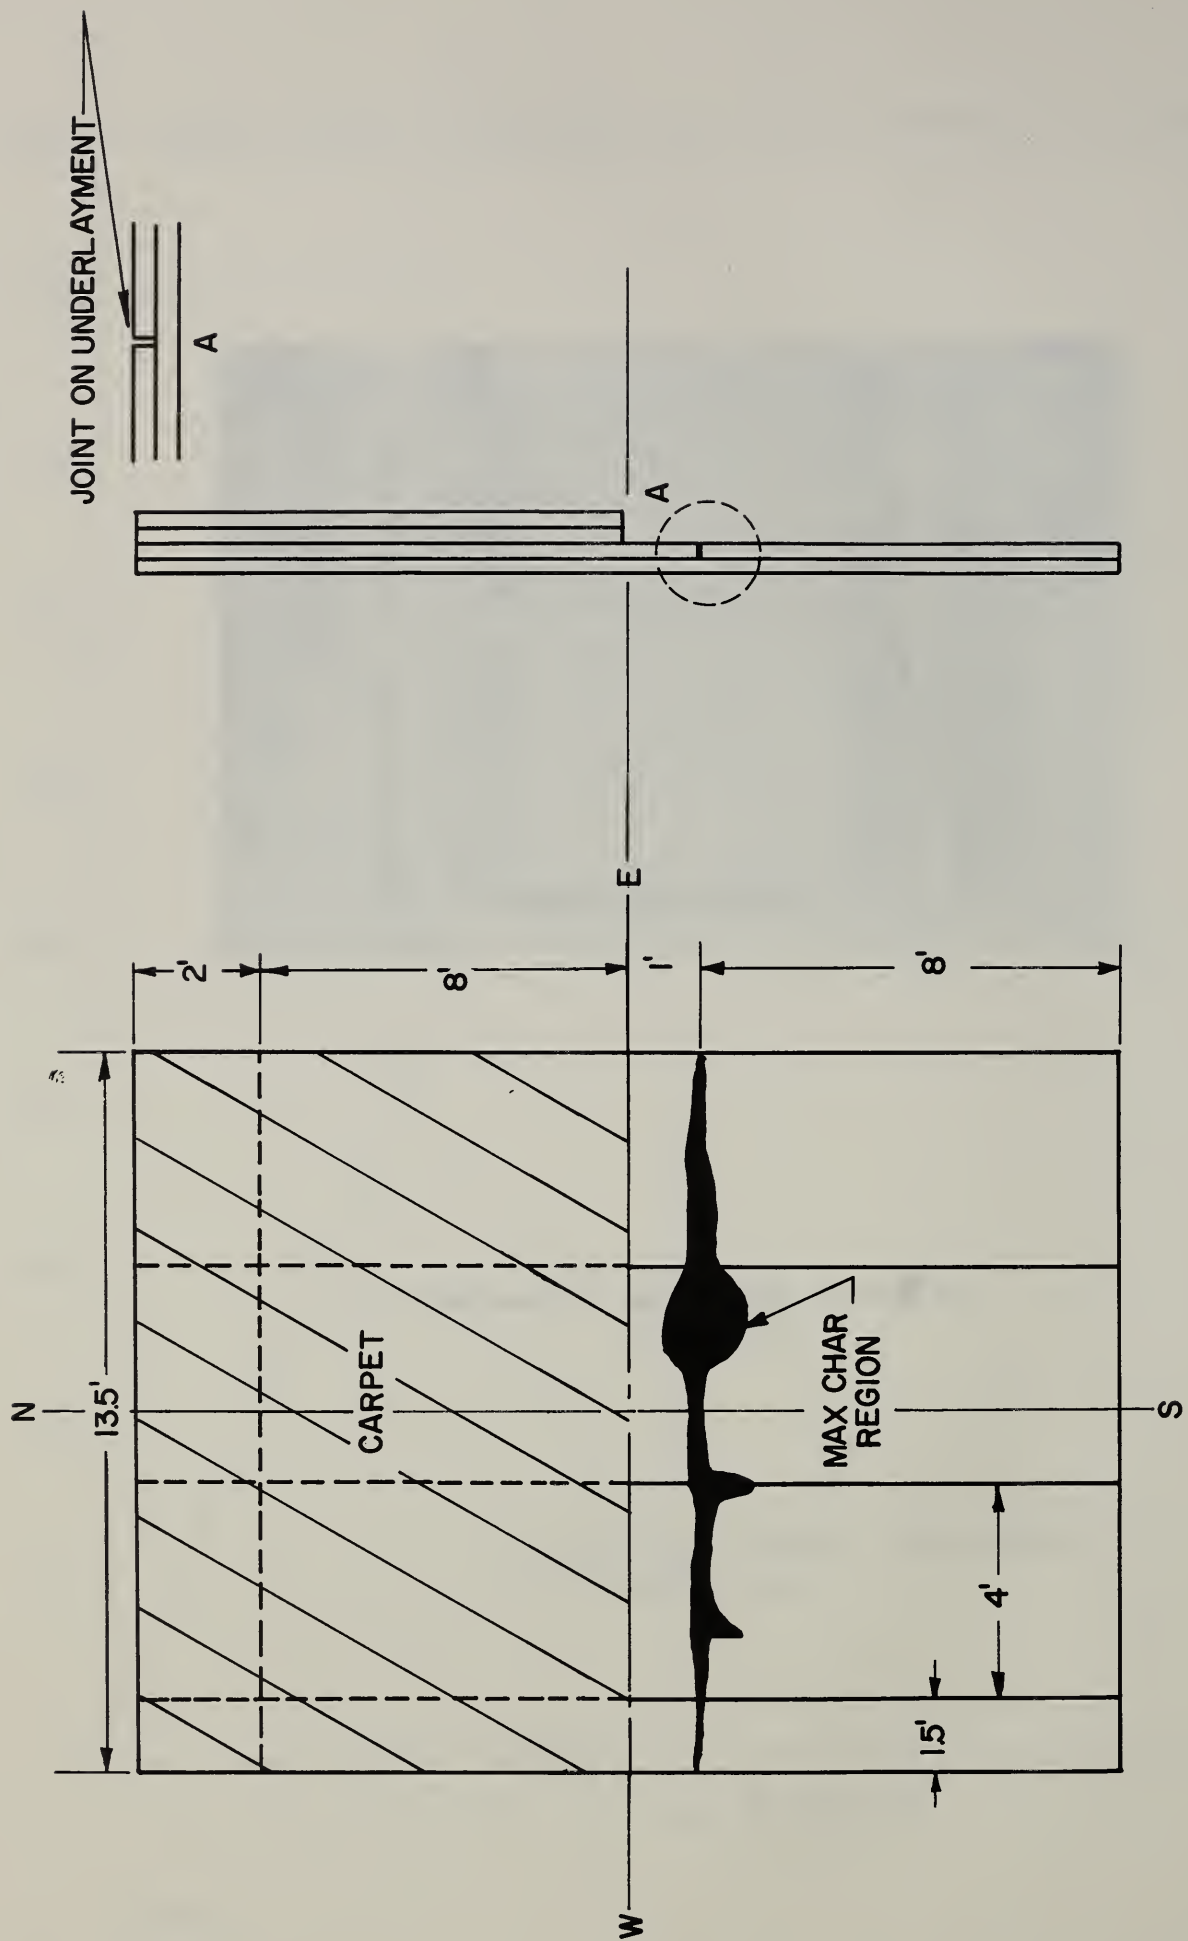
FIGURE 10. Char Region on Unexposed Surface after Test #L-1

Flame penetration at the joint between the two sheets of plywood in the upper layer of the bare floor near the center was observed at 13min:30sec. The location where flaming occurred and the associated charred region is shown in Figure 10. There was also a load failure, as evidence by the inability to maintain hydraulic pressure at 11min:38sec.

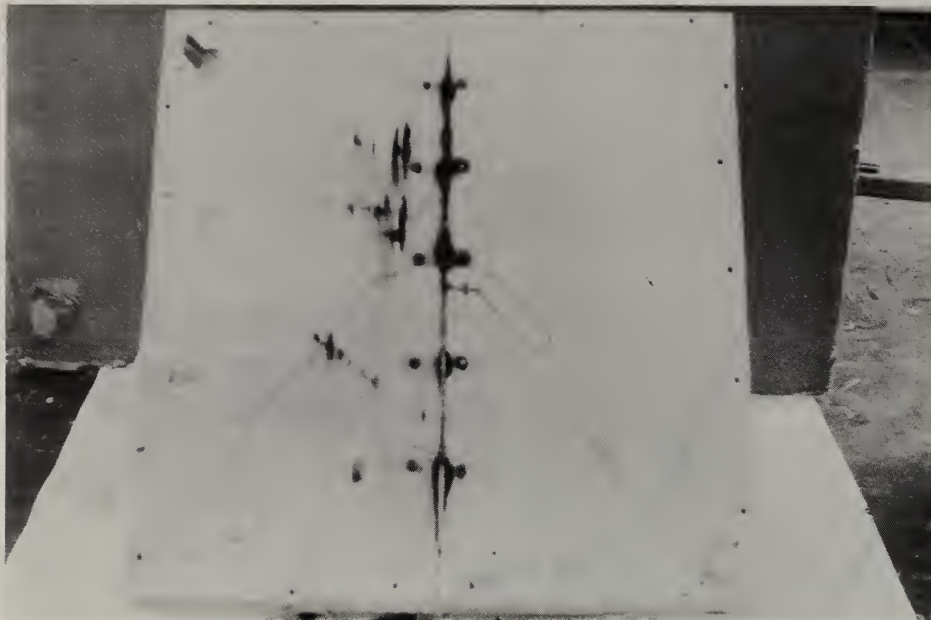
Fig. 18. Flame Through and Associated Char Region Test #S-3

As previously mentioned in test #S-3, the 1/8" fixed gap on the underlayment joint reduced the time of "flame through" by 4.5 minutes. For both the large scale and small scale tests the temperature rise on the unexposed surface was nearly the same. It may be that the artificial gap on small scale test #S-3 corresponded to the cracks made on the exposed surface due to the load in the full scale test #L-1.
