# AN INVESTIGATION ON THE FIRE SPREAD POTENTIAL OF PLASTIC PIPE INSTALLATIONS

September 18, 1970

. I. A. Benjamin and W. J. Parker

#### AN INVESTIGATION ON THE FIRE SPREAD POTENTIAL OF ABS PLASTIC DWV PIPE INSTALLATIONS

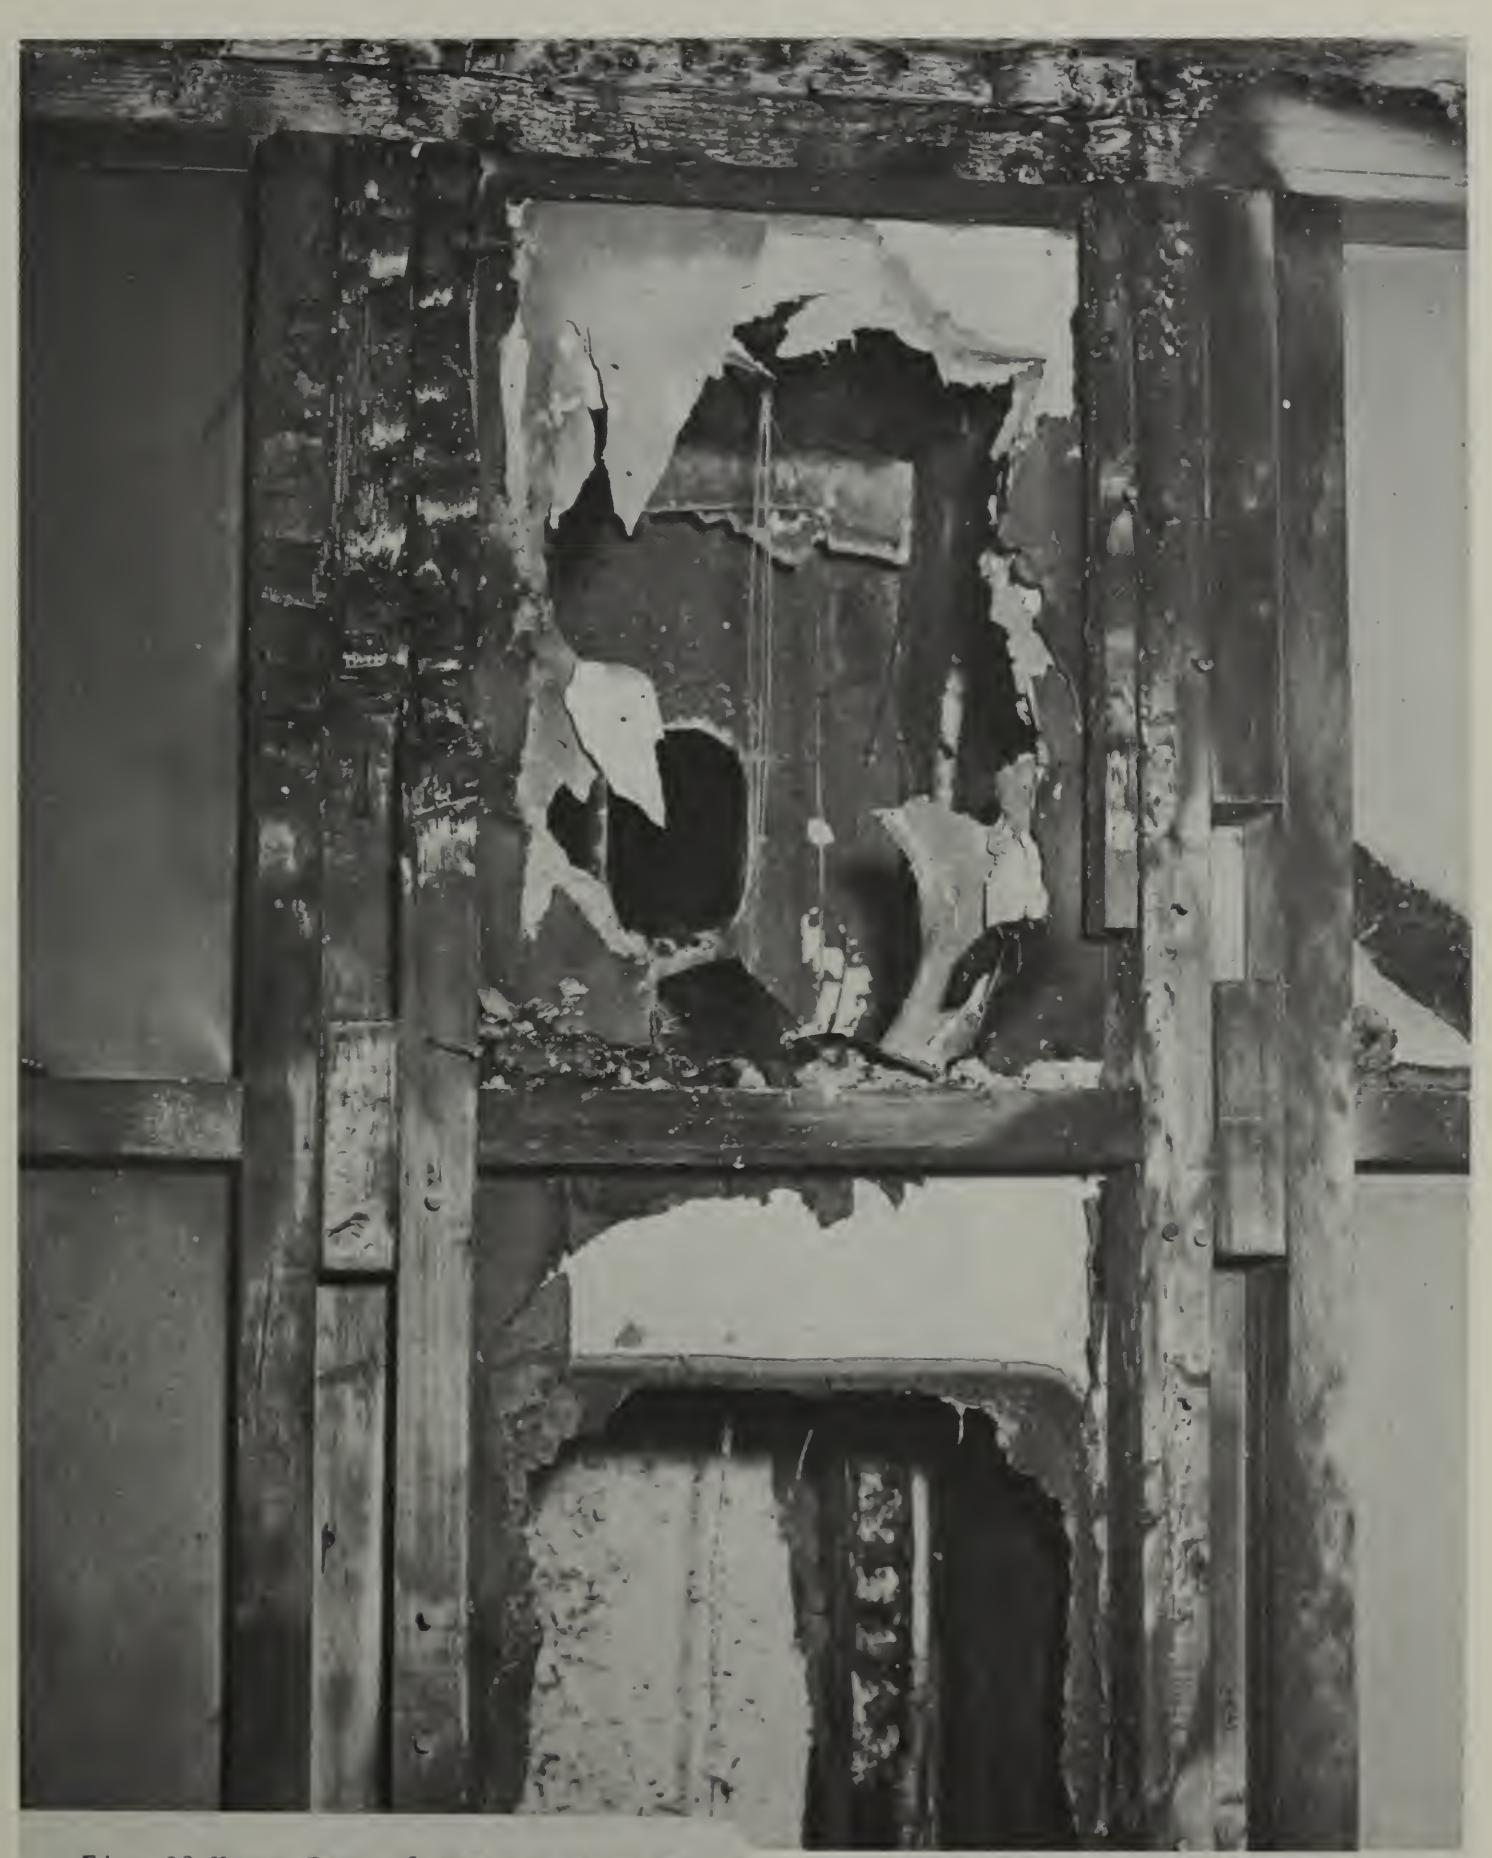
Fig. 30 Upper Part of Chase 7 After Test

- 87 min: There are flames out of the upper branch opening of chase 7 where the lateral fell off. These flames occasionally extend out about 1 foot and indicate that the paper on the gypsum board is burning.

- 90 min: There is heavy gray smoke through the joints at the top seal of chase 7.
- 95 min: The studs are burning in chase 7.
- 100 min: There is heavy gray wood smoke emerging from chase 7.

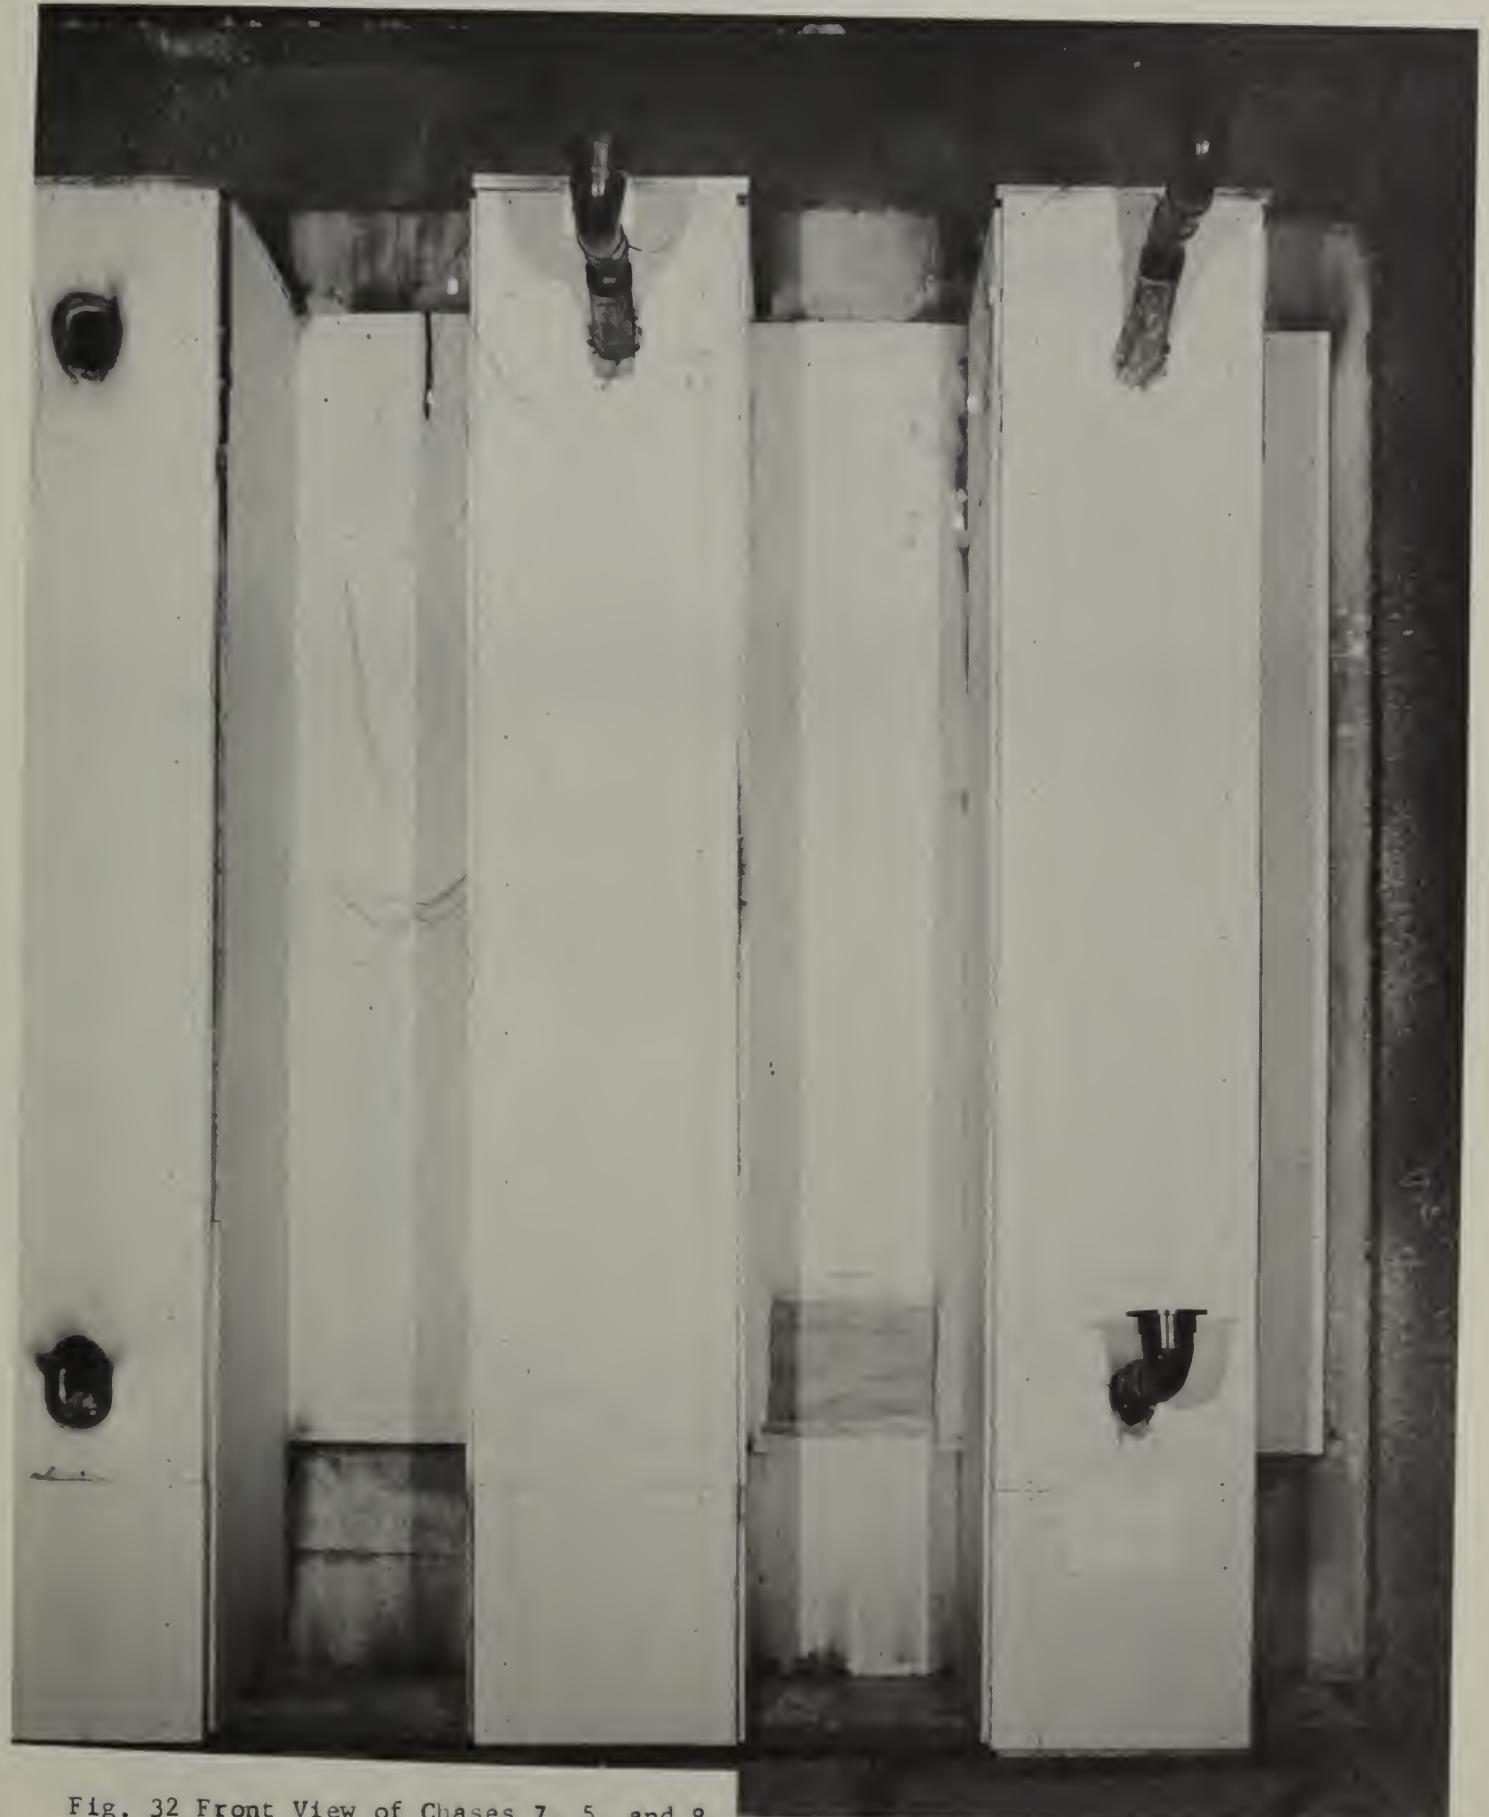
Fig. 32 Front View of Chases 7, 5, and 8 After Test

The top of chase 5 can be seen from the furnace side in figure 31. The gypsum board was broken away after the test in order to view the pipe. There was about 1/3 of a cubic foot of pipe remaining as melted material at the bottom of chases 5 and 8 and none at the bottom of chases 6 and 7. The upper stack restrainers softened and separated in chases 5 and 8. The unexposed side of chases 7, 5 and 8 are shown in figure 32 with the burned out holes visible in chase 7.
