# NATIONAL BUREAU OF STANDARDS REPORT

10 813

## FIRE ENDURANCE TESTS OF ALUMINUM BULKHEAD AND DECK ASSEMBLIES

SOCIETY OF NAVAL ARCHITECTS AND MARINE ENGINEERS

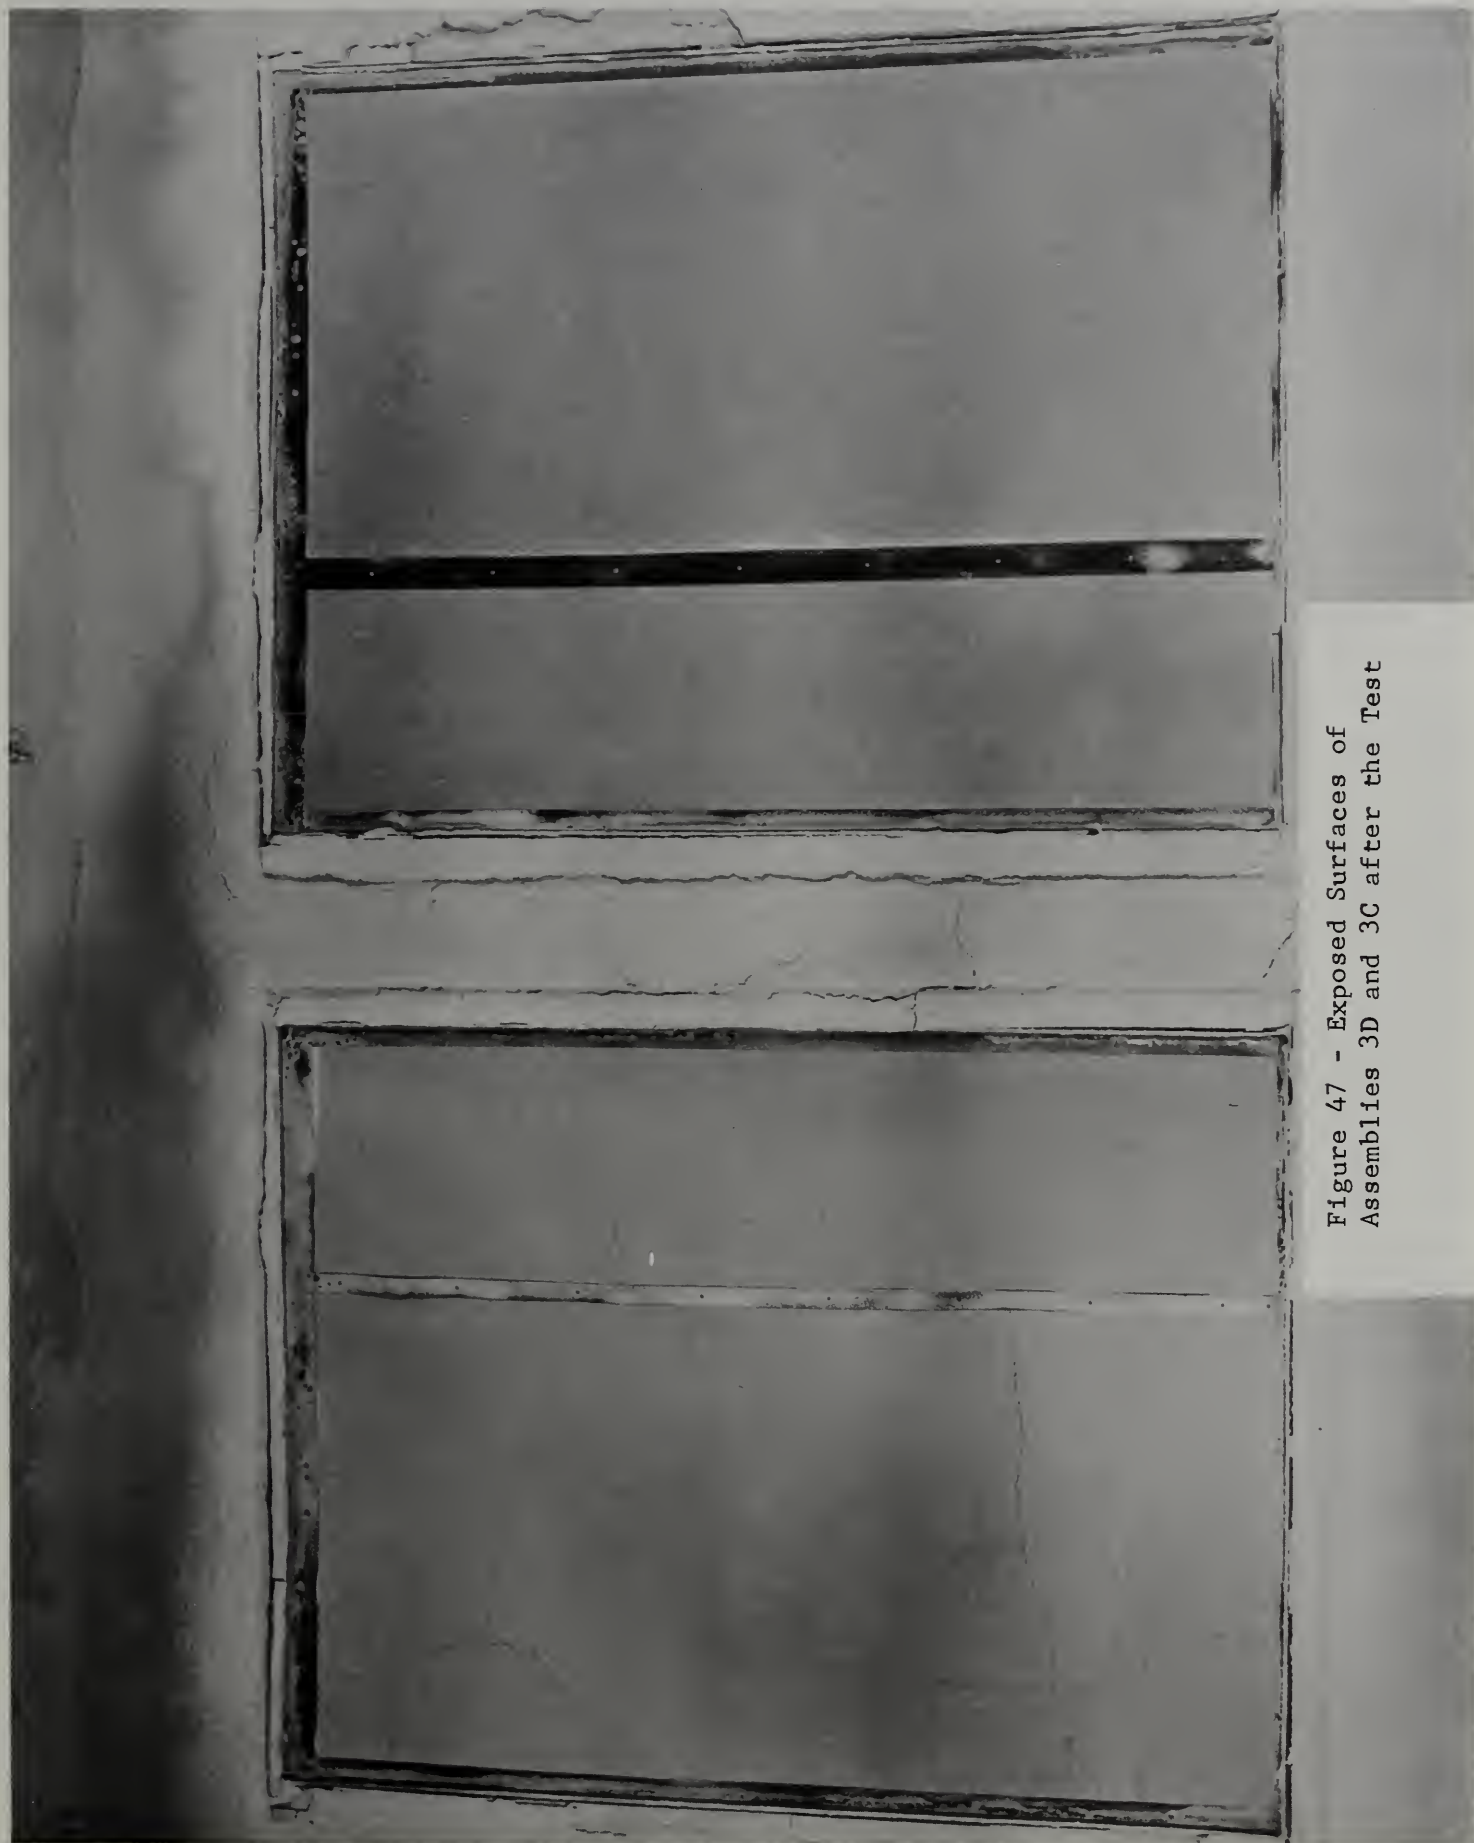
Figure 47 - Exposed Surfaces of  
Assemblies 3D and 3C after the Test

35 minutes	Bowing of aluminum frame from raceway at lower left corner of unexposed side of 3C. Panel 3D exposed side deformed. Light grey smoke escaping at the top of panel 3C.
38 minutes	Dull noise. Slight flaming at left hand edge of 3D.
42 1/2 minutes	Louder noise on 3C.
44 1/2 minutes	Louder noise from panel 3D.
50 minutes	Horizontal crack on Marinite on fire side of panel 3C approximately 1/3 height. Slight bowing at lower left of unexposed corner of 3D are similar to 3C at 35 minutes.
53 minutes	Aluminum retainer buckled out approximately 1/2 inch over a 4 inch length at upper left corner of 3C.
55 minutes	Slight bowing at lower right unexposed corner of 3C.
58 minutes	No ignition of cotton pads at upper left corner of 3C and 3D.

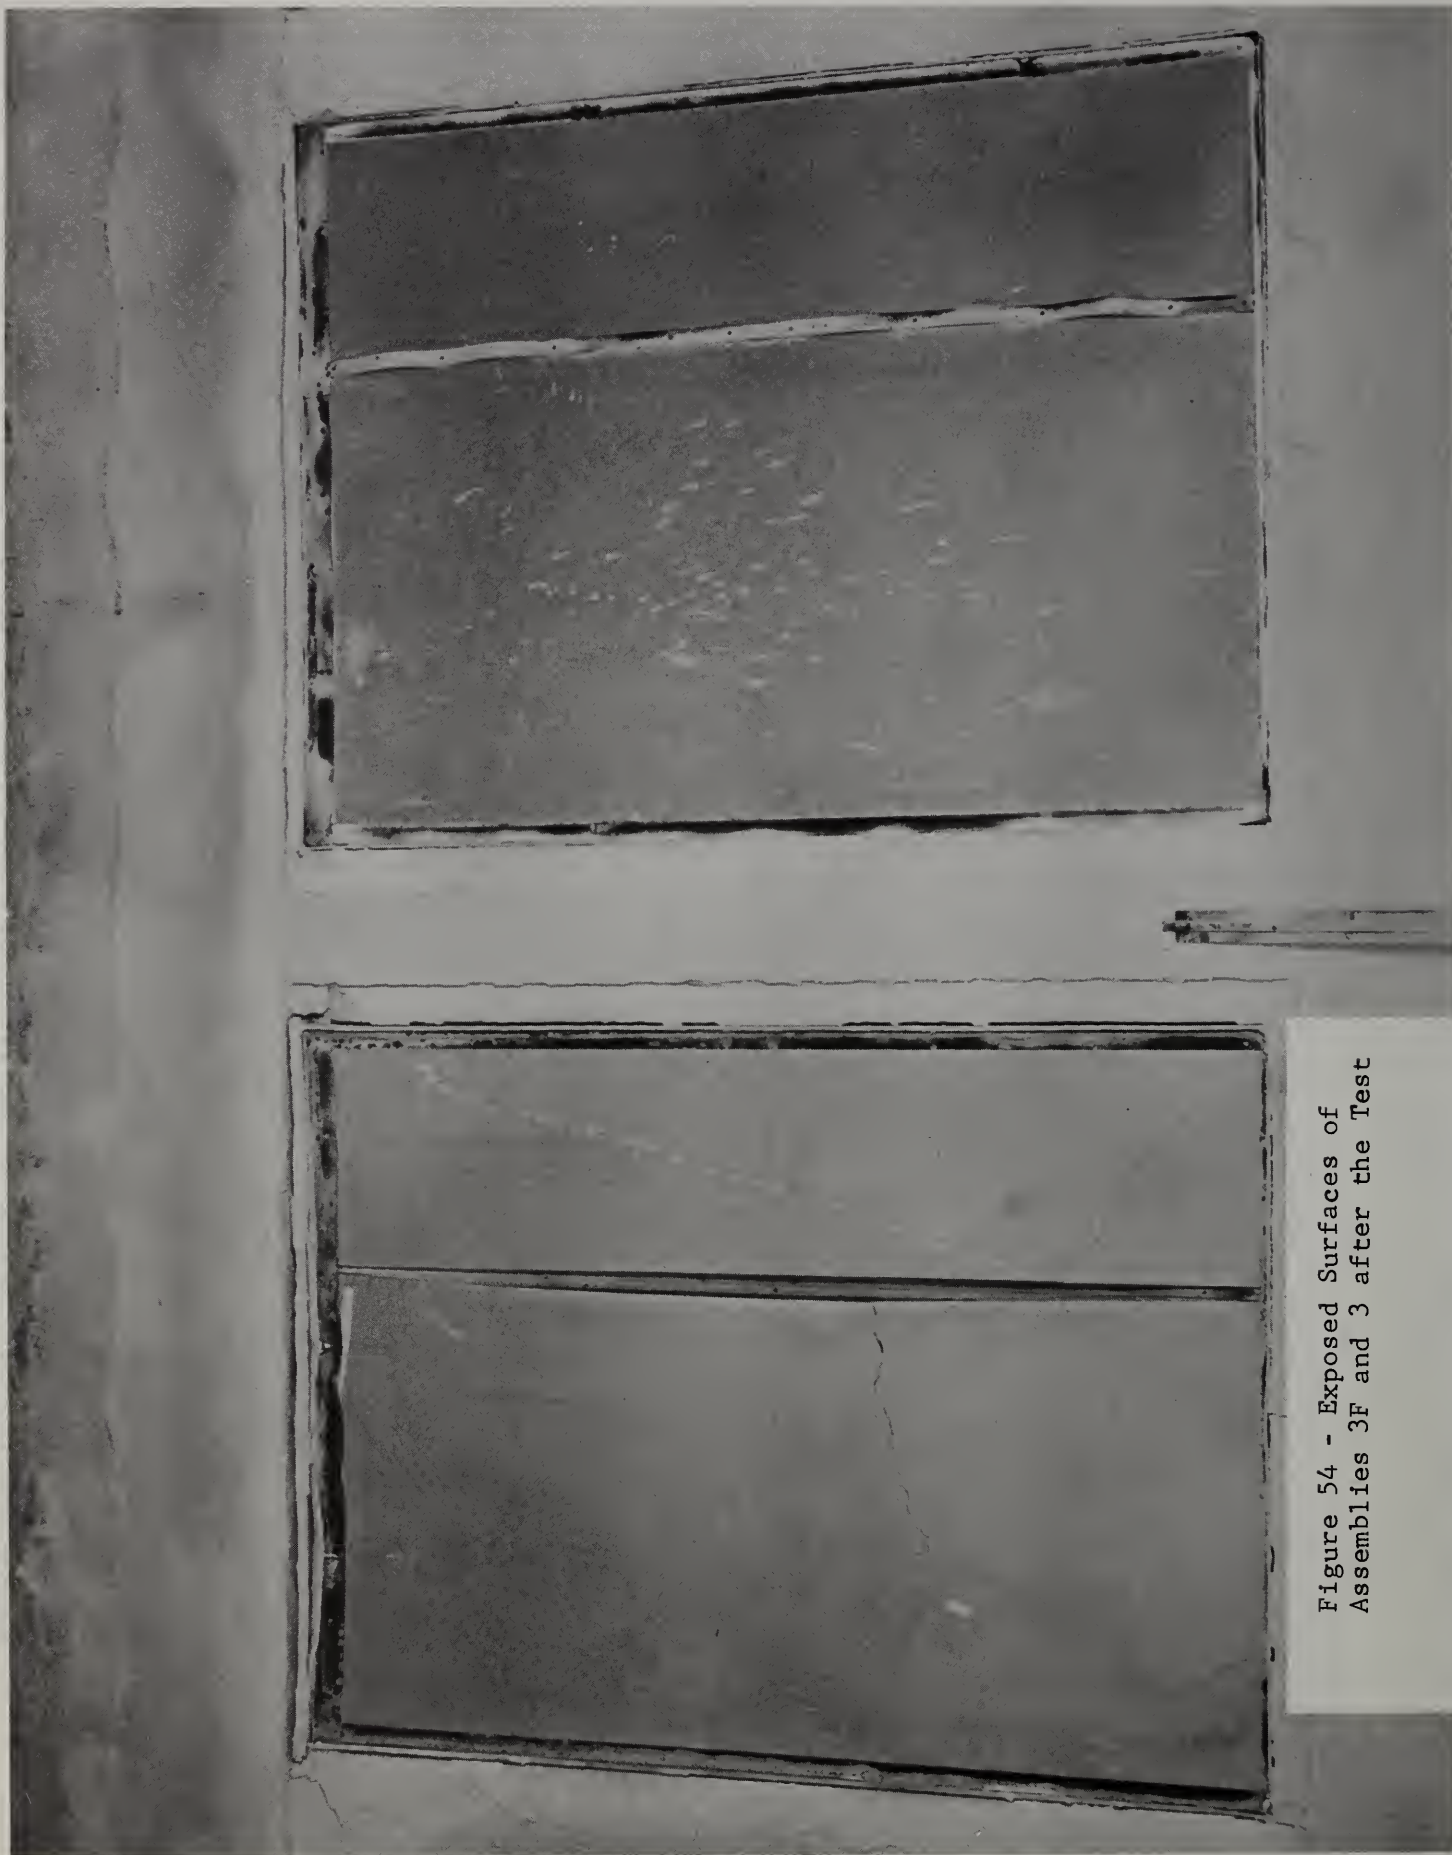
Figure 54 - Exposed Surfaces of  
Assemblies 3F and 3 after the Test

3 minutes	Buckling of exposed surface of 3F.
8 minutes	Paint burning on exposed side of H post on 3.
13 minutes	Exposed surface of 3 deflected away from the furnace. H post separated from the wall at the bottom of the exposed surface.
25 minutes	Exposed section of the H post on 3 fell into the furnace.
50 minutes	Smoke escaping around H post at the top of the unexposed surface of 3.

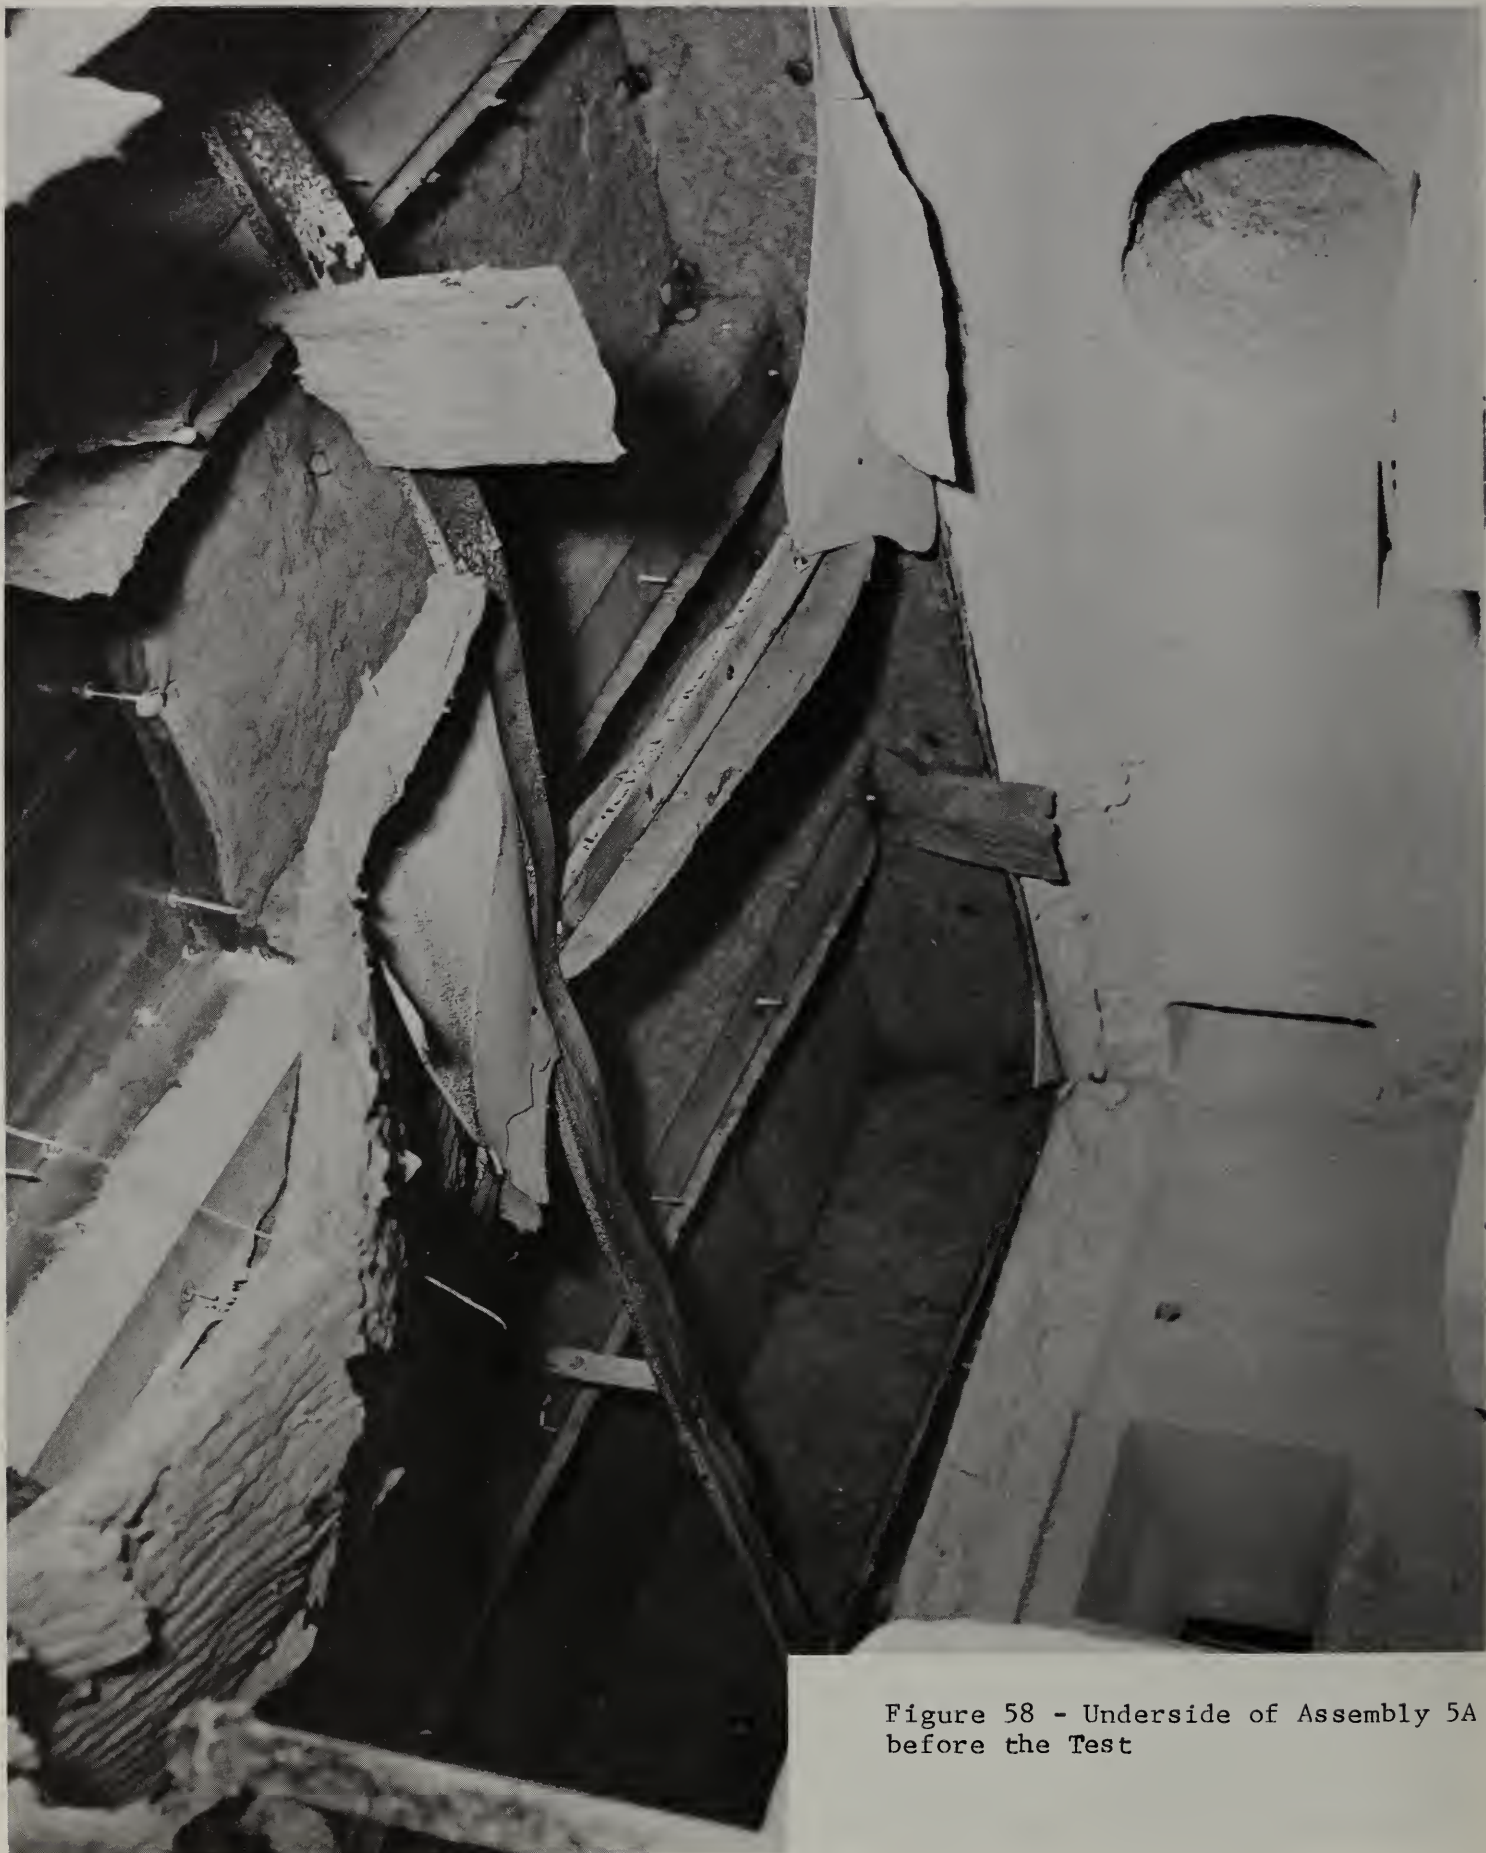
Figure 58 - Underside of Assembly 5A  
before the Test

The deck assemblies tested had both surface temperature and core temperature failures within one hour. Assembly 5A performed better than 5B1 in spite of the delamination of the asbestos cement board panel and the subsequent loss of insulation due to the melting of the aluminum speed clips and pins. Core failure occurred in 56 minutes with the 3/16 inch panels. By 28 minutes the breakup of the panels allowed hot flame gases to contact the mineral wool insulation. After a delay in passing through 2 inches of insulation the additional heat caused the core temperature to start rising rapidly at about 37 minutes, as seen in Figure 35. The even faster rate of temperature rise observed in this figure after 56 minutes was caused by direct exposure of the aluminum plate to the fire following the falling off of the insulation. The first visual report of aluminum plate exposure occurred at 52 minutes. If the panel had remained intact, the assembly might have met the requirements of Class A-30 and possibly Class A-60 as well.

4. Neither of the decks tested qualified for a Class A rating because core temperature failures occurred within 60 minutes. Delamination of the marine veneer early in the test (starting at 23 minutes) was responsible for the failure of Assembly 5A.
