FIELD MEASUREMENT OF HCl CONCENTRATION
FROM
PVC ELECTRICAL CONDUIT INVOLVED IN FIRE

SINGLE STORY HOUSE

6 June 1972

February 4, 1972

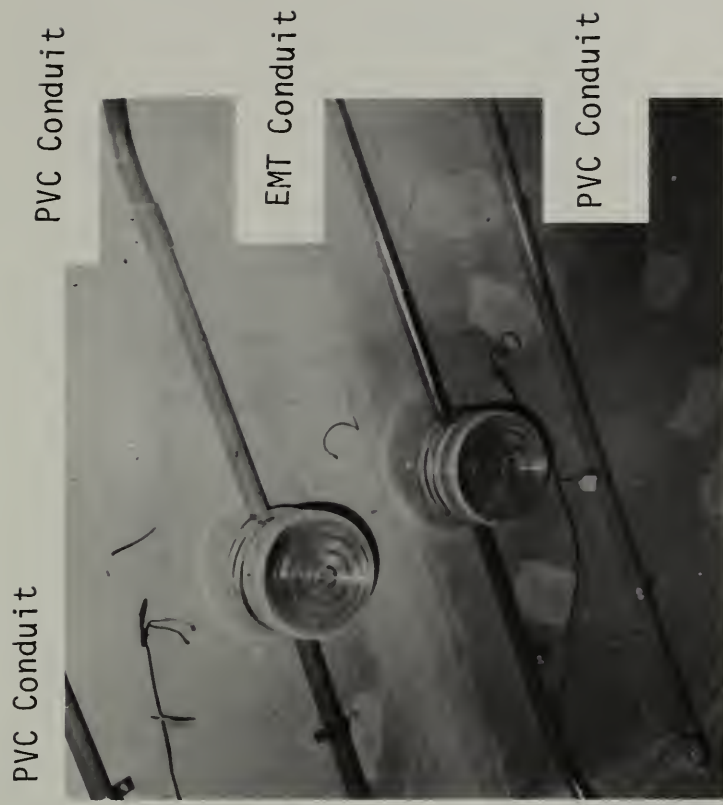
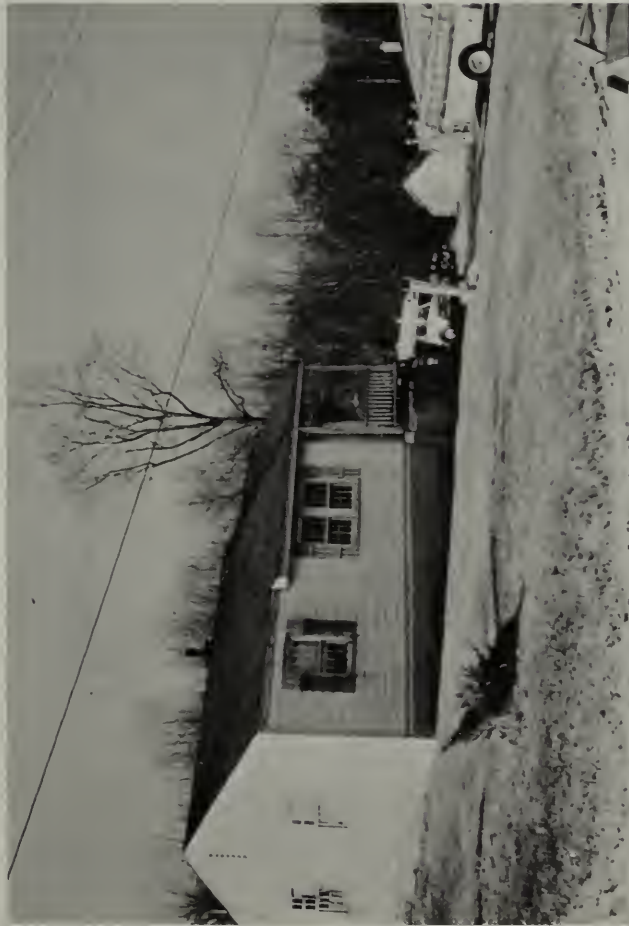
Fig. 1 Photograph of Test House (front, Room B and D) and Ceiling of Fire Room

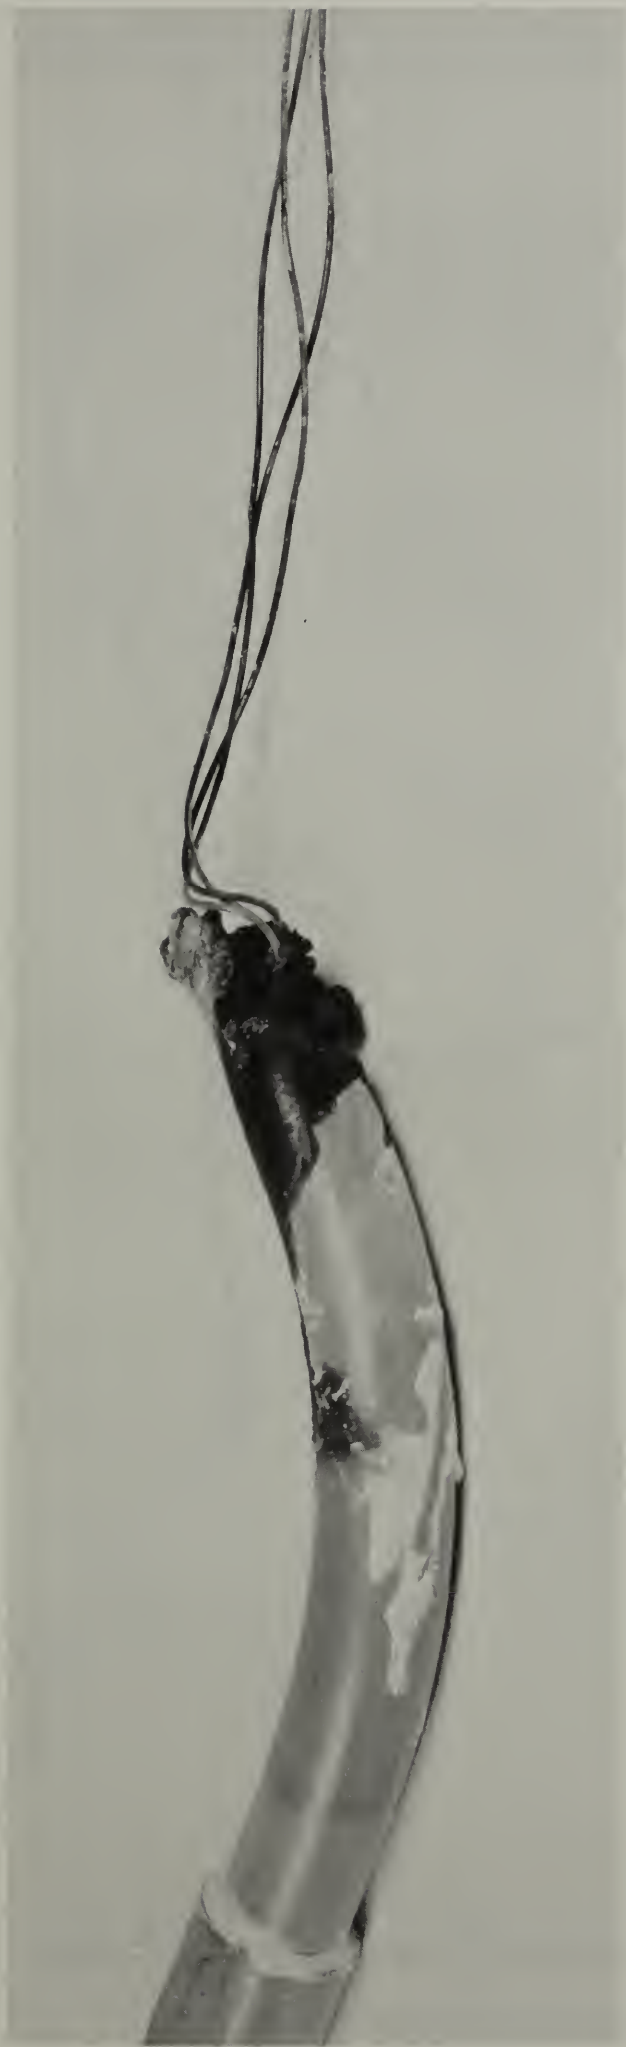
Because of the intensity of the fire in the fire room, practically all PVC conduit and wire insulation was decomposed leaving only a small amount of charred residue and bare copper wire. The maximum temperature reached was 850°C. The copper wire (melting point about 1100°C) did not melt. Where the conduit pierced a wall into another room, the charred residue from the thermoplastic conduit and internal wiring effectively blocked most of the smoke and gas movement through the conduit. The conduit in the adjoining rooms was almost unaffected with no signs of softening or charring. The detail of this is shown in Figure 5.

Fig. 5 PVC Conduit at Intersection of the Wall Between Room A and the Fire Room
(Note charred residue and complete decomposition of conduit and insulation
at the burned end. Some wires were removed)

3. The expansion and charring (intumescent) nature of PVC electrical conduit may serve to seal the interior conduit openings against extensive HCl penetration of an otherwise sealed wall. Sealing of the wall opening around the exterior of the conduit with noncombustible material is important.
4. The maximum HCl measured in two rooms with PVC conduits represents only about 0.4% of the potential HCl from burned conduit systems assuming no losses.
5. Information on the CO and O₂ concentrations in the adjacent rooms is missing due to an equipment malfunction at the start of the test.
6. Because of blockage from charred section, and the deposition of vapors in passing through 10 foot section of PVC conduit, the HCl concentration level from the PVC conduit source was of the same order of magnitude as that from the EMT source. Both generating sources were 7.3 feet in length.
