NATIONAL BUREAU OF STANDARDS REPORT

**Evaluation of Flooring Materials
in Army Installations**

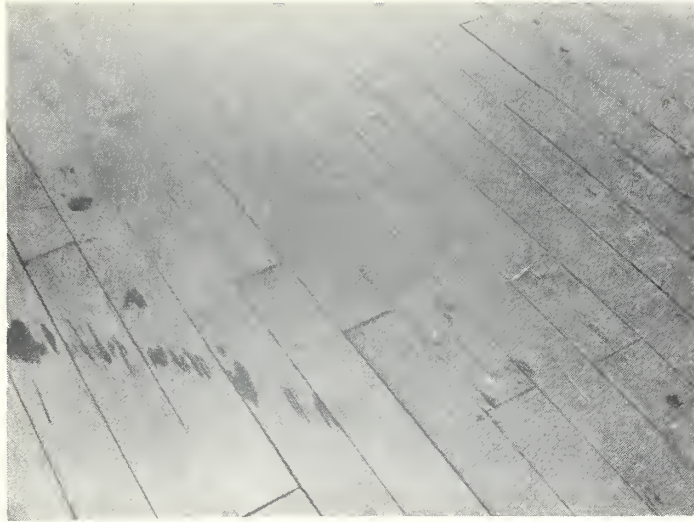
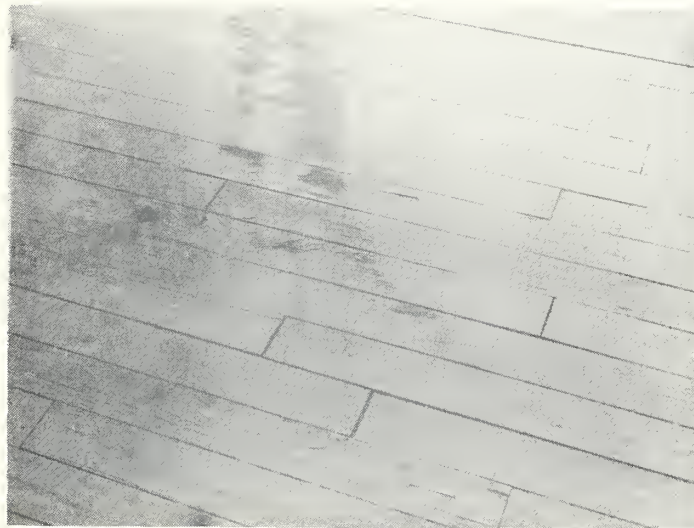
Figure 1. Typical mobilization-type barracks floor with 25/32-in., tongued-and-grooved, flat-grained pine having a 3 1/4-in. face. The flooring was laid over 1-in., diagonally-placed boards. Note splintered segments torn out, and wide cracks between strips and end joints.

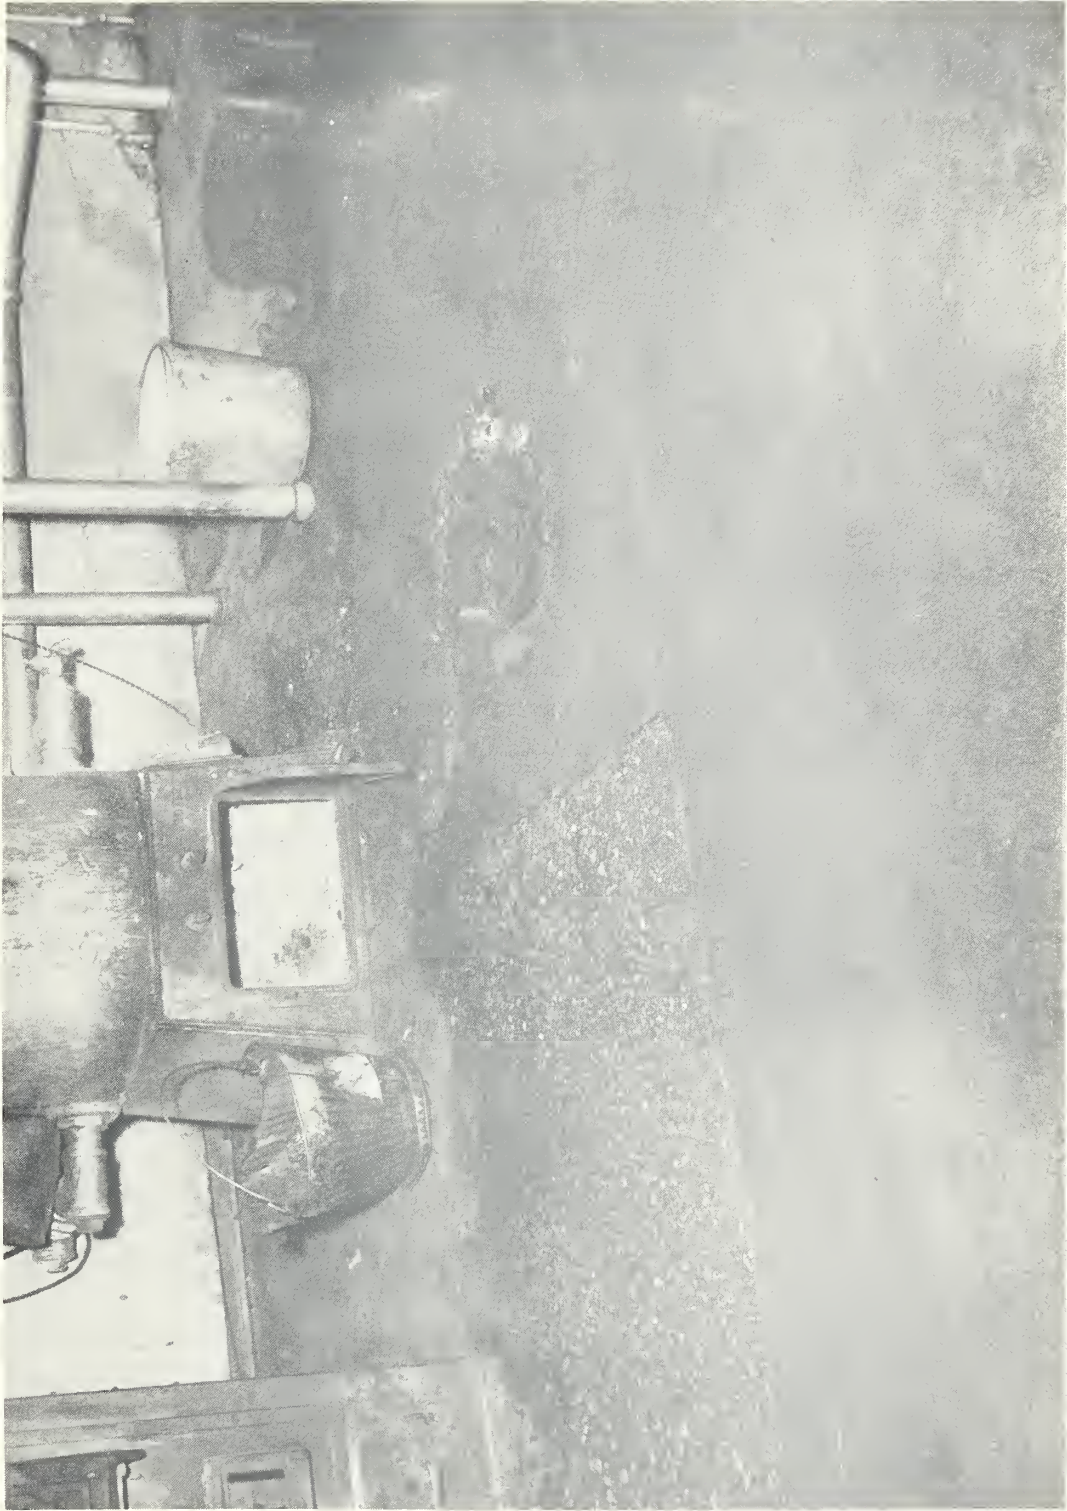
Figure 2. Concrete floor, 1-1/2 in. thick, eight years old, over typical, original wood floor in company-type kitchen. Note exposure of aggregate, structural cracks and damage around drain.

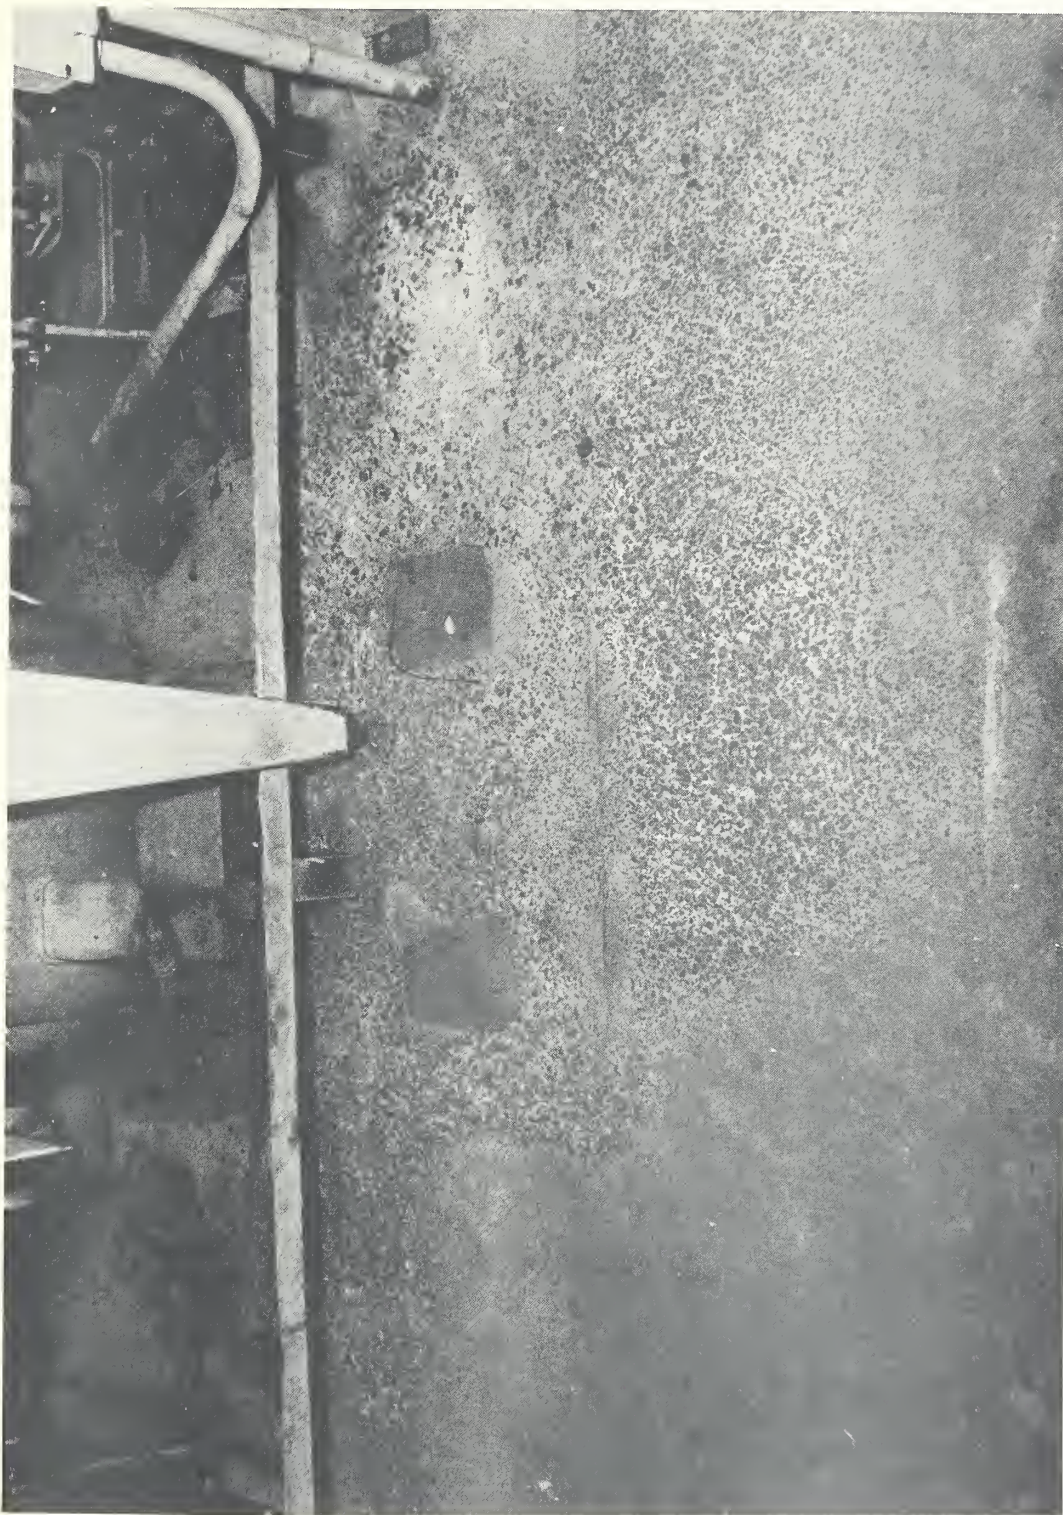
Figure 3. Magnesium oxychloride floor, two years old, over concrete in kitchen. Note disintegration caused by water from dishwasher.

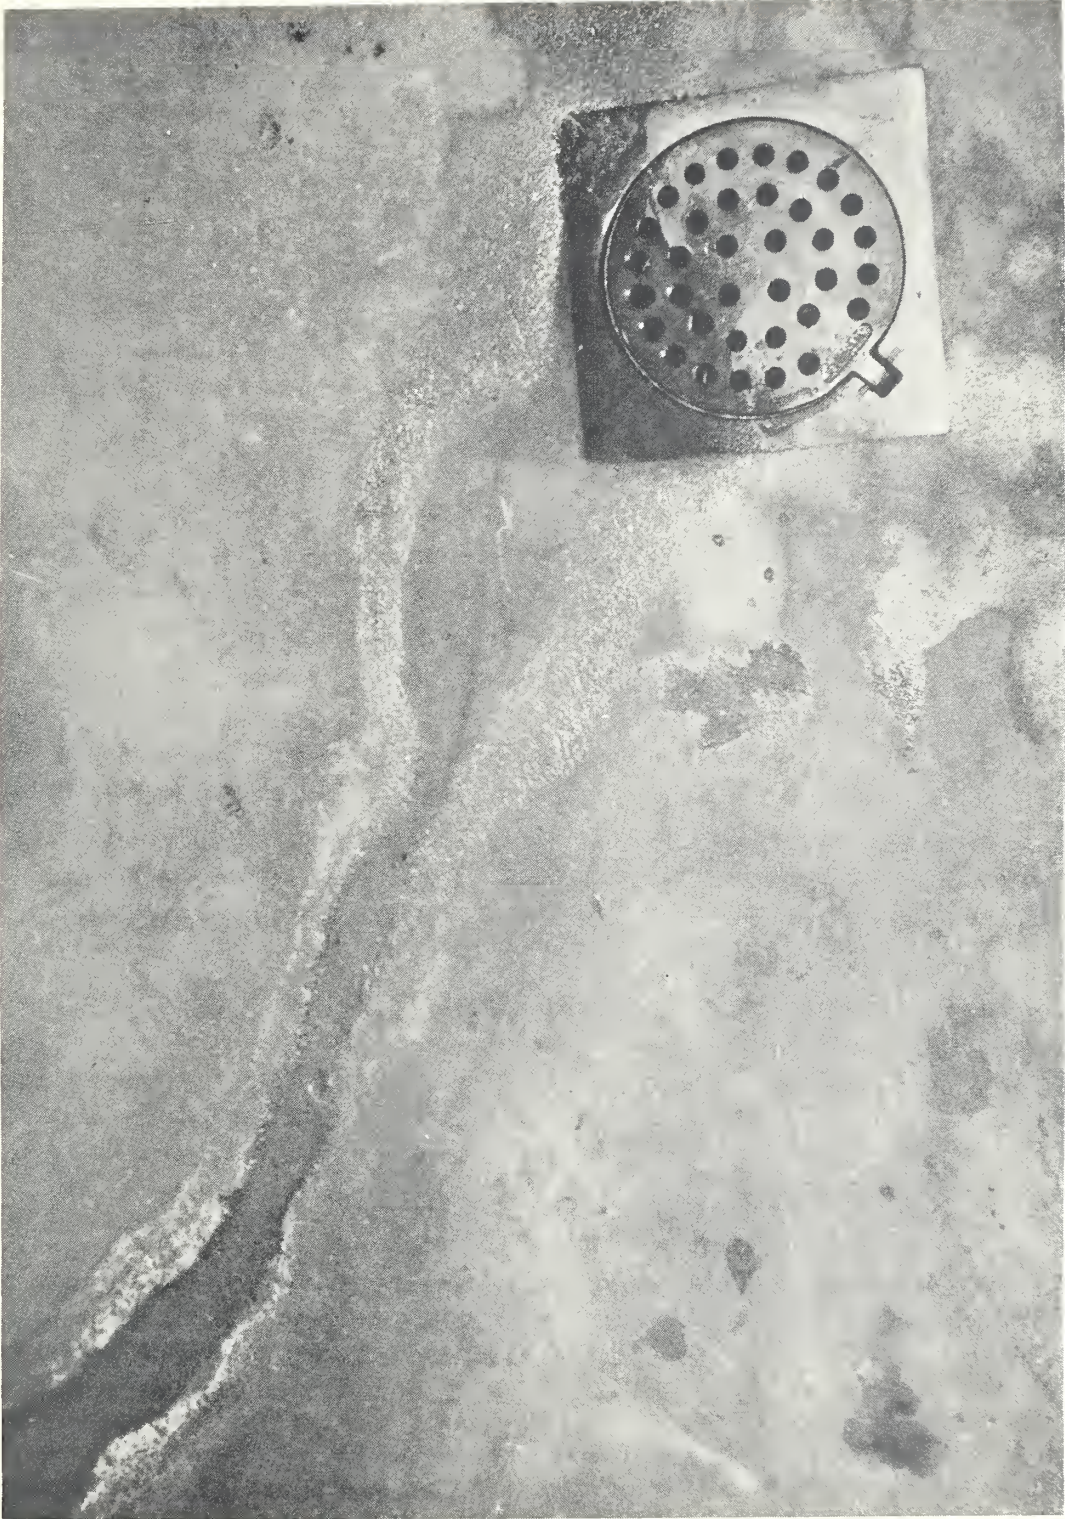
Figure 4. Magnesium oxychloride floor, one month old, in kitchen of company-type mess hall. Note eroded channel caused by drain from refrigerator.

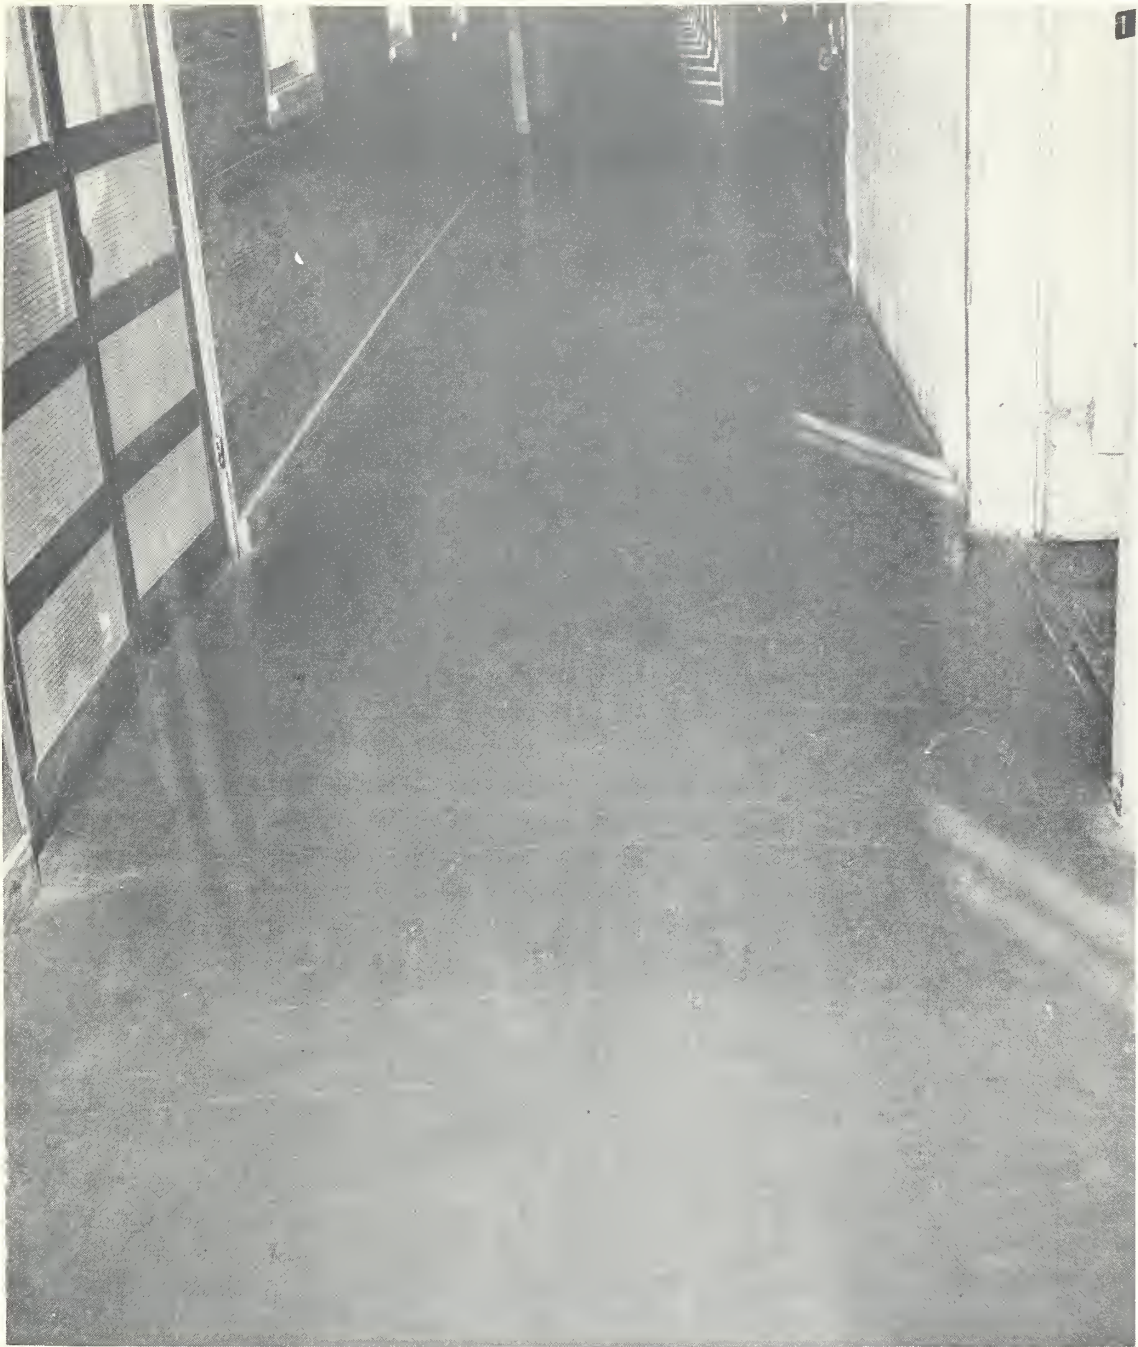
Figure 5. Magnesium oxychloride floor, one year old, in hospital corridor. Note numerous cracks running across corridor, apparently caused by structural movement of wood subfloor.

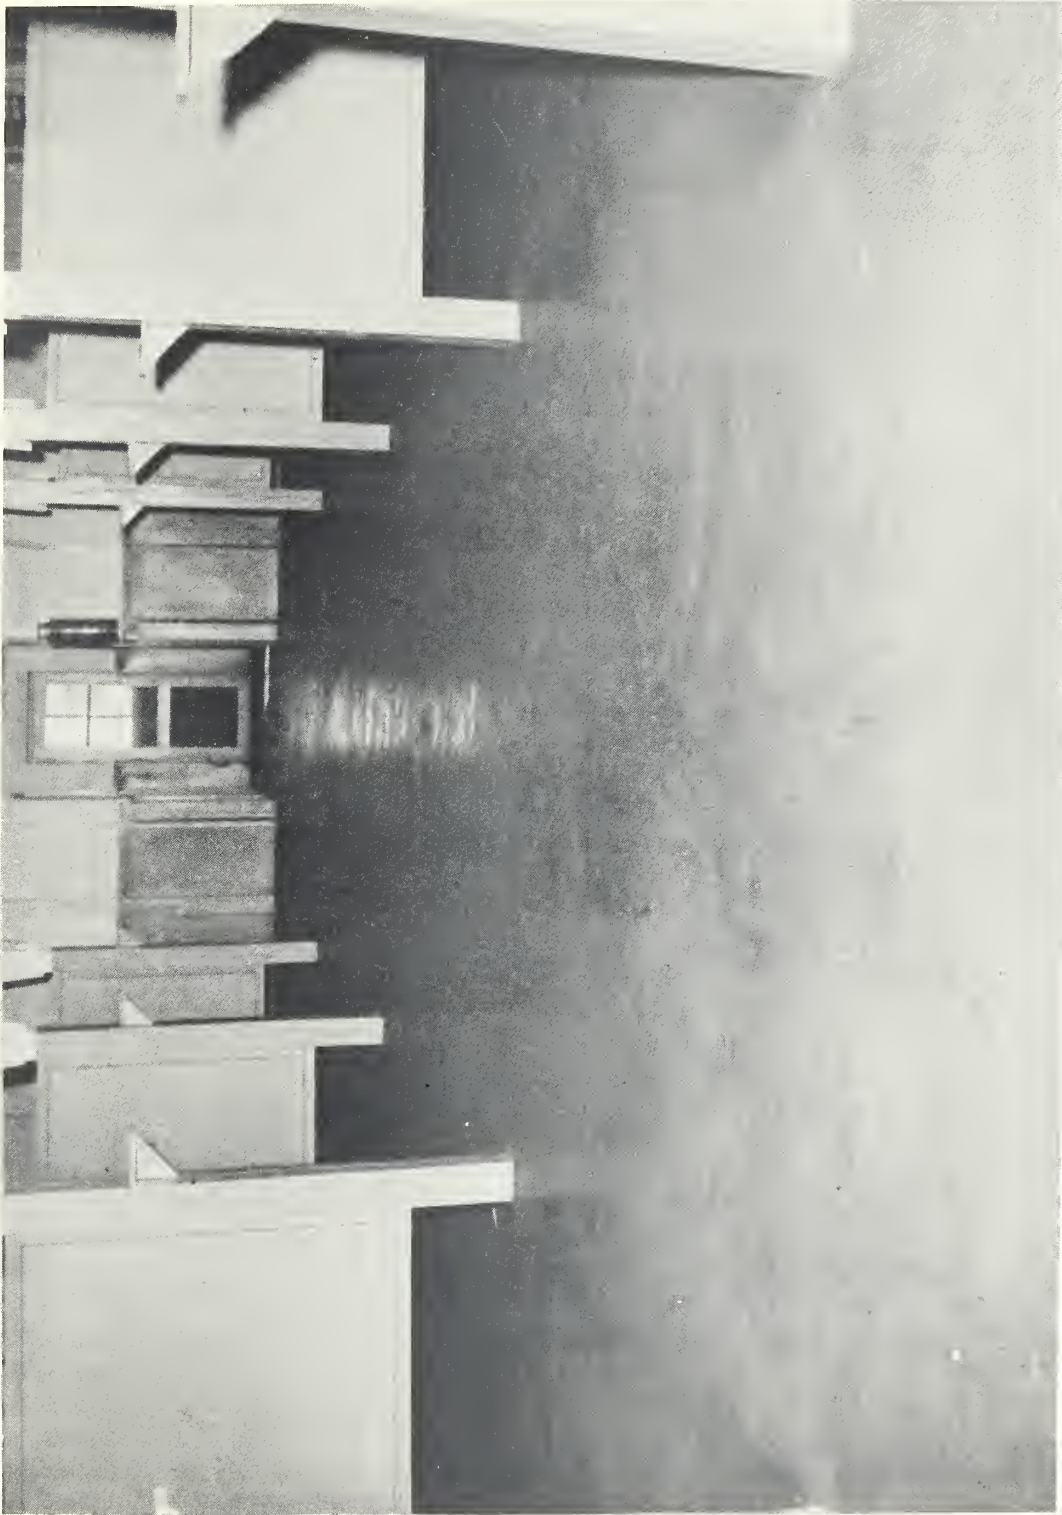
Figure 6. Magnesium oxychloride floor, 5/8-in. thick, one year old, laid over wood in a mobilization-type barracks. Installation was made in accordance with recommended method.

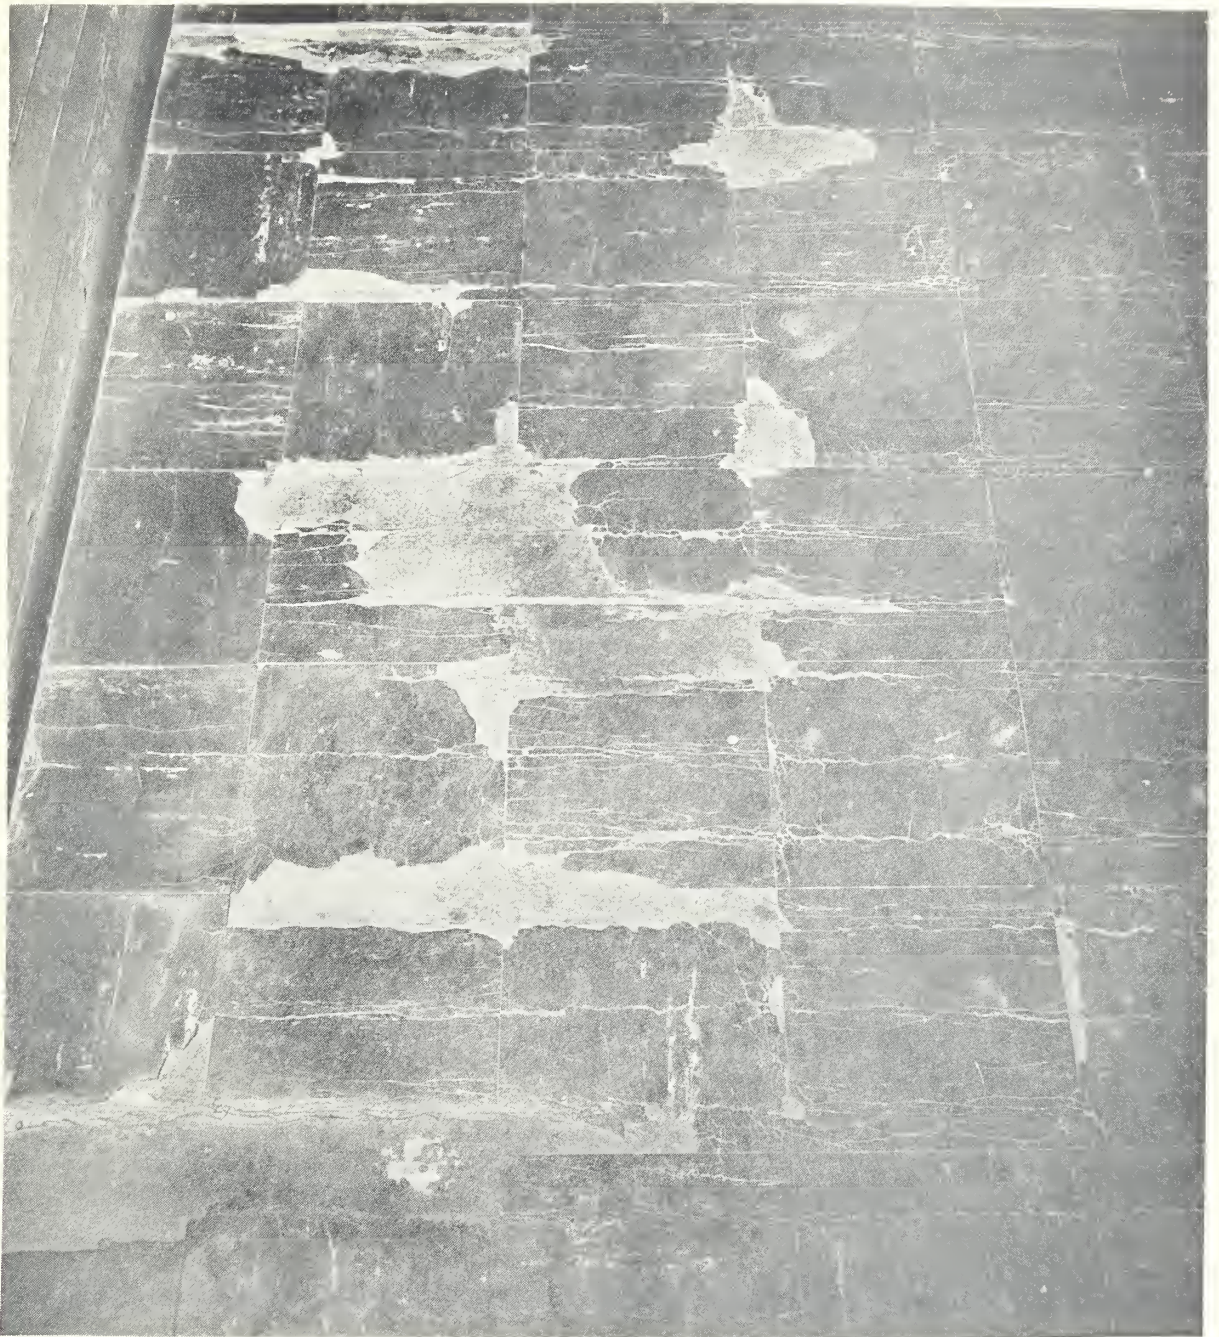
Figure 7. Asphalt tile, 1/8-in. thick, four years old, laid over a strip-pine floor with a 15-lb, asphalt-saturated felt underlayment in a mobilization-type barracks. Note deterioration of tiles and numerous cracks running parallel to tongued-and-grooved, strip-pine flooring.

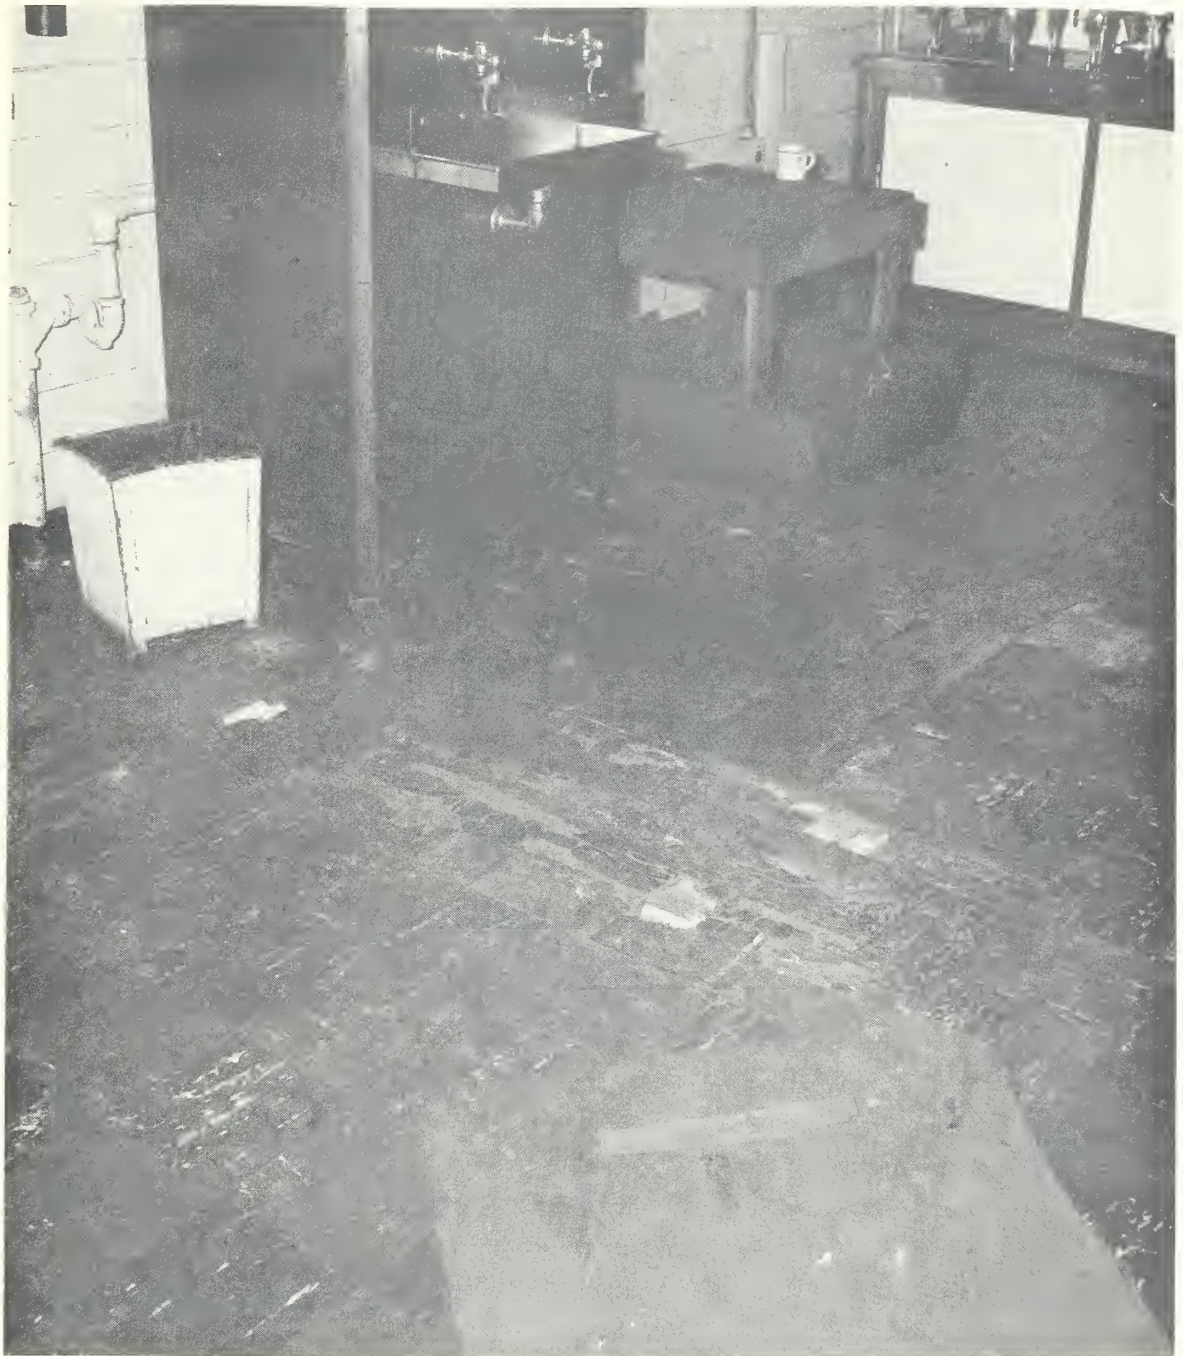
Figure 8. Asphalt tile, five years old, laid over 1/4-in. plywood adjacent to drinking fountain. Spillage of water has caused delamination of plywood and subsequent failure of asphalt tile.

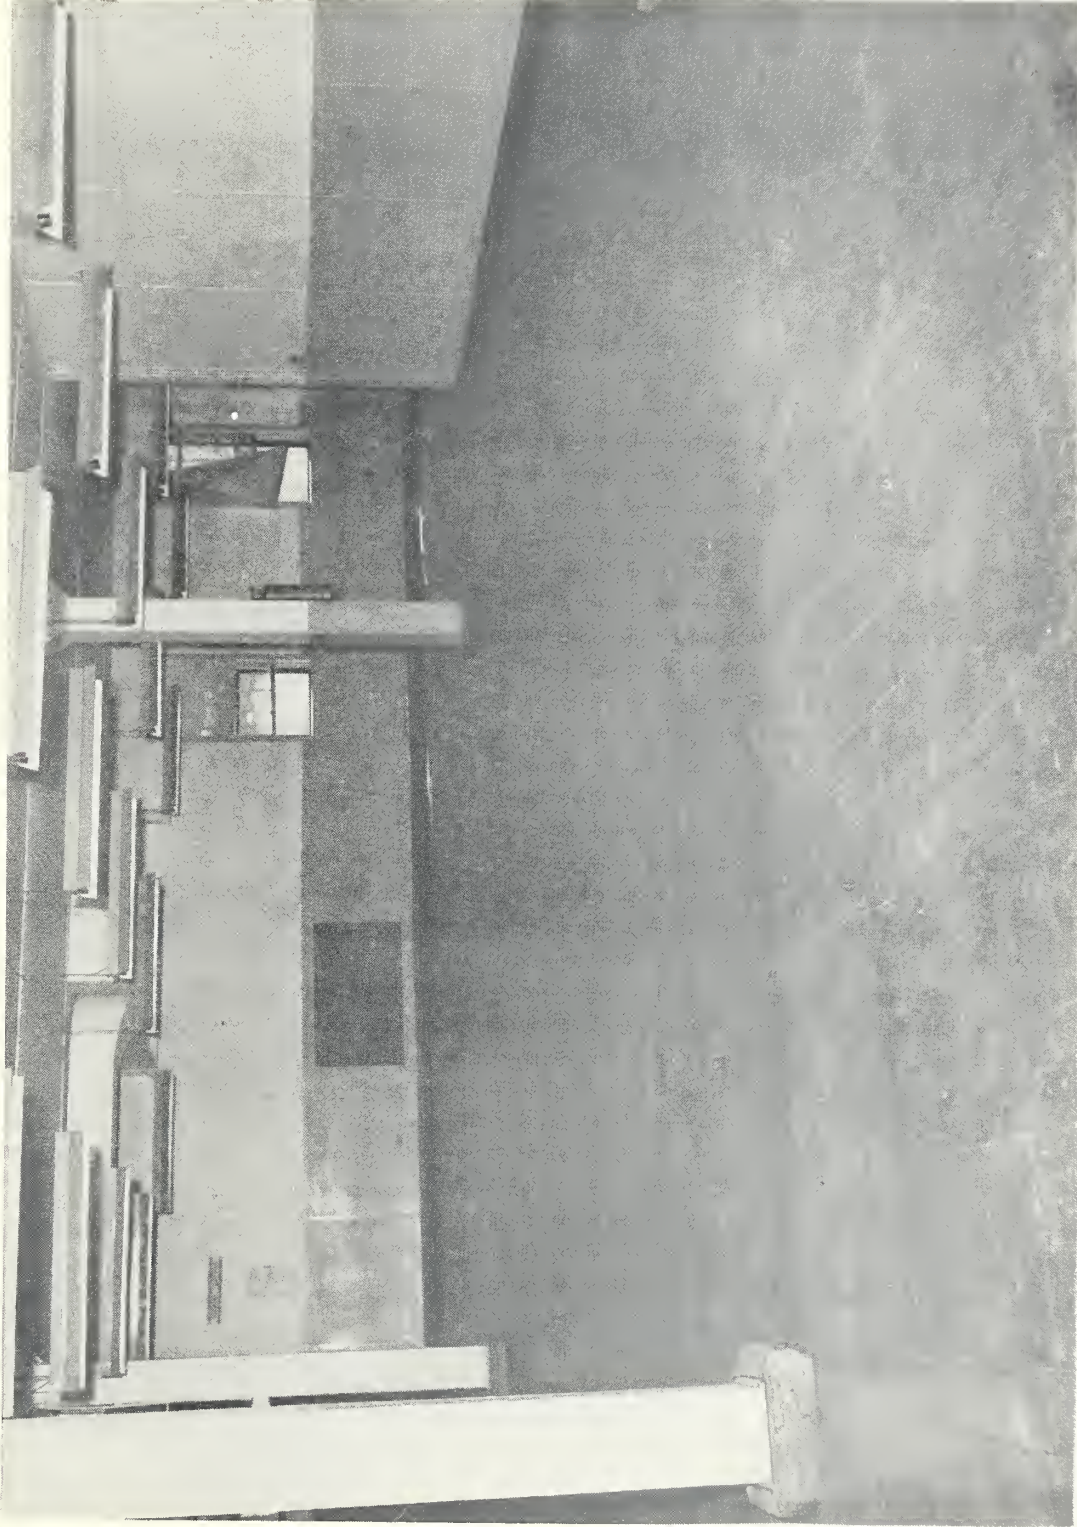
Figure 2. Asphalt tile, six years old, laid over concrete on grade in administration building. This floor was flooded twice by overflow of nearby stream, but still has excellent bond to concrete.

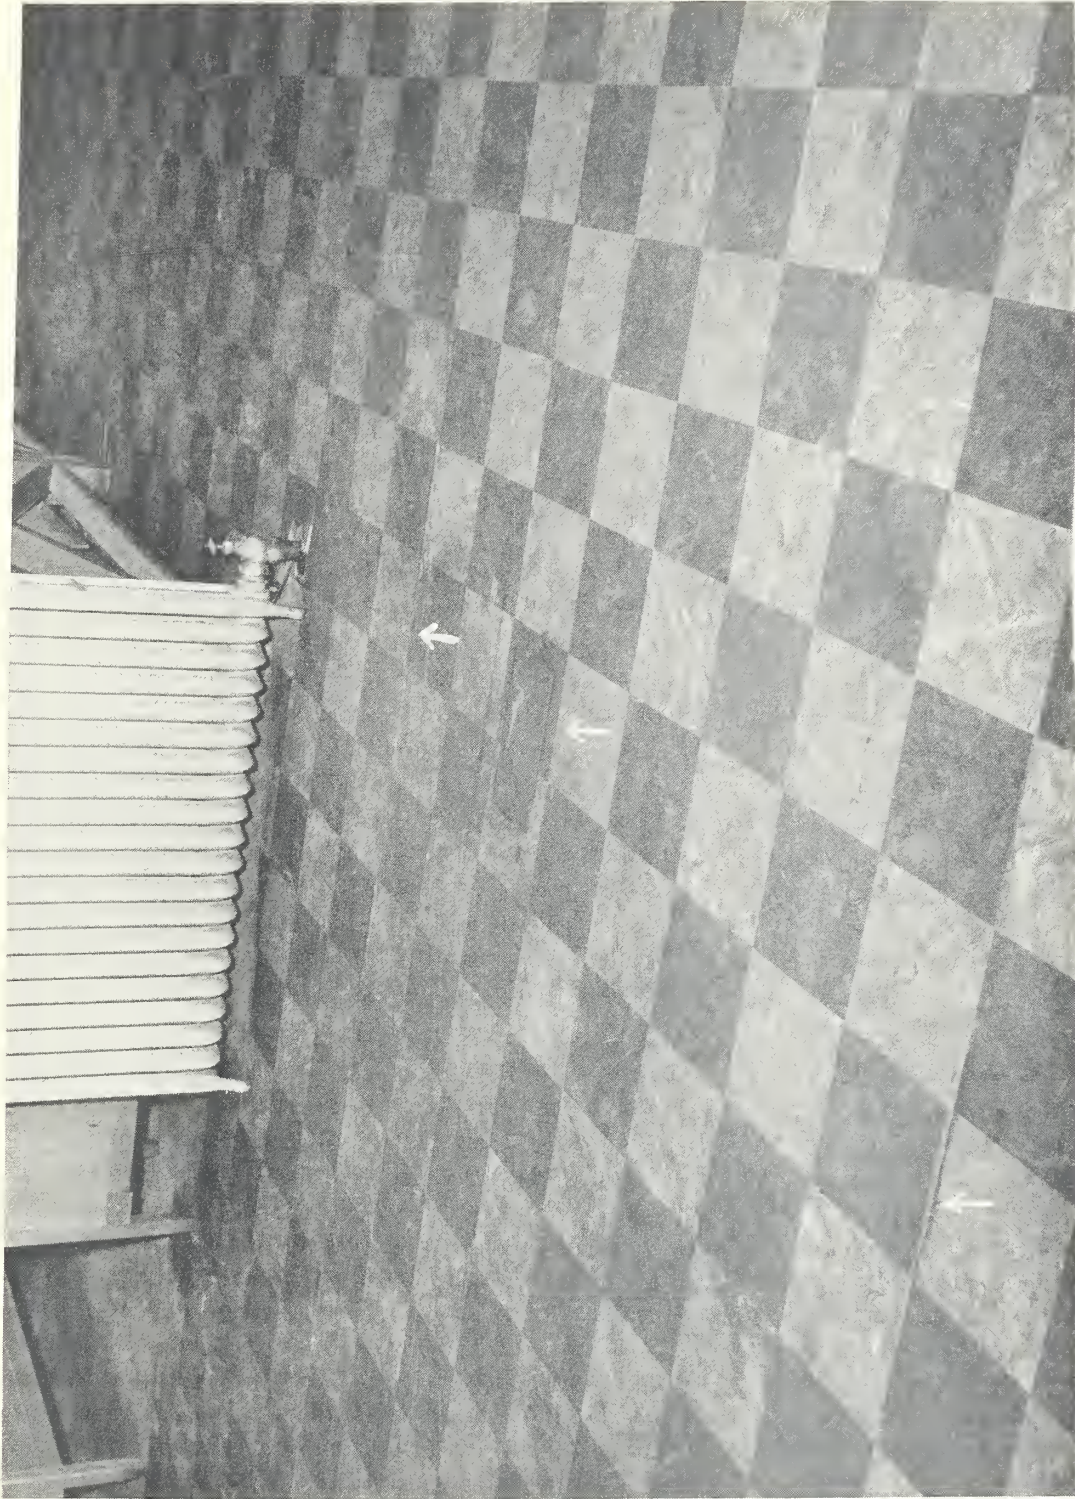
Figure 10. Linoleum, inlaid, sheet form, 1/8-in., build-
fourteen years old, laid in large administration build-
ing. Note failure at seams and patching.

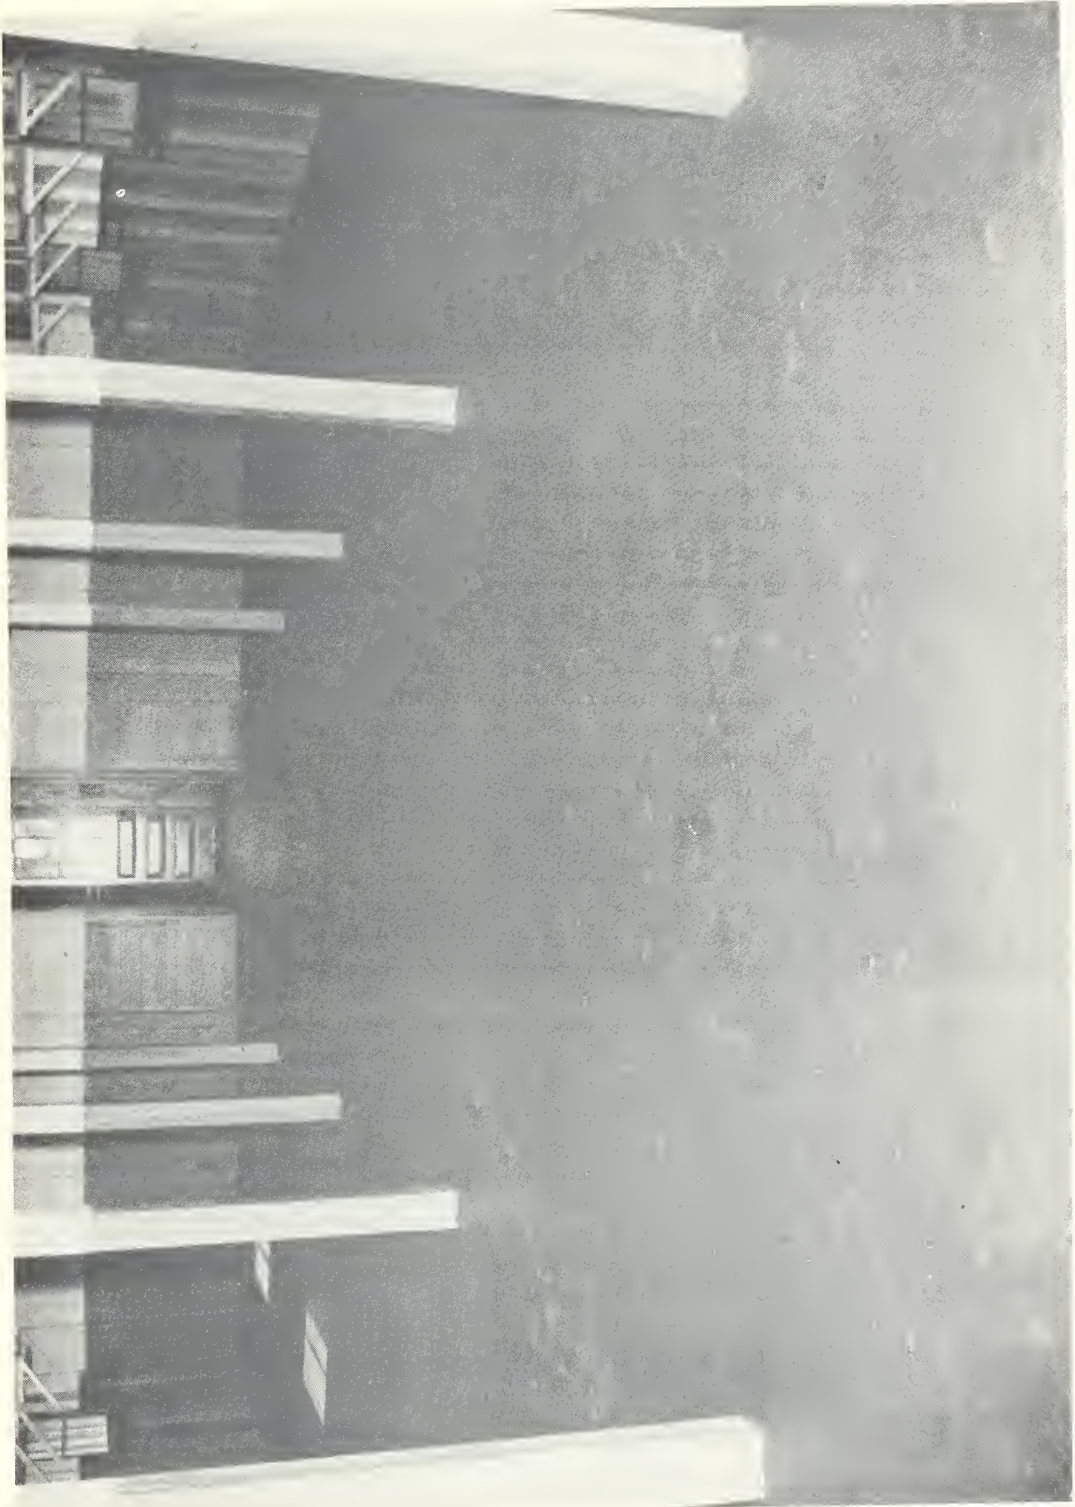
Figure 11. Linoleum, burlap-backed, 1/8-in., one year old, laid over sanded wood floor and felt underlayment.

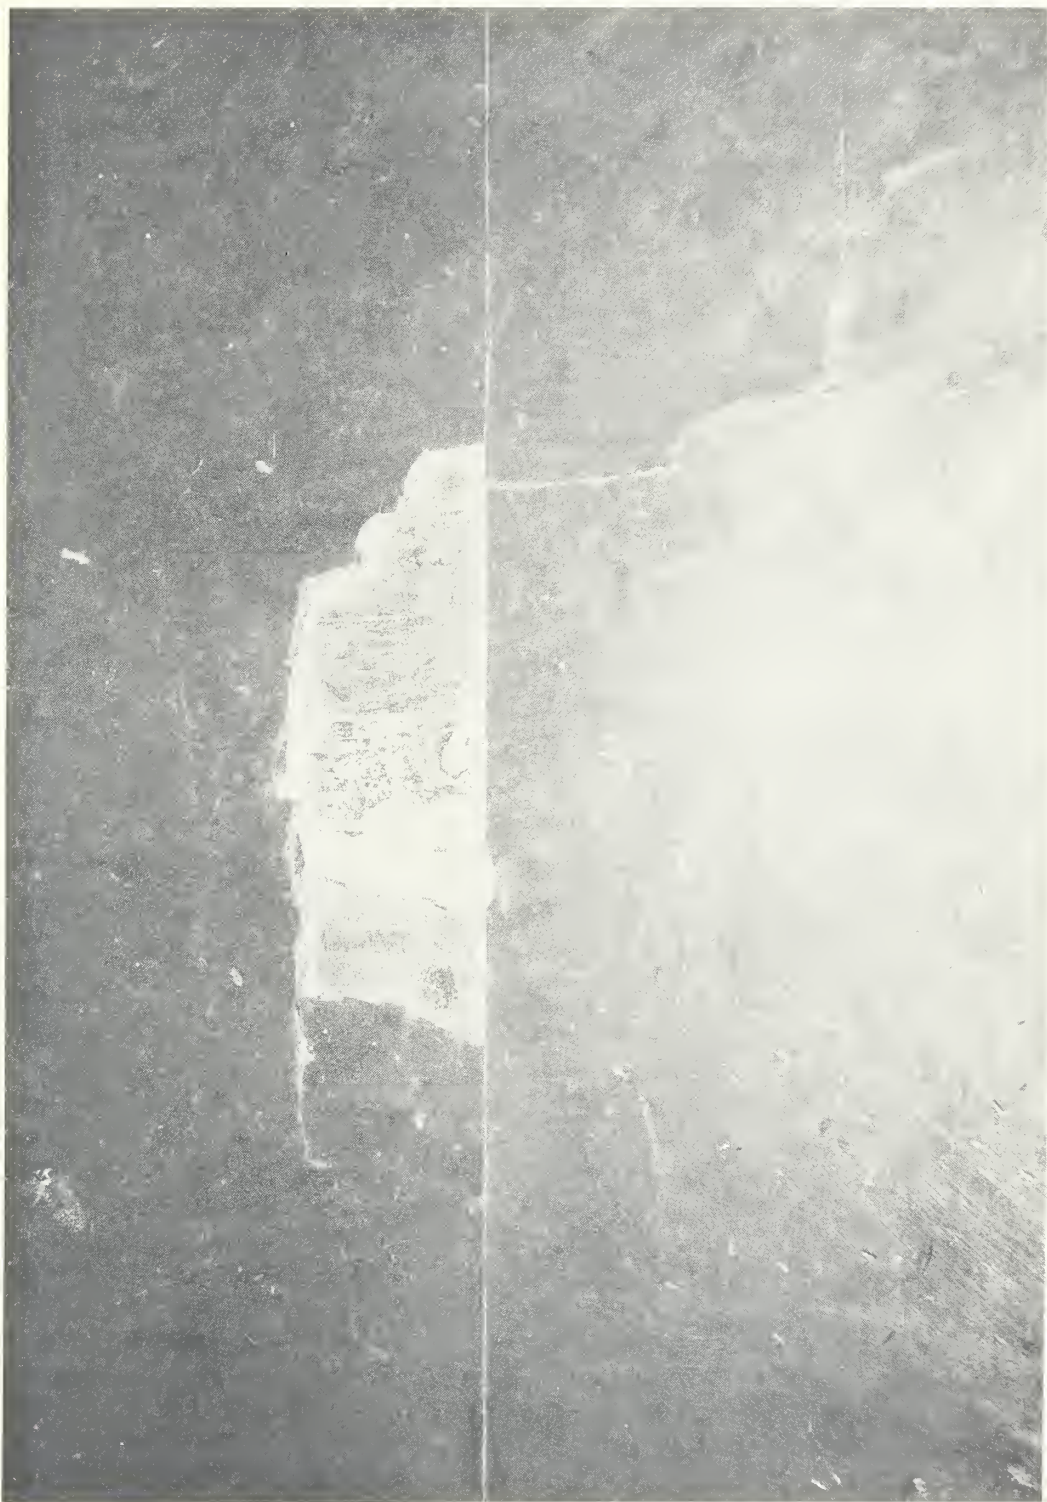
Figure 12. Felt-backed, pitch composition floor covering, one year old, laid over pine flooring in mobilization-type barracks. Note scars, seam failure and wear.

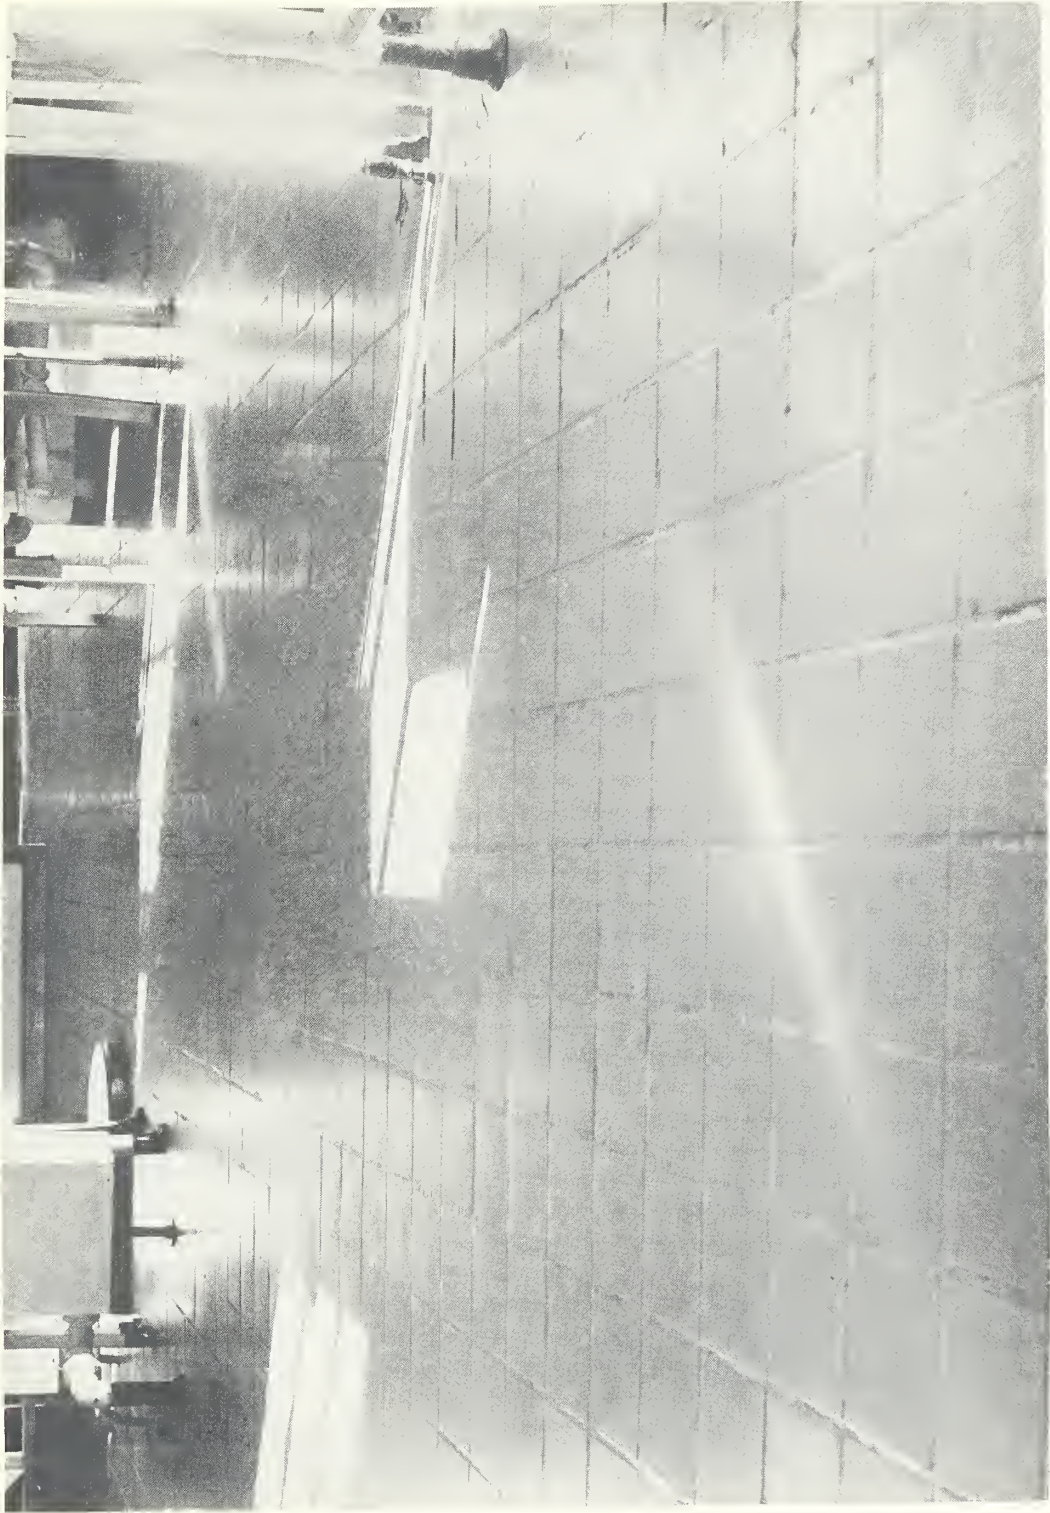
Figure 13. Quarry tile floor with acid-resistant mortar joints, thirteen years old, in permanent-type kitchen.
